Your Ref: TP/IP/50679/2019
Our Ref : CI/TPD19014930/N

18 September 2019

MECHANICAL INSPECTION REPORT OF MOTOR VAN GBF 5904D

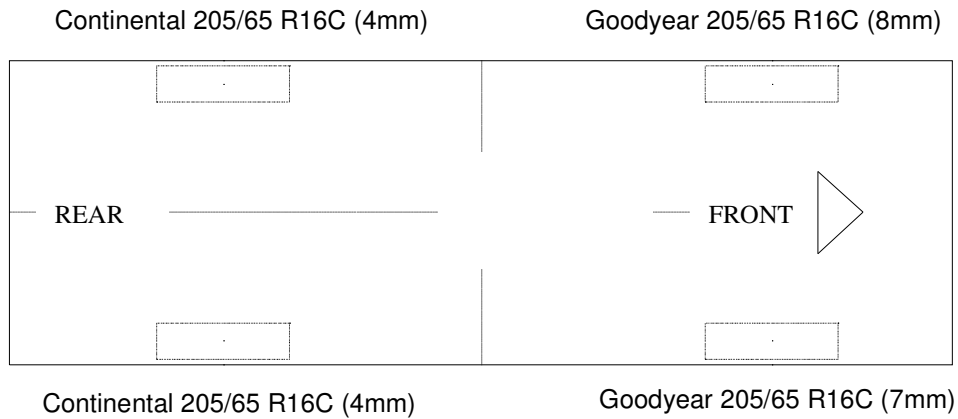
6. The 4 tyres were observed to be in serviceable condition and sufficiently inflated for vehicular operation. We did not find any tear, cut or burst mark(s) on the outer and the inner sidewalls as well as across the tread of the 4 tyres. The tyre brand, tyre size and remaining tread depth of the 4 tyres of the Motor Van were recorded as follows:-

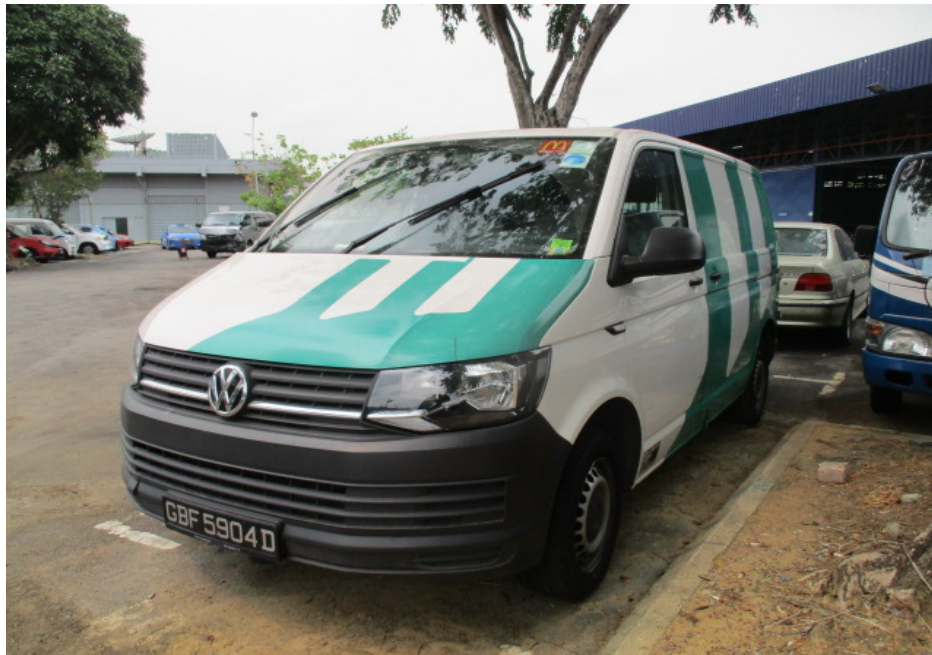
Photo 1 shows a general view of the front left body of the Motor Van at the time of our inspection. The Motor Van was observed to have sustained minimal impact damage that was confined to its frontal portion. The mileage of the Motor Van was recorded to be 88, 385km.

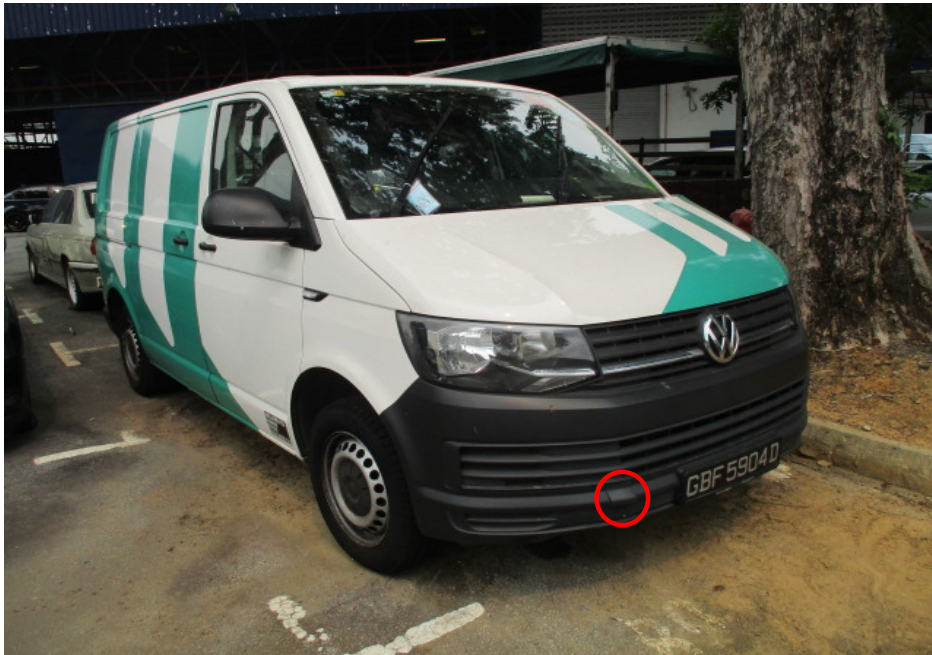
4. The mileage of the Motor Van at the time of our inspection was 88, 385km.
5. The Motor Van was observed to have sustained minimal impact damage at its frontal portion. Its front right tow hook cover as well as its front bumper was observed to be slightly dislodged as a result of the accident.

Photo 2 shows a general view of the front right body of the Motor Van at the time of our inspection. The Motor Van was observed to have sustained minimal impact damage that was confined to its frontal portion. Its front right tow hook cover (circled) as well as its front bumper was observed to be slightly dislodged as a result of the accident.

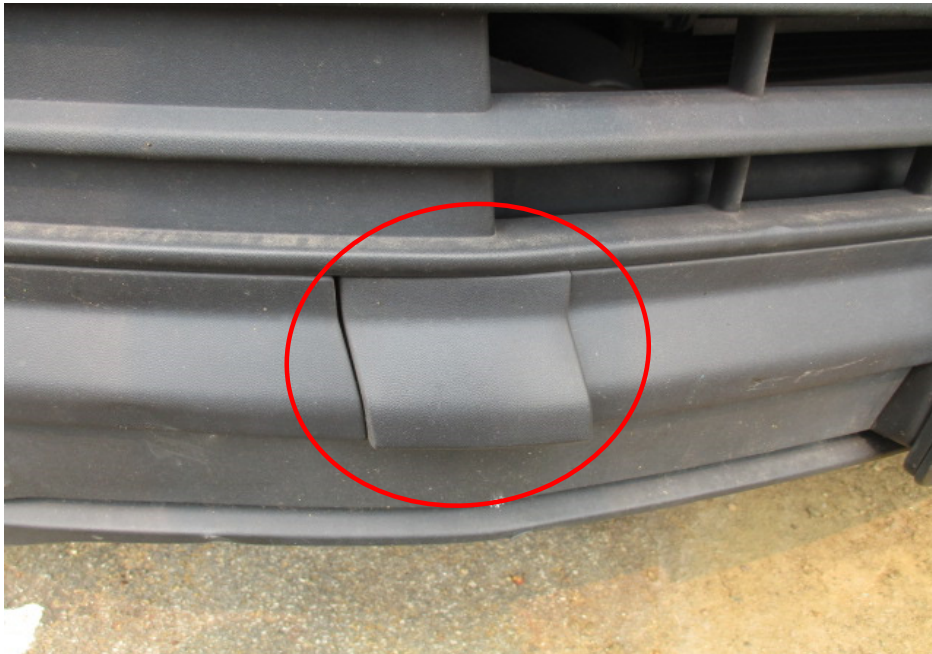
Photo 3 shows a close up view of the slightly dislodged front right tow hook cover (circled) of the Motor Van at the time of our inspection.

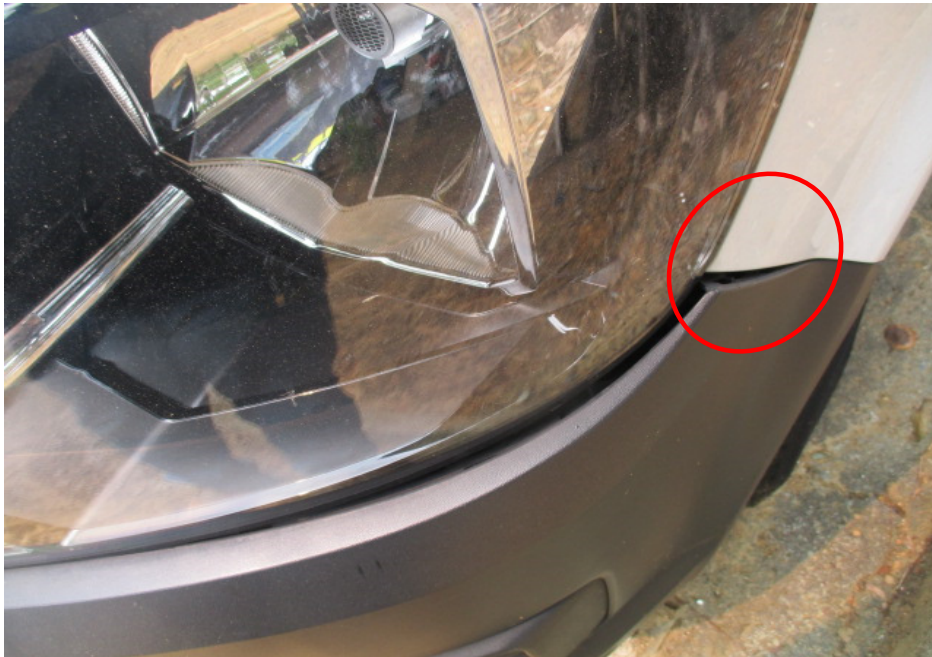
Photo 4 shows a close up view of the slightly dislodged front bumper (circled) of the Motor Van at the time of our inspection.

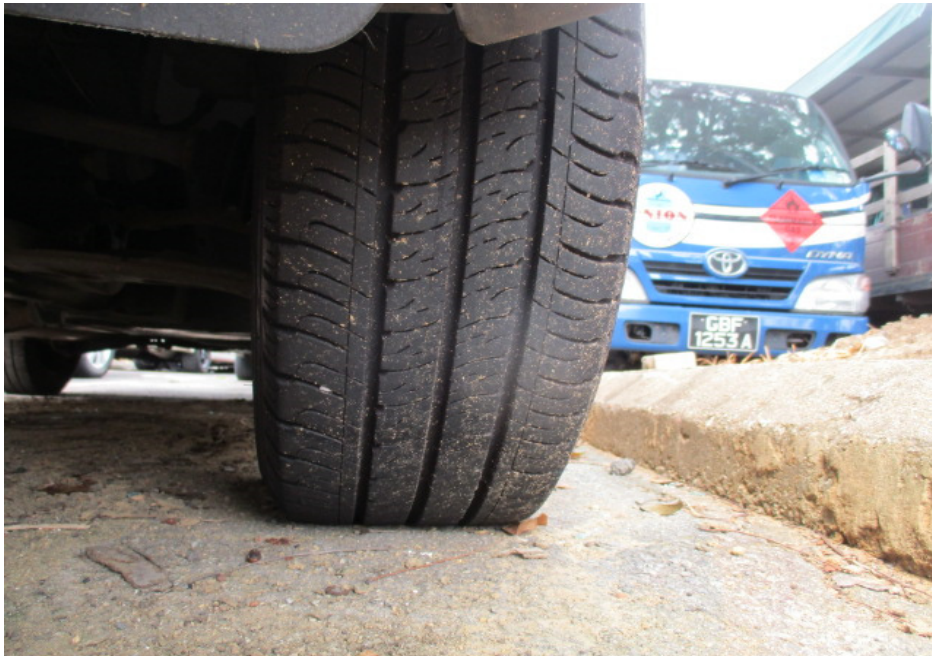
Photo 5 shows the condition of the front left tyre of the Motor Van, which was observed to be in serviceable condition with remaining tread depth of approximately 8mm. The tyre, which was wrapped around standard steel wheel rim, was also observed to be sufficiently inflated for vehicular operation. There was no tear, cut or burst mark(s) on the outer and the inner sidewalls as well as across the tread of the 4 tyres.

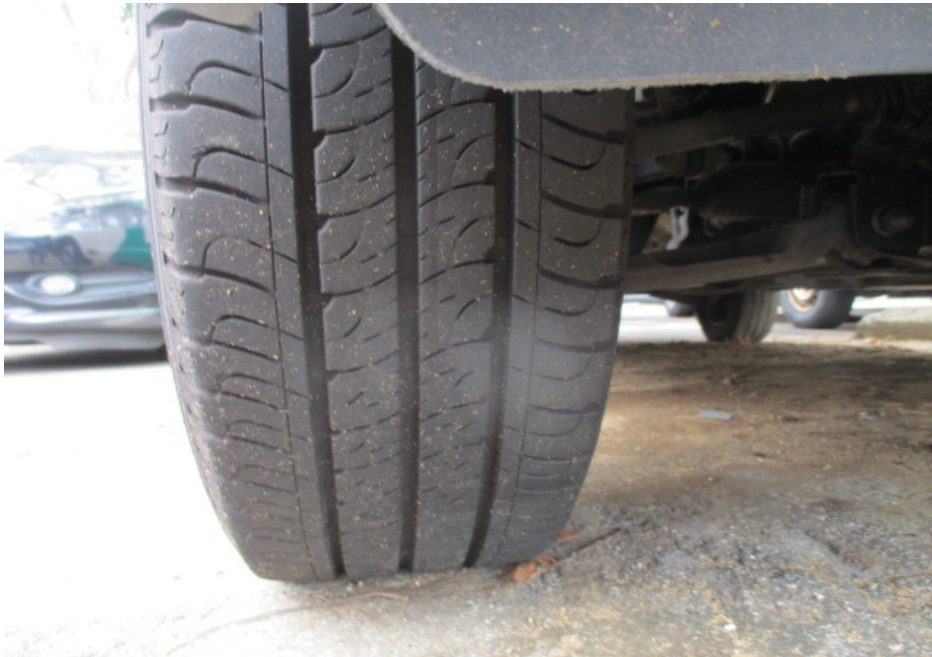
Photo 6 shows the condition of the front right tyre of the Motor Van, which was observed to be in serviceable condition with remaining tread depth of approximately 7mm. The tyre, which was wrapped around standard steel wheel rim, was also observed to be sufficiently inflated for vehicular operation.

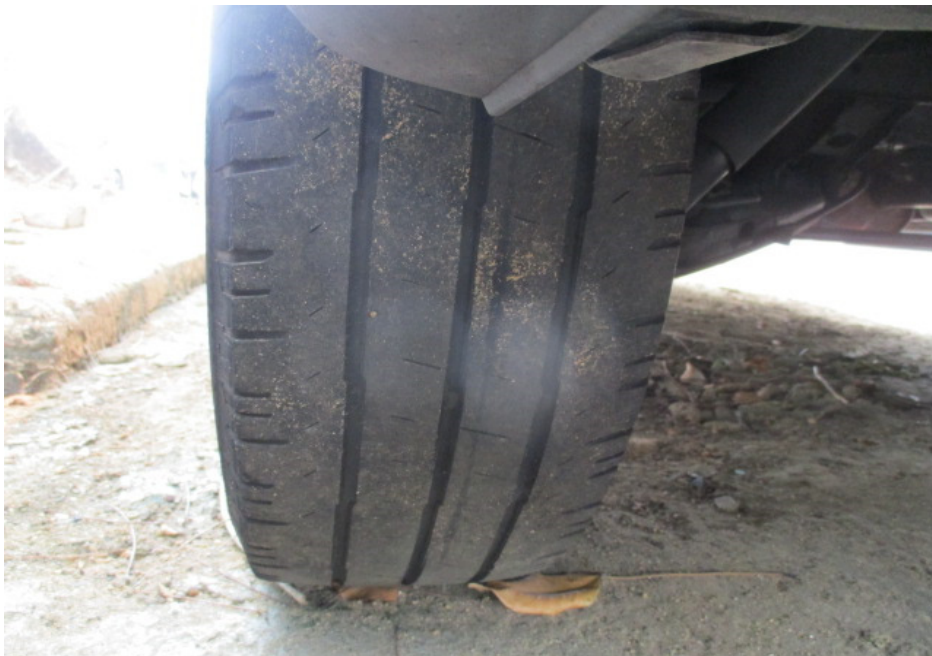
Photo 7 shows the condition of the rear left tyre of the Motor Van, which was observed to be in serviceable condition with remaining tread depth of approximately 4mm. The tyre, which was wrapped around standard steel wheel rim, was also observed to be sufficiently inflated for vehicular operation. There was also no damage found on the 4 wheel rims of the Motor Van.

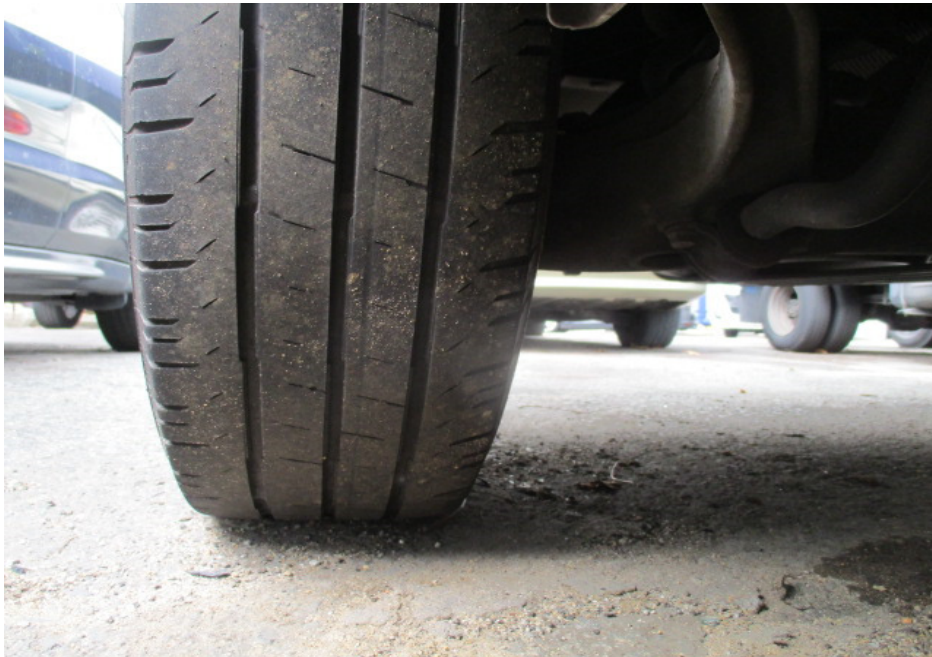
Photo 8 shows the condition of the rear right tyre of the Motor Van, which was observed to be in serviceable condition with remaining tread depth of approximately 4mm. There was also no tear, cut or burst mark(s) on the outer and the inner sidewalls as well as across the tread of the 4 tyres.

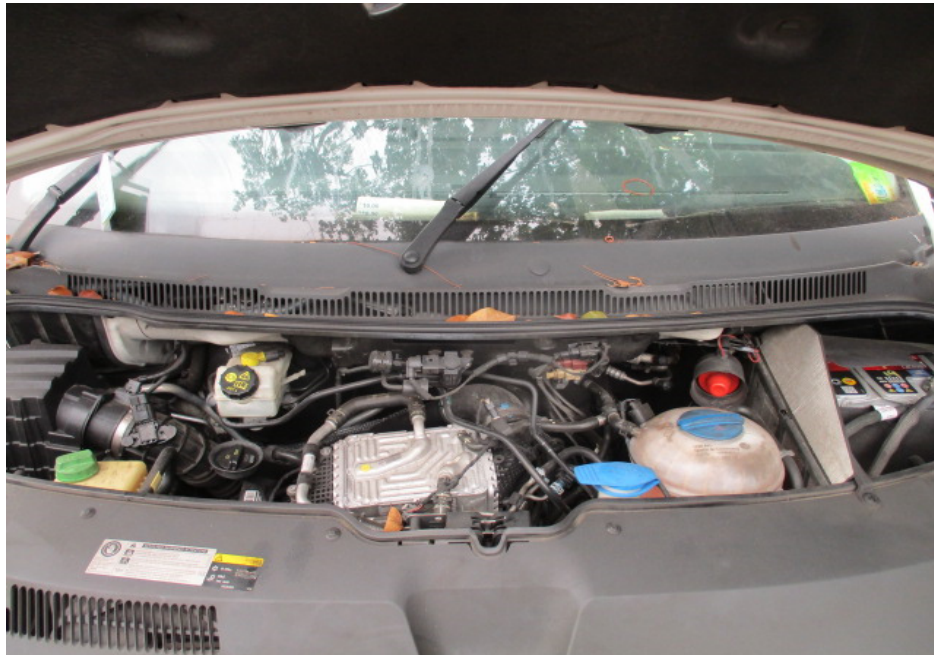
Photo 9 shows a general view of the Motor Van's engine compartment. The various parts and components inside the engine compartment were unaffected by the accident. There was also no sign(s) or indication(s) of fluid leakage and/or fluid stain within the engine compartment. The wirings and cables were all observed to be intact and adequately secured to their respective connectors and/or connecting ports.

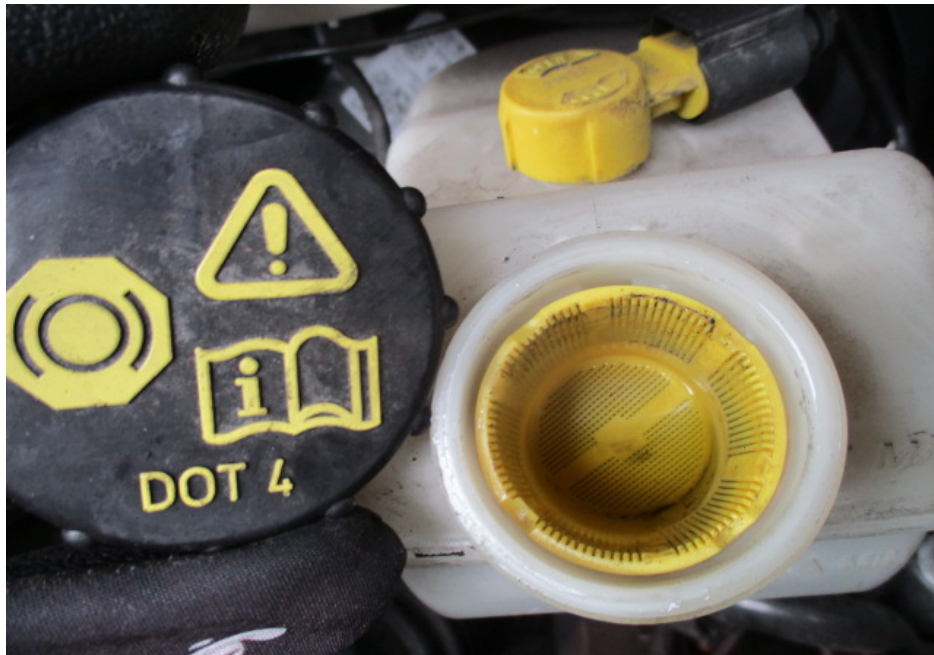
Photo 10 shows the brake fluid reservoir of the Motor Van at the time of our inspection. The brake fluid was observed to be of sufficient level and without any visible contamination.

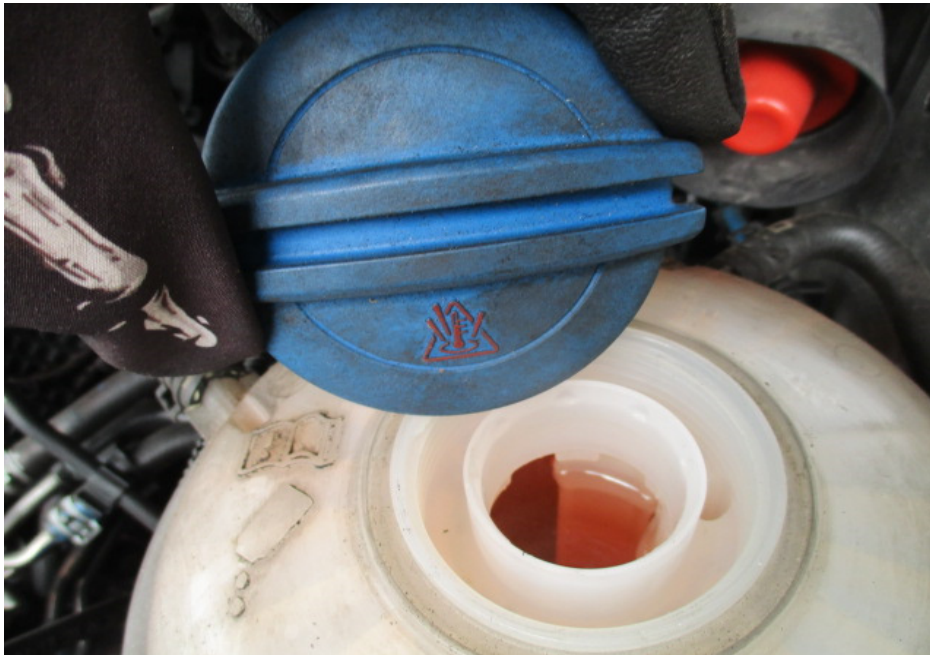
Photo 11 shows the engine coolant reservoir of the Motor Van at the time of our inspection. The engine coolant was observed to be of sufficient level and without any visible contamination.

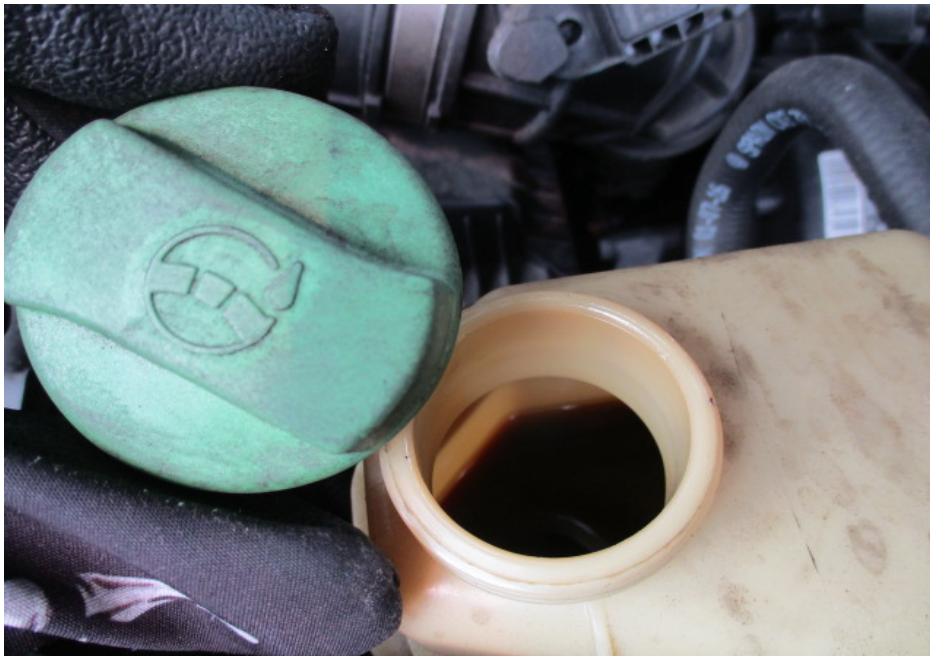
Photo 12 shows the power steering fluid reservoir of the Motor Van at the time of our inspection. The power steering fluid was observed to be of sufficient level and without any visible contamination.

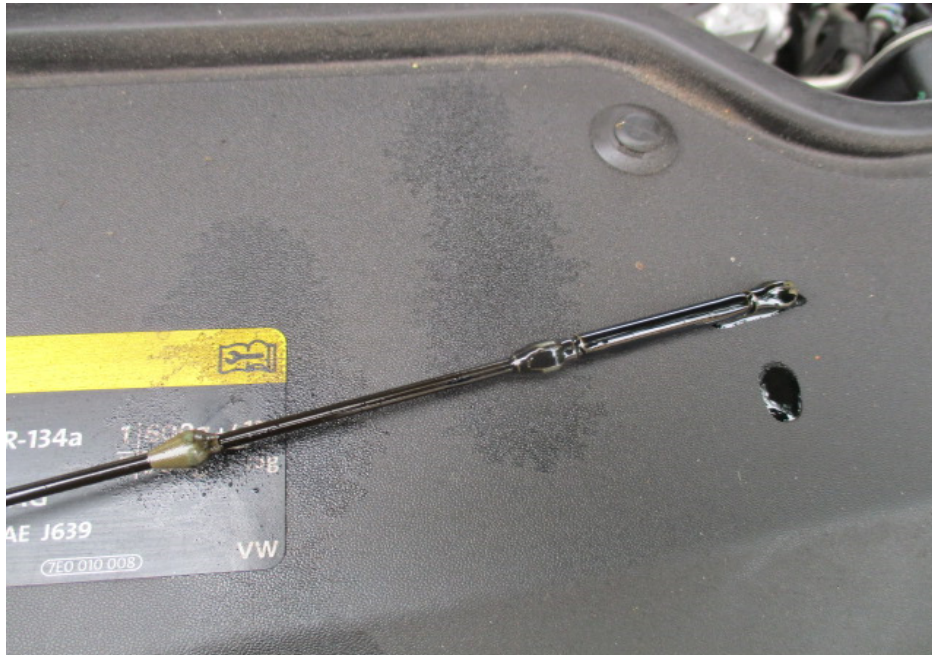
Photo 13 shows the engine dip stick of the Motor Van at the time of our inspection. The engine oil was observed to be of sufficient level and without any visible contamination.

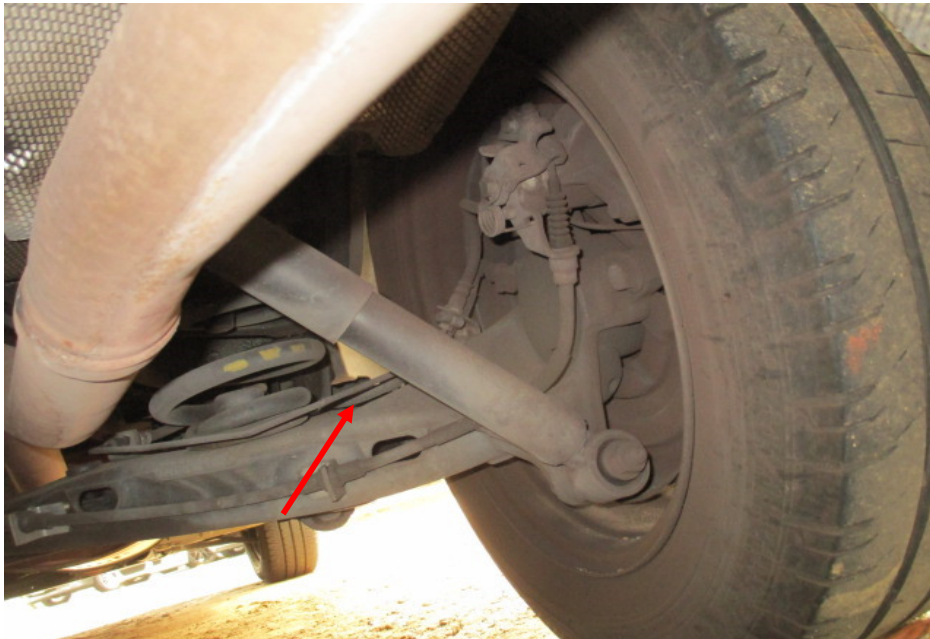
Photo 14 shows the brake pipe (arrowed) at the rear right wheel of the Motor Van. We did not observe any leakage of brake fluid at the time of our inspection of the Motor Van. Our static tests of the Motor Van's braking system had indicated that there was no internal leakage of pressure/vacuum. Hence the braking system was likely to be in serviceable condition at the material time of accident.

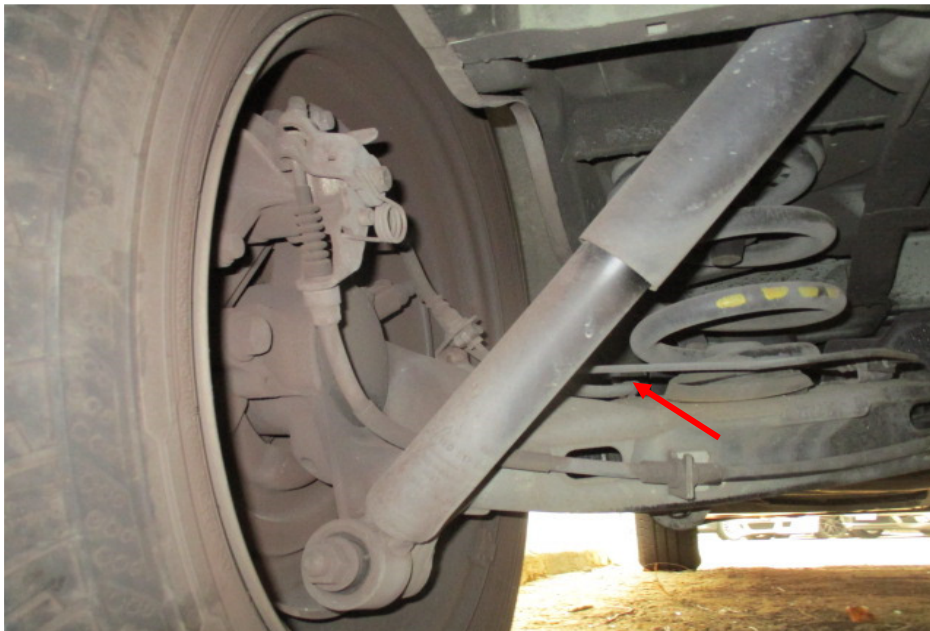
Photo 15 shows the brake pipe (arrowed) at the rear left wheel of the Motor Van. We did not observe any leakage of brake fluid at the time of our inspection of the Motor Van. Our static tests of the Motor Van's braking system had indicated that there was no internal leakage of pressure/vacuum. Hence the braking system was likely to be in serviceable condition at the material time of accident.

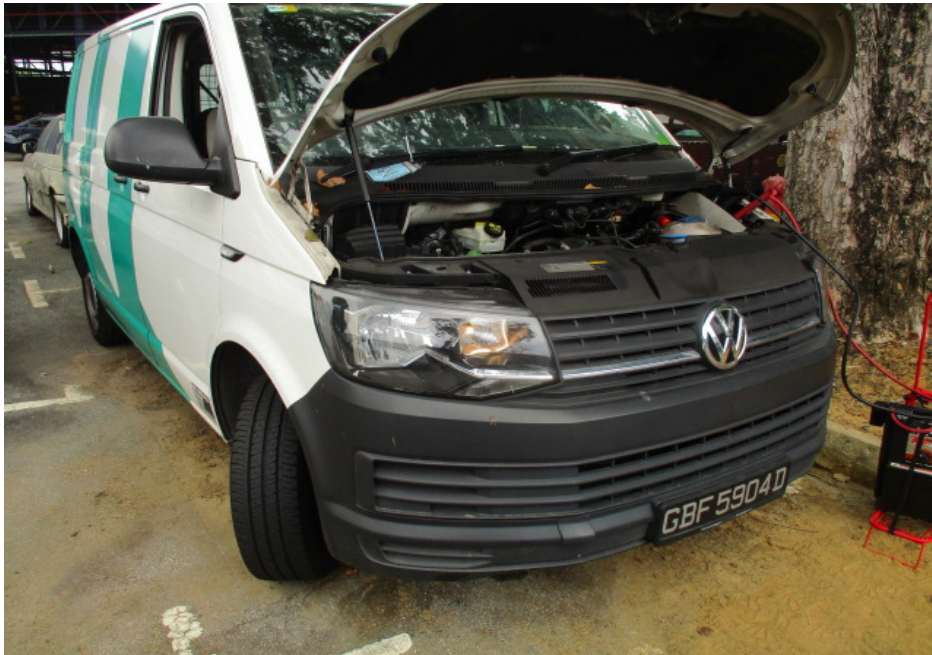
Photo 16 shows the front right wheel of the Motor Van turned to its full right. During our steering system test, we did not experience any abnormal free play and/or resistance when we had turned the steering wheel towards the left and right. This would suggest that the steering system of the Motor Van was likely to be in serviceable condition at the material time of accident.

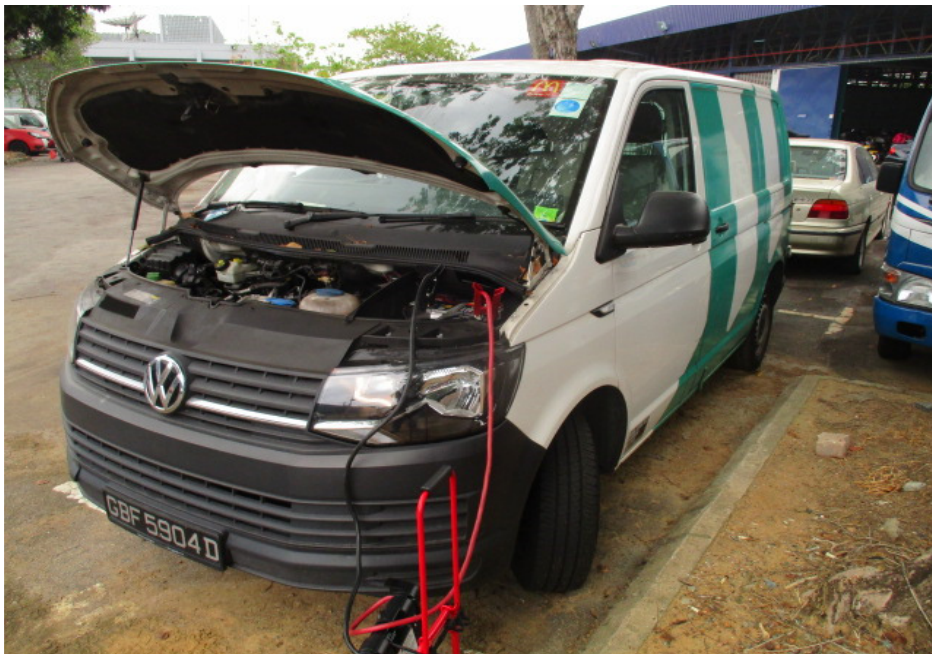
Photo 17 shows the front left wheel of the Motor Van turned to its full left. During our steering system test, we did not experience any abnormal free play and/or resistance when we had turned the steering wheel towards the left and right. This would suggest that the steering system of the Motor Van was likely to be in serviceable condition at the material time of accident.

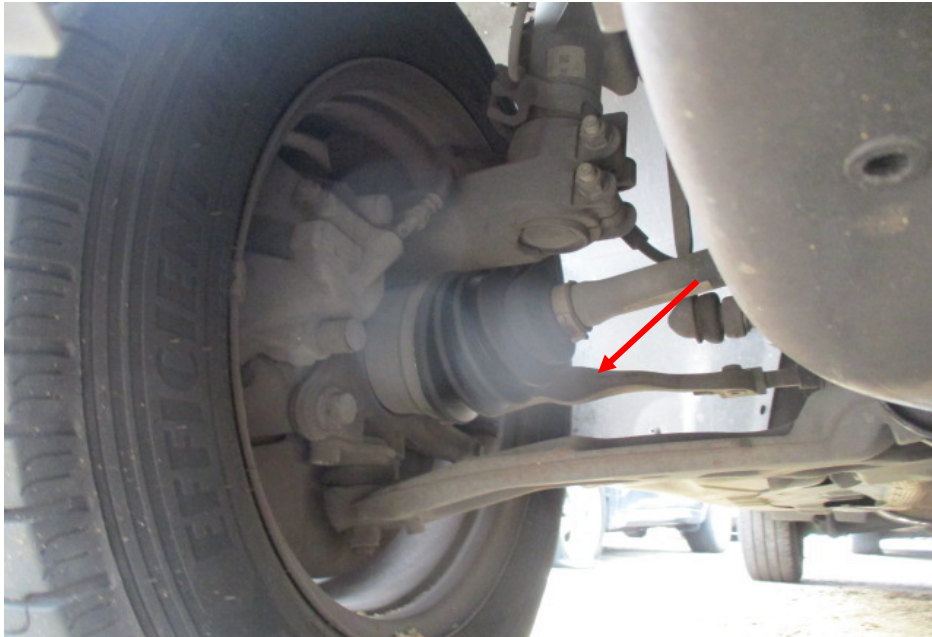
Photo 18 shows the various undercarriage components at the front right wheel of the Motor Van, in particular the steering tie rod (arrowed). The various steering components were all found to be intact, suggesting that the steering system of the Motor Van was likely to be in serviceable condition at the material time of accident. There was also no sign of fluid stain(s) observed on the various undercarriage components.

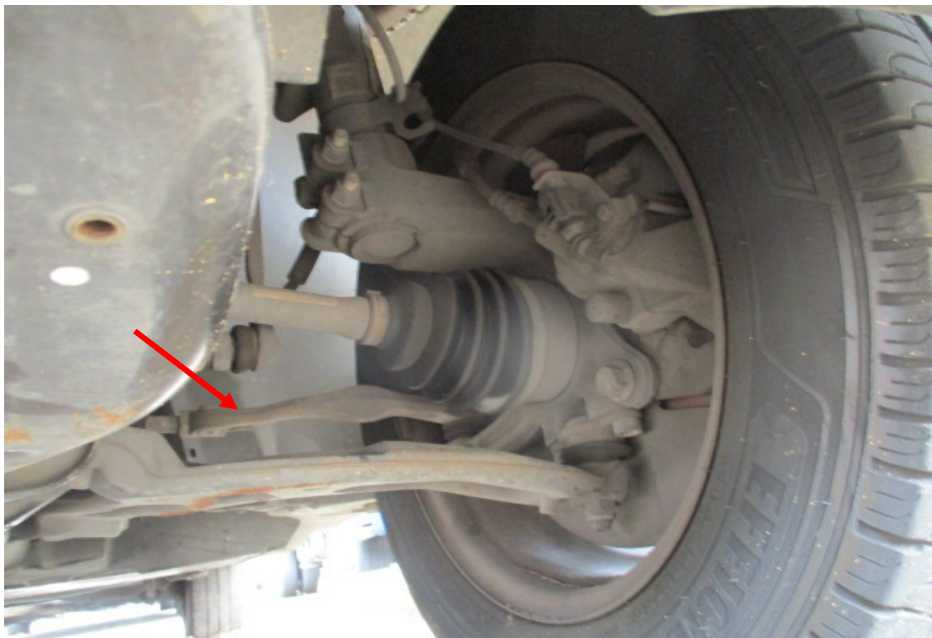
Photo 19 shows the various undercarriage components at the front left wheel of the Motor Van, in particular the steering tie rod (arrowed). The various undercarriage components of the Motor Van were all found to be intact without any visible damage. There was also no sign of fluid stain(s) observed on the various undercarriage components.

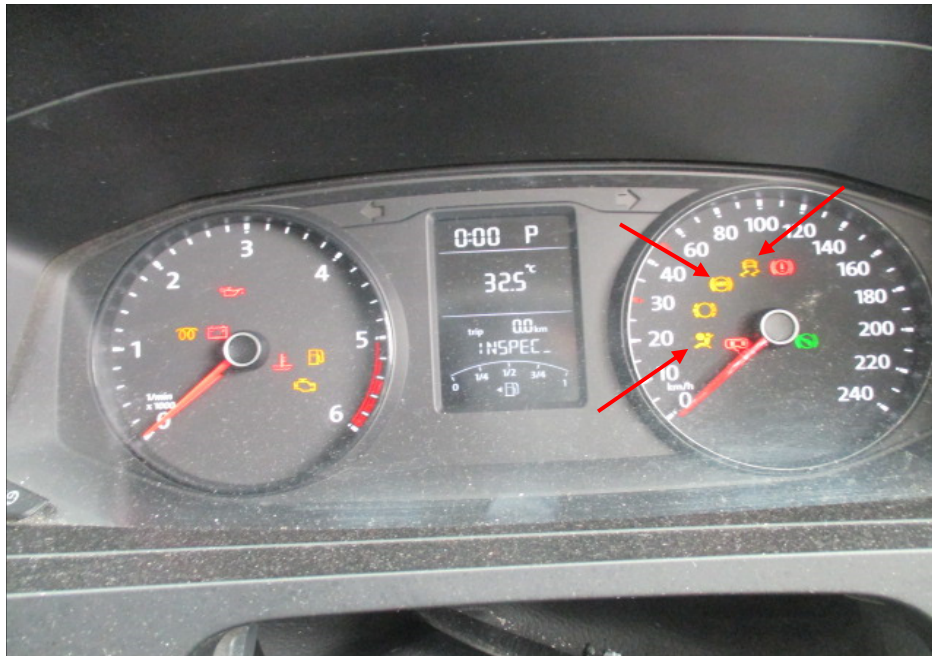
Photo 20 shows the warning lights for the various electronic operating systems of the Motor Van appearing on its instrument panel during the self-test when the engine is cranked, in particular the ESC, ABS and SRS light (arrowed).

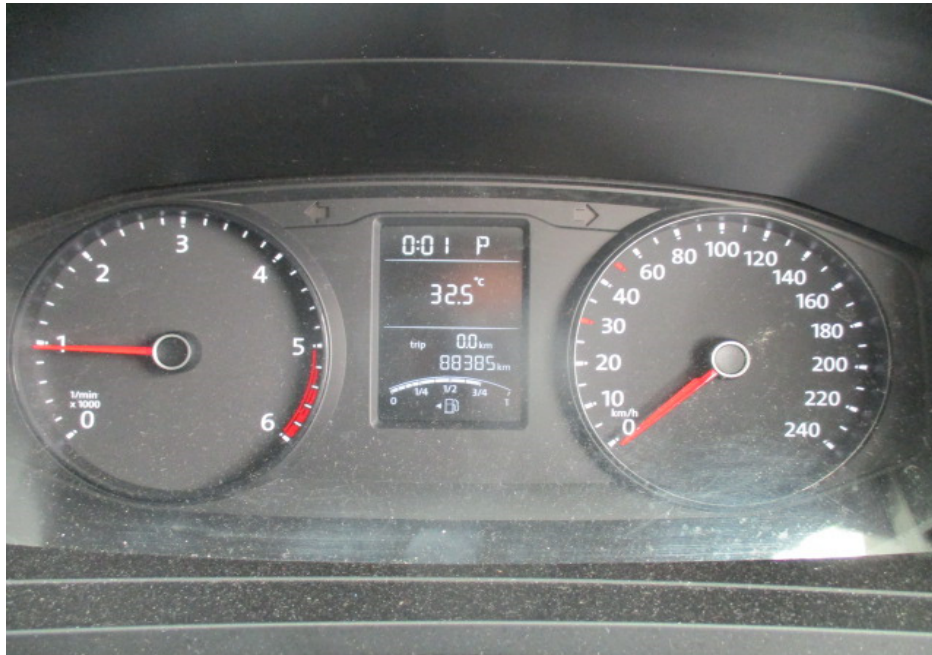
Photo 21 shows no warning lights illuminated on the instrument panel of the Motor Van after the engine was cranked. This would suggest that there was no abnormality to the various electronic operating systems of the Motor Van, like the ESC, ABS and SRS.
