Your Ref: TP/IP/49955/2019  
Our Ref : CI/TPD19014931/N

16 September 2019

**Fatal Accident Investigation Team**

**MECHANICAL INSPECTION REPORT OF MOTOR CAR SMH 5996Y**

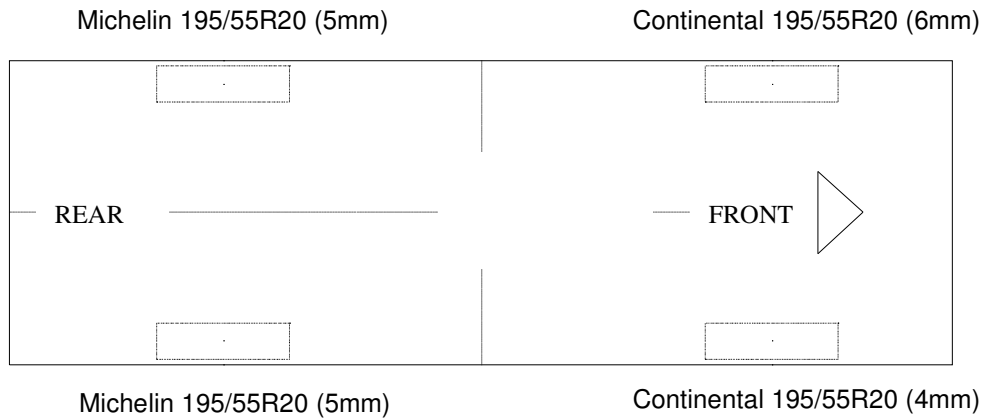
6. The condition of the Motor Car's 4 tyres was observed to be in serviceable condition. We did not find any tear, cut or burst mark(s) on the outer and the inner sidewalls as well as across the tread of the 4 tyres. The 4 tyres were also observed to be sufficiently inflated for vehicular operation. The tyre brand, tyre size and remaining tread depth of the 4 tyres were recorded as follows:-

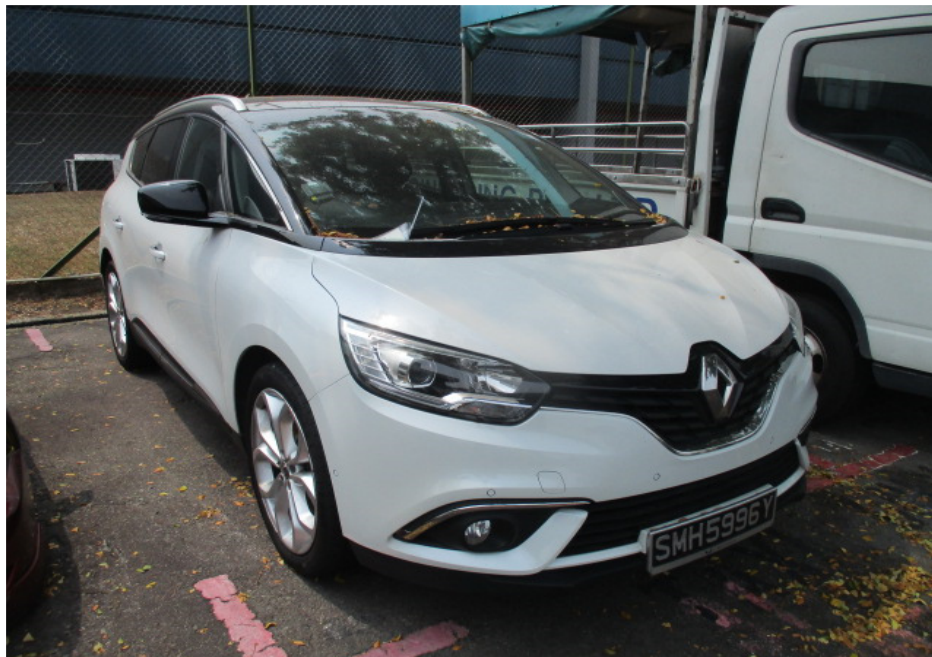
**Photo 1** shows a general view of the front right body of the Motor Car at the time of our inspection. The Motor Car was observed to be in good general condition except for some relatively minor impact damage at its left portion. The mileage of the Motor Car was recorded to be 49, 032km.

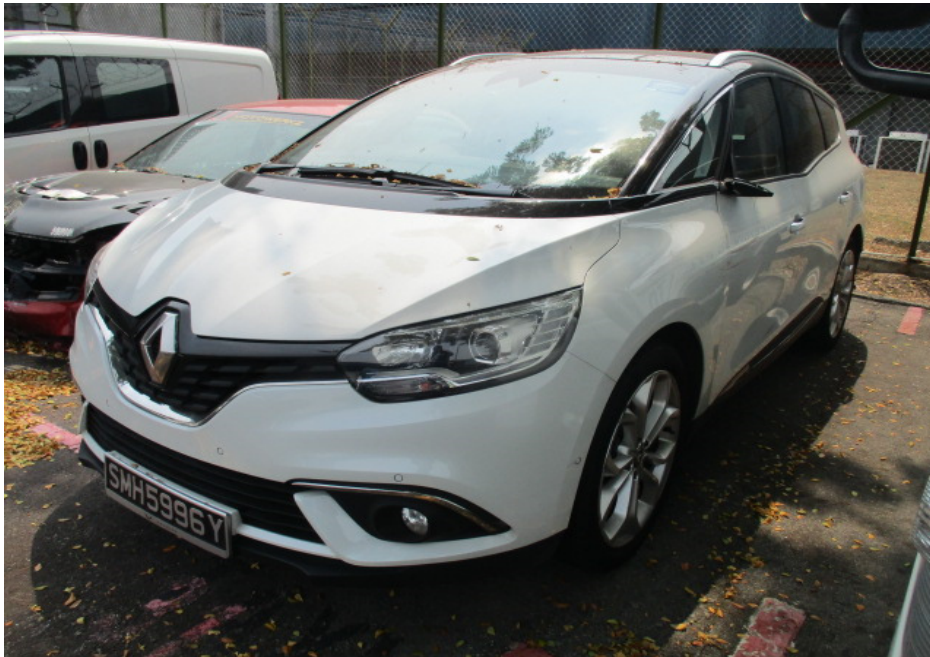
4. The mileage of the Motor Car at the time of our inspection was 49, 032km.
5. The Motor Car had sustained relatively minor impact damage that was confined to its left portion. Its left front fender and left front door was observed to have been grazed; its left side mirror was observed to be dislodged.

**Photo 2** shows a general view of the front left body of the Motor Car at the time of our inspection. The Motor Car was observed to be in good general condition. However we had observed relatively minor impact damage that was confined to its left portion. Its left front fender and left front door was observed to have been grazed; its left side mirror was observed to be dislodged.

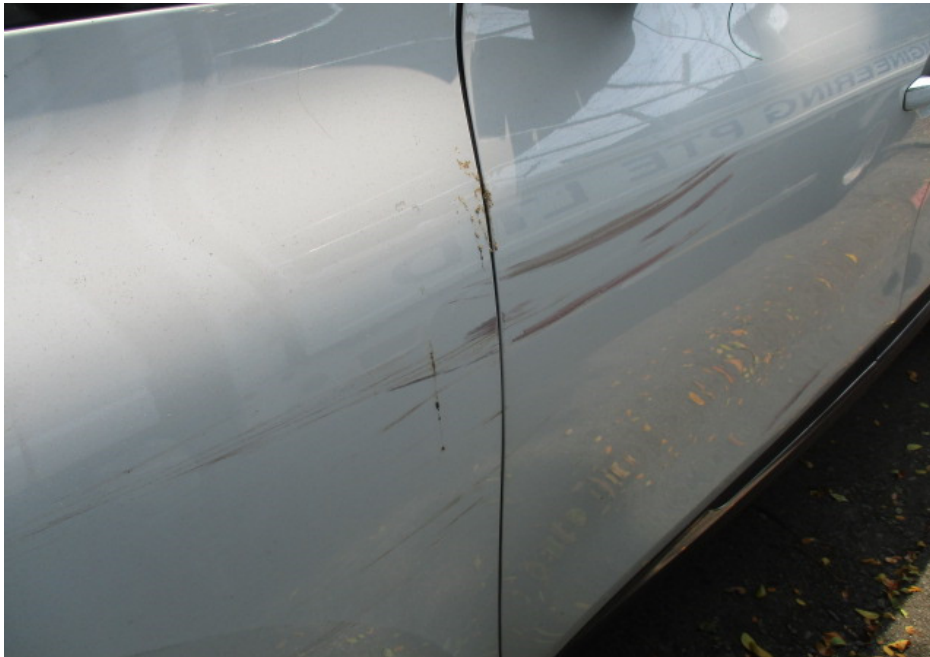
**Photo 3** shows a closer view of the graze marks on the left front fender and left front door of the Motor Car at the time of our inspection.

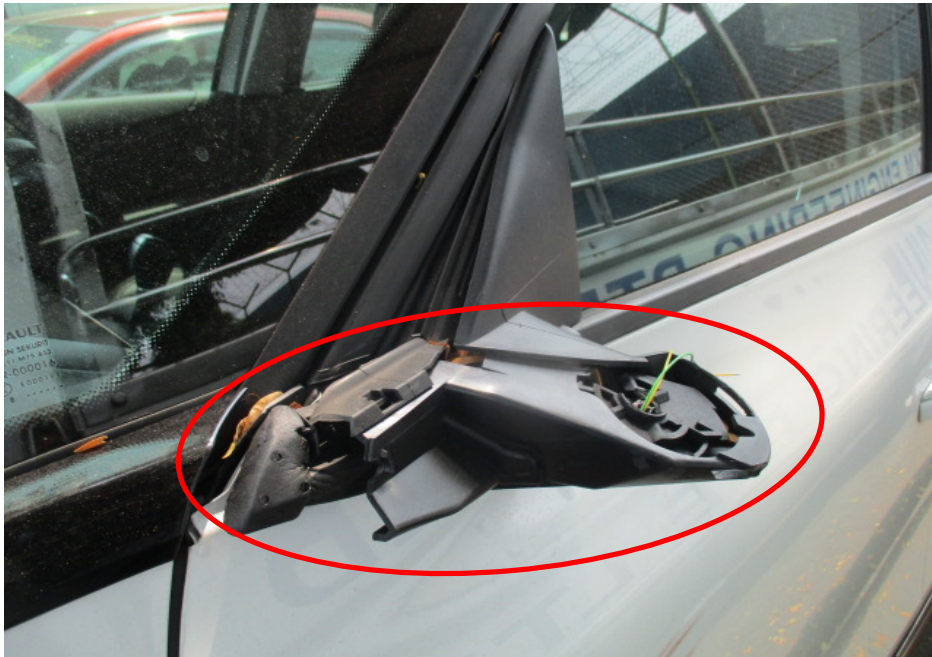
**Photo 4** shows a closer view of the dislodged left side mirror of the Motor Car at the time of our inspection (circled).

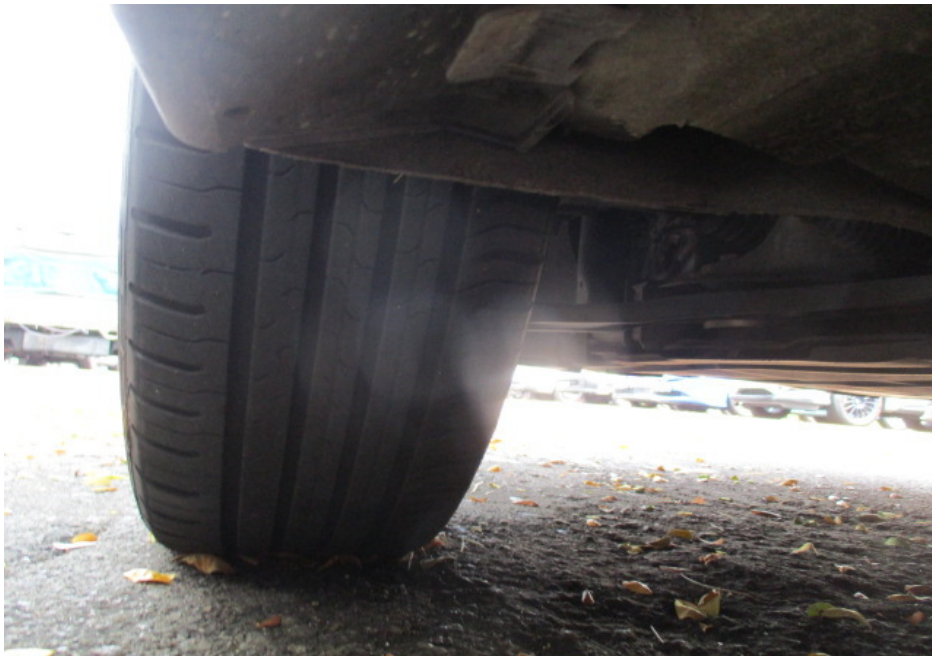
**Photo 5** shows the condition of the front left tyre of the Motor Car, which was observed to be in serviceable condition with remaining tread depth of approximately 6mm. The tyre, which was wrapped around alloy wheel rim, was also observed to be sufficiently inflated for vehicular operation. There was no tear, cut or burst mark(s) on the outer and the inner sidewalls as well as across the tread of the 4 tyres.

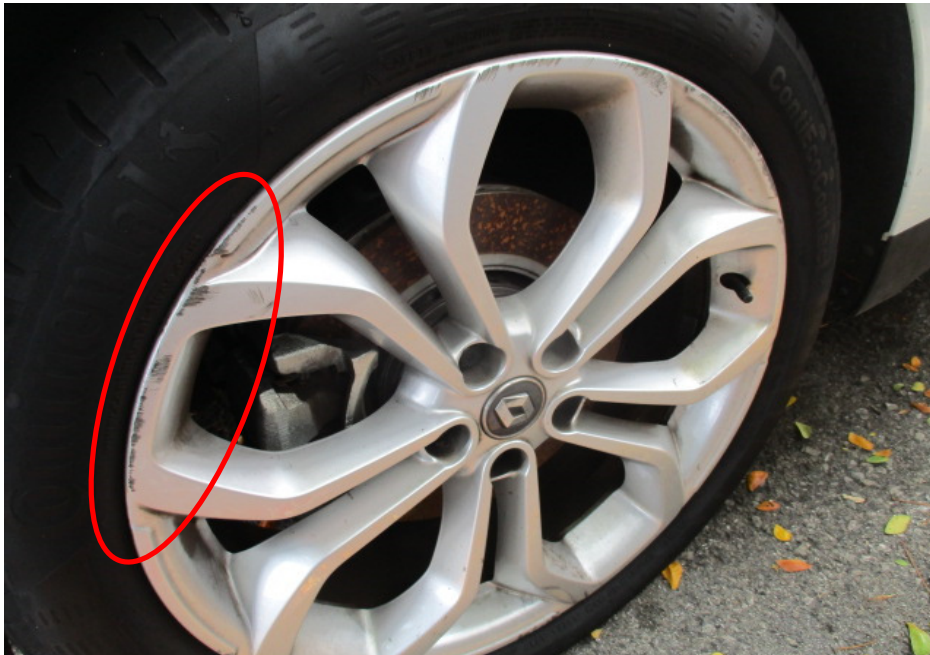
7. The 4 tyres were observed to be wrapped around alloy wheel rims that were found to be without any damage. We had however found some relatively minor marks of grazing nature on the edges of the front wheel rim, at the left side of the Motorcar. See photos 1 – 9 below.

**Photo 6** shows the left front wheel rim and tyre of the Motorcar at the time of our inspection. The front tyre was observed to be in serviceable condition and sufficiently inflated for vehicular operation. Some relatively minor marks of grazing nature were observed on the edges of the front wheel rim (circled), at the left side of the Motorcar.

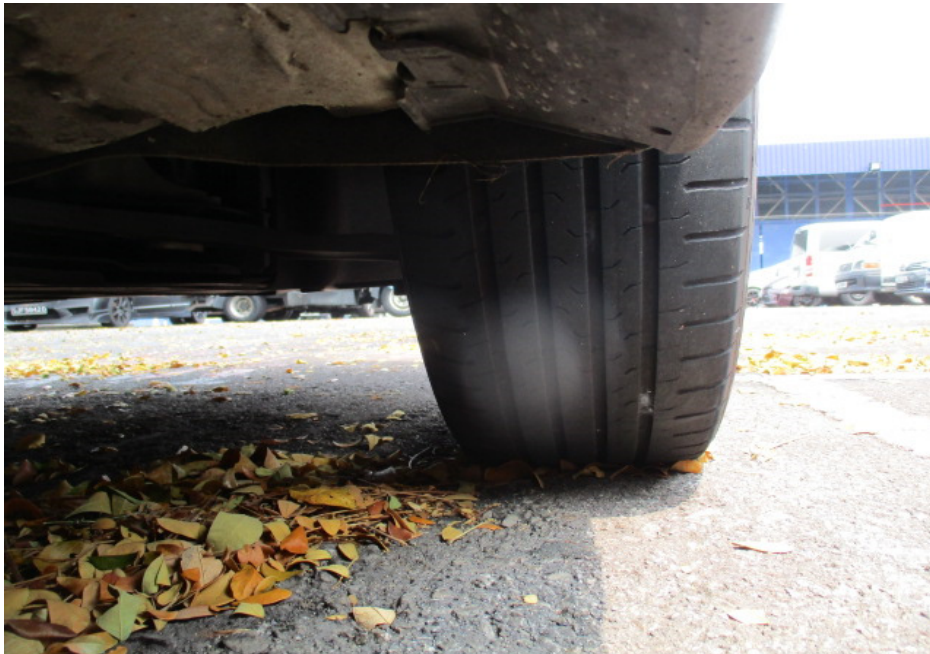
**Photo 7** shows the condition of the front right tyre of the Motor Car, which was observed to be in serviceable condition with remaining tread depth of approximately 4mm. The tyre, which was wrapped around alloy wheel rim, was also observed to be sufficiently inflated for vehicular operation.

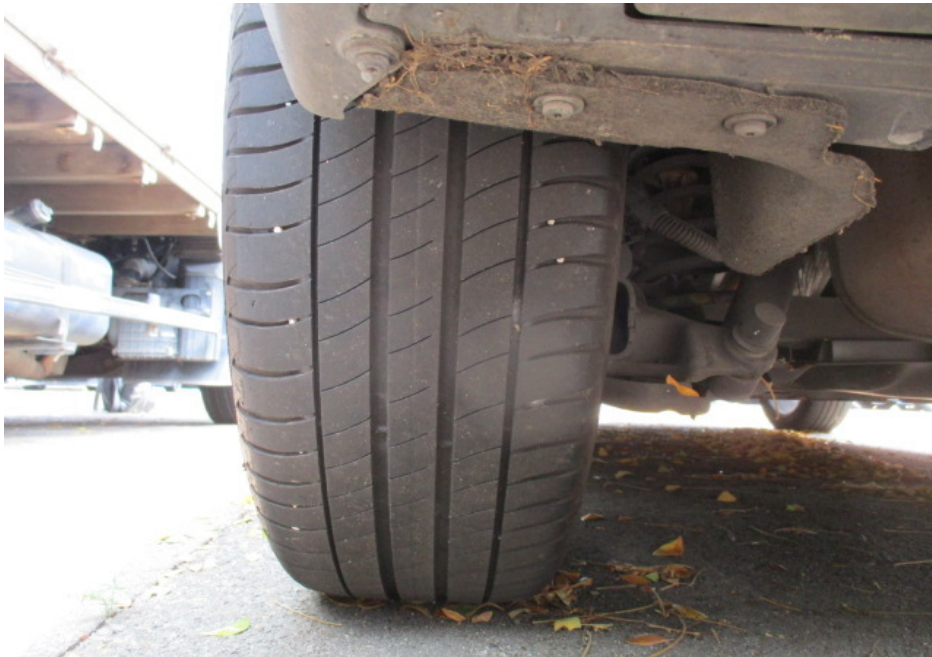
**Photo 8** shows the condition of the rear left tyre of the Motor Car, which was observed to be in serviceable condition with remaining tread depth of approximately 5mm. The tyre, which was wrapped around alloy wheel rim, was also observed to be sufficiently inflated for vehicular operation.

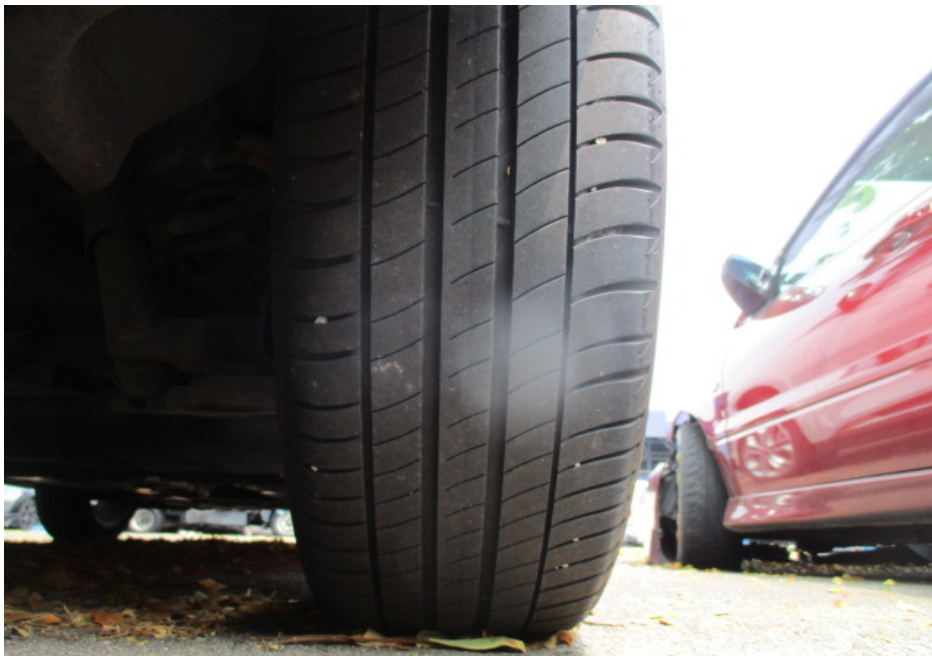
**Photo 9** shows the condition of the rear right tyre of the Motor Car, which was observed to be in serviceable condition with remaining tread depth of approximately 5mm. There was also no tear, cut or burst mark(s) on the outer and the inner sidewalls as well as across the tread of the 4 tyres.

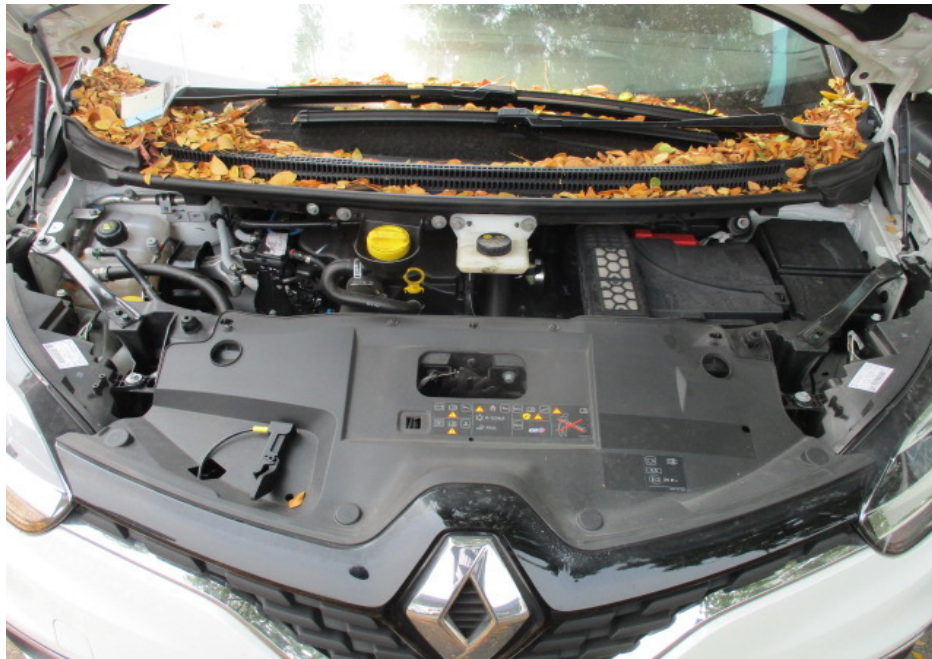
**Photo 10** shows a general view of the Motor Car's engine compartment. The various parts and components inside the engine compartment were unaffected by the accident. There was also no sign(s) or indication(s) of fluid leakage and/or fluid stain within the engine compartment.

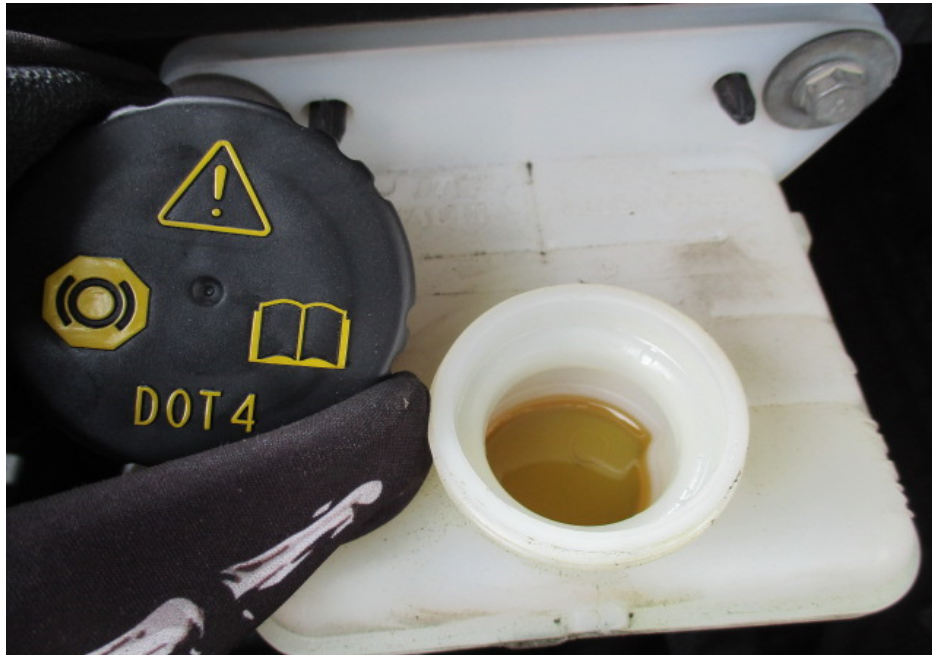
**Photo 11** shows the brake fluid reservoir of the Motor Car at the time of our inspection. The brake fluid was observed to be of sufficient level and without any visible contamination.

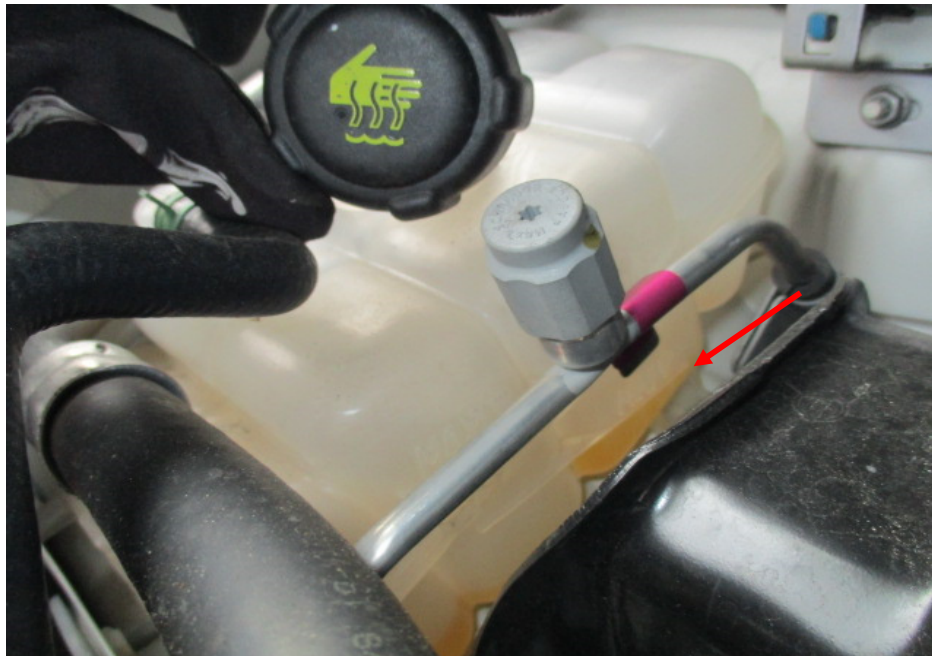
**Photo 12** shows checks being carried out to the engine coolant of the Motor Car at the time of our inspection. The engine coolant was observed to be of sufficient level (arrowed) and without any visible contamination.

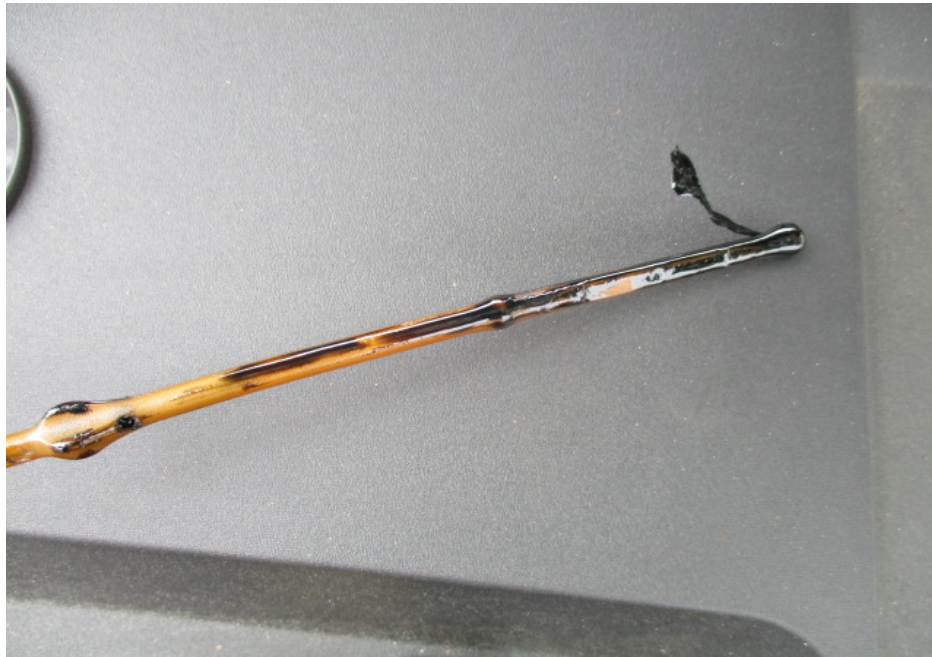
**Photo 13** shows the engine oil dip stick of the Motor Car at the time of our inspection. The engine oil was observed to be of sufficient level and without any visible contamination.

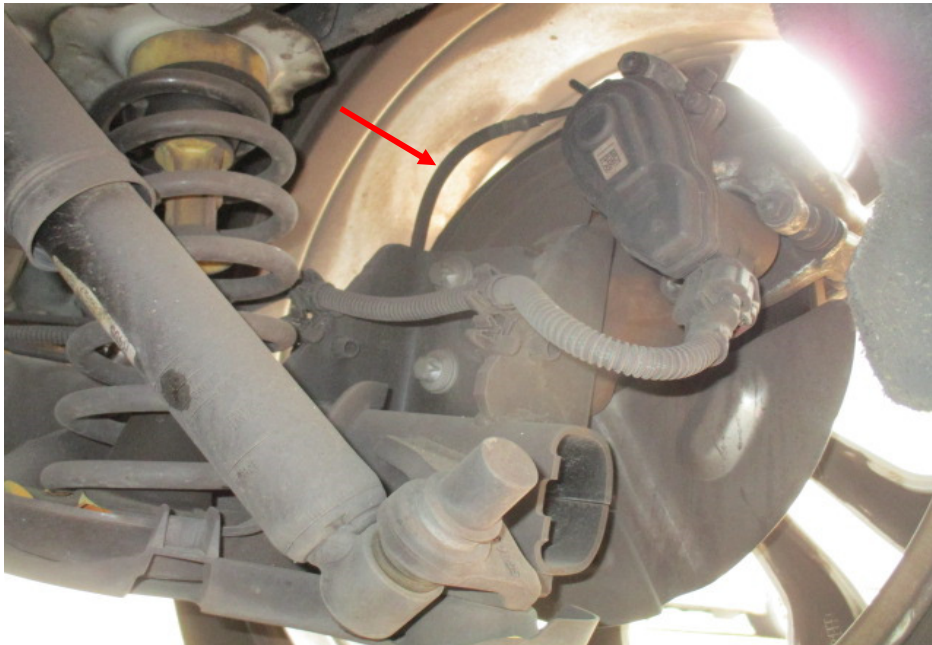
**Photo 14** shows the brake hose/pipe (arrowed) at the rear right wheel of the Motor Car. We did not observe any leakage of brake fluid at the time of our inspection of the Motor Car. Static tests of the Motor Car's braking system had indicated that there was no internal leakage of pressure/vacuum. Hence the braking system was likely to be in serviceable condition at the material time of accident. The undercarriage components of the Motor Car were also all found to be intact and without any visible damage.

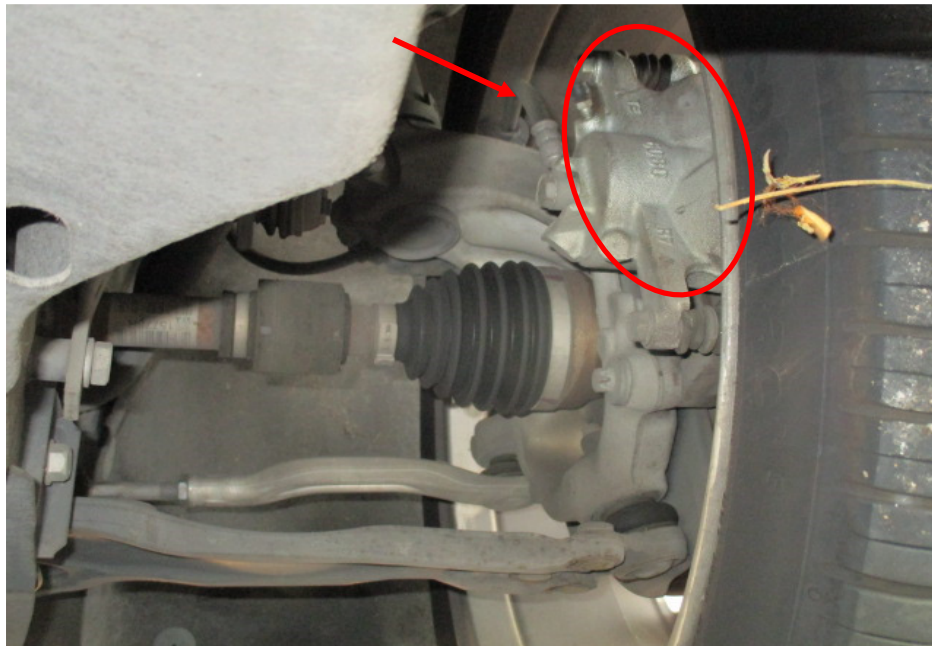
**Photo 15** shows the brake hose/pipe (arrowed) at the front left wheel of the Motor Car. No leakage of brake fluid was observed. Visual examination of the various components of the braking system like the brake caliper (circled), brake pedal etc. had revealed all to be intact and without visible damage.

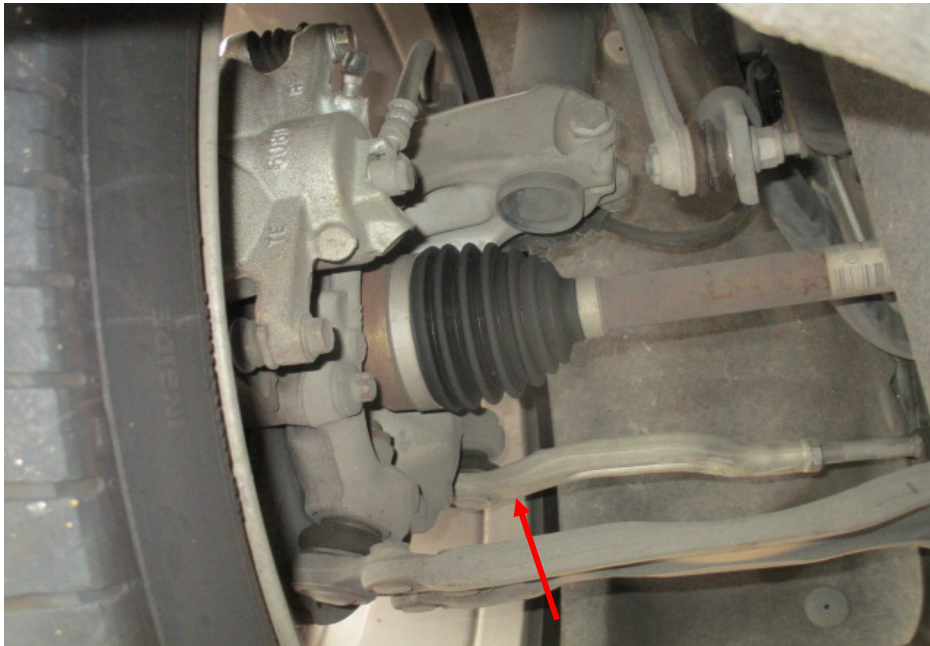
**Photo 16** shows the various undercarriage components at the front right wheel of the Motor Car, in particular the steering tie rod (arrowed). The various steering components were all found to be intact, suggesting that the steering system of the Motor Car was likely to be in serviceable condition at the material time of accident. There was also no sign of fluid stain observed on the various undercarriage components at the front right wheel of the Motor Car.

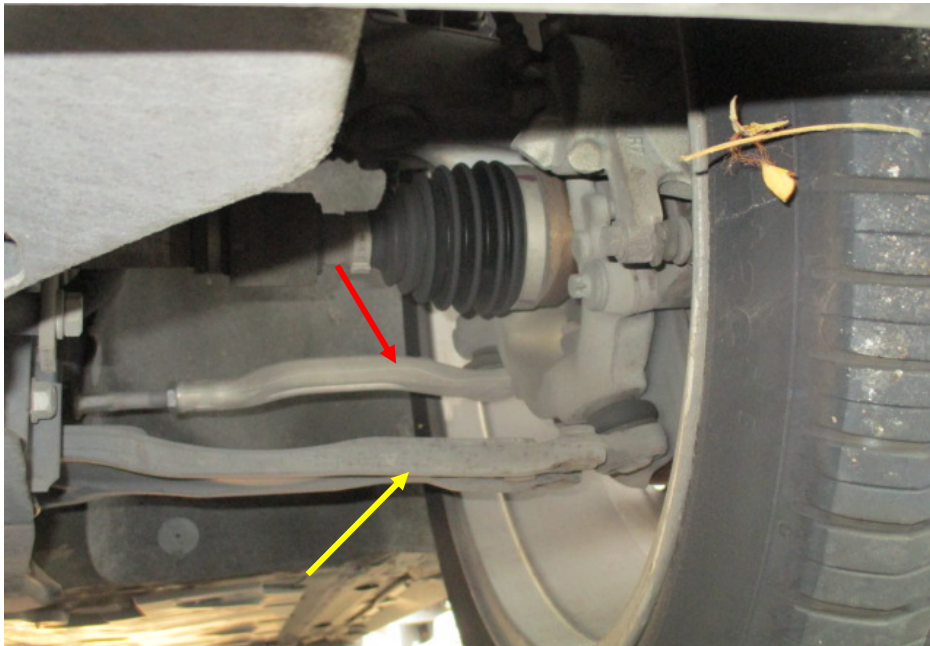
**Photo 17** shows the various undercarriage components at the front left wheel of the Motor Car, which had included the steering tie rod (red arrow) and left drive shaft (yellow arrow). The various undercarriage components of the Motor Car were all found to be intact without any visible damage.

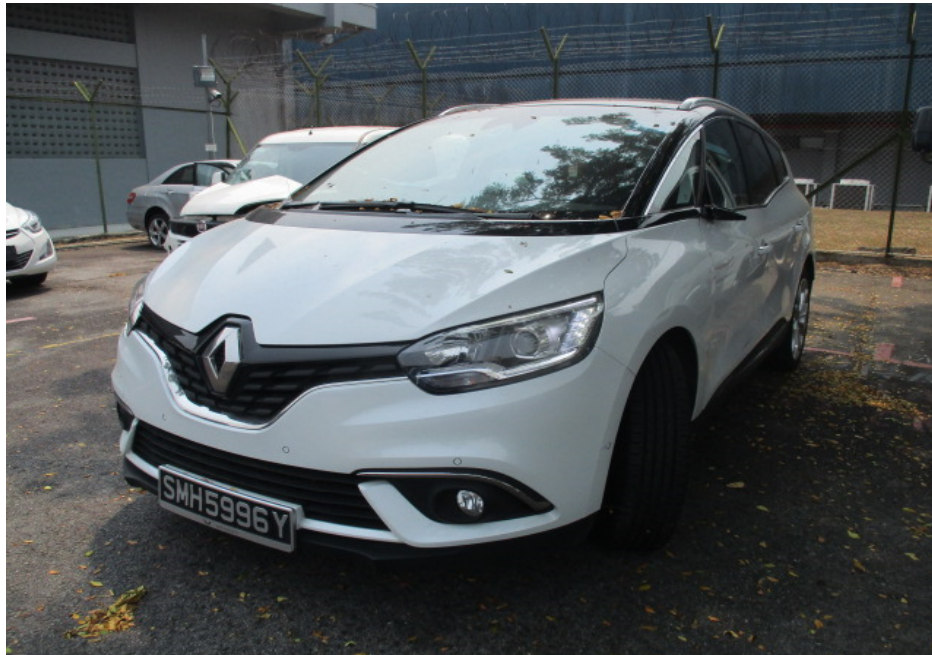
**Photo 18** shows the front left wheel of the Motor Car turned to its full left. During our steering system test, we did not experience any abnormal free play and/or resistance when we had turned the steering wheel towards the left and right. This would suggest that the steering system of the Motor Car was likely to be in serviceable condition at the material time of accident.

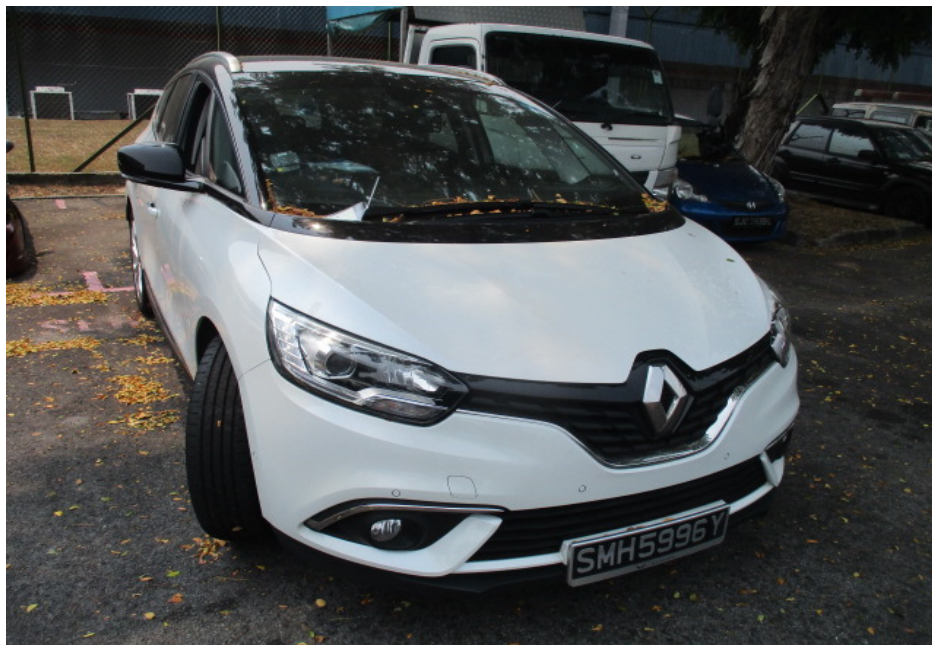
**Photo 19** shows the front right wheel of the Motor Car turned to its full right. During our steering system test, we did not experience any abnormal free play and/or resistance when we had turned the steering wheel towards the left and right. This would suggest that the steering system of the Motor Car was likely to be in serviceable condition at the material time of accident.

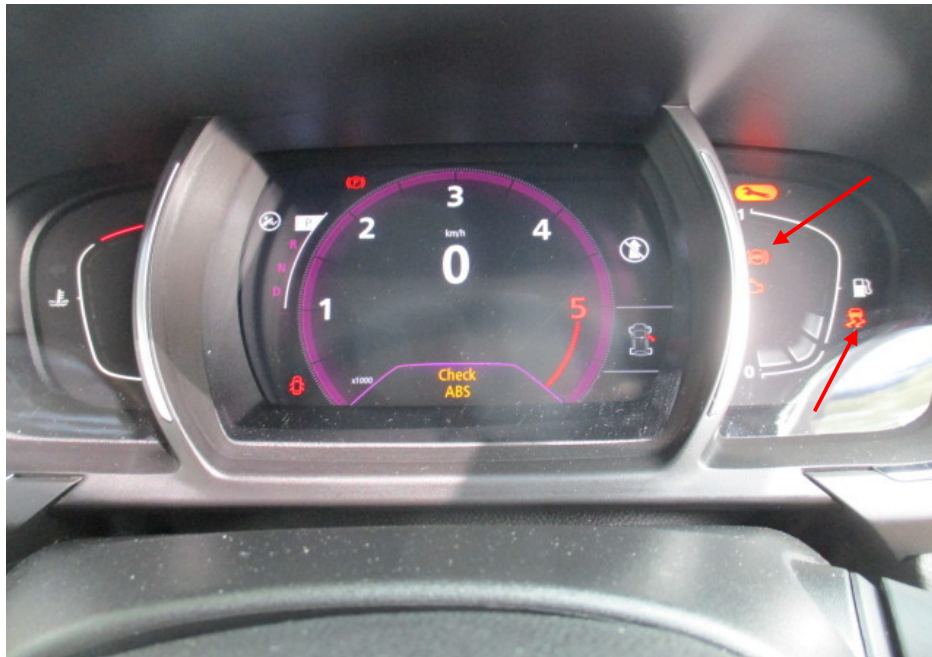
**Photo 20** shows the warning lights for the various electronic operating systems of the Motor Car appearing on its instrument panel during the self-test when the engine is cranked, in particular the ESC light & ABS light (arrowed).

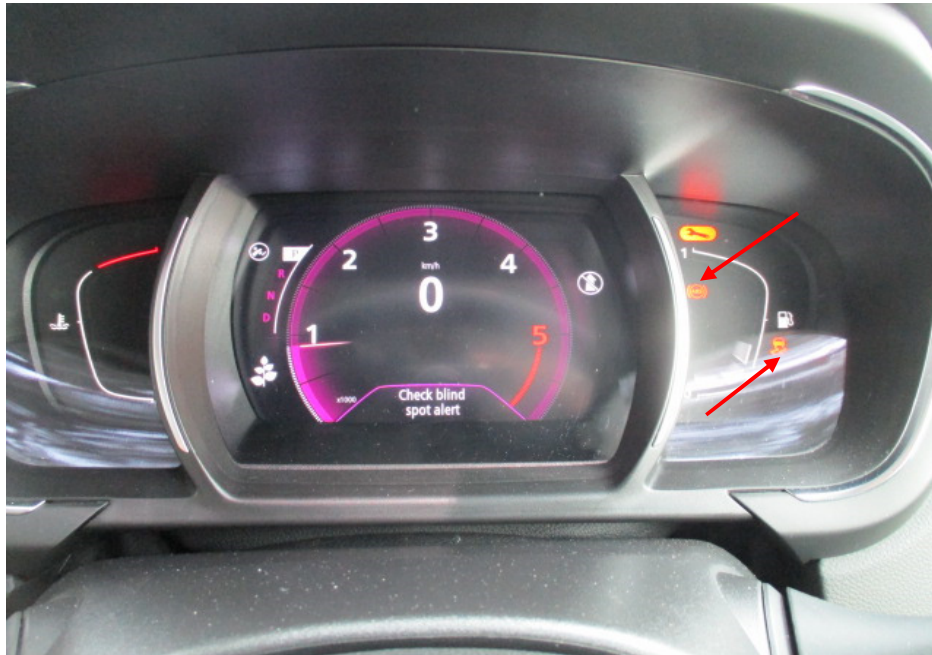
**Photo 21** shows no warning lights illuminated on the instrument panel of the Motor Car after the engine was cranked. This would suggest that there was no abnormality to the various electronic operating systems of the Motor Car. The ABS light and ESC light had however remained illuminated after the self-test (arrowed) due to a fault in the system as a result of the accident.
