1.		Policy Particulars	- THIRD PARTY CLAIM		
	Insured Veh.	GBE 2041T	Veh. Inspected	SJN 3481H	
	Policy No.	DMCVSN3060071800	Coverage (\$)	0.00	
	Claim No.	SNM19D203949	Excess (\$)	0.00	
	Assign From		Assign Date	27/08/2019

2.		Vehicle Partic	culars & Condition		
	Make & Model	HONDA FREED	c.c	1496	
	Engine No.	HIDDEN	Year of Reg.	2009	
	Chassis No.	GB31033276	Colour	MAROON	
	Odometer	152078	Steering	IN ORDER	
	Brakes	IN ORDER	Modification	SPORTS RIM	
	General	GOOD

ADJUSTMENT ON REPAIR COST FOR VEHICLE NO. SJN 3481H

PHOTOGRAPHS FOR VEHICLE NO. SJN 3481H

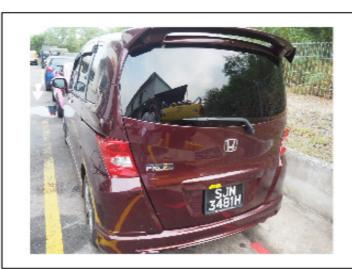
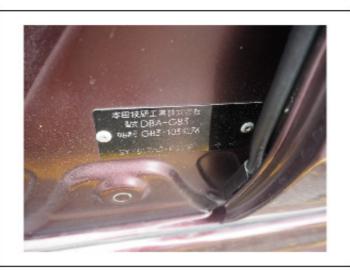
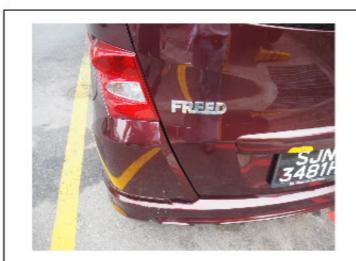
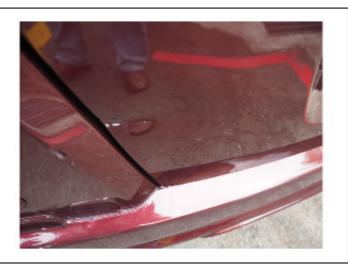
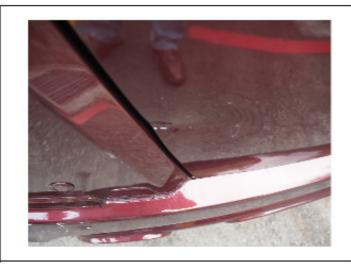
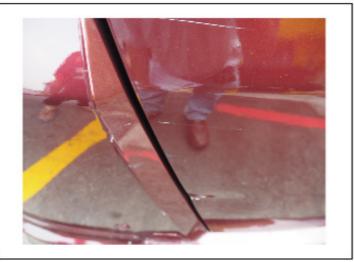
INSPECTION

4.		Description	on of Damages		
	THE VEHICLE SUS	STAINED DAMAGES AT THE REA	AR PORTION.		
	DAMAGES SEE DI	ETAILS.			
5.		General	Information		
	Accident Date	22/08/2019	Inspection Date	27/08/2019	
	Survey held at	96 MOTORSPORTS PTE LTD			
		62/64 KAKI BUKIT AVENUE 6 SINGAPORE 417893 ARK @ KB			
5a.		Re	emarks		
		ON WAS CONDUCTED ON A"WIT CE TO YOUR INSTRUCTIONS, W		REPAIRS.	
5b.	Estimate Days of Repair				
	ESTIMATED NOR	MAL PERIOD FOR REPAIR:	5 Working Days
