Your Ref: Audi A5 Coupe
(chassis number WAUZZZF56JA018855)
Our Ref : CI/TP19015354/D

INSPECTION REPORT OF AN UNREGISTERD AUDI A5 COUPE MOTOR CAR WITH CHASSIS NUMBER WAUZZZF56JA018855

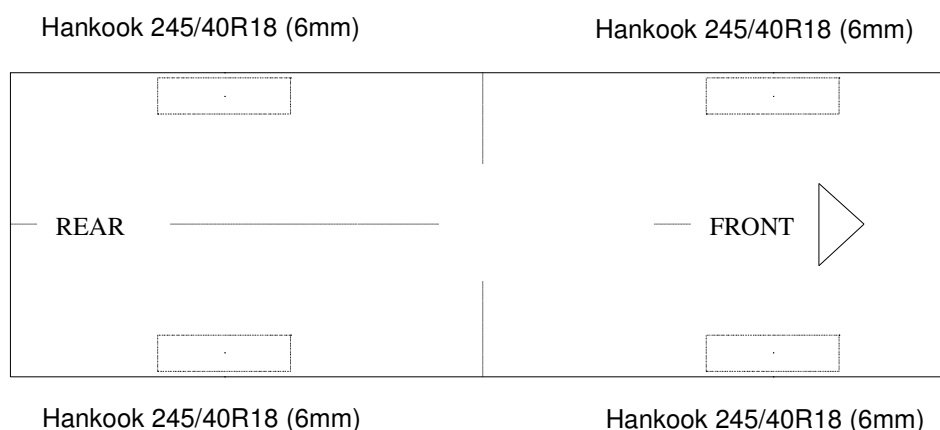
6. It was fitted with 18inch sport wheel rims that were wrapped with tyres that were observed to be of serviceable condition. The tyres were also sufficiently inflated for vehicular operation. The tyre brand, tyre size and approximate remaining tread depth of the Motor Car's 4 tyres were recorded as follows: -

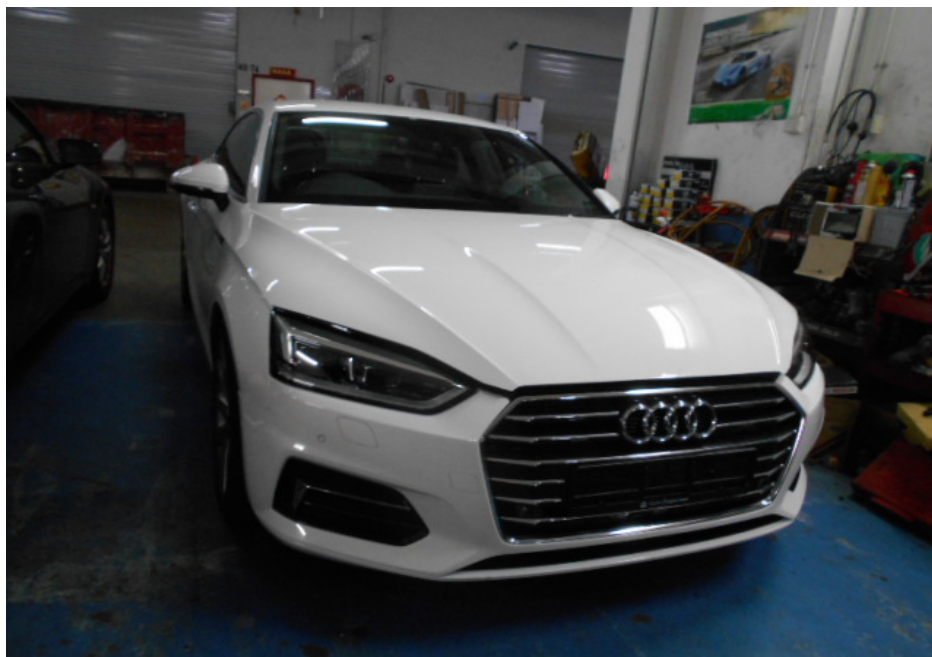
Photo 1 shows a general view of the front right body of the Motor Car at the time of my inspection. The Motor Car was observed to be in relatively good general condition with no loose exterior fittings observed. The mileage of the Motor Car recorded at the time of my inspection was 13,709km.

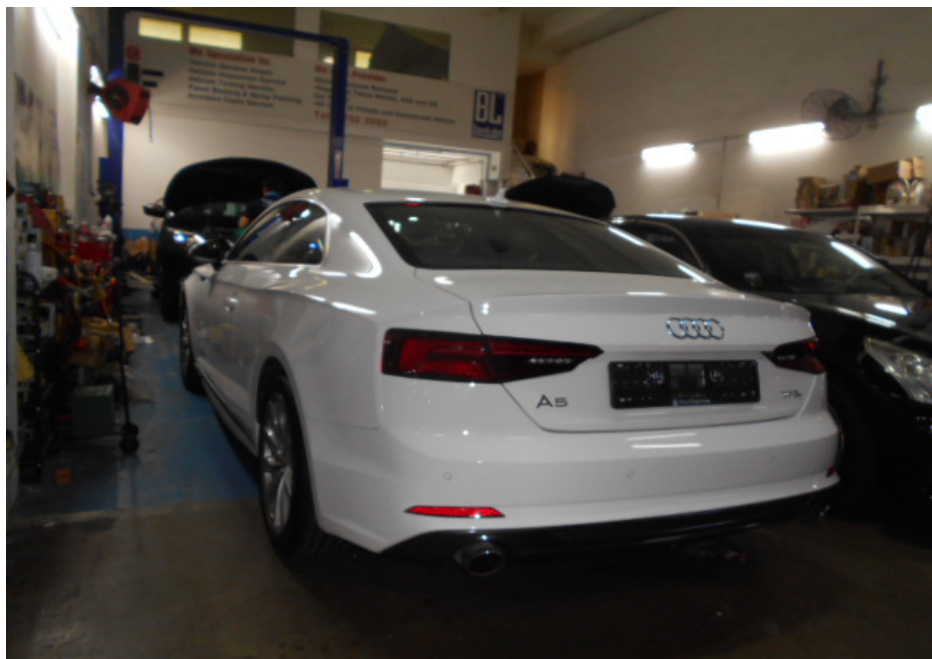
Photo 2 shows a general view of the rear left body of the Motor Car at the time of my inspection. The Motor Car was observed to be in relatively good general condition with no loose exterior fittings observed.

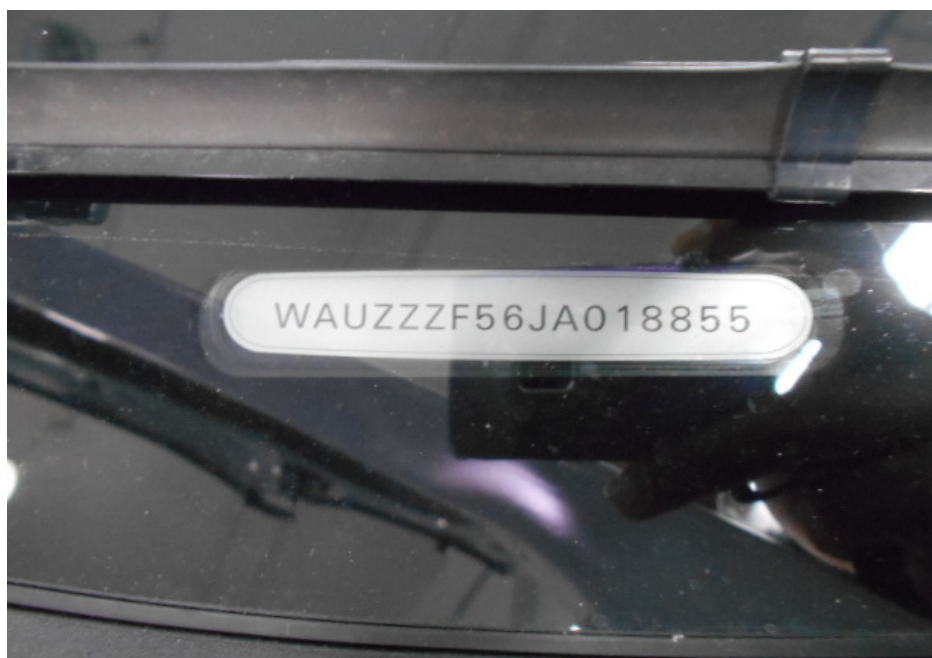
Photo 3 shows the chassis number of the Motor Car. The chassis number recorded was WAUZZZF56JA018855.

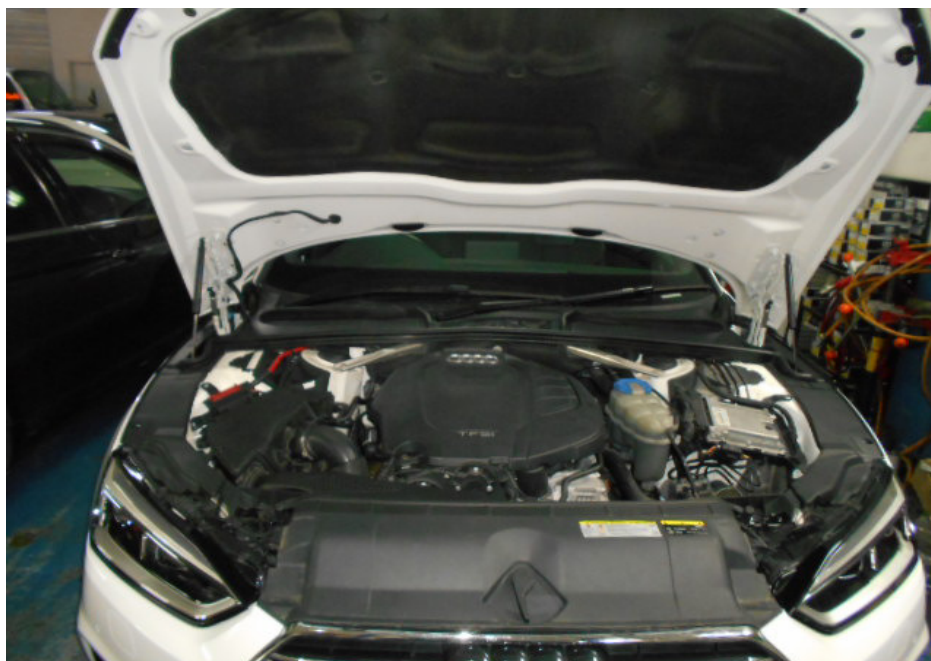
12. My examination of the engine compartment of the Motor Car revealed that the various parts and components inside the engine compartment were all intact and properly fitted. The brake fluid and engine coolant were all found to be of sufficient level for operating purposes. Visually, there was also no contamination found to these fluids.
13. My checks on the underside of the Motor Car revealed no sign(s) or indication(s) of fluid leakage and/or fluid stain(s). The engine block and automatic transmission assembly were both secured properly. They were not mounted onto the structure/chassis body or any integral body part of the Motor Car. All undercarriage components of the Motor Car were also observed to be intact and secured in an appropriate manner.

Photo 4 shows a general view of the engine compartment of the Motor Car at the time of my inspection. The various parts and components inside the engine compartment were all observed to be intact and properly fitted. There was also no sign(s) or indication(s) of fluid leak and/or fluid stain found inside the engine compartment. The brake fluid and engine coolant were all found to be of sufficient level for operating purposes. Visually, there was also no contamination found to these fluids.

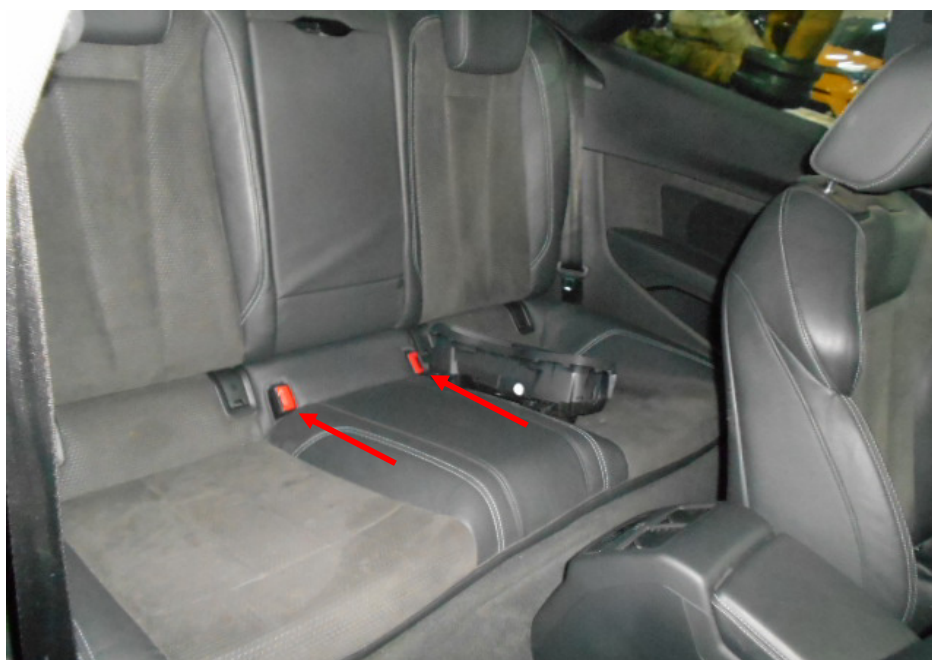
10. The seats of the Motor Car were found to be secured to the floor board of the Motor Car via seat rails bolted onto the floor board. Retractable seat belt reels and pre-tensioners were fitted on all seats of the Motor Car. The seat belt reels were tested and able to be fastened securely into the respective pre-tensioners that were fixed to the side of all the seats.

Photo 5 shows the rear seats of the Motor Car. All the seats of the Motor Car were found to be secured to the floor board of the Motor Car via seat rails bolted onto the floor board. The seats were also fitted with a retractable seat belt reel and pre-tensioner (arrowed). The seat belts were tested and were able to be fastened into the respective pretensions that were fitted on the side of each individual seat.

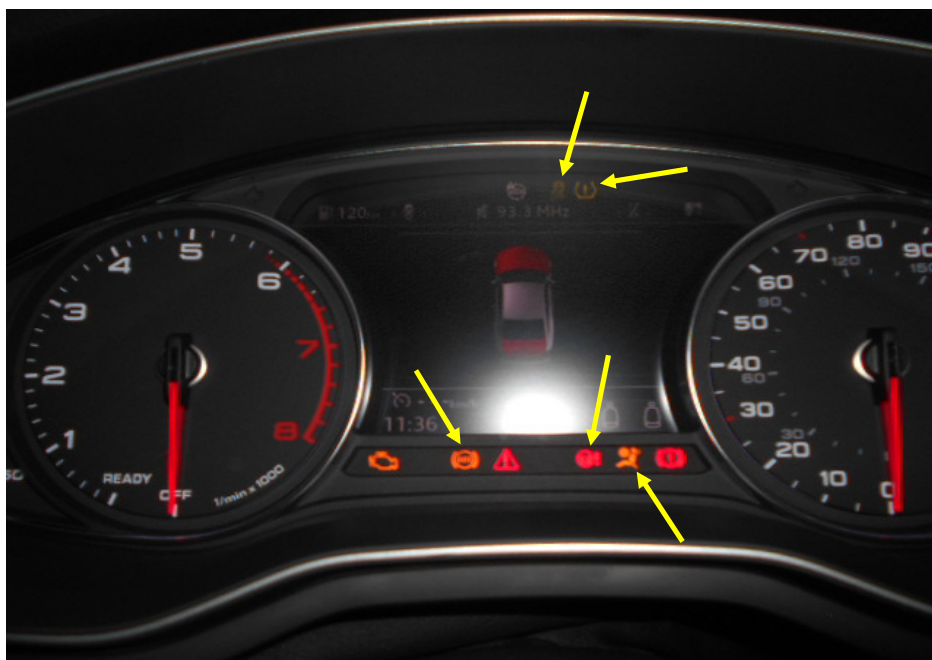
Photo 6 shows the warning lights for the various electronic safety features appearing on the instrument panel of the Motor Car during its self-test when the engine is cranked, in particular the ABS, SRS, TPM, ESC and ESS lights (arrowed).

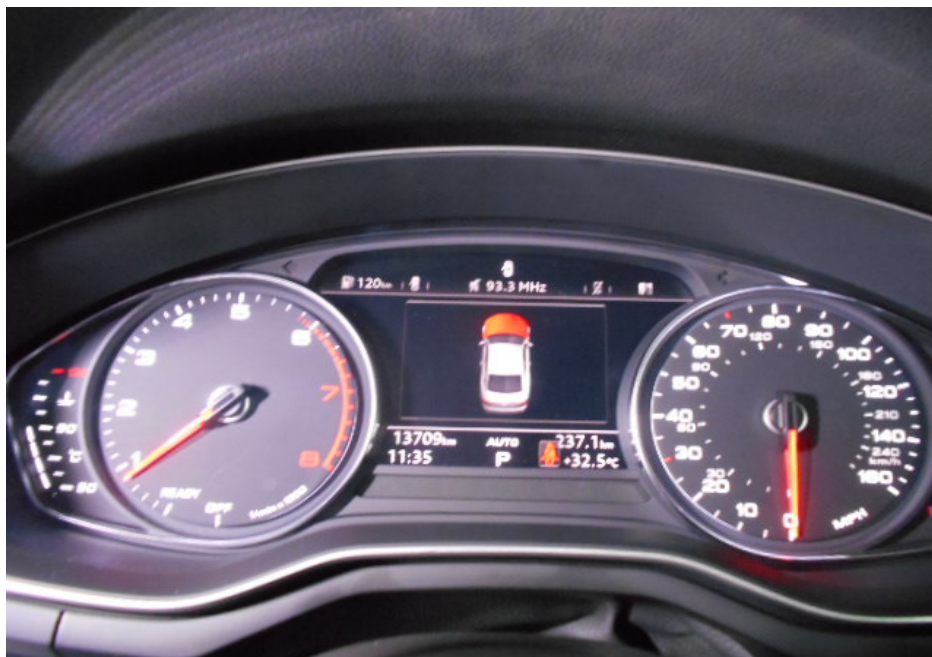
11. The Motor Car's automatic self-test of the functionality of its various electronic safety features like the Anti-Lock Brake System (ABS), Supplemental Restraint System (SRS), Tyre Pressure Monitor (TPM), Electronic Stability Control (ESC) and Electromechanical Steering System (ESS) during cranking of the engine had indicated that these electronic systems were in working condition. This was determined from the respective warning lights disappearing from the instrument panel after the self-test.

Photo 7 shows the respective warning lights no longer illuminated, indicating that there is no fault detected to the ABS, SRS, TPM, ESC and ESS systems of the Motor Car during the self-test. These electronic systems were hence in working condition at the time of my inspection.

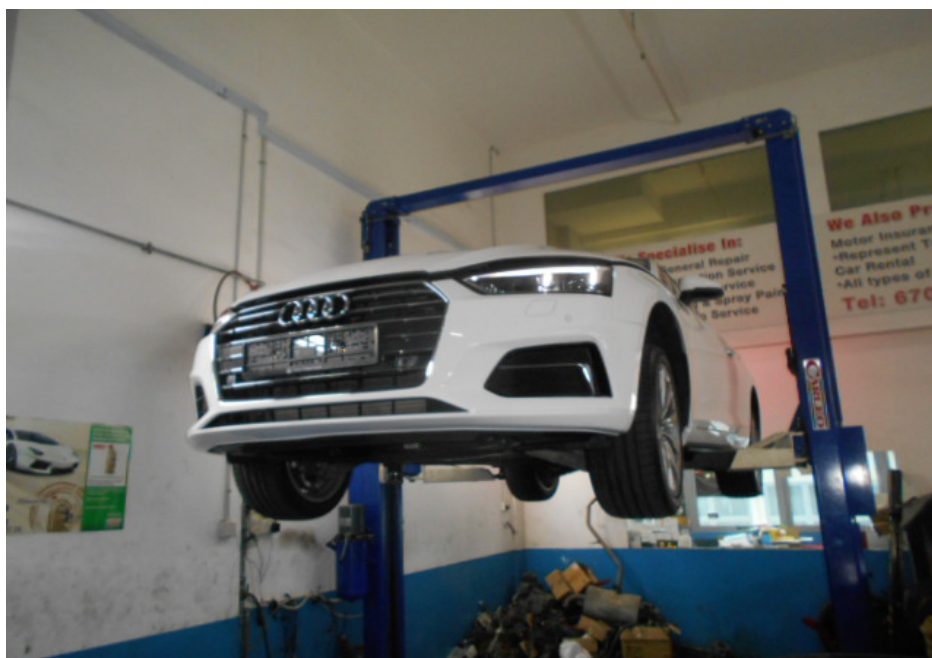
Photo 8 shows the Motor Car hoisted up for checks on its undercarriage. There was no sign(s) or indication(s) of fluid leakage and/or fluid stain(s) on the underside of the Motor Car. The undercarriage components of the Motor Car were also all observed to be intact and secured in an appropriate manner.

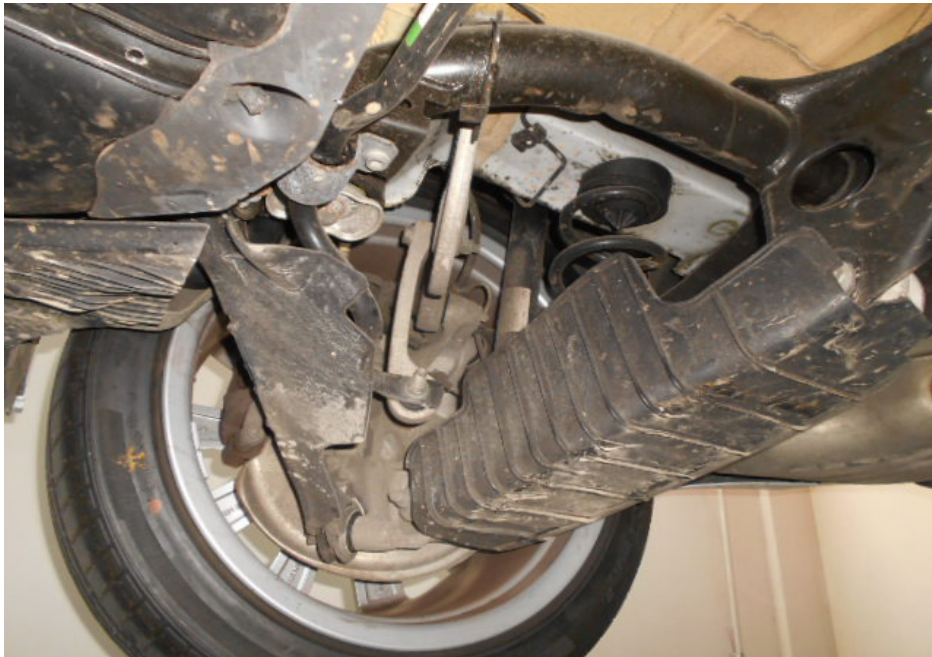
Photo 9 shows a general view of the control arms and linkages at the rear right wheel of the Motor Car. I did not observe any fluid leak and/or fluid stain on the underside of the Motor Car. All of the Motor Car's undercarriage components were observed to be intact and secured in an appropriate manner.

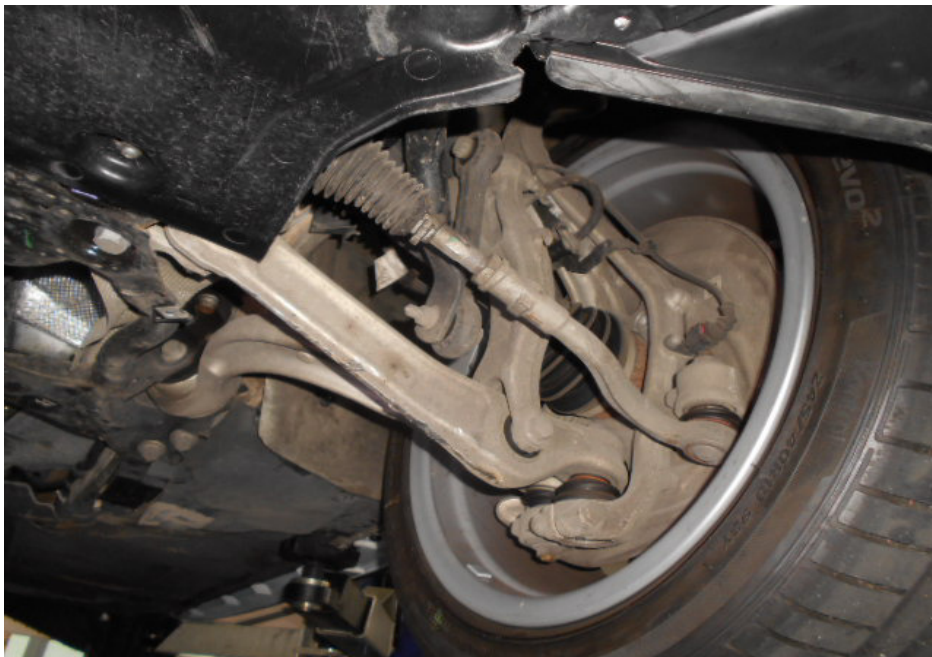
Photo 10 shows the various undercarriage components at the front left wheel of the Motor Car. The mechanical components, control arms and linkages were all found to be intact and secured in an appropriate manner.

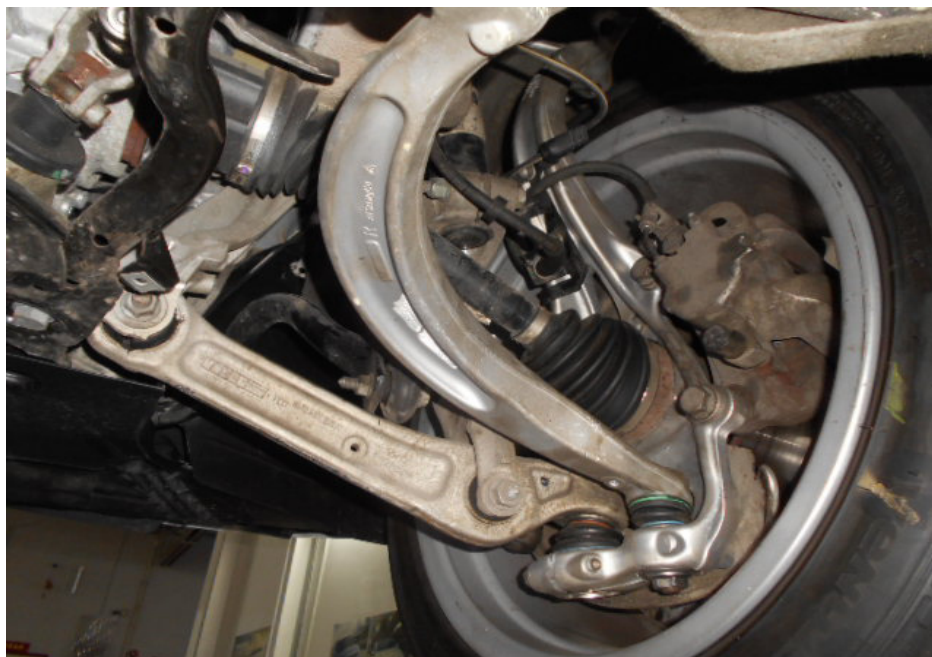
Photo 11 shows the various undercarriage components at the front right wheel of the Motor Car. The mechanical components, control arms and linkages were all found to be intact and secured in an appropriate manner. I also did not observe any fluid leak and/or fluid stain on the underside of the Motor Car.

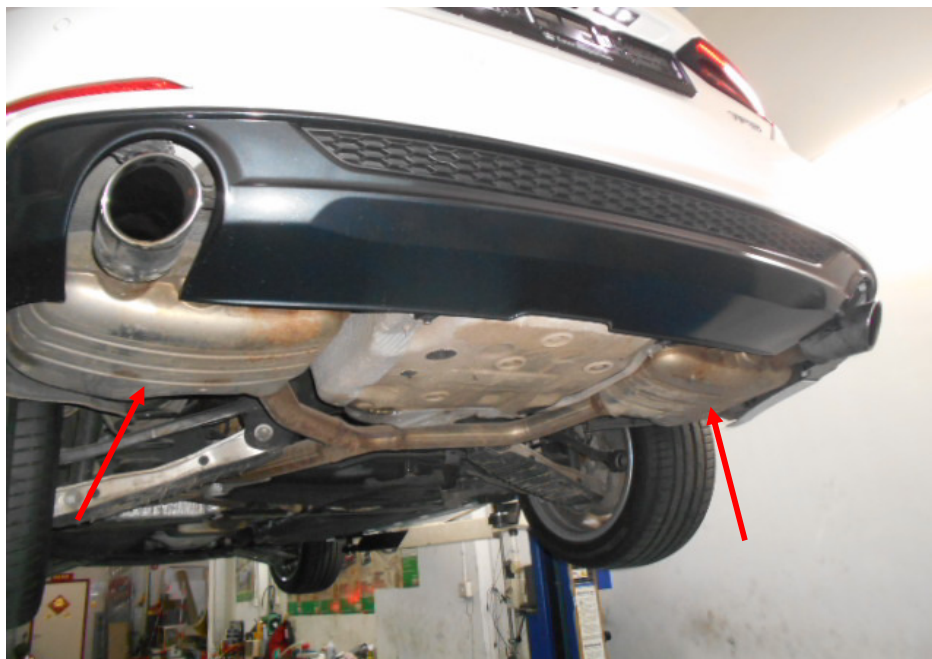
Photo 12 shows the Motor Car's rear exhaust mufflers (arrowed). My examination of the Motor Car's exhaust system revealed no sign(s) or indication(s) of any cut or weld marks along its exhaust pipes and on its rear mufflers.

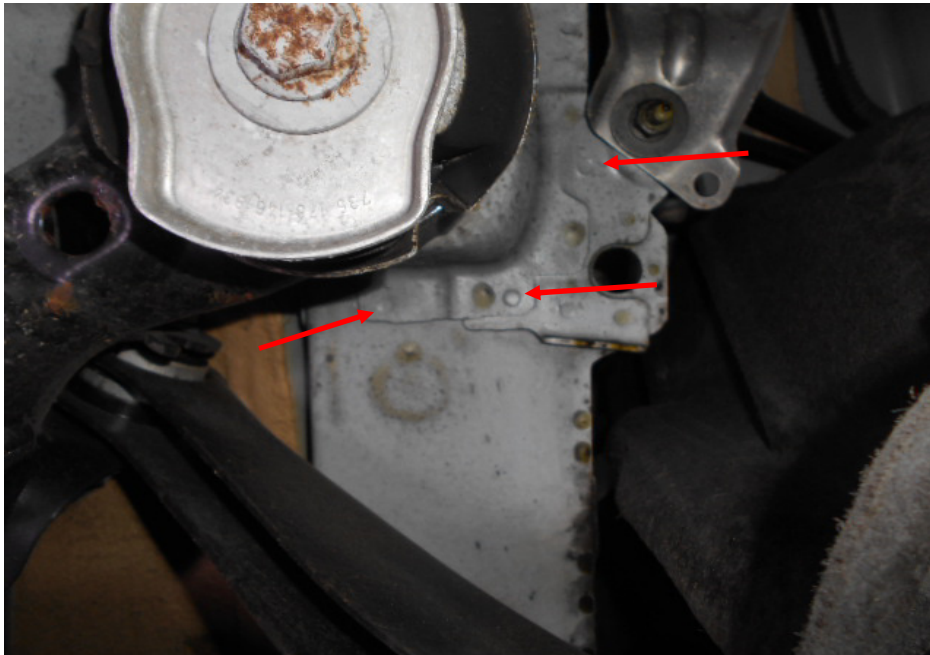
9. Visually, I did not find any weld marks, other than original spot weld marks, on the structure/chassis body of the Motor Car. The original factory sealant at the joints along the structure/chassis body was also untouched, again indicating that no replacement of the chassis body was carried out; and that the structure/chassis body was originally fitted.

Photo 13 shows the structure/chassis body at the rear right underside of the Motor Car. Visually, I did not find any weld marks other than original spot weld marks (arrowed) along the structure/chassis. This would indicate that no work was done on the structure/chassis body of the Motor Car and that the structure/chassis body was originally fitted.

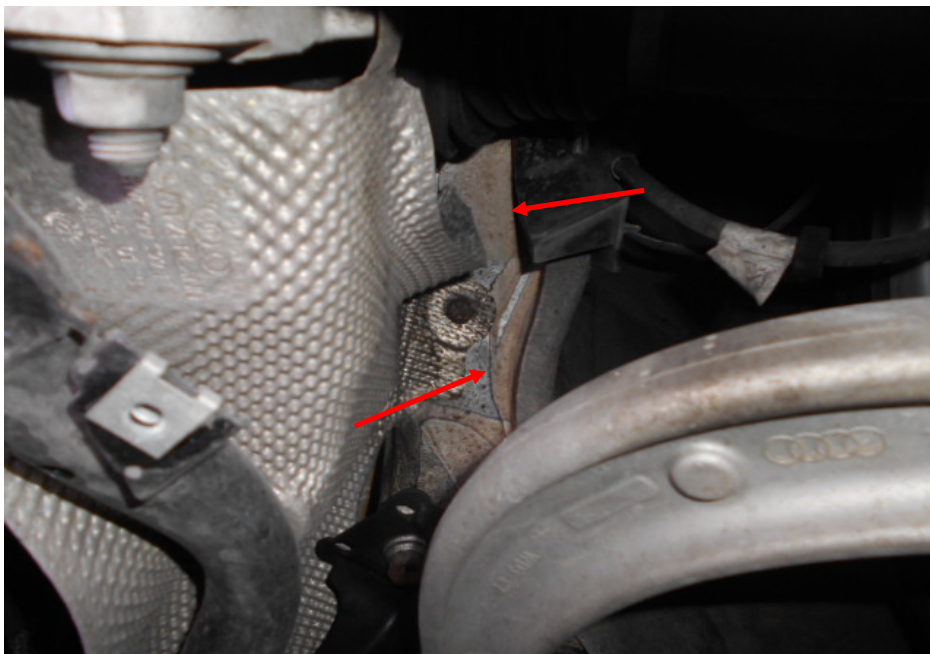
Photo 14 shows the structure/chassis body at the front left underside of the Motor Car. The original factory sealant (arrowed) at the joints along the structure/chassis body was untouched, indicating no work was done on the structure/chassis body of the Motor Car and that the structure/chassis body was originally fitted. Visually, I also did not find any weld marks other than original spot weld marks along the structure/chassis.

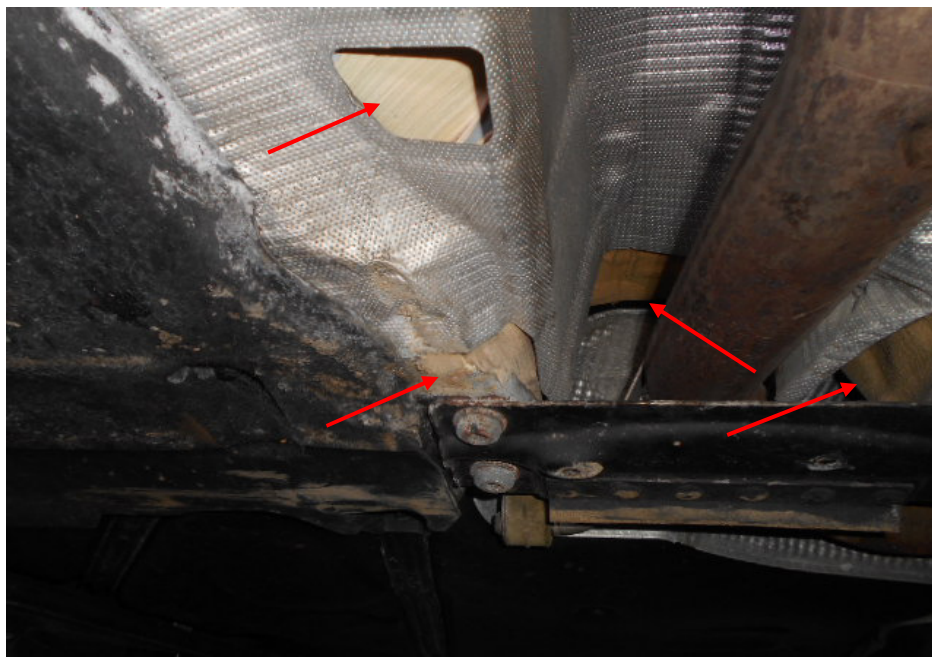
Photo 15 shows the underside centre of the Motor Car. The original factory sealant at the joints (arrowed) along the floor board was observed to be untouched. Generally, I had found no work done on the structure/chassis body of the Motor Car and that the structure/chassis body was originally fitted.
