Your Ref: Mercedes Benz C200  
(chassis number WDD2050422R039528)  
Our Ref : CI/TP19015538/D

03 September 2019

**INSPECTION REPORT OF AN UNREGISTERD MERCEDES BENZ C200  
MOTOR CAR WITH CHASSIS NUMBER WDD2050422R039528**

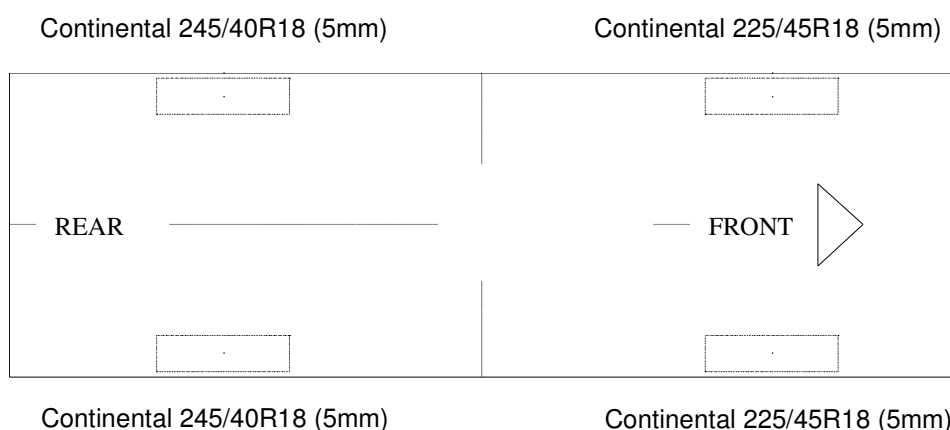
6. It was fitted with 18inch sport wheel rims that were wrapped with tyres that were observed to be of serviceable condition. The tyres were also sufficiently inflated for vehicular operation. The tyre brand, tyre size and approximate remaining tread depth of the 4 tyres of the Motor Car were recorded as follows: -

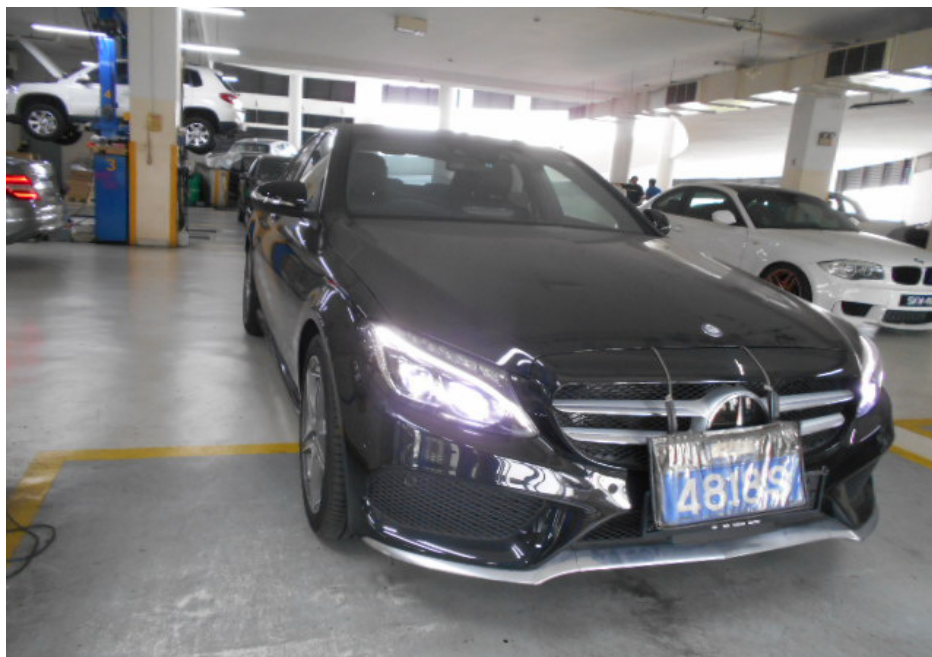
**Photo 1** shows a general view of the front right body of the Motor Car at the time of my inspection. The Motor Car was observed to be in relatively good general condition with no loose exterior fittings observed. The mileage of the Motor Car recorded at the time of my inspection was 8,818km.

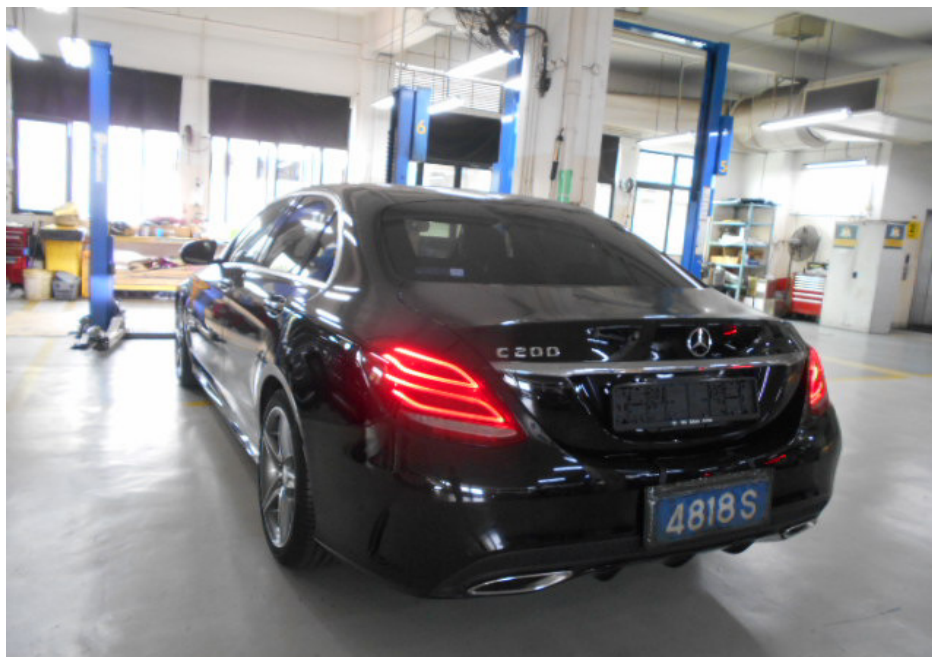
**Photo 2** shows a general view of the rear left body of the Motor Car at the time of my inspection. The Motor Car was observed to be in relatively good general condition with no loose exterior fittings observed.

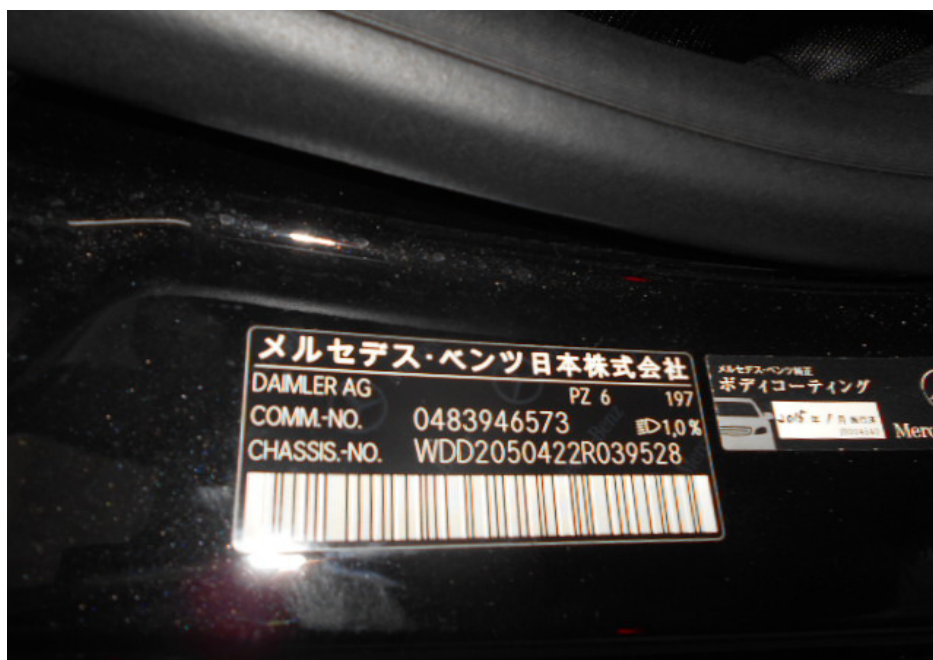
**Photo 3** shows the chassis number of the Motor Car. The chassis number recorded was WDD2050422R039528.

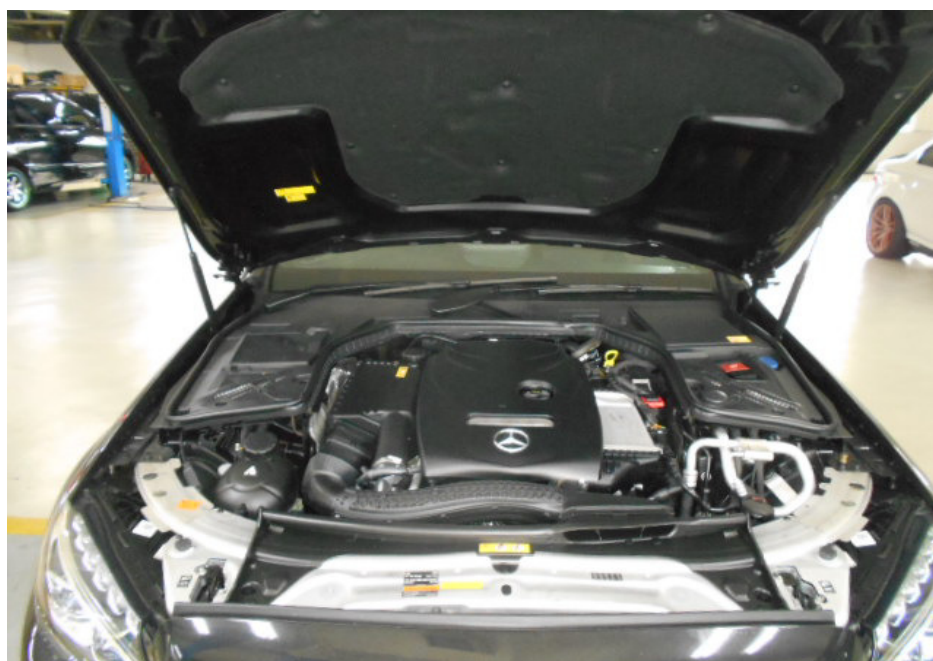
12. My examination of the engine compartment of the Motor Car revealed that the various parts and components inside the engine compartment were all intact and properly fitted. The engine oil, brake fluid and engine coolant were all found to be of sufficient level for operating purposes. Visually, there was also no contamination found to these fluids.
13. My checks on the underside of the Motor Car revealed no sign(s) or indication(s) of fluid leakage and/or fluid stain(s). The engine block and automatic transmission assembly were both secured properly. They were not mounted onto the structure/chassis body or any integral body part of the Motor Car. All undercarriage components of the Motor Car were also observed to be intact and secured in an appropriate manner.

**Photo 4** shows a general view of the engine compartment of the Motor Car at the time of my inspection. The various parts and components inside the engine compartment were all observed to be intact and properly fitted. There was also no sign(s) or indication(s) of fluid leak and/or fluid stain found inside the engine compartment. The engine oil, brake fluid and engine coolant were all found to be of sufficient level for operating purposes. Visually, there was also no contamination found to these fluids.

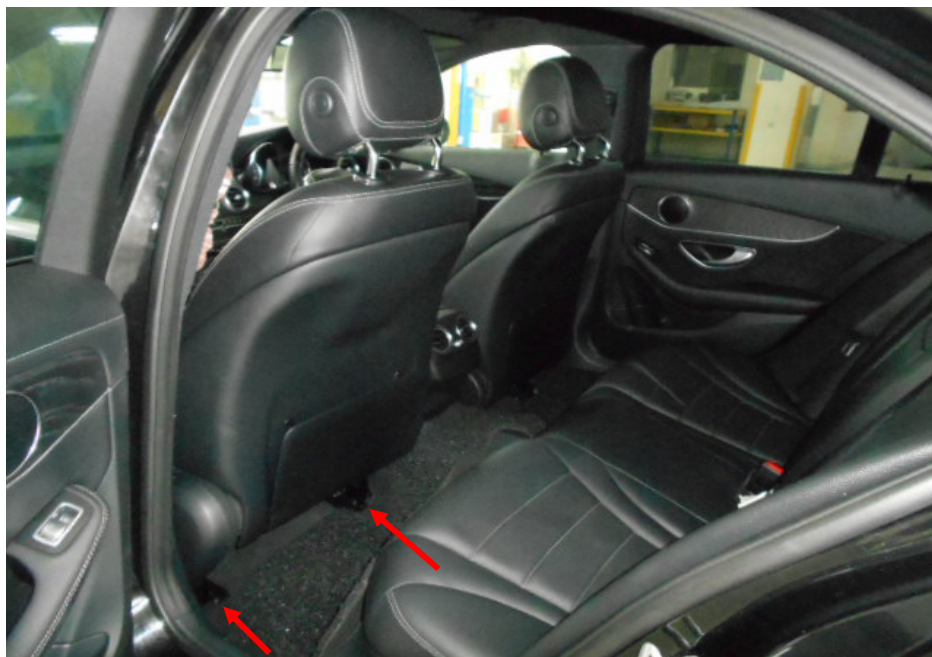
10. The seats of the Motor Car were found to be secured to the floor board of the Motor Car via seat rails bolted onto the floor board. Retractable seat belt reels and pre-tensioners were fitted on all the seats of the Motor Car. The seat belt reels were able to be fastened securely into the respective pre-tensioners that were fixed to the side of all the seats.

**Photo 5** shows the rear seats of the Motor Car. All the seats were secured via seat rails (arrowed) to the floor board. The seats were also individually fitted with a retractable seat belt reel and pre-tensioner. The seat belts were tested and able to be fastened to the pretensioners that were fitted on the side of each individual seat.

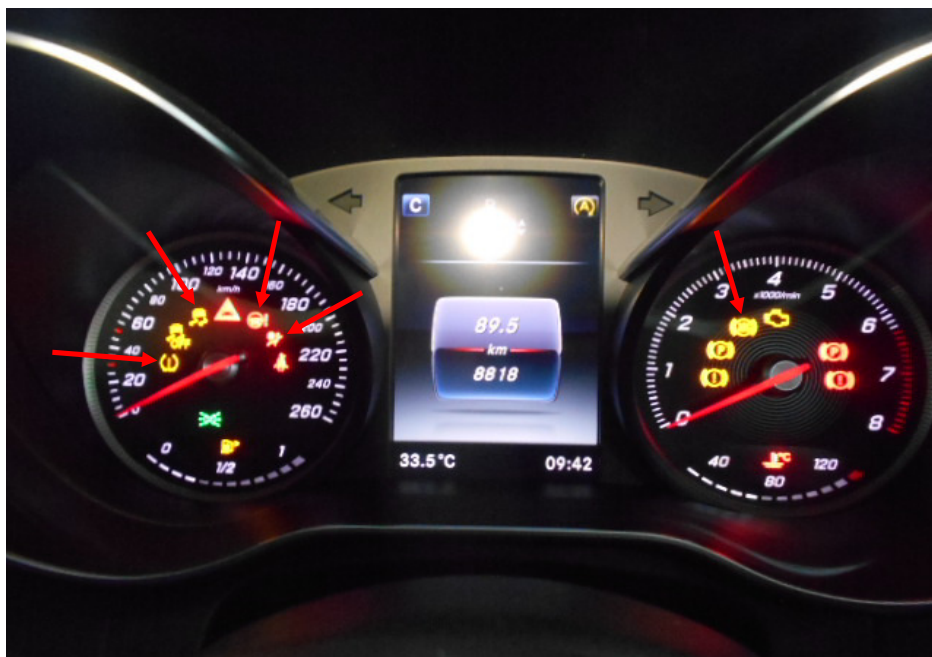
**Photo 6** shows the warning lights for the various electronic safety features appearing on the instrument panel of the Motor Car during its self-test when the engine is cranked, in particular the ABS, SRS, PSA, TPM and TCS lights (arrowed).

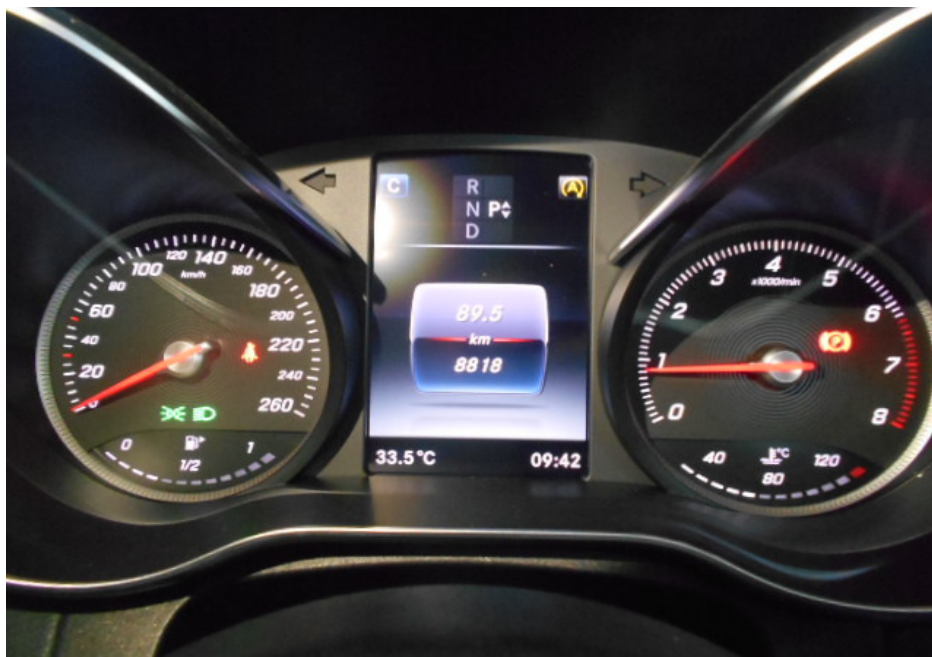
11. The Motor Car's automatic self-test of the functionality of its various electronic safety features like the Anti-Lock Brake System (ABS), Supplemental Restraint System (SRS), Power Steering Assist (PSA), Tyre Pressure Monitor (TPM) and Traction Control System (TCS) during cranking of the engine had indicated that these electronic systems were in working condition. This was determined from the respective warning lights disappearing from the instrument panel after the self-test.

**Photo 7** shows the respective warning lights no longer illuminated, indicating that there is no fault detected to the ABS, SRS, PSA, TPM and TCS of the Motor Car during the self-test. These electronic systems were hence in working condition at the time of my inspection.

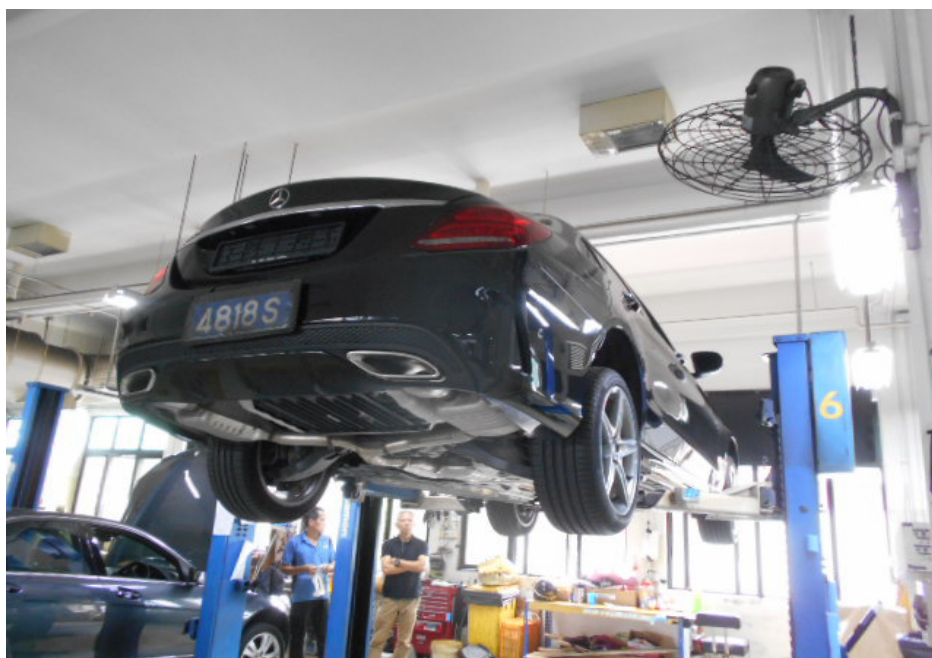
**Photo 8** shows the Motor Car hoisted up for checks on its undercarriage. There was no sign(s) or indication(s) of fluid leakage and/or fluid stain(s) on the underside of the Motor Car. The undercarriage components of the Motor Car were also all observed to be intact and secured in an appropriate manner.

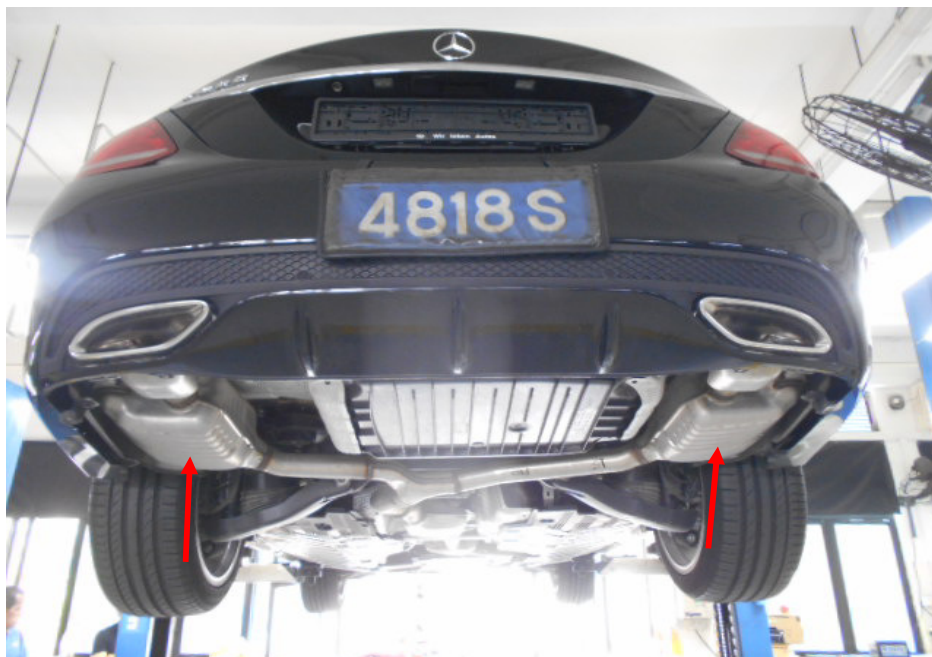
**Photo 9** shows the Motor Car's rear exhaust mufflers (arrowed). My examination of the Motor Car's exhaust system revealed no sign(s) or indication(s) of any cut or weld marks along its exhaust pipes and on its rear mufflers.

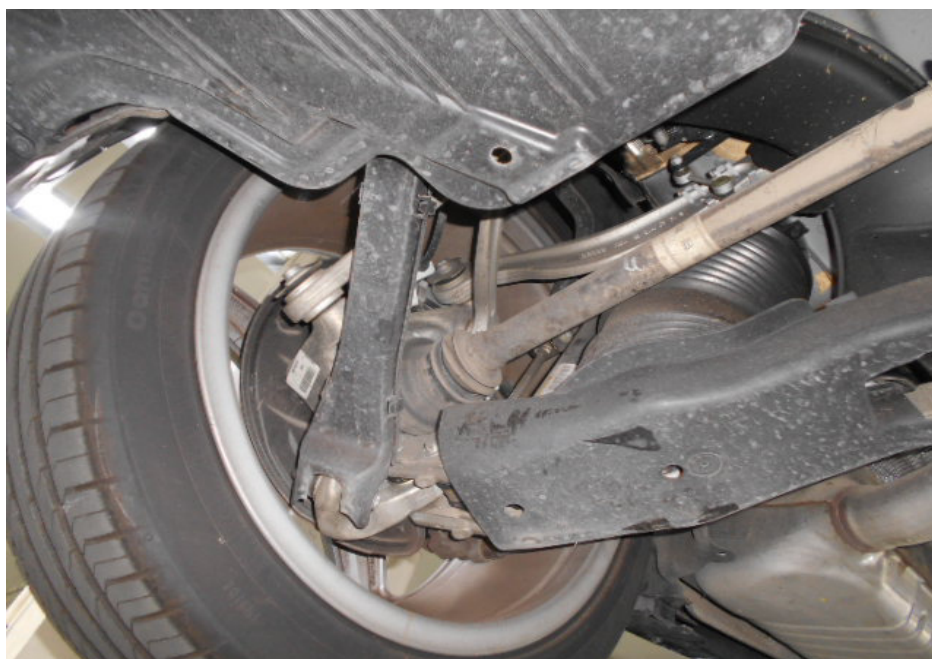
**Photo 10** shows a general view of the control arms and linkages at the rear right wheel of the Motor Car. I did not observe any fluid leak and/or fluid stain on the underside of the Motor Car. All of the Motor Car's undercarriage components were observed to be intact and secured in an appropriate manner.

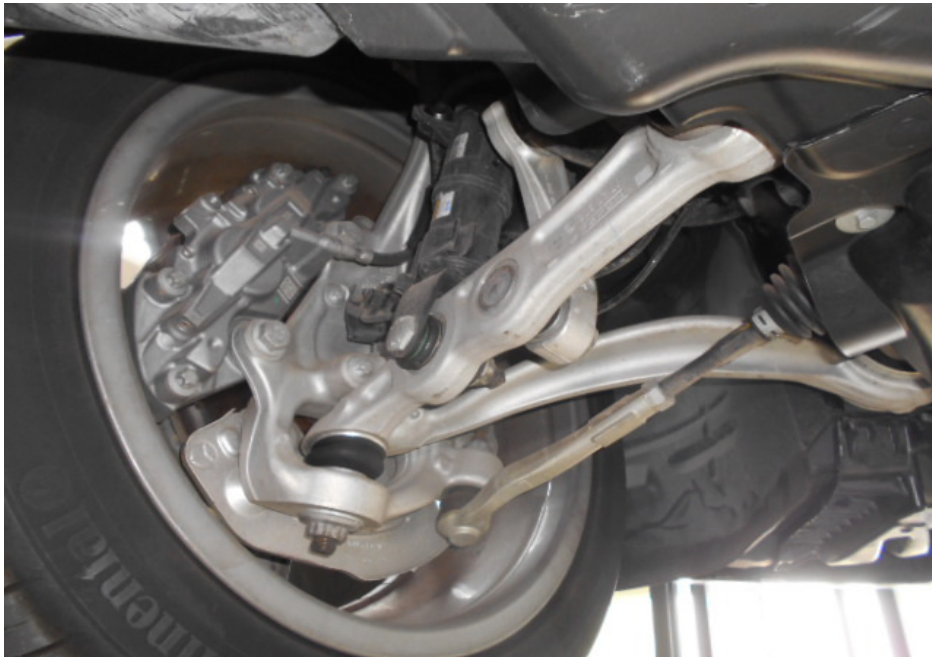
**Photo 11** shows the various undercarriage components at the front left wheel of the Motor Car. The mechanical components, control arms and linkages were all found to be intact and secured in an appropriate manner.

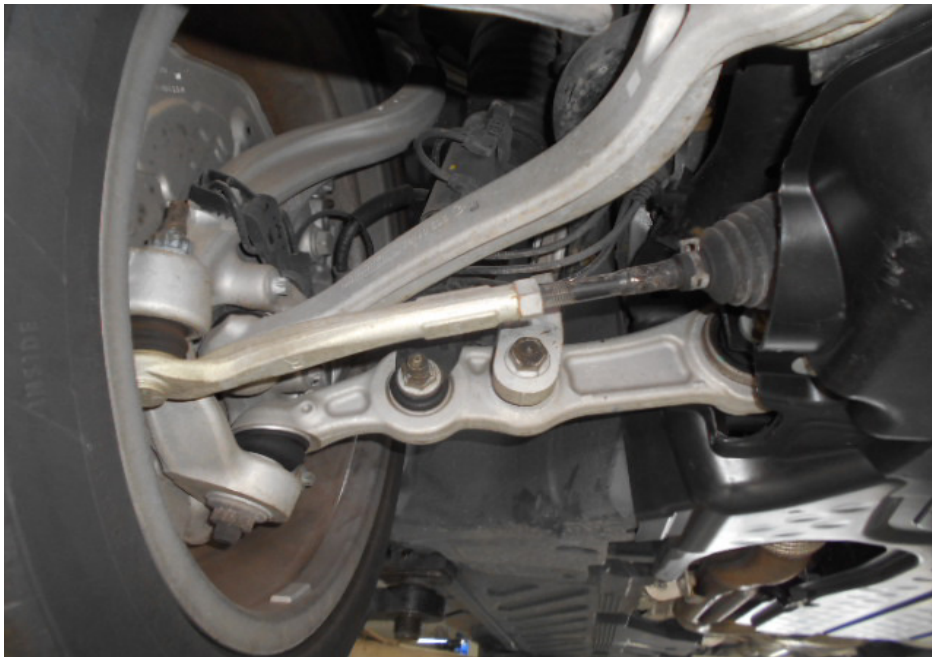
**Photo 12** shows the various undercarriage components at the front right wheel of the Motor Car. The mechanical components, control arms and linkages were all found to be intact and secured in an appropriate manner.

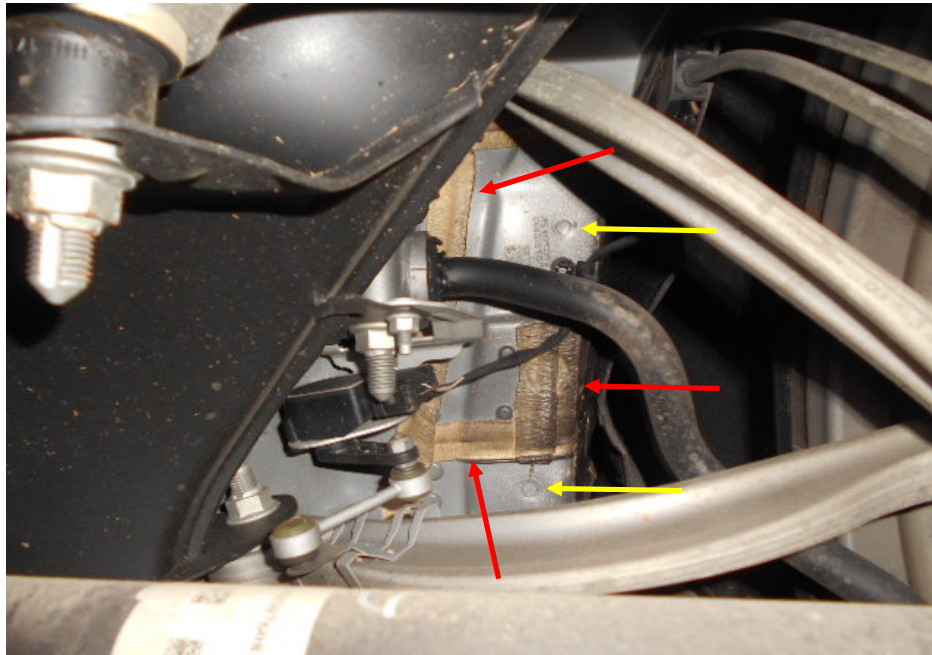
9. Visually, I did not find any weld marks, other than original spot weld marks, on the structure/chassis body of the Motor Car. The original factory sealant at the joints along the structure/chassis body was also untouched, again indicating that no replacement of the structure/chassis body was carried out; and that the structure/chassis body was originally fitted.

**Photo 13** shows the structure/chassis body at the rear left underside of the Motor Car. Visually, I did not find any weld marks other than original spot weld marks (yellow arrow) on the structure/chassis body of the Motor Car. The original factory sealant (red arrow) at the joints along the structure/chassis body was also untouched, indicating no work was done on the structure/chassis body of the Motor Car and that the structure/chassis body was originally fitted.

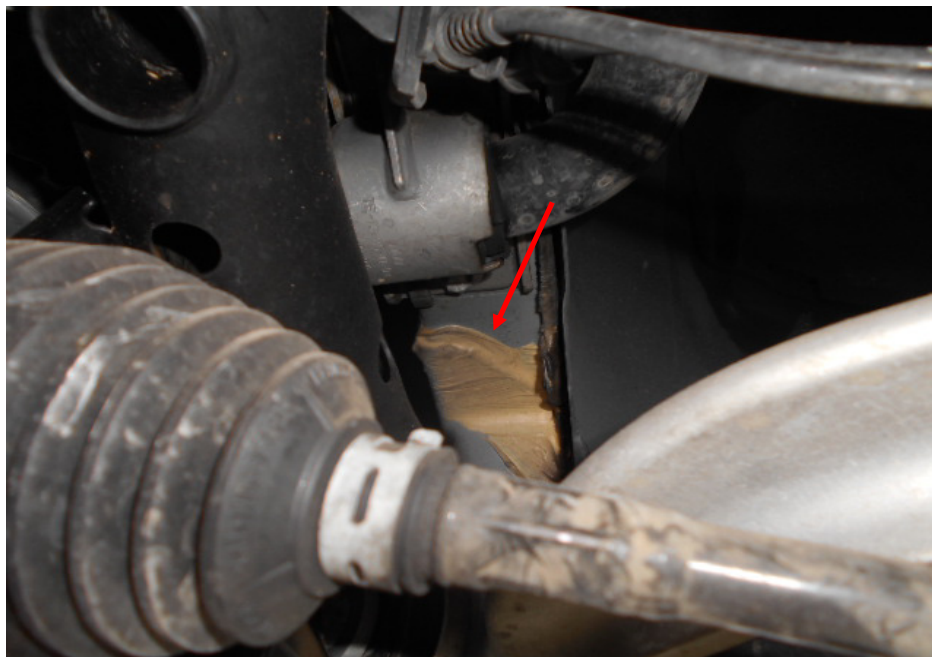
**Photo 14** shows the structure/chassis body at the front right underside of the Motor Car. The original factory sealant (arrowed) at the joints along the structure/chassis body was untouched, indicating that the structure/chassis body of the Motor Car was originally fitted.

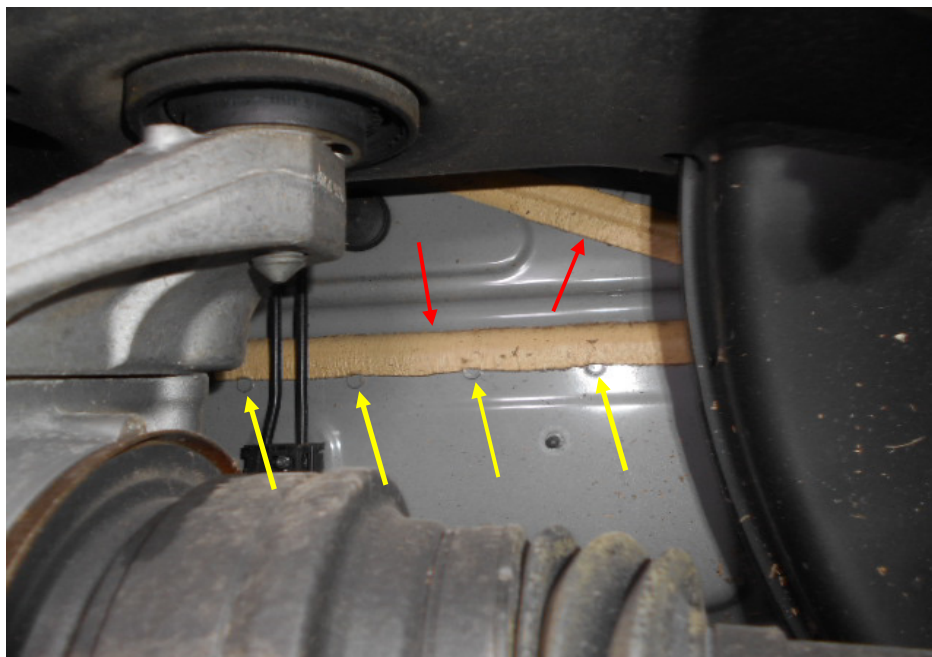
**Photo 15** shows the rear centre underside of the Motor Car. The original factory sealant at the joints (red arrow) along the floor board was observed to be untouched. I also did not find any weld marks other than original spot weld marks (yellow arrow) on the non-detachable body panels of the Motor Car. Generally, I had found no work done on the structure/chassis body of the Motor Car and that the structure/chassis body was originally fitted.

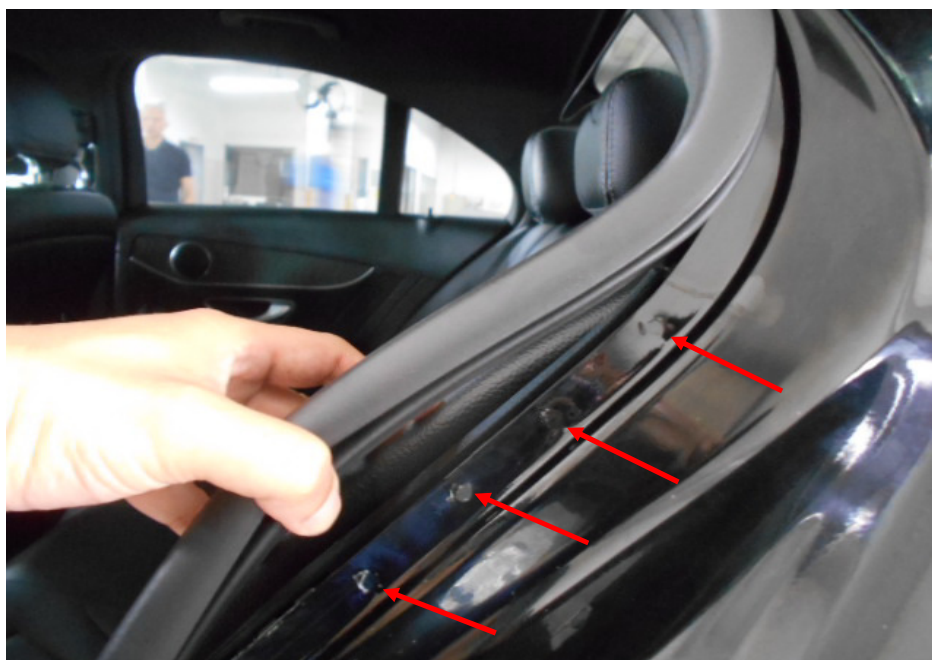
**Photo 16** shows the rear left "C" pillar of the Motor Car. I did not find any weld marks other than original spot weld marks (arrowed) on the body panels of the Motor Car, indicating that there was no re-welding works carried out; and that the non-detachable body panels of the Motor Car were originally fitted.

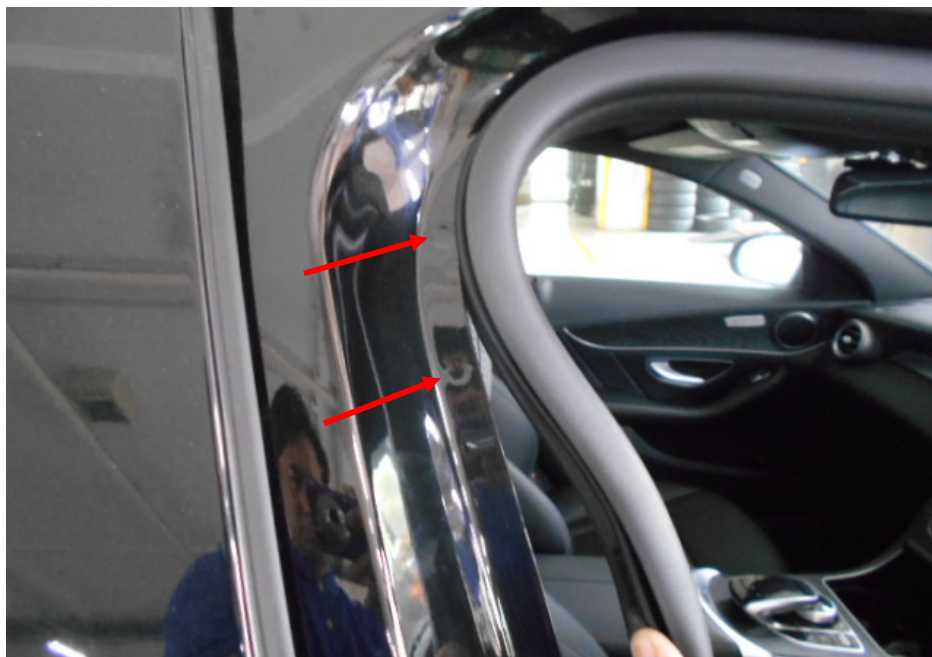
**Photo 17** shows the right “B” pillar of the Motor Car. I did not find any weld marks other than original spot weld marks (arrowed) on the body panels of the Motor Car, indicating that there was no re-welding works carried out; and that the non-detachable body panels of the Motor Car were originally fitted.
