Your Ref : FBN 1804T
Our Ref : CI/TP19015539/D

AUTOMOBILE TECHNICAL REPORT OF A YAMAHA XMAX SCOOTER FBN 1804T

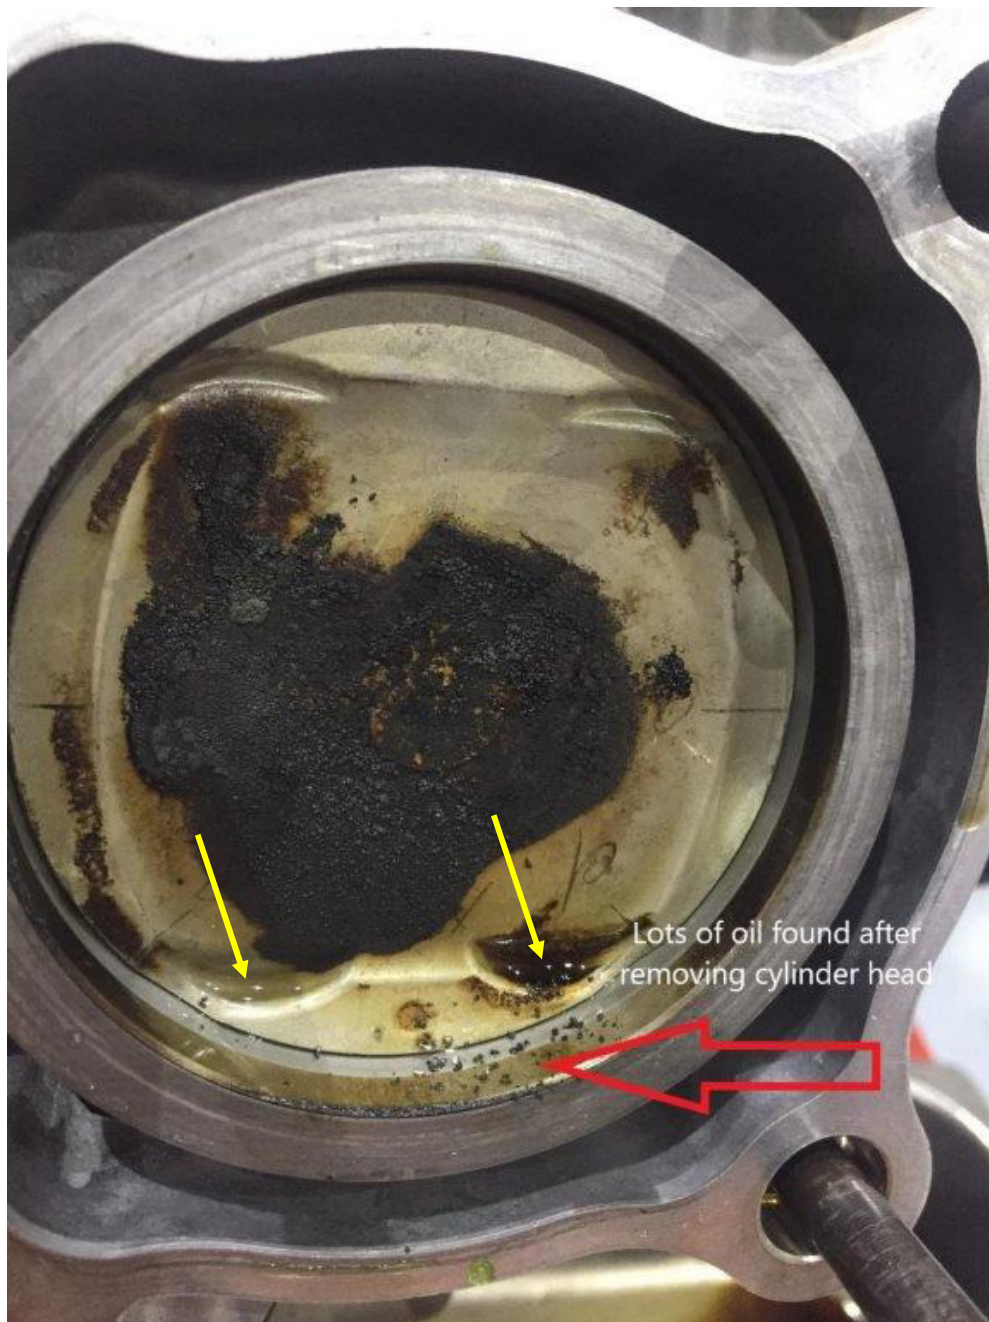
4. Firstly, photographs taken by Hong Leong Corporation Holdings Pte Ltd had showed engine oil accumulation at the piston crown after the engine top block of the Scooter was separated from its engine lower block. The presence of engine oil at the piston crown is an indication that engine oil had seeped into the combustion chambers of the Scooter's engine. See photo 1 below.

Photo 1 shows the engine oil accumulation (yellow arrow) at the piston crown after the engine top block of the Scooter was separated from its engine lower block (photograph taken by Hong Leong Corporation Holdings Pte Ltd during their checks of the Scooter). The presence of engine oil at the piston crown is an indication that engine oil had seeped into the combustion chambers of the Scooter's engine.

6. The engine oil, accumulated at the piston crown, will eventually burn off during engine combustion (when the engine is in operation). The seepage of engine oil into the combustion chambers of the Scooter, and thereafter getting burned off through engine combustion, was the reason for the abnormal loss of engine oil. However, this process needs to occur over a period of time for the engine oil to reach a level of reduction where the owner will be able to reasonably notice.

15. The accumulation of engine oil found at the piston crown of the Scooter is an indication that engine oil had seeped into the combustion chamber when the engine was not in operation. As previously commented in paragraph 6 above, when the engine is in operation, engine oil that had seeped into the combustion chamber will burn off through engine combustion without leaving any accumulation. In other words, if the Scooter is supported on its centre stand with its engine in operation, engine oil will not seep into the combustion chamber as the various mechanical parts inside the engine expands due to heat.

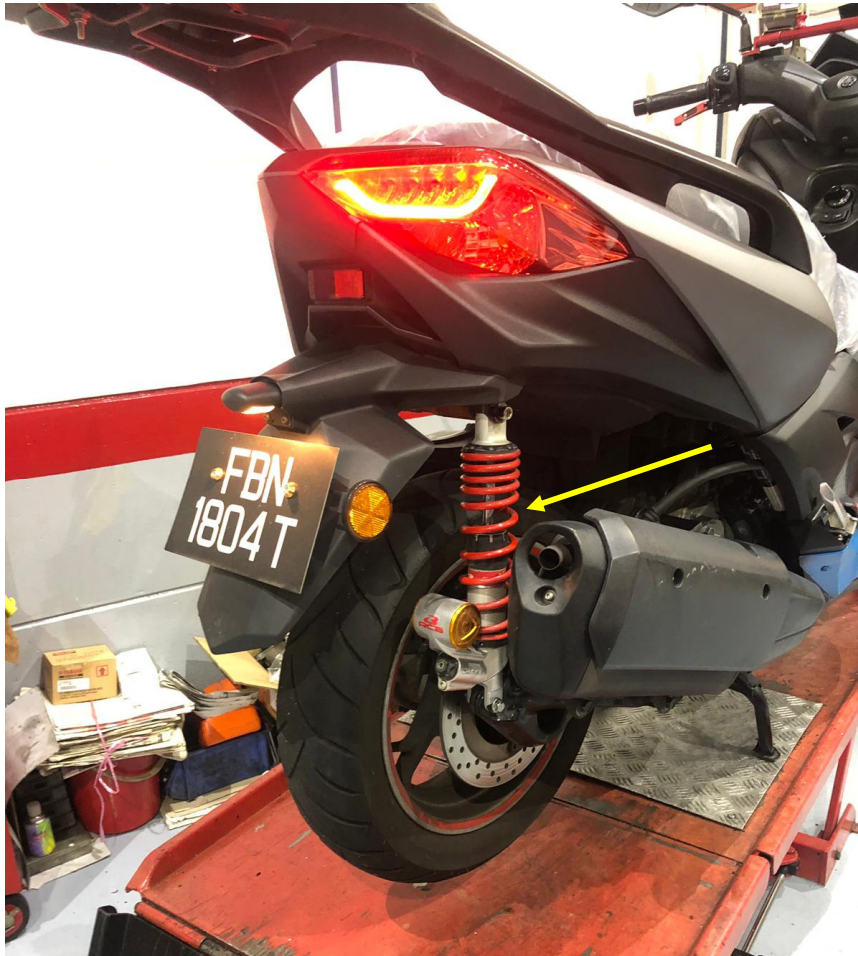
Photo 2 shows the rear right shock absorber (arrowed) of the Scooter (photograph taken by Hong Leong Corporation Holdings Pte Ltd during their checks of the Scooter). The rear shock absorbers fitted on the Scooter were non-original. Refer to photo 4 below for comparison.

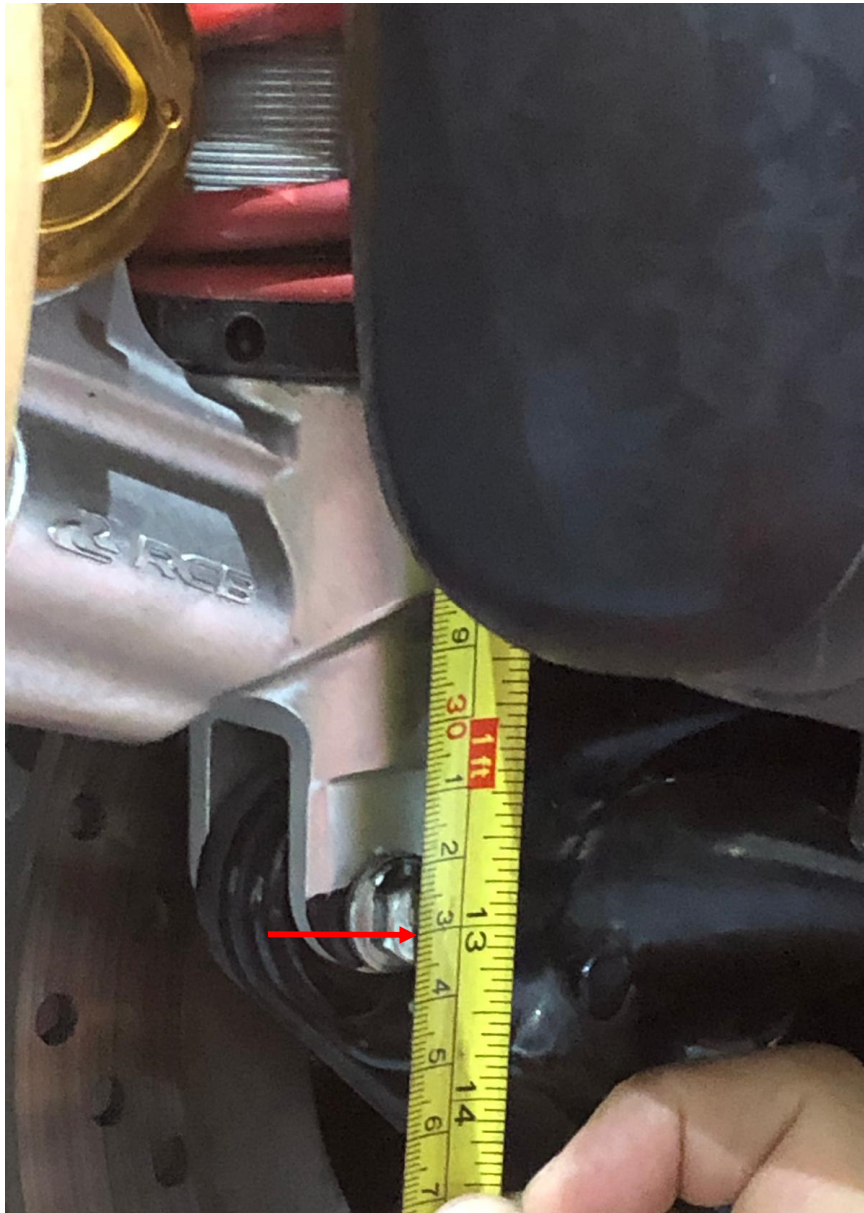
7. The photographs taken by Hong Leong Corporation Holdings Pte Ltd had also showed that the rear shock absorbers fitted on the Scooter were non-original. Measurements carried out revealed that the height of the non-original rear shock absorbers of the Scooter was 2cm shorter as compared with the height of an original rear shock absorbers. See photo 2 – 5 below.

Photo 3 shows measurement of the rear right shock absorber of the Scooter. The height of the non-original rear shock absorbers was measured to be 33cm (arrowed). This was 2cm shorter as compared to the height of an original rear shock absorbers. Refer to photograph 5 below.

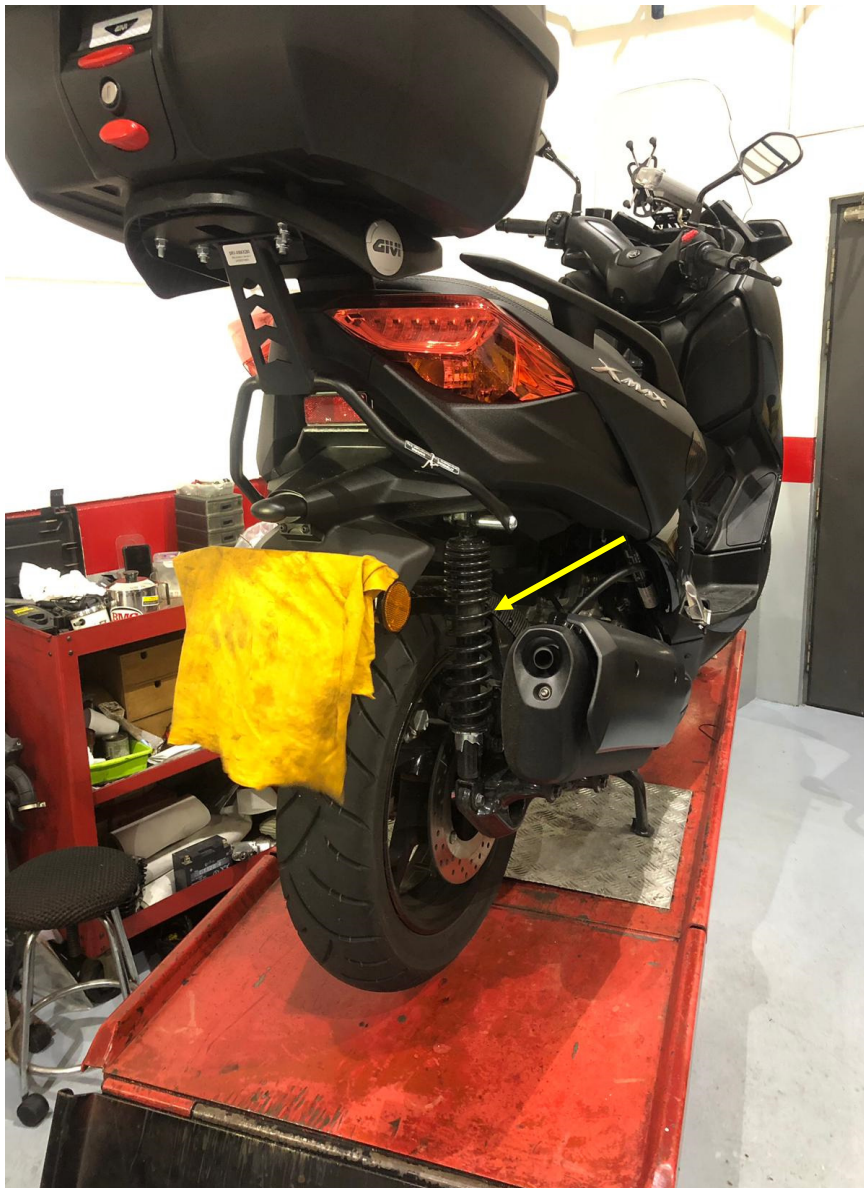
Photo 4 shows the rear right shock absorber (arrowed) of a similar make and model scooter as the Scooter for comparison purposes (photograph taken by Hong Leong Corporation Holdings Pte Ltd during their checks of the Scooter). The rear shock absorbers fitted on the Scooter were non-original. Refer to photograph 2 above

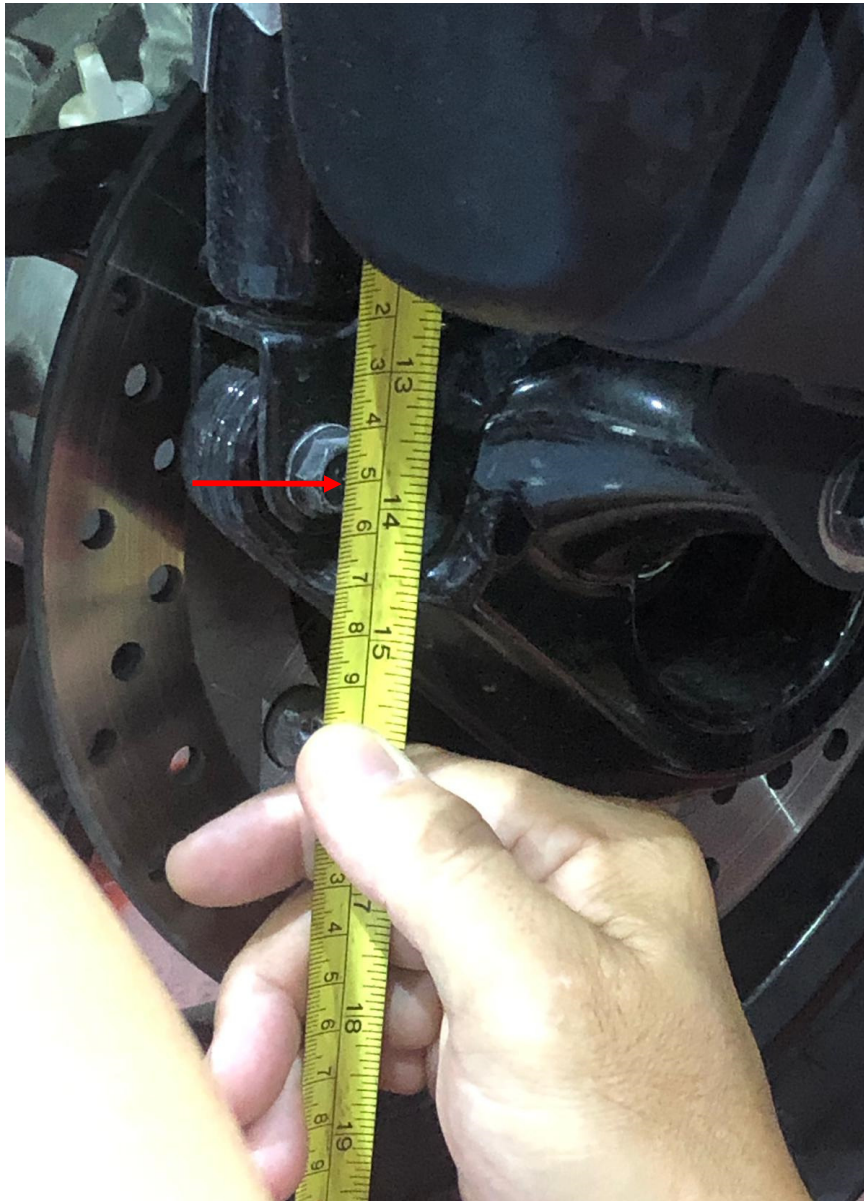
Photo 5 shows measurement of the rear right shock absorber of the similar make and model scooter as the Scooter. The height of an original rear shock absorbers was measured to be 35cm (arrowed). The non-original rear shock absorbers fitted on the Scooter was 2cm shorter as compared to the height of an original rear shock absorbers. Refer to photograph 3 above.

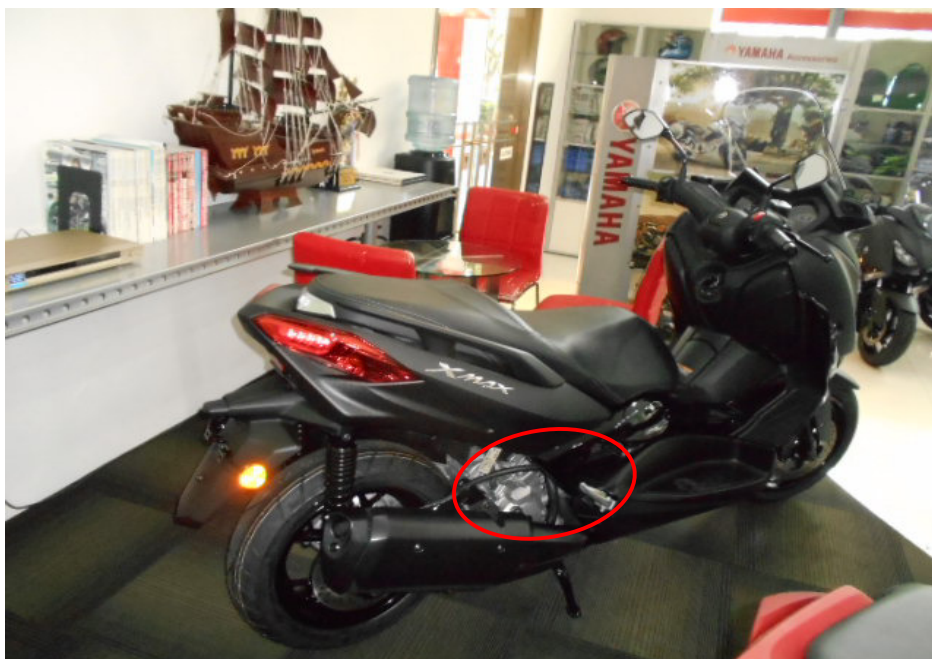
9. Notably, it was observed that the engine of the similar make and model scooter was tilted slightly upwards at the engine front block when the centre stand is applied/engaged. In other words, from a side view perspective, the engine front block is higher than the engine rear block, above ground level. The engine oil sump was observed to be fitted onto the end of the engine rear block, and is the lowest part of the engine, above ground level. See photo 6 – 8 below.

Photo 6 shows a similar make and model scooter as the Scooter. The engine area is highlighted by the red circle. From my observations, the engine of the Scooter was a horizontal incline engine. The mechanical components inside a horizontal incline engine are all horizontally aligned. When the centre stand is applied/engaged, I had observed that the engine front block is tilted slightly upwards.

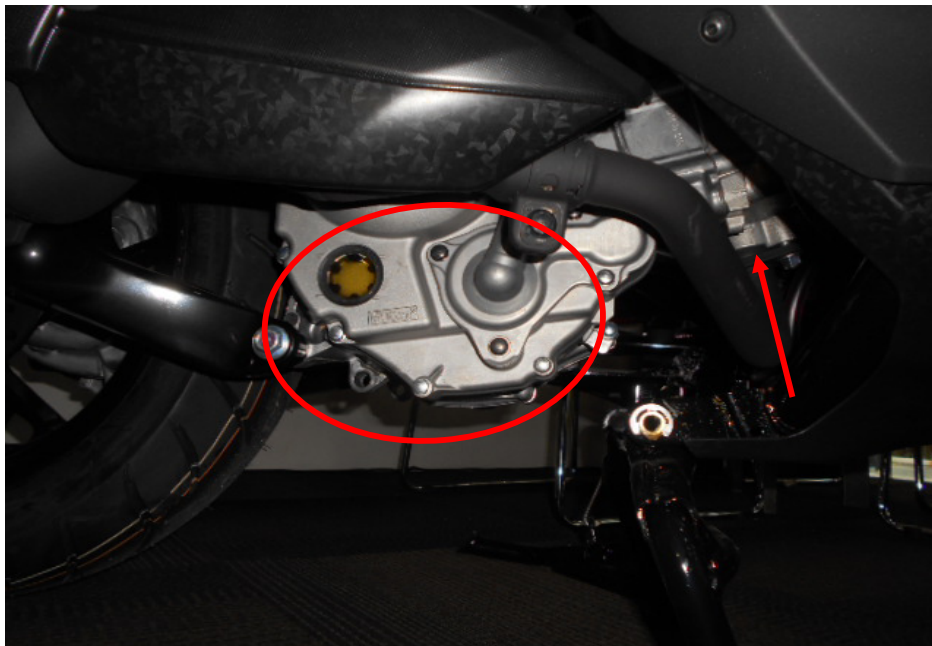
Photo 7 shows a closer view of the engine of a similar make and model scooter as the Scooter. From a side view perspective, the engine front block (arrowed) is higher than the engine rear block, above ground level. The engine oil sump (circled), fitted onto the end of the engine rear block, is the lowest part of the engine, above ground level. In general, the engine was tilted slightly upwards at the engine front block.

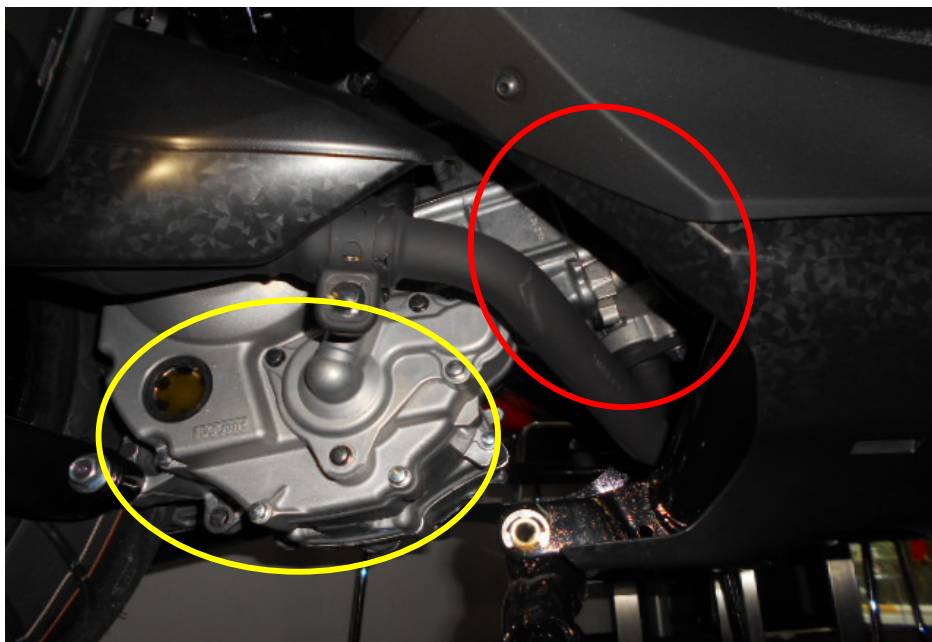
Photo 8 shows a closer view of the engine of a similar make and model scooter as the Scooter. From a side view perspective, the engine front block (red circle) is higher than the engine rear block, above ground level. The engine oil sump (yellow circle), fitted onto the end of the engine rear block, is the lowest part of the engine, above ground level.

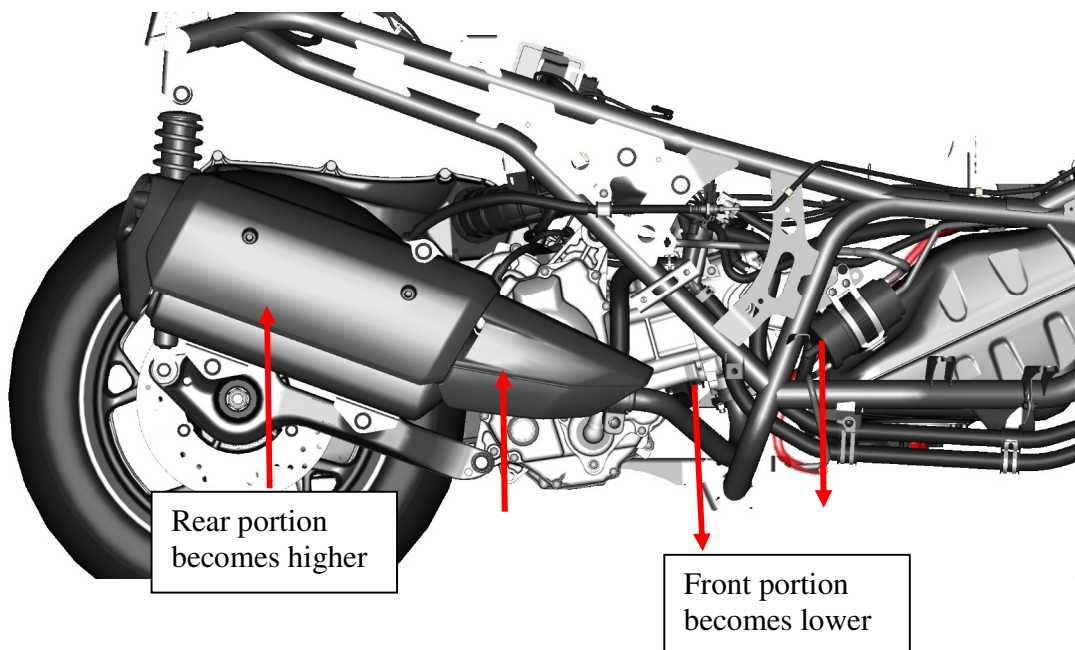
11. When the rear portion of the Scooter becomes higher, the engine oil sump also becomes higher above ground level as compared to a similar make and model scooter that is fitted with original rear shock absorbers. When this occurs, the engine front block will correspondingly tilt downwards from its original upward angled tilt position. In other words, instead of a slight upward tilt at the engine front block, the position of the engine will be altered from its original position, where the entire engine of the Scooter becomes more parallel to ground. See illustration below.

12. The engine oil sump of the Scooter, fitted onto the end of the engine rear block and originally lower in height to the engine front block, now becomes more similar in height above ground level with the engine front block due to the shorter non-original rear shock absorbers. This allows the engine oil to flow towards the engine front block when the centre stand of the Scooter is applied/engaged. Some engine oil could then seep into the piston crown area through gaps between the piston ring and the walls of the combustion chambers when the piston ring and piston contracts after the engine of the Scooter is cooled down.
