Your Ref: S9M01SZX
Our Ref : CI/ASM19015583/P

1st October 2019

**TECHNICAL INVESTIGATION REPORT OF MECHANICAL INCIDENT
INVOLVING THE INSURED VEHICLE XE 1588D ON 01 JULY 2019**

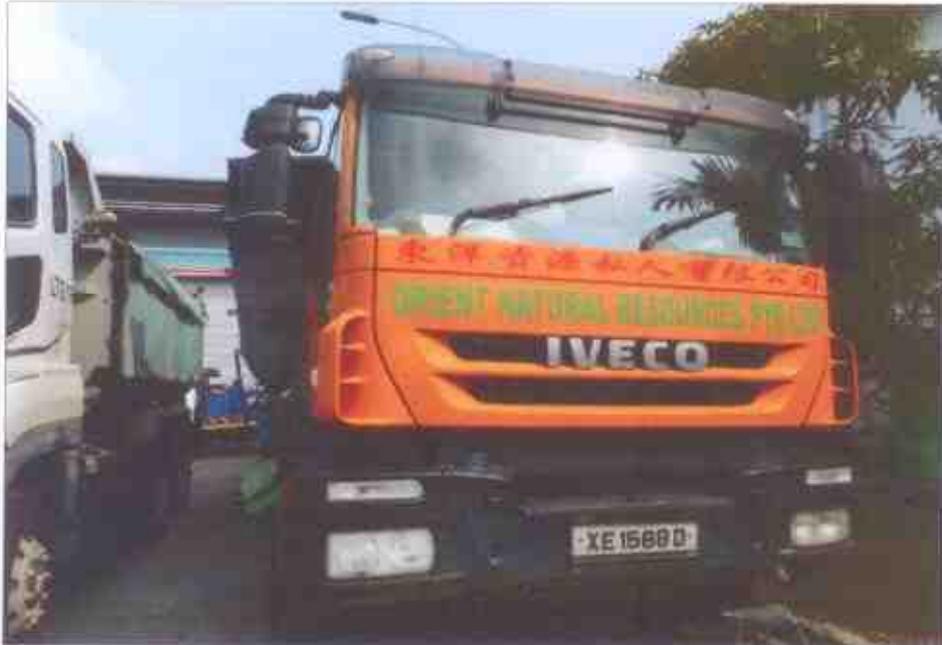
Photo 1 shows the front view of the Insured Vehicle at the time of our inspection. The driver's cabin of the Insured Vehicle was relatively unaffected by the mechanical damage.

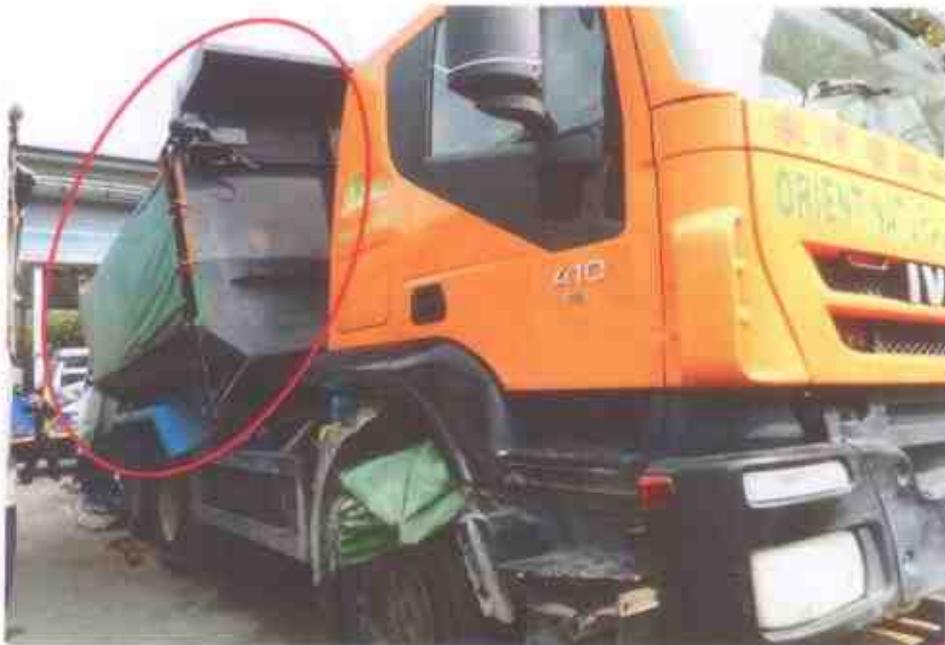
Photo 2 shows the right side view of the Insured Vehicle at the time of our inspection. The rear tipper of the Insured Vehicle was observed to be tilted to the right side. (circled).

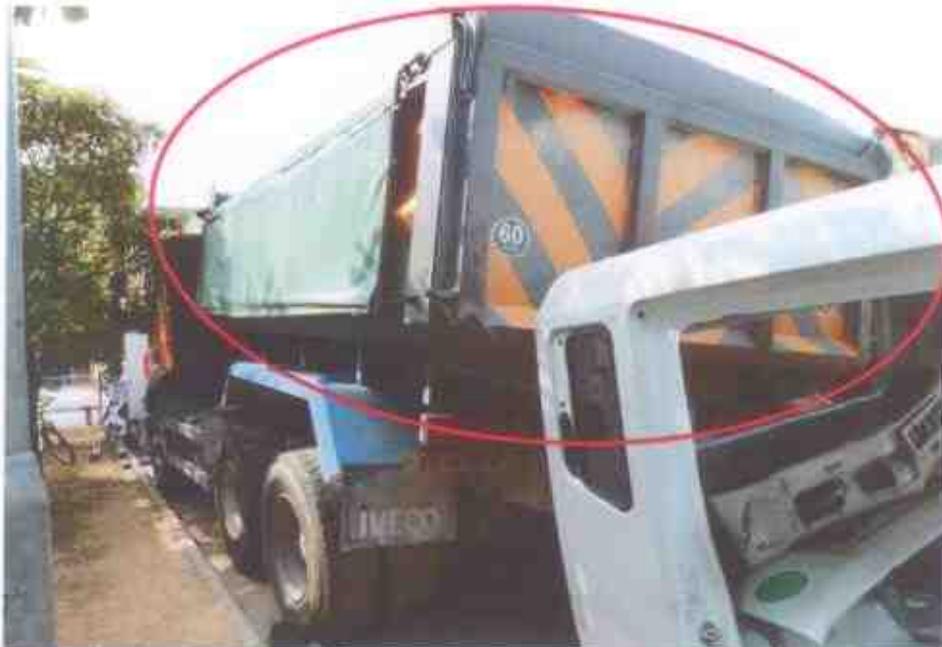
Photo 3 shows the rear left view of the Insured Vehicle at the time of our inspection. The rear tipper of the Insured Vehicle was observed to be tilted to the right side. (circled).

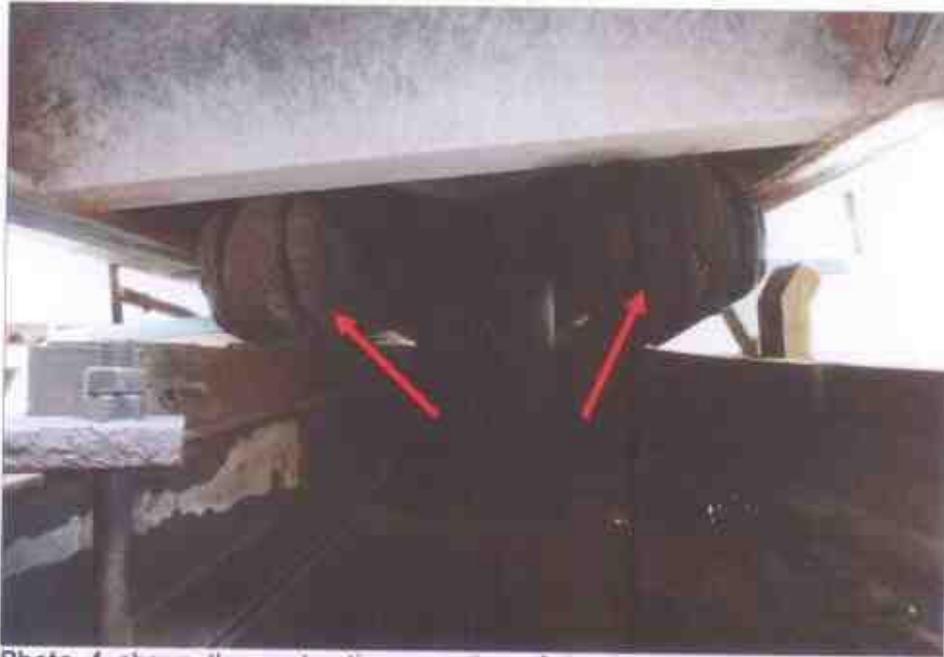
7. For this particular case, the mechanical damage appears to have originated at the centre tipper portion of the Insured Vehicle, where the tipper container and chassis are located at and the damage can be observed to be at the hoisting assembly of the Insured Vehicle. This can be determined from the damage of the hoisting frame components which were observed to have been bended as a result of the accident. See photos 4 - 6 below.

Photo 4 shows the centre tipper portion of the Insured Vehicle, where the hoisting assembly and hoisting frame are located and tilted to one side and the damage was confined to these particular areas (arrowed).

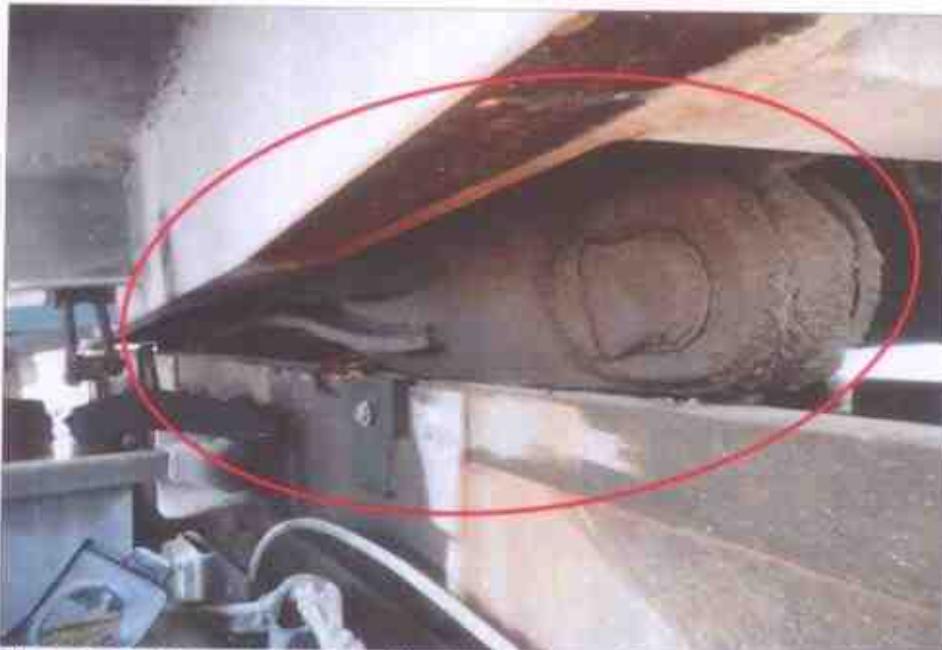
Photo 5 shows a general view of the hoisting frame. The various components of the frame assembly were observed to have been tilted and bend out of place (circled).

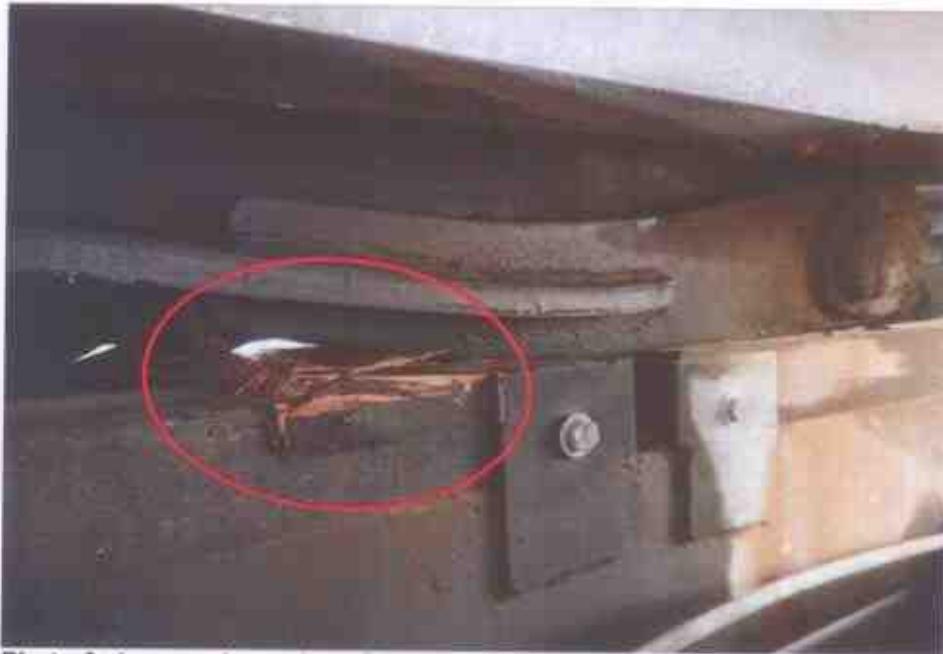
Photo 6 shows a closer view of the hoisting frame. The components of the frame assembly were observed to have been tilted, bend out of place and contacted and causing damage onto the chassis (arrowed) of the Insured Vehicle.

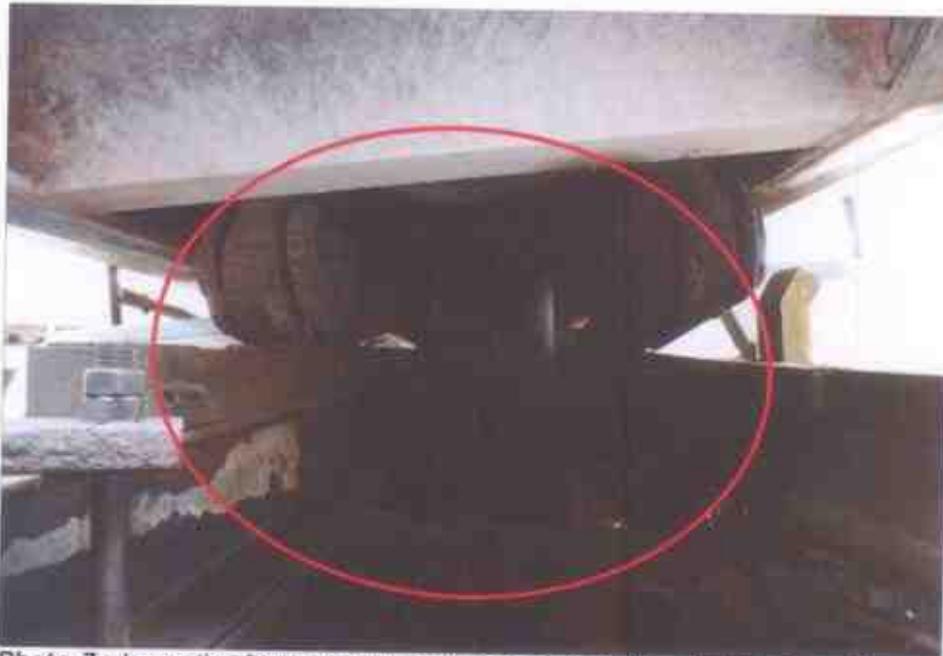
8. Upon closer examination of the centre tipper portion of the Insured Vehicle where the damage was confined to, we had found traces of hydraulic fluid residue on the Insured Vehicle's chassis leading from the hydraulic cylinder as well as on the hoisting frame of the of the Insured Vehicle. The leak of hydraulic fluid leaks is likely due to the broken seal in the hydraulic cylinder. This physical evidence would then appear to suggest that the cause of damage to the Insured Vehicle could have possibly been due to mechanical malfunction in nature. See photos 7 - 9 below.

Photo 7 shows the front general view of the hydraulic cylinder of the Insured Vehicle. We observed traces of hydraulic fluid residue on the hydraulic cylinder and the various components around it (circled). This physical evidence would then appear to suggest that the cause of damage to the Insured Vehicle could have possibly been due to mechanical malfunction in nature.

21. Having investigated and technically analysed the damages to the Insured Vehicle, we are of the view that the cause of damage to the Insured Vehicle was of mechanical malfunction. For this particular case, the mechanical malfunction had originated along the original factory fitted hoist cylinder from the Insured Vehicle.
22. We did not find any evidence which had suggested that the cause of damage to the Insured Vehicle was due to poor maintenance and/or recurring problem.
23. We did not find any evidence which had suggested that the cause of damage to the Insured Vehicle was due to overloading factor as the load it was carrying at the time of incident did not exceed the maximum load permitted.

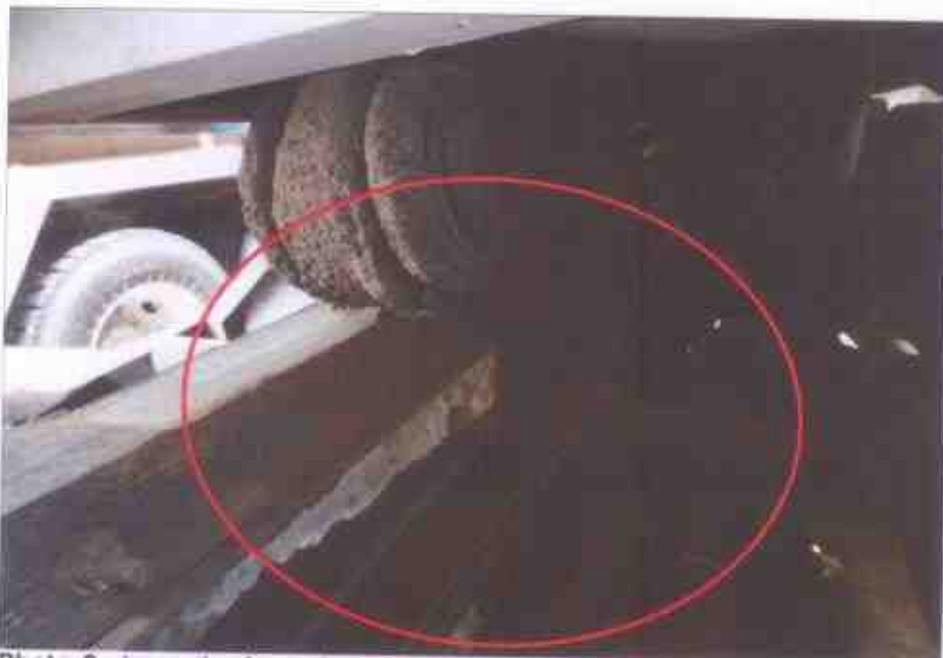
Photo 8 shows the front close up view of chassis of the Insured Vehicle. We observed traces of hydraulic fluid residue on the chassis itself and the various components around it (circled). This physical evidence would then appear to suggest that the cause of damage to the Insured Vehicle could have possibly been due to mechanical malfunction in nature.

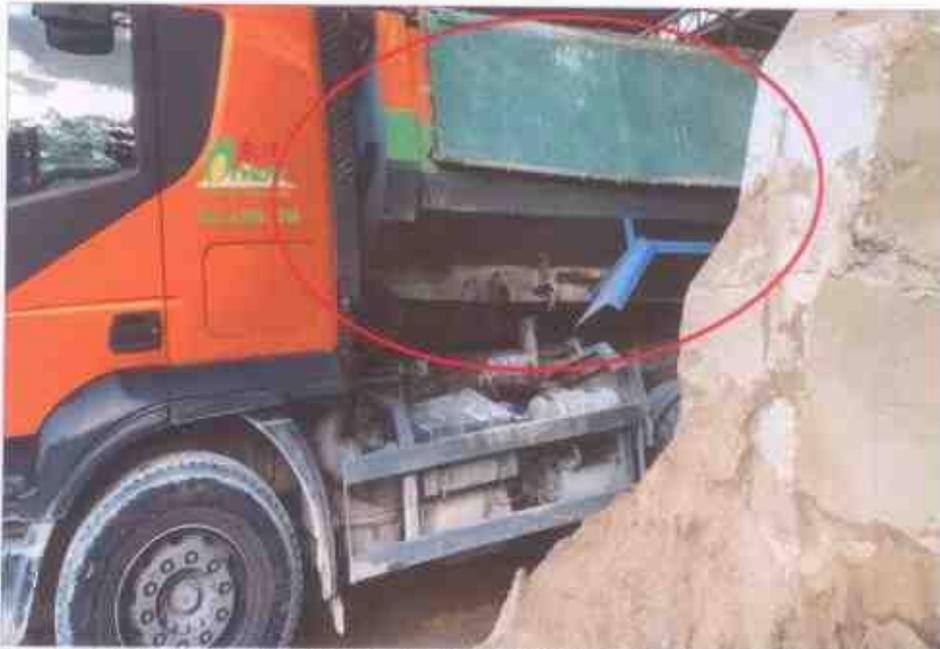
Photo 10 shows the left view of the Insured Vehicle at the incident scene. We observed the loaded tipper container to be lifted up and swayed out of position towards the right side upon the unloading process of the material load from the Insured Vehicle (circled).

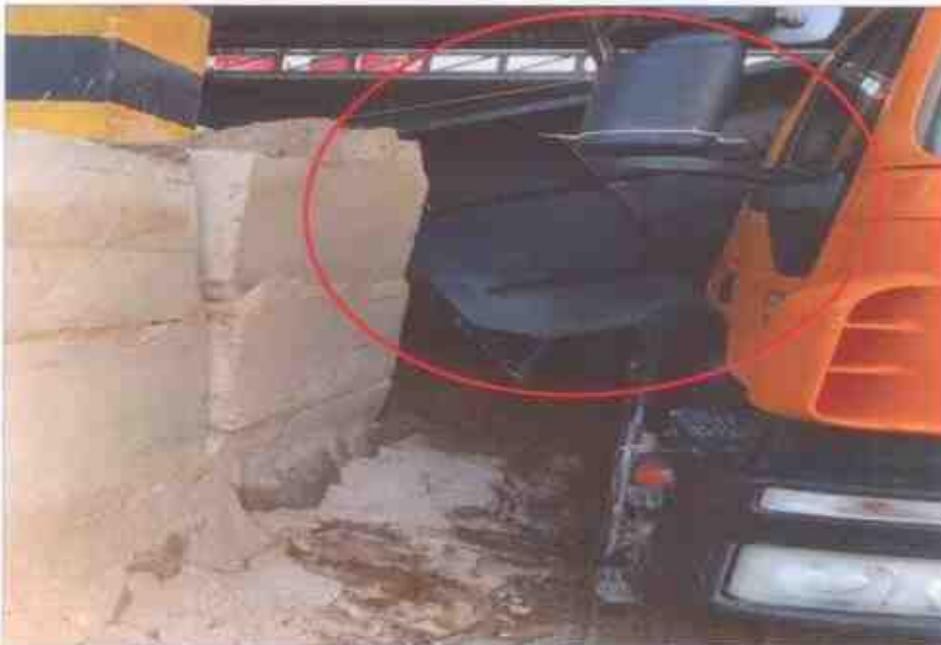
Photo 11 shows the right view of the Insured Vehicle at the incident scene. We observed the loaded tipper container to be swayed out of position and towards the right side upon the unloading process of the material load from the Insured Vehicle (circled).

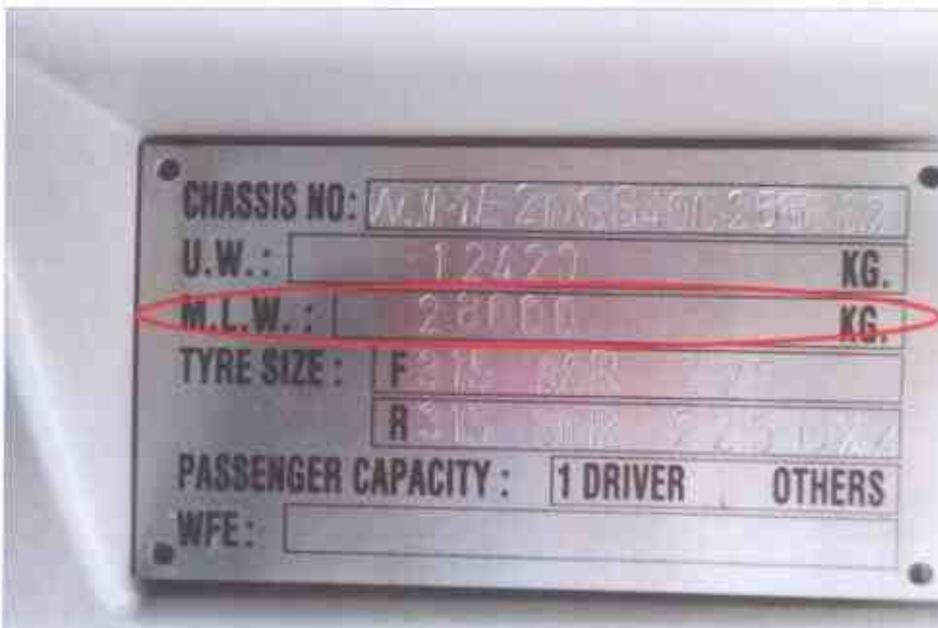
Photo 12 shows the chassis plate of the Insured Vehicle. The Max Laden Weight (M.L.W) permitted to carry by the Insured Vehicle is 28,000KG = 28 (Metric Ton) (circled).
