Report: Sompo Insurance Singapore Pte. Ltd. (HQ) - YM9319H

YM9319H (XB9454U) - Submitted by: Sompo Insurance Singapore Pte. Ltd. (HQ)

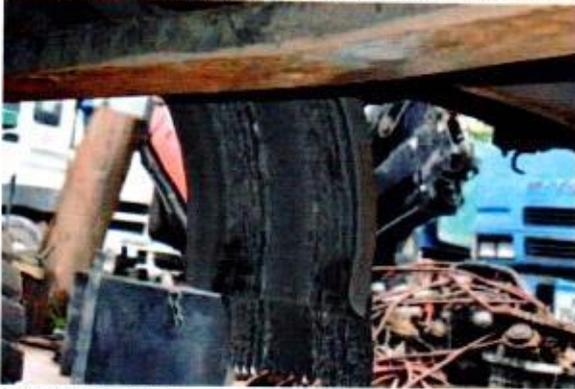
1/42: Dismantled Parts

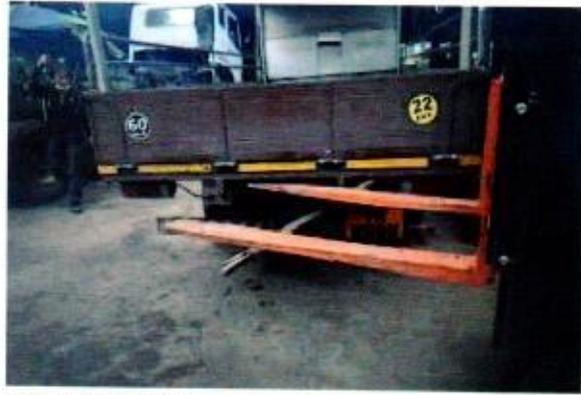
2/42: Dismantled Parts

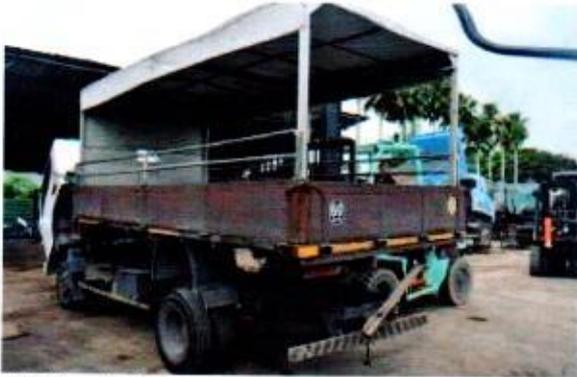
3/42: Dismantled Parts

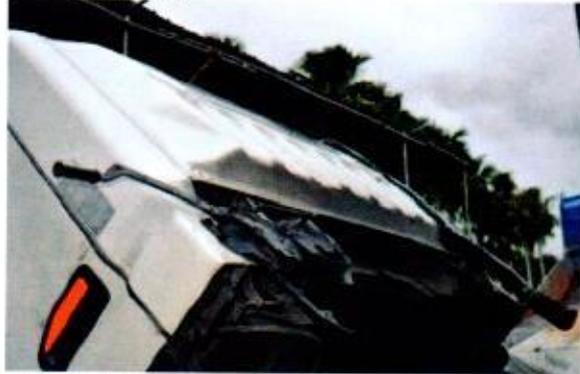
4/42: Dismantled Parts

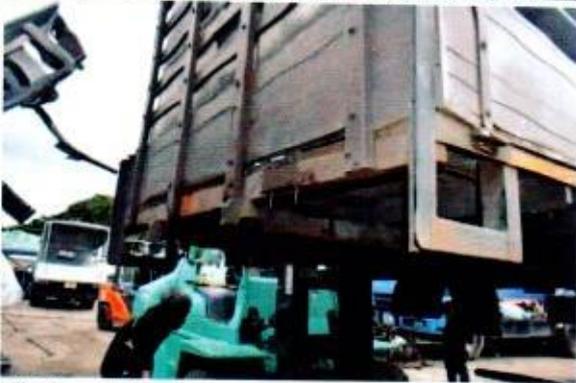
5/42: Dismantled Parts

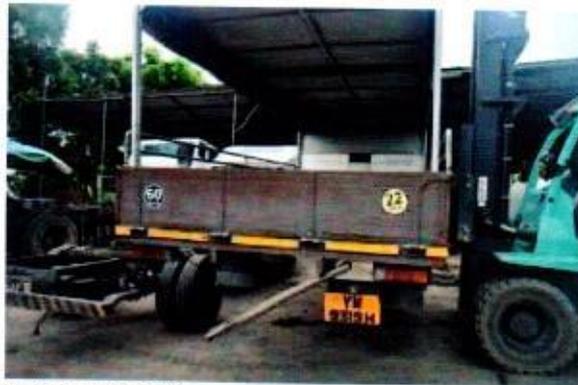
6/42: Dismantled Parts

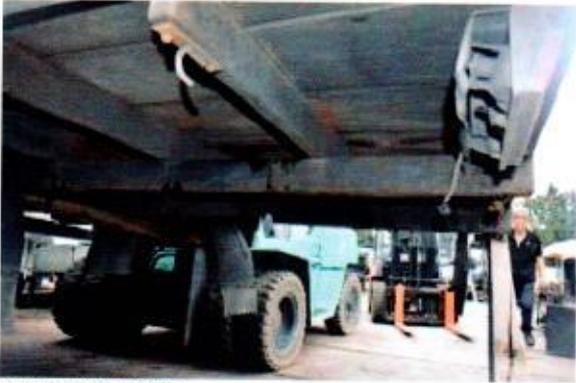
7/42: Dismantled Parts

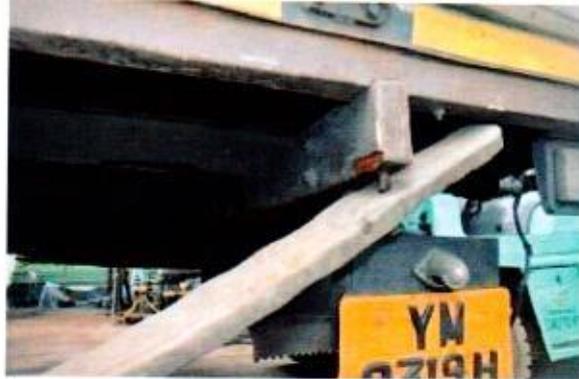
8/42: Dismantled Parts
