Your Ref: DHOM110096520909
Our Ref : CS/UOI19015641/N

9 September 2019

**TECHNICAL INVESTIGATION REPORT OF SMOKE INCIDENT INVOLVING THE
INSURED VEHICLE GBB 6579Z ON 2 SEPTEMBER 2019**

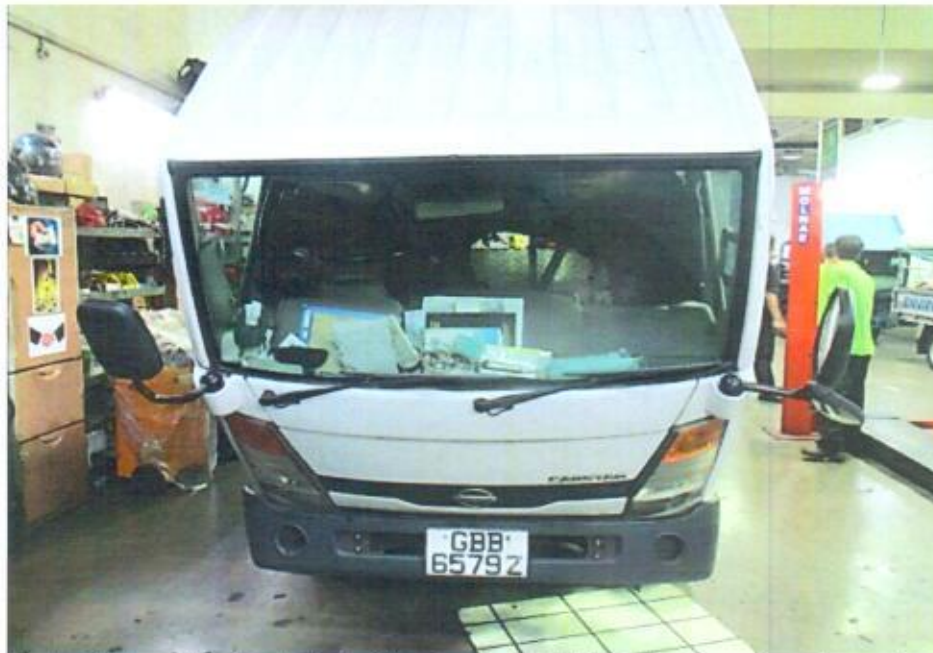
Photo 1 shows the front view of the Insured Vehicle at the time of our inspection. The damage to the Insured Vehicle was confined to its centre portion. The exterior body of the Insured Vehicle was relatively unaffected by the incident except for the centre portion.

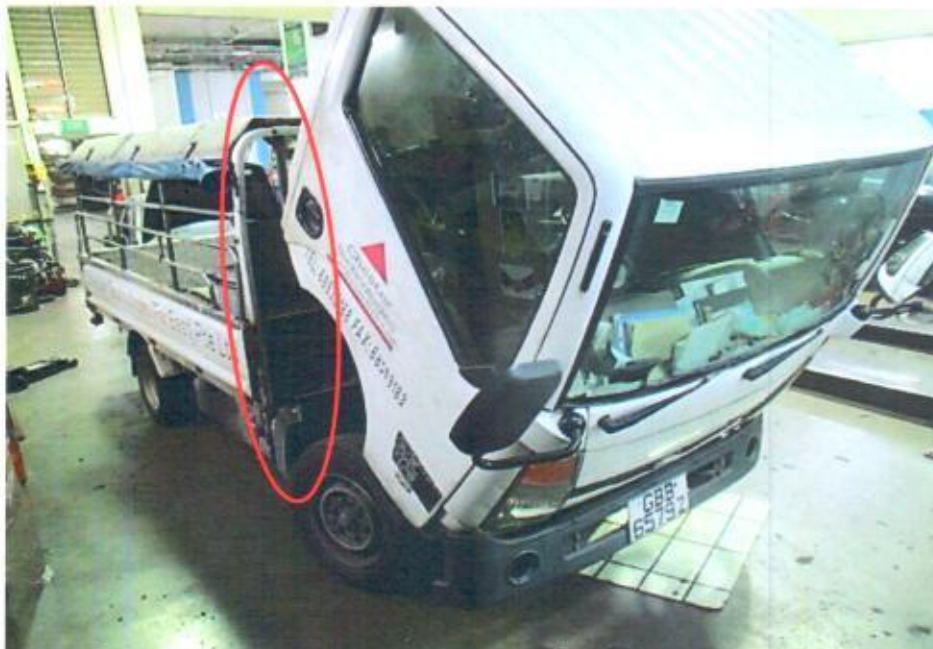
Photo 2 shows the right side view of the Insured Vehicle at the time of our inspection. The exterior body of the Insured Vehicle was relatively unaffected by the incident except for the centre portion. The damage to the Insured Vehicle was confined to its centre portion (circled).

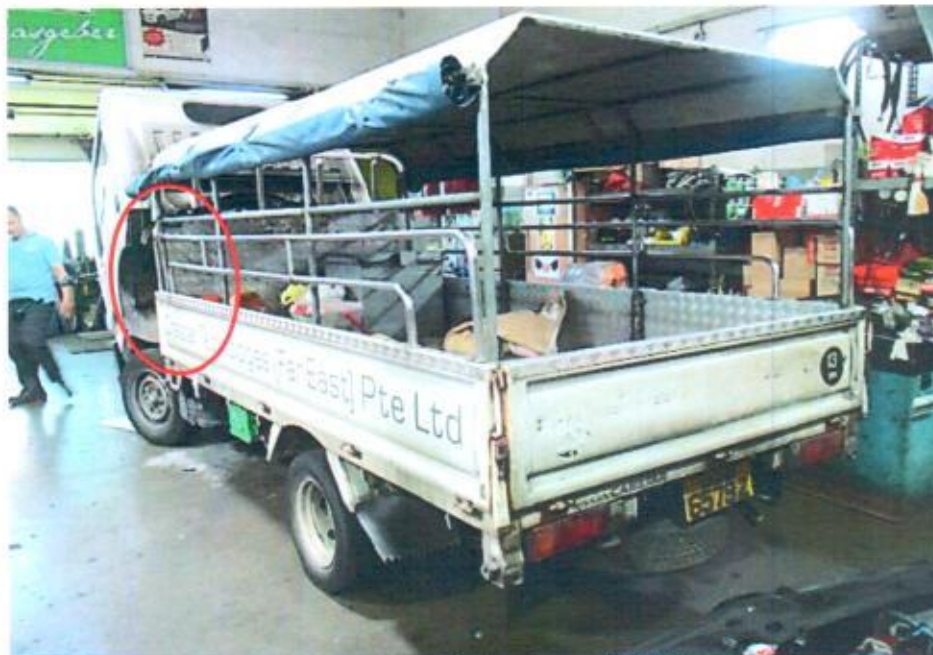
Photo 3 shows the left rear view of the Insured Vehicle at the time of our inspection. The exterior body of the Insured Vehicle was relatively unaffected by the incident except for the centre portion. The damage to the Insured Vehicle was confined to its centre portion. The damage was observed to be most severe at its left centre portion (circled).

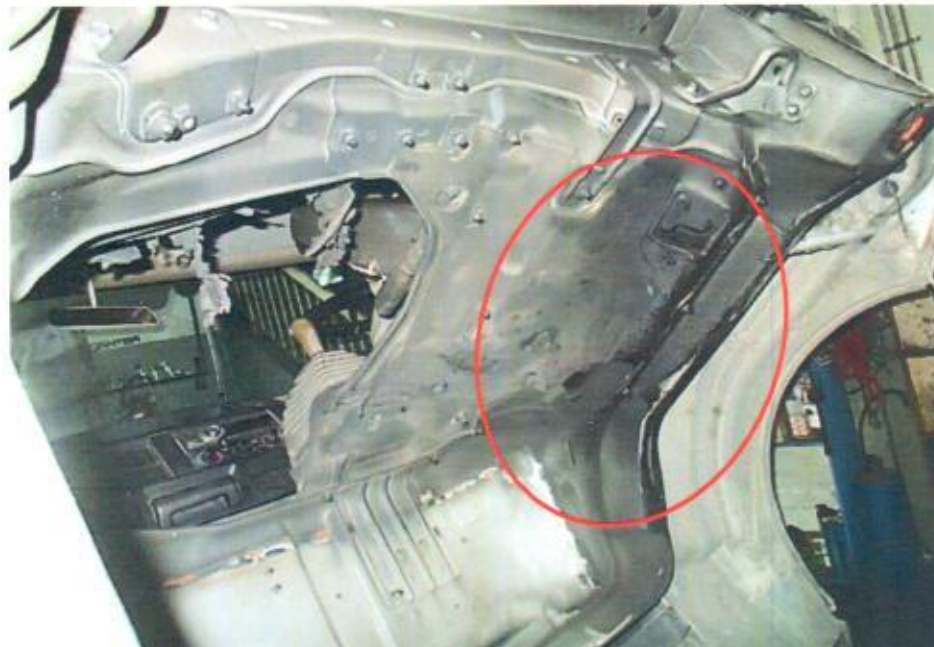
Photo 4 shows the exterior rear portion of the cab of the Insured Vehicle at the time of our inspection. The damage to the Insured Vehicle was confined to its centre portion (circled).

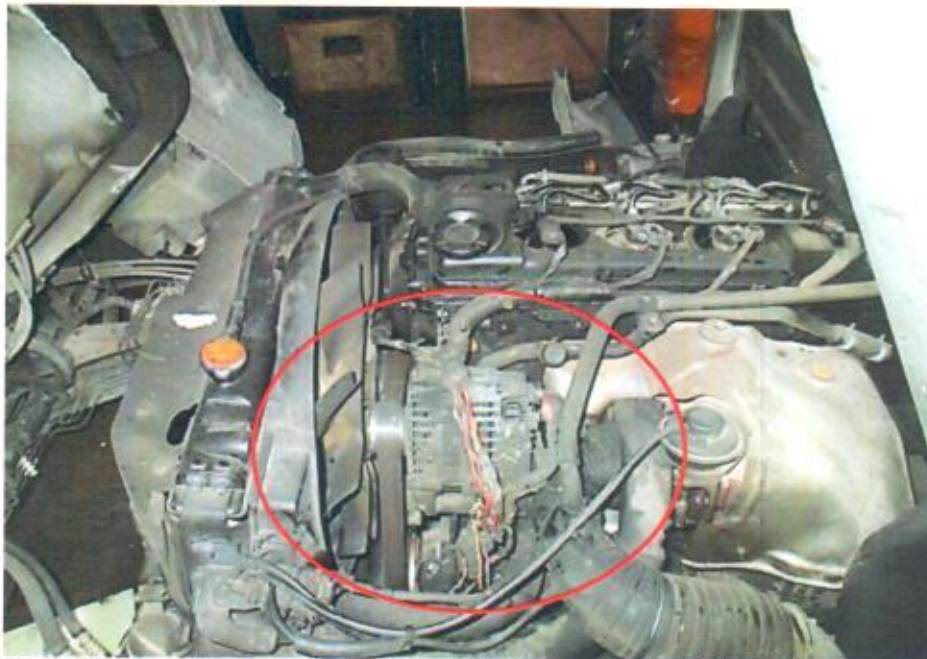
Photo 5 shows the engine compartment of the Insured Vehicle which is situated beneath the cab at the time of our inspection. The left portion of the engine compartment of the Insured Vehicle was significantly affected by the fire (circled).

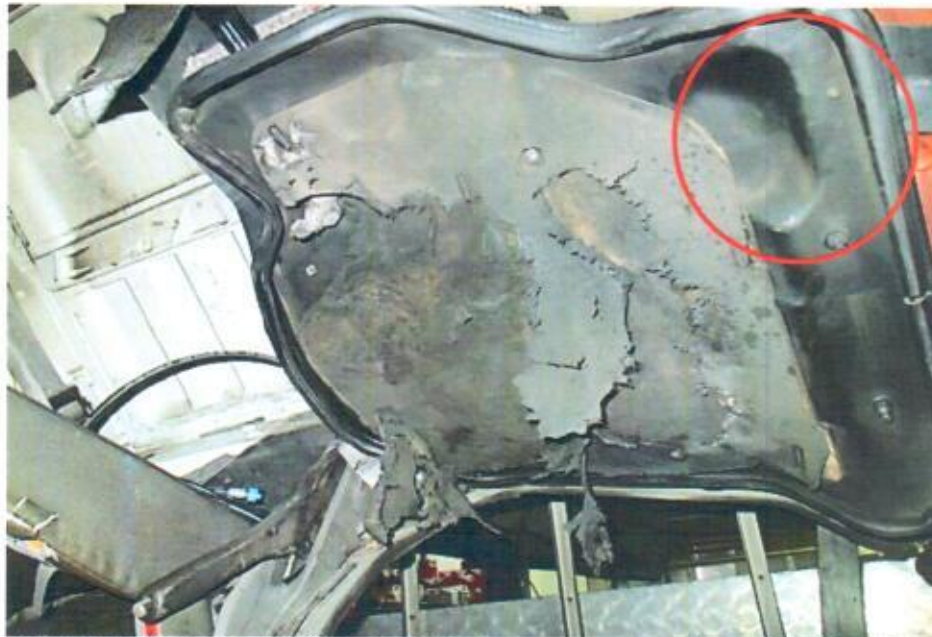
7. For this particular case, the smoke incident appears to have originated within the engine compartment of the Insured Vehicle. This can be determined from the burn pattern and the high heat intensity marks (whitish marks) found as well as the rust that had developed on the underside of the passenger side engine access panel of the Insured Vehicle.
8. The whitish marks are a result of exposure to prolonged heat intensity. Rust would normally start to develop around these areas soon after as prolonged exposure to high heat intensity usually causes steel/metal material body parts to be exposed to natural environmental condition. The rust that had developed on the underside of the passenger side engine access panel of the Insured Vehicle is an indication that the engine compartment had sustained exposure to prolonged high heat intensity. See photos 6 & 7 below.

Photo 6 shows the whitish marks that were found on the underside of the passenger side engine access panel of the Insured Vehicle (circled). Such whitish marks are a result of exposure to prolonged heat intensity. Rust would also begin to develop on these areas soon after. The development of rust is an indication that the area was exposed to prolonged exposure to high heat intensity, which had caused the steel/metal material of the passenger side engine access panel to be exposed to natural environmental condition

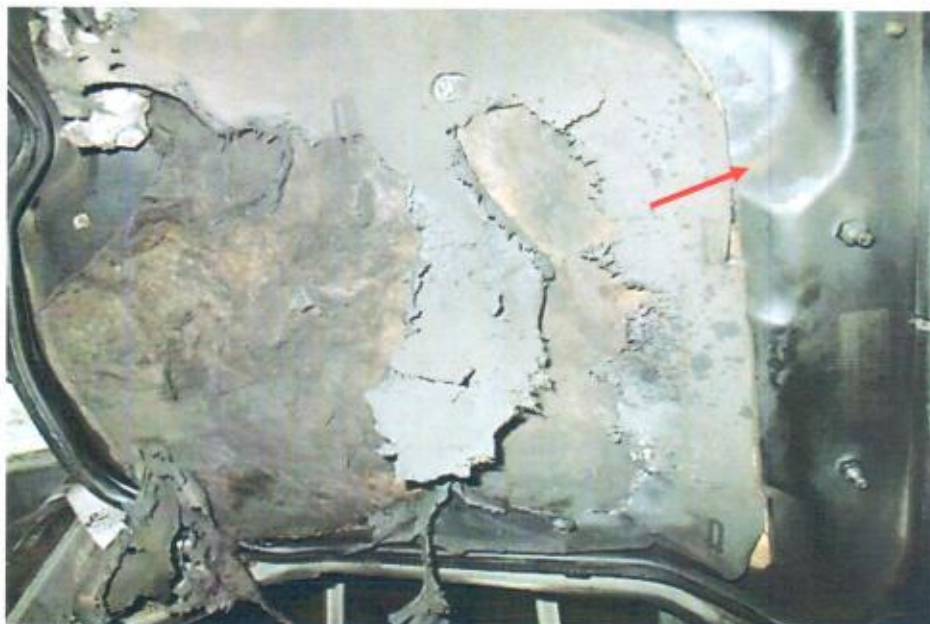
Photo 7 shows the rust that had developed around the underside of the passenger side engine access panel of the Insured Vehicle (arrowed) which is an indication that the incident to the Insured Vehicle had originated from the engine compartment.

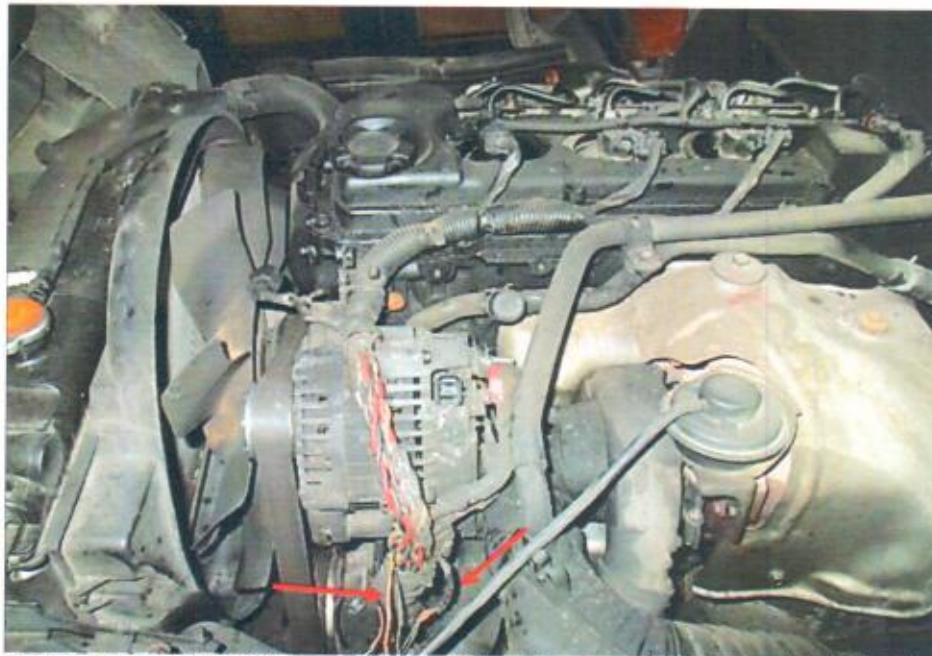
9. Upon closer examination of the left centre portion of the Insured Vehicle which was where the smoke incident had likely started, we had found traces of greenish residue on the wirings leading from the alternator. The wirings were original factory fitted wirings. The presence of greenish residue indicates internal heating of copper wires, a sign of an electrical short circuit occurring. The greenish residue is normally left behind from oxidation as a result of chemical reaction involving the copper wires. This physical evidence would then appear to suggest that the cause of the smoke incident to the Insured Vehicle could have possibly been due to electrical in nature. See photos 8 - 10 below.

Photo 8 shows the wirings leading from the alternator of the Insured Vehicle. The wirings were original factory fitted wirings. We observed traces of greenish residue on these wirings (arrowed). The presence of such greenish residue indicates internal heating of copper wires, a sign of an electrical short circuit occurring. The greenish residue is normally left behind from oxidation as a result of chemical reaction involving the copper wires. This physical evidence would then appear to suggest that the cause of the smoke incident to the Insured Vehicle could have possibly been due to electrical in nature.

23. The possibility of the smoke incident being due to electrical in nature would then seem more likely given that engine overheating and external factors would both seem unlikely. The smoke incident being due to electrical nature is also supported by the condition of the wirings that were found leading from the alternator of the Insured Vehicle, which was earlier discussed in paragraph 9 above.

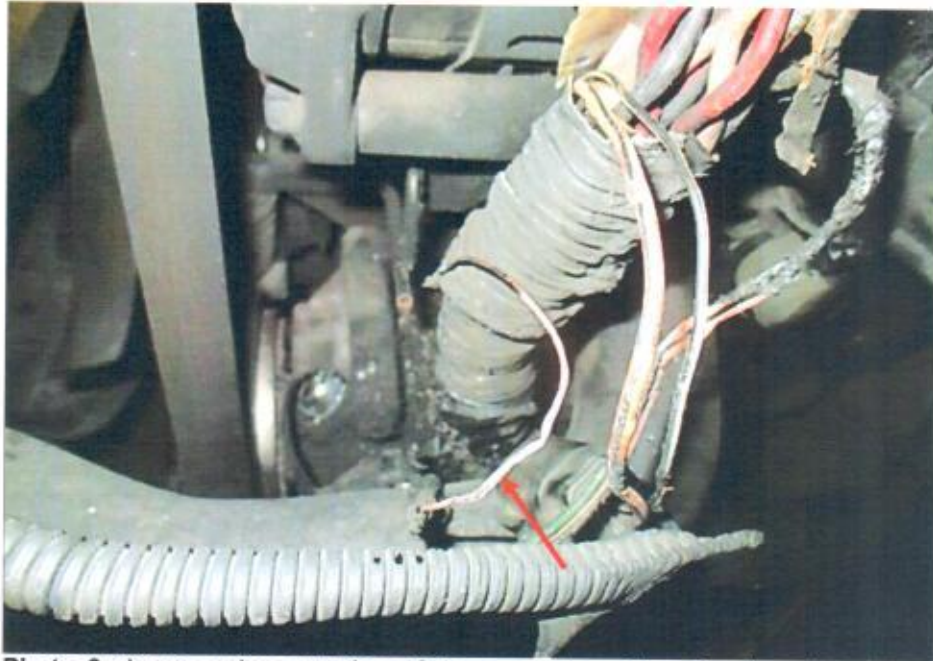
Photo 9 shows a close up view of the greenish residue found on the wirings leading from the alternator of the Insured Vehicle (arrowed). This seems to suggest the occurrence of an electrical short circuit.

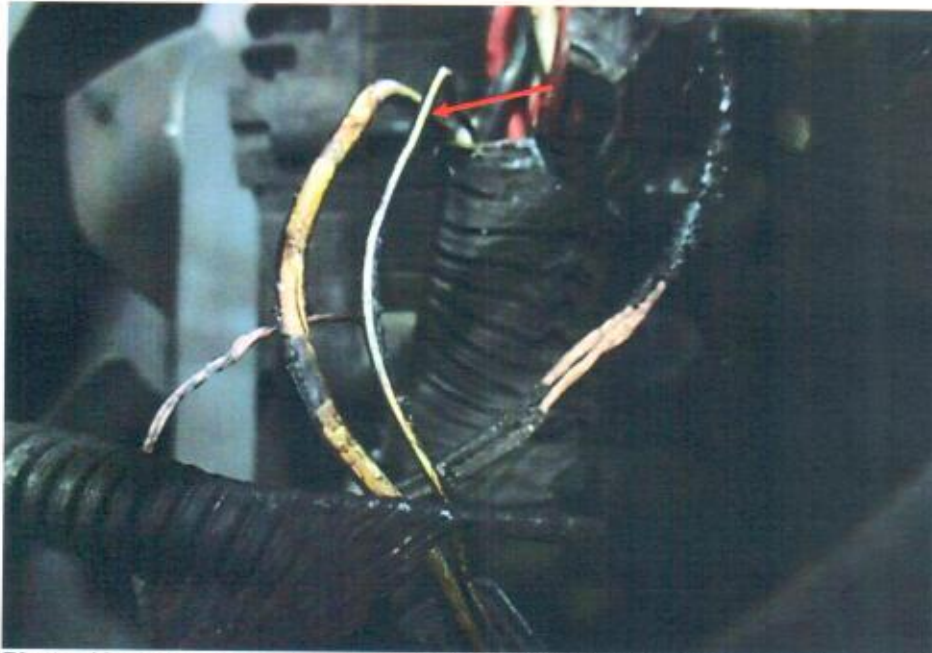
Photo 10 shows a close up view of the greenish residue found on the wirings leading from the alternator of the Insured Vehicle (arrowed). This seems to suggest the occurrence of an electrical short circuit.

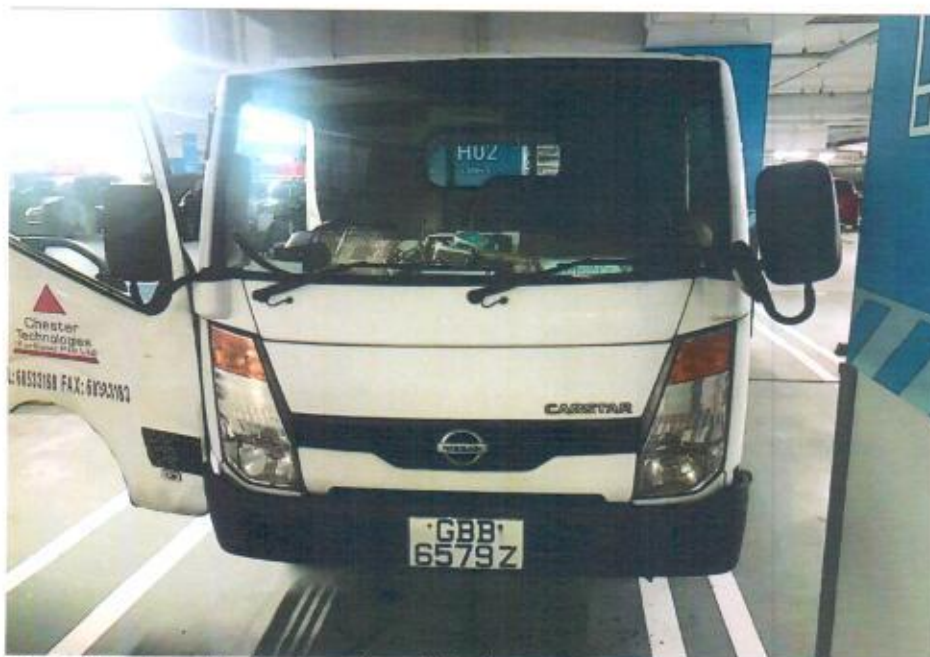
Photo 11 shows the front portion of the Insured Vehicle at the incident location post- incident.

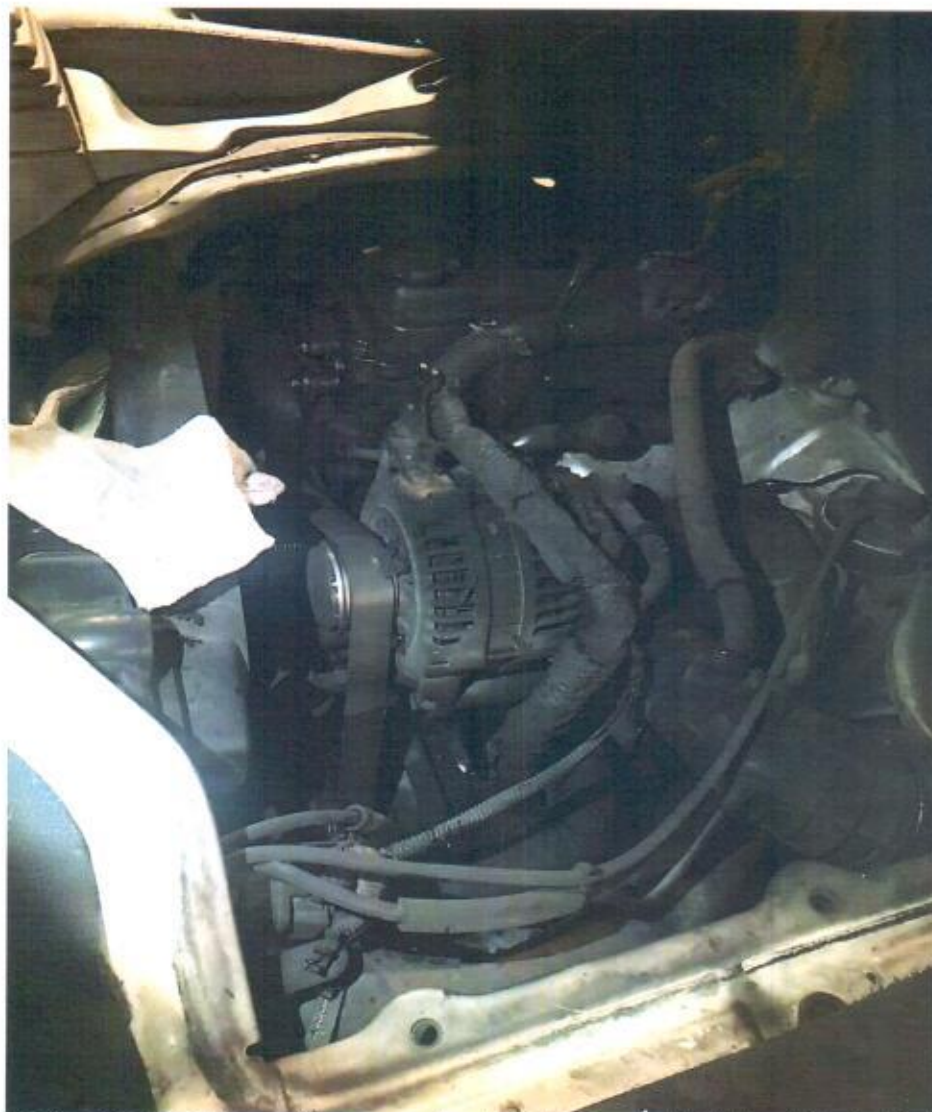
Photo 12 shows the engine compartment of the Insured Vehicle at the incident location post- incident. In general, the condition of the engine covered in soot had corresponded to the events that were related to us by Mr Lui, which is the smoke had emitted from the engine compartment.
