Your Ref: DHOM110096520909
Our Ref : CS/UOI19015641/N

9 September 2019

**TECHNICAL INVESTIGATION REPORT OF SMOKE INCIDENT INVOLVING THE
INSURED VEHICLE GBB 6579Z ON 2 SEPTEMBER 2019**

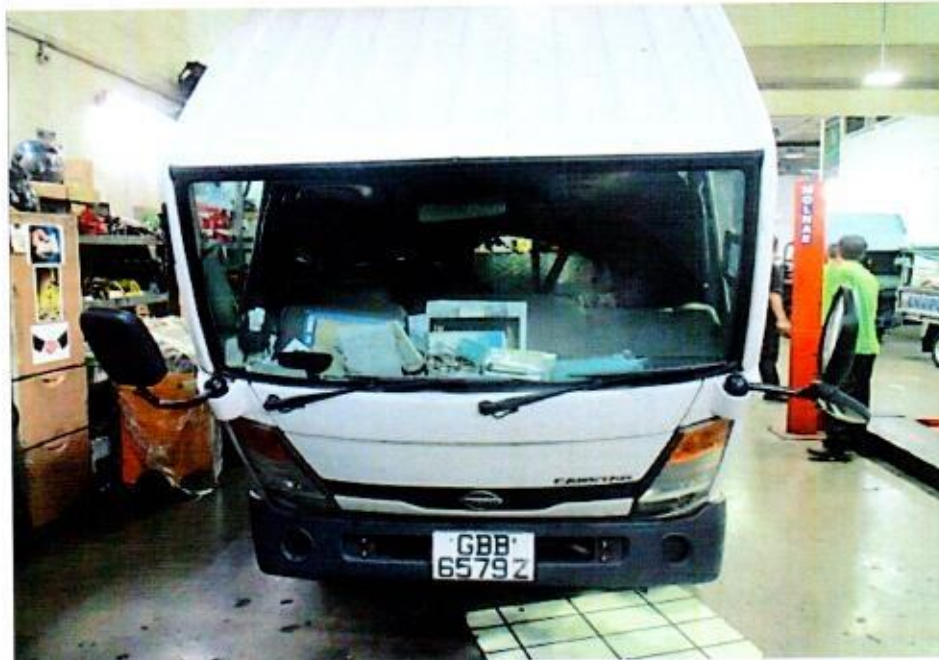
Photo 1 shows the front view of the Insured Vehicle at the time of our inspection. The damage to the Insured Vehicle was confined to its centre portion. The exterior body of the Insured Vehicle was relatively unaffected by the incident except for the centre portion.

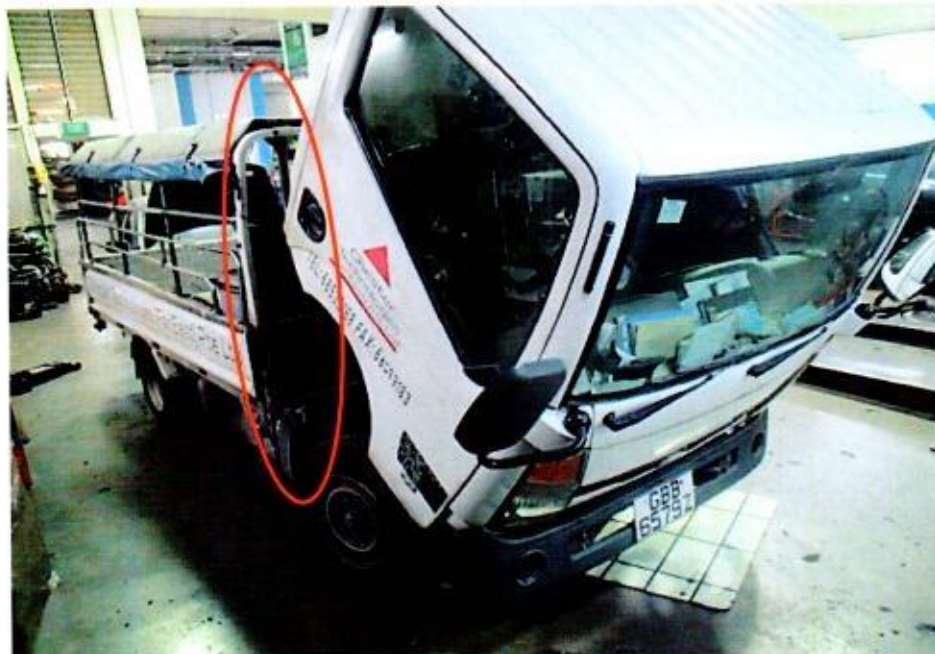
Photo 2 shows the right side view of the Insured Vehicle at the time of our inspection. The exterior body of the Insured Vehicle was relatively unaffected by the incident except for the centre portion. The damage to the Insured Vehicle was confined to its centre portion (circled).

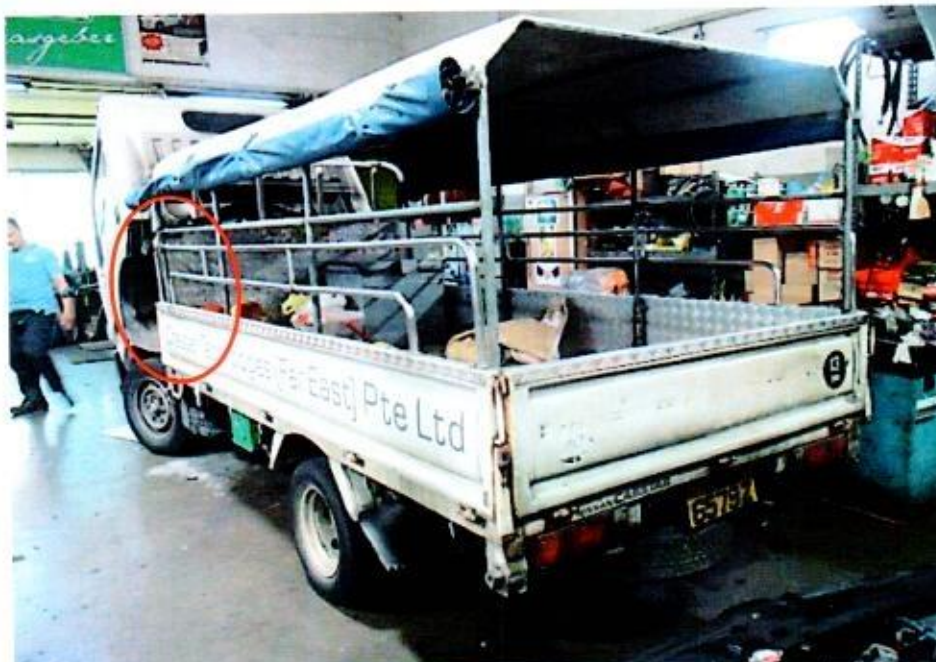
Photo 3 shows the left rear view of the Insured Vehicle at the time of our inspection. The exterior body of the Insured Vehicle was relatively unaffected by the incident except for the centre portion. The damage to the Insured Vehicle was confined to its centre portion. The damage was observed to be most severe at its left centre portion (circled).

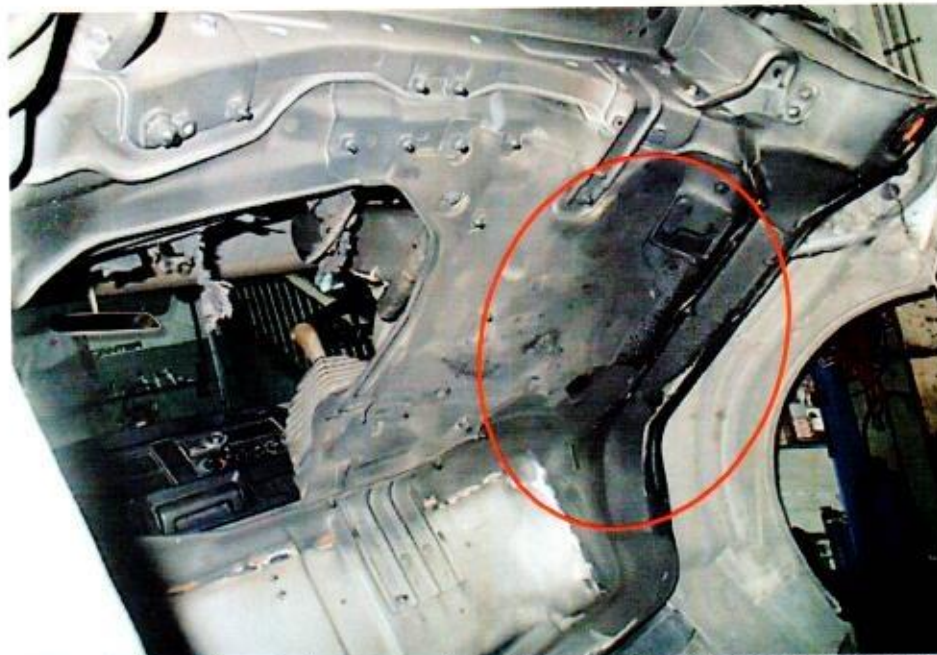
Photo 4 shows the exterior rear portion of the cab of the Insured Vehicle at the time of our inspection. The damage to the Insured Vehicle was confined to its centre portion (circled).

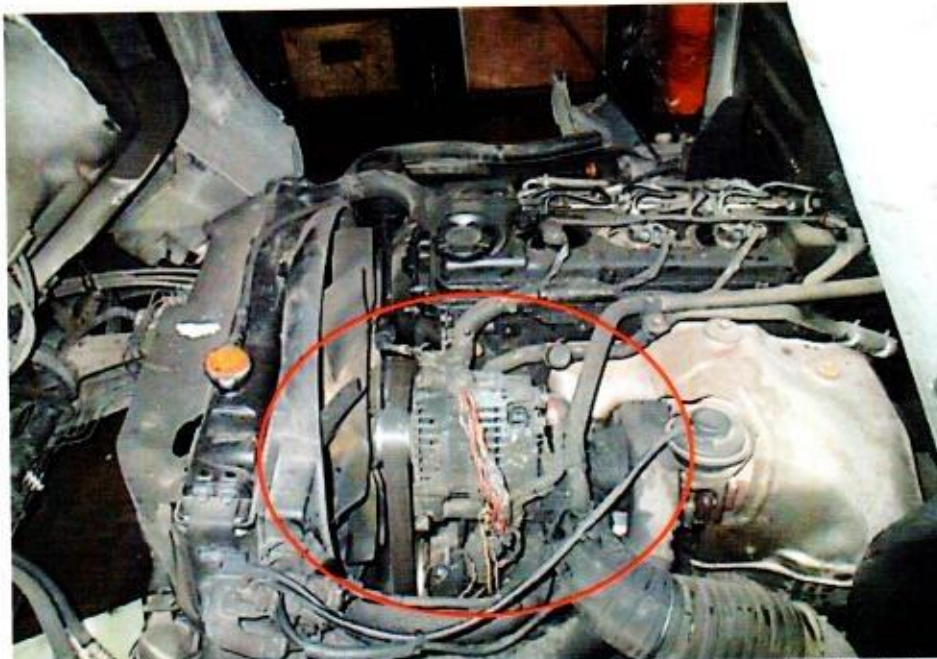
Photo 5 shows the engine compartment of the Insured Vehicle which is situated beneath the cab at the time of our inspection. The left portion of the engine compartment of the Insured Vehicle was significantly affected by the fire (circled).

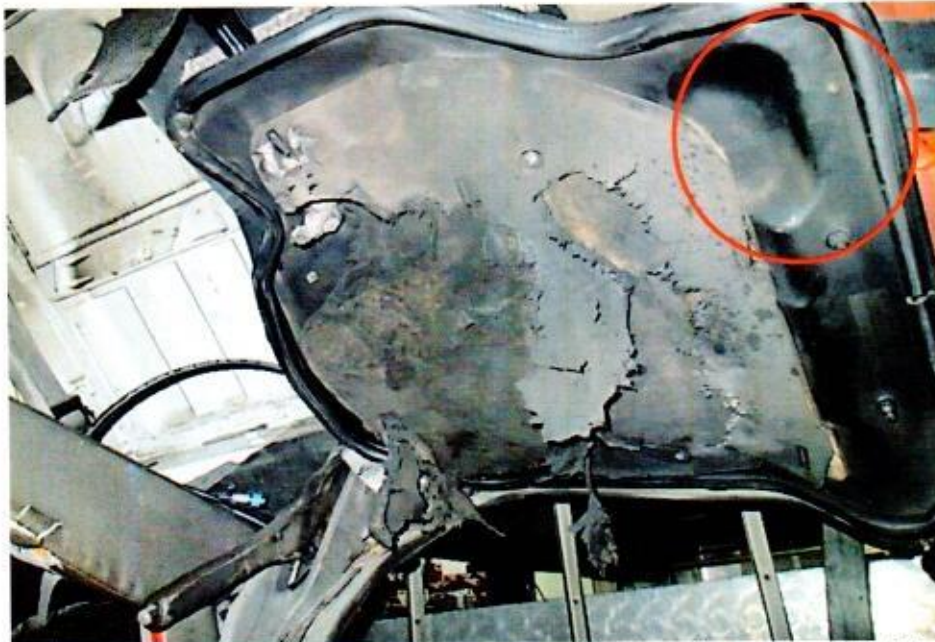
7. For this particular case, the smoke incident appears to have originated within the engine compartment of the Insured Vehicle. This can be determined from the burn pattern and the high heat intensity marks (whitish marks) found as well as the rust that had developed on the underside of the passenger side engine access panel of the Insured Vehicle.
8. The whitish marks are a result of exposure to prolonged heat intensity. Rust would normally start to develop around these areas soon after as prolonged exposure to high heat intensity usually causes steel/metal material body parts to be exposed to natural environmental condition. The rust that had developed on the underside of the passenger side engine access panel of the Insured Vehicle is an indication that the engine compartment had sustained exposure to prolonged high heat intensity. See photos 6 & 7 below.

Photo 6 shows the whitish marks that were found on the underside of the passenger side engine access panel of the Insured Vehicle (circled). Such whitish marks are a result of exposure to prolonged heat intensity. Rust would also begin to develop on these areas soon after. The development of rust is an indication that the area was exposed to prolonged exposure to high heat intensity, which had caused the steel/metal material of the passenger side engine access panel to be exposed to natural environmental condition

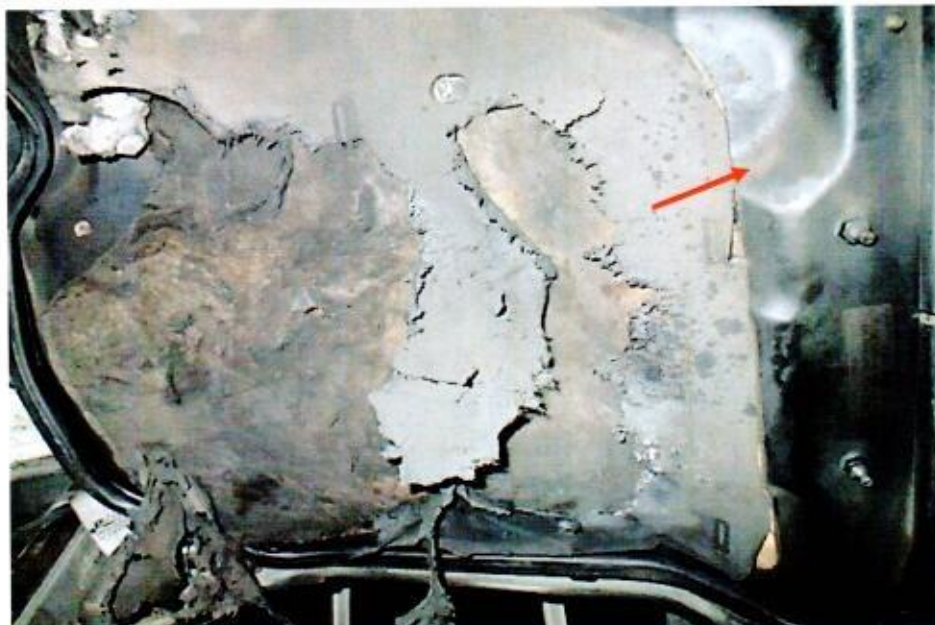
Photo 7 shows the rust that had developed around the underside of the passenger side engine access panel of the Insured Vehicle (arrowed) which is an indication that the incident to the Insured Vehicle had originated from the engine compartment.

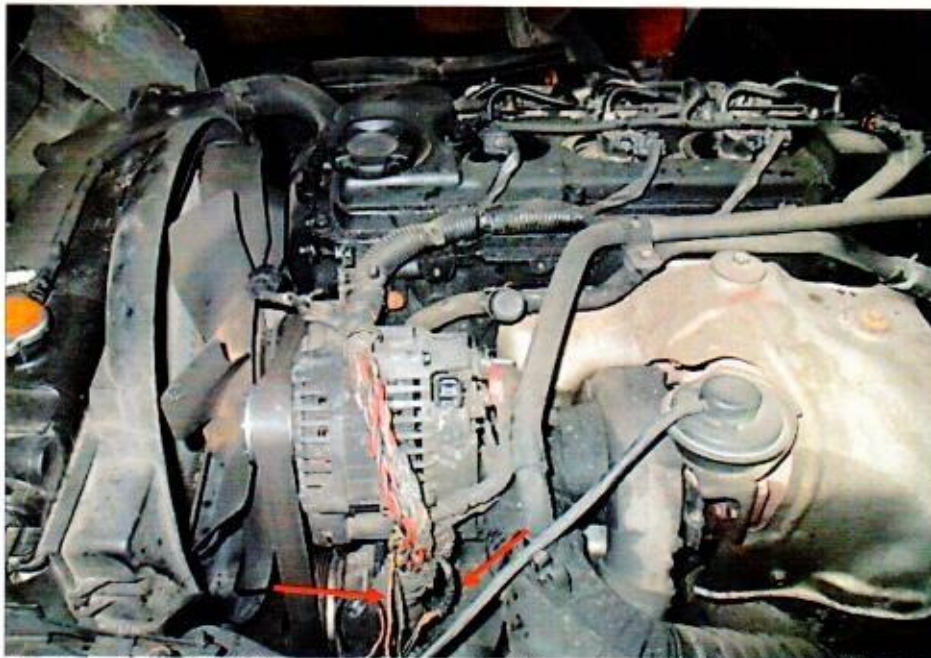
9. Upon closer examination of the left centre portion of the Insured Vehicle which was where the smoke incident had likely started, we had found traces of greenish residue on the wirings leading from the alternator. The wirings were original factory fitted wirings. The presence of greenish residue indicates internal heating of copper wires, a sign of an electrical short circuit occurring. The greenish residue is normally left behind from oxidation as a result of chemical reaction involving the copper wires. This physical evidence would then appear to suggest that the cause of the smoke incident to the Insured Vehicle could have possibly been due to electrical in nature. See photos 8 - 10 below.

Photo 8 shows the wirings leading from the alternator of the Insured Vehicle. The wirings were original factory fitted wirings. We observed traces of greenish residue on these wirings (arrowed). The presence of such greenish residue indicates internal heating of copper wires, a sign of an electrical short circuit occurring. The greenish residue is normally left behind from oxidation as a result of chemical reaction involving the copper wires. This physical evidence would then appear to suggest that the cause of the smoke incident to the Insured Vehicle could have possibly been due to electrical in nature.

23. The possibility of the smoke incident being due to electrical in nature would then seem more likely given that engine overheating and external factors would both seem unlikely. The smoke incident being due to electrical nature is also supported by the condition of the wirings that were found leading from the alternator of the Insured Vehicle, which was earlier discussed in paragraph 9 above.

25. Having investigated and technically analysed the damages of burnt nature to the Insured Vehicle, we are of the view that the cause of the smoke incident to the Insured Vehicle was of electrical in nature. For this particular case, the smoke incident had originated along the original factory fitted wirings leading from the alternator of the Insured Vehicle.
26. We did not find any evidence which had suggested that the cause of the smoke incident to the Insured Vehicle was due to poor maintenance and/or recurring electrical problem.
27. There were no modification(s) or additional electronic and/or electrical component(s) fitted on the Insured Vehicle at the time of our inspection of the Insured Vehicle.

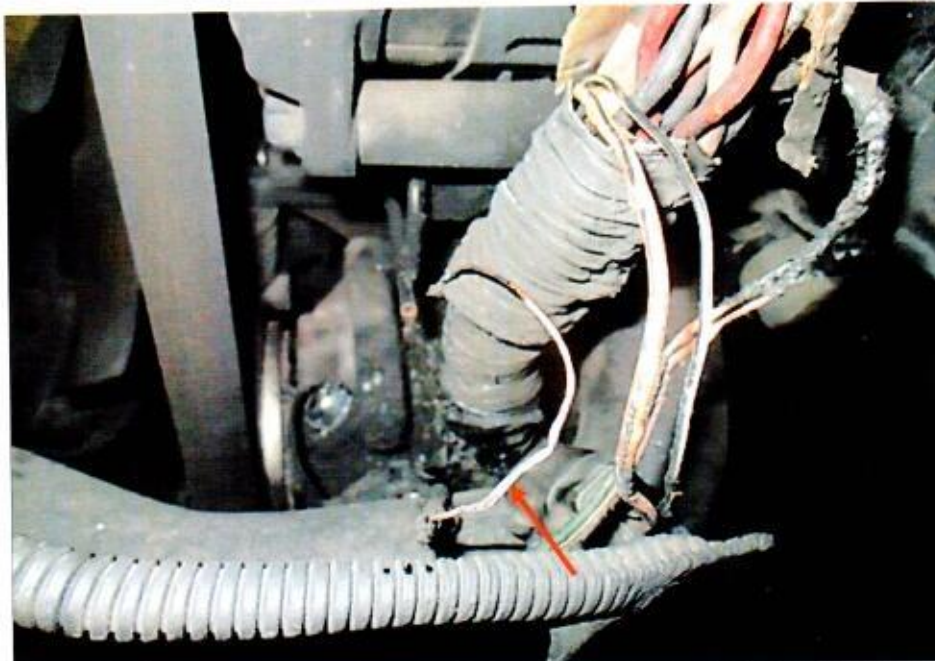
Photo 9 shows a close up view of the greenish residue found on the wirings leading from the alternator of the Insured Vehicle (arrowed). This seems to suggest the occurrence of an electrical short circuit.

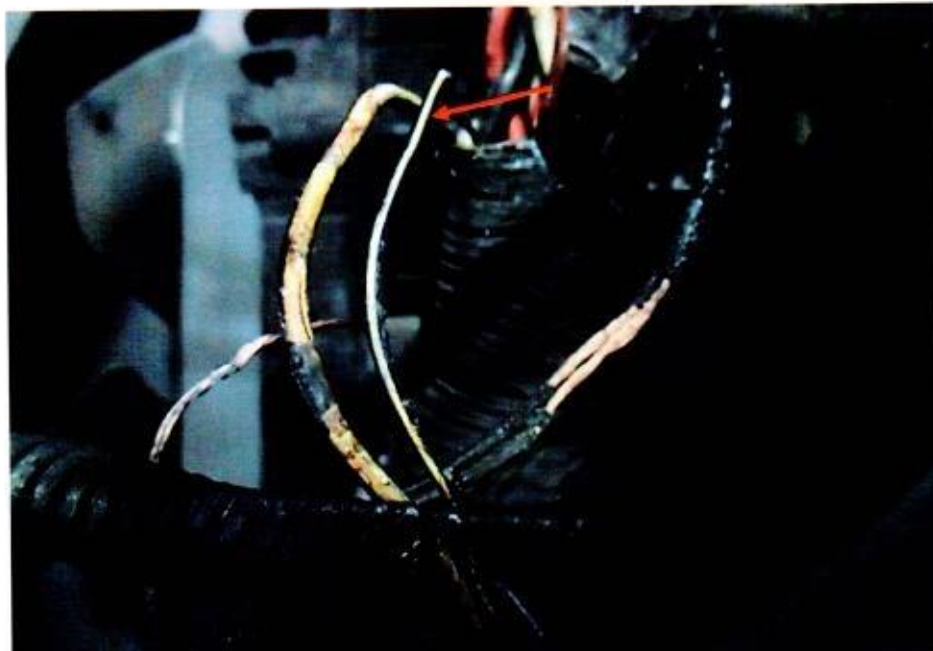
Photo 10 shows a close up view of the greenish residue found on the wirings leading from the alternator of the Insured Vehicle (arrowed). This seems to suggest the occurrence of an electrical short circuit.

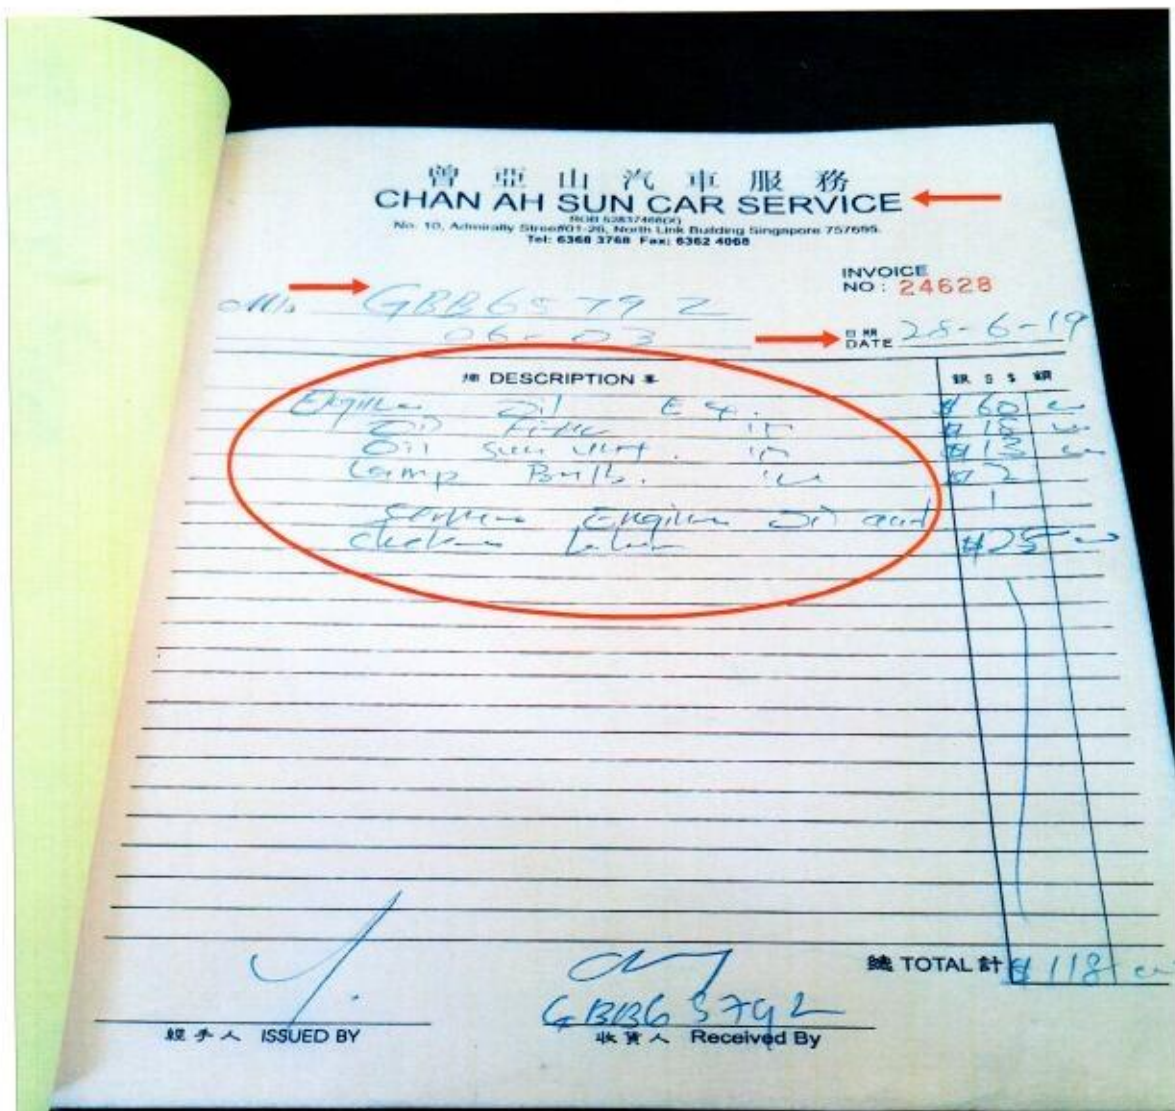
Invoice 1 shows the latest servicing done on the Insured Vehicle at CAS on 28 June 2019 (red arrows). The servicing package included changing of engine oil and oil filter. The oil sump bolt was replaced (circled).

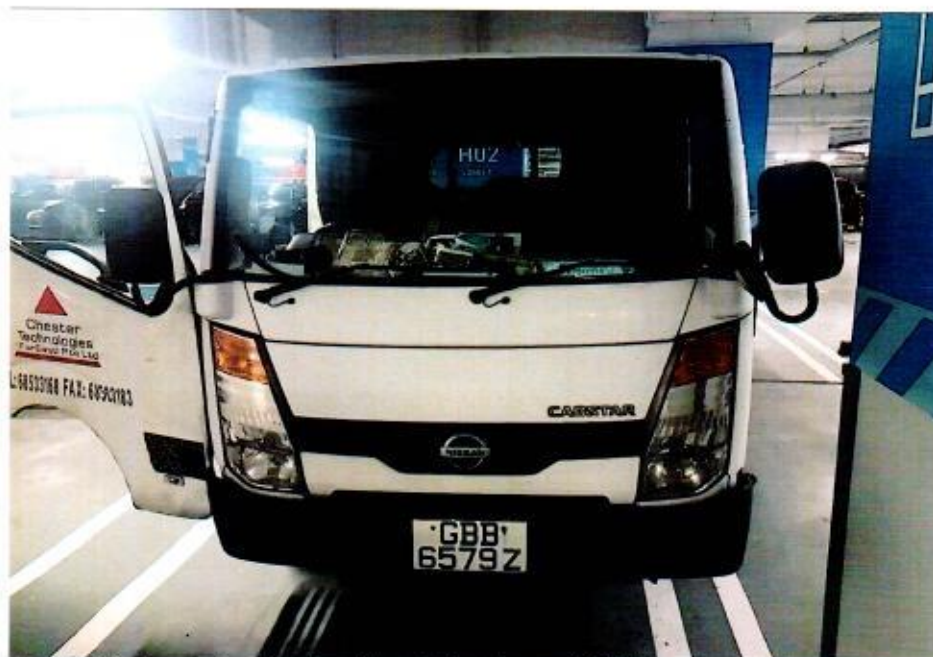
Photo 11 shows the front portion of the Insured Vehicle at the incident location post- incident.

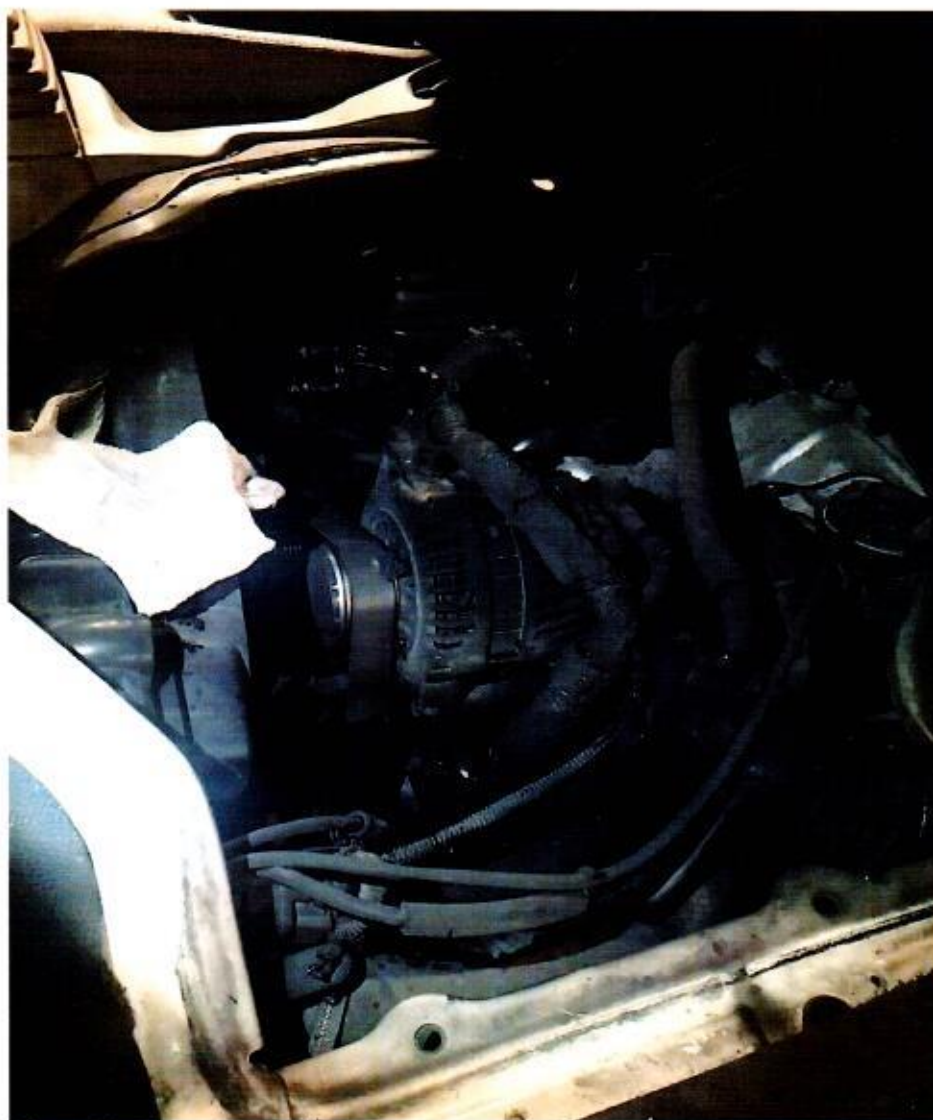
Photo 12 shows the engine compartment of the Insured Vehicle at the incident location post- incident. In general, the condition of the engine covered in soot had corresponded to the events that were related to us by Mr Lui, which is the smoke had emitted from the engine compartment.
