Your Ref: M600337
Our Ref : CI/MSG19015660/P

**TECHNICAL INVESTIGATION REPORT OF ROAD INCIDENT INVOLVING THE
INSURED VEHICLE YN 8539R ON 18th July 2019**

Vehicle Registration No.	: YN 8539R
Make / Model	: Mitsubishi Canter 3.0D
Chassis No	: FEB21EA10171
Year of Registration	: July 2015
Mileage	: 125,211Km

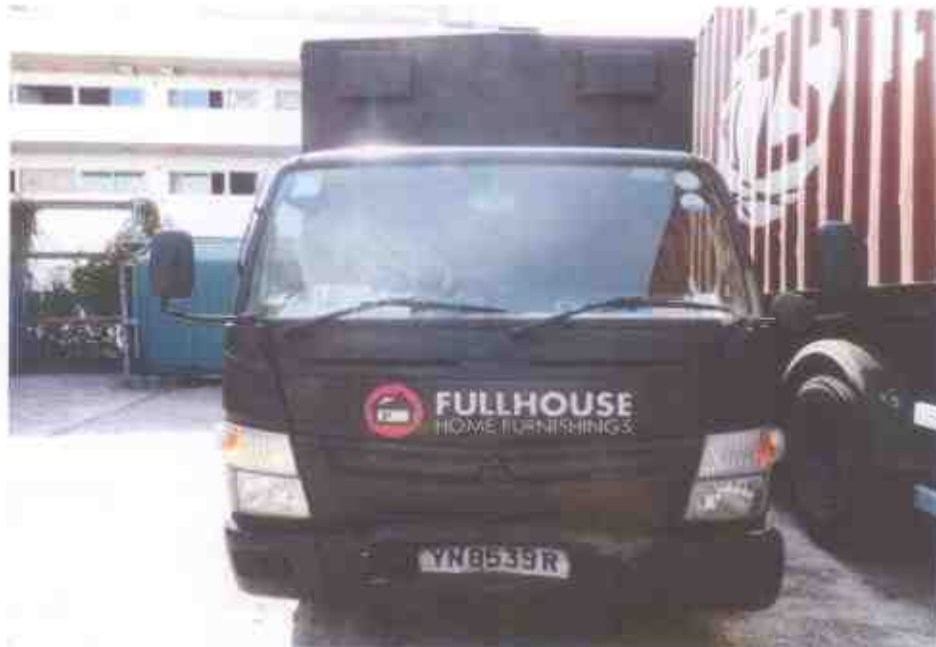
Photo 1 shows the general view of the front portion of the Insured Vehicle at the time of our inspection. The damage to the Insured Vehicle was confined to its front bumper portion and number plate is amongst the body parts that were found to have been affected as a result of the accident.

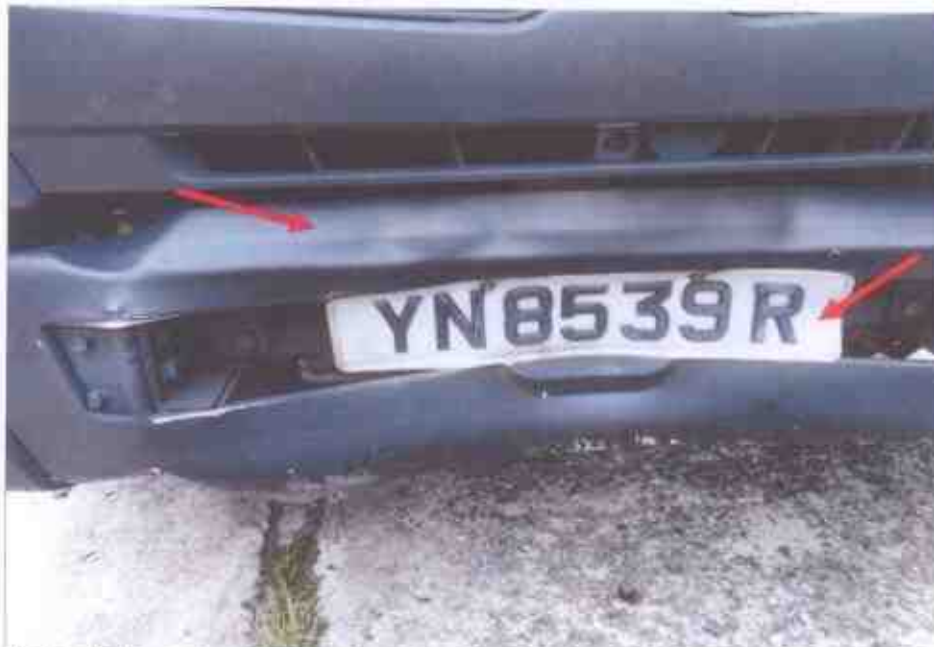
Photo 2 shows the close up view of the front portion of the Insured Vehicle at the time of our inspection. The damage to the Insured Vehicle was confined to its front bumper portion and number plate (arrowed) is amongst the body parts that were found to have been affected as a result of the accident.

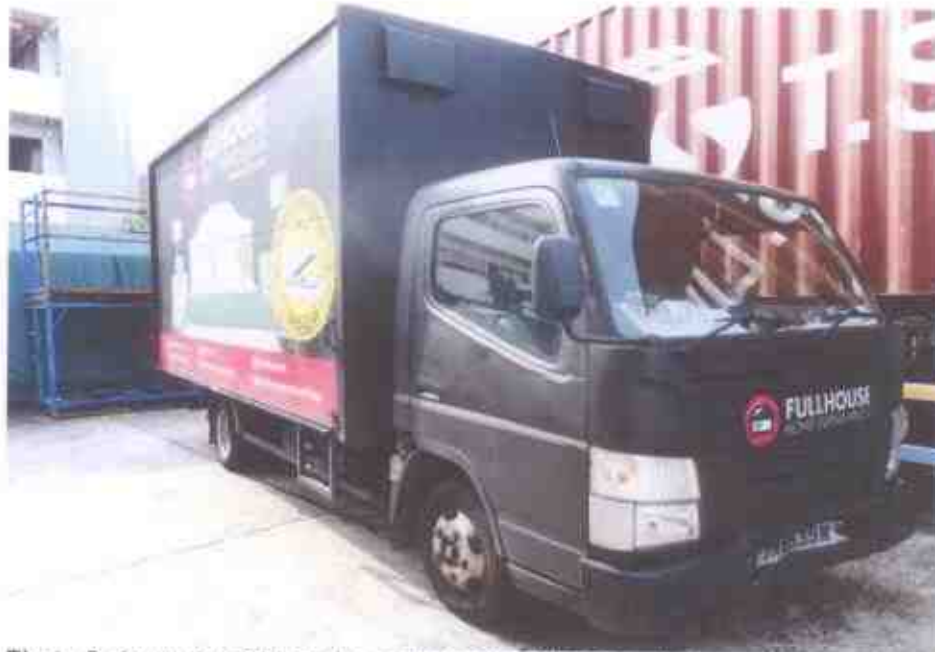
Photo 3 shows the right portion of the Insured Vehicle, which was observed to be unaffected by the accident.

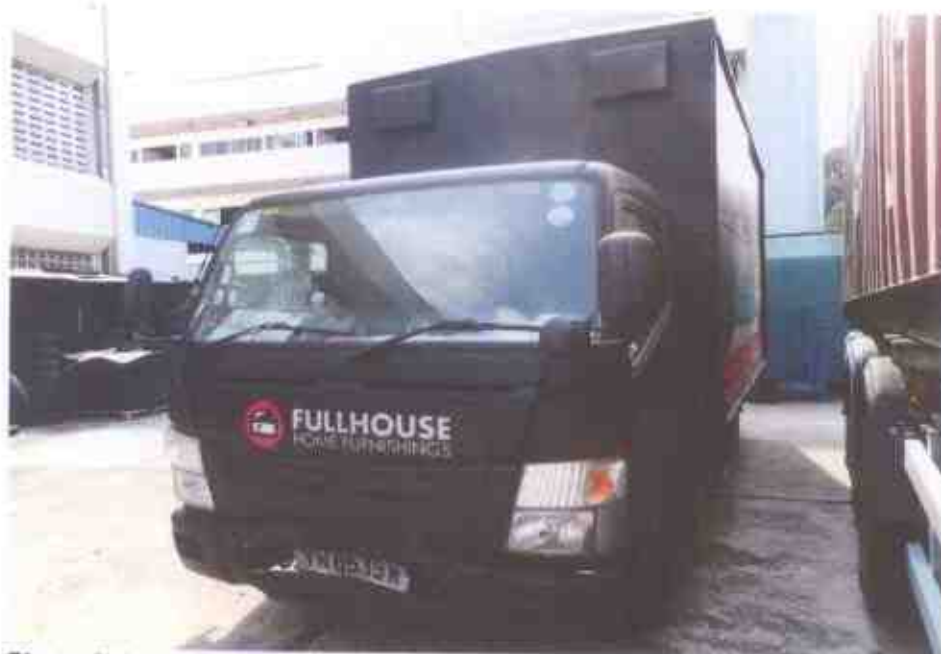
Photo 4 shows the left portion of the Insured Vehicle, which was observed to be unaffected by the accident.

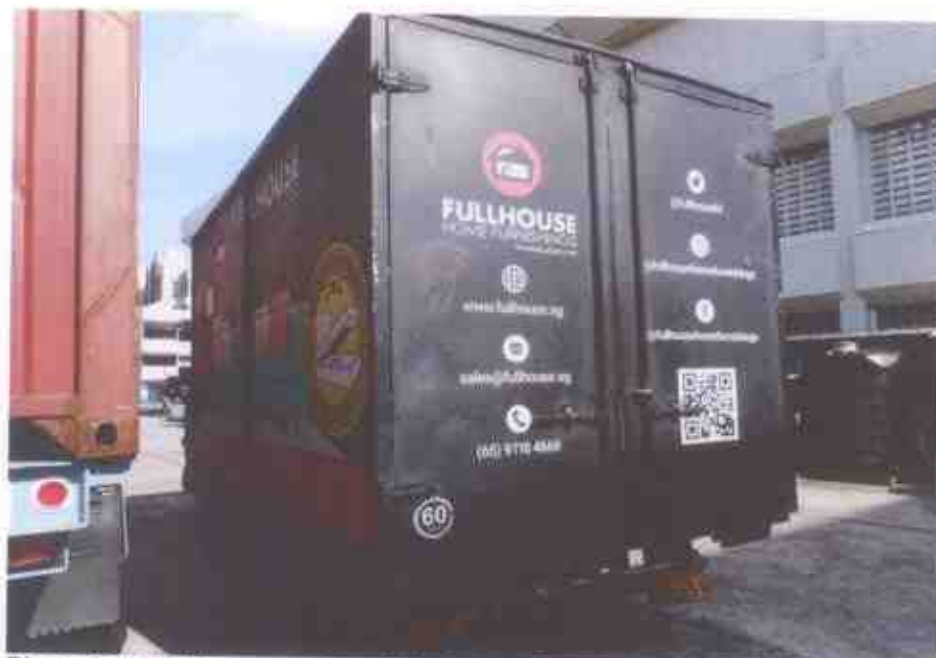
Photo 5 shows the rear portion of the Insured Vehicle, which was observed to be unaffected by the accident.

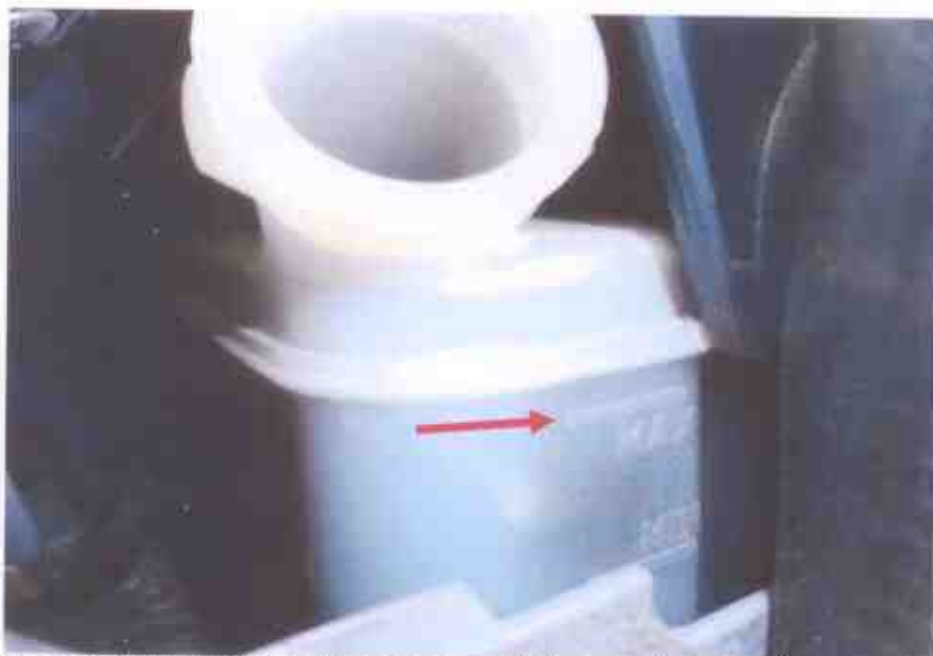
Photo 6 shows the brake fluid reservoir of the Insured Vehicle at the time of my inspection. The brake fluid was observed to be of sufficient level (arrowed) and without any visible contamination.

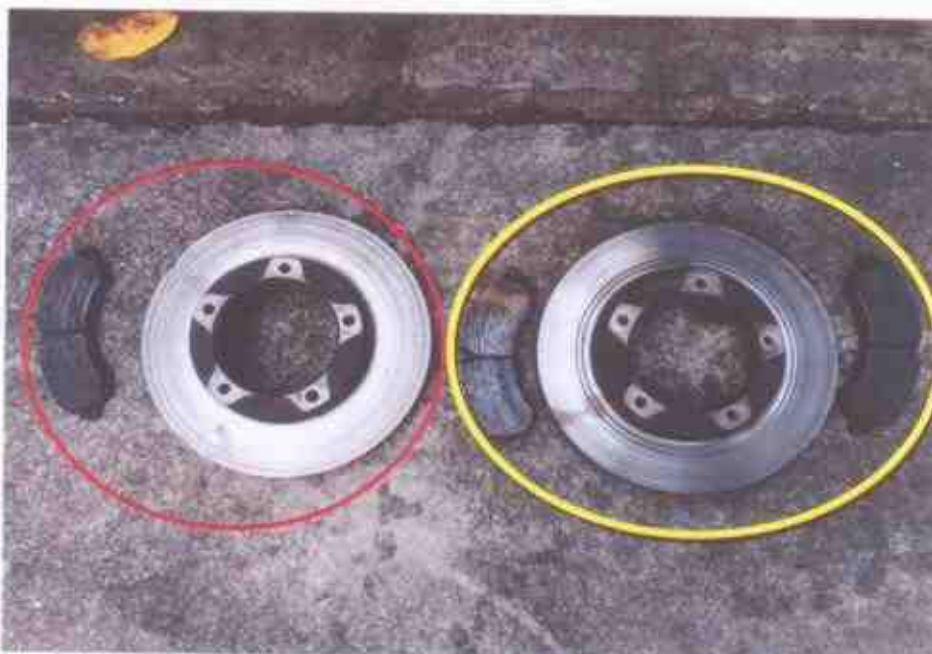
12. During our inspection of the Insured Vehicle at the workshop, we observed that the front disc brakes and brake pads were taken out of the Insured Vehicle and replaced by a new set of disc brakes and brake pads. We instructed the workshop to produce the old disc brakes and brake pads for inspection and we observed only the front left and right disc brakes and only 3 out of 4 brake pads. The front left outer brake pad was missing at the time of our inspection.

13. Upon closer inspection of both the front left and right disc brakes, we observed that the outer surface of the front left disc brake sustained abnormal damage and wear compared to the front right outer surface of the disc brake which was in good condition. This is suspected that upon the driver depressing the pedal brake to stop the Insured Vehicle, the piston from the brake caliper will push the brake pads onto the disc brakes to slow the Insured Vehicle down. With the missing outer brake pad, the disc brakes were forced to come into contact with the brake caliper instead of the brake pad which caused damage and abnormal wear on the disc brakes surface in which cause the braking efficiency of the Insured Vehicle to be reduced. See photos 6 - 8 below.

Photo 7 shows both front left (red circle), right (yellow circle) disc brakes and the 3 of 4 brake-pads of the Insured Vehicle. Front left outer brake pad was missing at the time of my inspection.

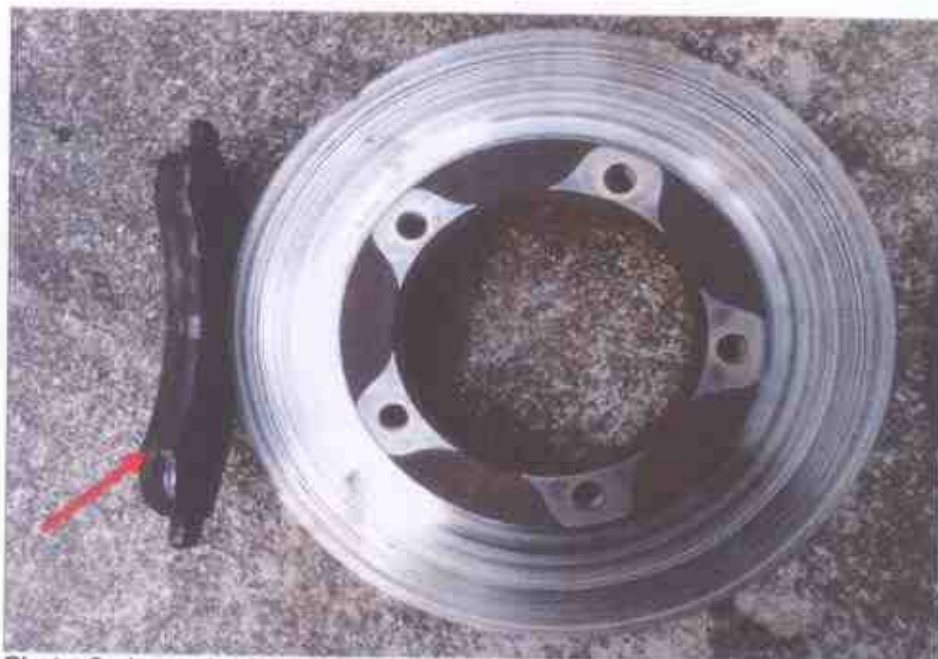
Photo 8 shows the front left inner brake pad (arrowed) and the front left disc brake of the Insured Vehicle. The brake pad's braking material was observed to be of sufficient level. However the other outer side of the brake pad was missing at the time of my inspection, which will cause the braking efficiency of the Insured Vehicle to be reduced.

14. The possible cause of the brake pads dislodging from the brake caplier are due to caplier bolts which were not properly tighten. In addition that vibration during driving will further loosen the bolts overtime and further more due to the heavy braking force exerted during braking of the vehicle will force the already loosen brake caliper bolts to give way and thus the brake pads to fall off.

15. For this case, it could be that when the driver applied brake to the Insured Vehicle at the material time the brake caliper bolt became detached causing the brake pad to fall off. Ultimately, leading to the driver unable to stop the Insured Vehicle in time and colliding into the vehicle in front.

17. Basing on our investigations, the braking system of the Insured Vehicle was compromised at the material time. This was due to its front left brake pad becoming detached from the caliper at some point in time when the driver was applying brake to bring the Insured Vehicle to a stop at a traffic junction. The cause of this was due to the caliper bolts not tightened properly.

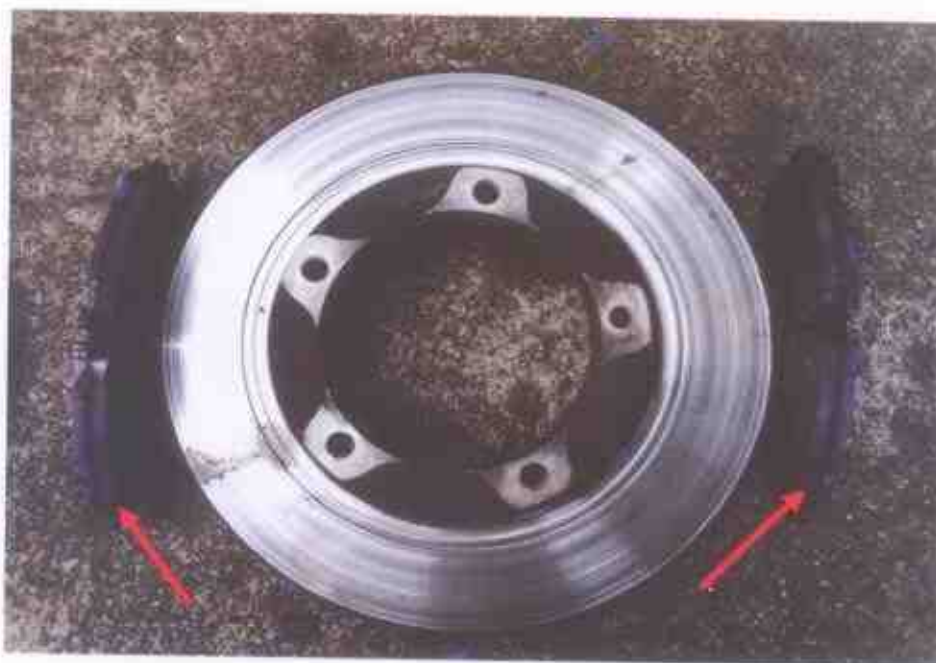
Photo 9 shows the front right inner and outer brake pads (arrowed) and the front right disc brake of the Insured Vehicle. The brake pad's braking material was observed to be of sufficient level. However the other outer side of the brake pad was missing at the time of my inspection, which will reduce the braking efficiency of the Insured Vehicle.
