Preliminary Advice

Insured Vehicle No : SKQ4736P

TP Vehicle No : SBS1Z

VEHICLE DAMAGE INSPECTION REPORT

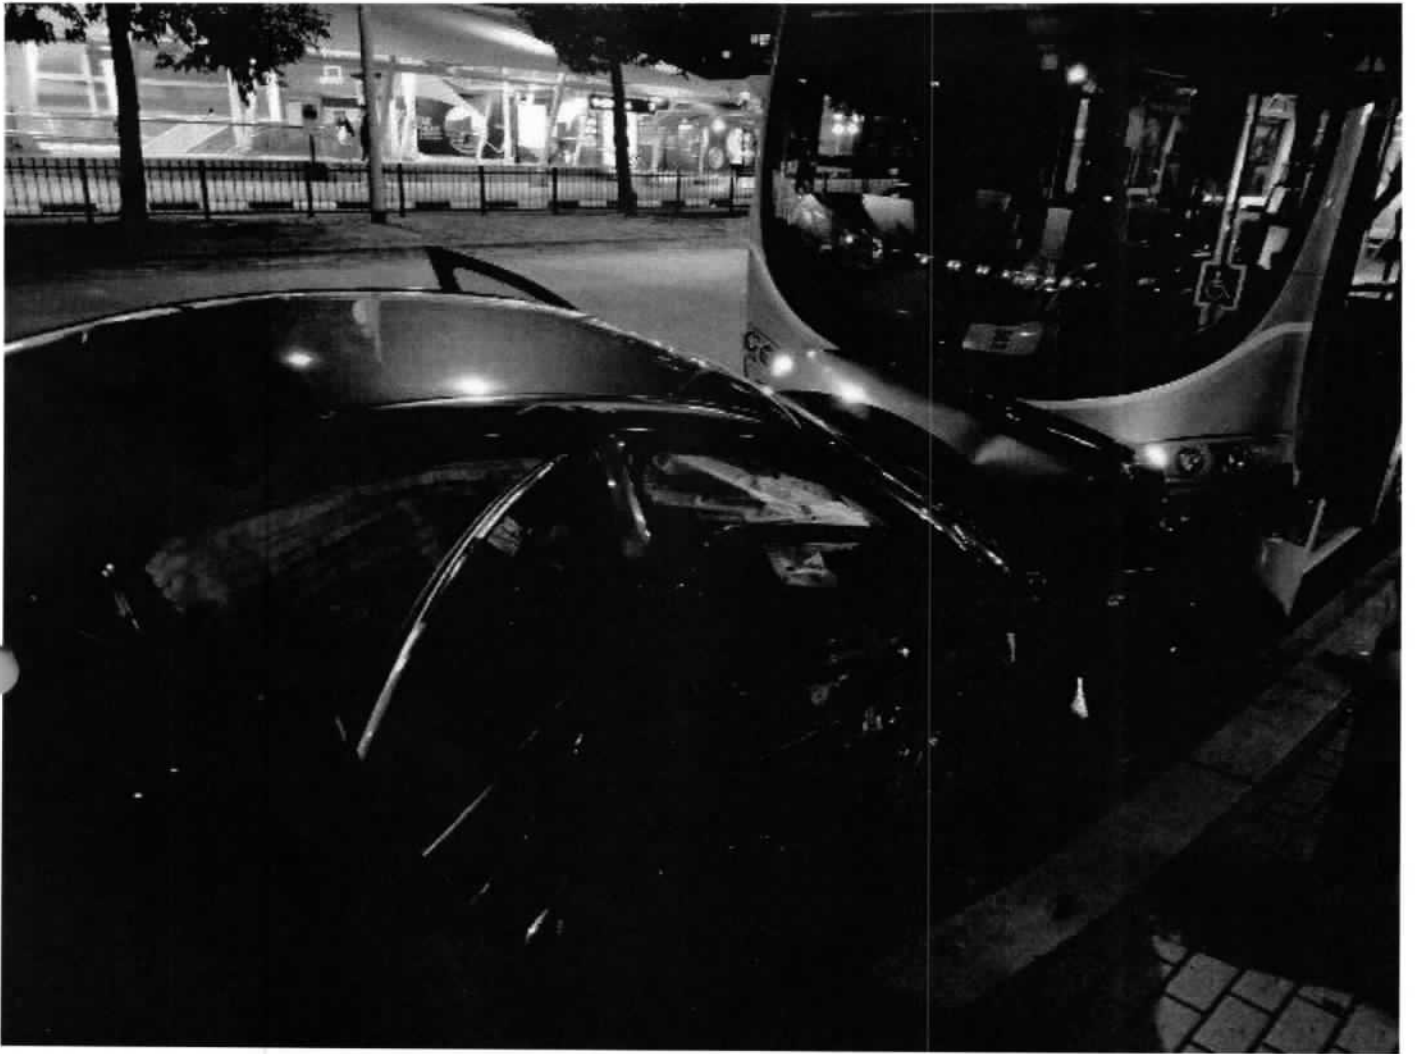
Accident Photo

As a result of the accident, the front portion of the bus was dented in. Neither the passengers in my bus or myself was injured.

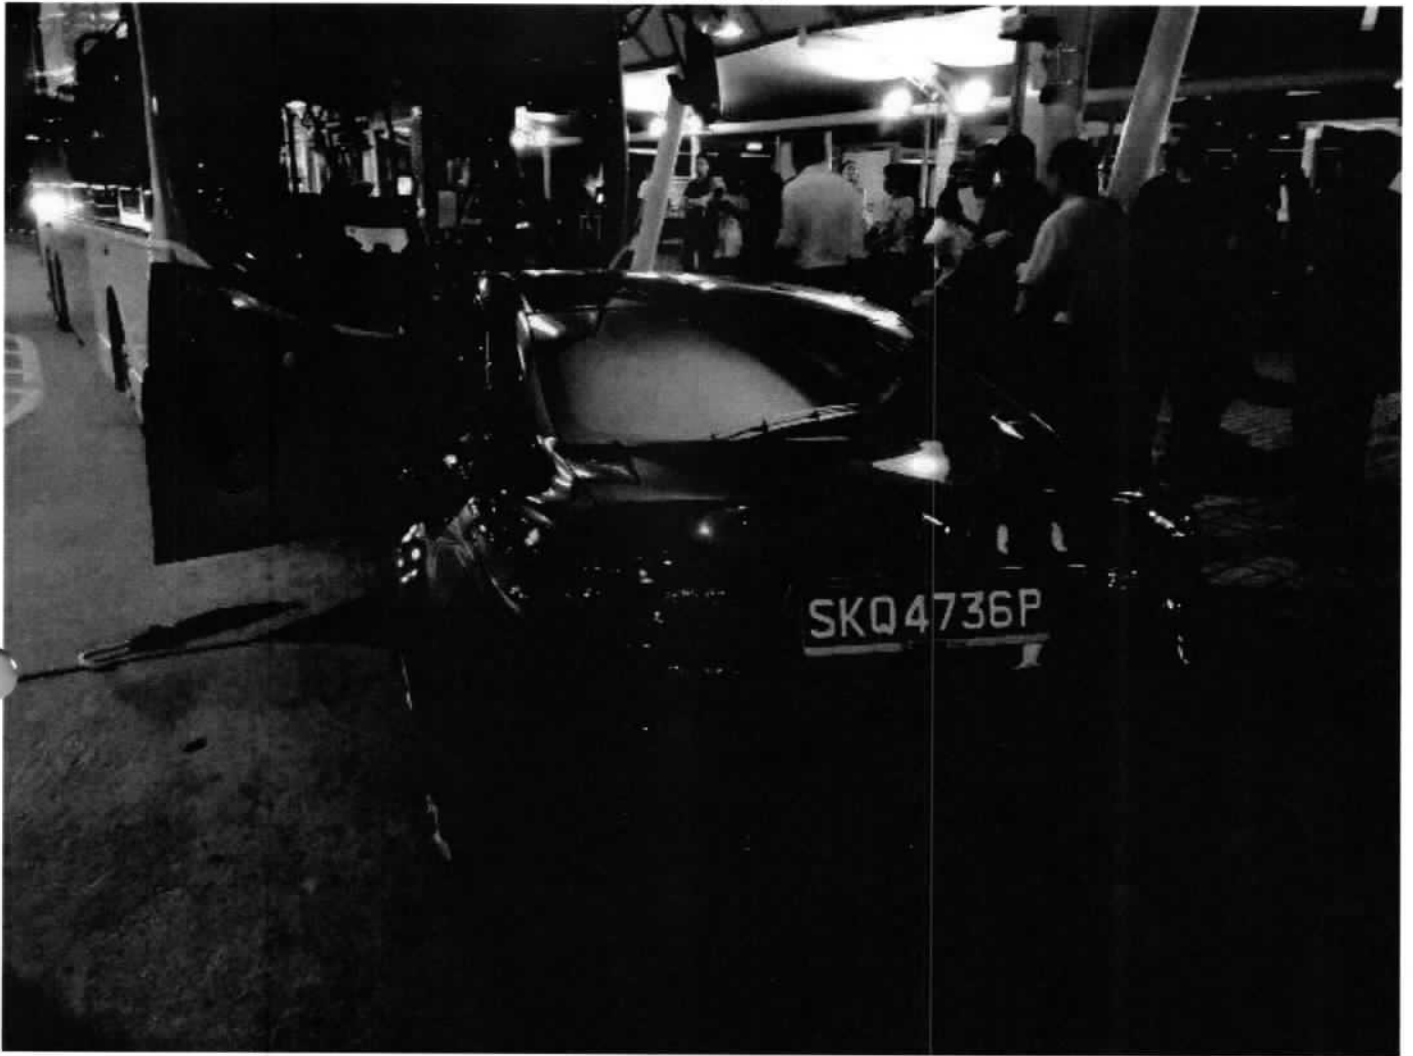
Accident Photo

The vehicle sustained impact / damages front portion and parts claimed are consistent to the accident.
