AUTOMOBILE INSPECTION REPORT OF INSURED VEHICLE SJF 9241L

Vehicle Registration No. : SJF 9241L
Make / Model : Honda Civic 1.8L A
Chassis No : JHMFD16308S215060
Year of Registration : 2008 (April)
Mileage : N.A.

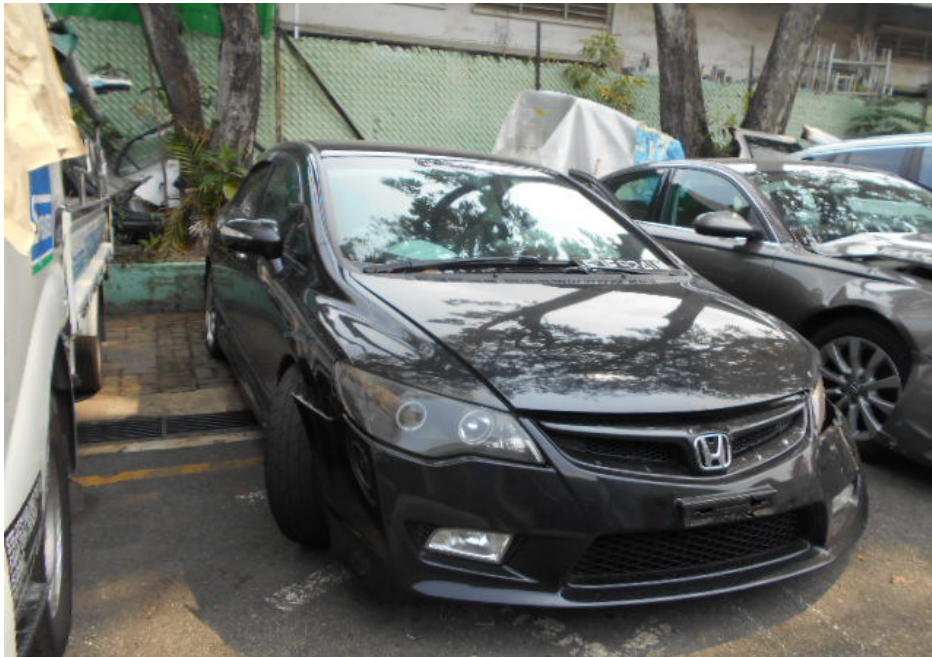
Photo 1 shows the front right body of the insured vehicle at the time of my inspection. The insured vehicle sustained relatively moderate damage at its left front portion. Other body areas of the insured vehicle were unaffected.

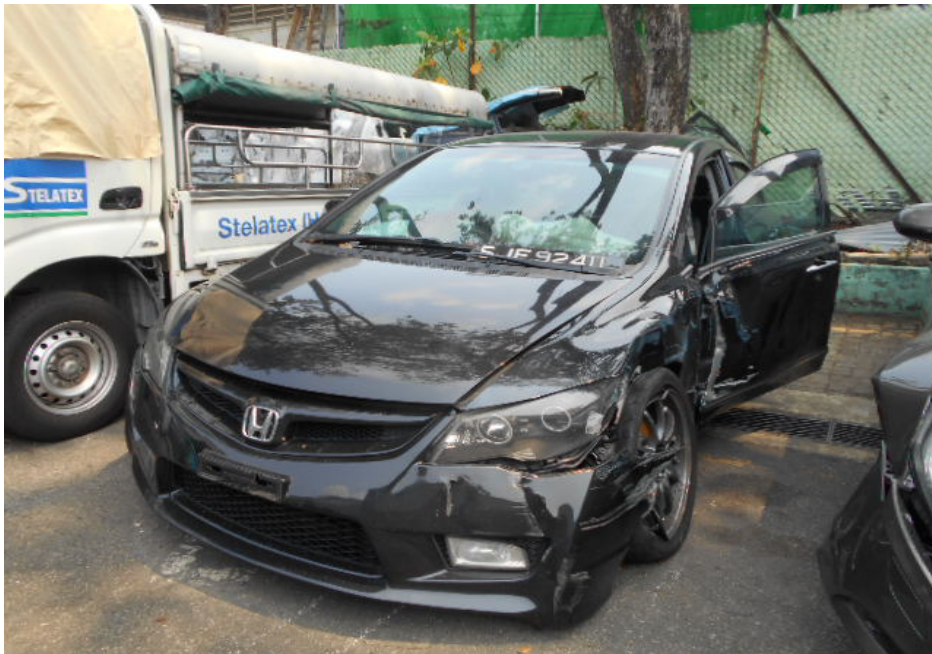
5. The insured vehicle was observed to have sustained relatively moderate impact damage at its left front portion. Without dismantling of any exterior body parts, I had observed damage to its front bumper, front left fender, front left headlamp, front left door, front left wheel rim, left wing mirror and front windscreen. The driver's airbag and front left passenger's airbag were also observed to be deployed. The driver's seat belt and front left passenger's seat belt were also found to be locked when I tested. See photo 1 – 4 below.

Photo 2 shows the front left body of the insured vehicle at the time of my inspection. The insured vehicle sustained relatively moderate damage at its left front portion. Without dismantling of any exterior body parts, I had observed damage to its front bumper, front left headlamp, front left fender, front left door and left wing mirror amongst others.

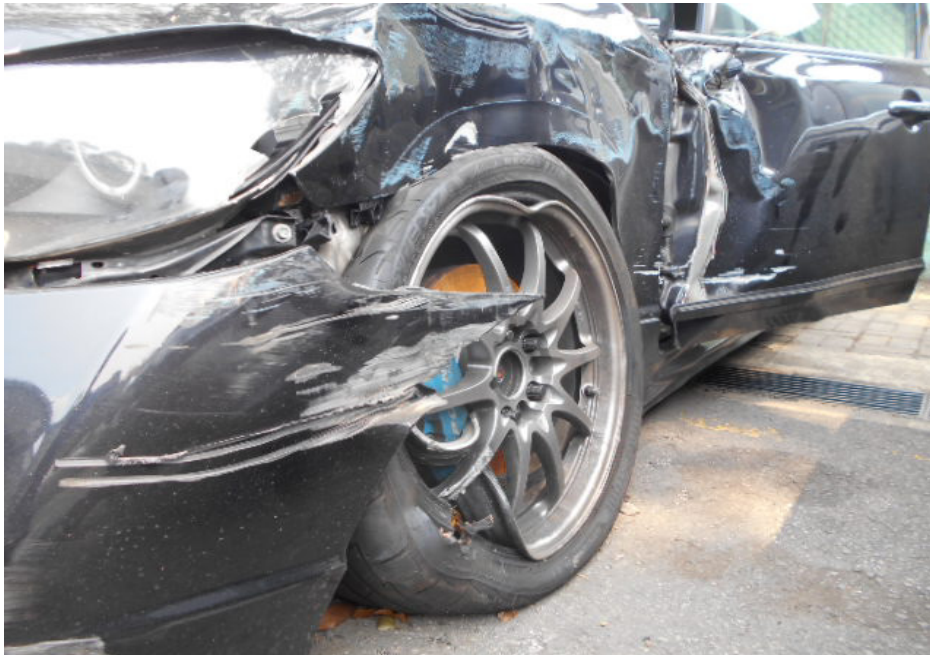
Photo 3 shows a closer view of the damage to the front bumper, front left wheel rim, front left fender, front left headlamp and front left door of the insured vehicle.

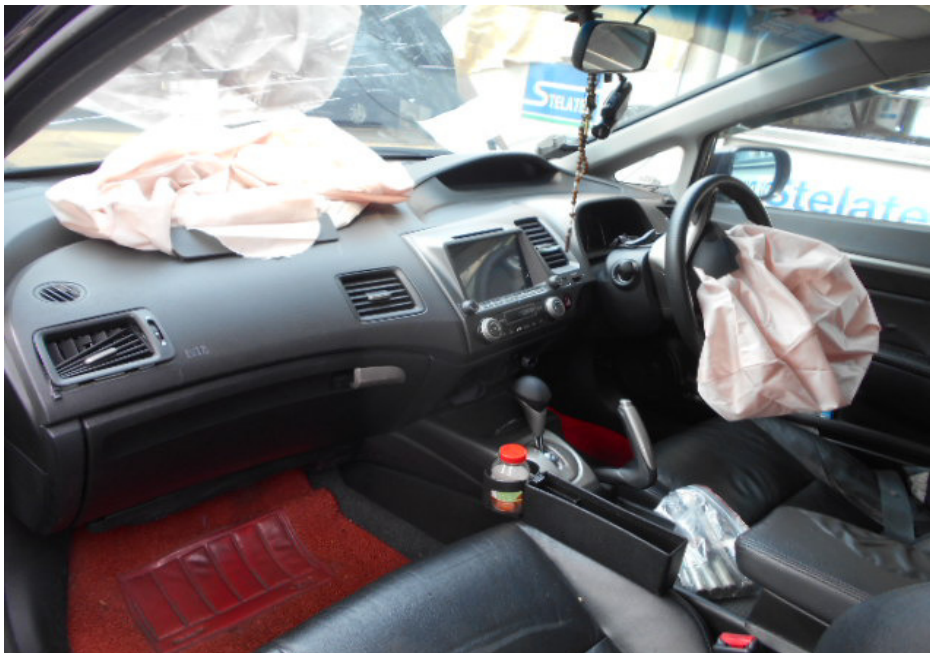
Photo 4 shows the interior compartment of the insured vehicle at the time of my inspection. The driver's airbag and front left passenger's airbag were observed to be deployed. The driver's seat belt and front left passenger's seat belt were also found to be locked when I tested.

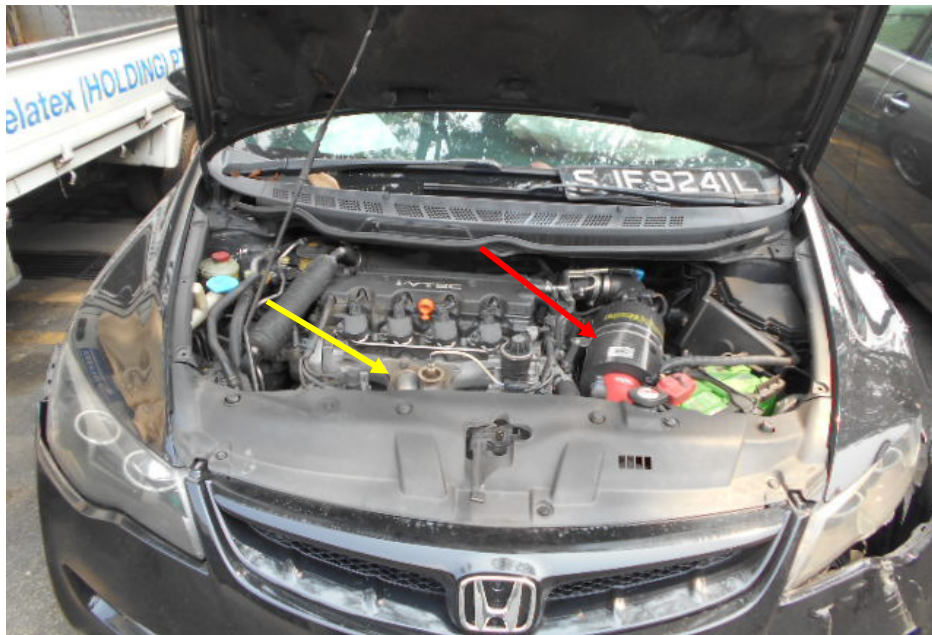
6. Upon checking the engine compartment of the insured vehicle, I had found several modifications and additional non-standard parts fitted. This includes an aftermarket air intake system with piping; an aftermarket exhaust manifold; and an additionally fitted front strut bar. See photo 5 – 9 below.

Photo 5 shows a general view of the engine compartment of the insured vehicle. Several modifications and additional non-standard parts were found fitted. This includes an aftermarket air intake system with piping (red arrow); an additionally fitted front strut bar; and an aftermarket exhaust manifold (yellow arrow).

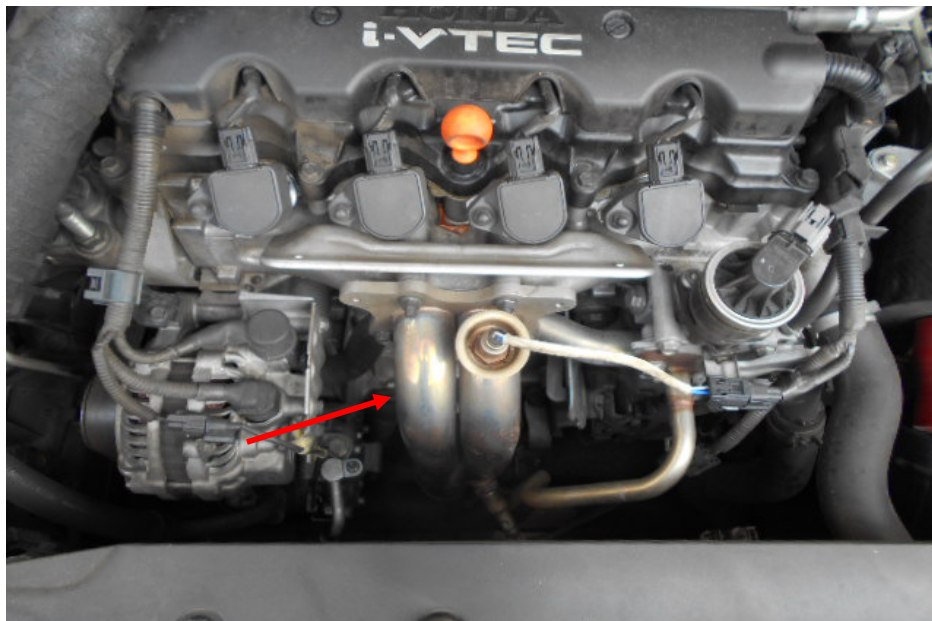
Photo 6 shows the aftermarket exhaust manifold (arrowed) that was fitted on the insured vehicle at the time of my inspection.

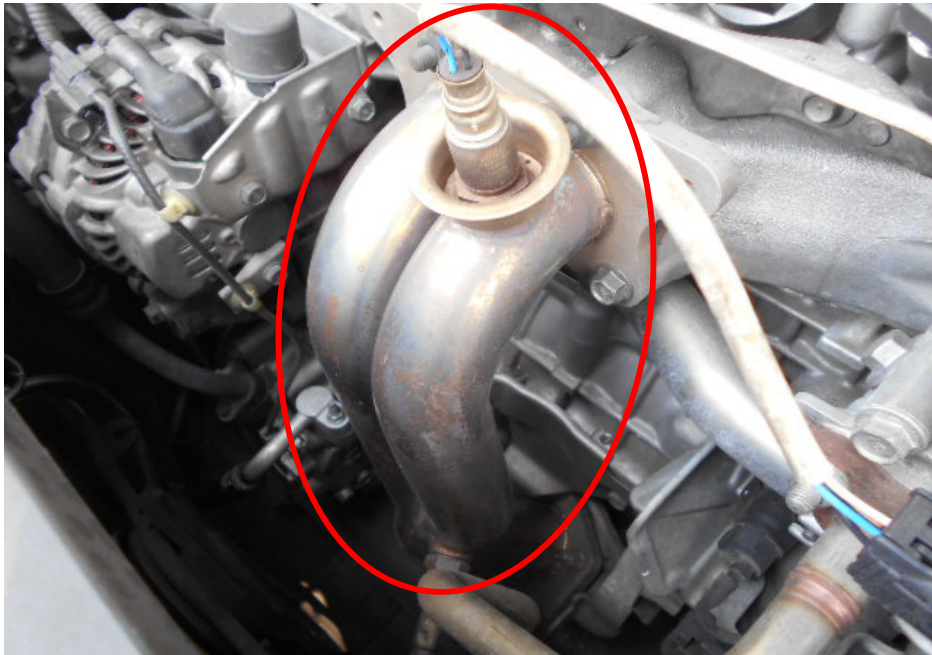
Photo 7 shows another view of the aftermarket exhaust manifold (circled) that was fitted on the insured vehicle at the time of my inspection. This exhaust manifold fitted on the insured vehicle is not LTA compliant. Owner does not have any approval letter from LTA for the aftermarket exhaust manifold. The overall engine performance of the insured vehicle will be improved.

Modification/additionally fitted non-standard part	LTA's guideline	Effect(s) on insured vehicle
Aftermarket air intake system	Compliant	Overall engine performance enhanced
Aftermarket exhaust manifold	Not compliant. Owner does not have any approval from LTA	Overall engine performance enhanced
Aftermarket front brake system	Compliant	Overall braking efficiency enhanced

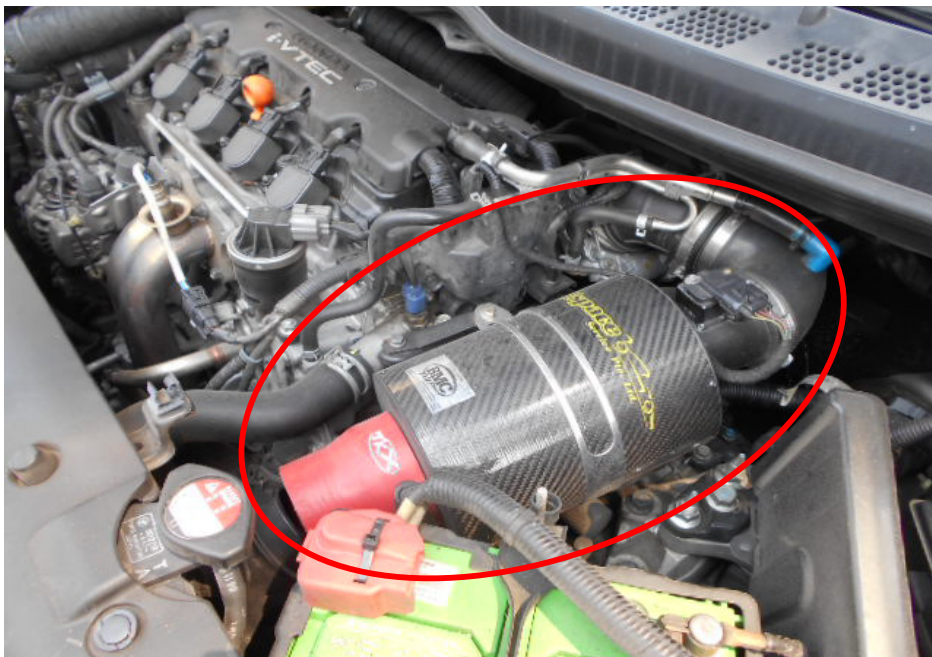
Photo 8 shows the aftermarket air intake system with piping (circled) that was fitted on the insured vehicle at the time of my inspection. This air intake system fitted on the insured vehicle is LTA compliant. The overall engine performance of the insured vehicle will be improved.

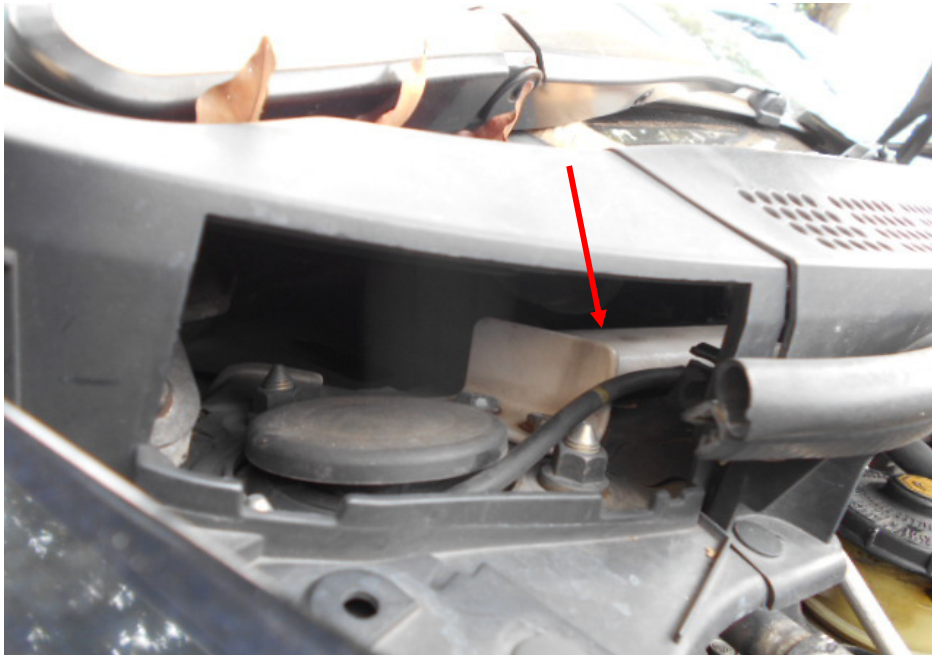
Photo 9 shows the additionally fitted front strut bar (arrowed) that was found inside the engine compartment of the insured vehicle. This strut bar is LTA compliant and improves the stability of the insured vehicle during cornering.

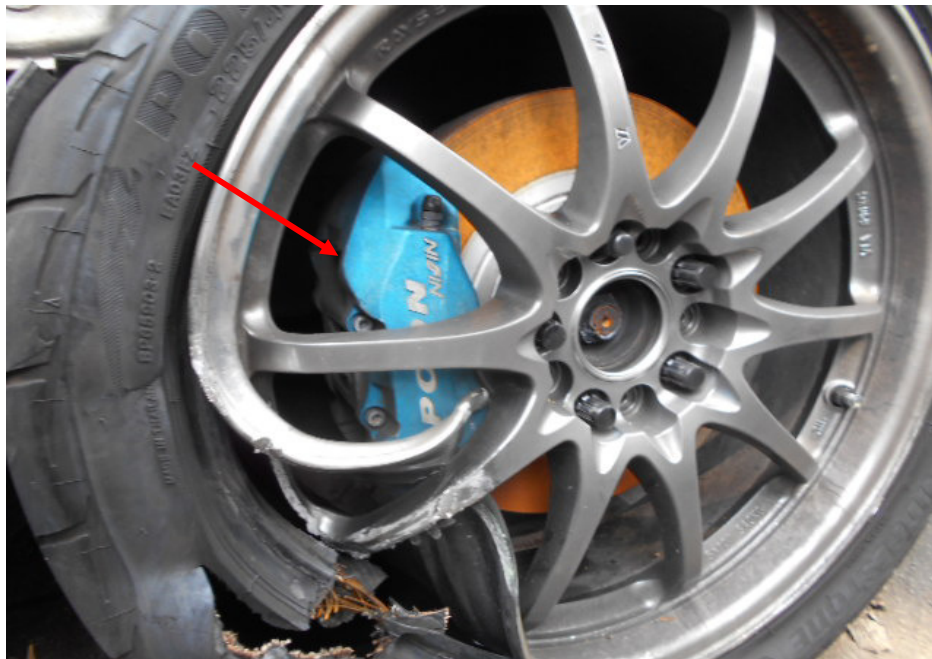
7. Checks on the underside of the insured vehicle revealed an aftermarket front brake system. See photo 10 & 11 below.

Photo 10 shows the aftermarket front brake caliper (arrowed) that was fitted on the front left wheel of the insured vehicle. The front brake system of the insured vehicle was observed to be of an aftermarket brand.

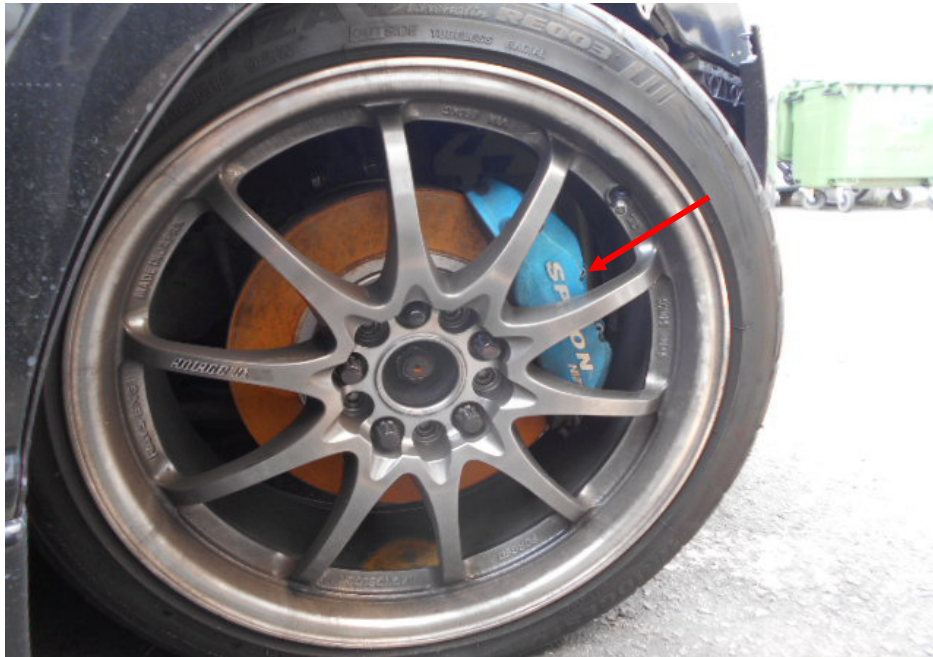
Photo 11 shows the aftermarket front brake caliper (arrowed) that was fitted on the front right wheel of the insured vehicle. The front brake system of the insured vehicle is LTA compliant. The overall braking efficiency will be enhanced.

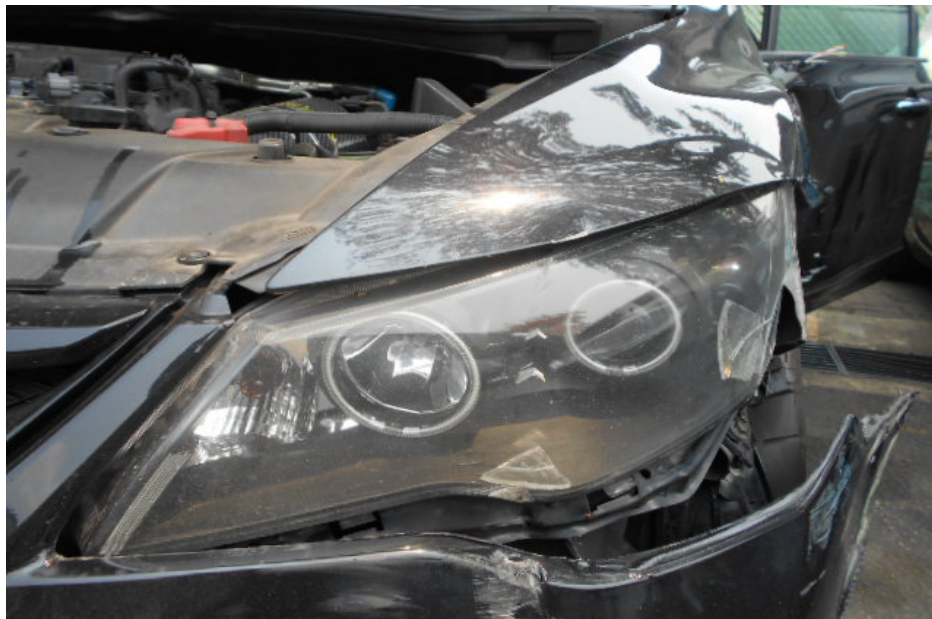
8. A pair of aftermarket front headlamps and an additionally fitted sprint booster device were also found fitted on the insured vehicle upon my further examination. A letter from LTA for the approval of the aftermarket front headlamps was found on the insured vehicle. See photo 12 – 15 below.

Photo 12 shows the aftermarket front left headlamp that was fitted on the insured vehicle. This aftermarket front headlamp is LTA compliant.

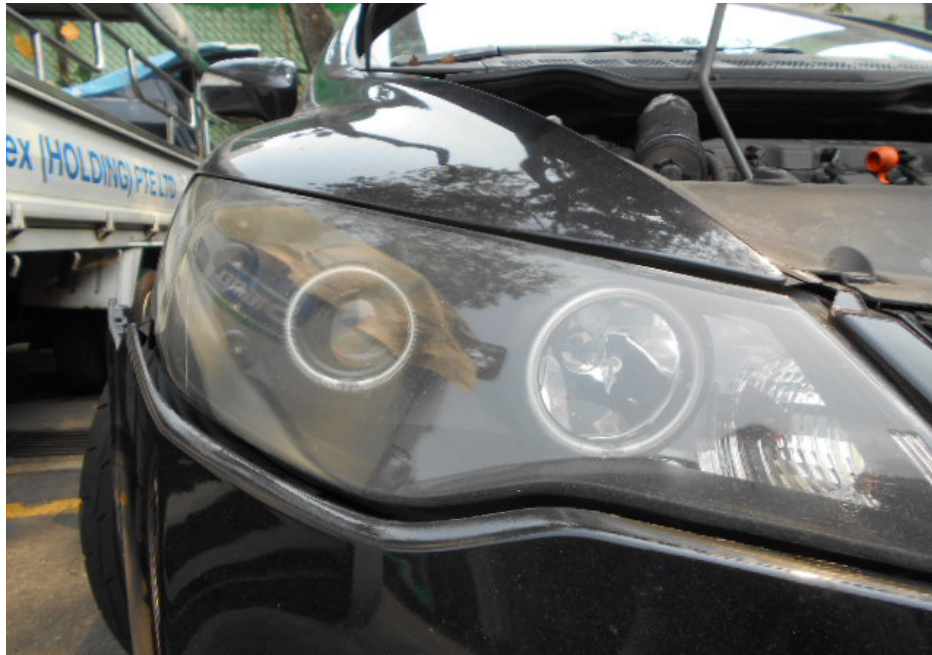
Photo 13 shows the aftermarket front right headlamp that was fitted on the insured vehicle. This aftermarket front headlamp is LTA compliant and a cosmetic type of modification.

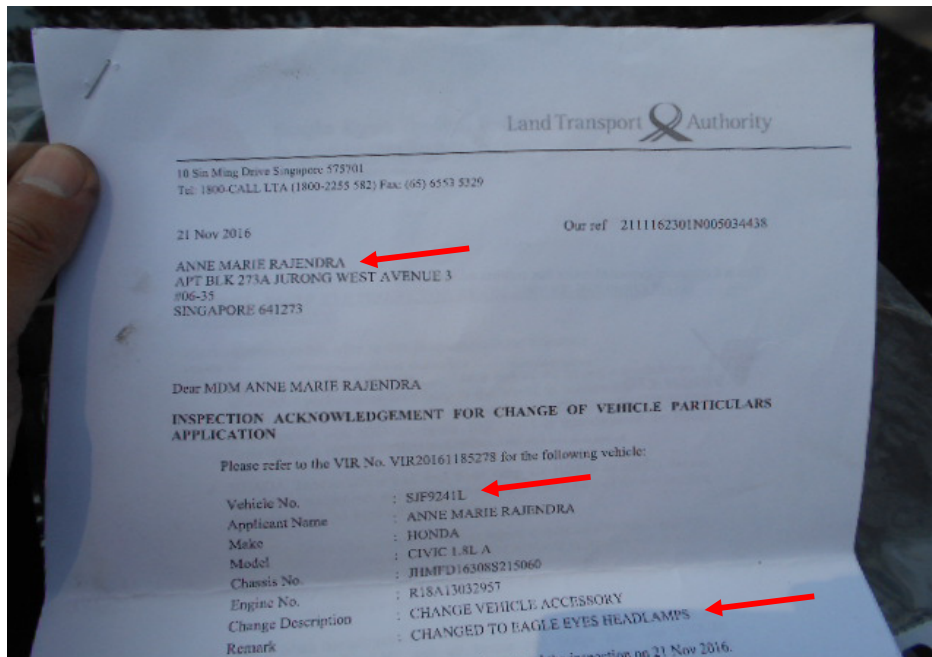
Photo 14 shows the approval letter from LTA pertaining to the aftermarket front headlamps that were fitted on the insured vehicle.

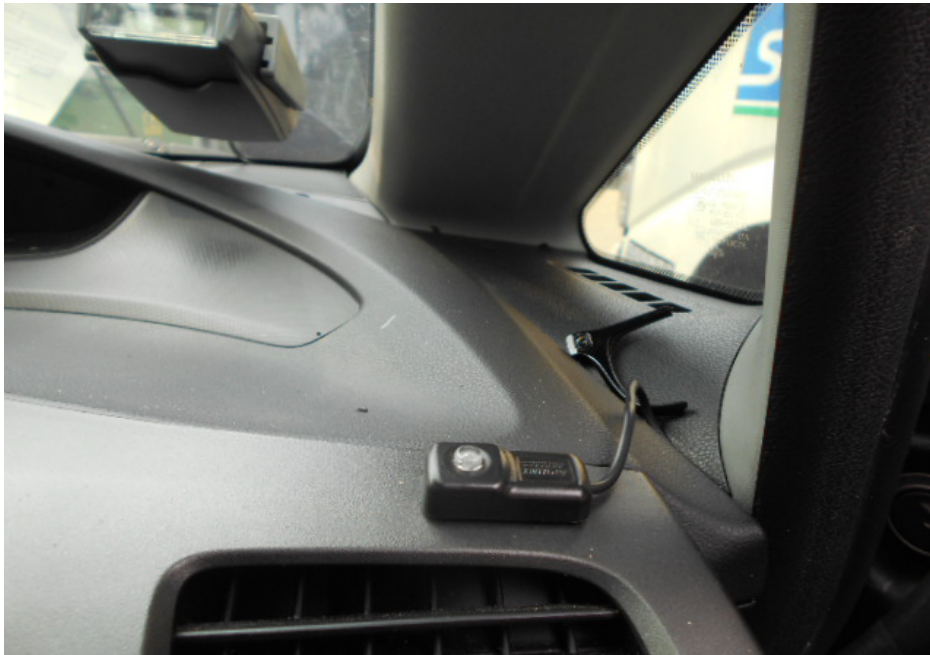
Photo 15 shows the accessory for the additionally fitted boost sprinter device that was fitted on the insured vehicle at the time of my inspection. The boost sprinter device is LTA compliant. It enhances the acceleration/throttle response of the insured vehicle.
