## ACCIDENT VEHICLE SURVEY REPORT

Vehicle Reg No.:	SJT6951S	Odometer:	138788km
Make & Model:	Hyundai Avante 1.6 AT	Colour:	Silver
Chassis number:	KMH DU41MAU896401	Date of accident:	04/05/2019
Year of Regn.:	27/10/2009	Date inspected:	05/05/2019
Repairer at:	Sau Hock Motor Services	Date inspected (After Repair):	13/05/2019
	Blk 10 Ang Mo Kio Ind Park 2A #02-14		
	AMK AutoPoint		
	Singapore 568047

**1. Policy Particulars :- THIRD PARTY CLAIM (RESURVEY INSPECTION)**

## ADJUSTMENT ON REPAIR COST FOR VEHICLE NO. SJT 6951S

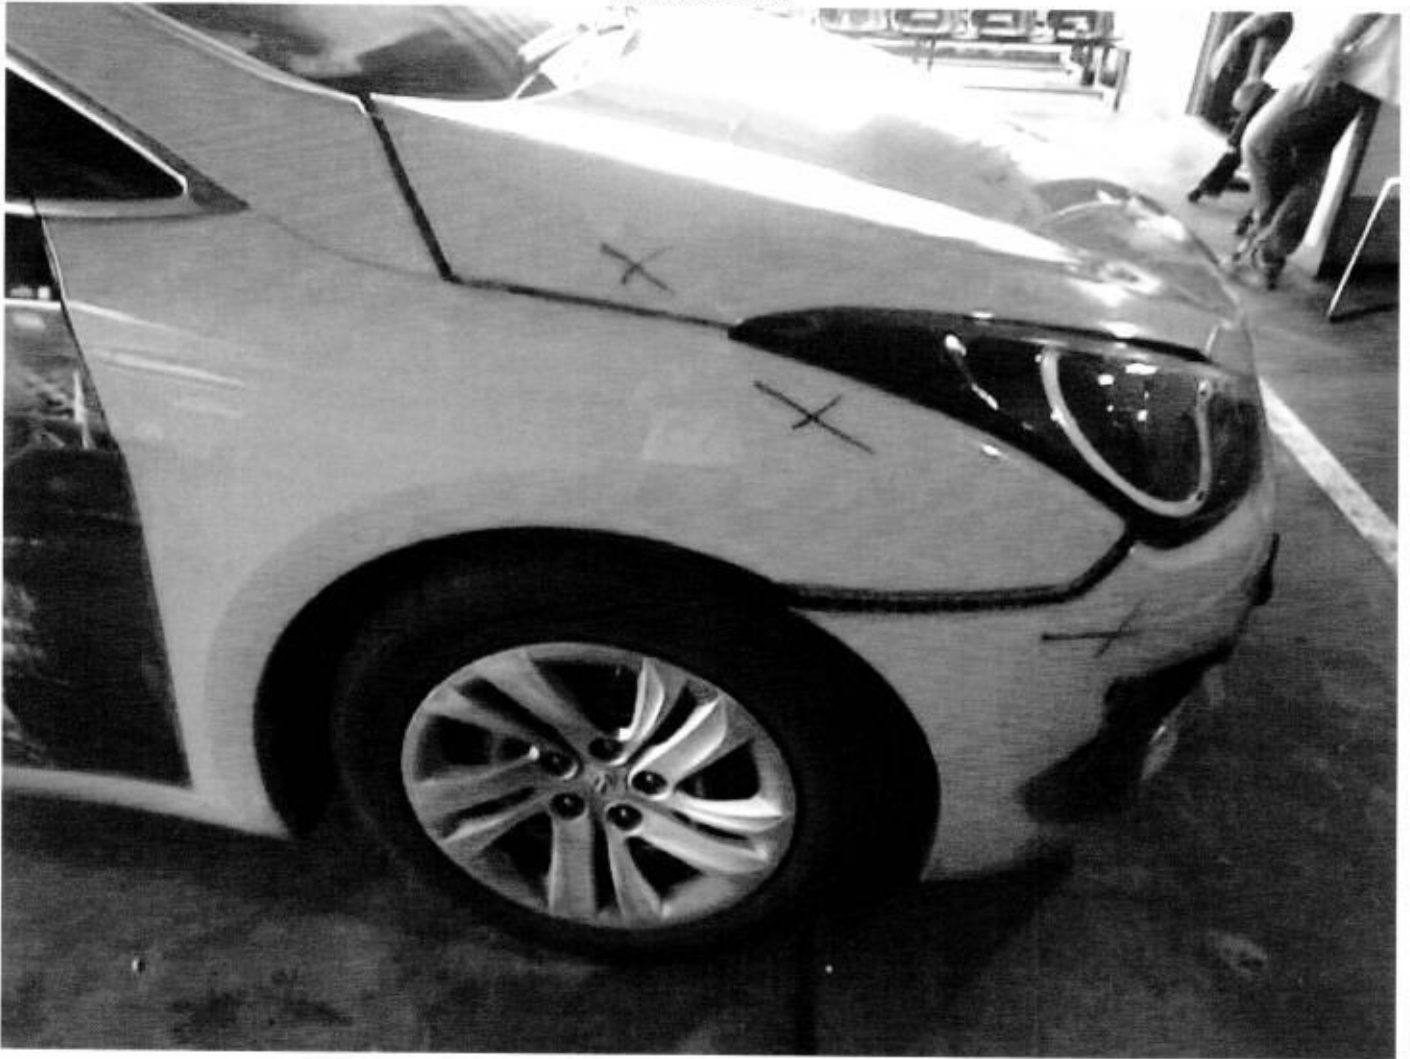
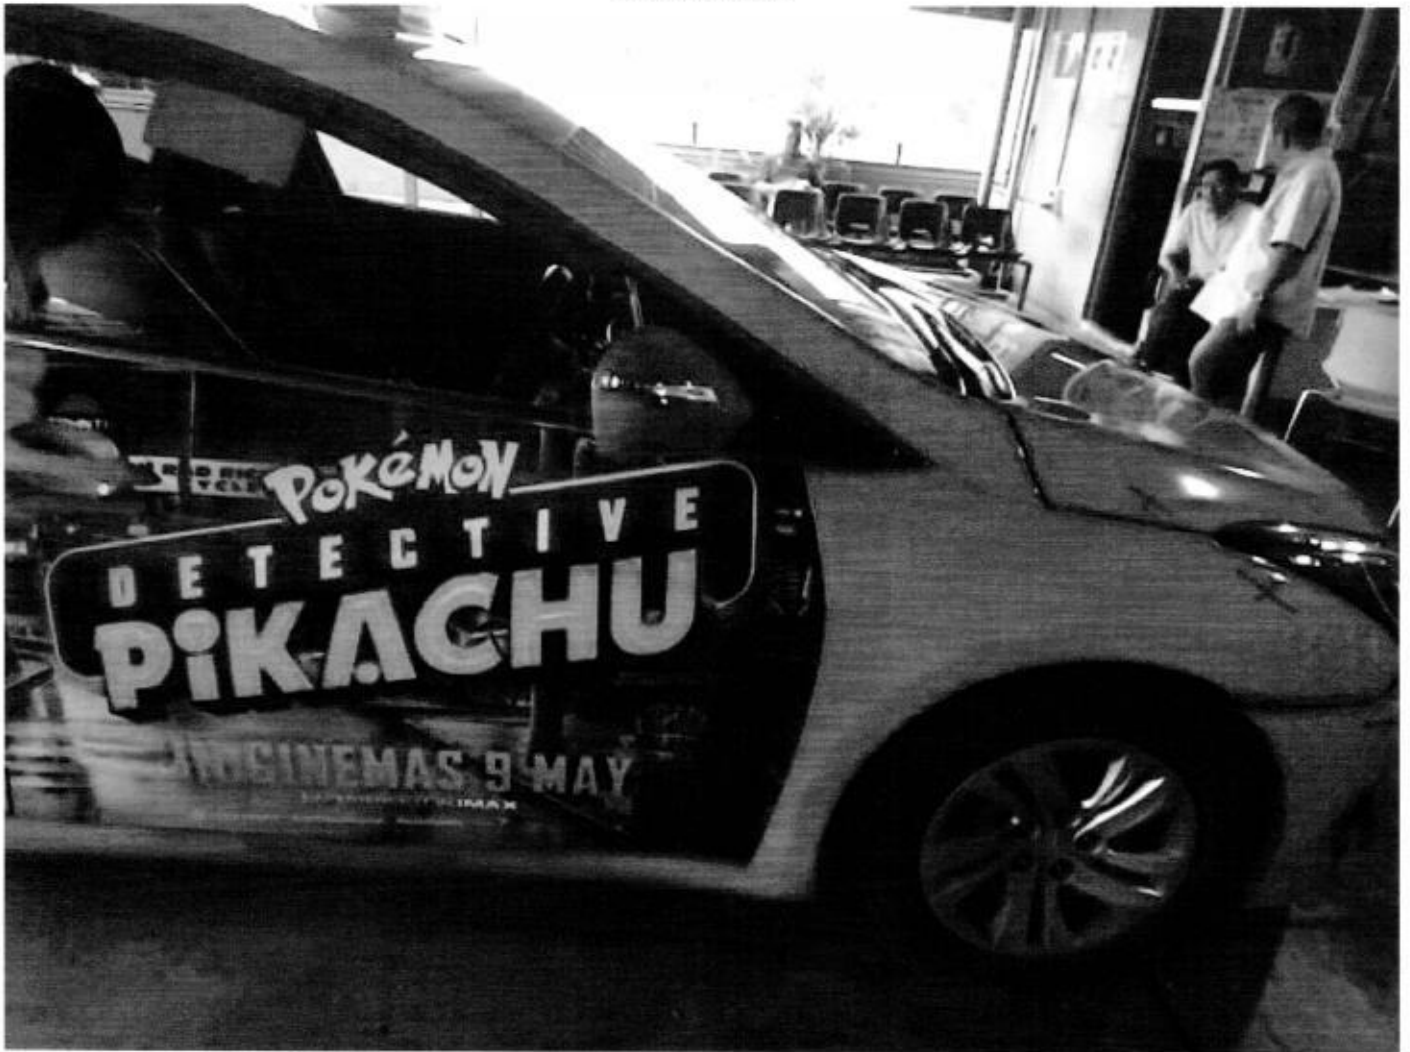
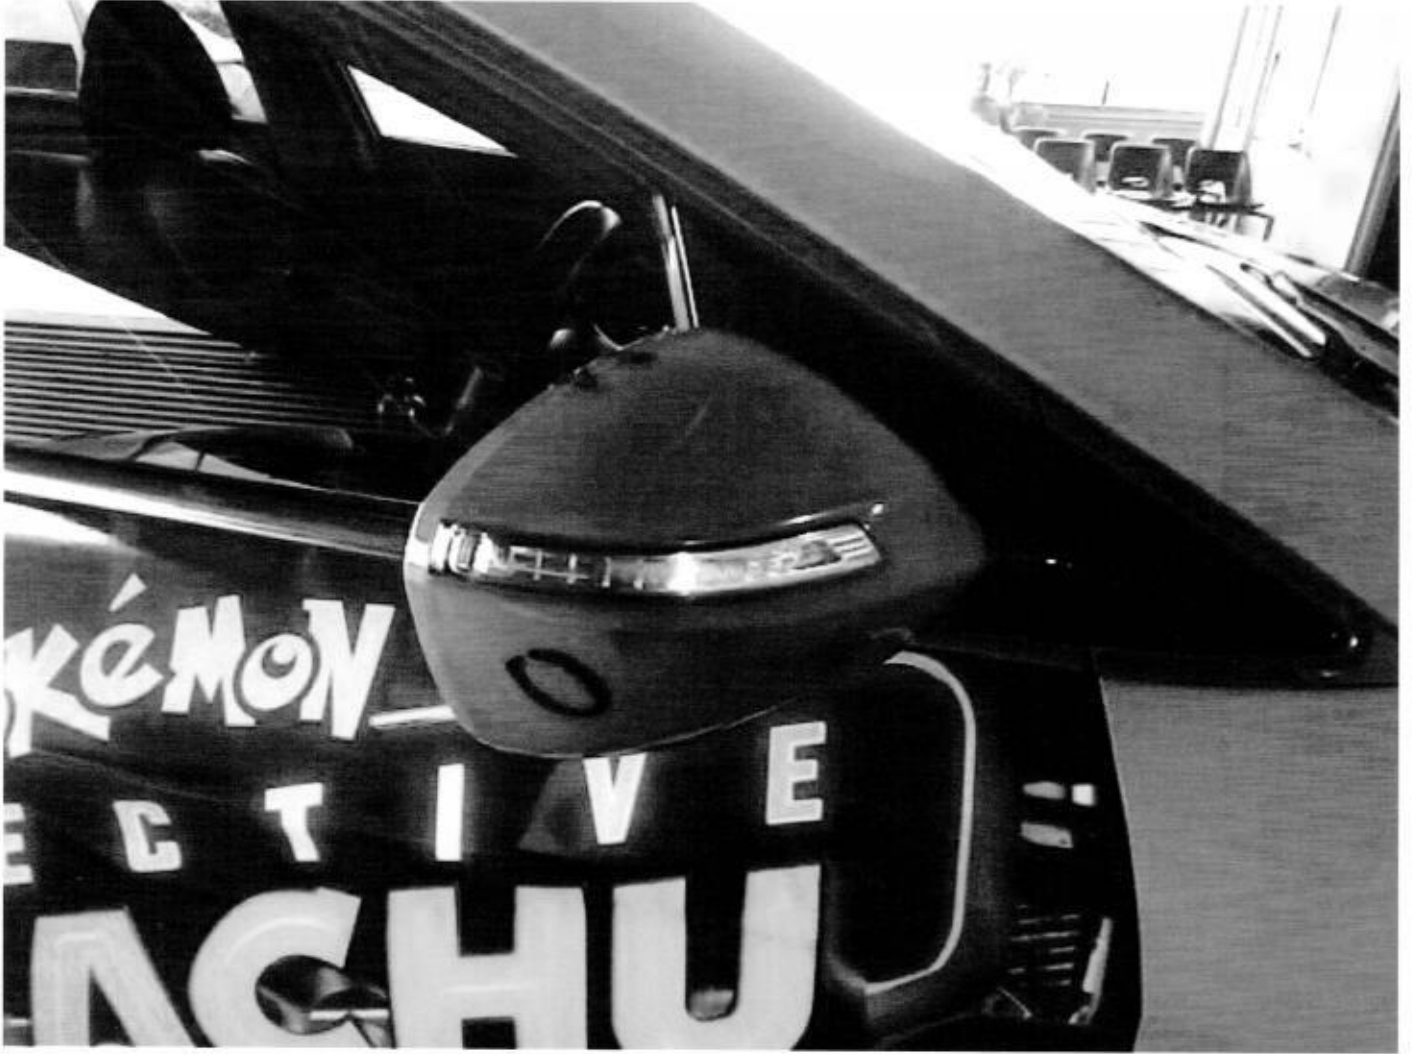
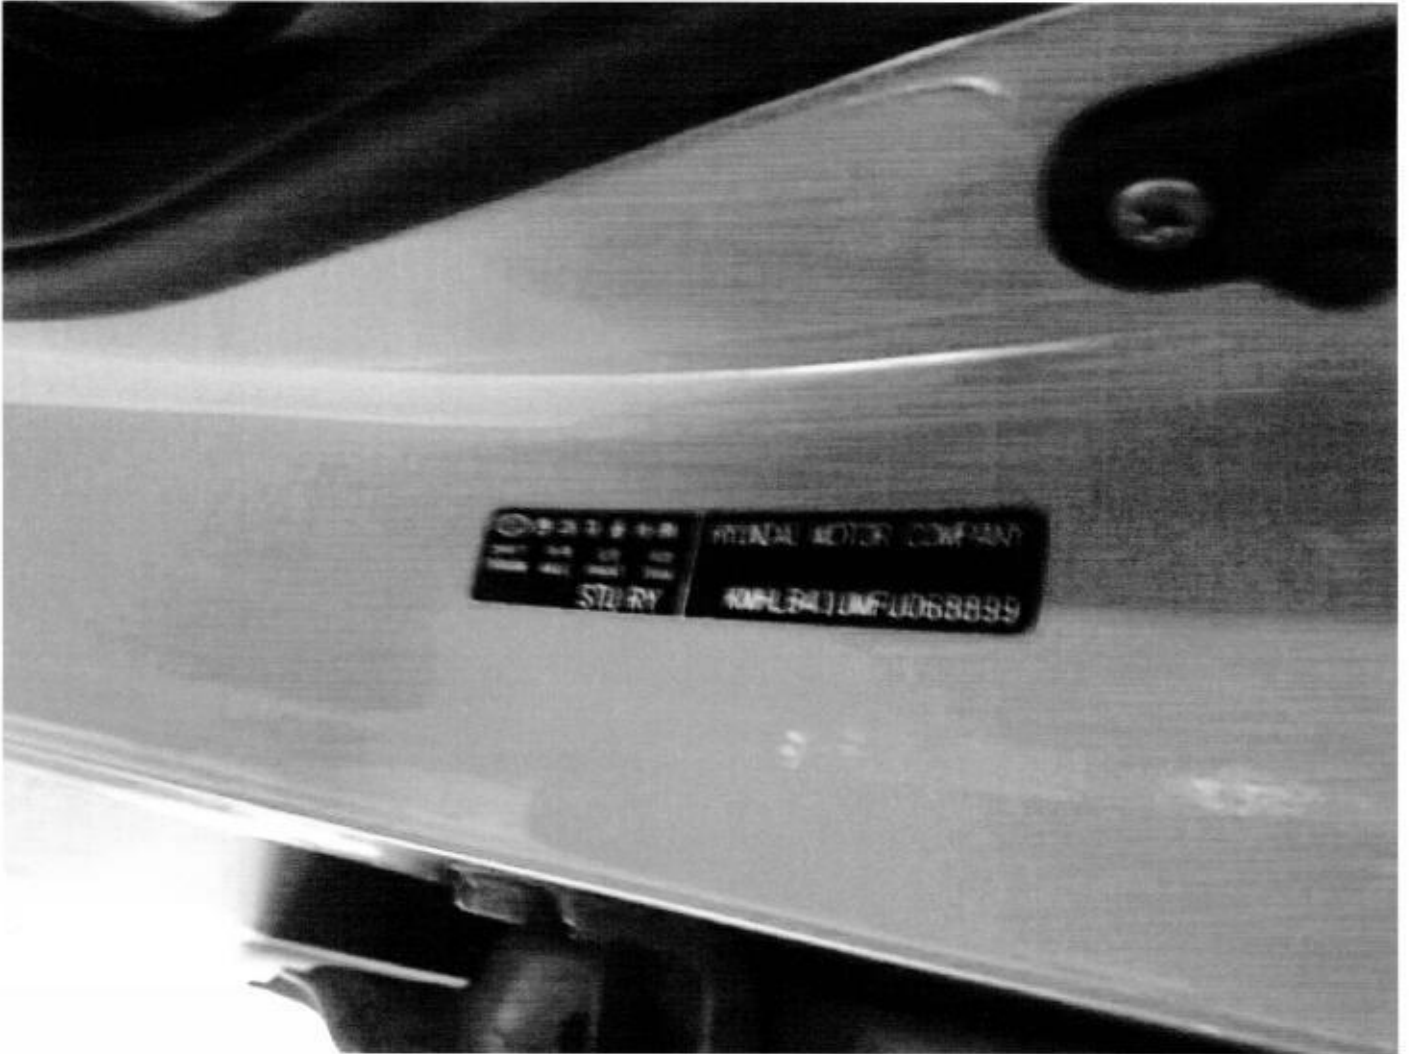
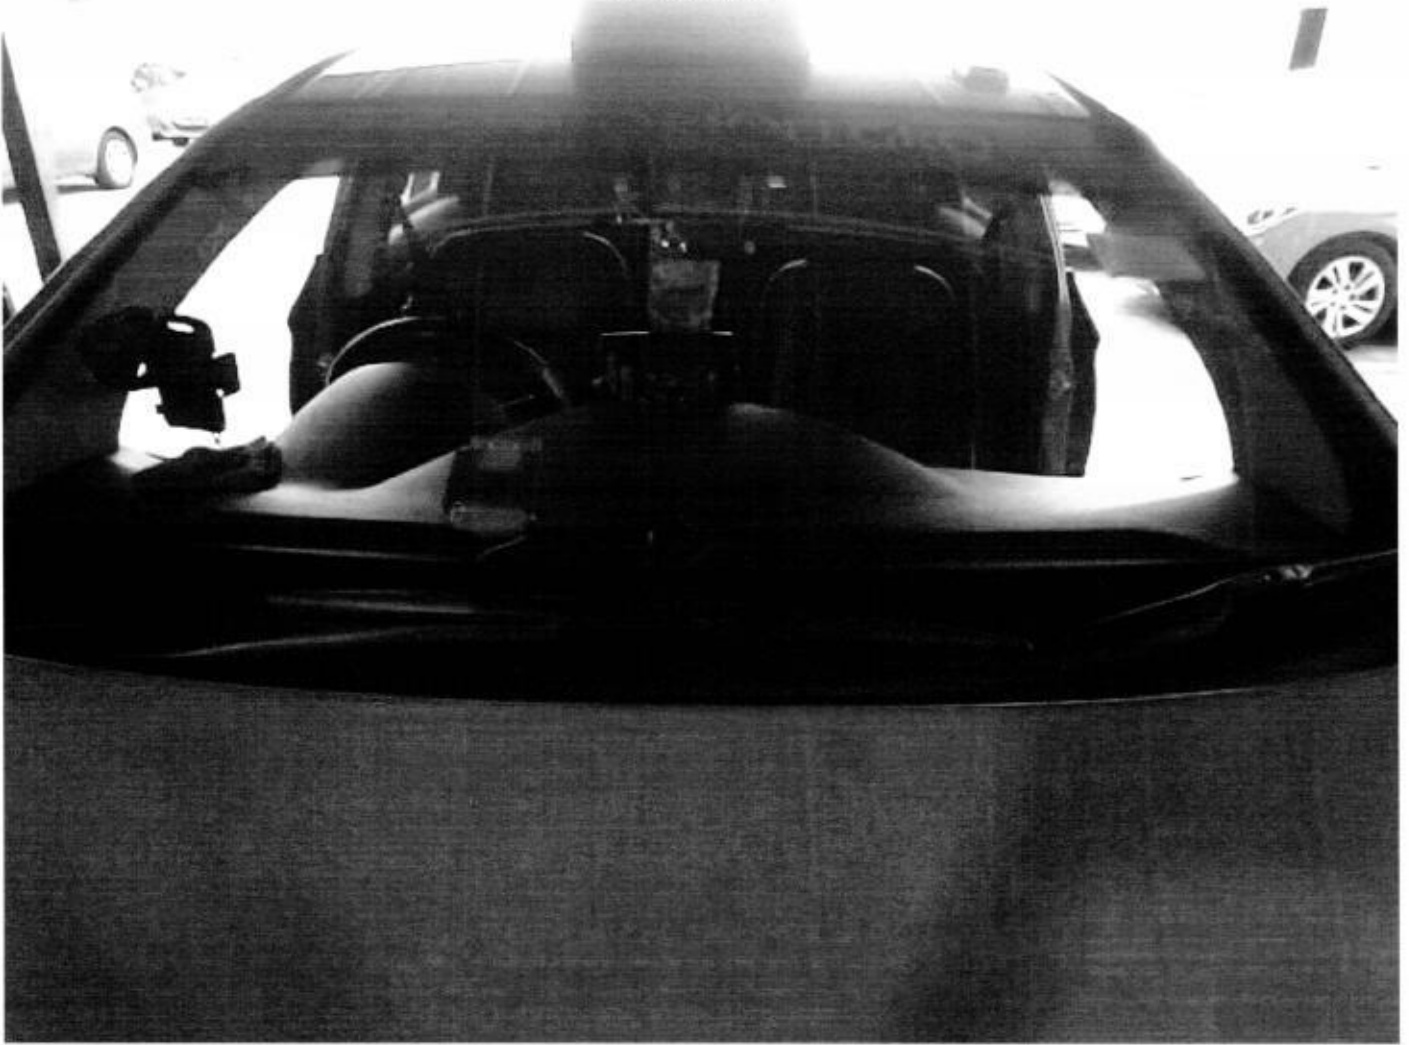
Accident Photo

Impact on the front portion.  
Please see details as described in the Annex for parts and labour.
