LKK Auto Consultants Pte Ltd

1. Policy Particulars :- THIRD PARTY (FOLLOW THROUGH INSPECTION)

ADJUSTMENT ON REPAIR COST FOR VEHICLE NO. SHD 755P

PHOTOGRAPHS FOR VEHICLE NO. SHD 755P

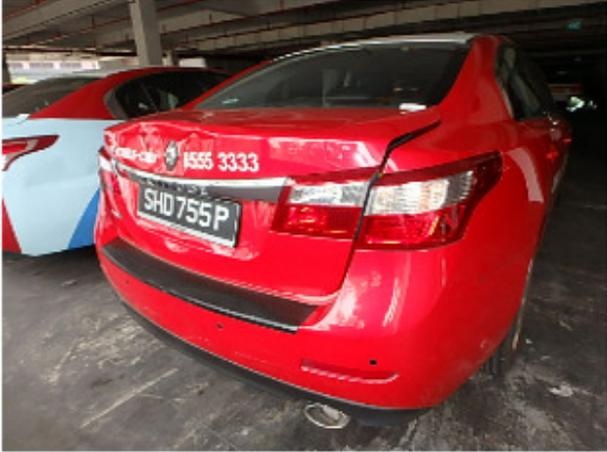
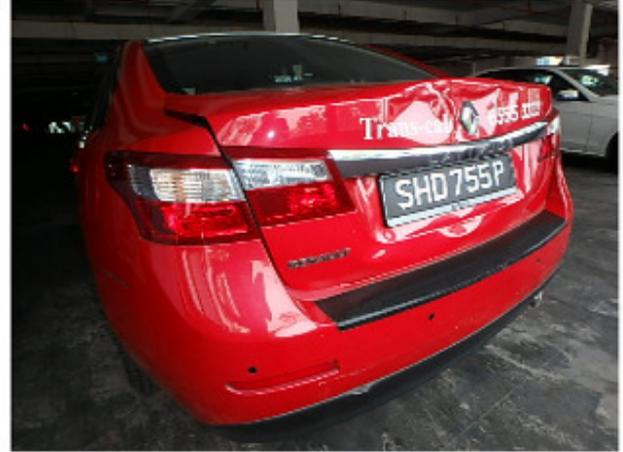
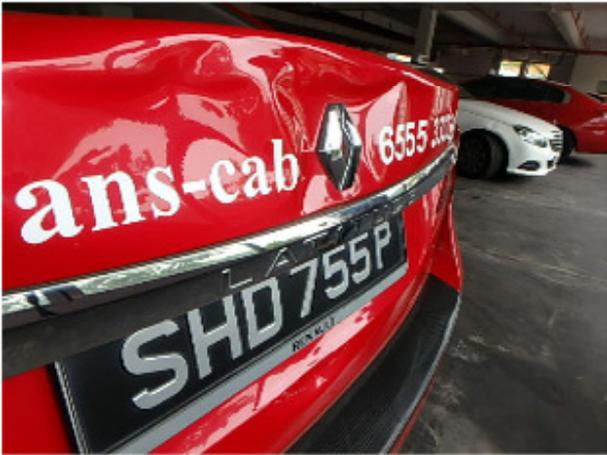
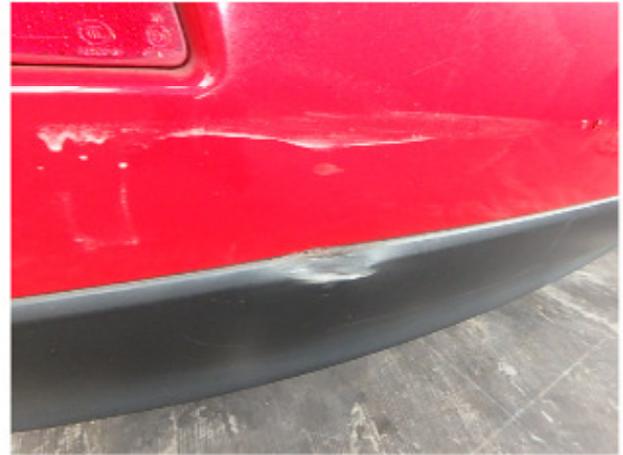
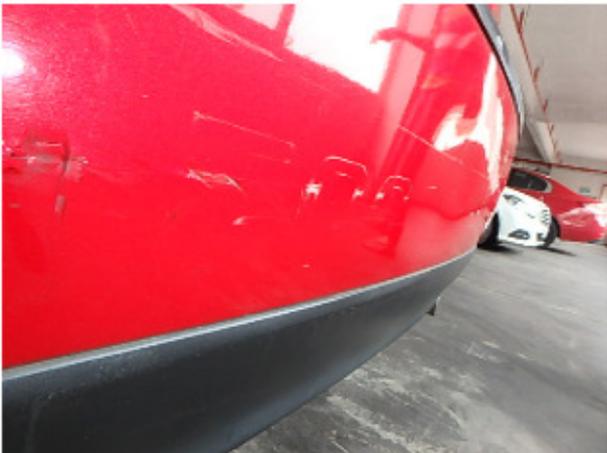
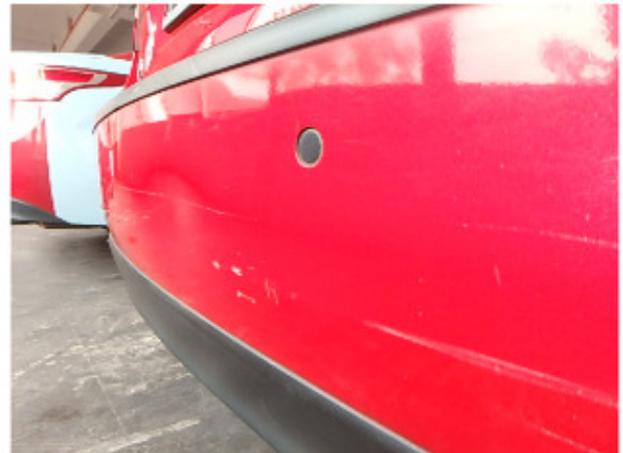
INSPECTION

THE VEHICLE SUSTAINED DAMAGES AT THE REAR PORTION.
DAMAGES SEE DETAILS.
