VEHICLE DAMAGE INSPECTION REPORT

Our File No: CS/AIG19016247/UYD3S2
Date: 20/09/2019

Handling Insurer: AIG Asia Pacific Insurance Pte. Ltd. Policy No: 1800102003
Claimant Vehicle No : SKQ7897M **Insured Vehicle No :** SDP3838Z
 Date of Loss: 11/09/2019 Nature of Claim: TP Claim No: 7870513903SG

Reg No: **SKQ7897M**
 Make & Model: HONDA JAZZ, 1.5 VTIR (A) Engine No: L15B31000248
 Reg. Date: 26/12/2014 (Man. Year: 2014) Chassis No: JHMGK5850FX201899
 Colour: Red Odometer: 103784 km
 Engine Capacity: 1498 cc
 Market Value/New Car Price: N/A
 Sum Insured (S\$): **Market Value/New Car Price**

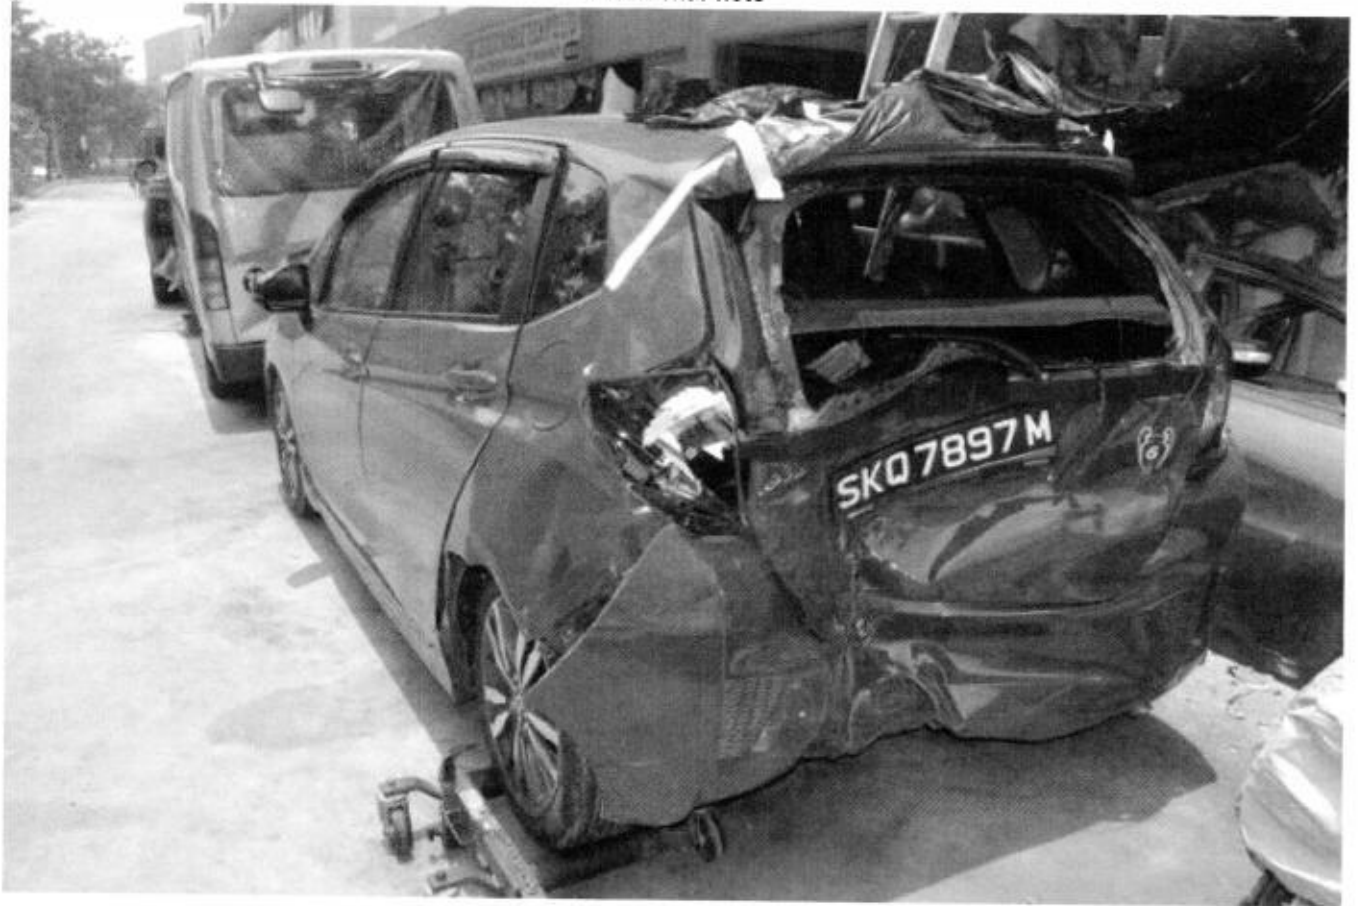
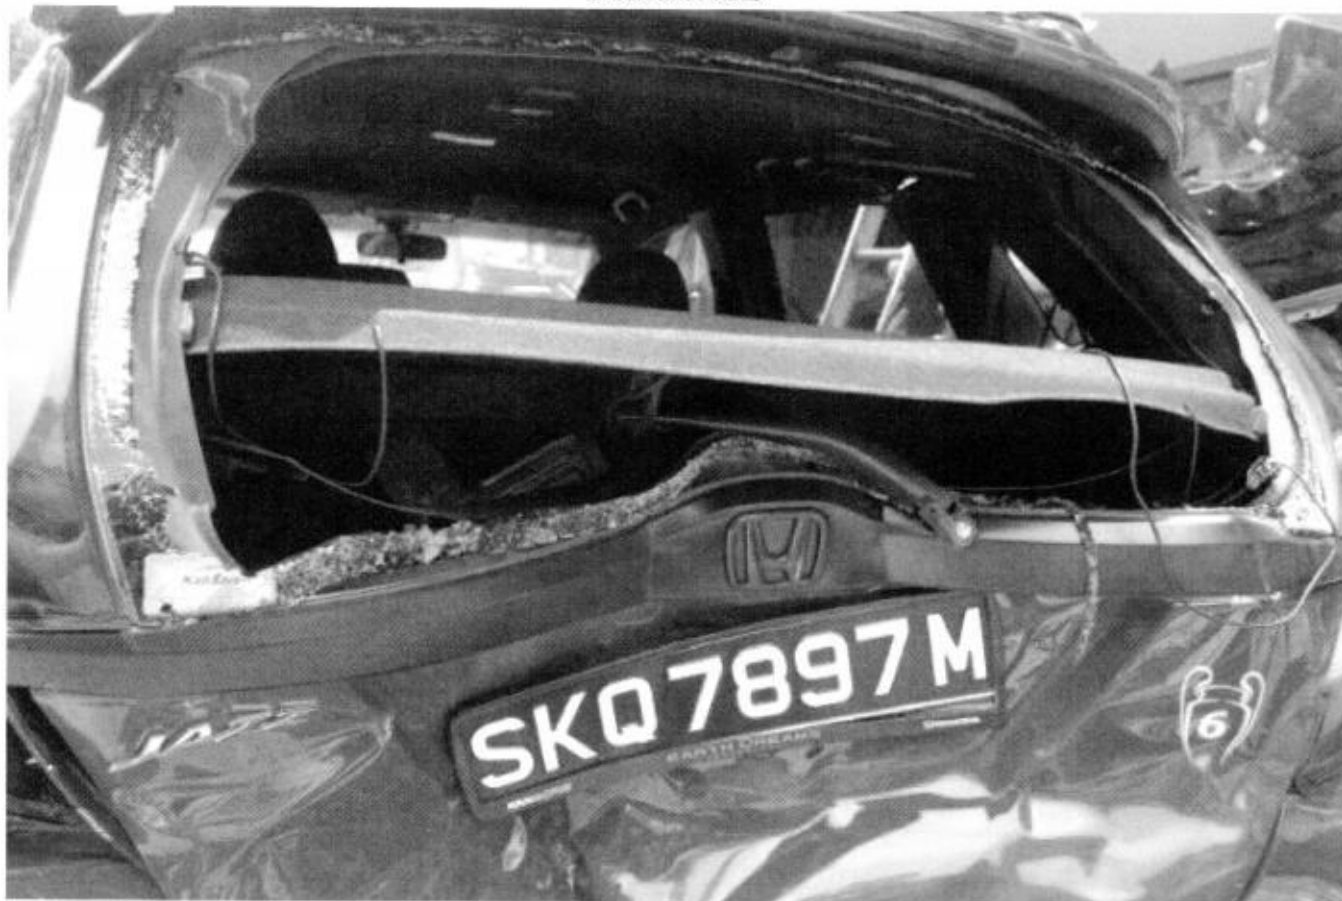
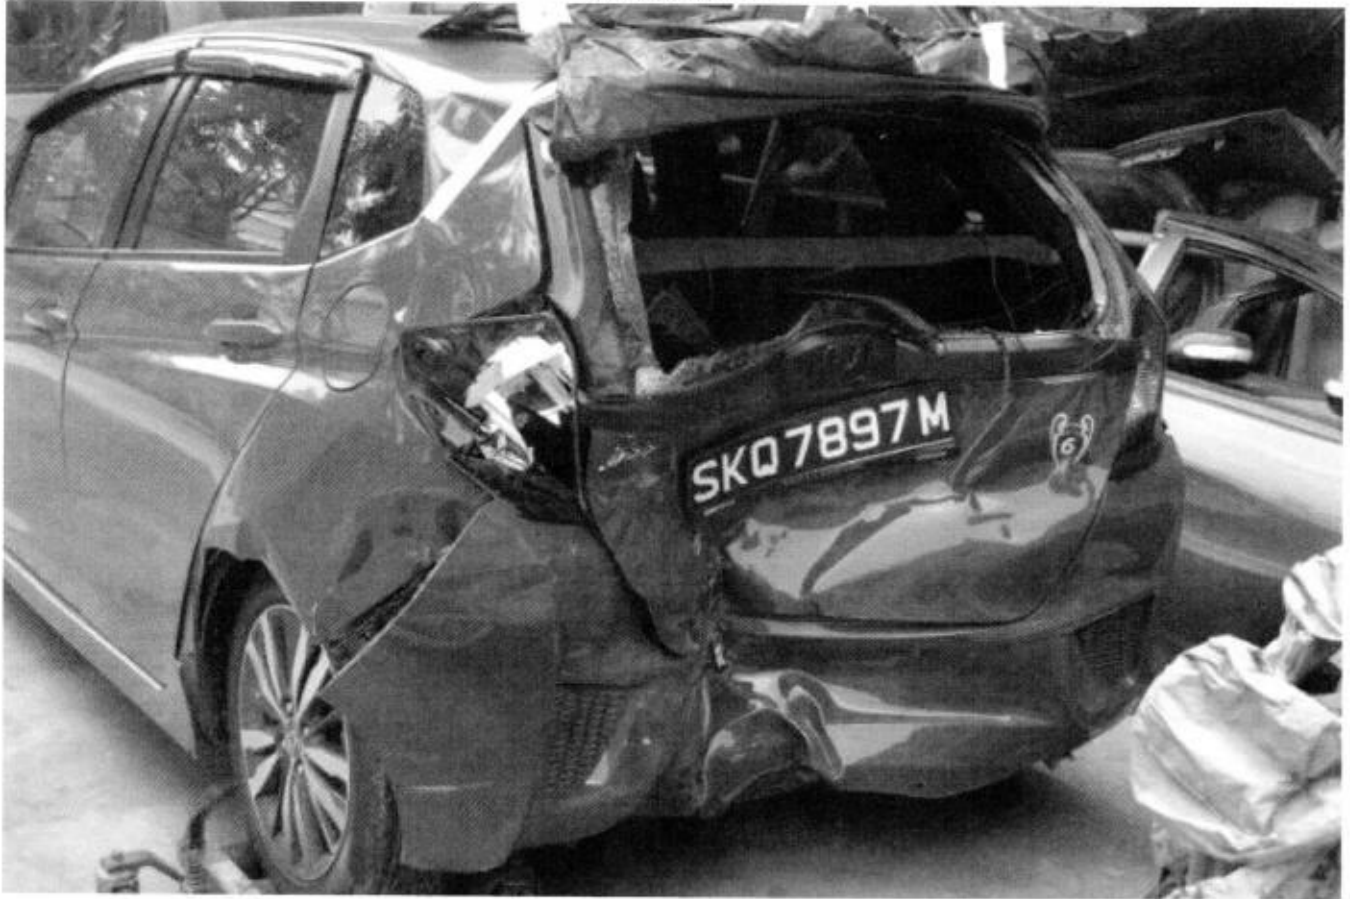
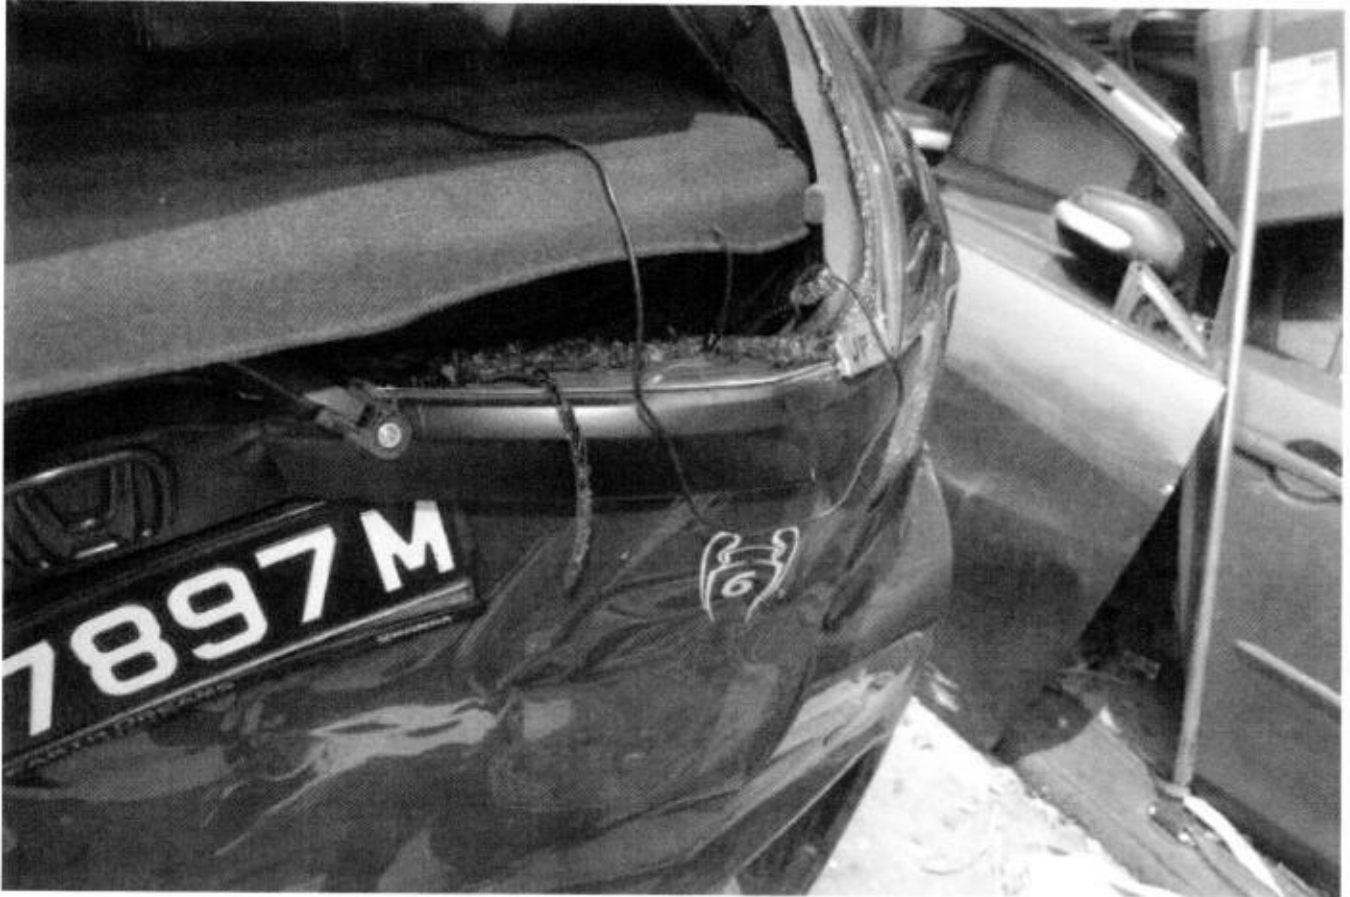
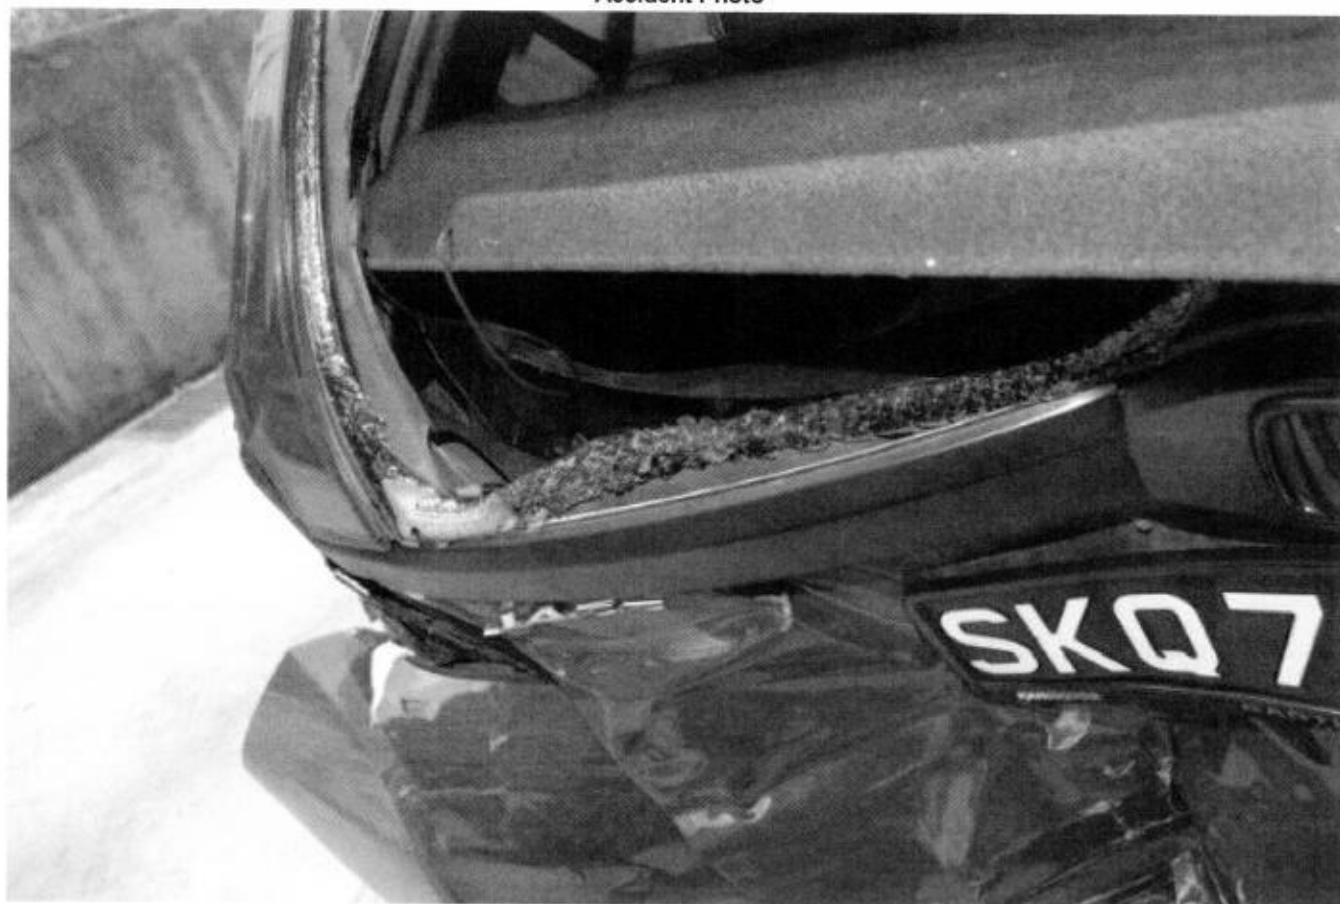
Accident Photo

FRONT / REAR PORTION

No.	Qty	Part No.	Particulars	Condition	Repairer's	Amount
1	1		*REAR TAILGATE	Badly Dented	814.20 FL	*814.20 FL
2	1		*REAR TAILGATE HINGE LH	Not Necessary	40.30 FL	*- FL
3	1		*REAR TAILGATE HINGE RH	Not Necessary	40.30 FL	*- FL
4	1		*REAR TAILGATE LOCK	Dented / Jammed	157.20 FL	*157.20 FL
5	1		*REAR TAILGATE LOCK CABLE	Jammed	110.00 FL	*110.00 FL
6	1		*REAR TAILGATE INNER TRIM	Distorted	98.20 FL	*98.20 FL
7	1		*REAR TAILGATE WIPER MOTOR	Jammed	178.20 FL	*178.20 FL
8	1		*REAR TAILGATE WIPER ARM	Bent	59.20 FL	*59.20 FL
9	1		*REAR TAILGATE OUTER CENTRE GARNISH	Cracked	195.20 FL	*195.20 FL
10	1		*REAR NUMBER PLATE LAMP	*Check	32.80 FL	*- FL
11	1		*REAR TAILGATE LOGO	Necessary	20.70 FL	*20.70 FL
12	1		*REAR TAILGATE JAZZ EMBLEM	Necessary	35.40 FL	*35.40 FL
13	1		*REAR TAILGATE LOCK OUTER HANDLE	*Check	175.20 FL	*- FL
14	1		*REAR FENDER LH	Badly Dented / Buckled	659.20 FL	*659.20 FL
15	1		*REAR FENDER RH	Badly Dented / Buckled	659.20 FL	*659.20 FL

16	1		*REAR FENDER INNER TRIM LH	Distorted	165.20 FL	*165.20 FL
17	1		*REAR FENDER INNER TRIM RH	*Check	165.20 FL	*- FL
18	1		*REAR TAILLAMP LH	Broken	287.20 FL	*287.20 FL
19	1		*REAR TAILLAMP RH	Cracked	287.20 FL	*287.20 FL
20	1		*REAR BUMPER	Distorted	456.20 FL	*456.20 FL
21	1		*REAR BUMPER BRACKET LH	Bent	90.00 FL	*90.00 FL
22	1		*REAR BUMPER BRACKET RH	Bent	90.00 FL	*90.00 FL
23	1		*REAR BUMPER AIR COVER LH	Torn	48.20 FL	*48.20 FL
24	1		*REAR BUMPER AIR COVER RH	*Check	48.20 FL	*- FL
25	1		*REAR BUMPER SIDE RETAINER LH	Bent	23.50 FL	*23.50 FL
26	1		*REAR BUMPER SIDE RETAINER RH	Bent	23.50 FL	*23.50 FL
27	1		*REAR WINDSCREEN GLASS	Shattered	855.20 FL	*855.20 FL
28	1		*REAR WINDSCREEN MOULDING	Necessary	149.20 FL	*149.20 FL
29	1		*REAR TAILGATE RUBBER	Twisted	92.30 FL	*92.30 FL
30	1		*REAR FENDER INNER SHIELD LH	Torn	83.70 FL	*83.70 FL
31	1		*REAR FENDER INNER SHIELD RH	Not Necessary	83.70 FL	*- FL
32	1		*REAR DOOR LH (NPA)	Repair	0.00 FL	*- FL

33	1		*REAR DOOR RH (NPA)	Repair	0.00 FL	*- FL
34	1		*ROOF PANEL (NPA)	Repair	0.00 FL	*- FL
35	1		*REAR TAILLAMP PANEL LH	Bent	85.30 FL	*85.30 FL
36	1		*REAR TAILLAMP PANEL RH	*Check	85.30 FL	*- FL
37	1		*REAR LUGGAGE COMPARTMENT TOP COVER	*Check	198.20 FL	*- FL
38	1		*REAR END PANEL	Badly Dented	390.20 FL	*390.20 FL
39	1		*REAR END PANEL TOP GARNISH	Distorted	120.40 FL	*120.40 FL
40	1		*REAR SPARE TYRE PANEL	Crumpled / Buckled	897.20 FL	*897.20 FL
41	1		*REAR SPARE TYRE PANEL TOP COVER	*Check	550.87 FL	*- FL
42	1		*REAR SPARE TYRE	*Check	280.00 FL	*- FL
43	1		*REAR SPARE TYRE COMPARTMENT	*Check	127.20 FL	*- FL
44	1		*REAR TAILGATE INNER TRIM CLIPS	Necessary	30.00 FS	*30.00 FS
45	1		*REAR TAILGATE WIPER BLADE	Bent	26.00 FS	*26.00 FS
46	1		*REAR NUMBER PLATE	Bent	45.00 FS	*40.00 FS
47	1		*REAR BUMPER CLIP	Necessary	30.00 FS	*30.00 FS
48	1		*REAR REVERSE SENSOR	Shorted	200.00 FS	*200.00 FS
49	1		*REAR WINDSCREEN SEALANT	Necessary	60.00 FS	*40.00 FS

IN VIEW OF THE ABOVE, THE VEHICLE IS UNECONOMICAL TO BE REPAIRED.
