Your Ref : TP / 4356165818SG
Our Ref : CC3/AIG19016320/N

4 October 2019

**AUTOMOBILE TECHNICAL INVESTIGATION REPORT OF ACCIDENT
INVOLVING SJV 5105P AND SLT 230E ON 14 SEPTEMBER 2019**

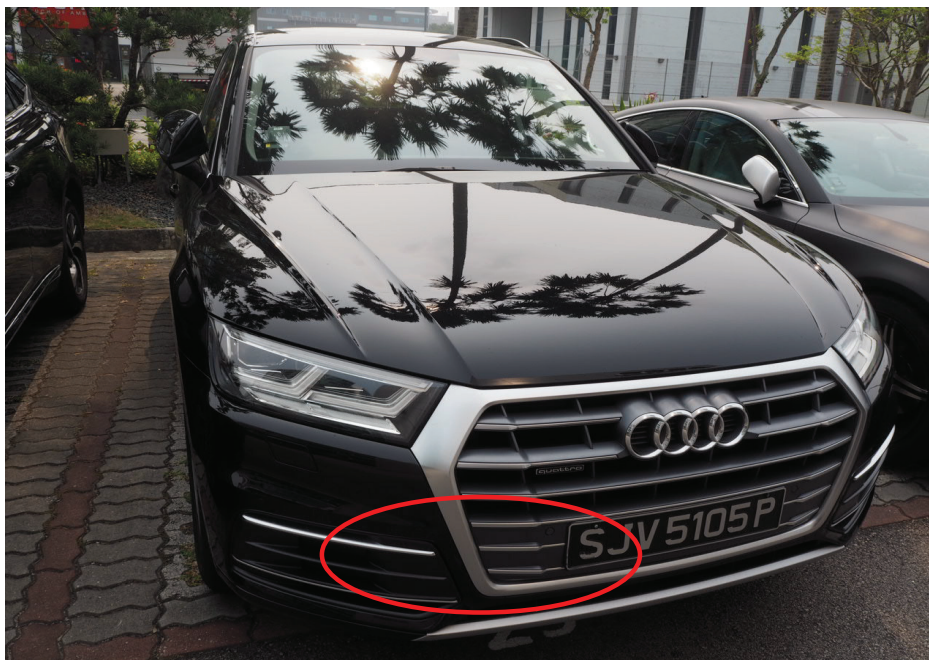
Photo 1 shows the general view of the front portion of the Audi at the time of the Pre- Repair Survey conducted by LKK Auto Consultants Pte. Ltd. which was taken about 4 days after the accident. The damage to the Audi was observed to be confined to the right portion of its front bumper and front number plate.

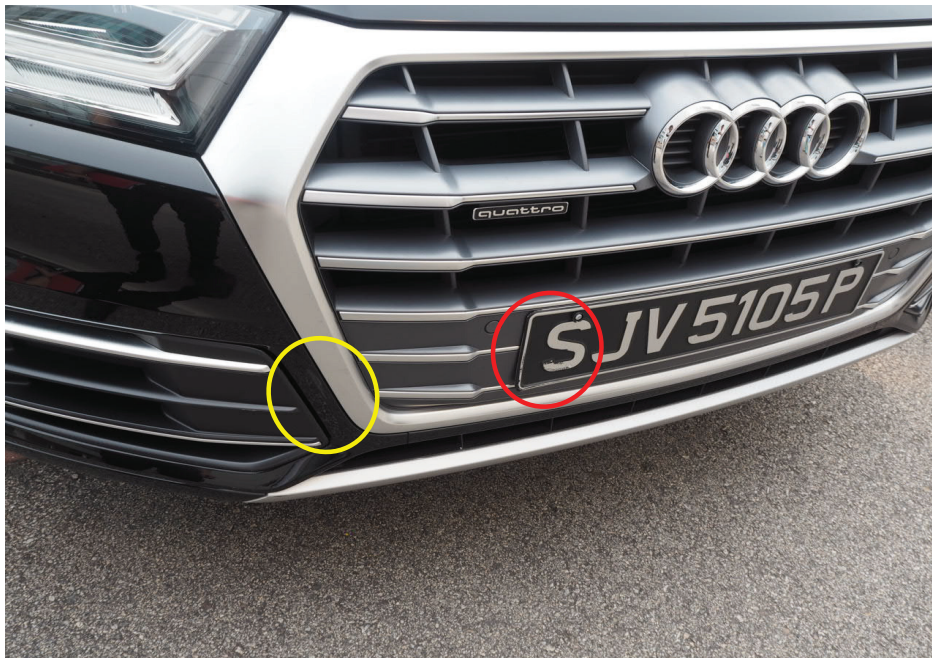
Photo 2 shows a closer view of the damage observed on the right portion of the Audi's front bumper (yellow circle) and front number plate (red circle).

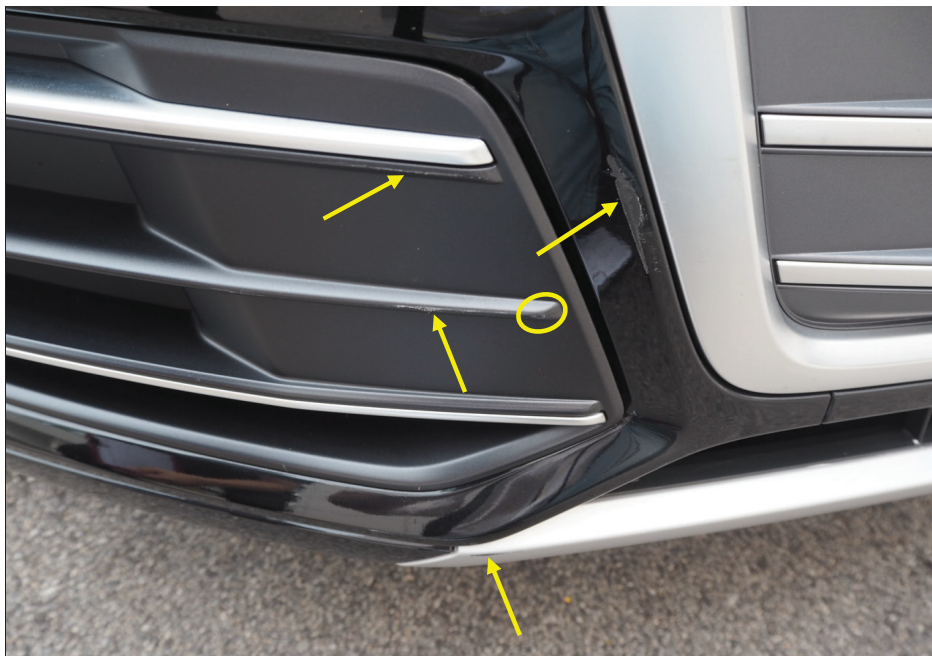
Photo 3 shows a close up view of the graze marks on the front right grille as well as on the right lower portion of the Audi's front bumper (arrowed). Upon closer examination, we observed a circular indentation on the front right grille of the Audi (circled).

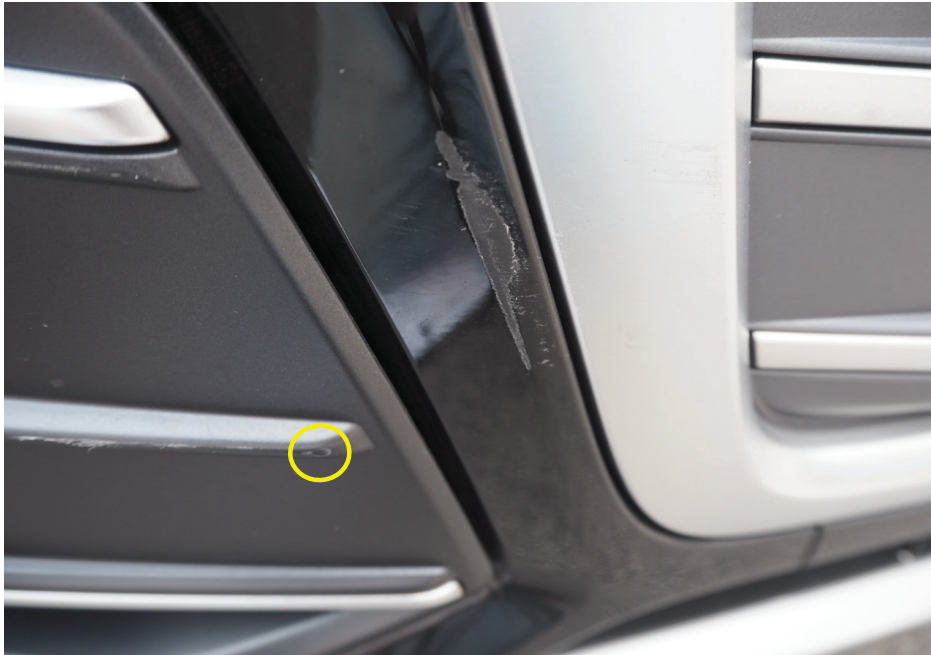
Photo 4 shows a close up view of the circular indentation on the front right grille of the Audi (circled).

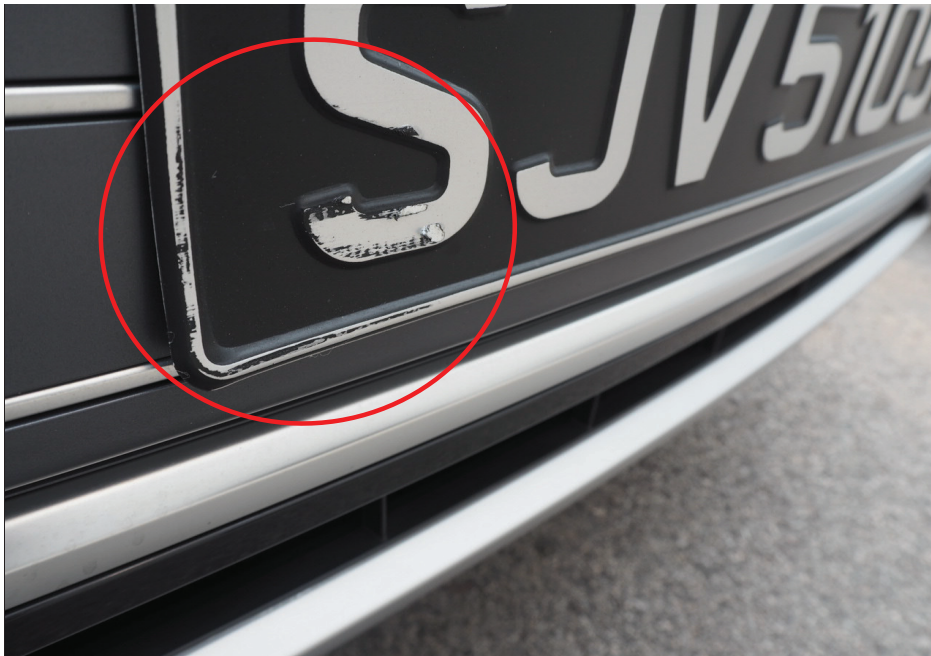
Photo 5 shows a close up view of the black marks on the lower portion of the alpha- numeric letterings of the Audi's front number plate (circled).

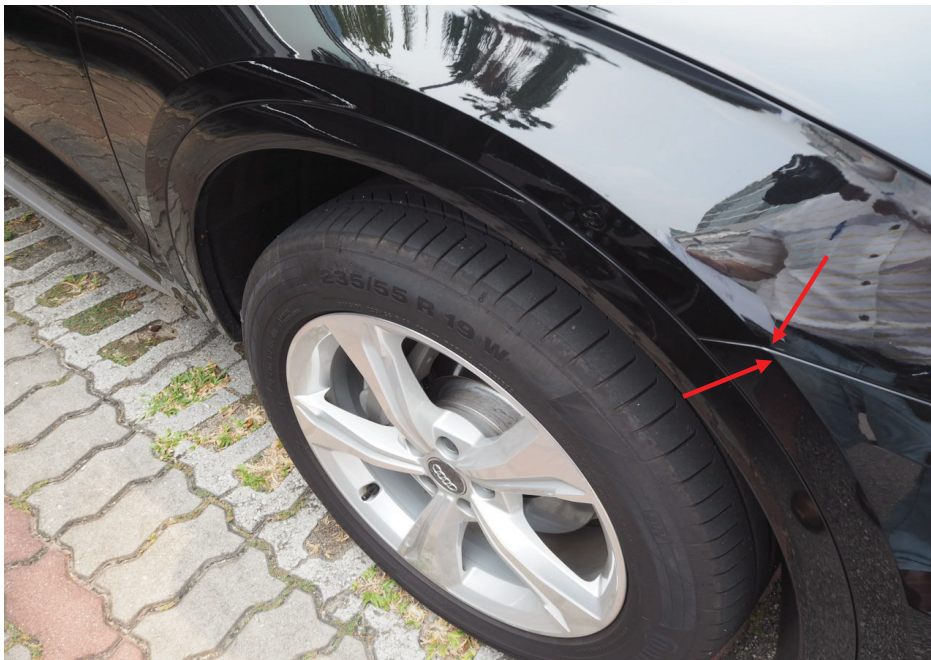
Photo 6 shows a close up view of the right corner edge of the front bumper of the Audi. We observed that there was no misalignment at the corner edges (red arrows).

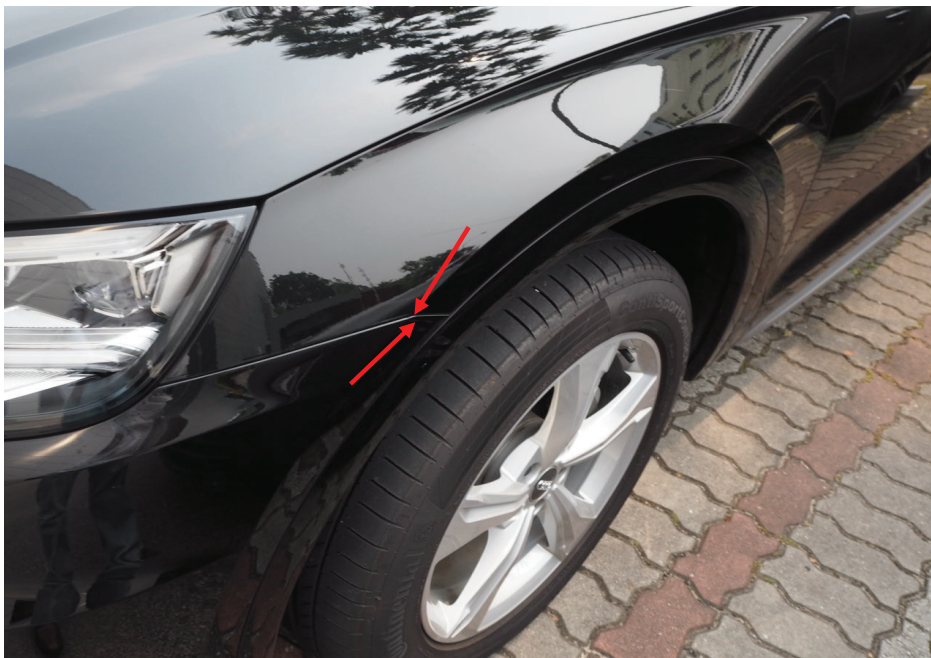
Photo 7 shows a close up view of the left corner edge of the front bumper of the Audi. We observed that there was no misalignment at the corner edges (red arrows).

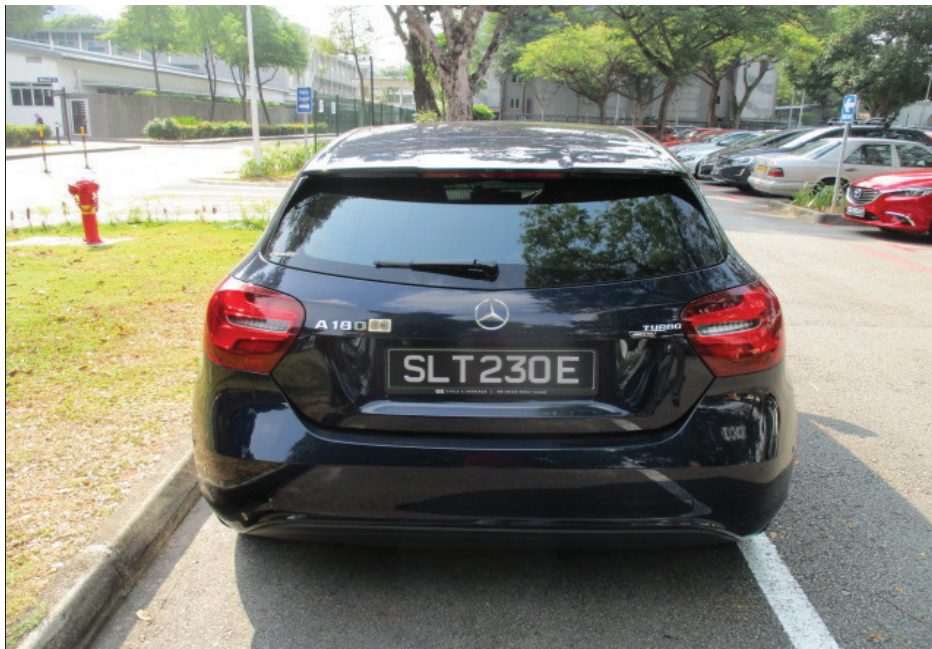
Photo 8 shows the general view of the rear portion of the Mercedes at the time of our inspection. The physical inspection carried out had primarily focused on the rear portion of the Mercedes, in particular its rear bumper as the accident was reported to be of a rear to head nature where the Mercedes was in front of the Audi at the material time. The mileage recorded was 29, 604km.
