VEHICLE DAMAGE INSPECTION REPORT

Our File No: CC3/TMI19016349/K1SF3S2
 Date: 20/09/2019

Handling Insurer: Tokio Marine Insurance Singapore Ltd Policy No: MZ000374
 Claimant Vehicle No: SHA7555U Insured Vehicle No: SGP6825E
 Date of Loss: 13/09/2019 Nature of Claim: TP Claim No: M1907223

Reg No: SHA7555U
 Make & Model: HYUNDAI IONIQ HYBRID, 1.6 GLS DCT (A) Engine No: G4LEJU081764
 Reg. Date: 13/09/2018 (Man. Year: 2018) Chassis No: KMHC851CVKU107504
 Colour: Blue Odometer: 177700 km
 Engine Capacity: 1580 cc
 Market Value/New Car Price: N/A
 Sum Insured (S\$): Market Value/New Car Price

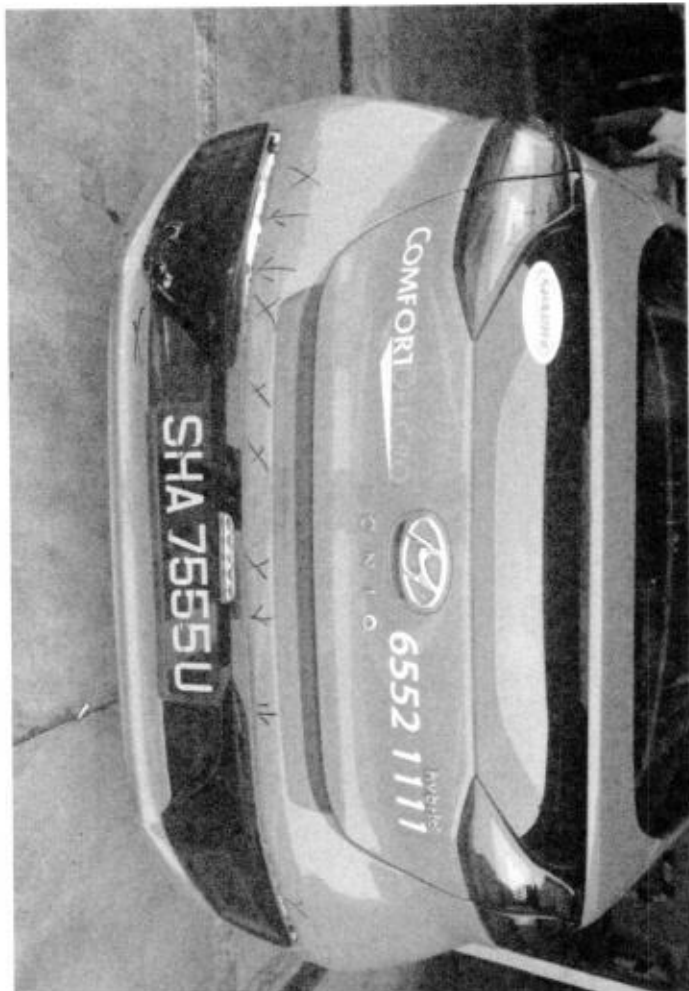
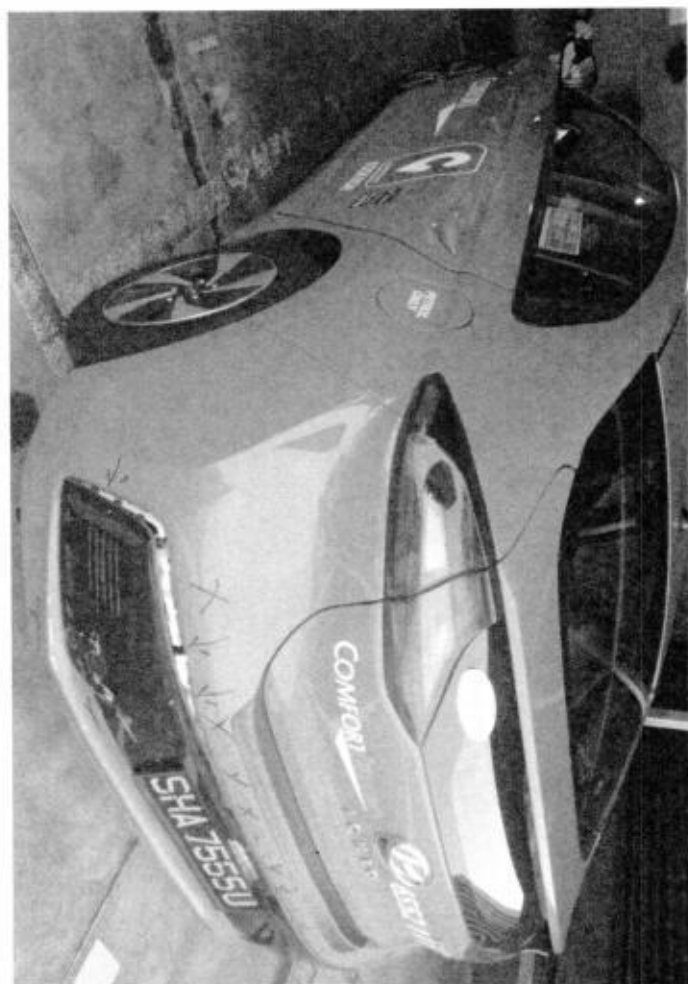
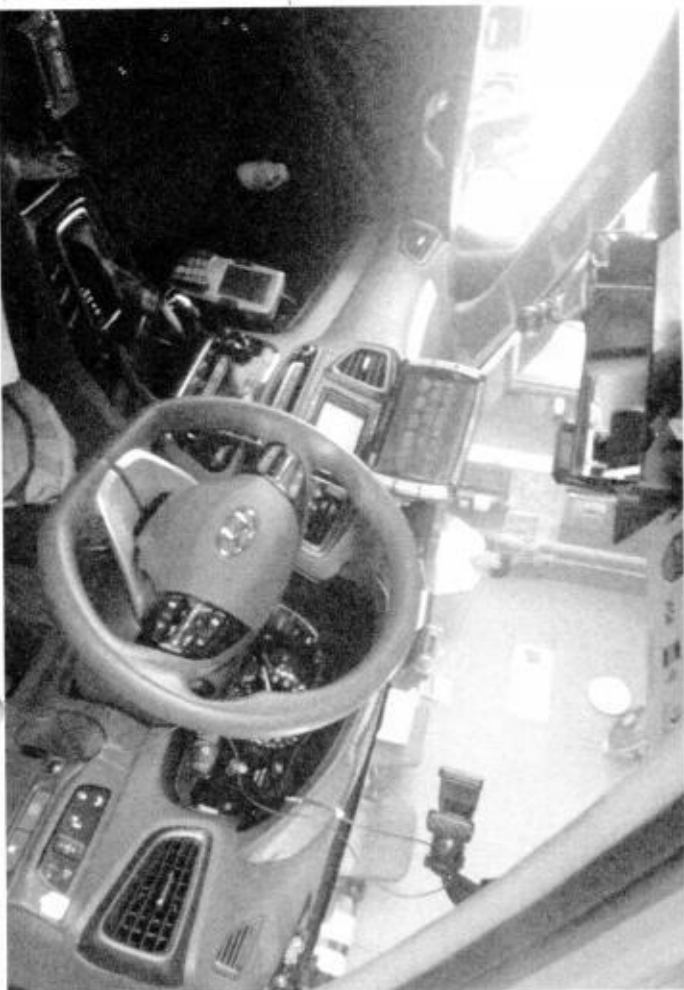
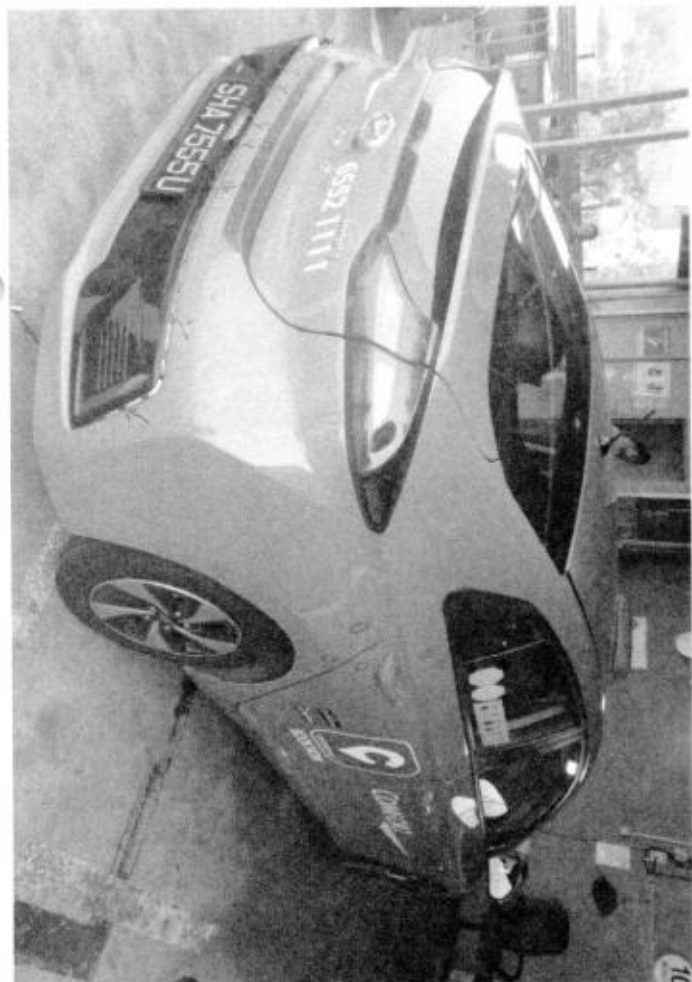
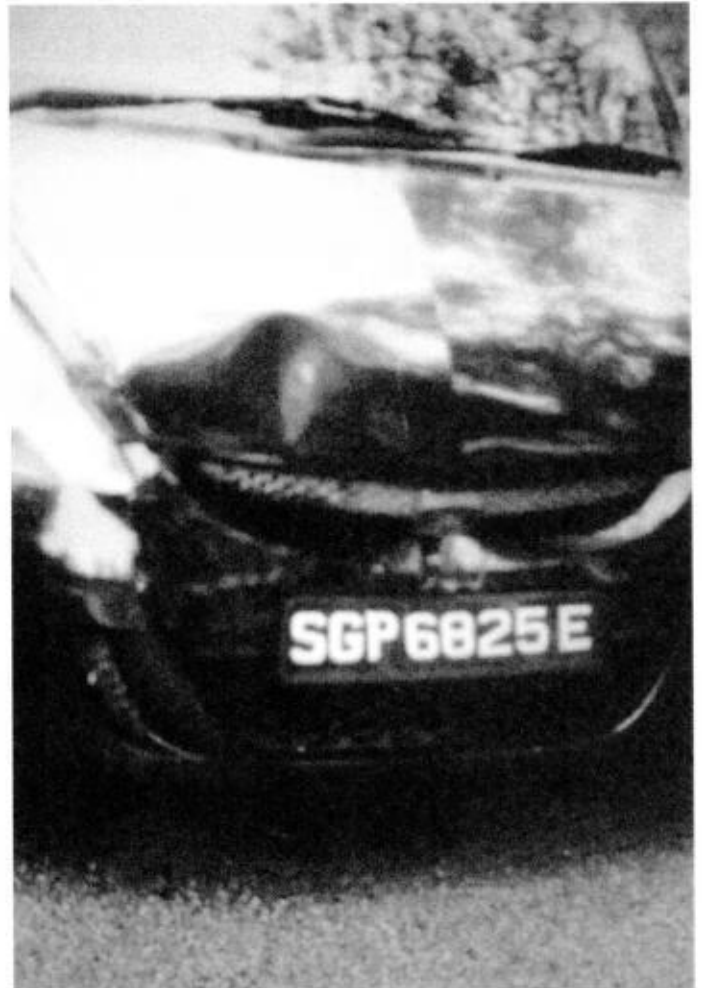
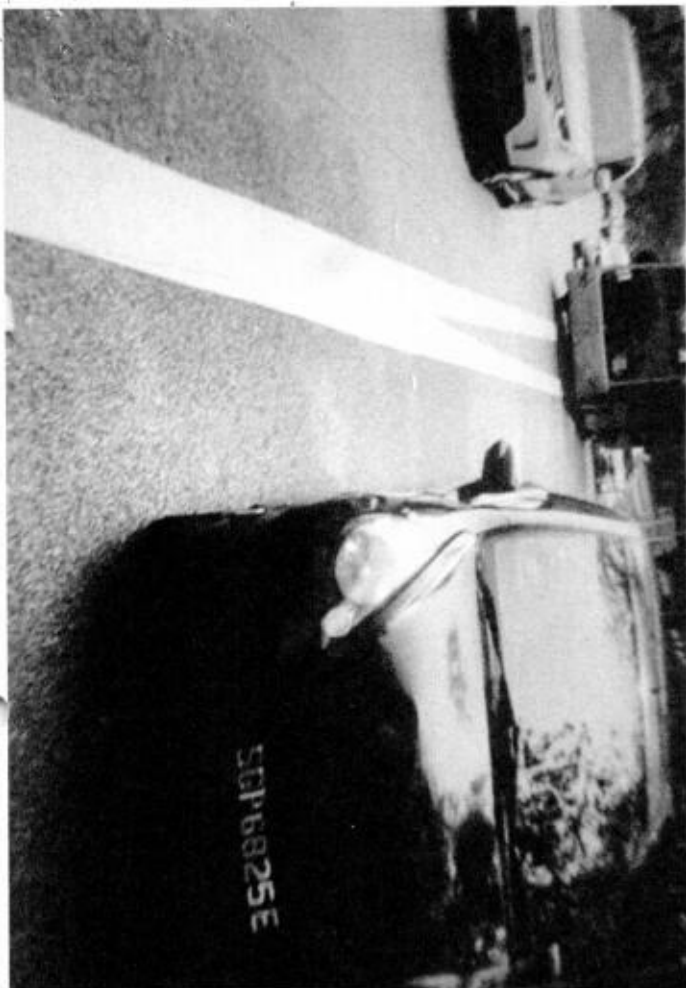
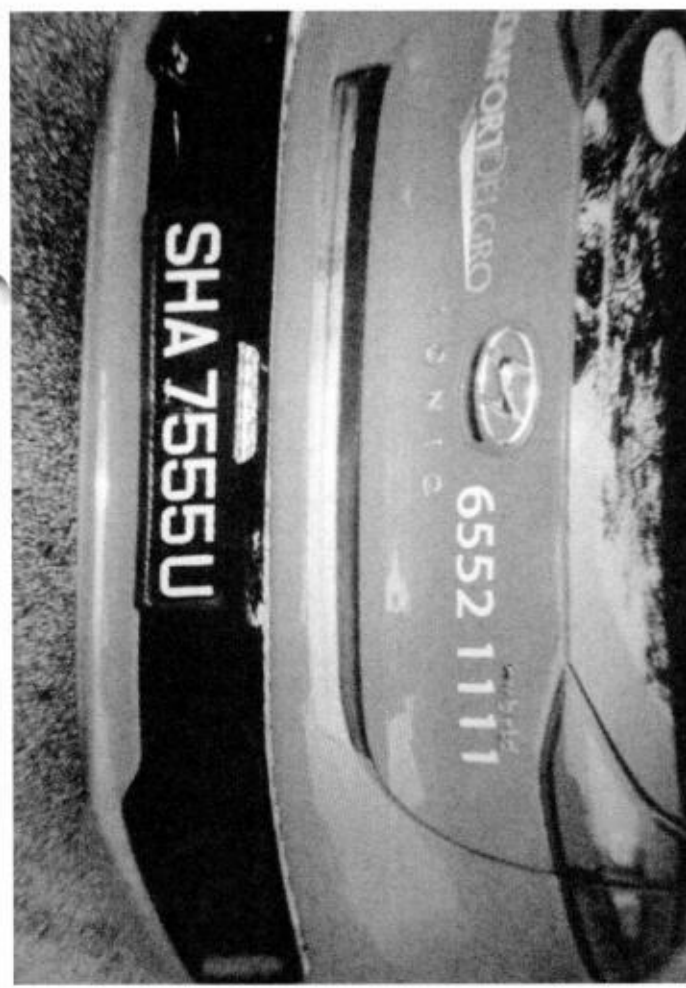
Des. of Damages: Frt / Rear / O/S / N/S / U/C / Rooftop or

rear

The U/C / Chassis frame / Body Structure affected due to collision.

No.	Qty	Part No.	Particulars	Condition	Repairer's	Amount
1	1		*REAR BUMPER ASSY	Cracked	459.40 FL	*459.40 FL
2	1		*REAR BUMPER REINFORCEMENT	Cracked	294.80 FL	*294.80 FL
3	1		*REAR BUMPER REINFORCEMENT BRACKET LH	Buckled	138.10 FL	*138.10 FL
4	1		*REAR BUMPER REINFORCEMENT BRACKET RH	Buckled	138.10 FL	*138.10 FL
5	1		*REAR BUMPER STAY	Serviceable	138.10 FL	*- FL
6	1		*REAR BUMPER CENTRE MLDG	Cracked	451.25 FL	*451.25 FL
7	1		*REAR BUMPER LOWER CENTRE MLDG	Cracked	47.50 FL	*47.50 FL
8	1		*REAR BUMPER SIDE BRACKET LH	Serviceable	33.10 FL	*- FL
9	1		*REAR BUMPER SIDE BRACKET RH	Serviceable	33.10 FL	*- FL
10	10		*REAR BUMPER CLIPS	Necessary	22.00 FL	*22.00 FL
11	2		*REAR BUMPER REFLECTOR LAMP (LH/RH)	Serviceable	63.80 FL	*- FL
12	1		*REAR BUMPER MAT	Necessary	50.00 F	*50.00 FS
13	1		*REVERSE SENSOR	Shorted	135.70 F	*135.70 FS
14	1		*REAR NUMBER PLATE	Cracked	25.00 F	*25.00 FS
Supplementary #1						
15	1		*REAR FOG LAMP	Cut	201.50 FL	*201.50 FL

16	1		*REAR TOWING COVER	Cut	5.40 FL	*5.40 FL

No	Particulars	Lab.Type	Repairer's	Amount
Labour Items				
1	PANEL BEATING	New	350.00	320.00
2	SPRAYPAINT	New	250.00	200.00
3	WIRING	New	50.00	0.00
4	REMOVE/REFIX REVERSE SENSOR	New	100.00	30.00
Gross Labour Cost (S\$)			750.00	550.00
