Your Ref: S9M020Q0  
Our Ref : CS/ASM19016412/N

20 September 2019

### **TECHNICAL INVESTIGATION REPORT OF FIRE INCIDENT INVOLVING THE INSURED VEHICLE PA 2621A ON 12 SEPTEMBER 2019**

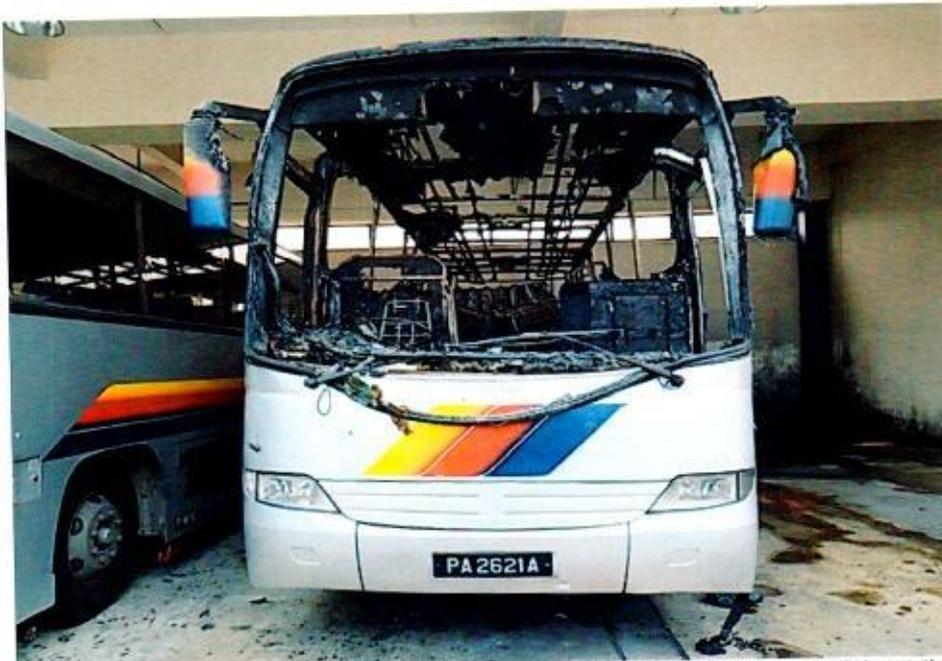
**Photo 1** shows the general view of the front portion of the Insured Vehicle at the time of our inspection. The front portion of the Insured Vehicle was significantly affected by the fire.

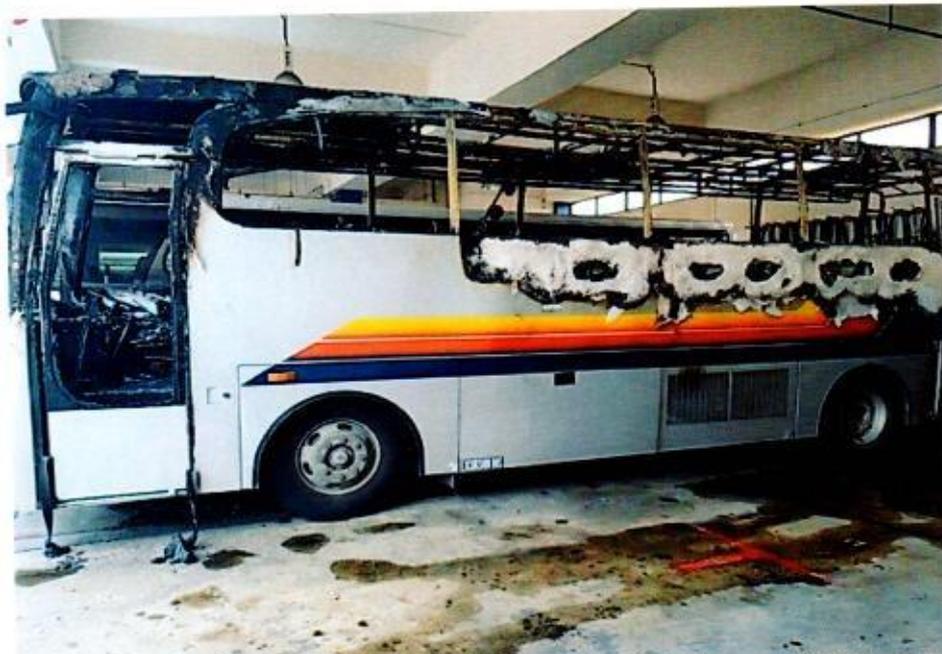
**Photo 2** shows the general view of the left portion of the Insured Vehicle at the time of our inspection. The exterior body of the Insured Vehicle had sustained fire damage at the top portion as well as rear portion. Affected parts had included the side mirrors, roof, windows, rear panels, both windscreens and engine panel, amongst others.

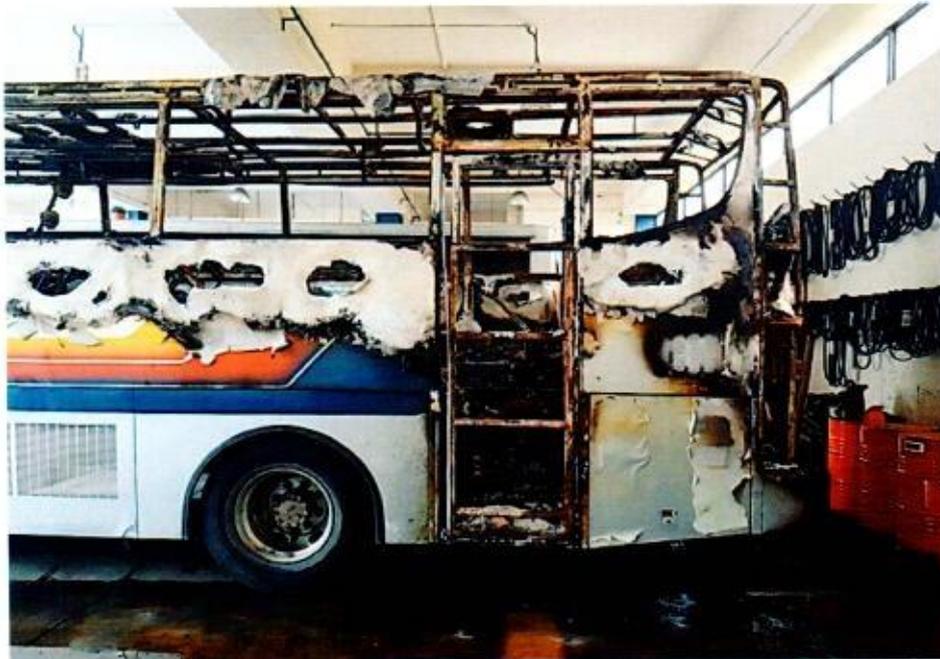
**Photo 3** shows a closer view of the left rear portion of the Insured Vehicle at the time of our inspection. The fire damage was observed to be more severe at its left rear portion.

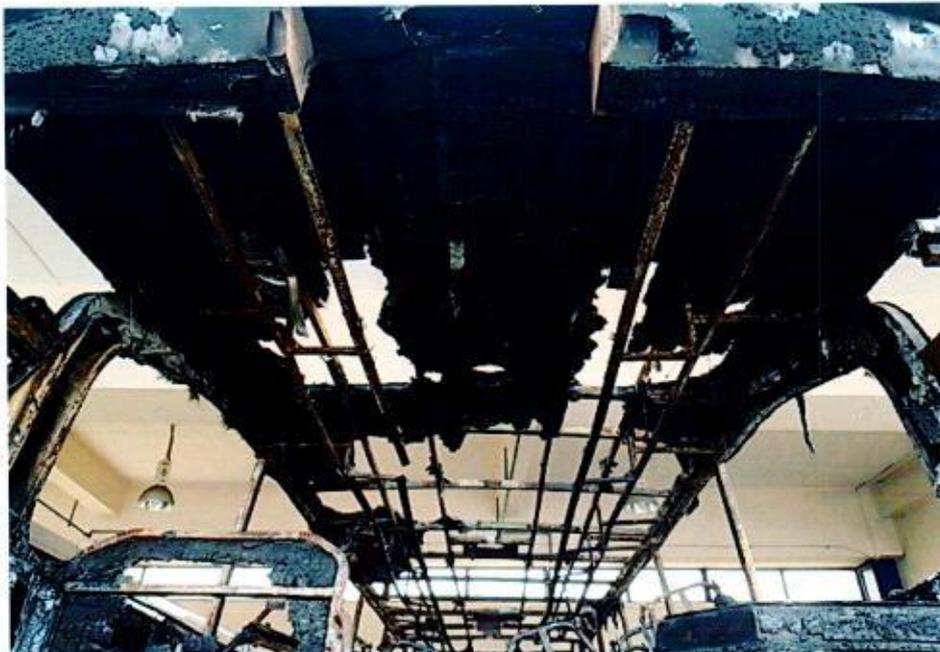
**Photo 4** shows the general view of the top portion of the Insured Vehicle at the time of our inspection. The roof of the Insured Vehicle had sustained severe fire damage.

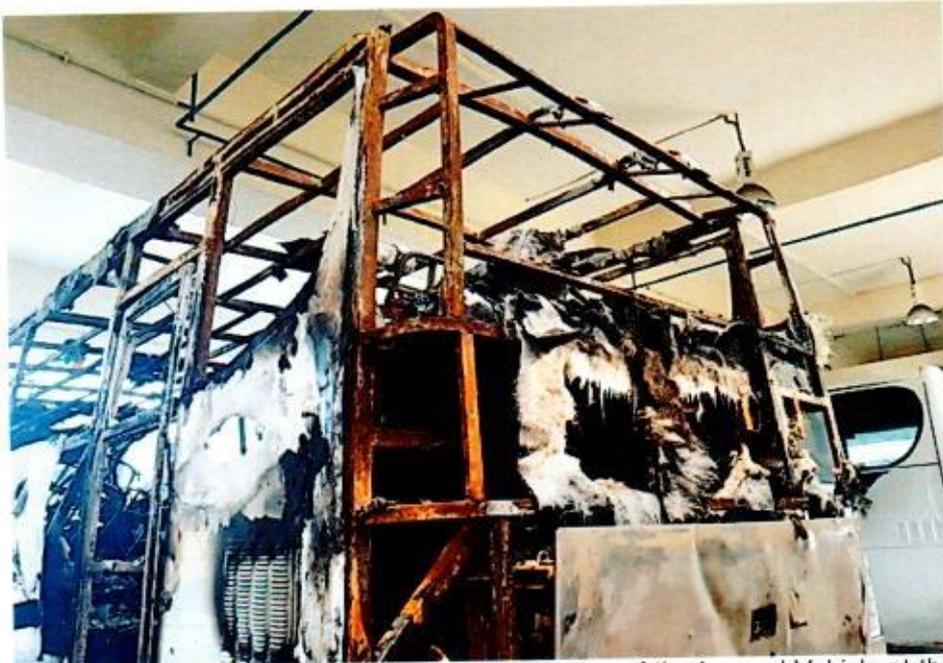
**Photo 5** shows the general view of the rear portion of the Insured Vehicle at the time of our inspection. The Insured Vehicle had sustained severe fire damage at the rear portion.

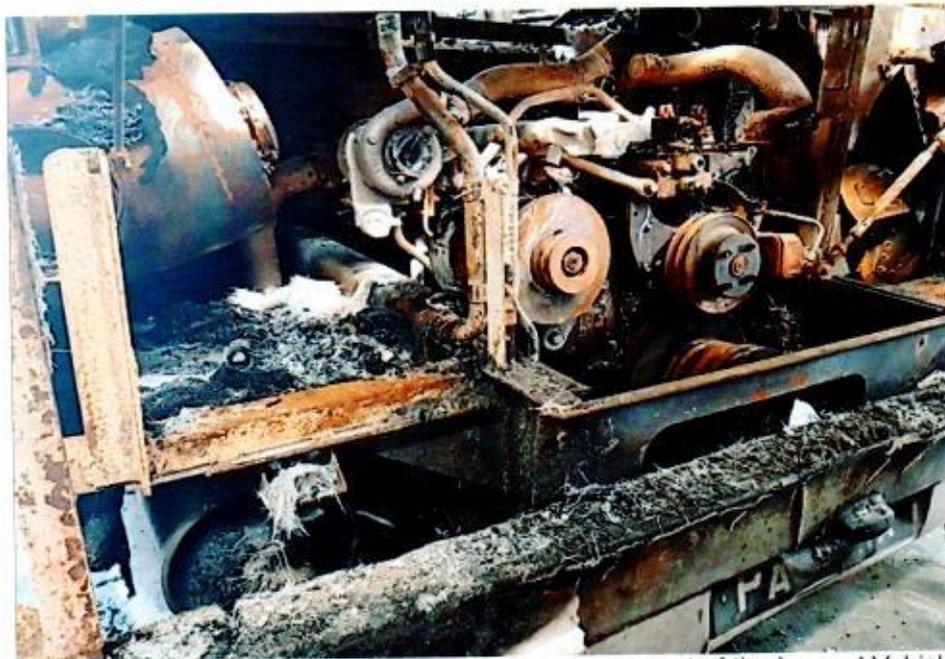
**Photo 6** shows a general view of the engine compartment of the Insured Vehicle at the time of our inspection. The engine compartment of the Insured Vehicle was severely affected by the fire. Most of the parts inside the engine compartment were found to be completely burnt and/or melted as a result of the fire.

7. For this particular case, the fire appears to have originated within the engine compartment of the Insured Vehicle, somewhere around the rear right portion of the engine compartment. This can be determined from the nature of the fire damage which was more extensive at the rear right portion. Basing on the circumstances of the fires' origin at the material time of incident as well as examining the area where the extent of fire damage was most severe, we can determine that the fire had likely started from the rear right portion of the engine compartment of the Insured Vehicle.

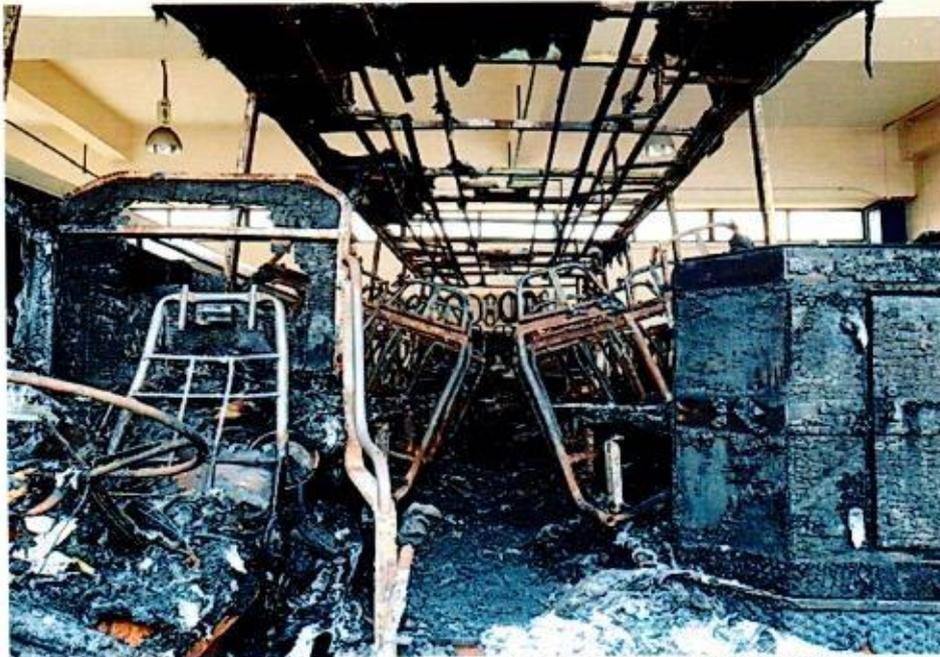
Photo 7 shows the interior cabin of the Insured Vehicle at the time of inspection. The interior rear cabin was completely burnt.

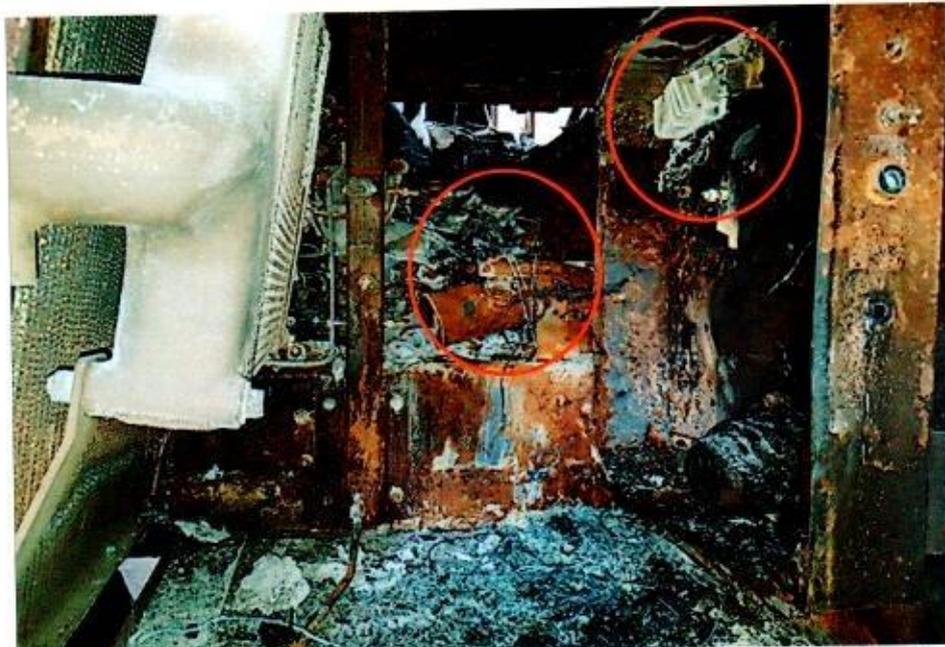
8. Upon closer examination of the rear right portion of the engine compartment of the Insured Vehicle as well as around the immediate vicinity to where the fire had likely started, we had found greenish residue on several burnt stretches of original factory fitted wirings around the rear right portion of the engine compartment. The presence of such greenish residue indicates internal heating of copper wires, a sign of an electrical short circuit occurring. The greenish residue is normally left behind from oxidation as a result of chemical reaction involving the copper wires. This physical evidence would then appear to suggest that the cause of fire to the Insured Vehicle could have possibly been due to electrical in nature. See photos 8 - 10 below.

**Photo 8** shows a closer view of the rear right portion of the burnt engine compartment of the Insured Vehicle. Upon closer examination, we had found greenish residue on several burnt stretches of original factory fitted wirings around the rear right portion of the engine compartment (circled).

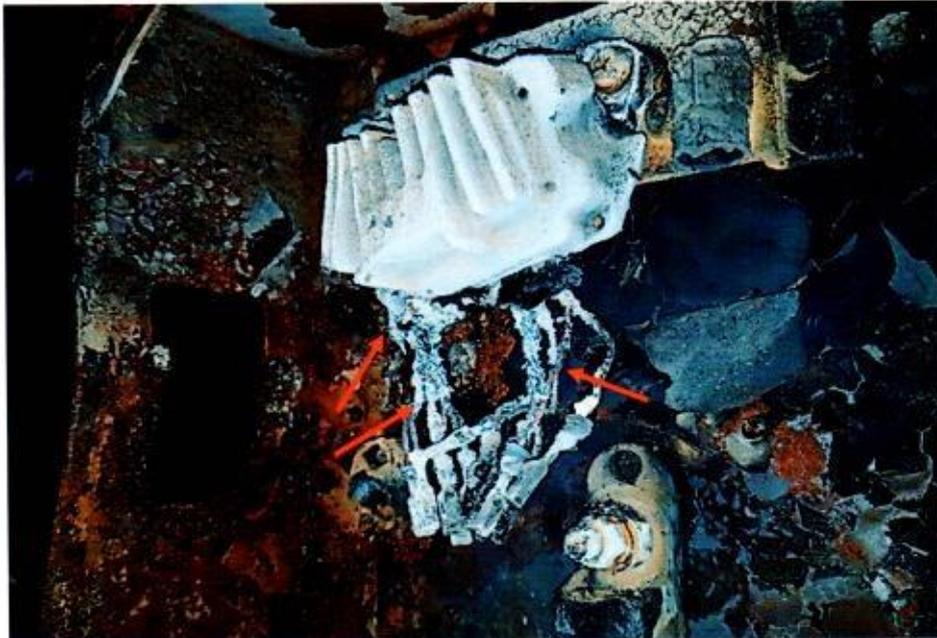
**Photo 9** shows a close up view of the greenish residue found on several burnt stretches of original factory fitted wirings, around the rear right portion of the engine compartment (arrowed) of the Insured Vehicle. The presence of such greenish residue indicates internal heating of copper wires, a sign of an electrical short circuit occurring. The greenish residue is normally left behind from oxidation as a result of chemical reaction involving the copper wires.

25. The possibility of the fire being due to electrical in nature would then seem more likely given that engine overheating and external factors would seem unlikely. The fire being due to electrical nature is also supported by the faint traces of greenish residue that were found on several burnt stretches of original factory fitted around the rear right portion of the engine compartment of the Insured Vehicle, which was earlier discussed in paragraph 8 above.

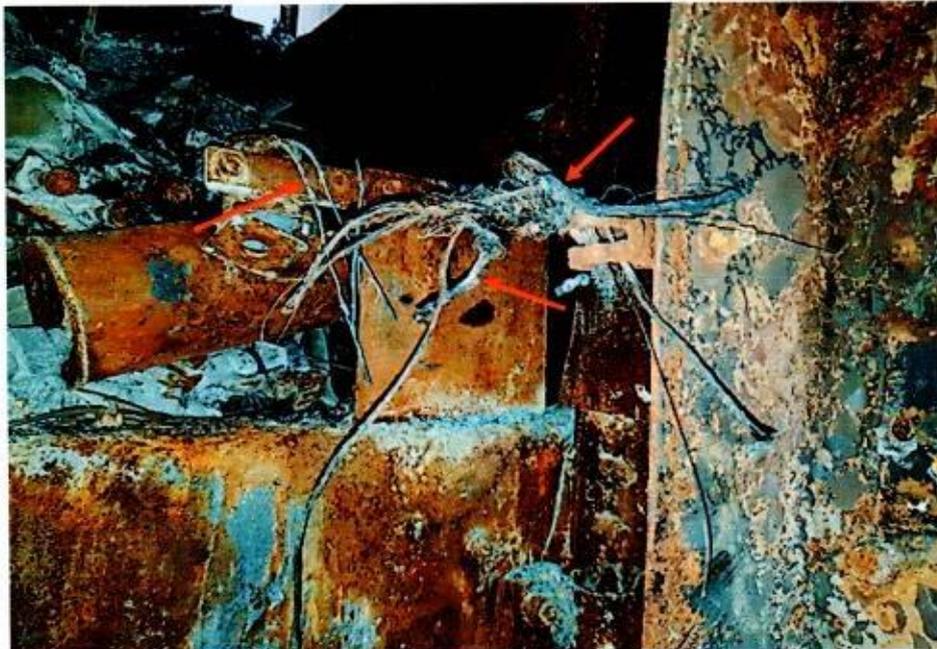
**Photo 10** shows a closer view of the greenish residue that was found on several burnt stretches of original factory fitted wirings around the rear right portion of the engine compartment (arrowed) of the Insured Vehicle. This seems to suggest the occurrence of an electrical short circuit.

27. Having investigated and technically analysed the damages of burnt nature to the Insured Vehicle, we are of the view that the cause of fire to the Insured Vehicle was of electrical in nature. For this particular case, the fire had originated along the original factory fitted wirings around the rear right portion of the engine compartment of the Insured Vehicle.

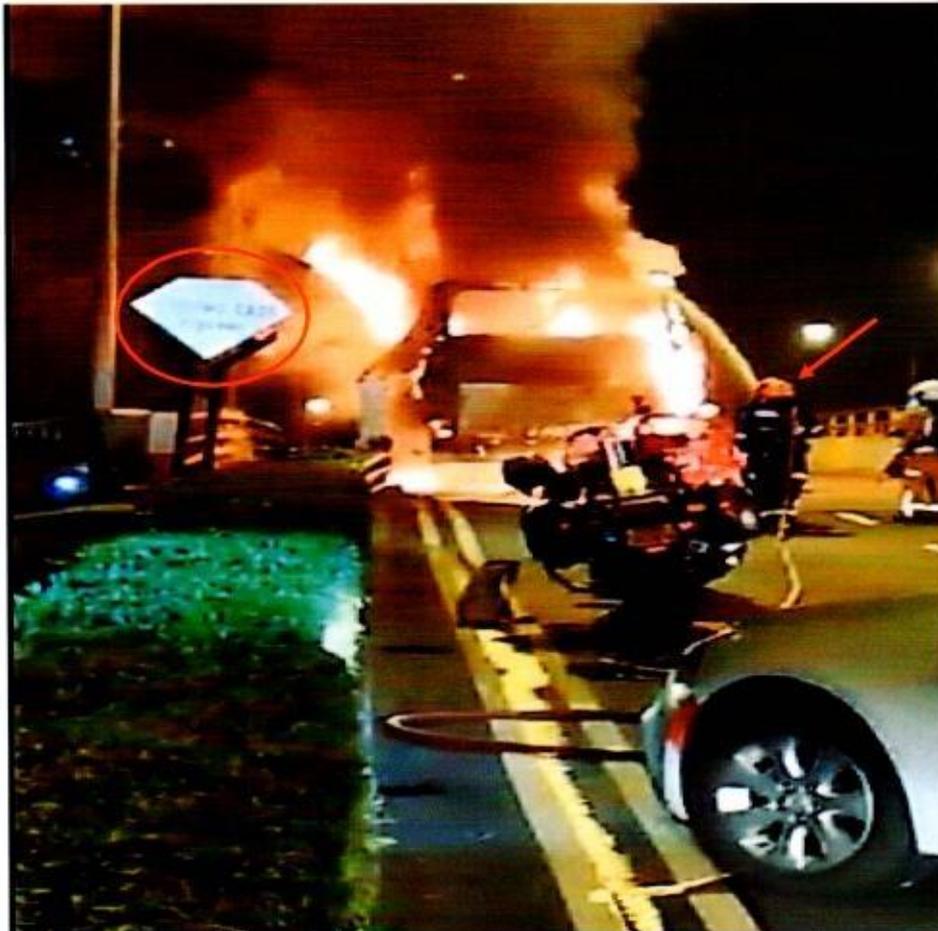
**Photo 11** shows the SCDF having arrived at the incident location and attempting to put out the fire (arrowed). In general, the information gathered from this photograph had corresponded to Mr Khor's statement, which is the fire started while Mr Khor was driving the Insured Vehicle on the 1st lane along the Jurong East Flyover (circled).

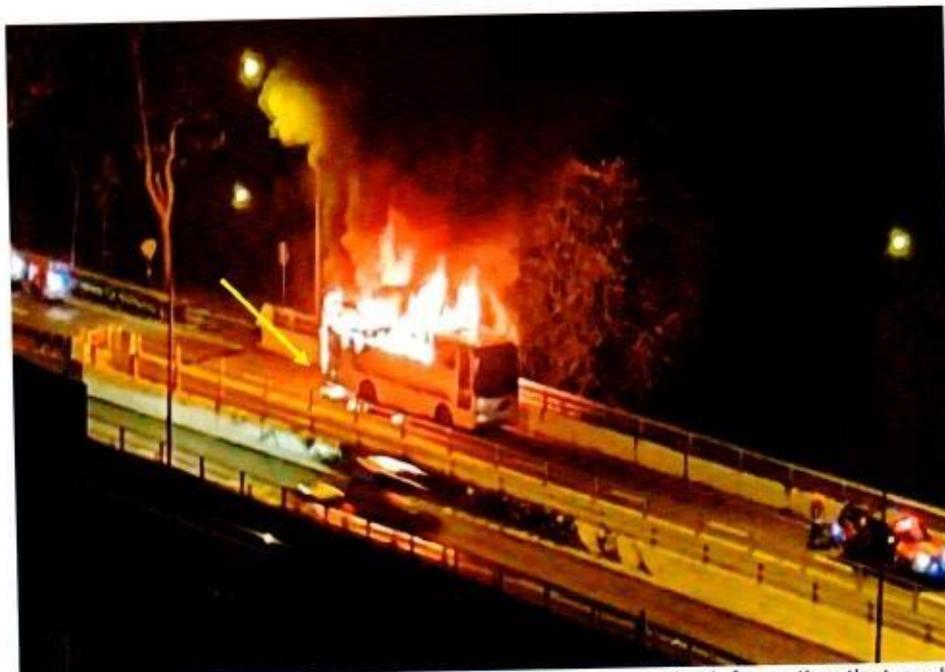
**Photo 12** shows the Insured Vehicle on fire. In general, the information that could be gathered from this photograph had corresponded to the events that were related to us by Mr Khor, which is the fire had started from the rear portion of the Insured Vehicle (arrowed).

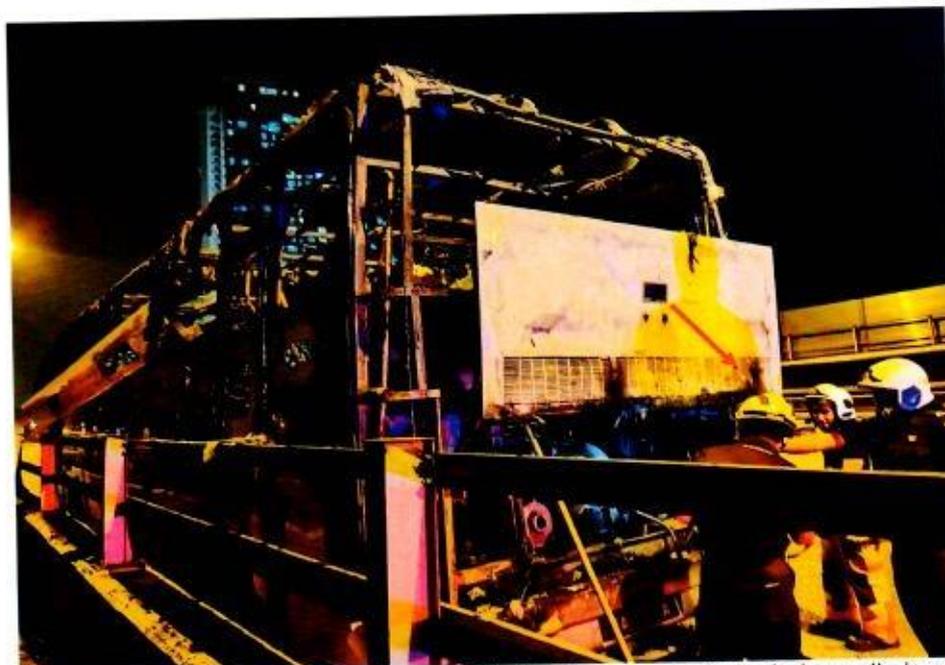
**Photo 13** shows a closer view of firefighters conducting their preliminary investigations post- incident. In general, the information that could be gathered from this photograph pertaining to the nature of fire damage had corresponded to the events that were related to us by Mr Khor, which is the fire had started from the rear portion of the Insured Vehicle (arrowed).
