Your Ref: S9M020Q0
Our Ref : CS/ASM19016412/N

20 September 2019

TECHNICAL INVESTIGATION REPORT OF FIRE INCIDENT INVOLVING THE INSURED VEHICLE PA 2621A ON 12 SEPTEMBER 2019

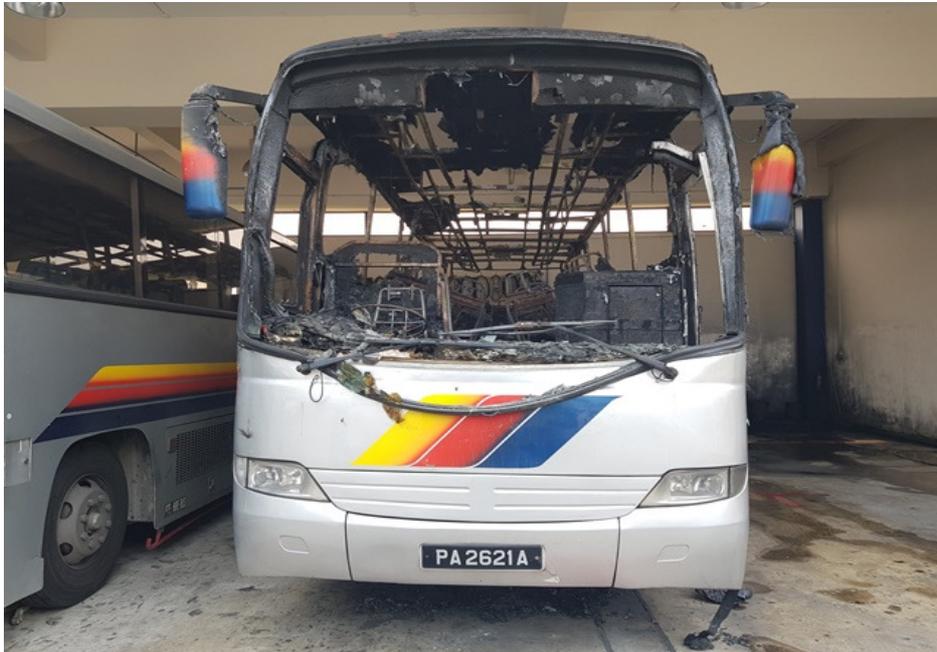
Photo 1 shows the general view of the front portion of the Insured Vehicle at the time of our inspection. The front portion of the Insured Vehicle was significantly affected by the fire.

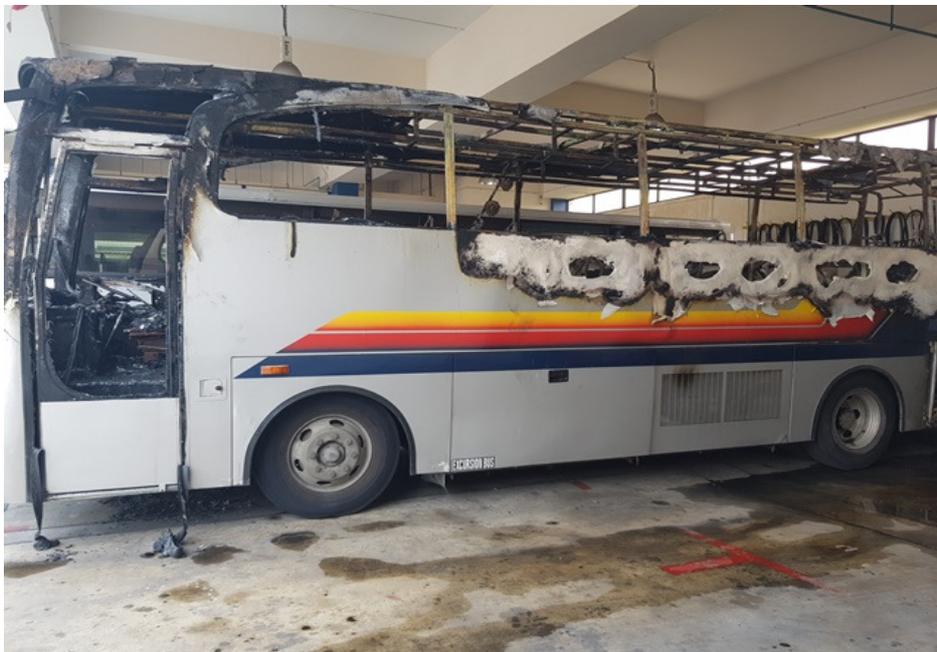
Photo 2 shows the general view of the left portion of the Insured Vehicle at the time of our inspection. The exterior body of the Insured Vehicle had sustained fire damage at the top portion as well as rear portion. Affected parts had included the side mirrors, roof, windows, rear panels, both windscreens and engine panel, amongst others.

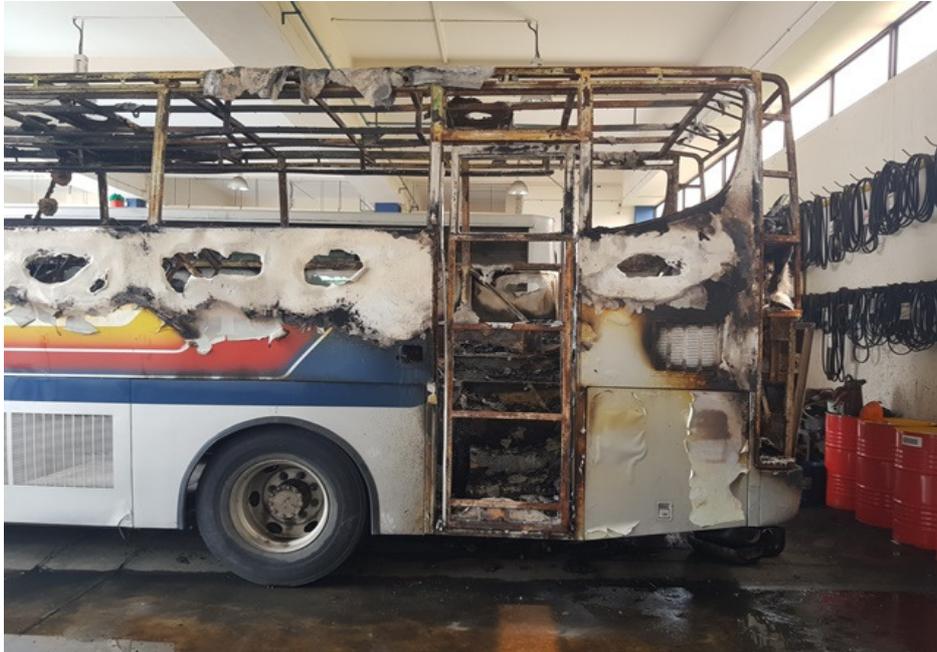
Photo 3 shows a closer view of the left rear portion of the Insured Vehicle at the time of our inspection. The fire damage was observed to be more severe at its left rear portion.

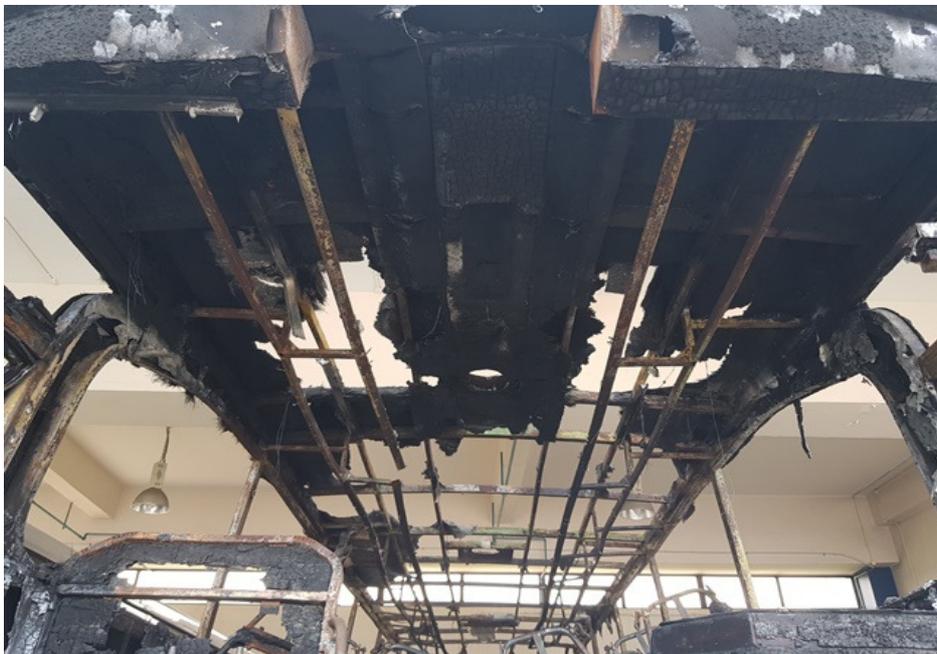
Photo 4 shows the general view of the top portion of the Insured Vehicle at the time of our inspection. The roof of the Insured Vehicle had sustained severe fire damage.

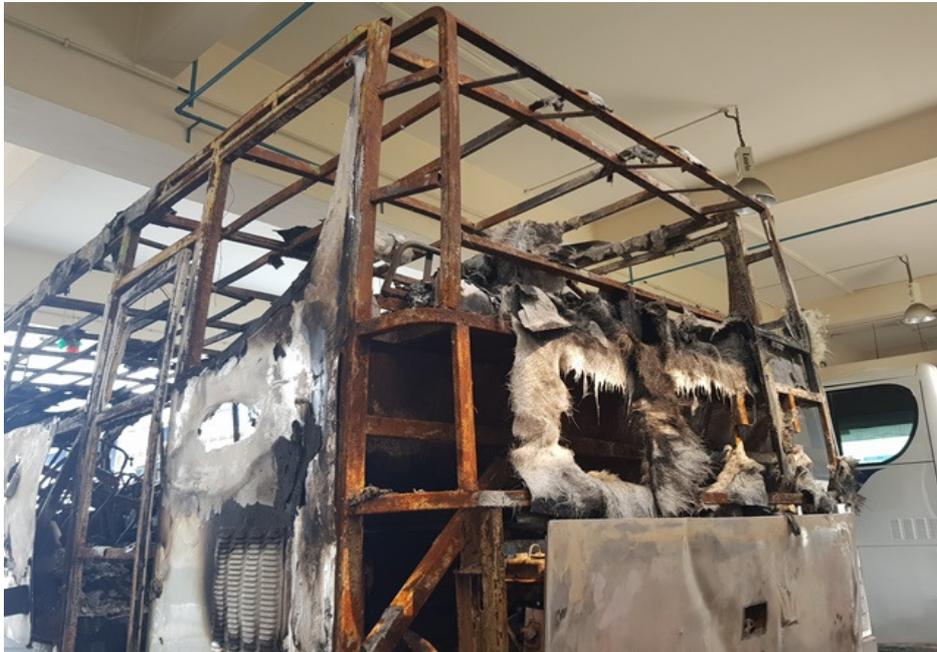
Photo 5 shows the general view of the rear portion of the Insured Vehicle at the time of our inspection. The Insured Vehicle had sustained severe fire damage at the rear portion.

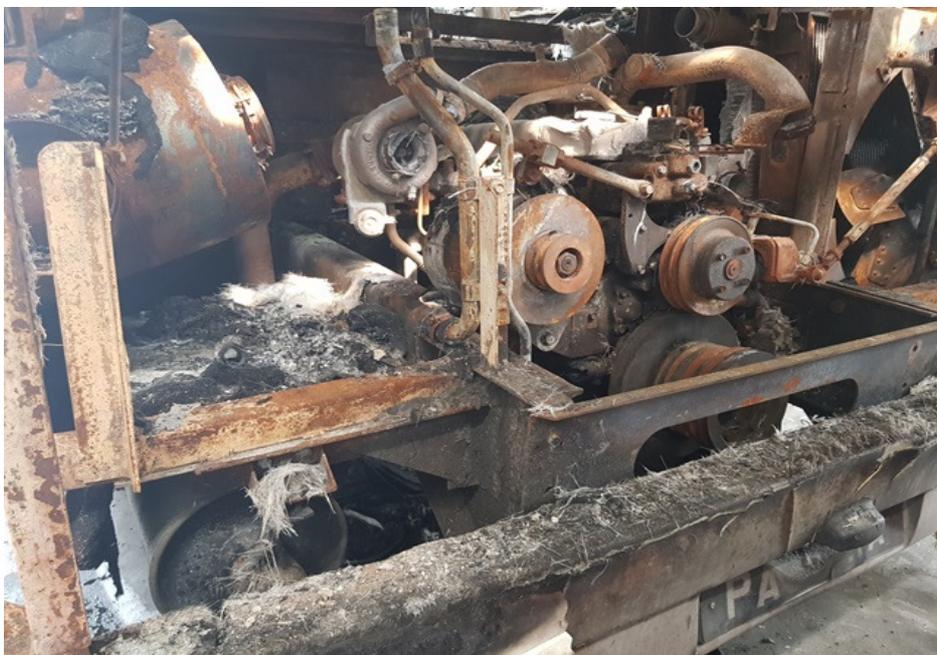
Photo 6 shows a general view of the engine compartment of the Insured Vehicle at the time of our inspection. The engine compartment of the Insured Vehicle was severely affected by the fire. Most of the parts inside the engine compartment were found to be completely burnt and/or melted as a result of the fire.

7. For this particular case, the fire appears to have originated within the engine compartment of the Insured Vehicle, somewhere around the rear right portion of the engine compartment. This can be determined from the nature of the fire damage which was more extensive at the rear right portion. Basing on the circumstances of the fires' origin at the material time of incident as well as examining the area where the extent of fire damage was most severe, we can determine that the fire had likely started from the rear right portion of the engine compartment of the Insured Vehicle.

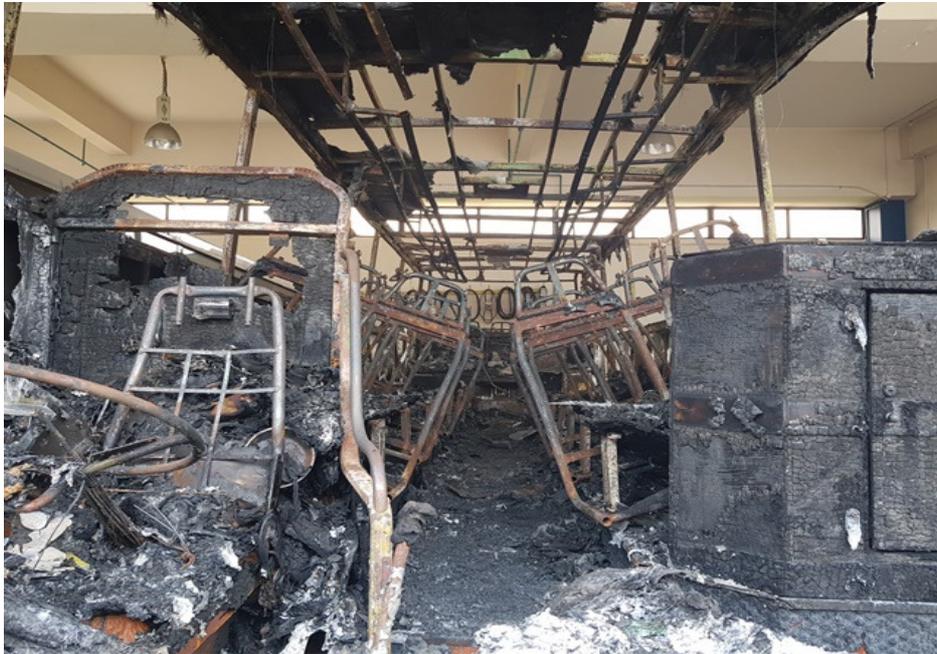
Photo 7 shows the interior cabin of the Insured Vehicle at the time of inspection. The interior rear cabin was completely burnt.

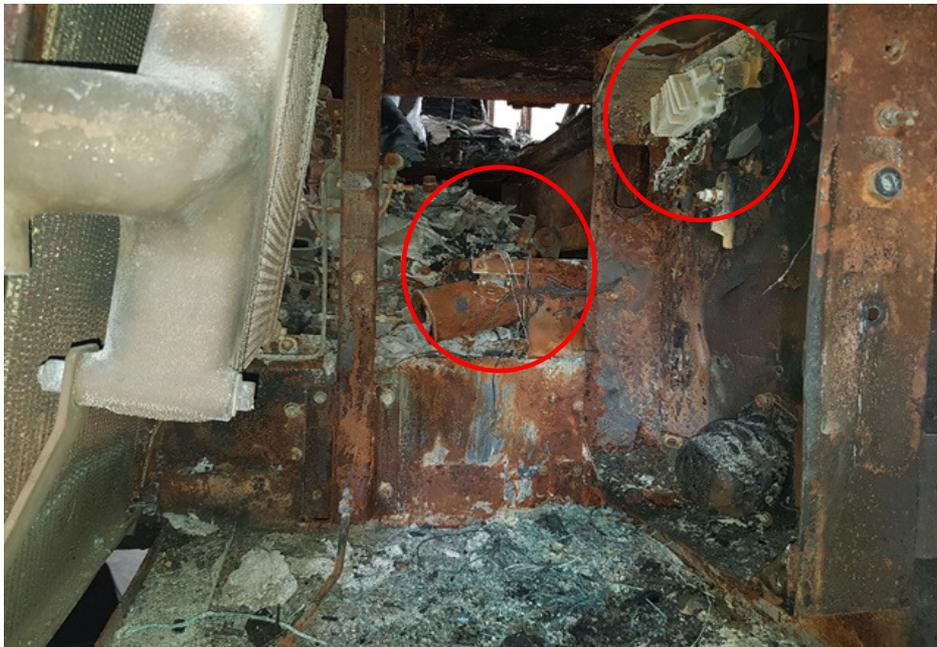
8. Upon closer examination of the rear right portion of the engine compartment of the Insured Vehicle as well as around the immediate vicinity to where the fire had likely started, we had found greenish residue on several burnt stretches of original factory fitted wirings around the rear right portion of the engine compartment. The presence of such greenish residue indicates internal heating of copper wires, a sign of an electrical short circuit occurring. The greenish residue is normally left behind from oxidation as a result of chemical reaction involving the copper wires. This physical evidence would then appear to suggest that the cause of fire to the Insured Vehicle could have possibly been due to electrical in nature. See photos 8 - 10 below.

Photo 8 shows a closer view of the rear right portion of the burnt engine compartment of the Insured Vehicle. Upon closer examination, we had found greenish residue on several burnt stretches of original factory fitted wirings around the rear right portion of the engine compartment (circled).

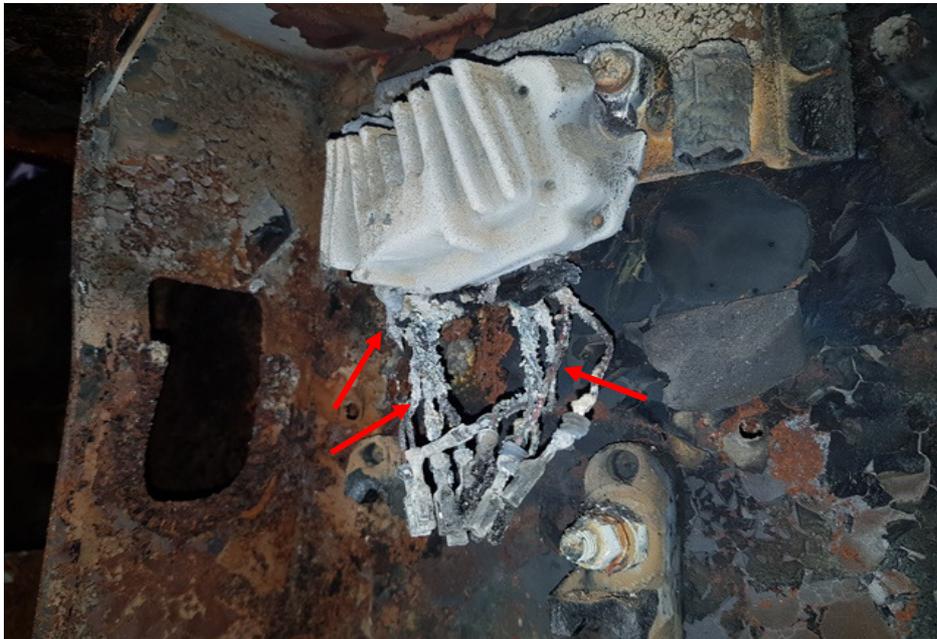
Photo 9 shows a close up view of the greenish residue found on several burnt stretches of original factory fitted wirings, around the rear right portion of the engine compartment (arrowed) of the Insured Vehicle. The presence of such greenish residue indicates internal heating of copper wires, a sign of an electrical short circuit occurring. The greenish residue is normally left behind from oxidation as a result of chemical reaction involving the copper wires.

25. The possibility of the fire being due to electrical in nature would then seem more likely given that engine overheating and external factors would seem unlikely. The fire being due to electrical nature is also supported by the faint traces of greenish residue that were found on several burnt stretches of original factory fitted around the rear right portion of the engine compartment of the Insured Vehicle, which was earlier discussed in paragraph 8 above.

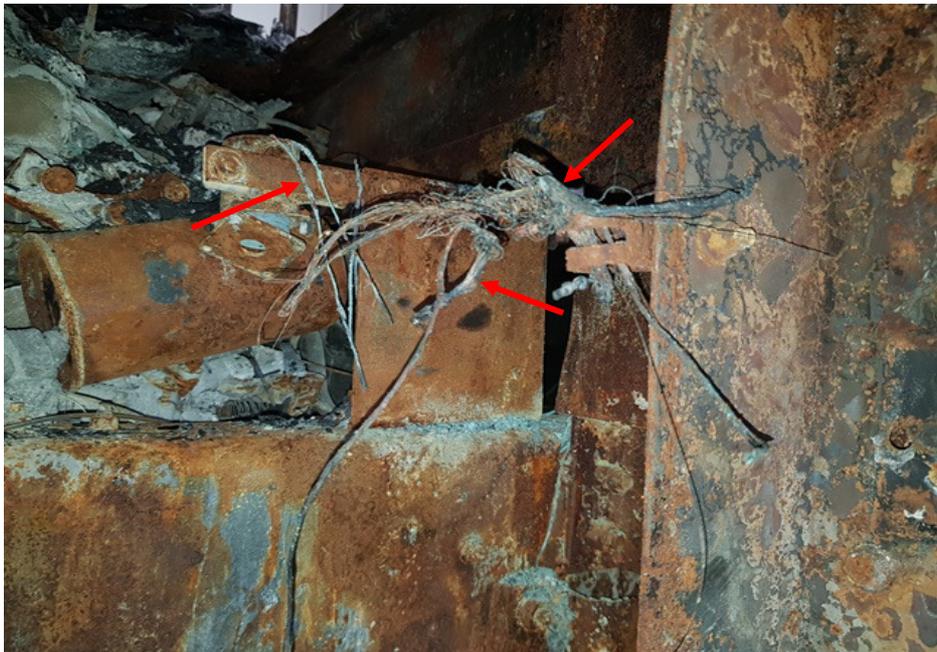
Photo 10 shows a closer view of the greenish residue that was found on several burnt stretches of original factory fitted wirings around the rear right portion of the engine compartment (arrowed) of the Insured Vehicle. This seems to suggest the occurrence of an electrical short circuit.

27. Having investigated and technically analysed the damages of burnt nature to the Insured Vehicle, we are of the view that the cause of fire to the Insured Vehicle was of electrical in nature. For this particular case, the fire had originated along the original factory fitted wirings around the rear right portion of the engine compartment of the Insured Vehicle.

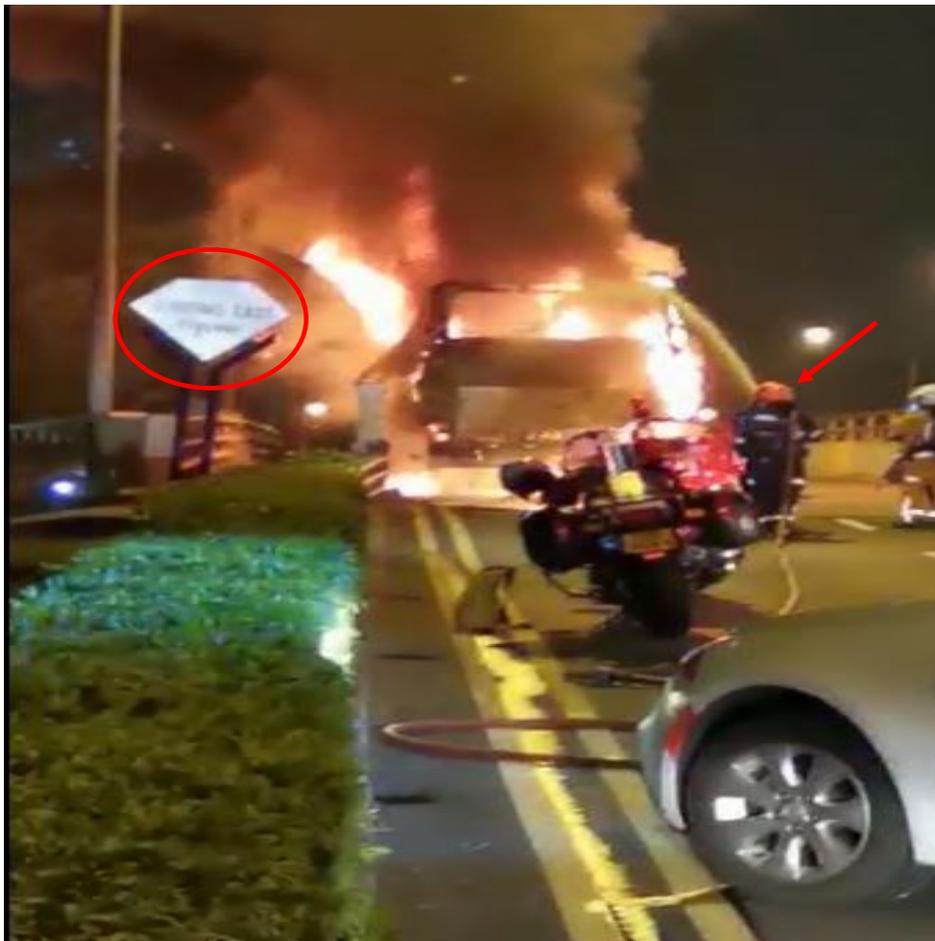
Photo 11 shows the SCDF having arrived at the incident location and attempting to put out the fire (arrowed). In general, the information gathered from this photograph had corresponded to Mr Khor's statement, which is the fire started while Mr Khor was driving the Insured Vehicle on the 1st lane along the Jurong East Flyover (circled).

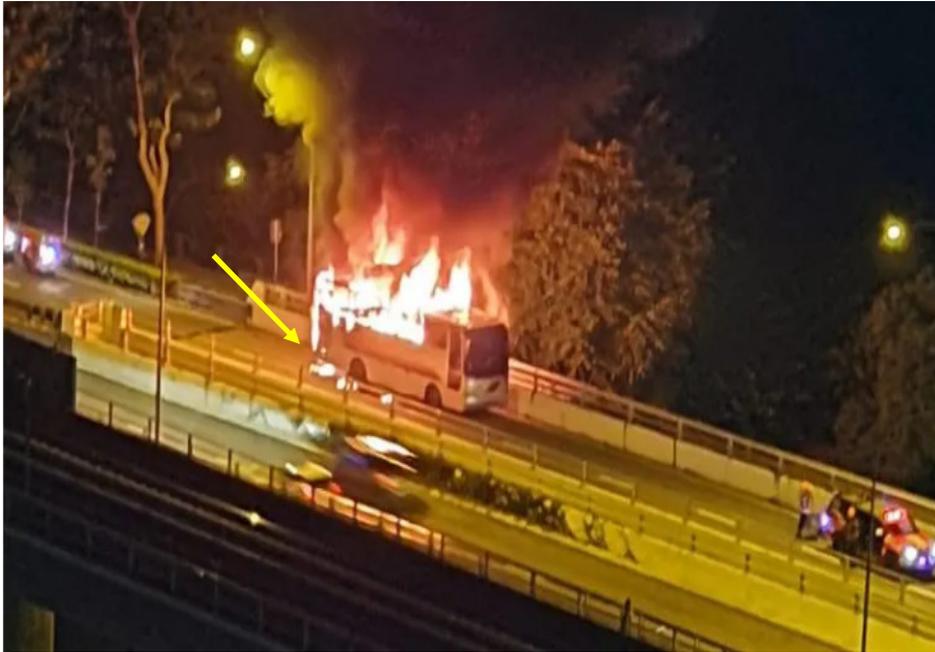
Photo 12 shows the Insured Vehicle on fire. In general, the information that could be gathered from this photograph had corresponded to the events that were related to us by Mr Khor, which is the fire had started from the rear portion of the Insured Vehicle (arrowed).

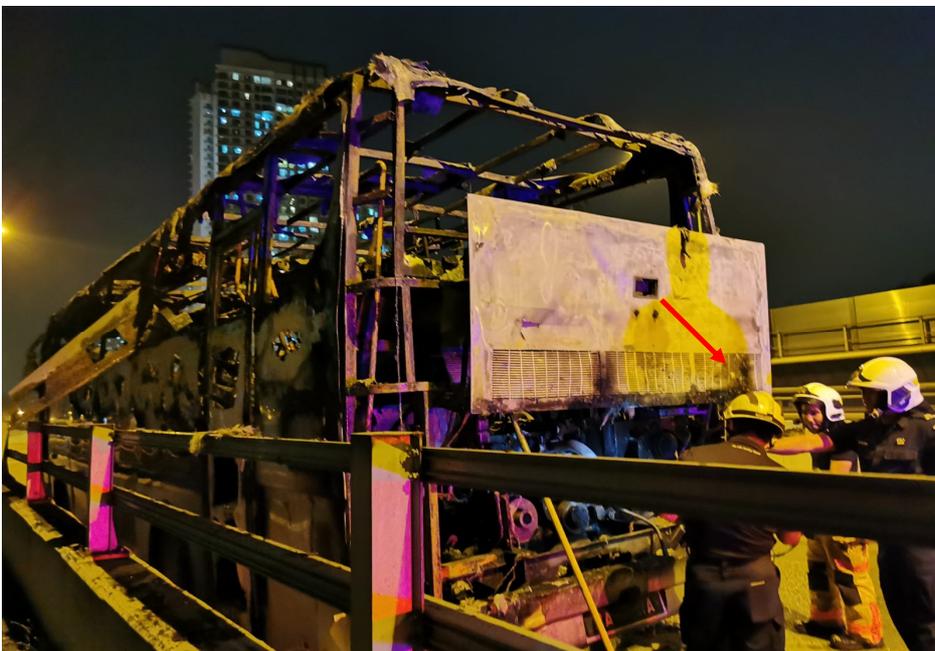
Photo 13 shows a closer view of firefighters conducting their preliminary investigations post- incident. In general, the information that could be gathered from this photograph pertaining to the nature of fire damage had corresponded to the events that were related to us by Mr Khor, which is the fire had started from the rear portion of the Insured Vehicle (arrowed).
