## VEHICLE INSPECTION REPORT

Date : 31 July 2019  
Our ref : CSPL/07/1912/TP

Registration No : SFW 8616 D  
Make / Model : Volkswagen Passat  
Chassis No : WVVZZZ3CZJE193991  
Engine No : CJS279624

## ADJUSTMENT ON REPAIR COST FOR VEHICLE NO. SFW 8616D

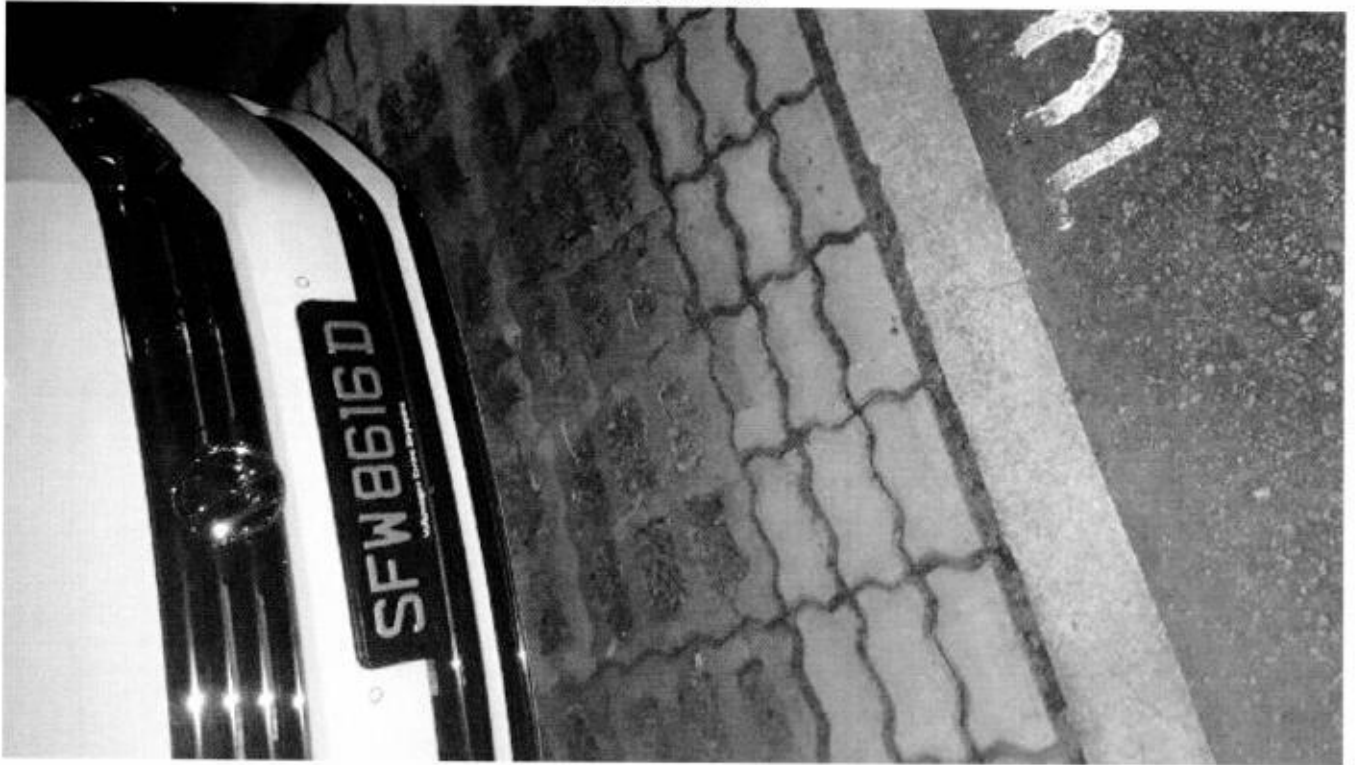
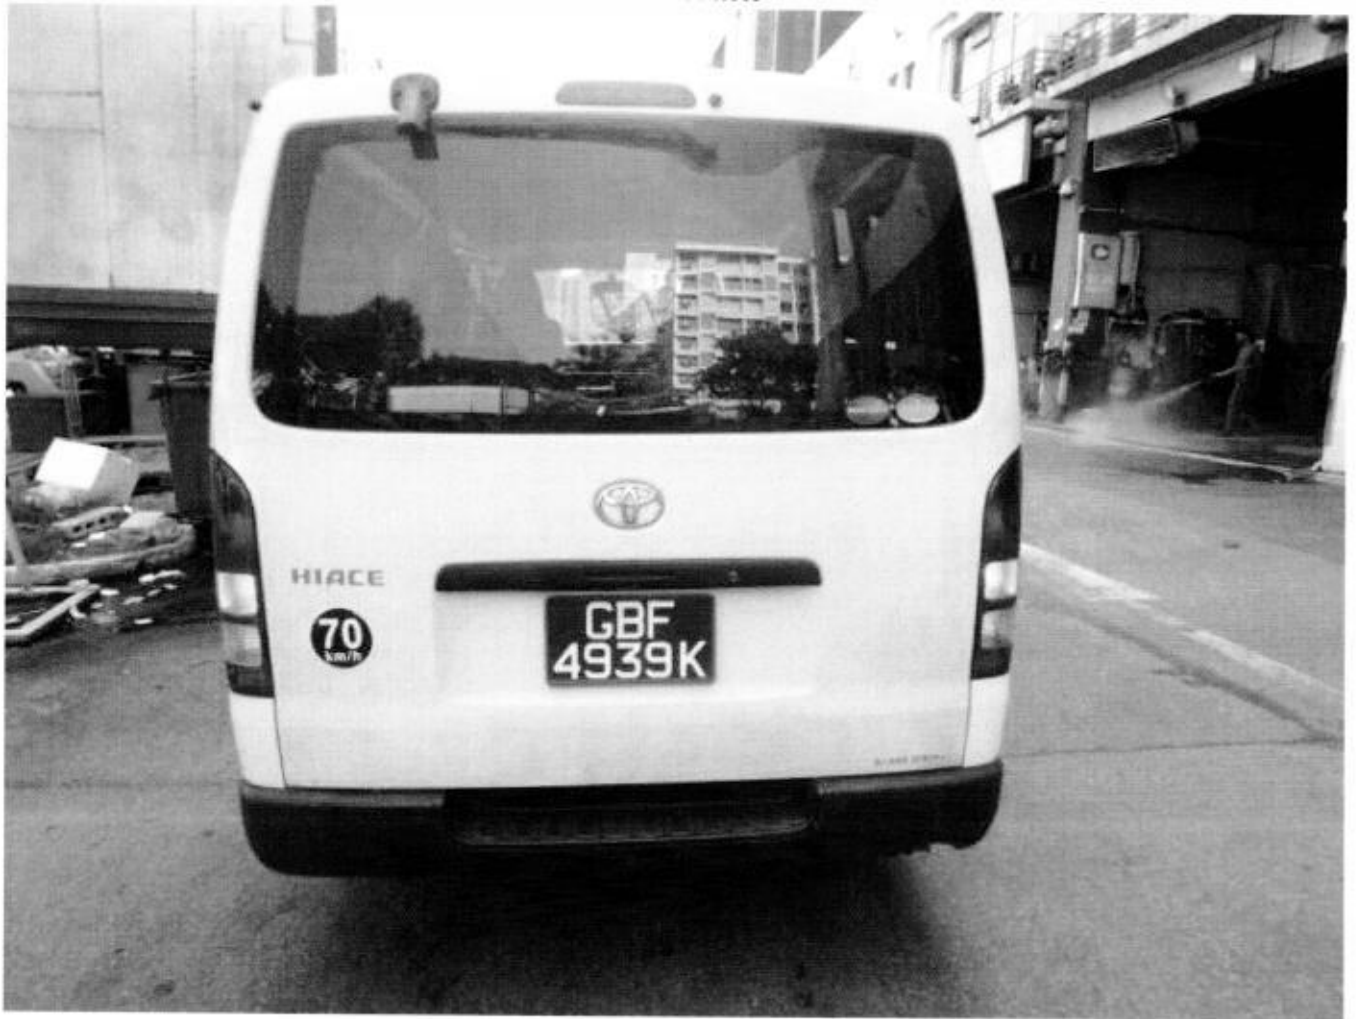
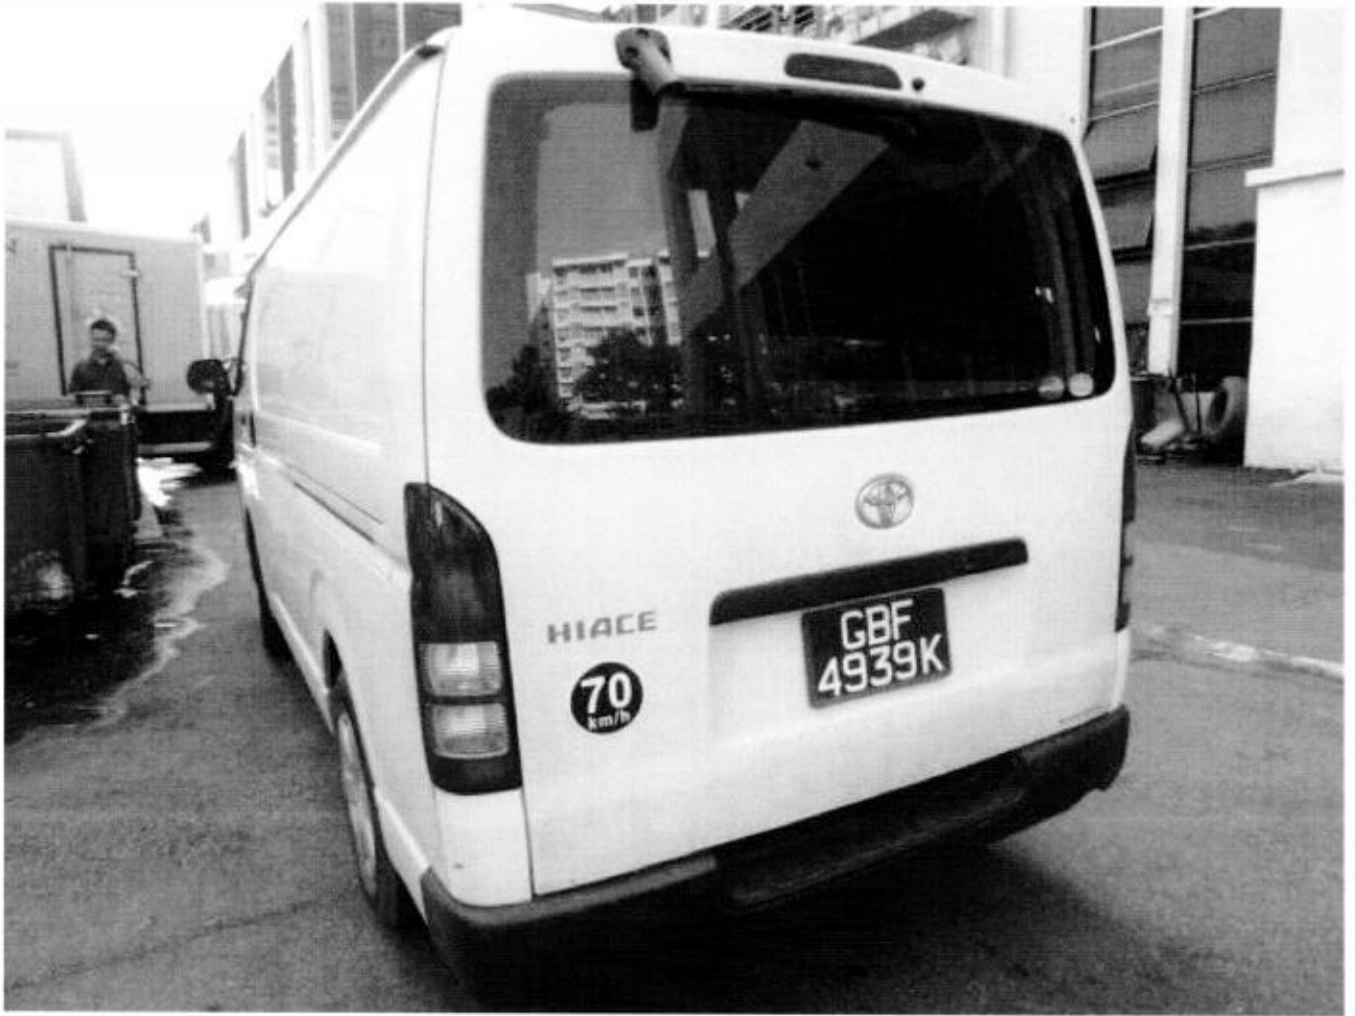
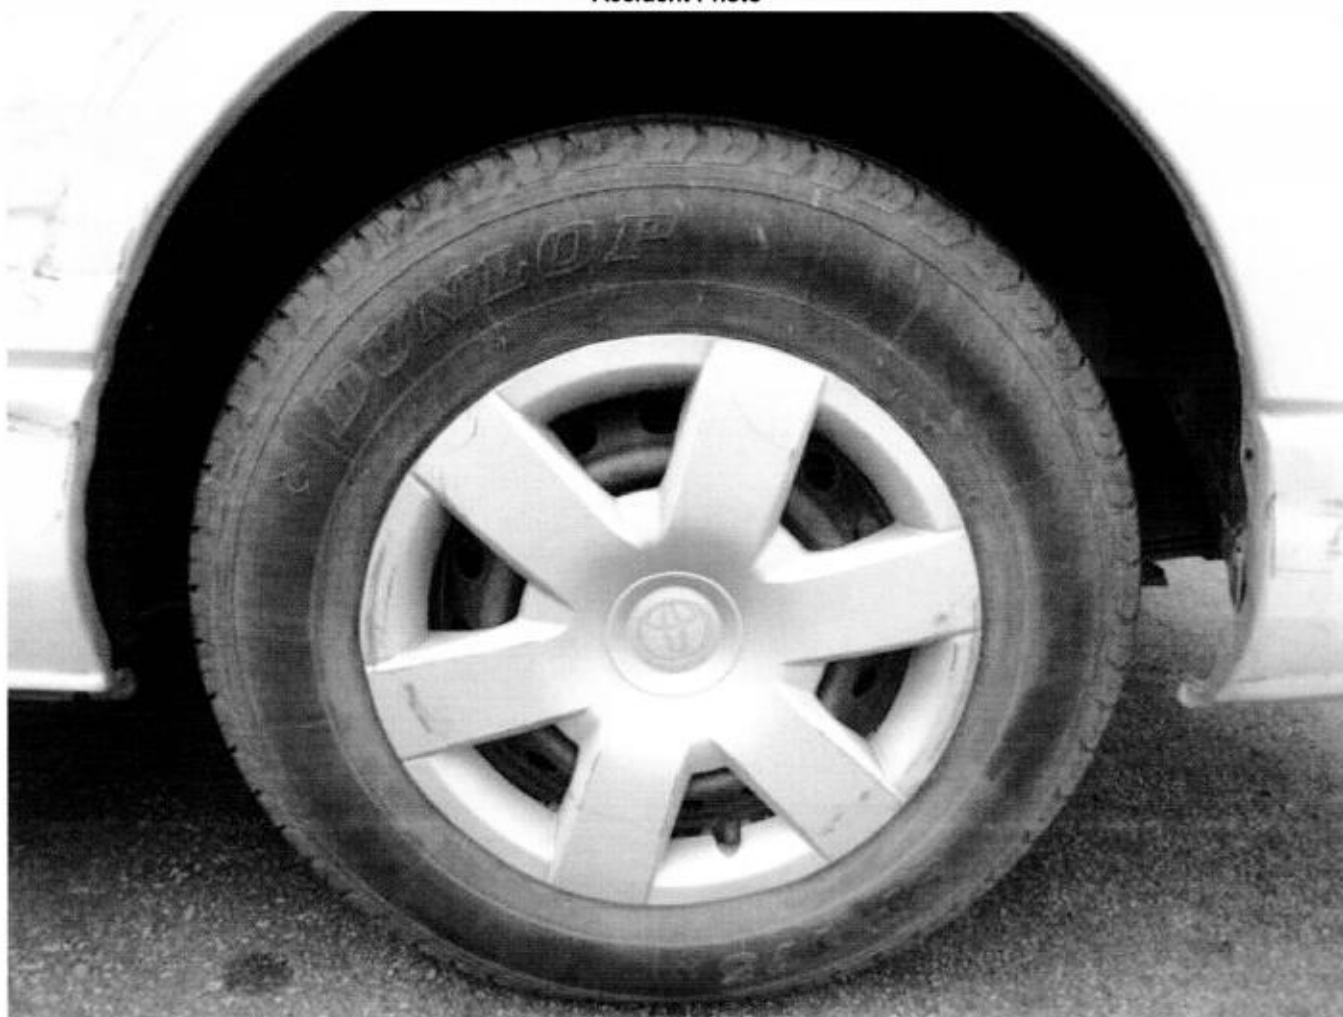
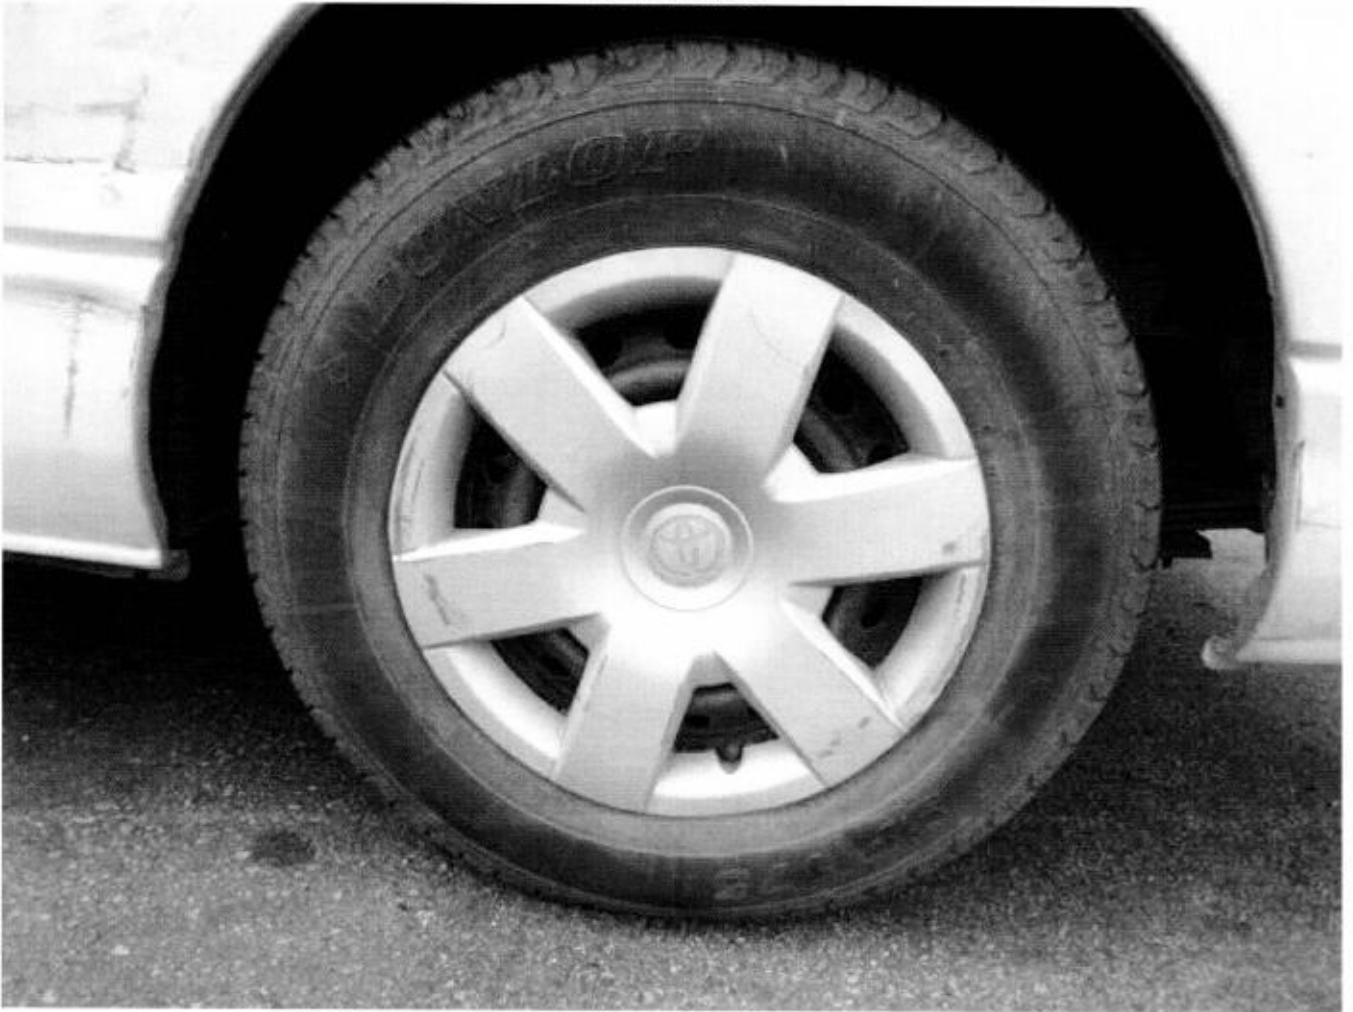
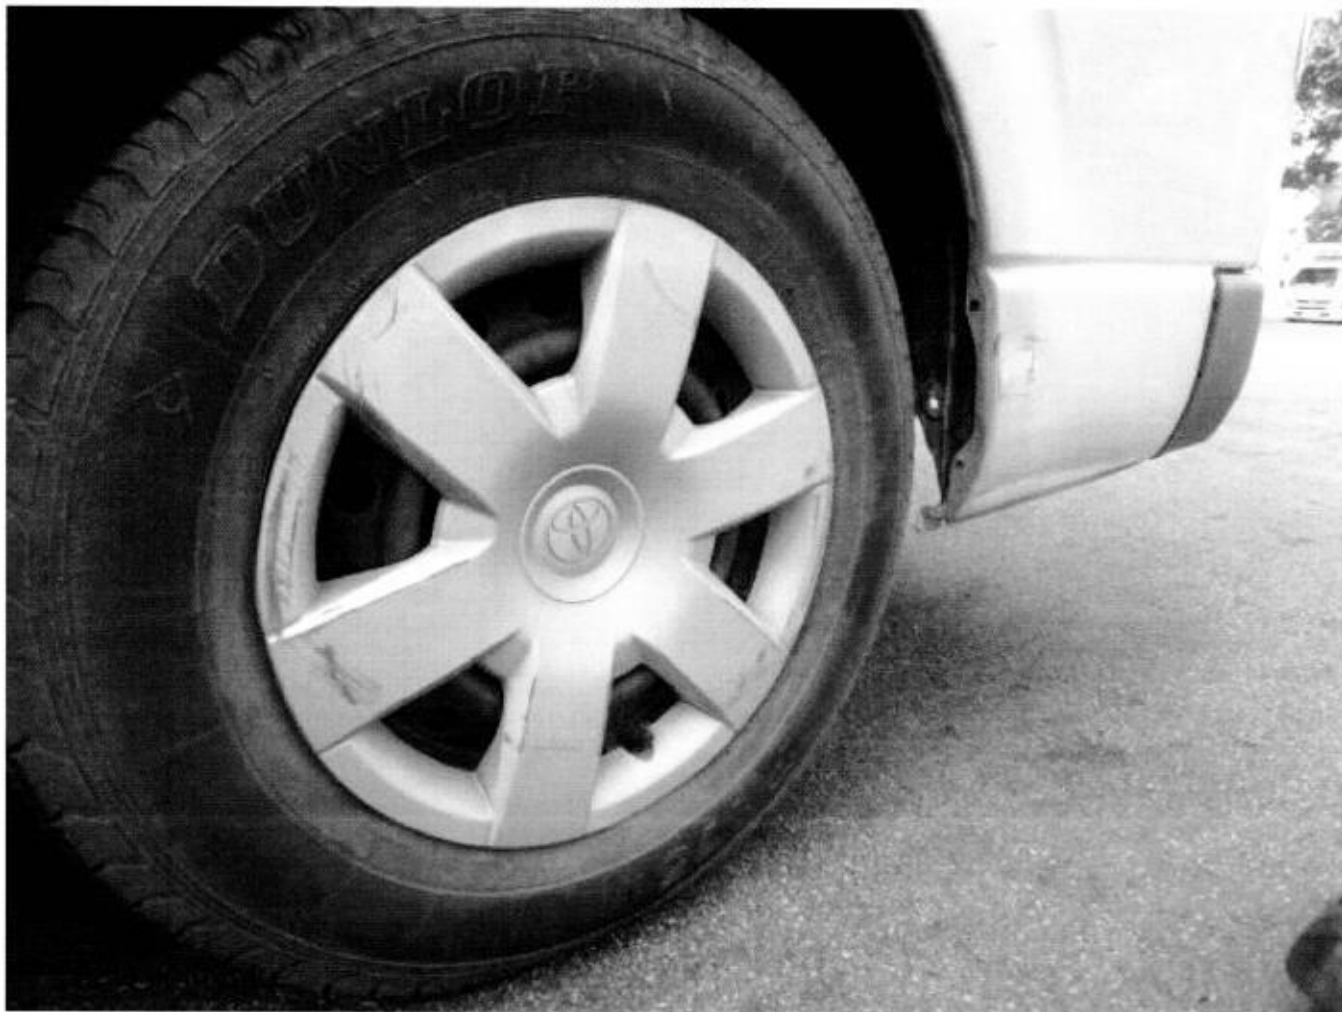
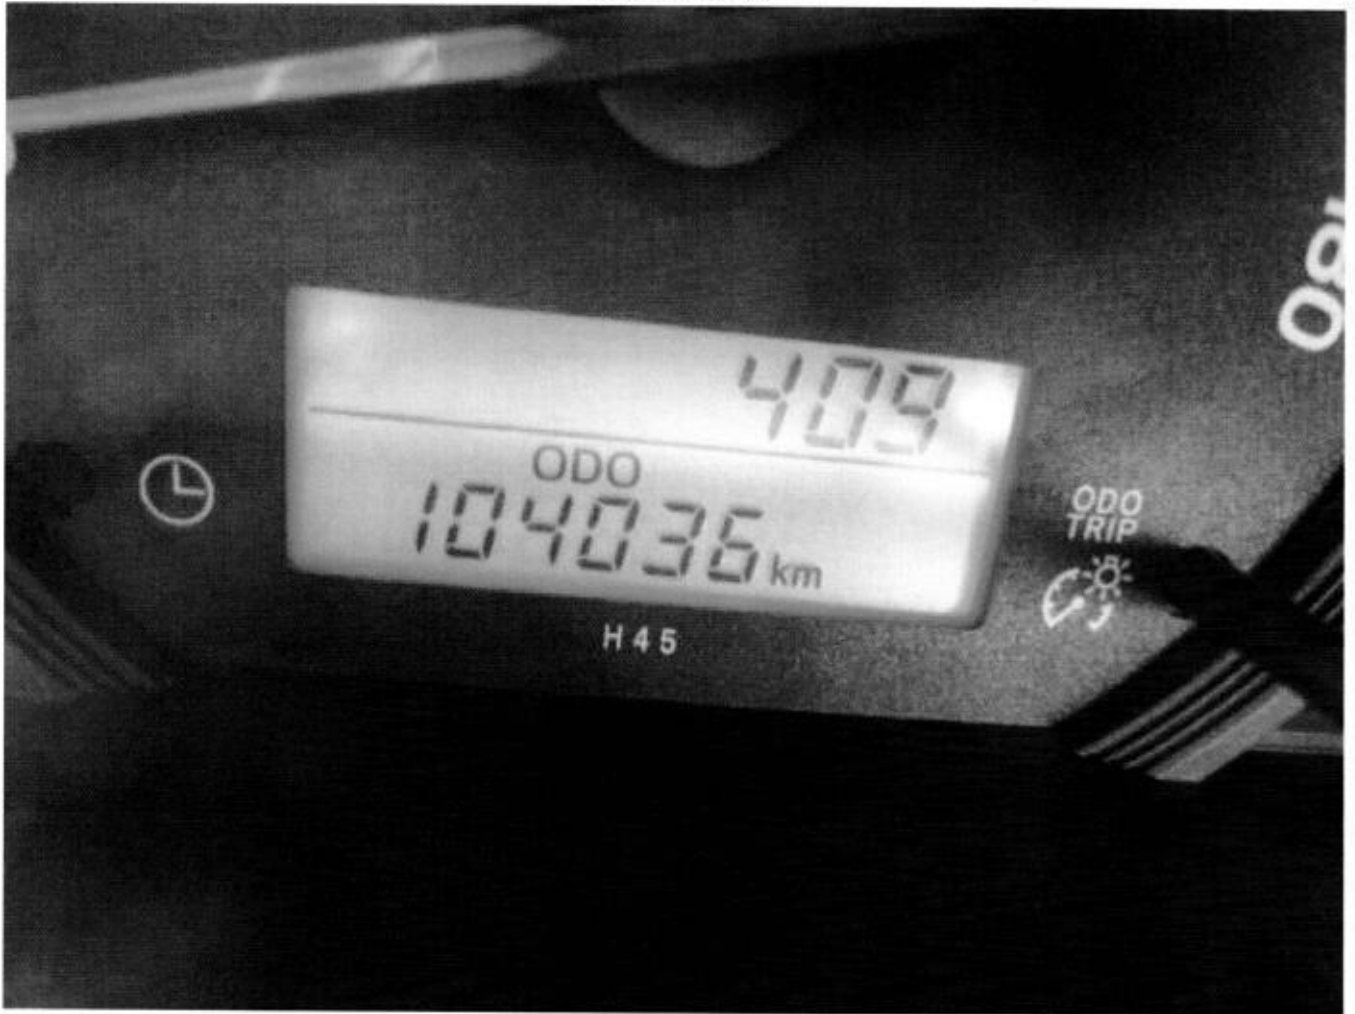
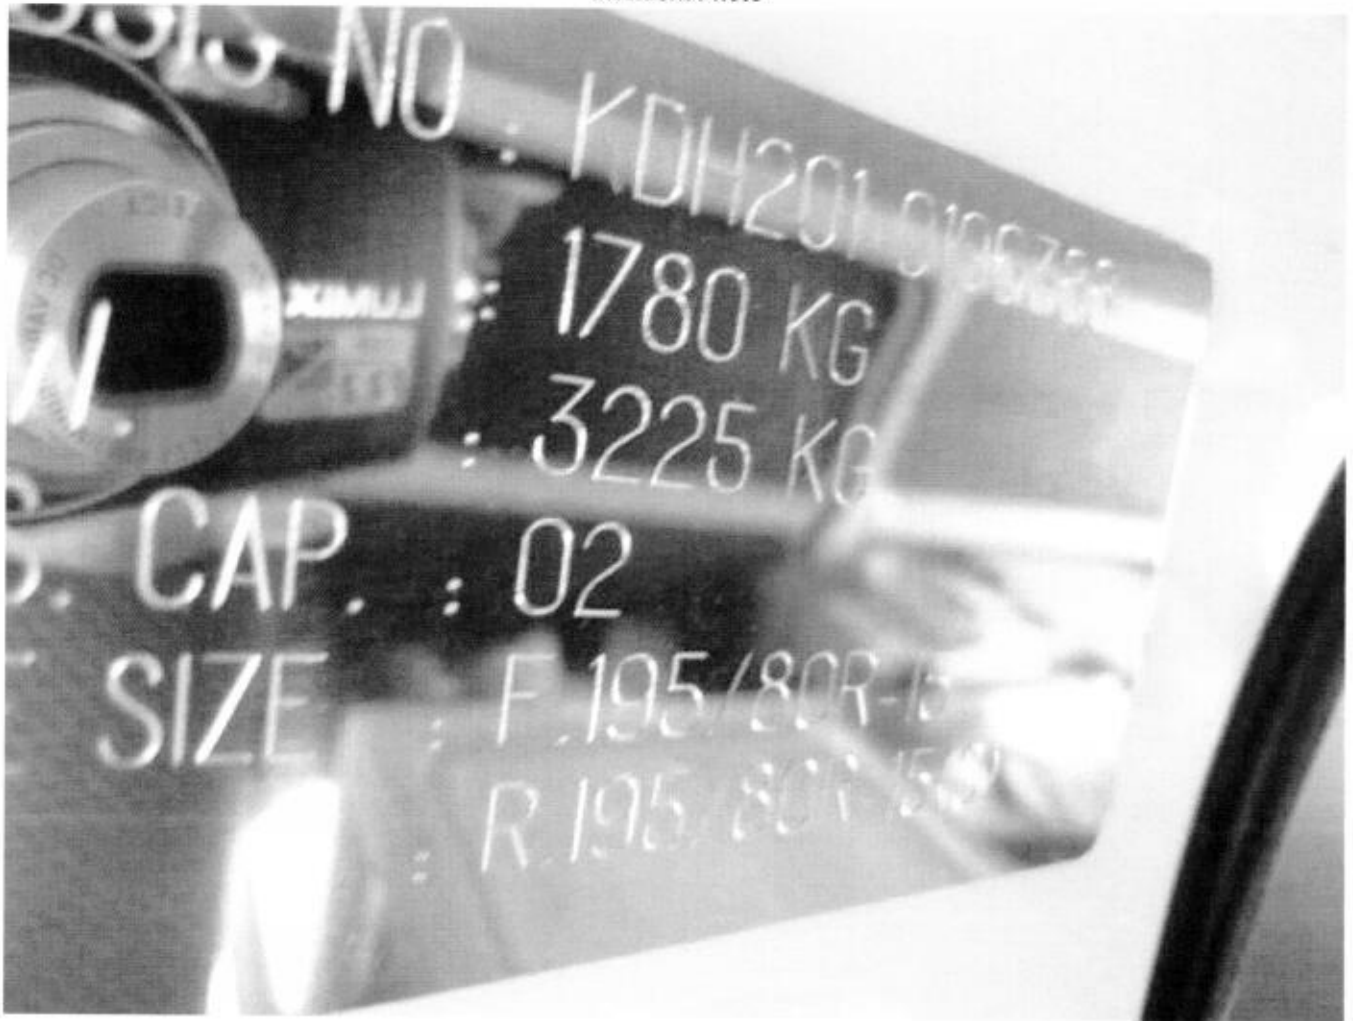
The impact damages sustained on the vehicle at the time of inspection is on the front o/s portion.  
(Details refer to the photographs attached)

<b>4. Description of Damages</b>				
THE VEHICLE SUSTAINED DAMAGES AT THE FRONT O/S PORTION. DAMAGES SEE DETAILS.				
<b>5. General Information</b>				
Accident Date	12/07/2019	Inspection Date	19/07/2019	
Survey held at	CARSMITH PTE LTD - 13 KAKI BUKIT RD 4 #01-20			
<b>5a. Remarks</b>				
A)THE INSPECTION WAS CONDUCTED ON A"WITHOUT PREJUDICE" BASIS. B)IN ACCORDANCE TO YOUR INSTRUCTIONS, WE HAVE NOT AUTHORISED REPAIRS.				
<b>5b. Estimate Days of Repair</b>				
ESTIMATED NORMAL PERIOD FOR REPAIR:		<b>5 Working Days</b>

The repairer has agreed to undertake the job at a **Lump Sum of \$ 7,100.00** on a contractual basis.
