REF: CS/CTE/19016804/Dtd307k

SHC 8381L

CHUNNI MOTOR WORK PTE LTD**REPAIR ESTIMATE***

VEHICLE DAMAGE INSPECTION REPORT

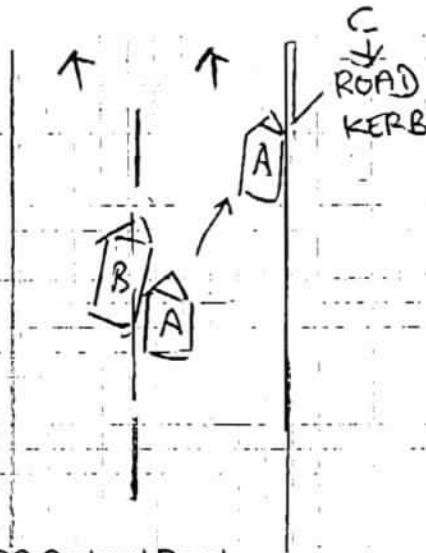
SKETCH PLAN

A - SHC 8381L
B - GBE 5536M
C - ROAD KERB

Along Grange Road TWDS Orchard Road.

On 18.09.2019 at about 14:35 hours I was travelling along Grange Road TWDS Orchard
Road with no passenger onboard .
While travelling on the extreme right lane , suddenly veh B (GBE 5536M) swerved into my
lane and collided into my taxi A - Front Left Portion . As the impact also caused my taxi to go
against the road kerb .
As it took place too fast I could not take evasive action to prevent the accident .
No injury in this accident .
I have company and photos and video at scene to support my claims .
Veh B (GBE 5536M) - Mr Tan Fook Meng
