Your Ref: TP/IP/58341/2019  
Our Ref : CI/TPD19016850/P

26<sup>th</sup> September 2019

**MECHANICAL INSPECTION REPORT OF MOTOR CAR SGT 6808J**

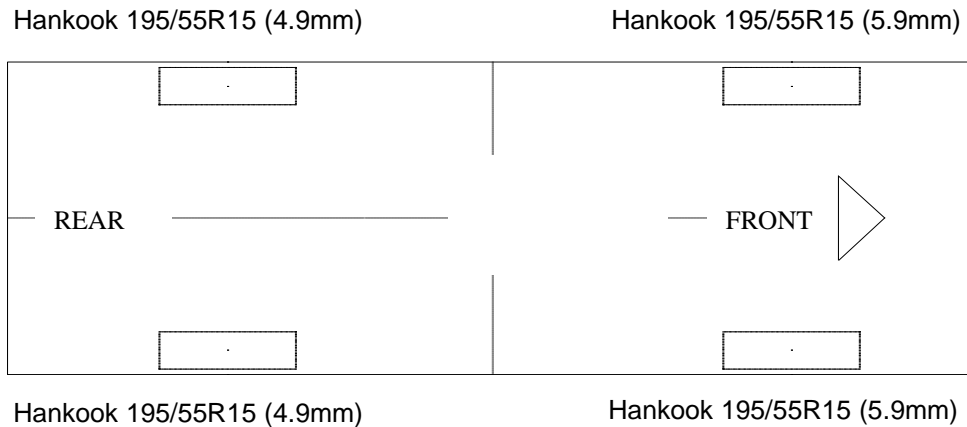
6. The condition of the Motor car's 4 tyres was observed to be in serviceable condition. I did not find any tear, cut or burst mark(s) on the outer and the inner sidewalls as well as across the tread of the 4 tyres. The 4 tyres were also observed to be sufficiently inflated for vehicular operation. The tyre brand, tyre size and remaining tread depth of the 4 tyres were recorded as follows:-

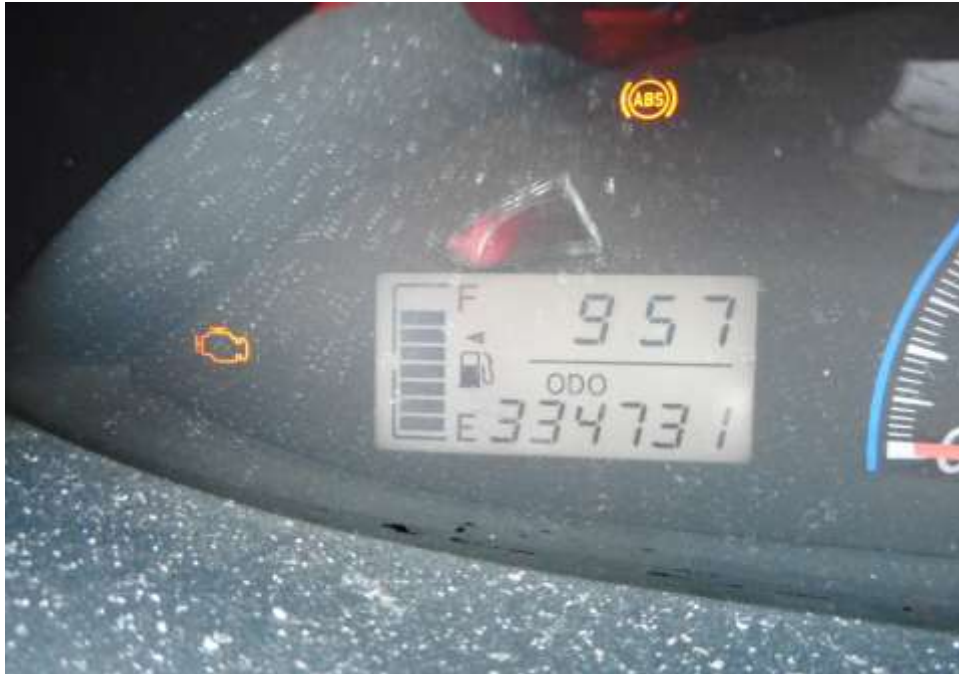
**Photo 1** shows the mileage of the Motor Car at the time of inspection 334,731km/

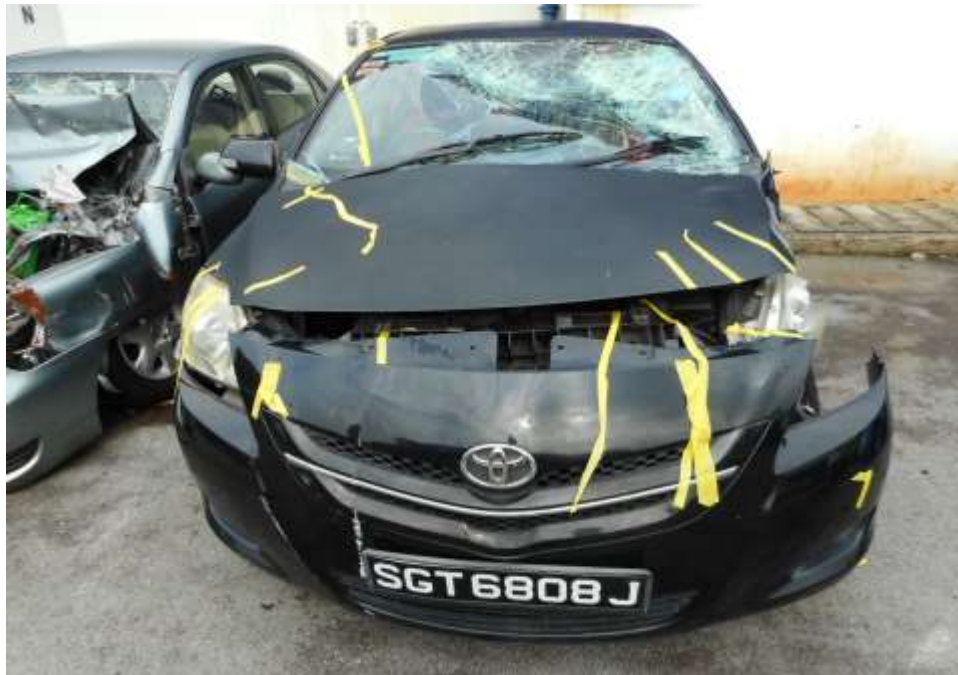
**Photo 2** shows a general view of the Motor Car's front body at the time of my inspection. The Motor car was observed to have sustained moderate damage at its front and left side portion. Its front windscreen, front bonnet, front bumper, front left headlamp, front left fender, front left door panel, front left windscreen and left rear mirror was amongst the body parts that were damaged as a result of the accident. The Supplemental Restraint System (SRS) was activated as a result of the accident.

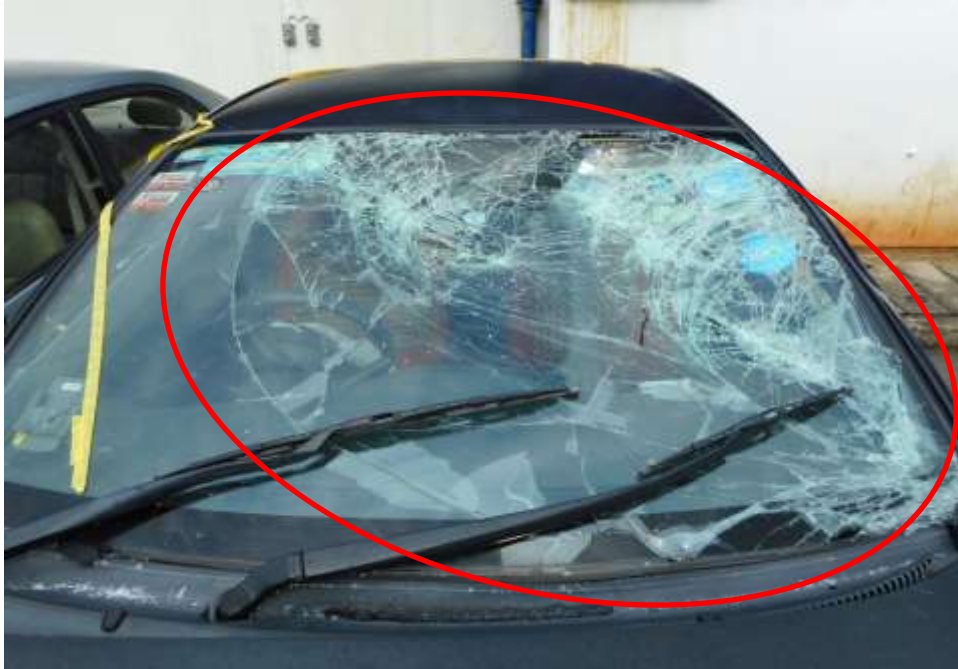
**Photo 3** shows the close up view of the Motor Car's front body at the time of my inspection. The Motor car front windscreen (circled) was observed to have sustained damage as a result of the accident.

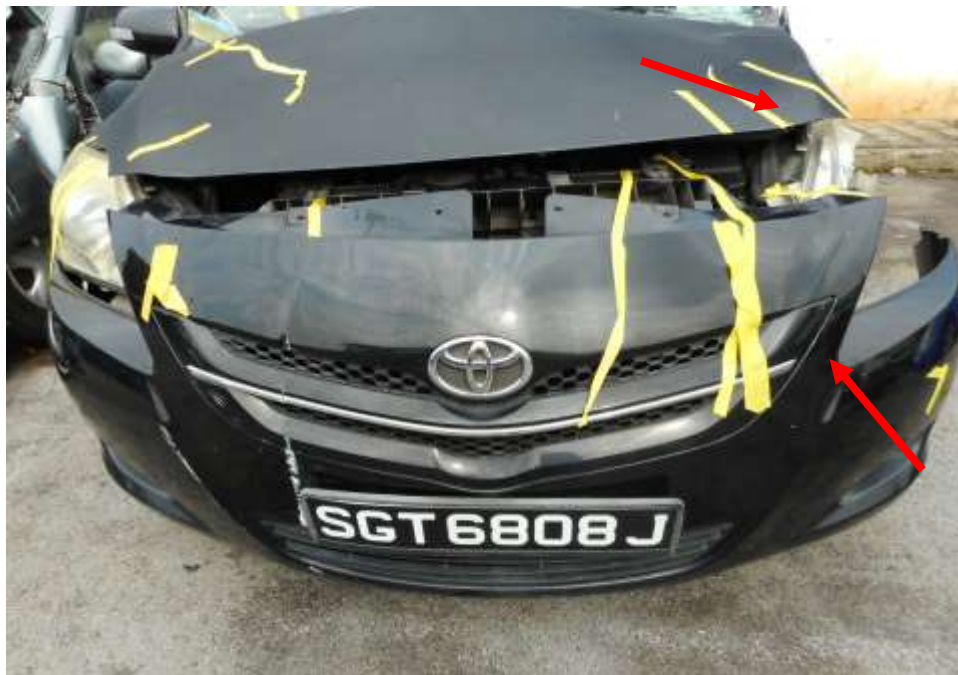
**Photo 4** shows a close up view of the Motor Car's front body at the time of my inspection. Its front bonnet and front bumper body panel (arrowed) was amongst the body parts that were damaged as a result of the accident.

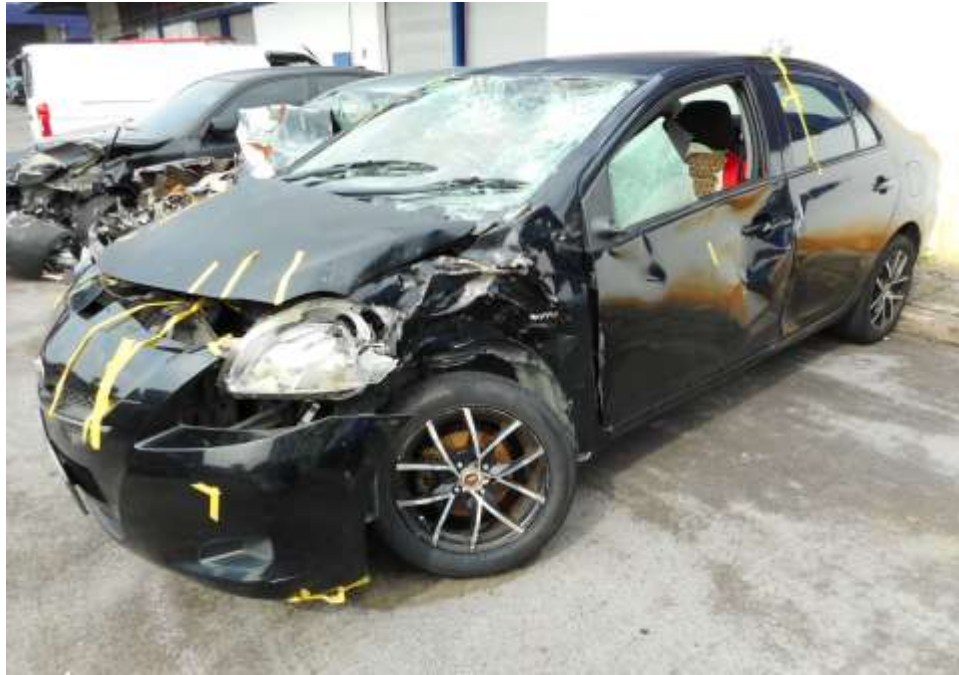
**Photo 5** shows the general view of the Motor Car's left body at the time of my inspection. Its front left headlamp, front left fender, front left door panel, front left windscreen and left rear mirror was amongst the body parts that were damaged as a result of the accident.

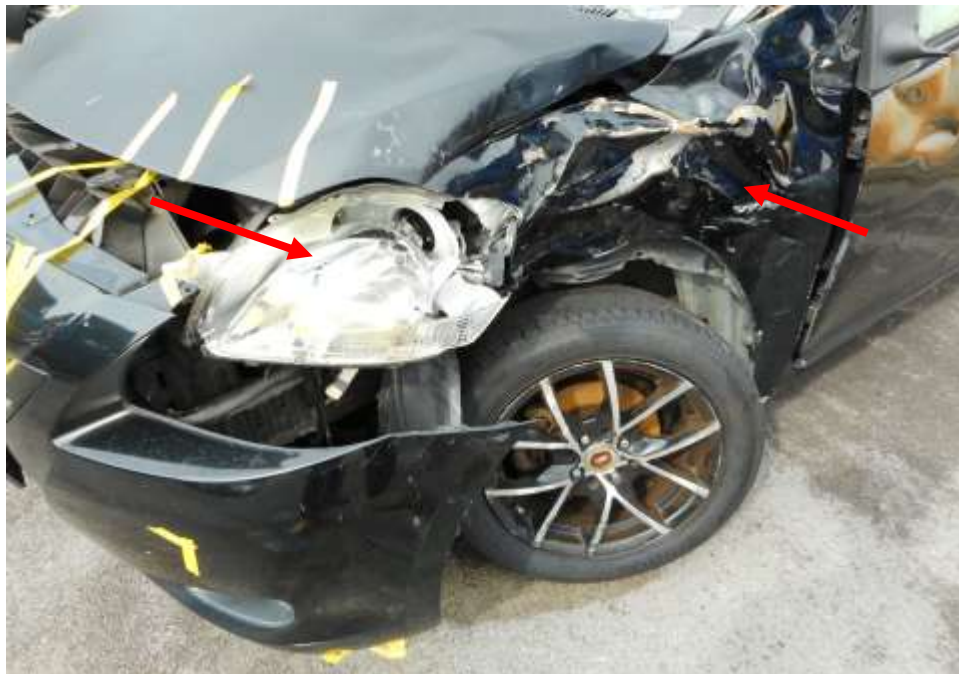
**Photo 6** shows a close up view of the Motor Car's left body at the time of my inspection. Its front left headlamp and front left fender (arrowed) was amongst the body parts that were damaged as a result of the accident.

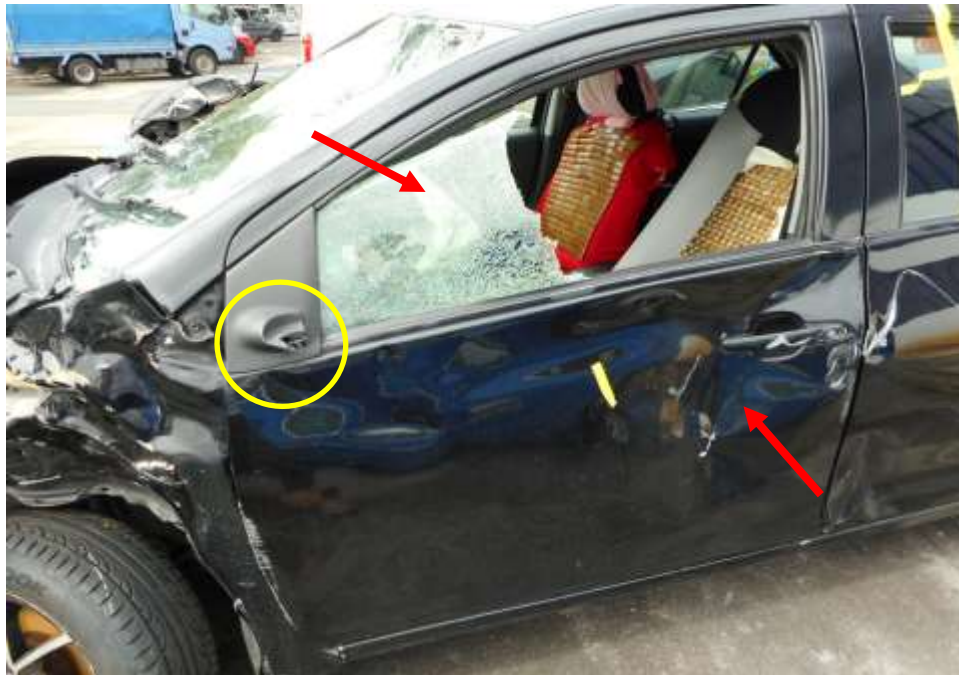
**Photo 7** shows the close up view of the Motor Car's left body at the time of my inspection. Its front left door panel, front left windscreen (red arrow) and left rear mirror (yellow circle) was amongst the body parts that were damaged as a result of the accident.

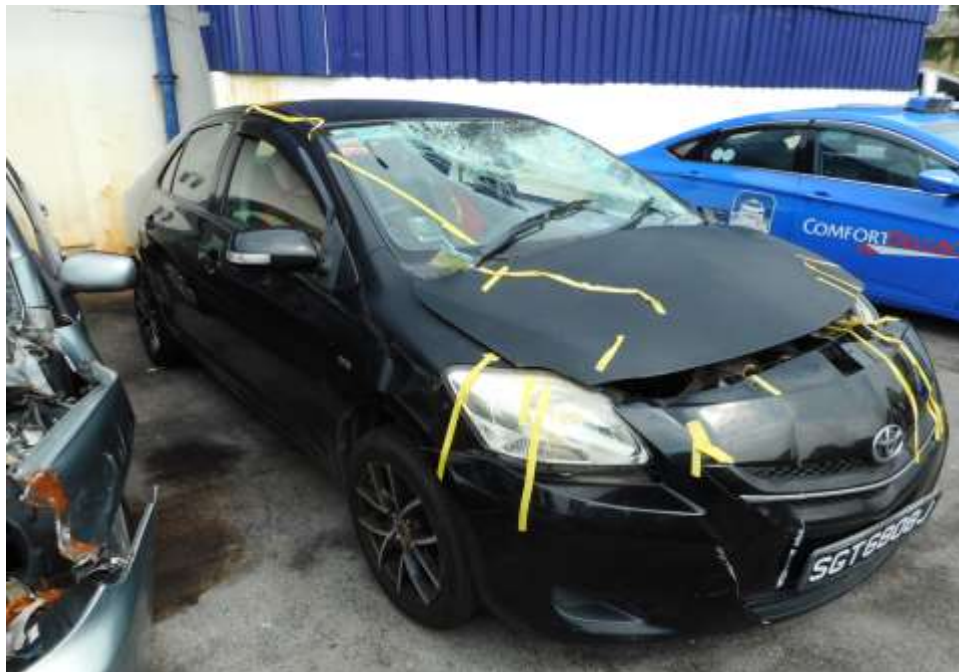
**Photo 8** shows a general view of the Motor Car's right body at the time of my inspection. The right portion of the Motor Car was observed to have been undamaged by the accident.

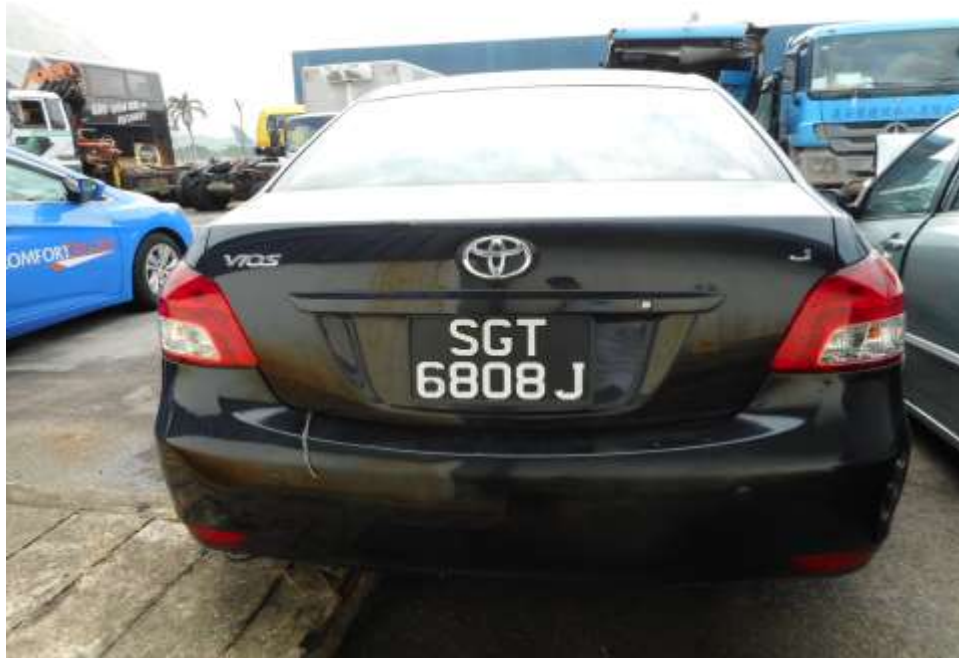
**Photo 9** shows a general view of the Motor Car's rear body at the time of my inspection. The rear portion of the Motor Car was observed to have been undamaged by the accident.

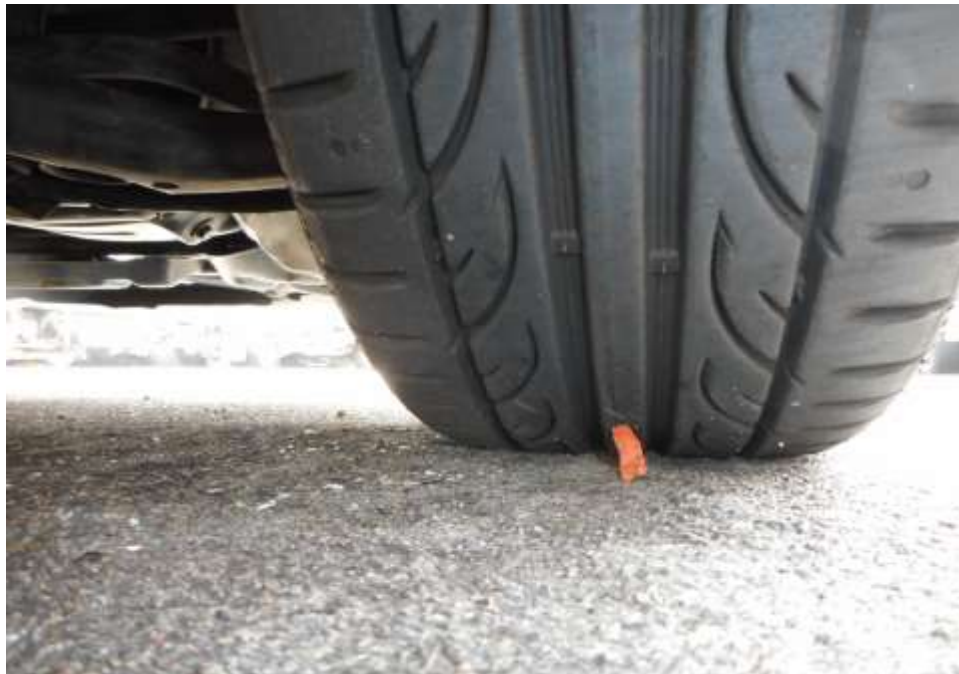
**Photo 10** shows the condition of the front right tyre of the Motor Car, which was observed to be in serviceable condition with remaining tread depth of approximately 5.9mm. The tyre was sufficiently inflated for vehicular operation. There was also no tear, cut or burst mark(s) on the outer and the inner sidewalls as well as across the tread of the Motor Car's 4 tyres.

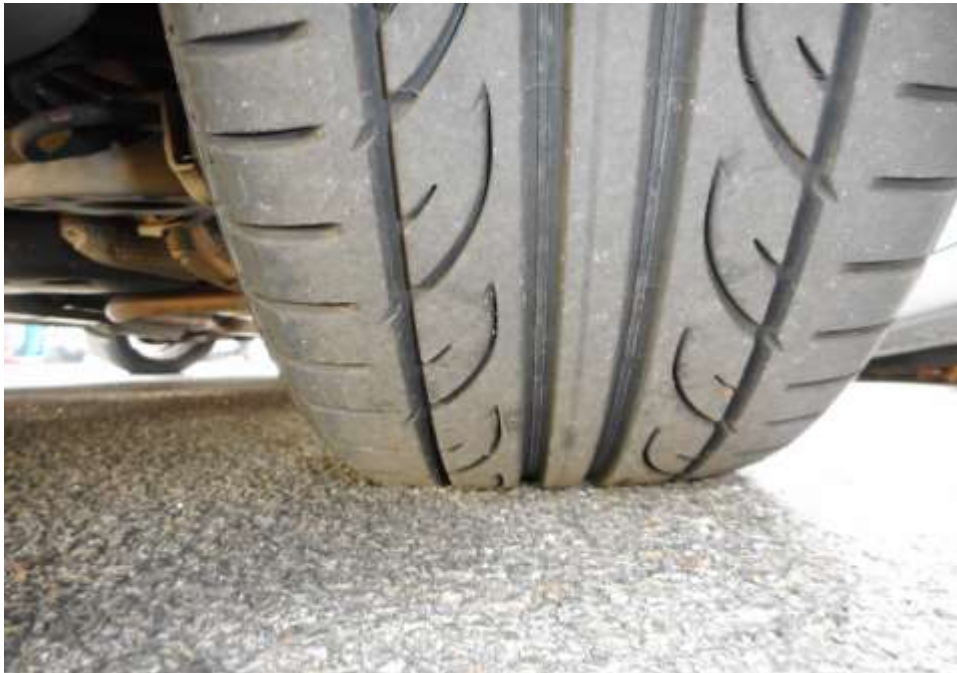
**Photo 11** shows the condition of the rear right tyre of the Motor Car, which was observed to be in serviceable condition with remaining tread depth of approximately 4.9mm. The tyre was also observed to be sufficiently inflated for vehicular operation with no tear, cut or burst mark(s).

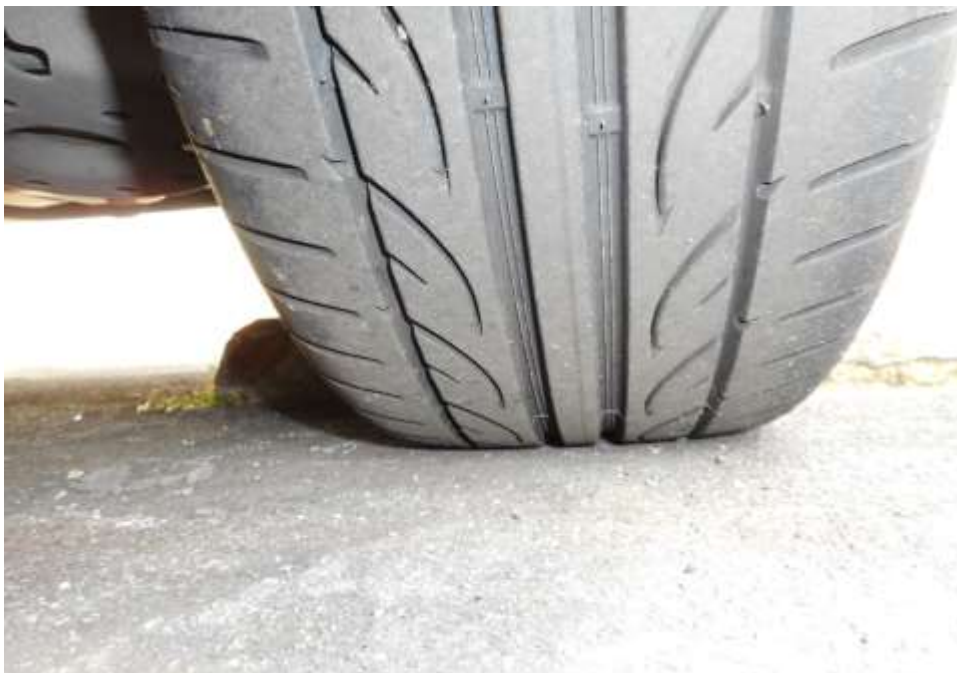
**Photo 12** shows the condition of the rear left tyre of the Motor Car, which was observed to be in serviceable condition with remaining tread depth of approximately 4.9mm. The tyre was also observed to be sufficiently inflated for vehicular operation with no tear, cut or burst mark(s).

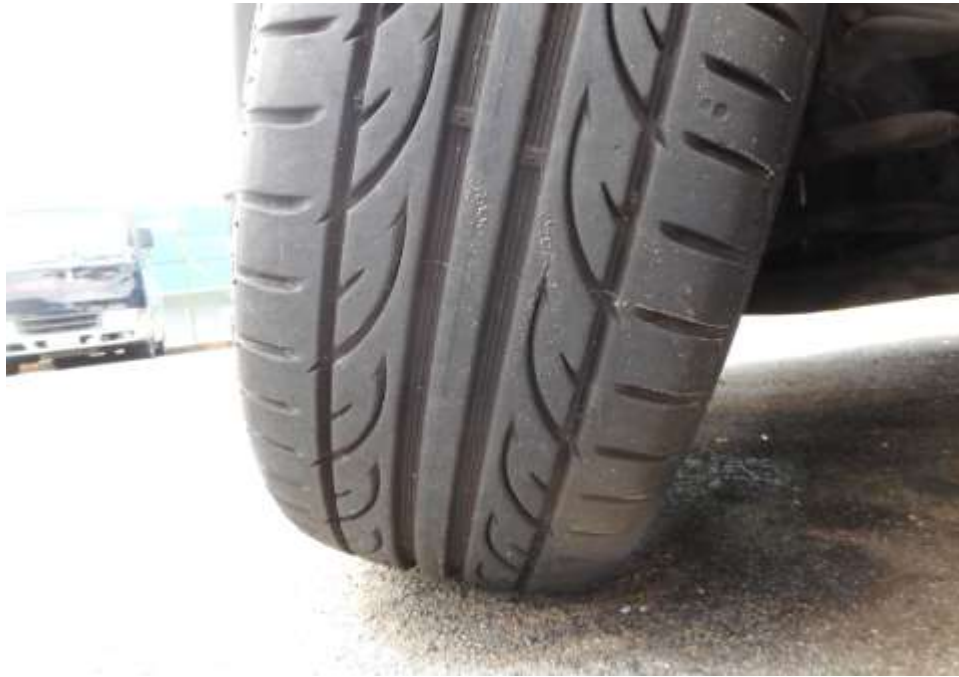
7. The 4 tyres were observed to be wrapped around alloy wheel rims however the front left rim was found to be damaged as a result of the accident. See photo 1 – 14 below.

**Photo 13** shows the condition of the front left tyre of the Motor Car, which was observed to be in serviceable condition with remaining tread depth of approximately 5.9mm. The tyre, which was wrapped around alloy wheel rim, was also observed to be sufficiently inflated for vehicular operation. There were minor scratches on the surface of the wheel rim as a result of the accident.

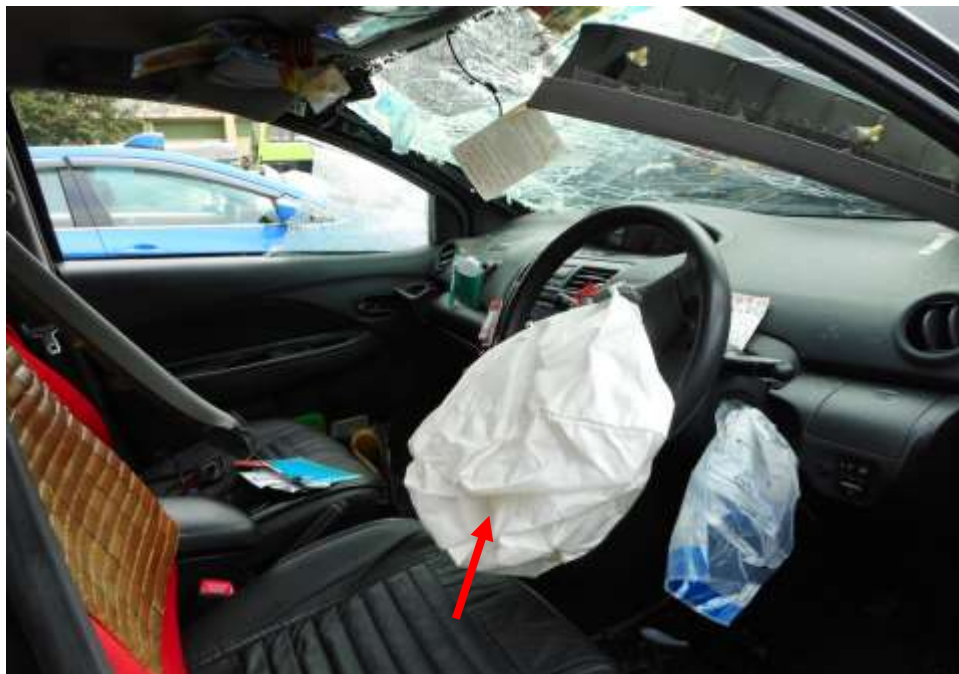
**Photo 14** shows the deployment of the Supplemental Restraint System (SRS) airbag (arrowed), as a result of the accident.

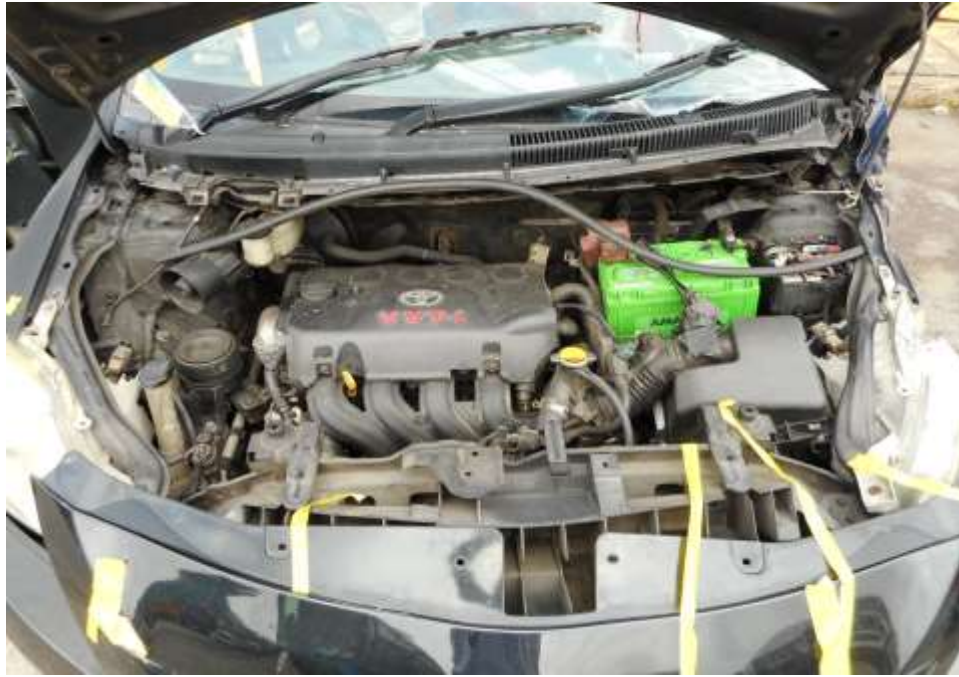
**Photo 15** shows a general view of the Motor Car's engine compartment and the various parts and components inside the engine compartment. There was also no sign(s) or indication(s) of fluid leakage and/or fluid stain within the engine compartment.

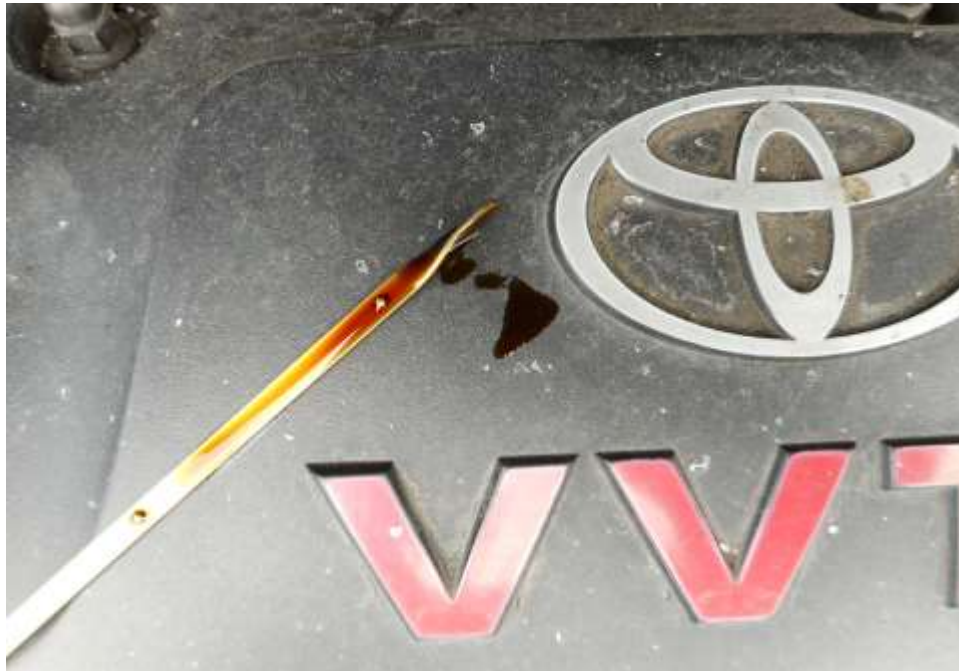
**Photo 16** shows checks being carried out to the engine oil of the Motor Car at the time of my inspection. The engine oil on the indicator dip stick was observed to be of sufficient level and without any visible contamination.

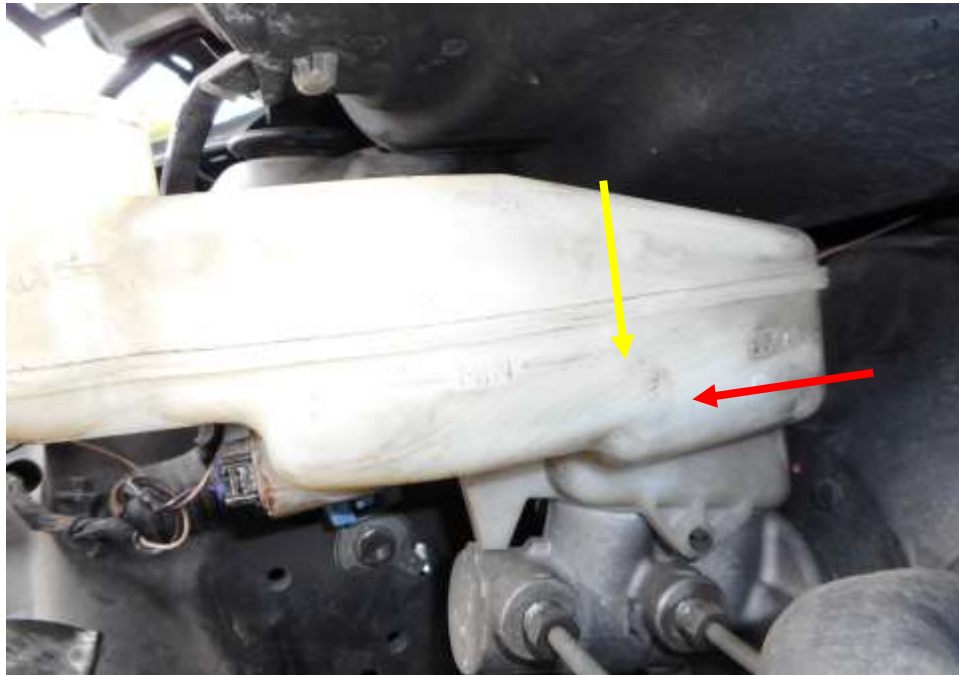
8. Upon examination of the engine compartment of the Motor Car, I had observed all the parts and components inside the engine compartment to be intact and unaffected by the accident. The engine oil and engine coolant were all found to be of sufficient level for operating purposes. Visually, there was also no contamination found to these fluids. However the brake fluid was observed to be insufficient level due to a leakage at the front left brake caplier as a result of the accident.

**Photo 17** shows the brake fluid reservoir of the Motor Car at the time of my inspection. The brake fluid was observed to be of insufficient level (red arrow) and below the minimum mark (yellow arrow). A leakage was observed at the brake caplier as a result of the accident.

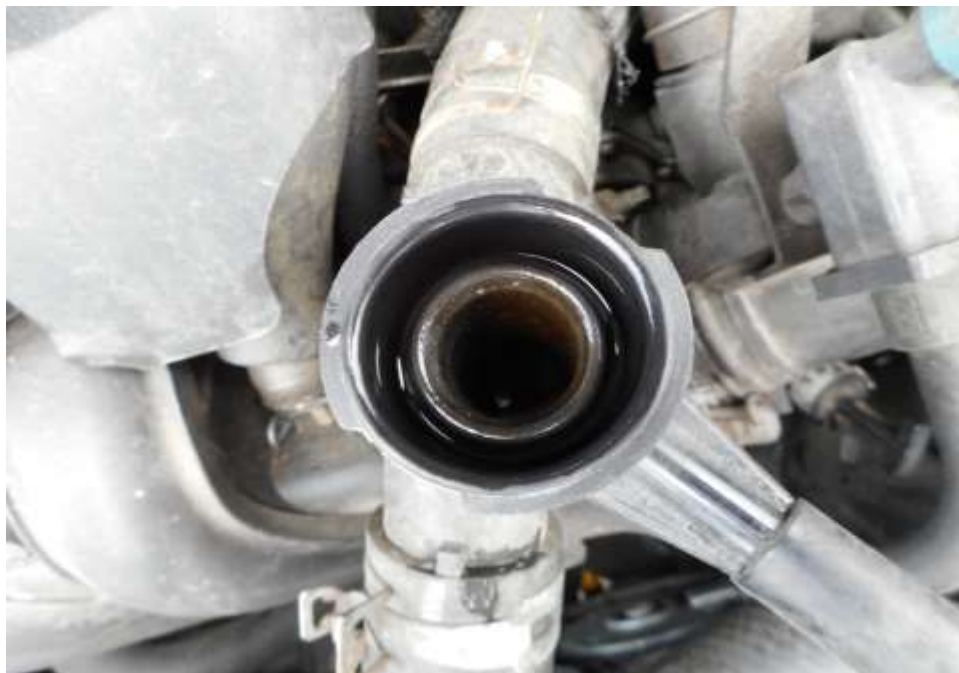
**Photo 18** shows checks being carried out to the engine coolant of the Motor Car at the time of my inspection. The engine coolant was observed to be of sufficient level and without any visible contamination.

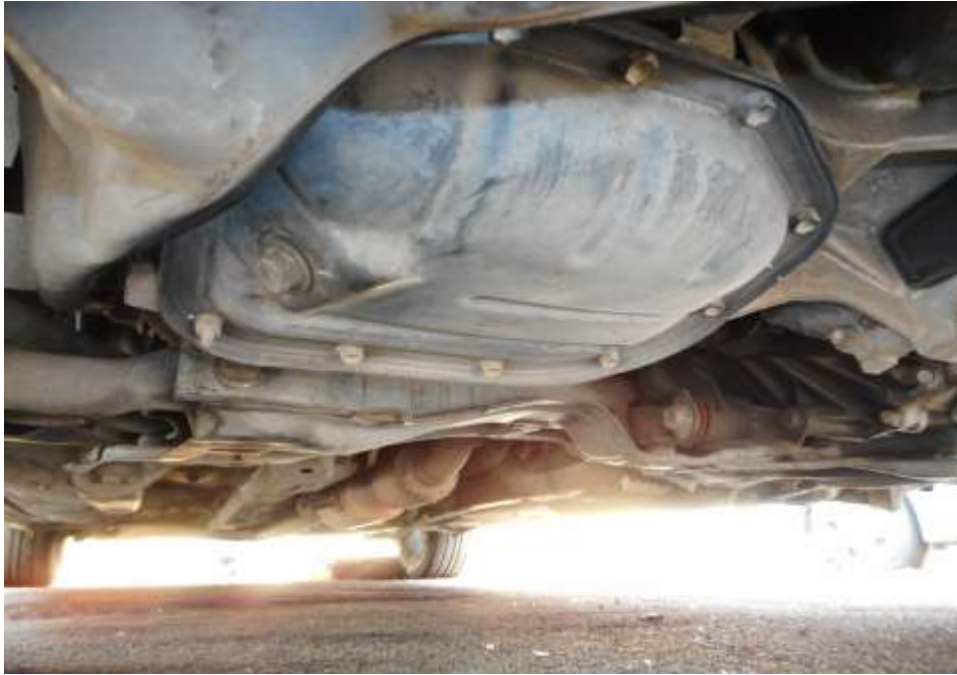
**Photo 19** shows the undercarriage of the Motor Car, at the area where the engine housing and transmission housing are located. I did not find any sign(s) or indication(s) of fluid leak and/or fluid stain(s) on the underside of the Motor Car.

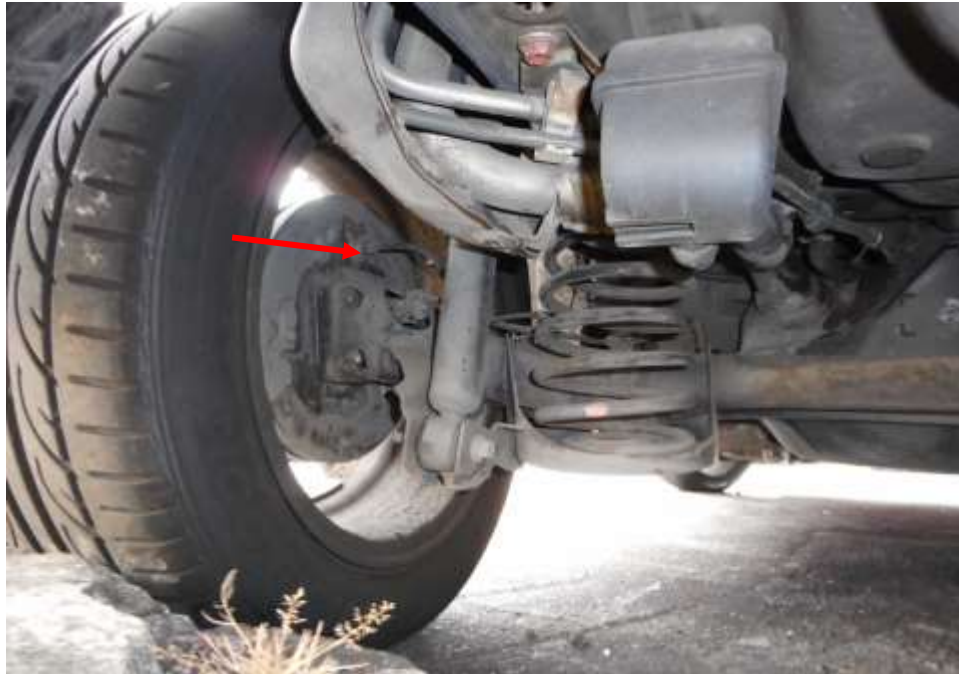
**Photo 20** shows the brake hose/pipe (arrowed) at the rear left wheel of the Motor Car. It was observed to be intact and undamaged by the accident.

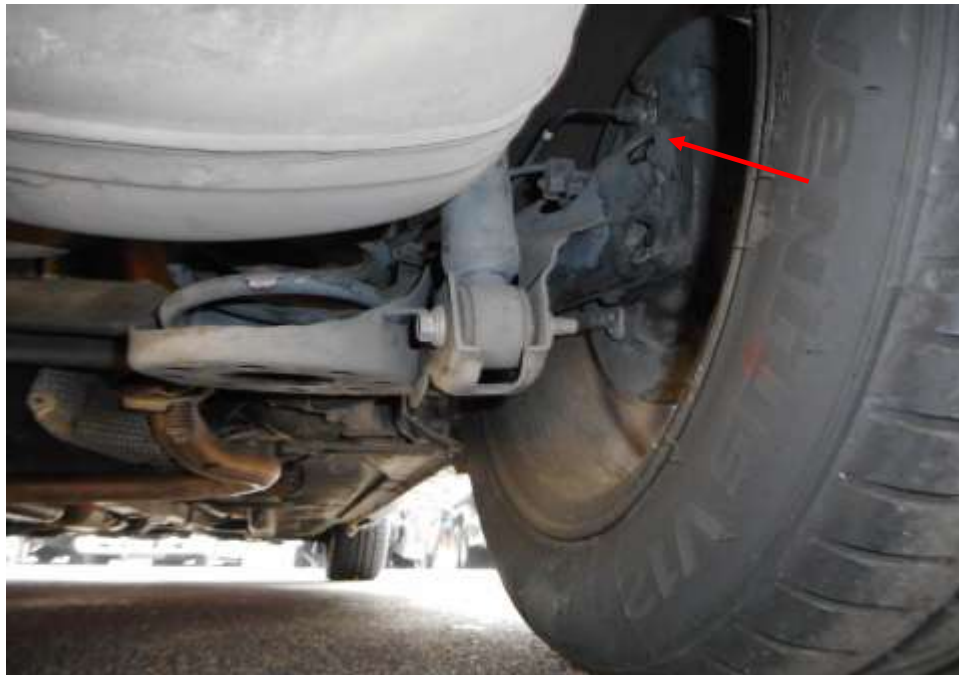
**Photo 21** shows the brake hose/pipe (arrowed) at the rear right wheel of the Motor Car. No leakage of brake fluid was observed. Visual examination of the various components of the braking system like the drum brake, brake booster, brake pedal etc had revealed all to be intact and without visible damage.

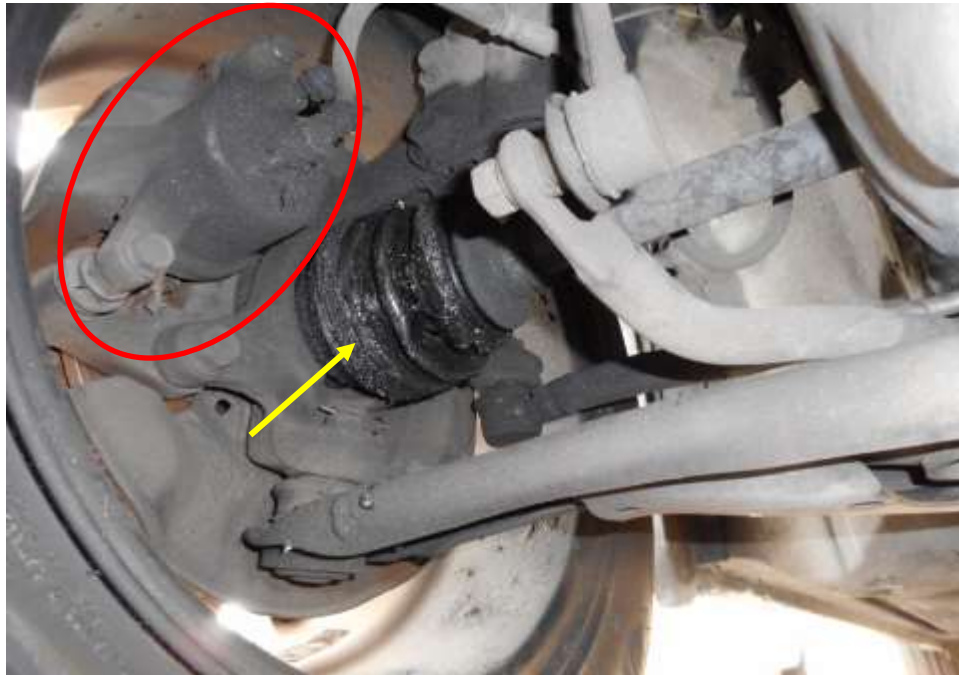
**Photo 22** shows the brake hose/pipe and the brake caliper (circled) at the front right wheel of the Motor Car, old brake fluid stain was observed on the surface of the brake caplier. Visual examination revealed that the rubber of the right outer CV joint is broken with grease flowing out (yellow arrow).

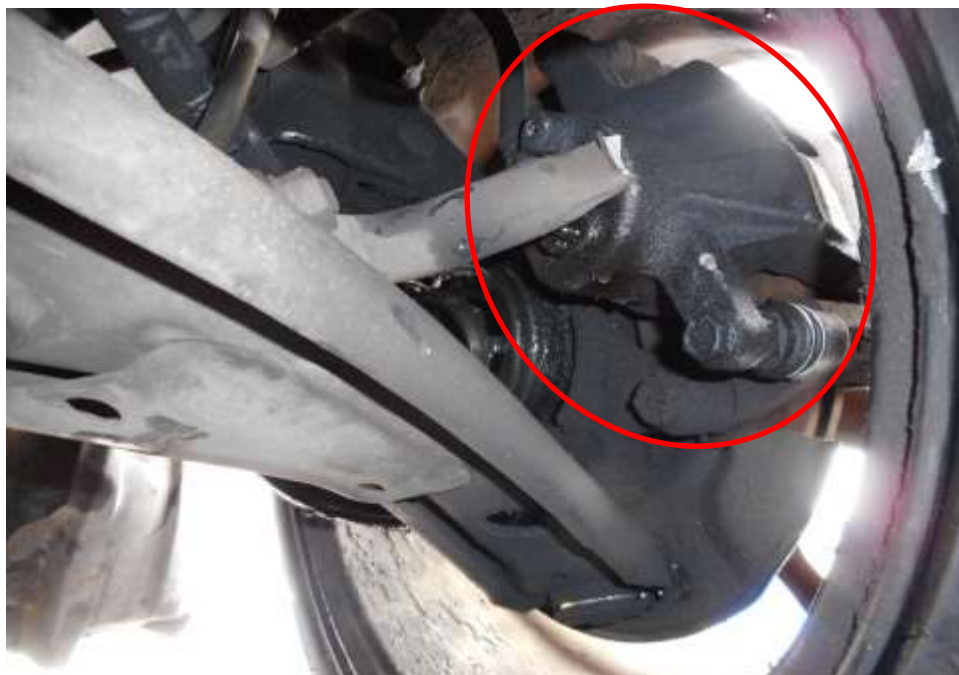
14. The brake fluid was observed to be insufficient level. There was sign(s) of old and fresh brake fluid stains leaking out from the front left brake caplier of the Motor Car as a result of the accident.

**Photo 23** shows the brake caplier (circled) at the front left wheel of the Motor Car. We observed old brake and fresh brake fluid stain on the surface on the brake caplier. The leakage was cause by the induced impact of the collision as a result of the accident.

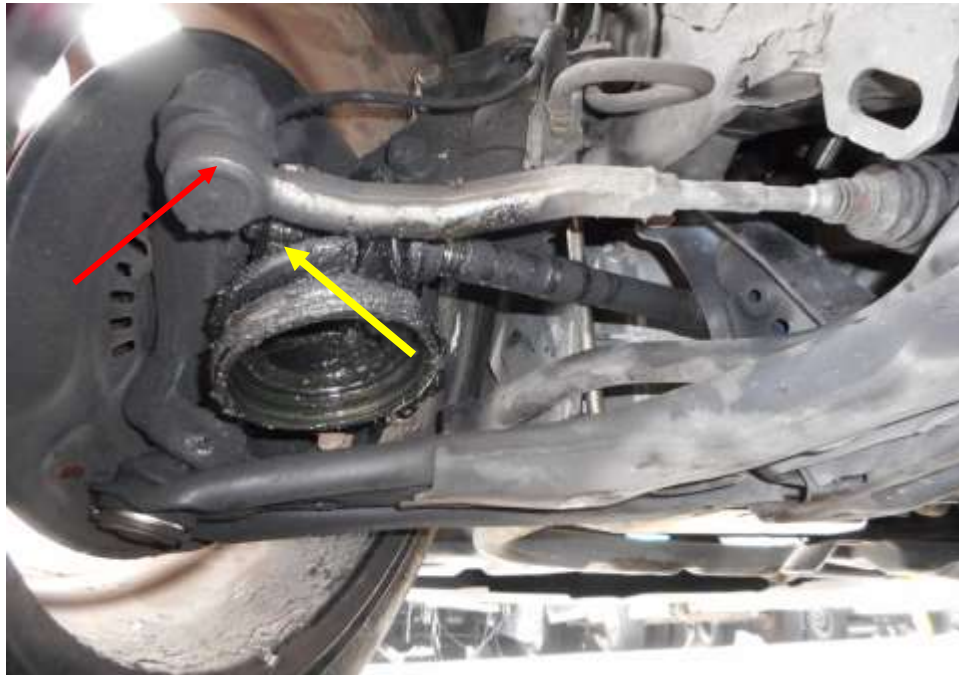
12. My subsequent checks on the underside of the various steering components were observed that the front left wheel outer CV joint was damaged as a result of the accident.

**Photo 24** shows the various undercarriage components at the front left wheel of the Motor Car, in particular the steering tie rod (red arrow) was found to be intact. However the outer CV joint of the left side drive shaft (yellow arrow) was observed to be damaged as a result of the accident. The various steering components were found to be intact, suggesting that the steering system of the Motor Car was likely to be in serviceable condition at the material time of accident.

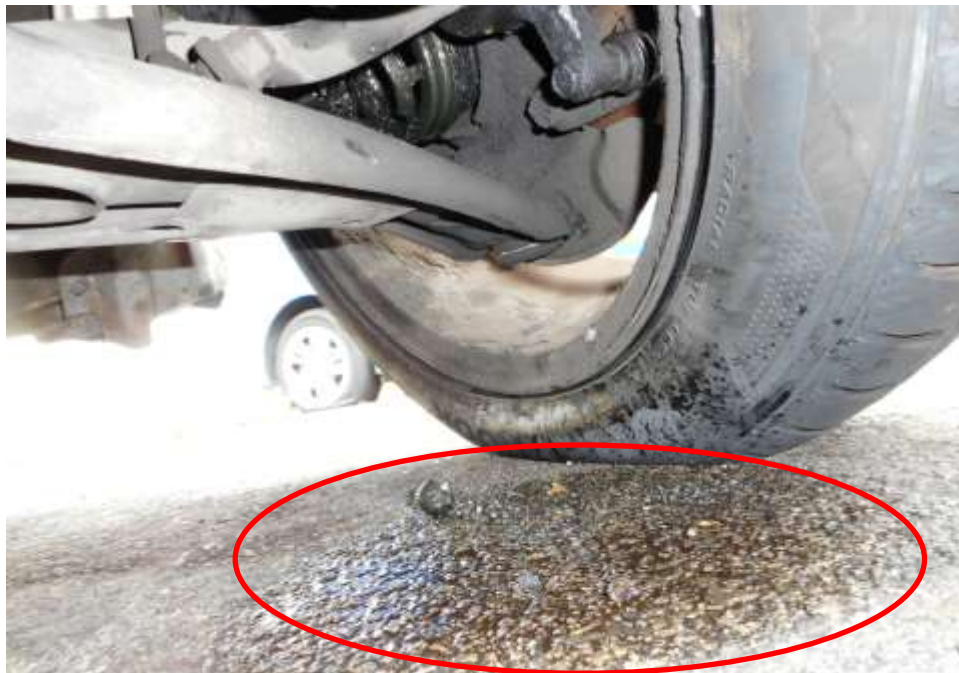
**Photo 25** shows the front left wheel, a patch of brake fluid stain (circled) on the ground from the leaking brake caplier and a ball bearing which is part of the CV joint assembly (arrowed) which have fallen out, both is caused by the induced impact as a result of the accident.

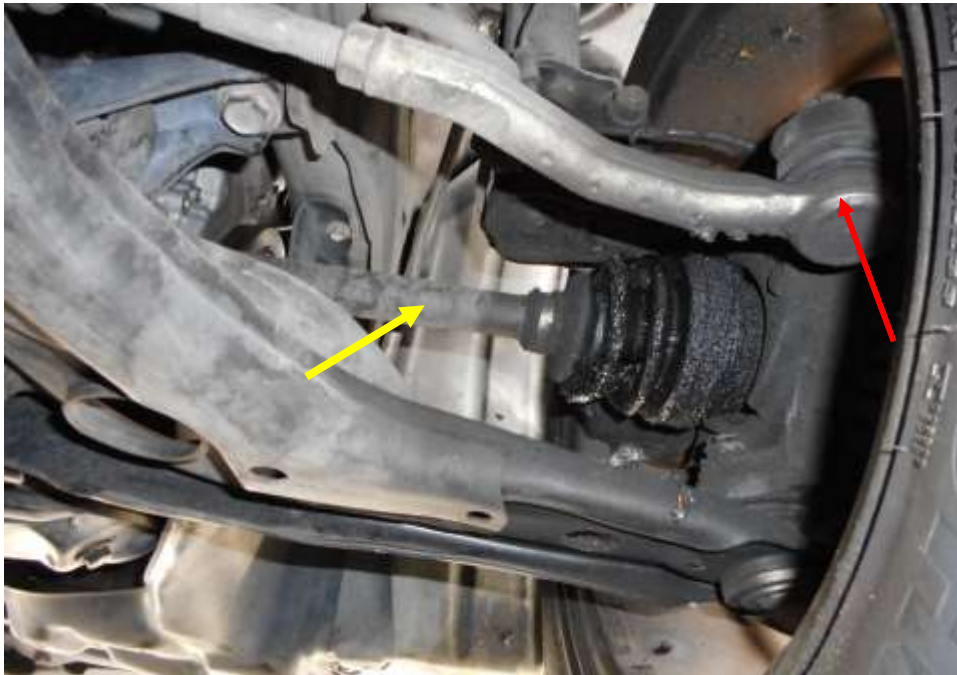
**Photo 26** shows the various undercarriage components at the front right wheel of the Motor Car, the steering tie rod (red arrow) and the driveshaft was found to be intact suggesting that it was serviceable at the time of the accident.

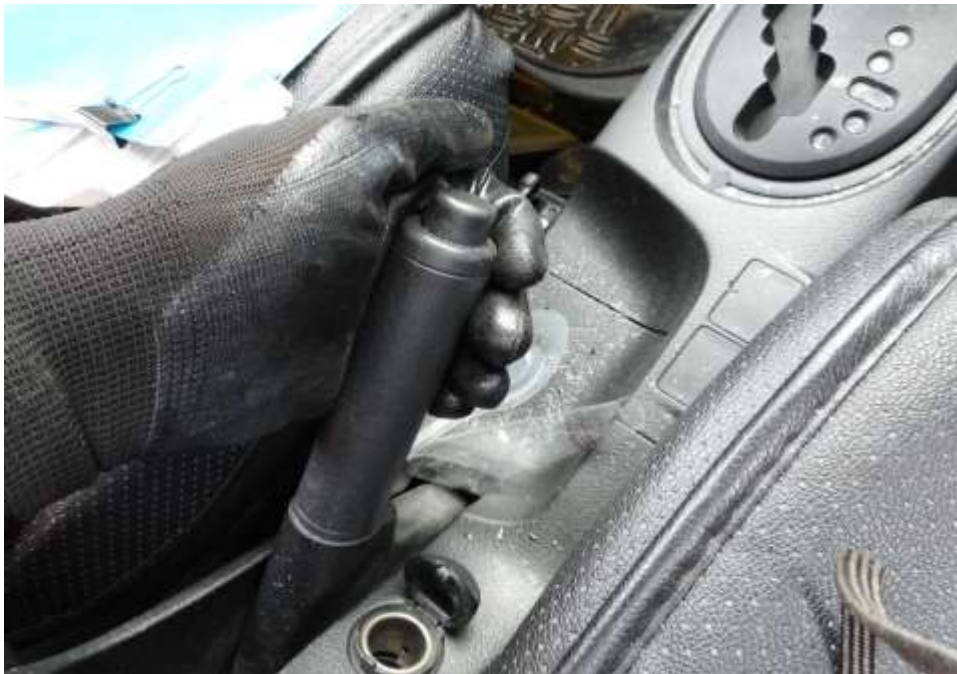
**Photo 27** shows the static test conducted on the handbrake of the Motor Car by pulling and releasing it multiple times and it did not reveal any abnormalities suggesting that it is in serviceable condition at the time of the accident.

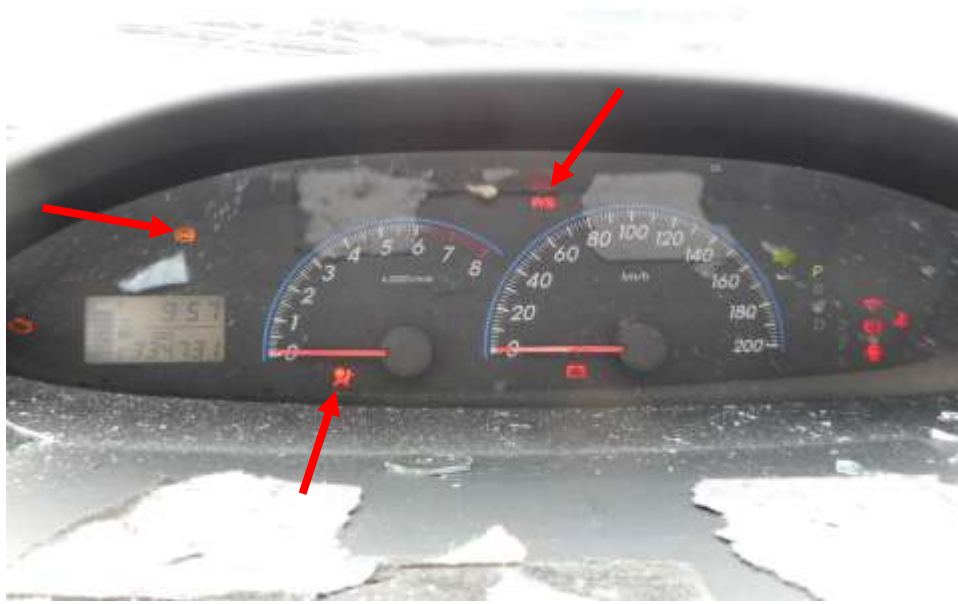
**Photo 28** shows the warning light for Anti-Lock Brake System (ABS), Electric Power Steering System (EPS) and Supplemental Restraint System (SRS) appearing on the instrument panel of the Motor Car during the self-test of its various electronic operating systems when its engine was cranked.

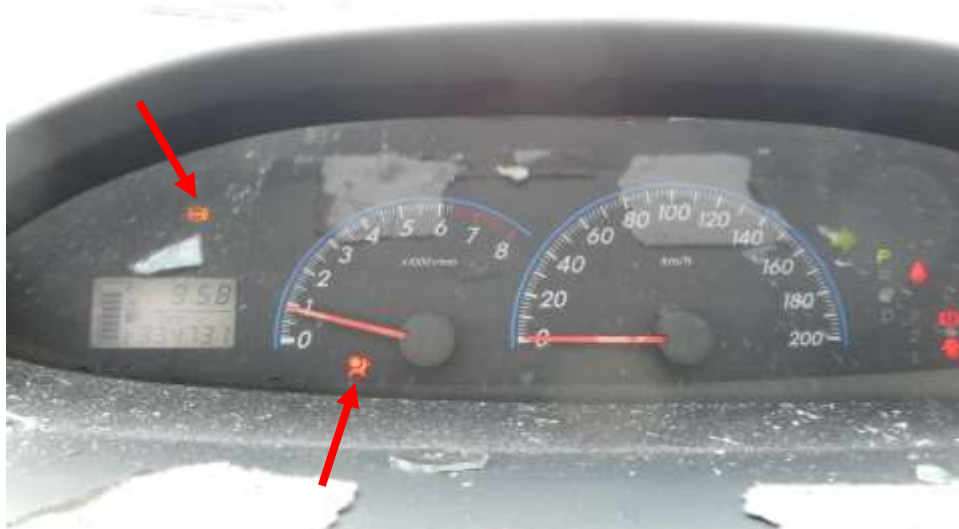
**Photo 29** shows the Supplemental Restraint System (SRS) and the Anti-Lock Brake System (ABS) warning lights illuminated on with an error warning message on the instrument panel of the Motor Car after the engine was cranked as because of the deployment of the airbag in the Motor Car and the insufficient level of brake fluid as a result of the accident which triggered the lights. However the other warning light disappeared after cranking, this would suggest that there was no abnormality to the various electronic operating systems of the Motor Car, like the EPS and etc.
