Your Ref: TP/IP/39437/2019
Our Ref : CI/TPD19016940/P

Fatal Accident Investigation Team

MECHANICAL INSPECTION REPORT OF MOTOR LORRY GBA 2169E

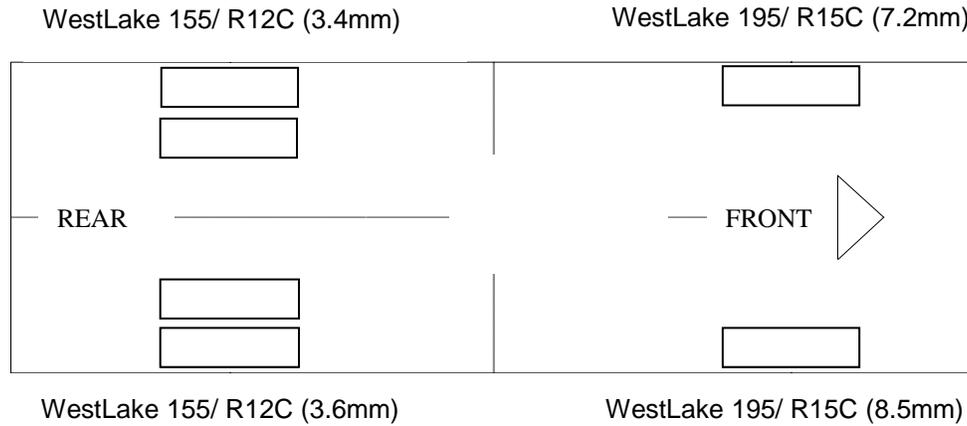
6. The 2 front tyres and 4 rear tyres of the Motor Lorry were observed to be in serviceable condition and sufficiently inflated for vehicular operation. I did not find any tear, cut or burst mark(s) on the outer and the inner sidewalls as well as across the tread of the 6 tyres. The tyre brand, tyre size and remaining tread depth of the 6 tyres of the Motor Lorry were recorded as follows:-

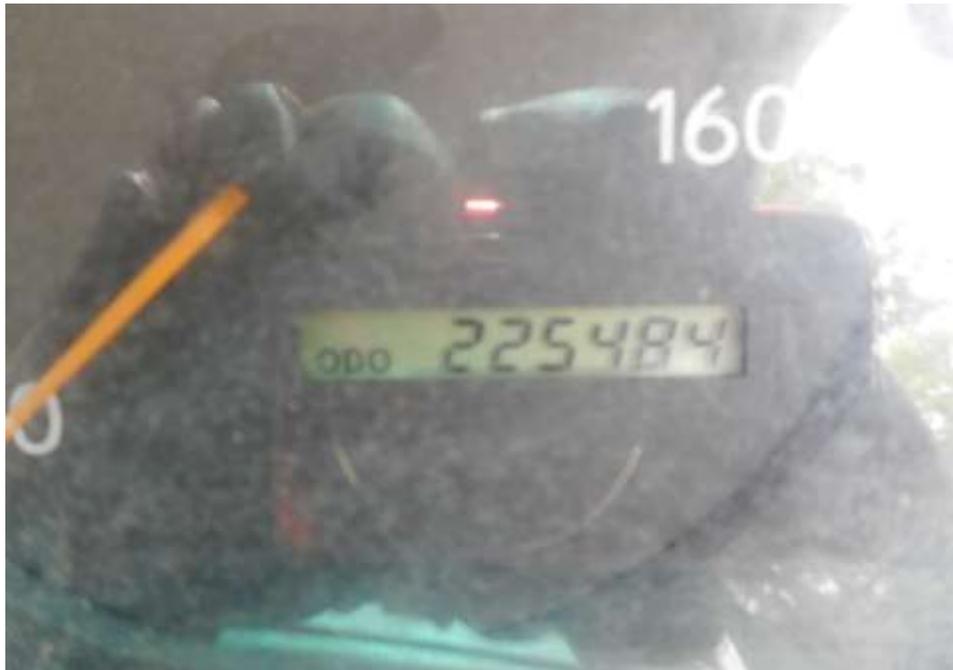
Photo 1 shows a general view of the instrument cluster of the Motor Lorry at the time of my inspection. The mileage of the Motor Lorry was 225,484km

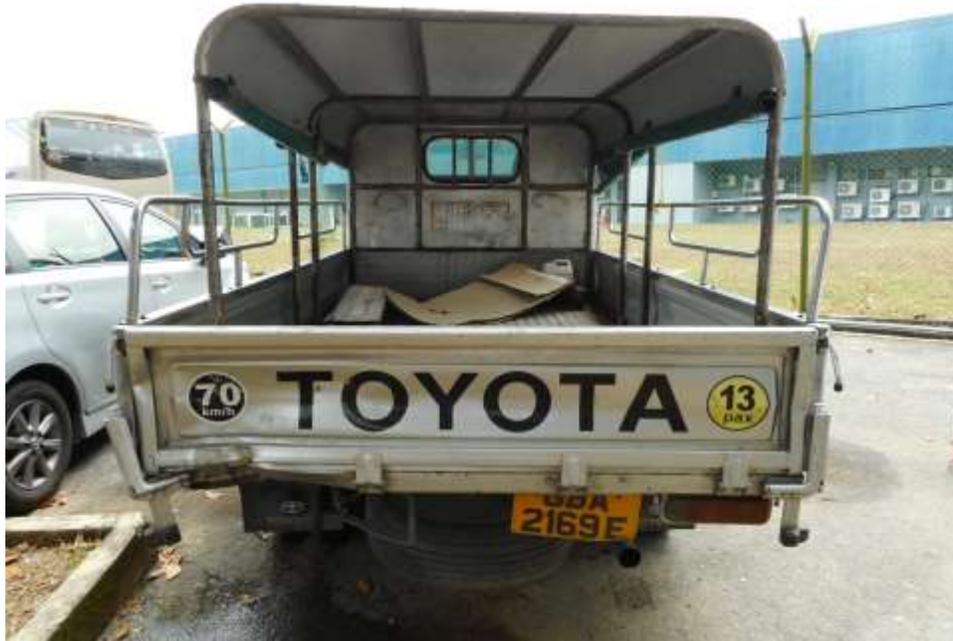
Photo 2 shows a general view of the Motor Lorry's rear portion at the time of my inspection. Its rear body panel were damage as a result of the accident at the time of my inspection

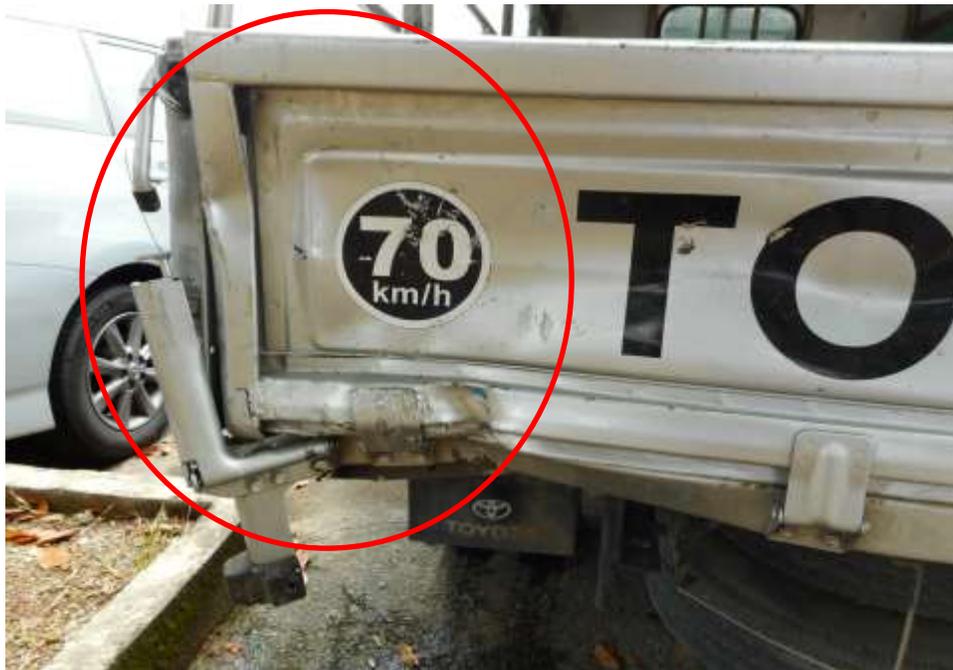
Photo 3 shows a close up view of the Motor Lorry's rear portion at the time of my inspection. Its rear body panel (circled) were damage as a result of the accident at the time of my inspection

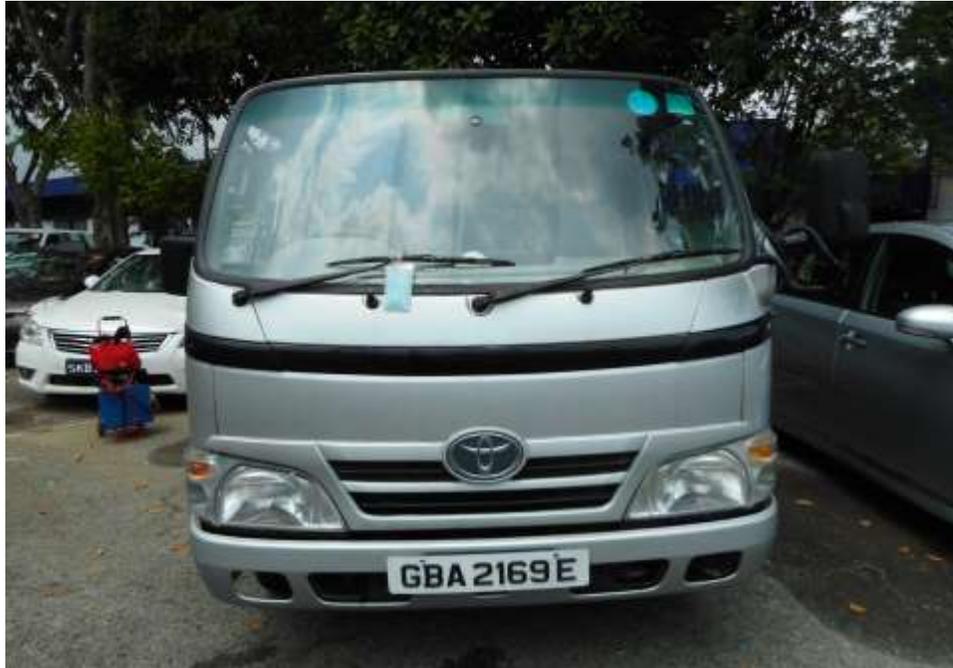
Photo 4 shows a general view of the front portion of the Motor Lorry at the time of my inspection. The Motor Lorry was observed to be intact and unaffected by the accident.

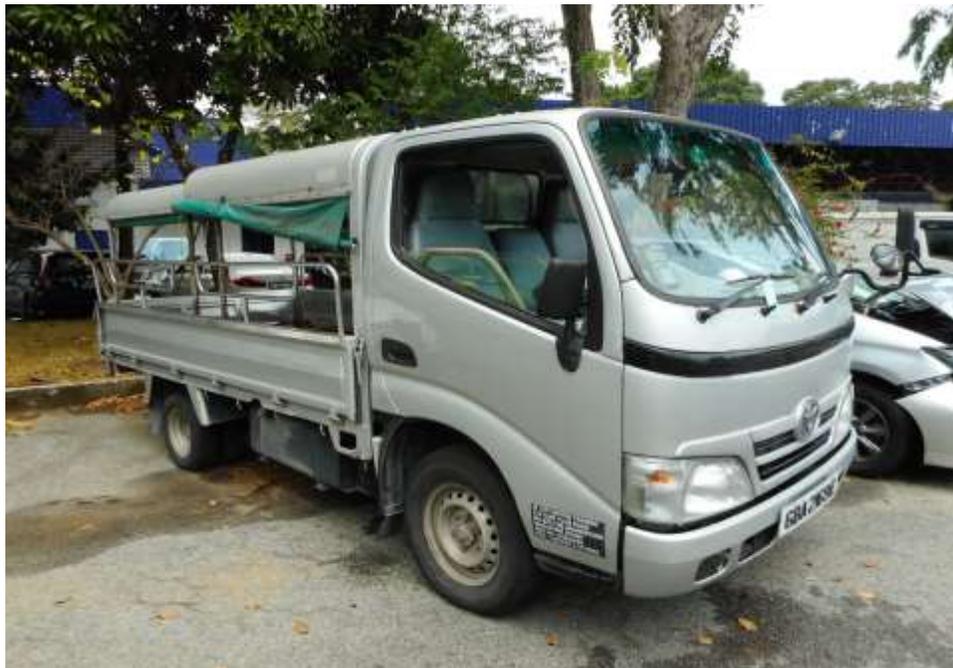
Photo 5 shows a general view of the right portion body of the Motor Lorry at the time of my inspection. The Motor Lorry was observed to be intact and unaffected by the accident.

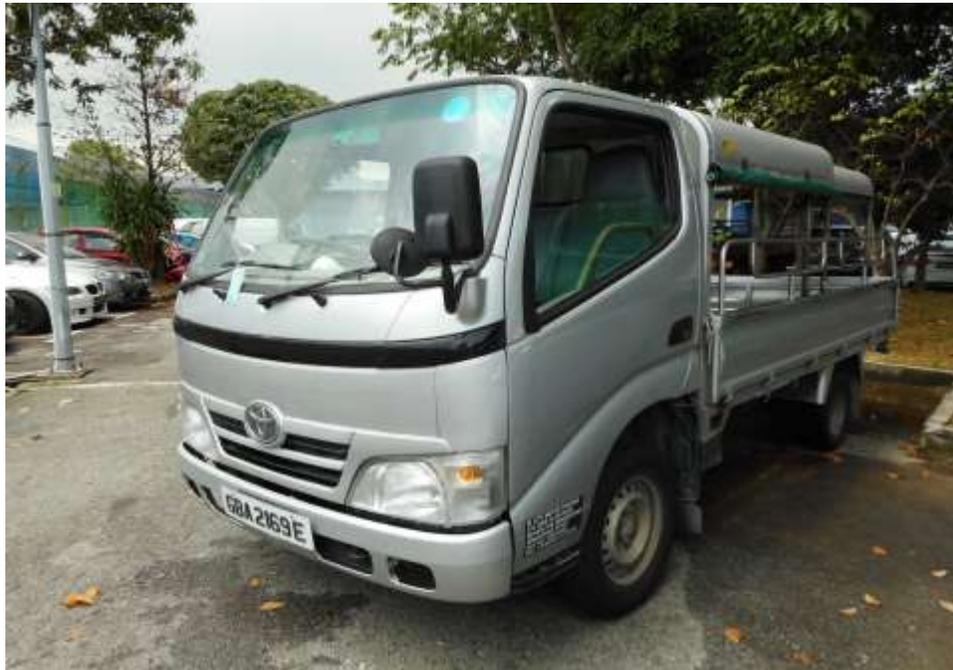
Photo 6 shows a general view of the left portion body of the Motor Lorry at the time of my inspection. The Motor Lorry was observed to be intact and unaffected by the accident.

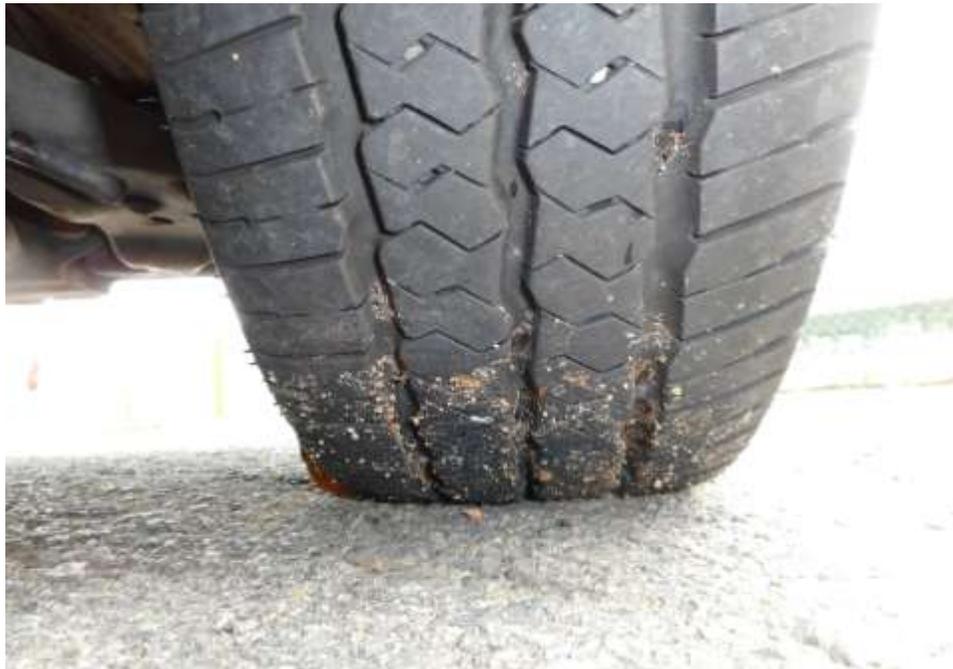
Photo 7 shows the condition of the front right tyre of the Motor Lorry, which was observed to be in serviceable condition with remaining tread depth of approximately 8.5mm. The tyre, which was wrapped around standard steel wheel rim, was also observed to be sufficiently inflated for vehicular operation. There was no tear, cut or burst mark(s) on the outer and the inner sidewalls as well as across the tread of the 6 tyres that were fitted on the Motor Lorry.

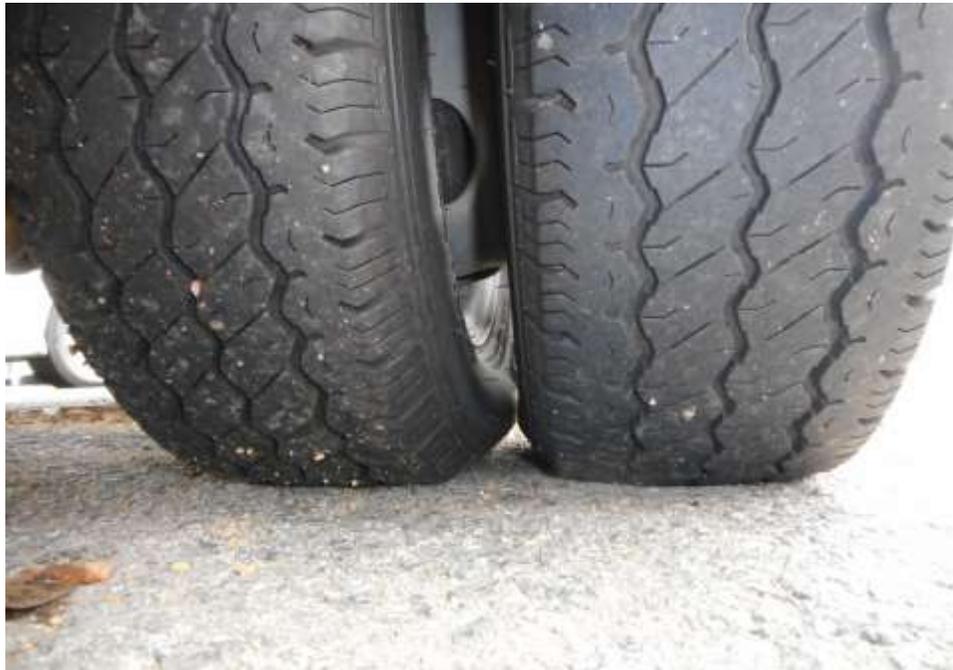
Photo 8 shows the condition of the rear right tyre of the Motor Lorry, which was observed to be in serviceable condition with remaining tread depth of approximately 3.6mm. The tyre, which was wrapped around standard steel wheel rim, was also observed to be sufficiently inflated for vehicular operation.

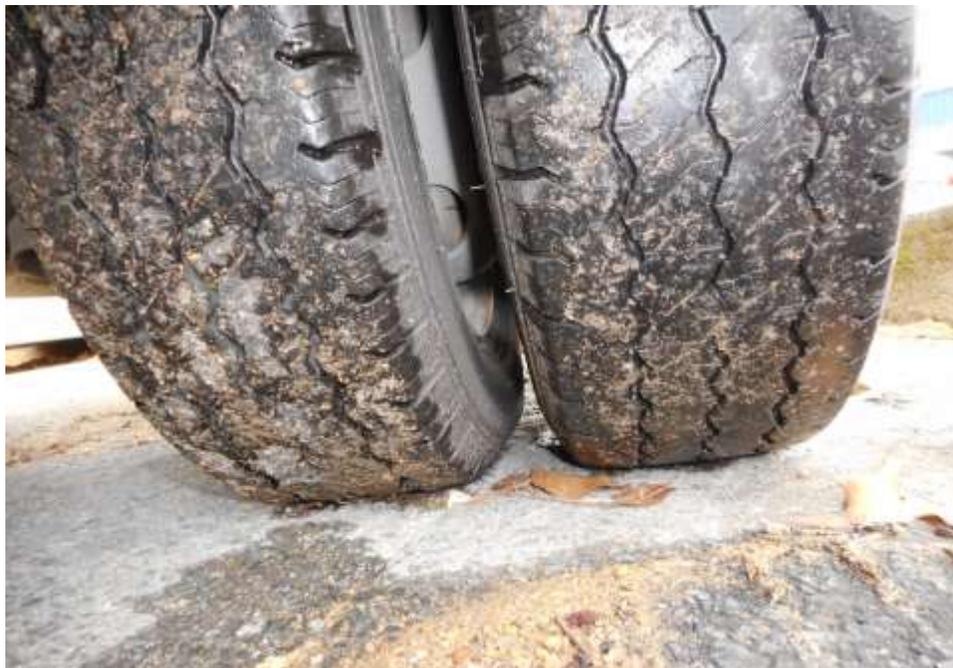
Photo 9 shows the condition of the rear left tyres of the Motor Lorry, which was observed to be in serviceable condition with remaining tread depth of approximately 3.4mm. The tyres, which were wrapped around standard steel wheel rim, were also observed to be sufficiently inflated for vehicular operation. There was also no damage found on all 6 steel wheel rims of the Motor Lorry.

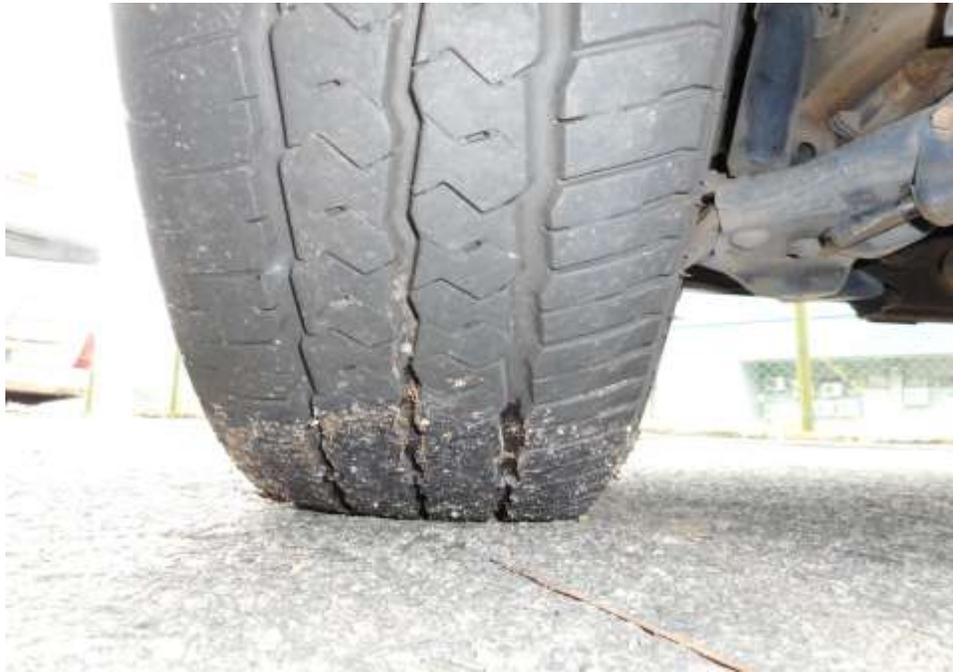
Photo 10 shows the condition of the rear right tyres of the Motor Lorry, which were observed to be in serviceable condition with remaining, tread depth of approximately 7.2mm. There was also no tear, cut or burst mark(s) on the outer and the inner sidewalls as well as across the tread of the 6 tyres that were fitted on the Motor Lorry.

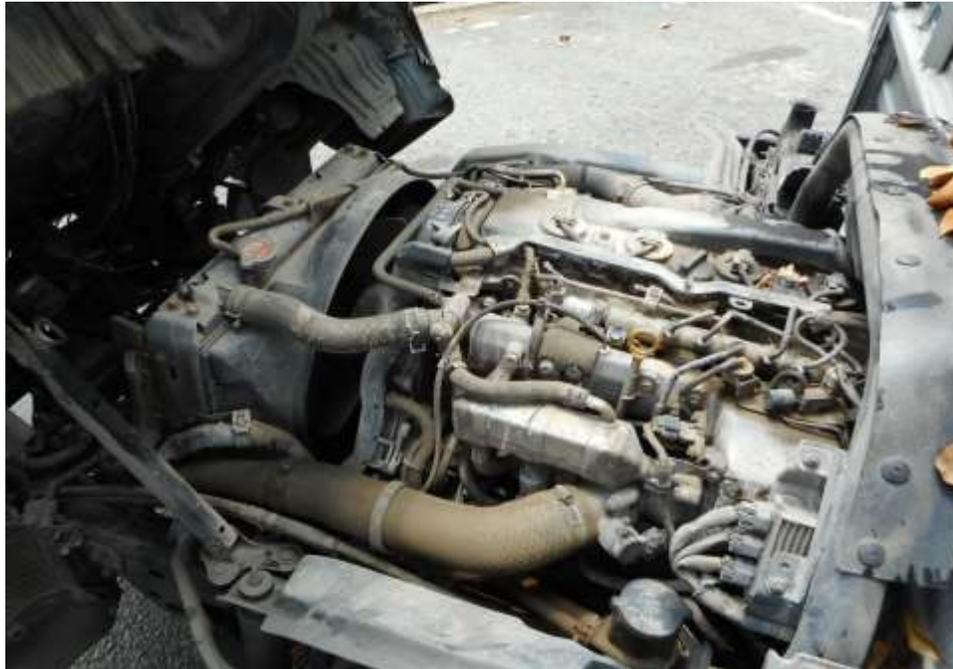
Photo 11 shows a general view of the Motor Lorry's engine compartment, which was accessed by lifting the front cabin of the Motor Lorry. The various parts and components inside the engine compartment were unaffected by the accident. There was also no sign(s) or indication(s) of fresh fluid leakage and/or fluid stain within the engine compartment (photograph shows the engine compartment as viewed from the right front side of the Motor Lorry).

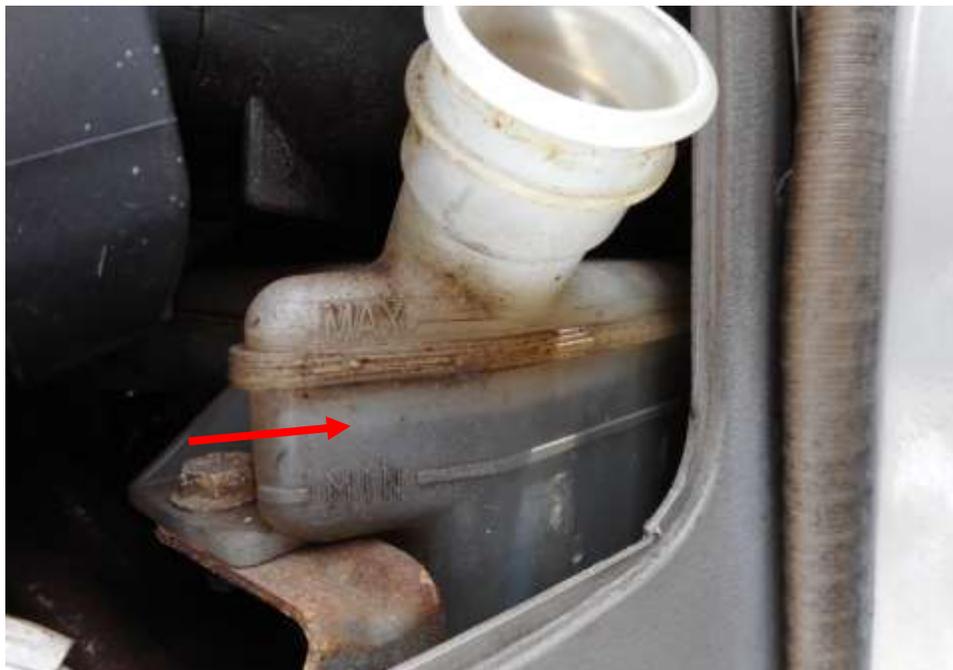
Photo 12 shows the brake fluid reservoir of the Motor Lorry at the time of my inspection. The brake fluid was observed to be of sufficient level (arrowed) and without any visible contamination.

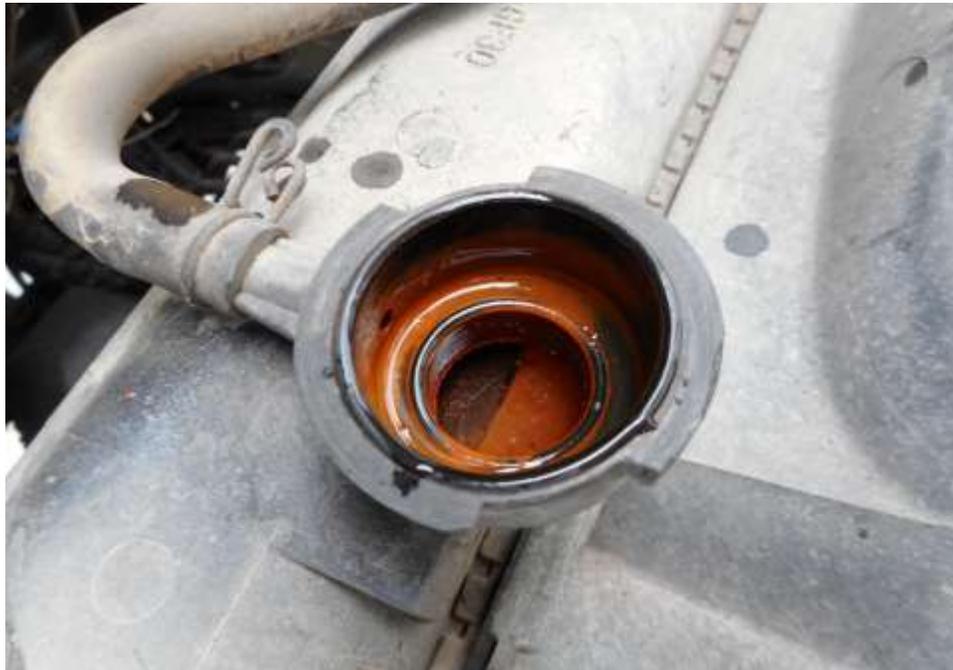
Photo 13 shows the engine coolant reservoir of the Motor Lorry at the time of my inspection. The engine coolant was observed to be of sufficient level and without any visible contamination.

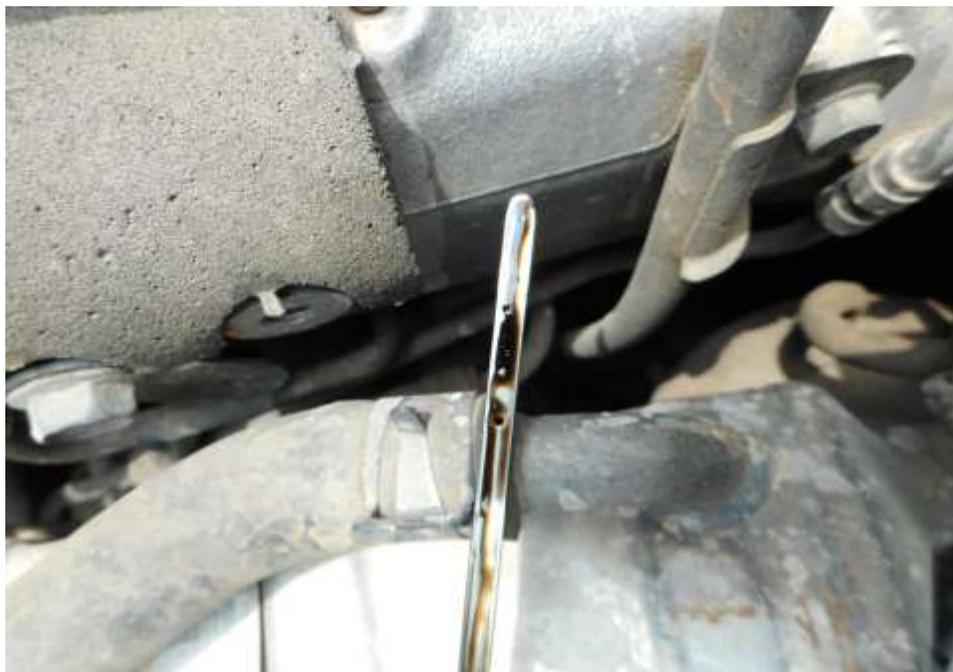
Photo 14 shows the engine oil dipstick of the Motor Lorry at the time of my inspection. The engine oil was observed to be of sufficient level and without any visible contamination.

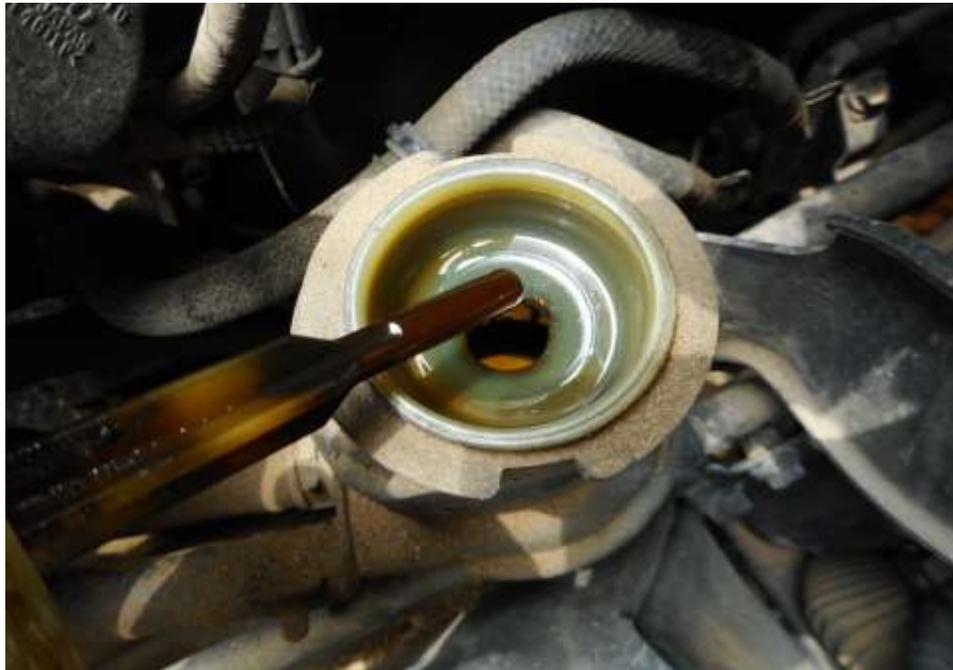
Photo 15 shows the power steering fluid reservoir of the Motor Lorry at the time of my inspection. The power steering fluid was observed to be of sufficient level and without any visible contamination.

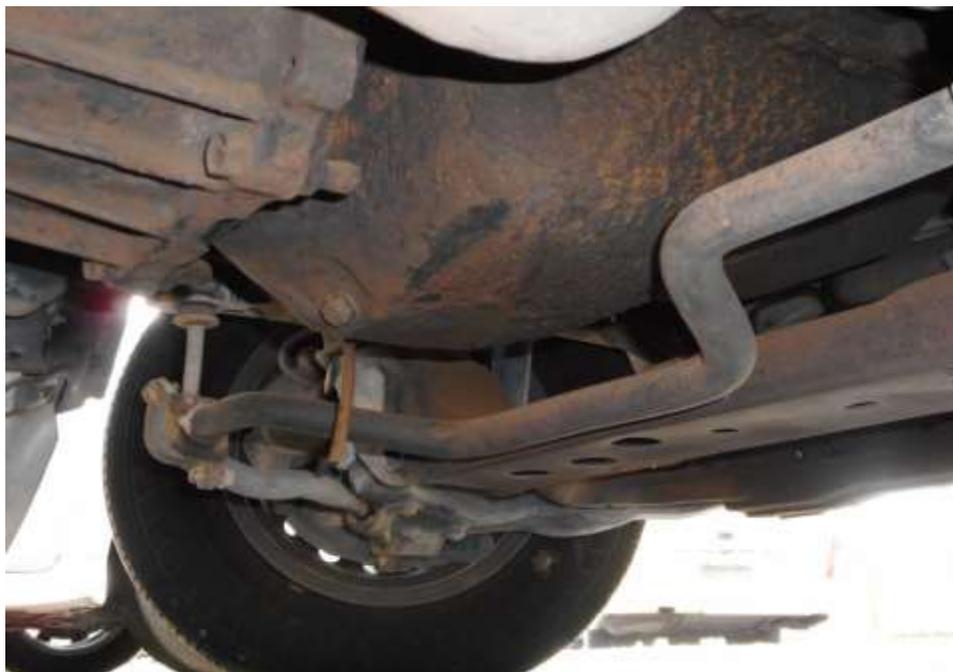
Photo 16 shows the undercarriage of the Motor Lorry, at the area where the engine housing and transmission housing are located. Observed was minor old engine oil stain on the housing of the engine oil sump

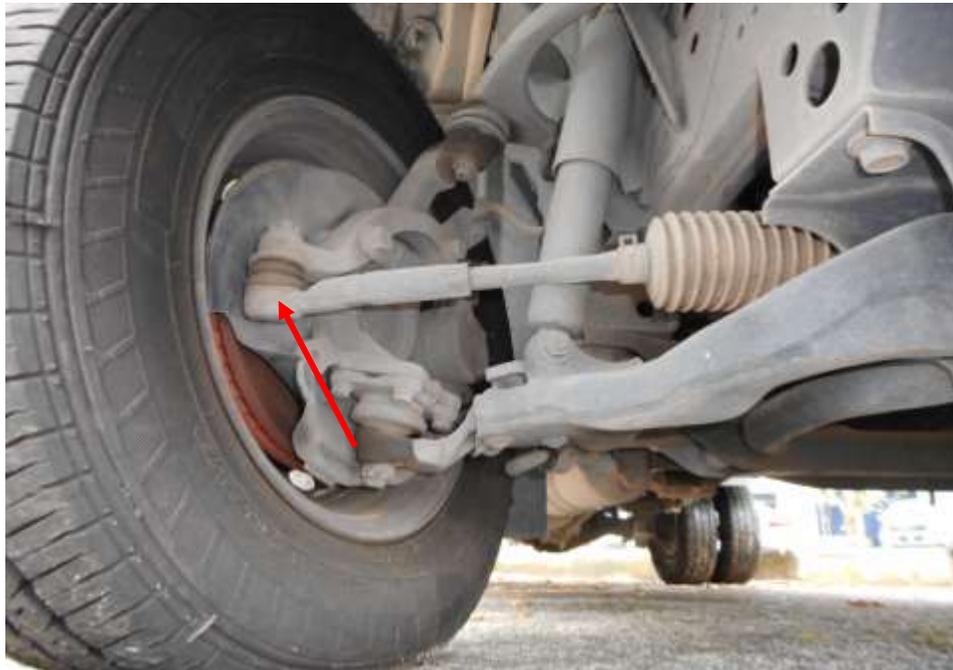
Photo 17 shows the various undercarriage components at the front right wheel of the Motor Lorry, in particular the steering tie rod end (arrowed). The various steering components were all found to be intact, suggesting that the steering system of the Motor Lorry was likely to be in serviceable condition at the material time of accident. There was also no sign of fluid stain(s) observed on the various undercarriage components.

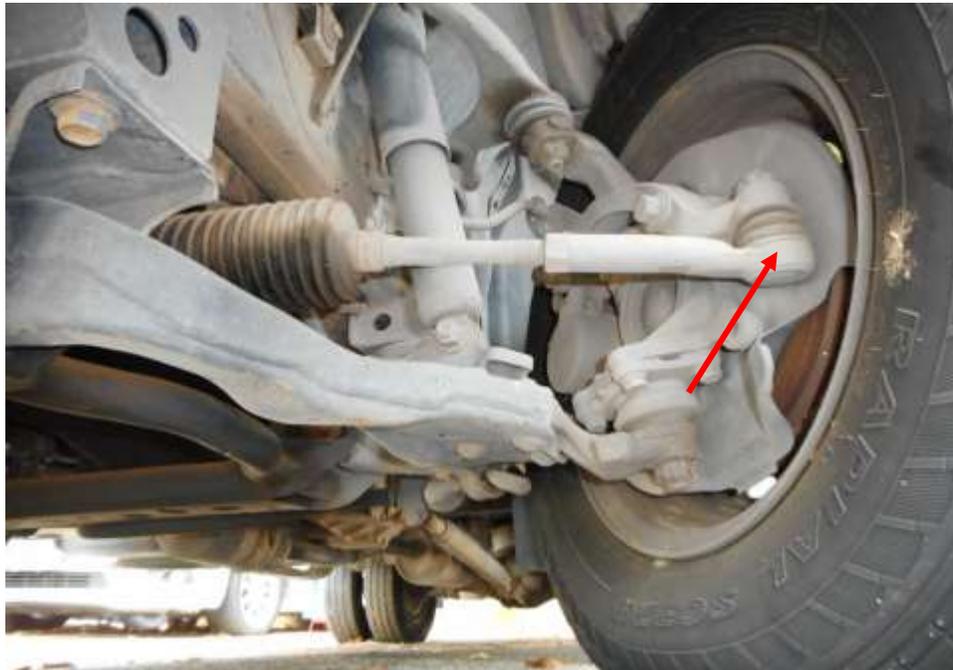
Photo 18 shows the various undercarriage components at the front left wheel of the Motor Lorry, in particular the steering tie rod end (arrowed). The various Undercarriage components of the Motor Lorry were all found to be intact without any visible damage. There was also no sign of fluid stain(s) observed on the various undercarriage components.

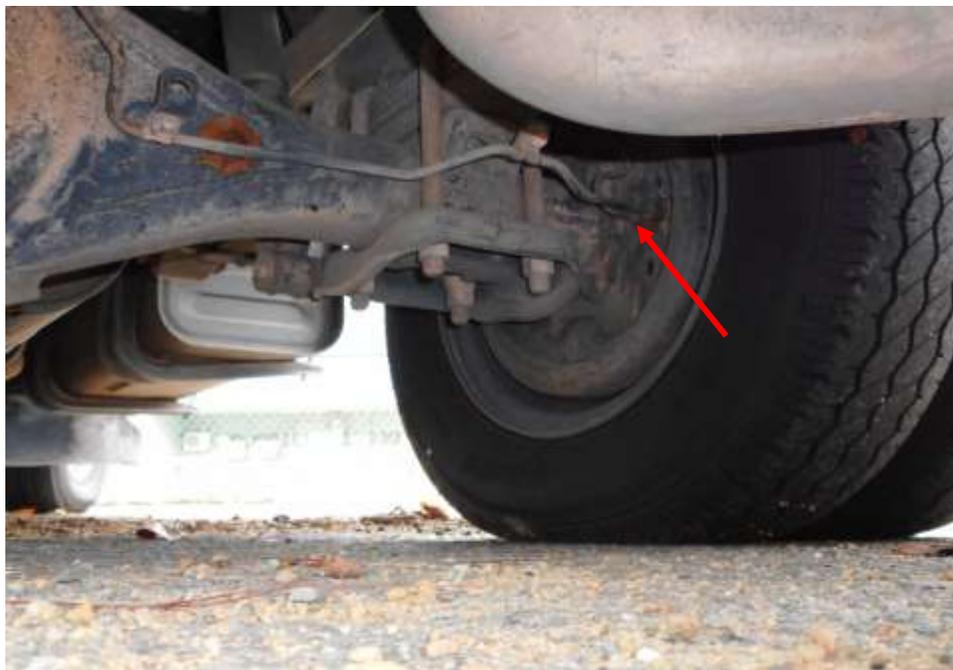
Photo 19 shows the brake pipe (arrowed) at the rear right wheel of the Motor Lorry. I did not observe any leakage of brake fluid at the time of my inspection of the Motor Lorry. My static tests of the Motor Lorry's braking system, along with my visual examination of the various mechanical components in the braking system, had indicated that there was no internal leakage of pressure/vacuum. Hence the braking system of the Motor Lorry was likely to be in serviceable condition at the material time of accident.

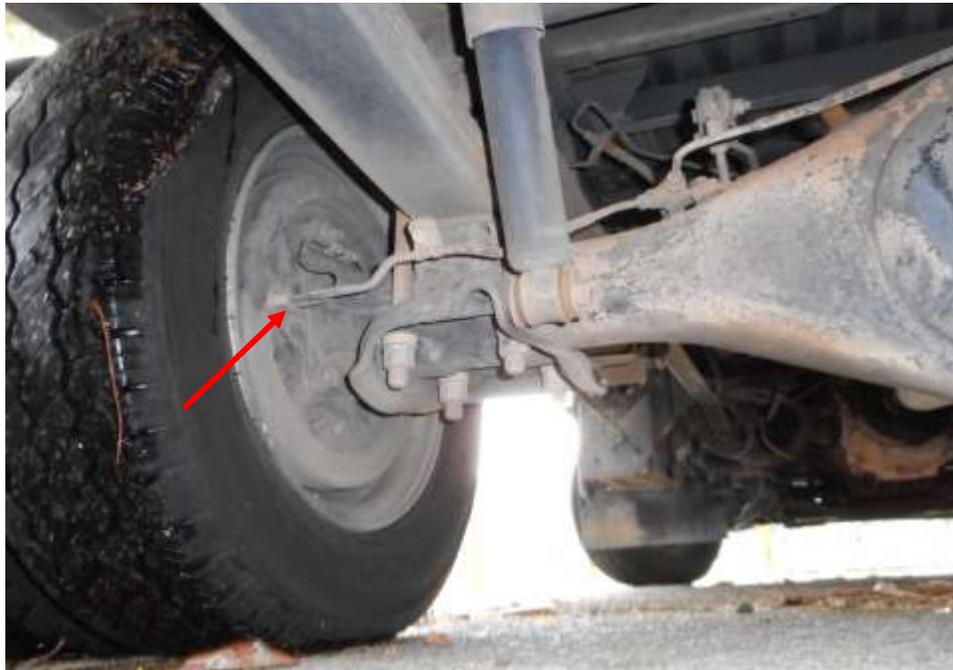
Photo 20 shows the brake pipe (arrowed) at the rear left wheel of the Motor Lorry. I did not observe any leakage of brake fluid at the time of my inspection of the Motor Lorry. My static tests of the Motor Lorry's braking system, along with my visual examination of the various mechanical components in the braking System had indicated that there was no internal leakage of pressure/vacuum. Hence the braking system of the Motor Lorry was likely to be in serviceable condition at the material time of accident.

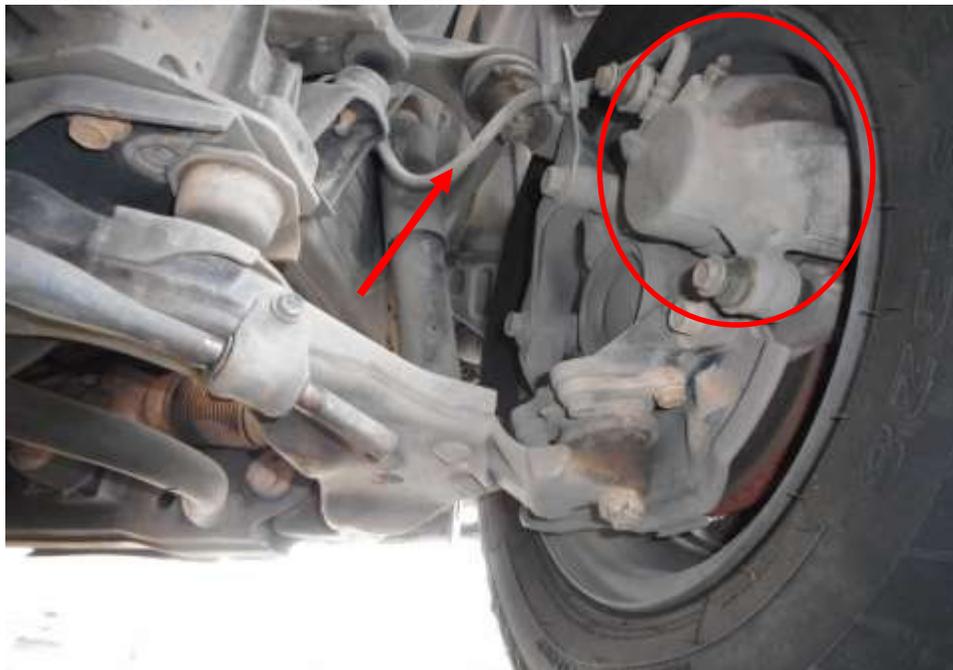
Photo 21 shows the brake hose/pipe (arrowed) at the front right wheel of the Motor Lorry. No leakage of brake fluid was observed. Visual examination of the various components of the braking system like the brake caliper (circled), brake booster, brake pedal etc had revealed all to be intact and without visible damage at the time of accident. There was also no sign of fluid stain(s) observed on the various undercarriage components.

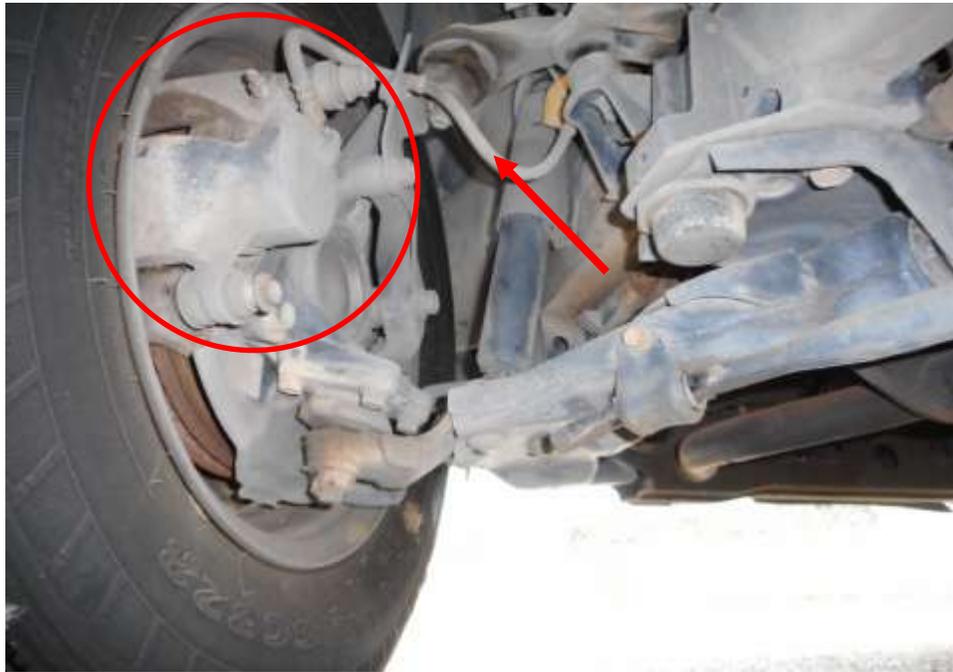
Photo 22 shows the brake hose/pipe (arrowed) at the front left wheel of the Motor Lorry. No leakage of brake fluid was observed. Visual examination of the various components of the braking system like the brake caliper (circled), brake booster, brake pedal etc had revealed all to be intact and without visible damage at the time of accident. There was also no sign of fluid stain(s) observed on the various undercarriage components.

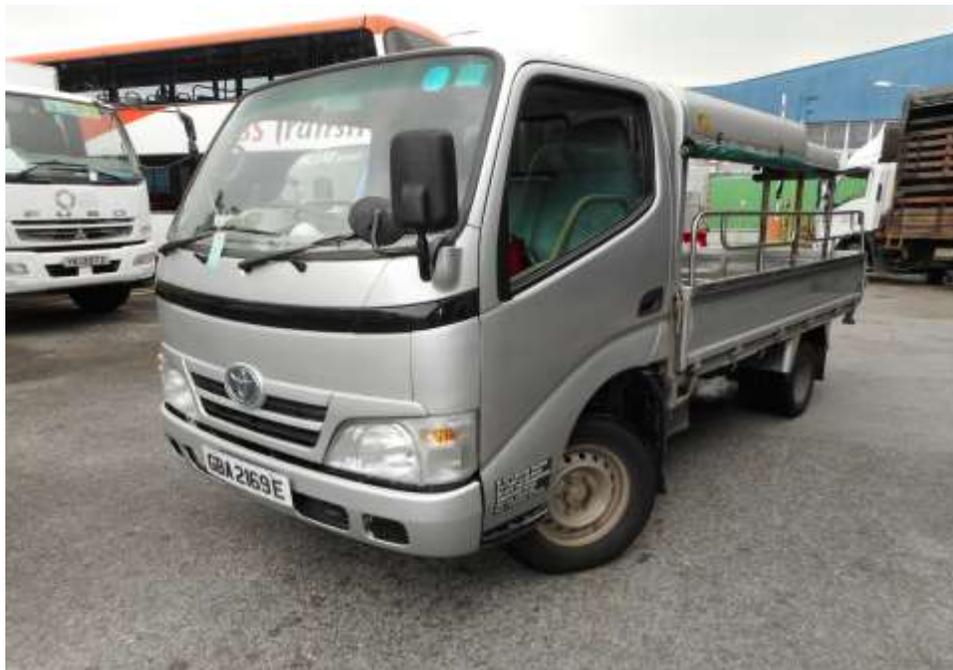
Photo 23 shows the front left wheel of the Motor Lorry turned to its full right. During my steering system test, I did not experience any abnormal free play and/or resistance when I had turned the steering wheel towards full left and full right. This would suggest that the steering system of the Motor Lorry was likely to be in serviceable condition at the material time of accident.
