Your Ref: TP/IP/50683/2019  
Our Ref : CI/TPD19016941/P

1<sup>st</sup> October 2019

**MECHANICAL INSPECTION REPORT OF MOTOR CAR SDJ 5565D**

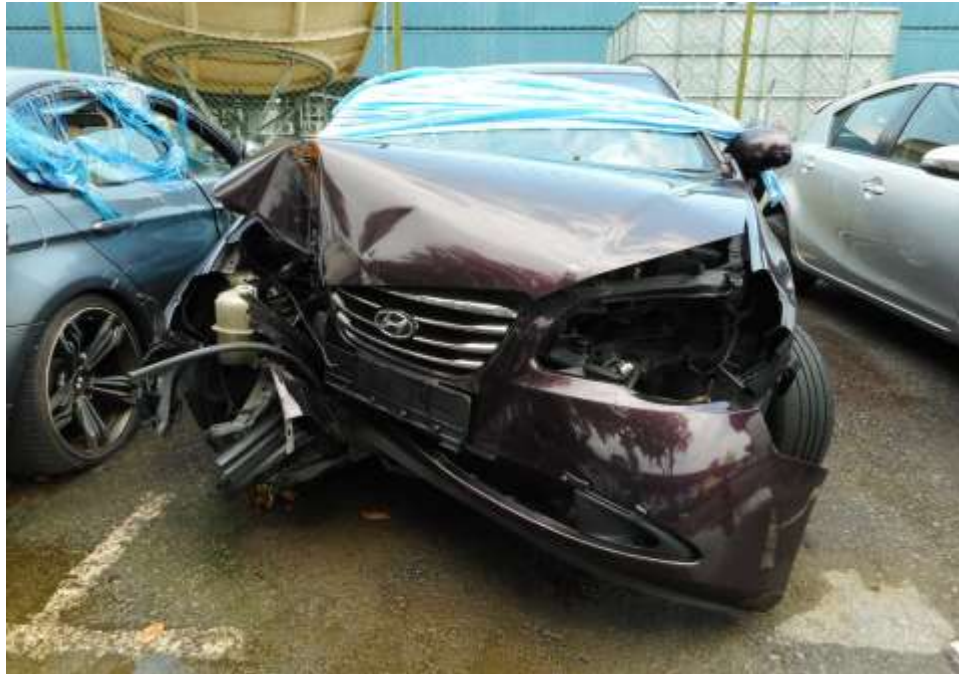
**Photo 1** shows a general view of the Motor Car's front body at the time of my inspection. The Motor car was observed to have sustained damage at its front portion. Its front bonnet, front bumper, both front headlamp, both front fender was amongst the body parts and various components in the engine compartments were also damaged as a result of the accident. The Supplemental Restraint System (SRS) was activated as a result of the accident.

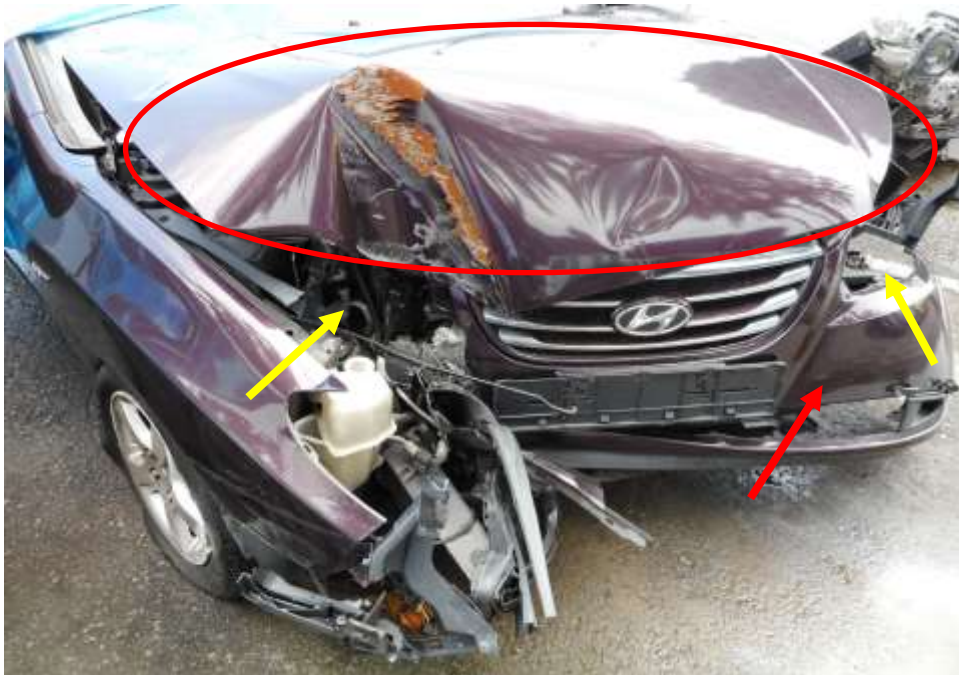
**Photo 2** shows the close up view of the Motor Car's front body at the time of my inspection. The Motor car was observed to have sustained damage at its front portion. Its front bonnet (circled), front bumper (red arrow) and both front headlamp (yellow arrow) was amongst the body parts and various components in the engine compartments were also damaged as a result of the accident.

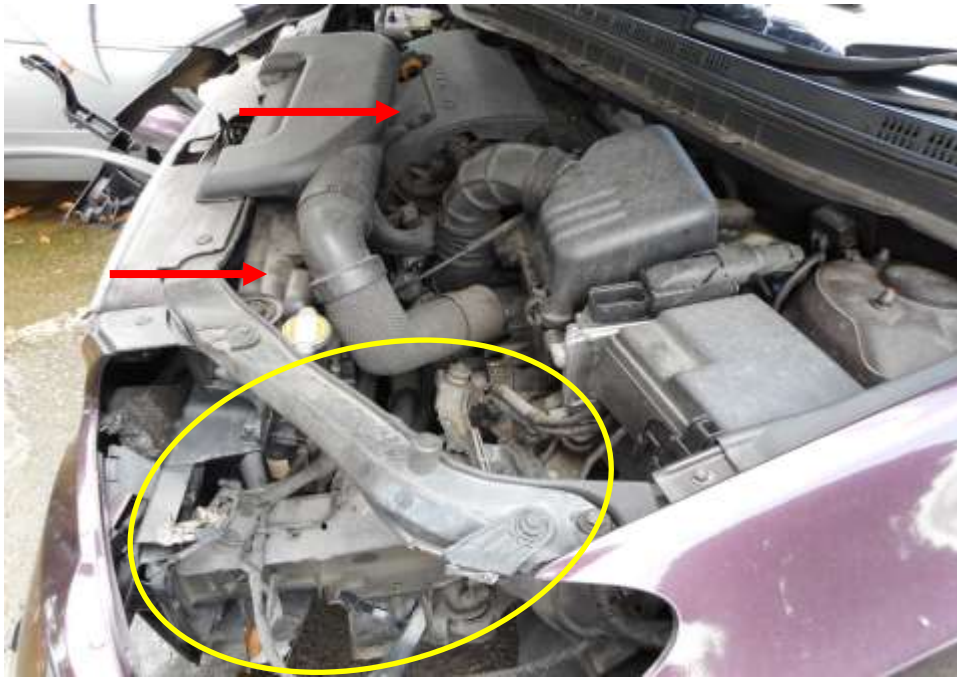
**Photo 3** shows a close up view of the Motor Car's engine compartment at the time of my inspection. Its battery was missing (yellow circle). Due to the induced impact of the accident, the Motor Car's engine system, ignition system, cooling system (red arrows) and various components in the engine compartments were also damaged as a result of the accident.

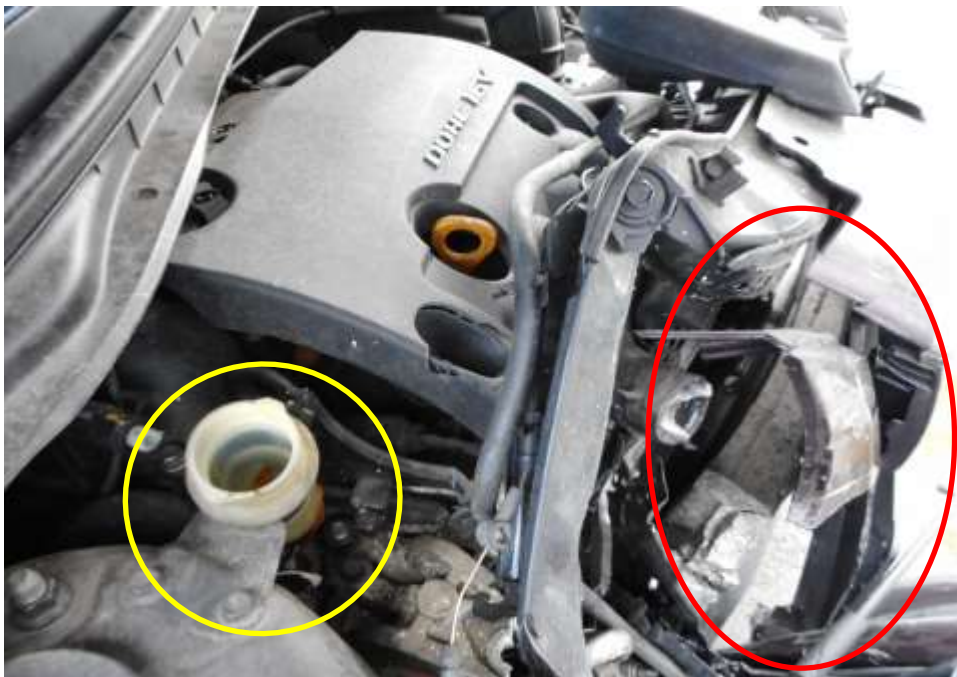
**Photo 4** shows a close up view of the Motor Car's engine compartment at the time of my inspection. Due to the induced impact of the accident, the Motor Car's braking system (yellow circle), cooling system (red circle) and various components in the engine compartments were also damaged as a result of the accident.

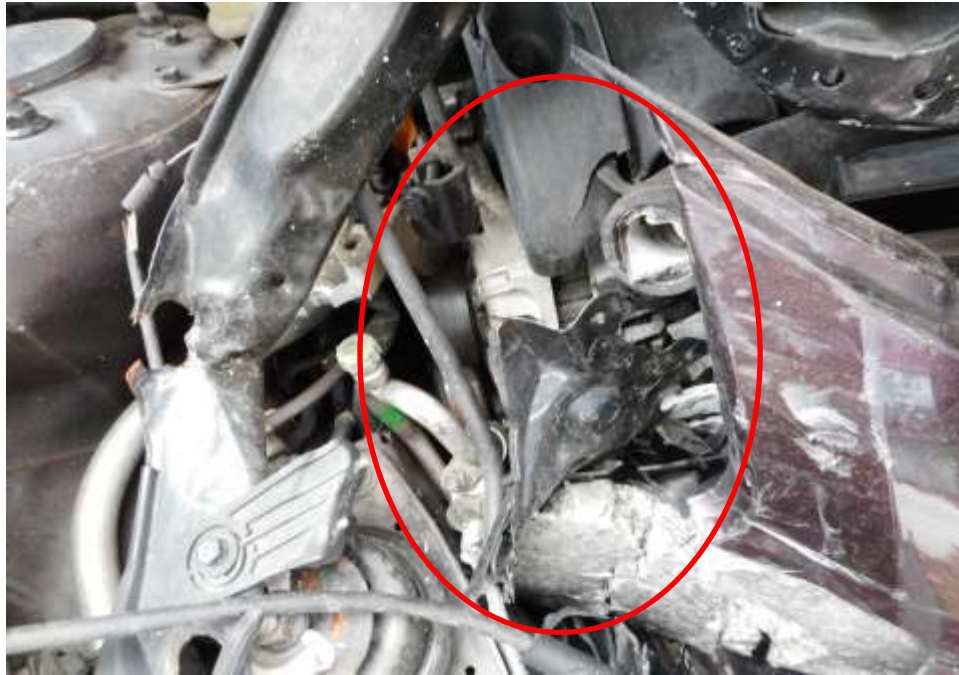
**Photo 5** shows a close up view of the Motor Car's engine compartment at the time of my inspection. Due to the induced impact of the accident, the Motor Car's ignition system (red circle) and various components in the engine compartments were also damaged as a result of the accident.

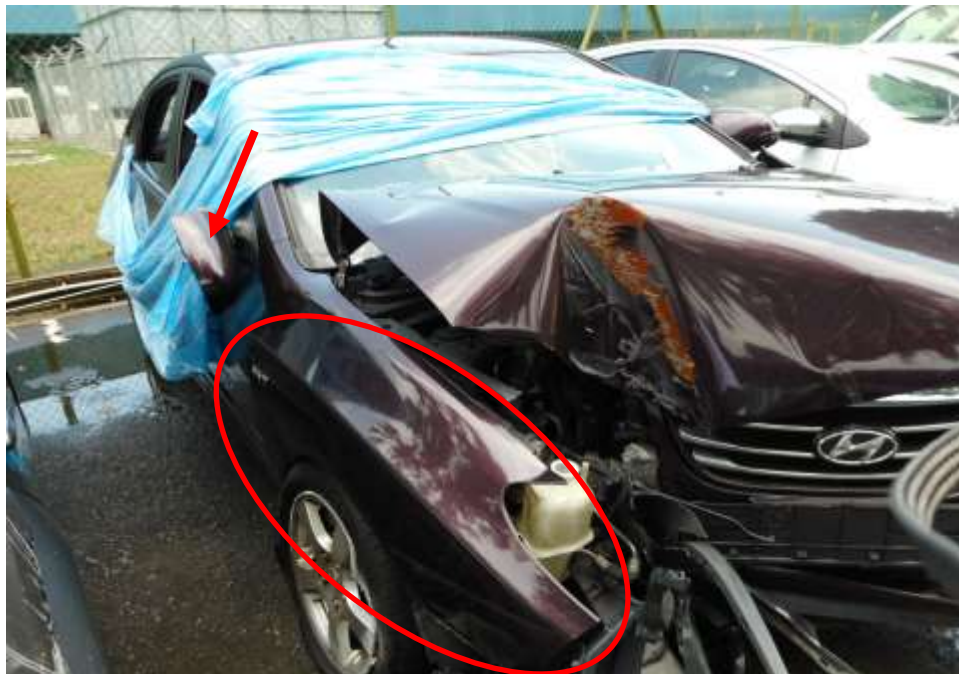
**Photo 6** shows the general view of the Motor Car's right body at the time of my inspection. Its front right fender (red circle) and right rear mirror (red arrow) was amongst the body parts that were damaged as a result of the accident.

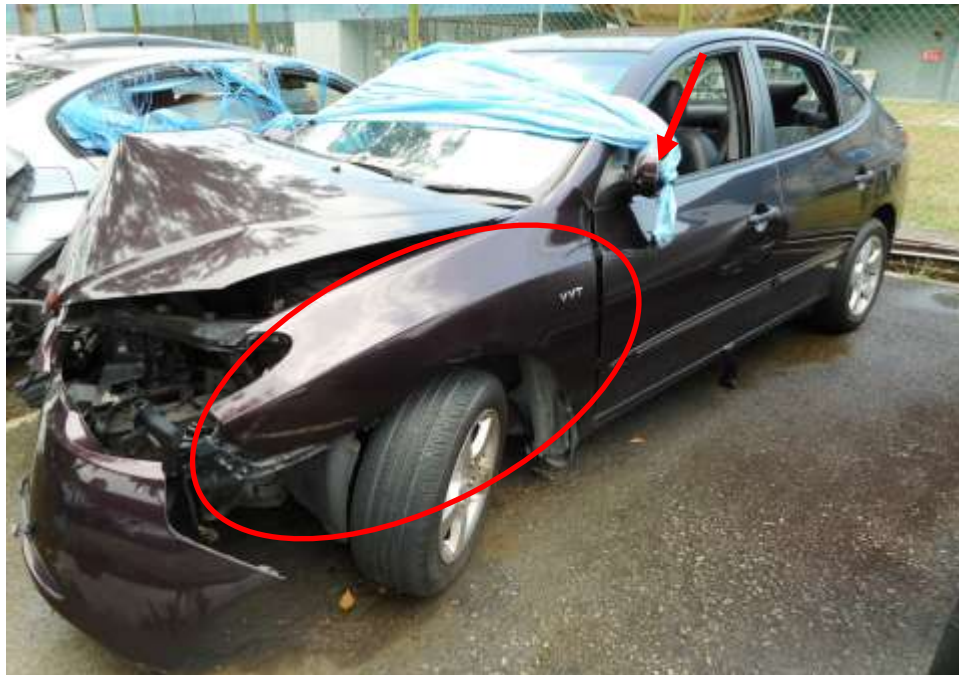
**Photo 7** shows the general view of the Motor Car's left body at the time of my inspection. Its front left fender (red circle) and left rear mirror (red arrow) was amongst the body parts that were damaged as a result of the accident.

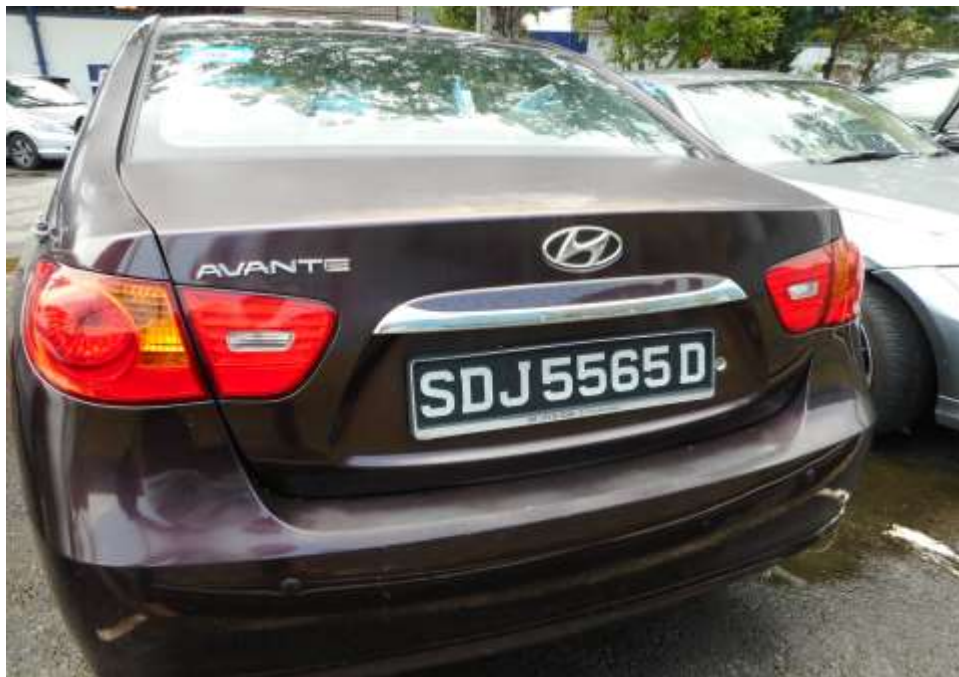
**Photo 8** shows a general view of the Motor Car's rear body at the time of my inspection. The rear portion of the Motor Car was observed to have been undamaged by the accident.

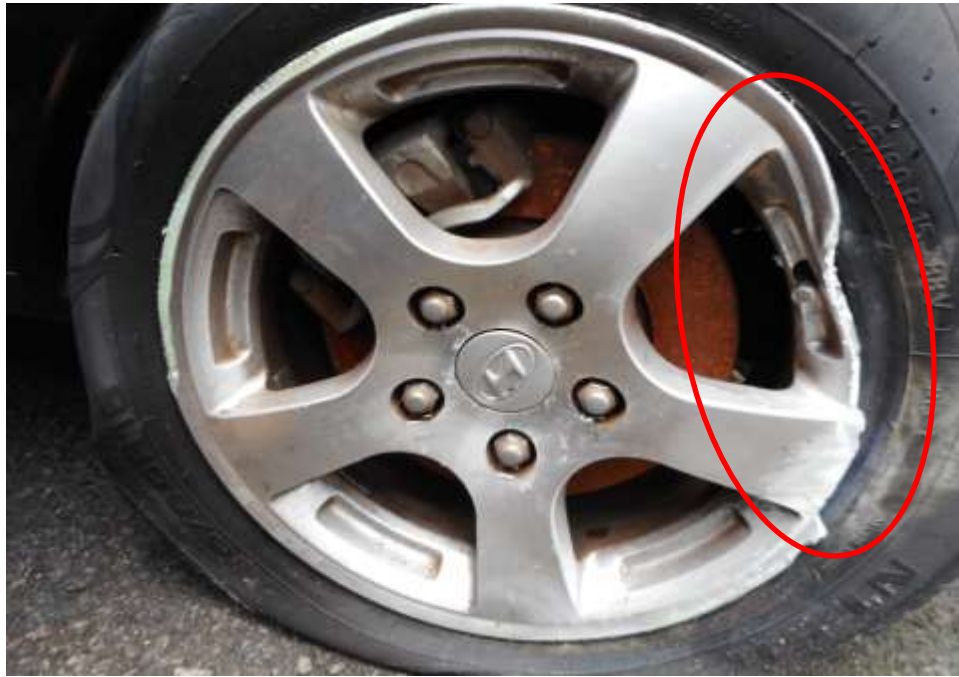
7. The 4 tyres were observed to be wrapped around alloy wheel rims however the front right rim was found to be damaged as a result of the accident. See photo 1 – 13 below.

**Photo 9** shows the condition of the front right tyre of the Motor Car, the rim was observed to be damaged (circled) as a result of the accident and the tyre was observed to be in deflated condition due to the air leakage from the damaged rim. The remaining tread depth of the tyre was approximately 5.1mm. There was also no tear, cut or burst mark(s) on the outer and the inner sidewalls as well as across the tread of the Motor Car's 4 tyres.

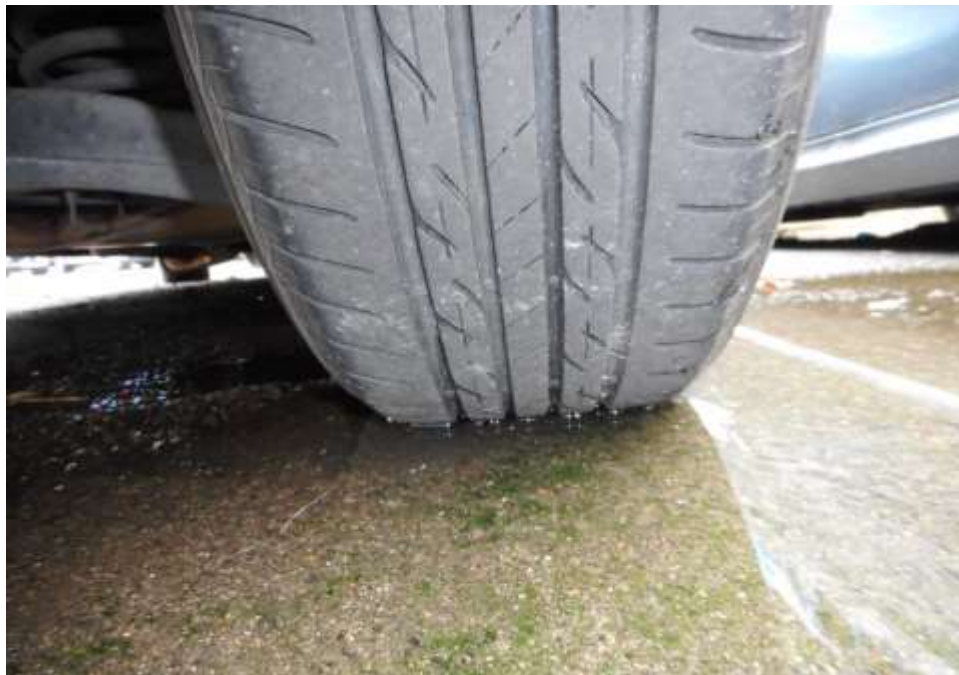
**Photo 10** shows the condition of the rear right tyre of the Motor Car, which was observed to be in serviceable condition with remaining tread depth of approximately 4.3mm. The tyre was also observed to be sufficiently inflated for vehicular operation with no tear, cut or burst mark(s).

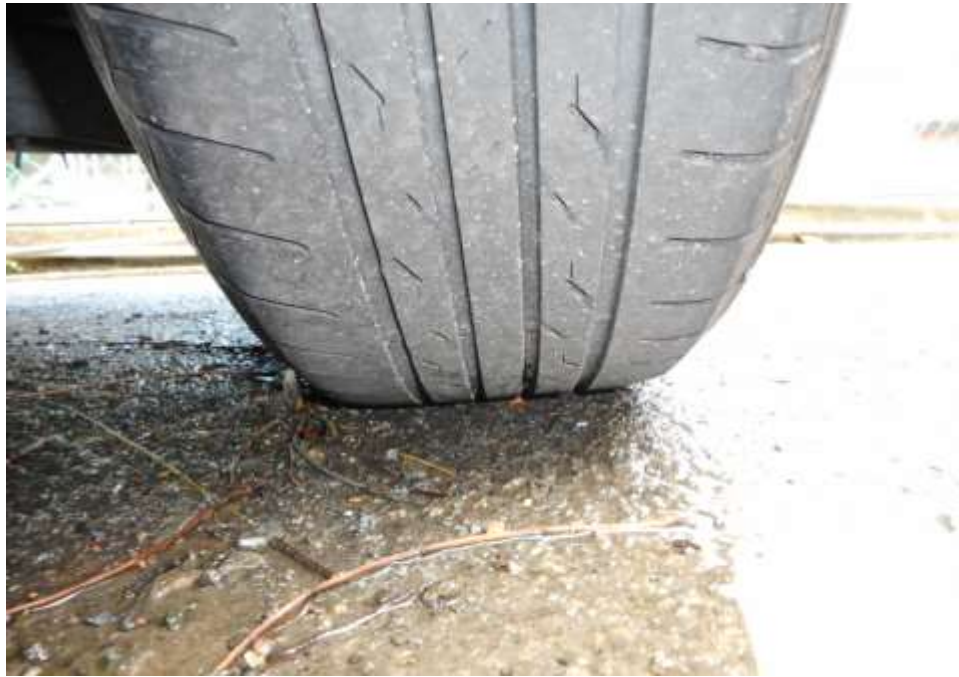
**Photo 11** shows the condition of the rear left tyre of the Motor Car, which was observed to be in serviceable condition with remaining tread depth of approximately 3.2mm. The tyre was also observed to be sufficiently inflated for vehicular operation with no tear, cut or burst mark(s).

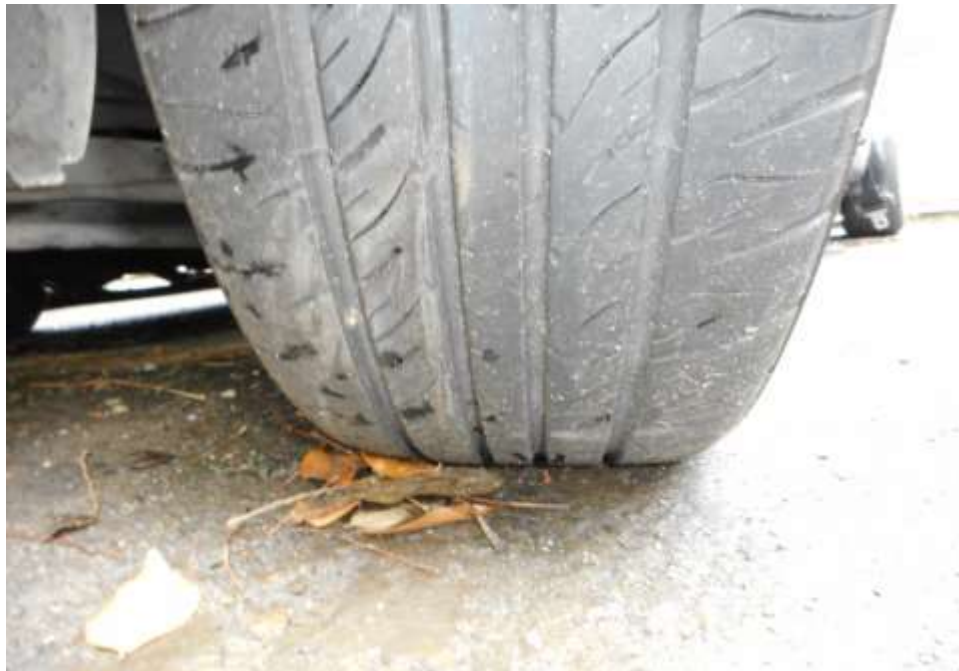
**Photo 12** shows the condition of the front left tyre of the Motor Car, which was observed to be in serviceable condition with remaining tread depth of approximately 4.8mm. The tyre, which was wrapped around alloy wheel rim, was also observed to be sufficiently inflated for vehicular operation. There were minor scratches on the surface of the wheel rim as a result of the accident.

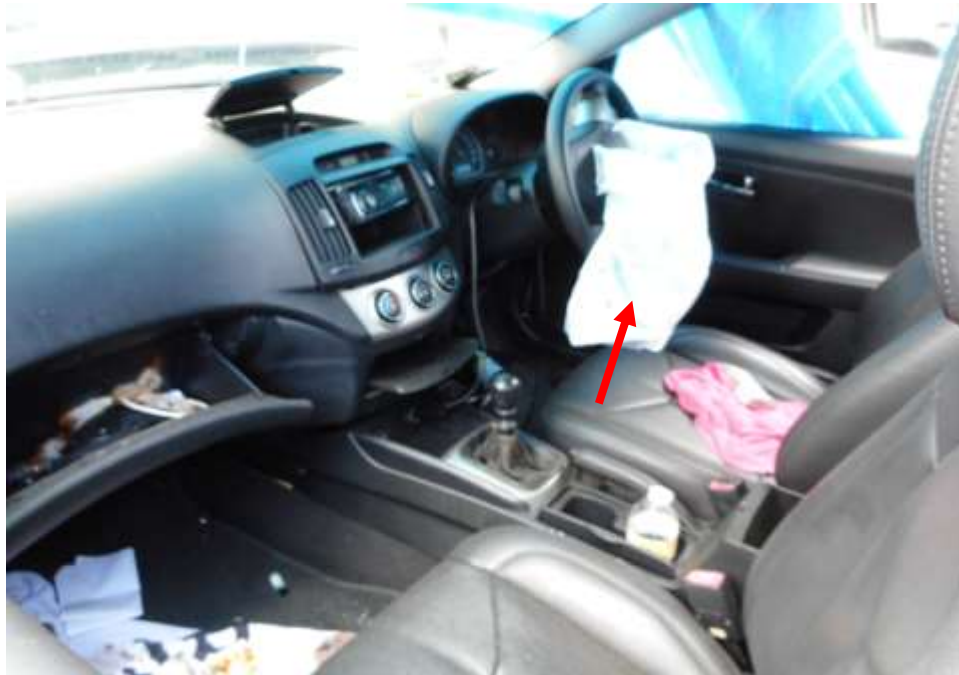
**Photo 13** shows the deployment of the Supplemental Restraint System (SRS) airbag (arrowed), as a result of the accident.

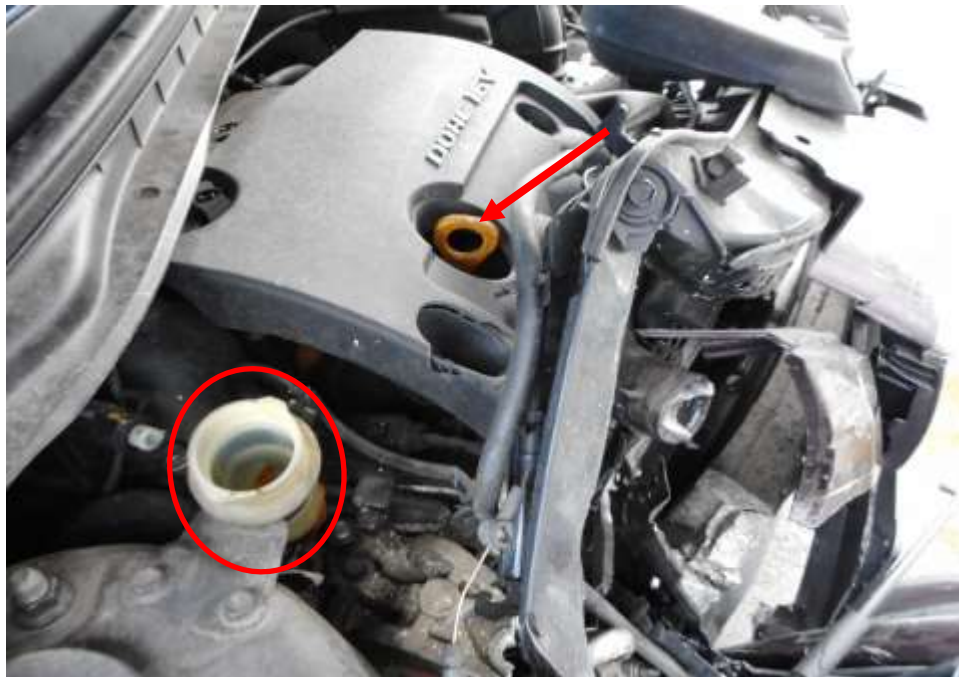
8. Upon examination of the engine compartment of the Motor Car, I had observed the parts and components inside the engine compartment to be affected by the accident. The engine coolant and brake fluid were all found to be of insufficient level for operating purposes and the engine oil dip stick was stuck as a result of the accident. See photo 14 and 15 below.

**Photo 14** shows a general view of the Motor Car's engine compartment and the various parts and components inside the engine compartment. The brake fluid reservoir (circled) and the engine oil dip stick (arrowed) was insufficient and stuck as a result of the accident

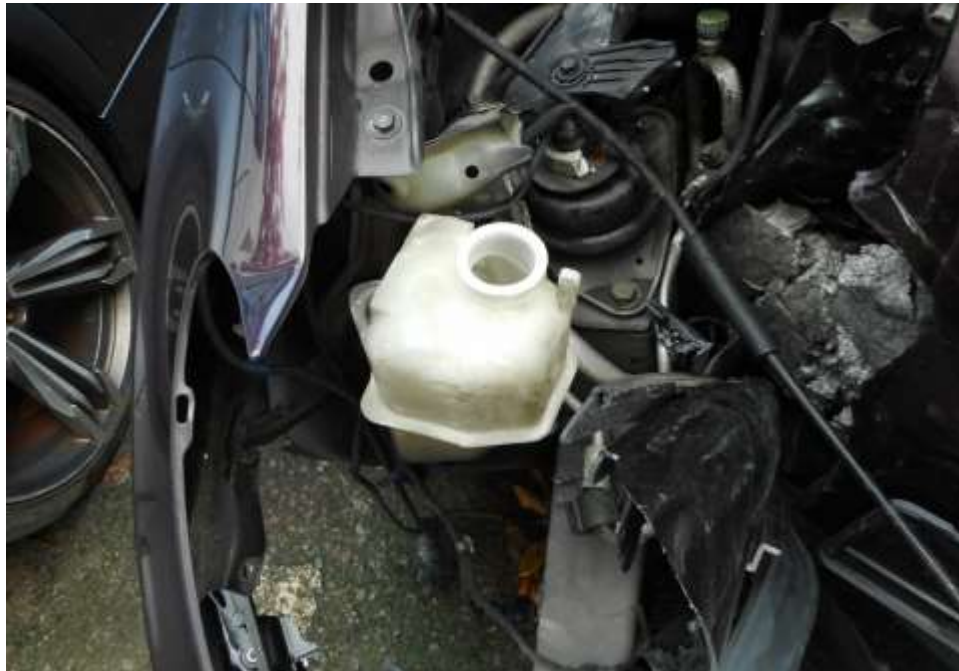
**Photo 15** shows coolant reservoir of the Motor Car at the time of my inspection. The coolant level was observed to be of insufficient as a result of the accident.

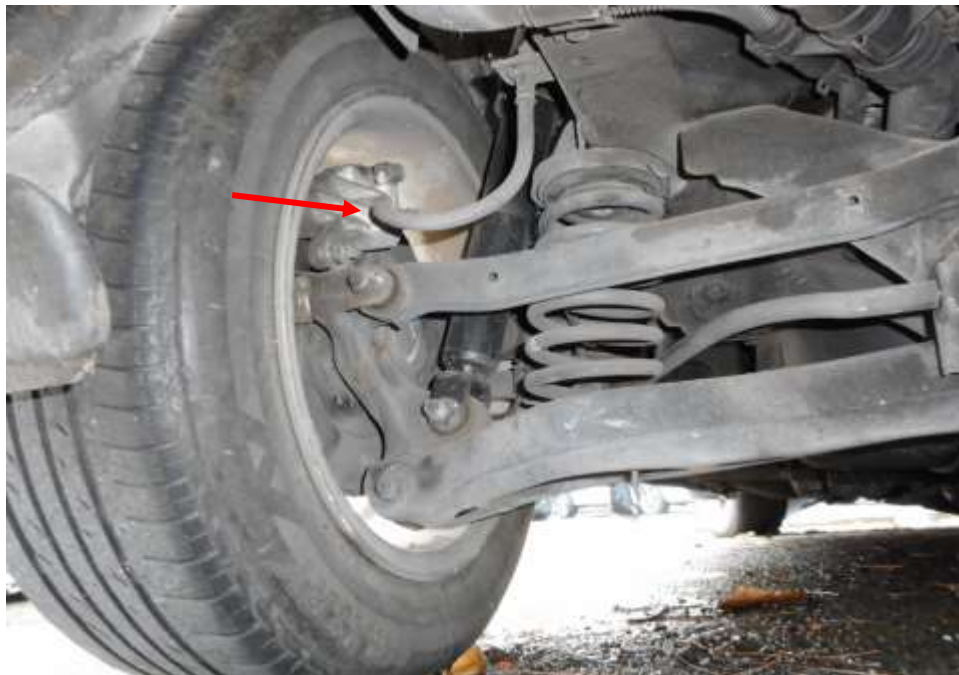
**Photo 16** shows the brake hose/pipe (arrowed) at the rear left wheel of the Motor Car and it was observed to be intact

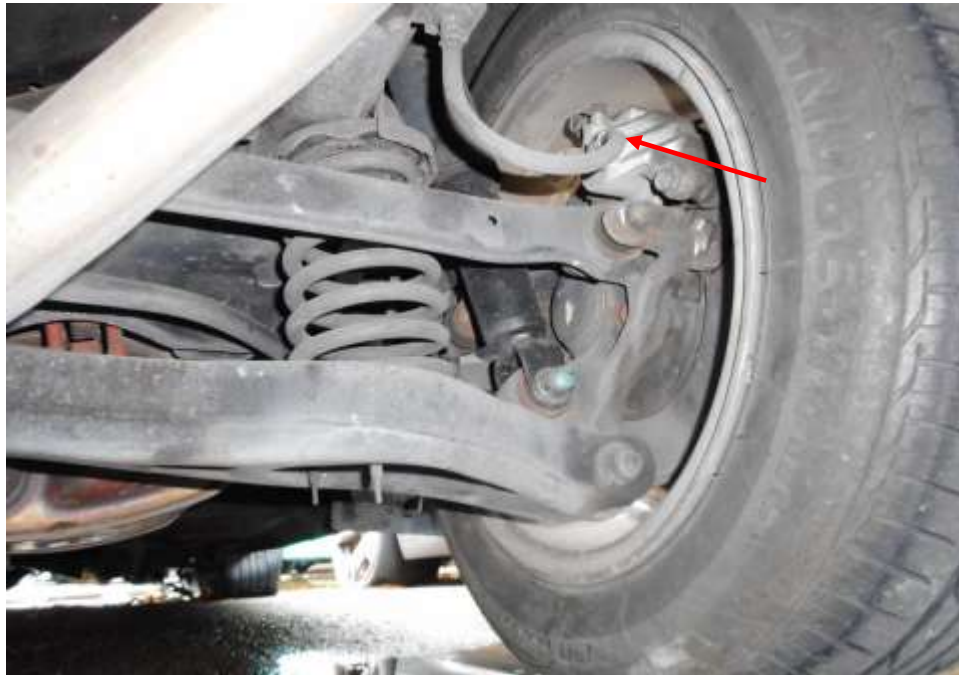
**Photo 17** shows the brake hose/pipe (arrowed) at the rear right wheel of the Motor Car and it was observed to be intact

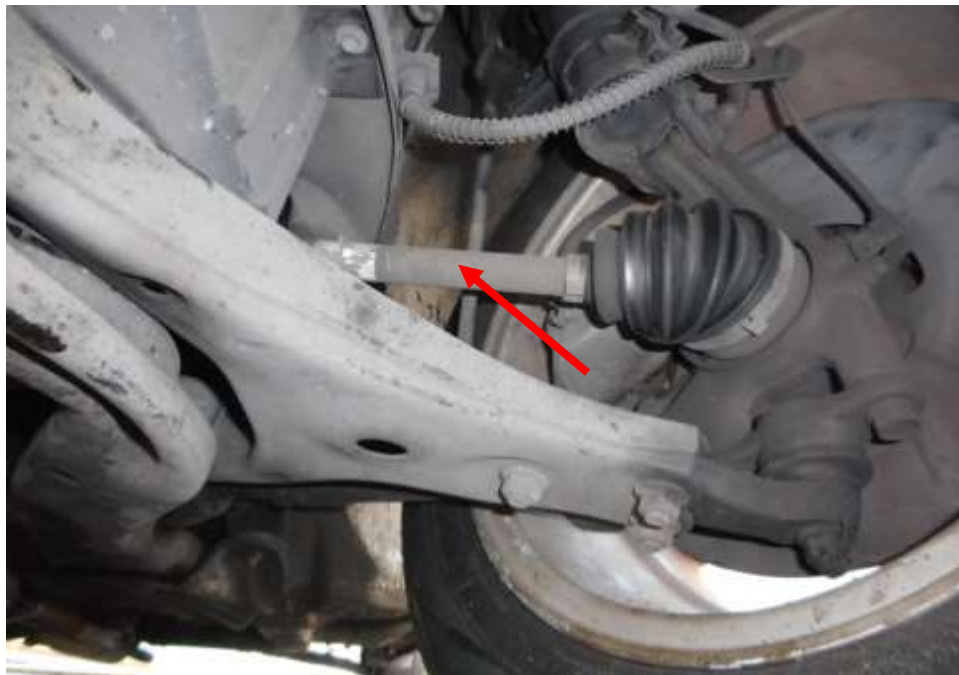
**Photo 18** shows the various undercarriage components at the front left wheel of the Motor Car, the driveshaft (red arrow) was found to be intact.

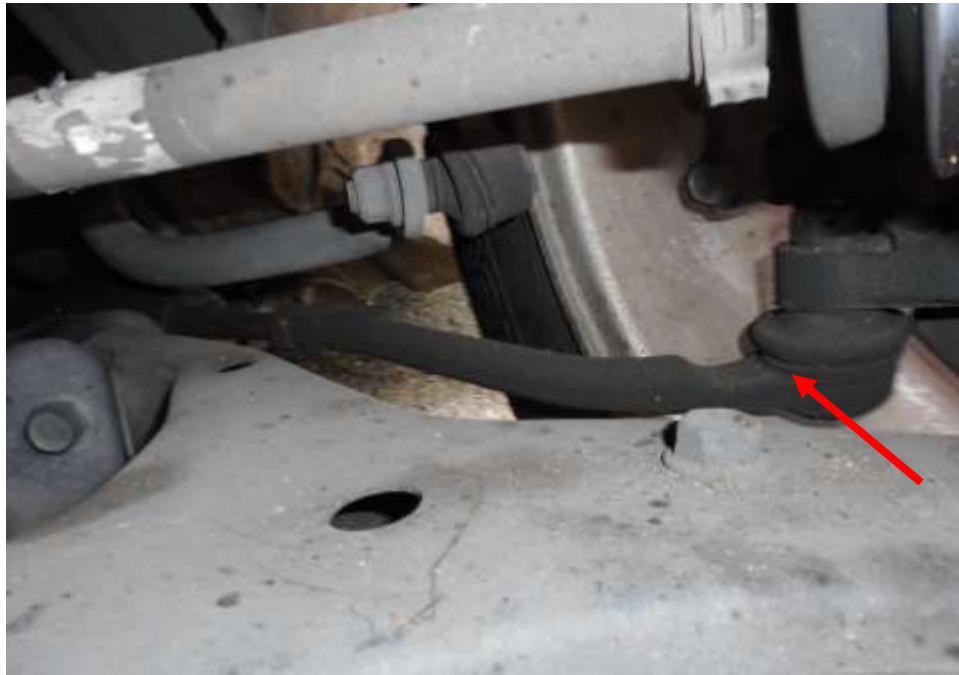
**Photo 19** shows the various undercarriage components at the front left wheel of the Motor Car, the steering tie rod (red arrow) was found to be intact.
