Re : Third Party Claim For Vehicle Registration No. SGH1396B

VEHICLE INSPECTION REPORT

VEHICLE DAMAGE INSPECTION REPORT

ADJUSTMENT ON REPAIR COST FOR VEHICLE NO. SGH 1396B

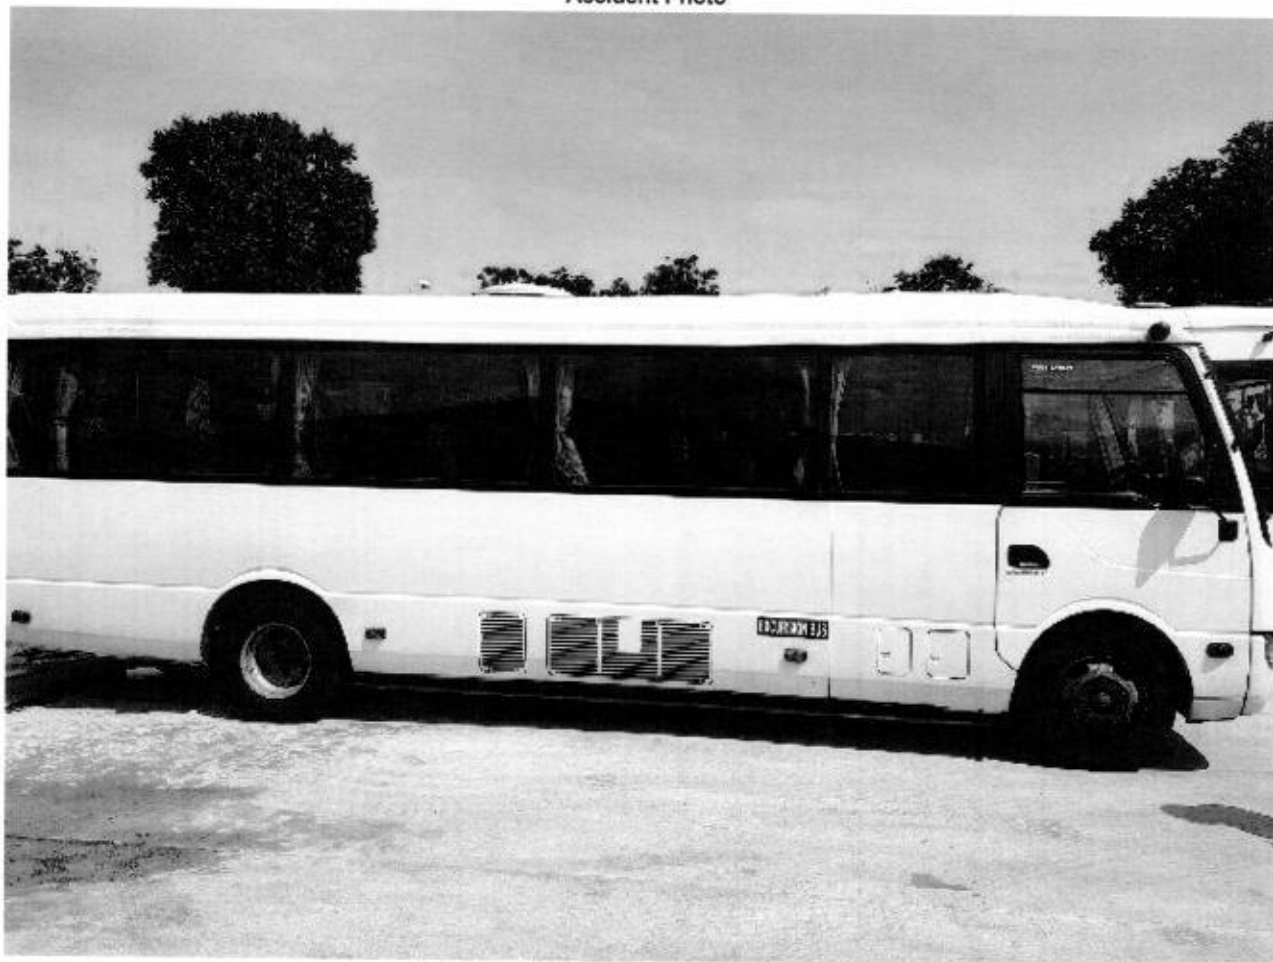
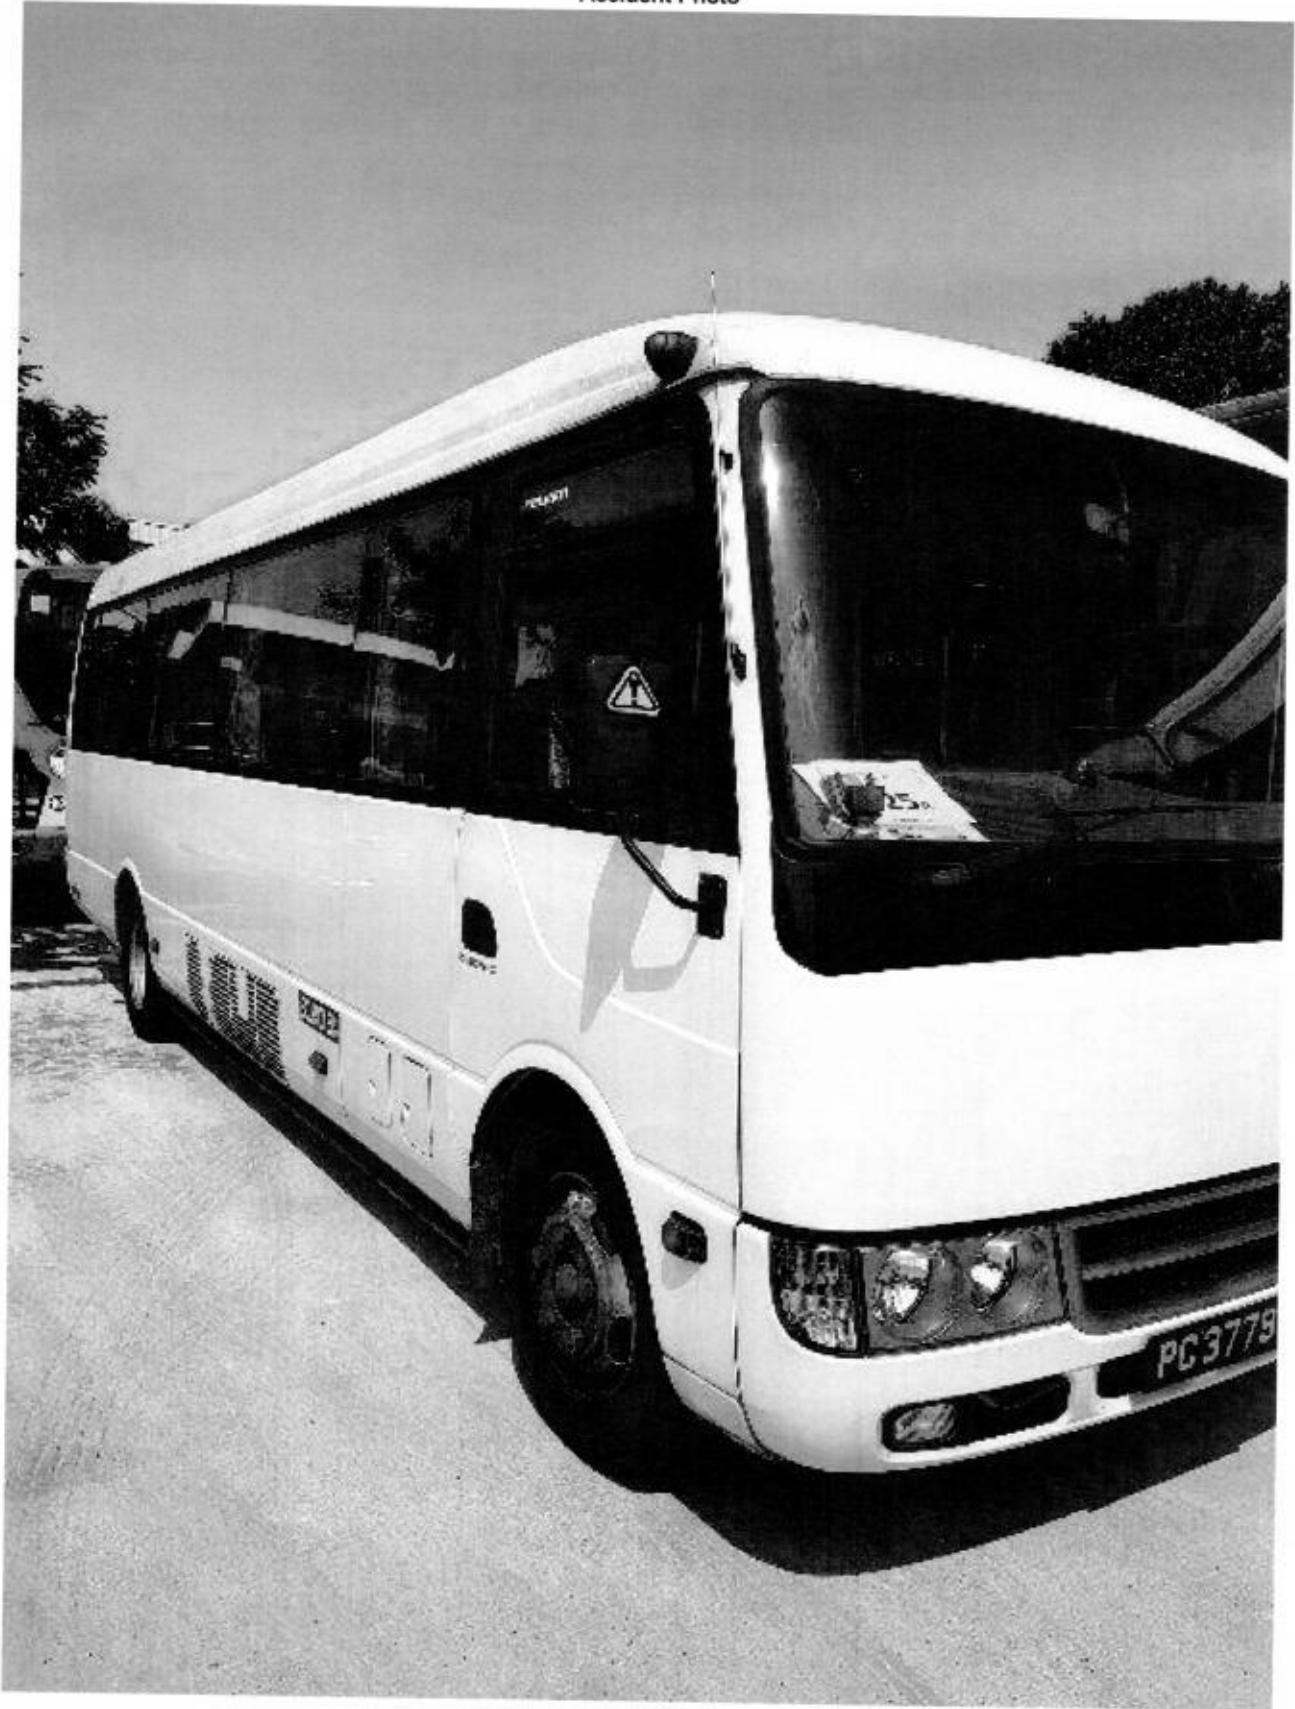
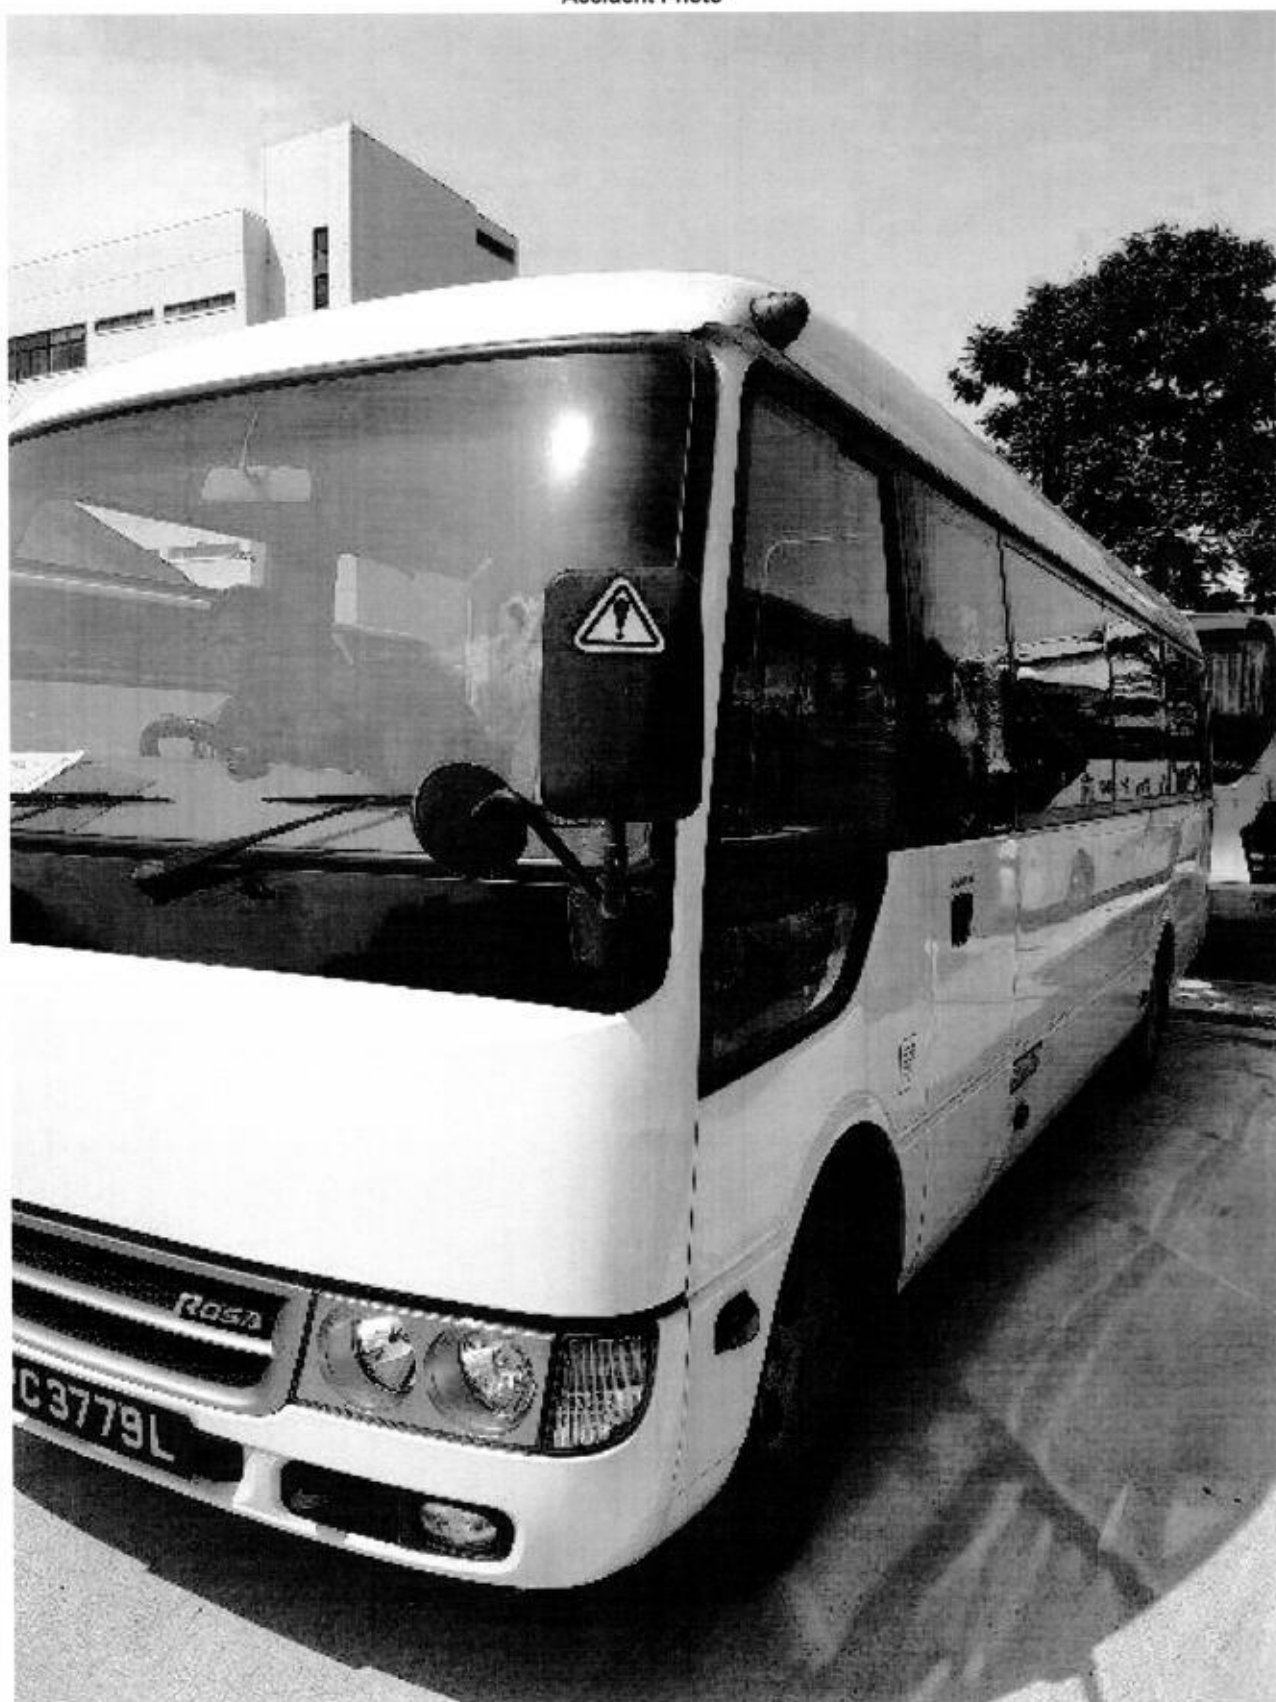
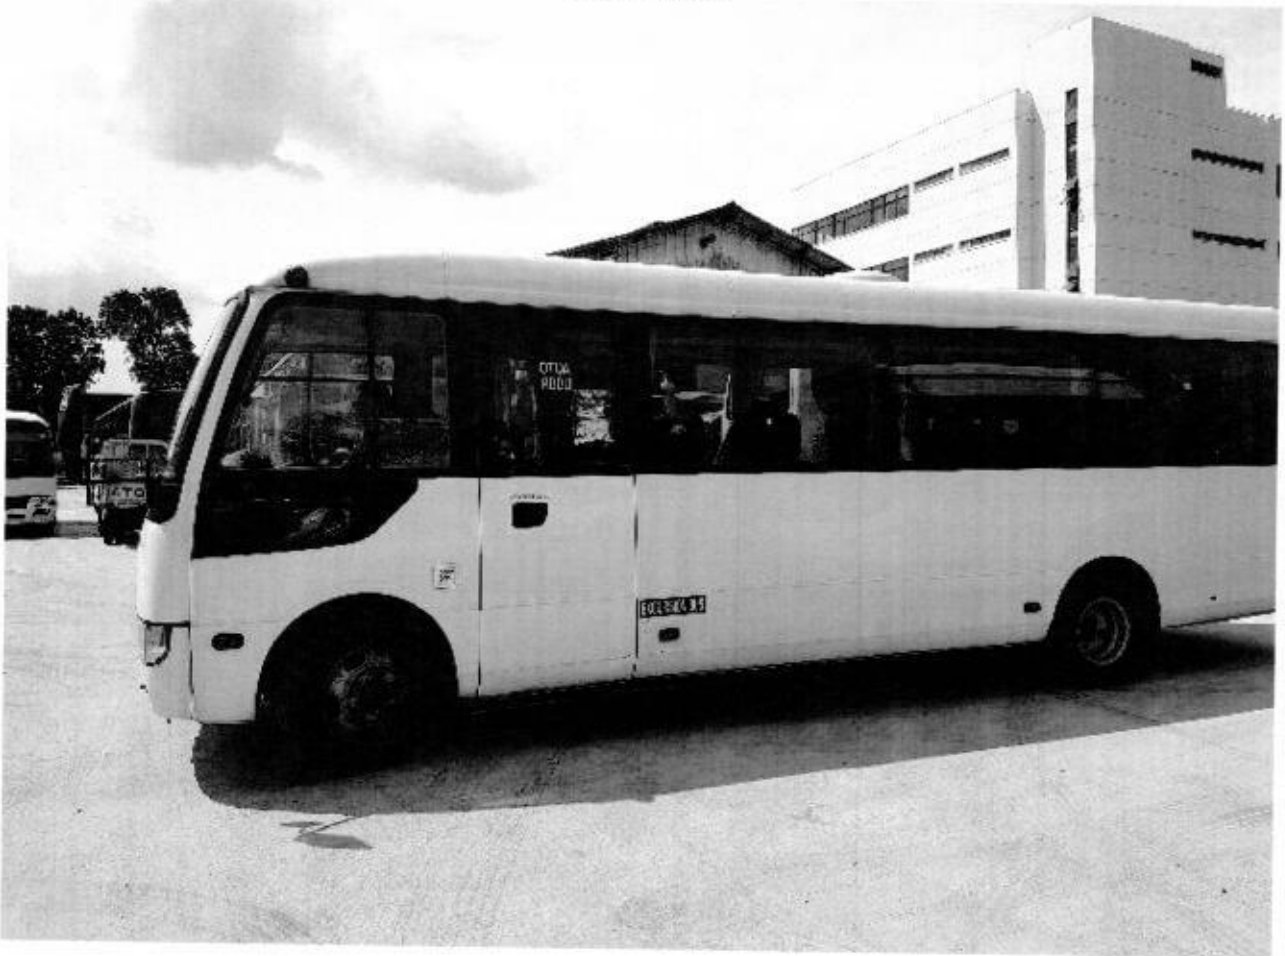
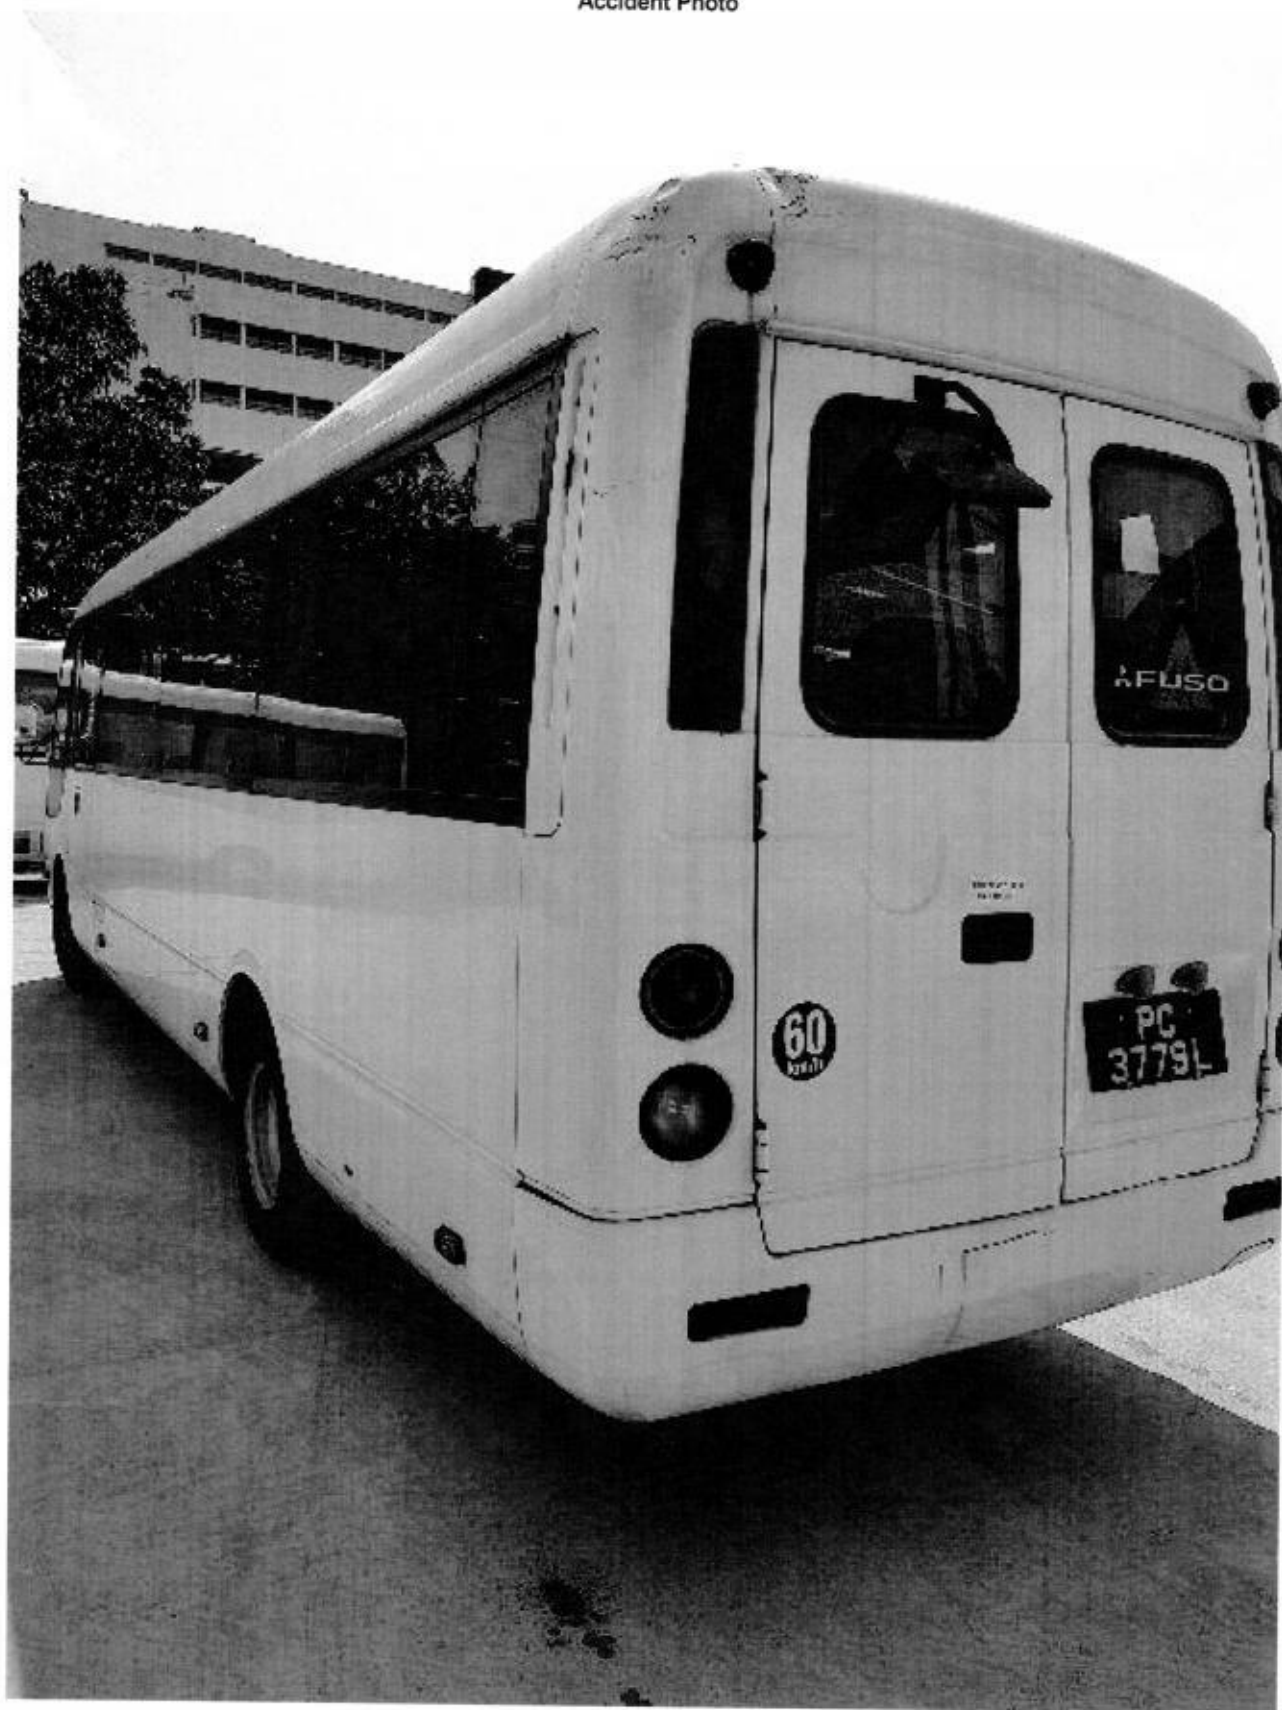
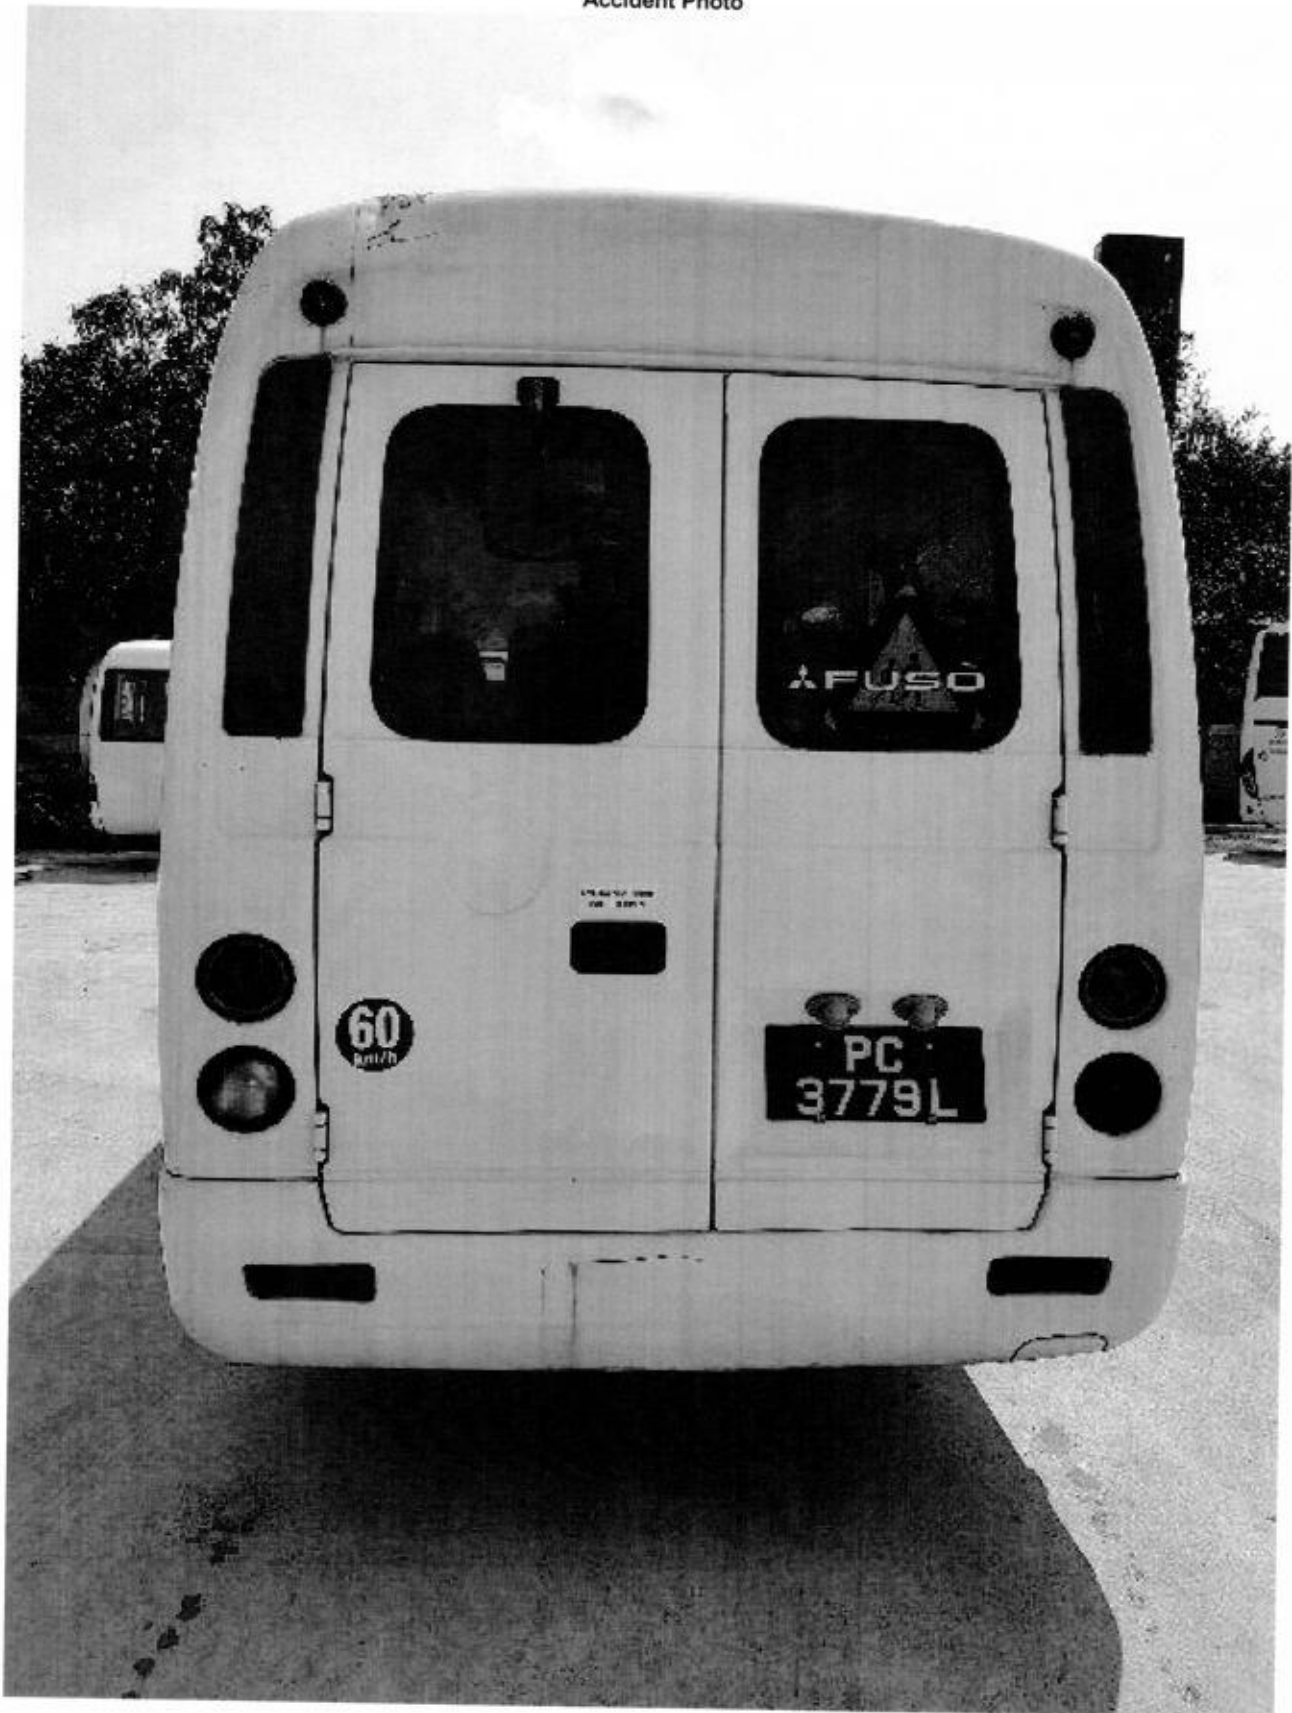
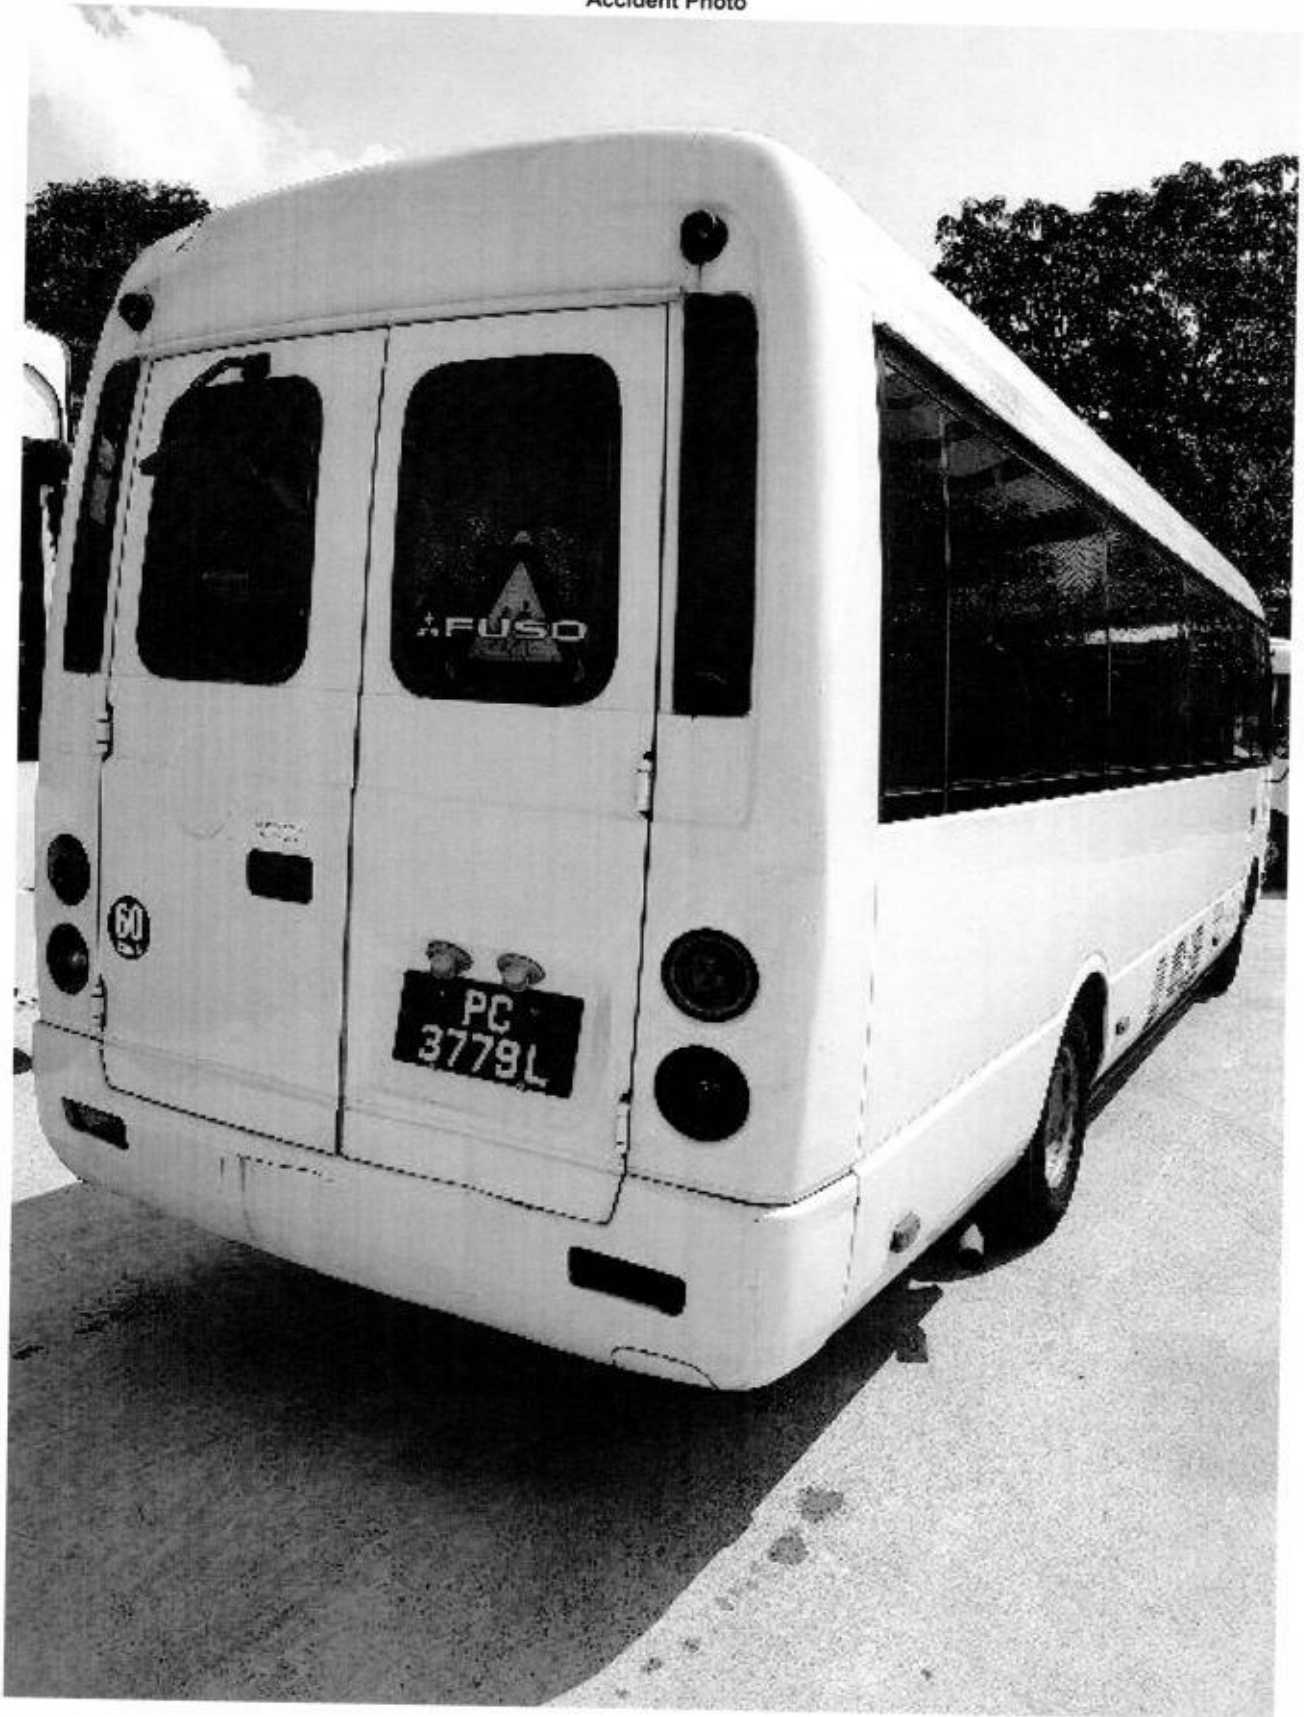
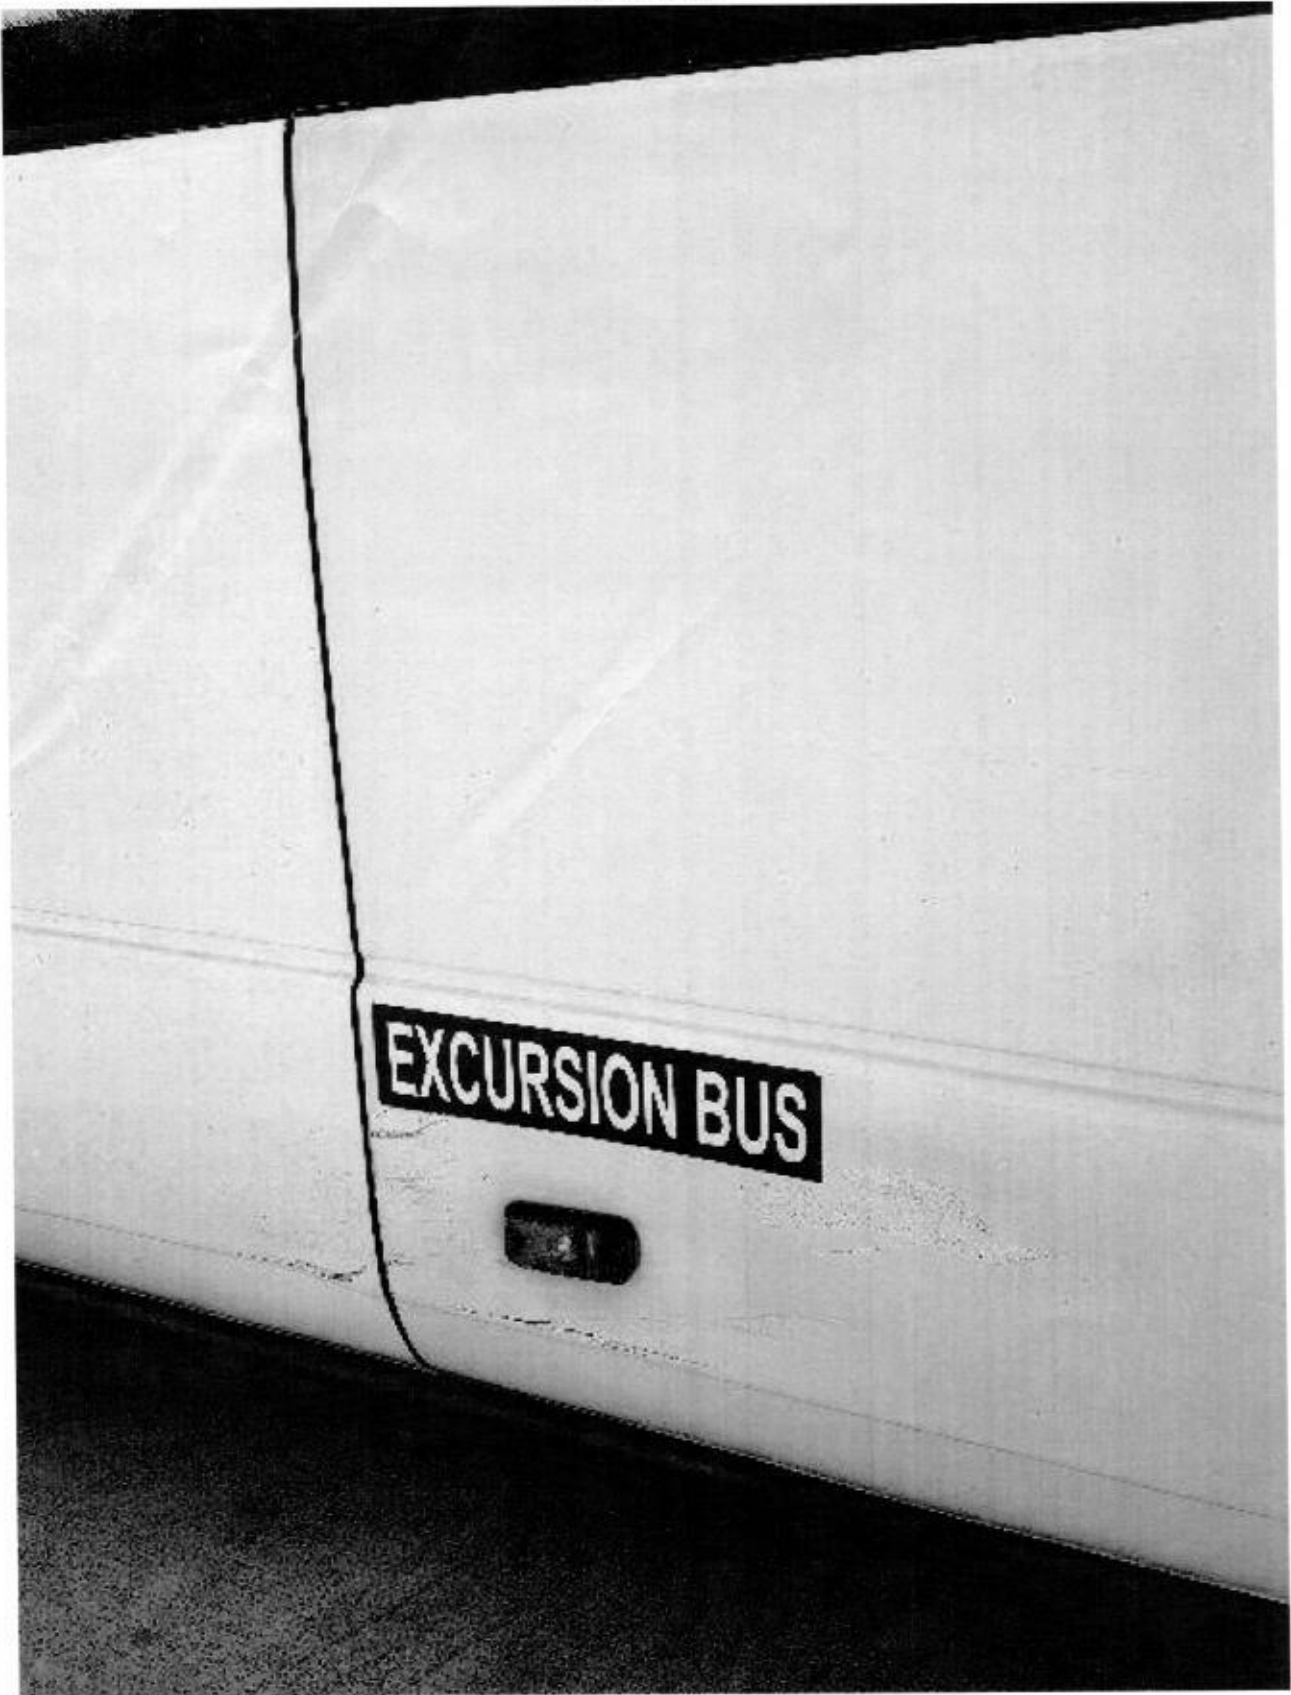
POINT OF IMPACT

On the off side front in the direction from right to left.

The impact of the collision has damaged / affected the bonnet, front bumper, o/s headlamp, front fender, front undercarriage and etc...

DAMAGE TO THE RH FRONT PORTION. (PLEASE REFER TO PHOTOS ATTACHED)
