Your Ref: S9M01Y5H  
Our Ref : CS/ASM19017062/P

**M/s AXA Insurance Pte. Ltd.**

**TECHNICAL INVESTIGATION REPORT OF FIRE INCIDENT INVOLVING THE INSURED VEHICLE XE 4759H ON 22<sup>th</sup> AUGUST 2019**

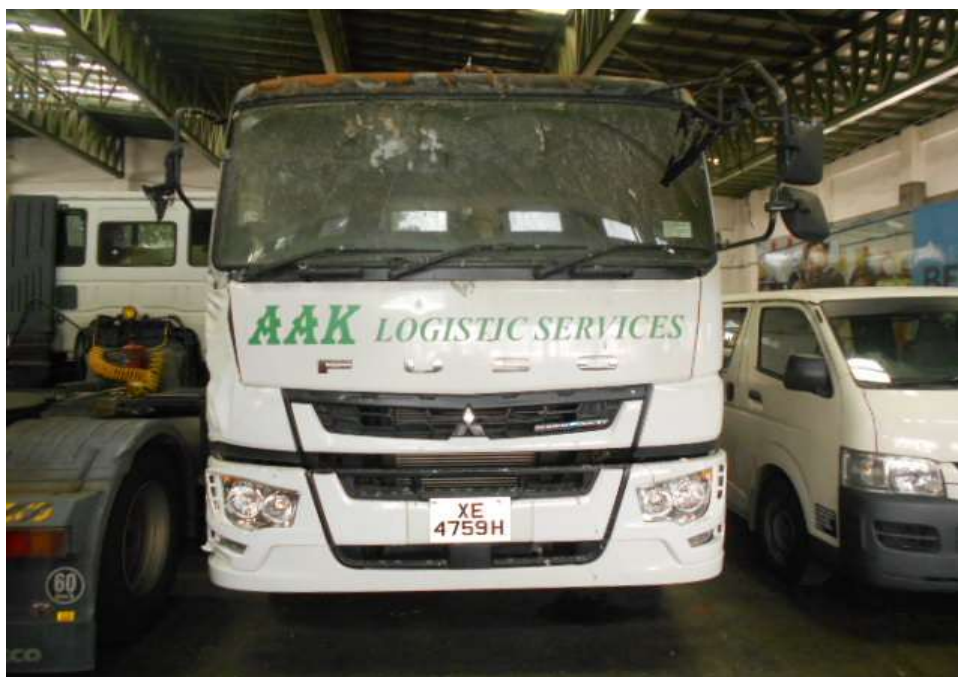
**Photo 1** shows the front view of the Insured Vehicle at the time of our inspection. The heat and smoke damage to the Insured Vehicle was confined to its cabin portion. The rear portion of the Insured Vehicle was relatively unaffected by the fire.

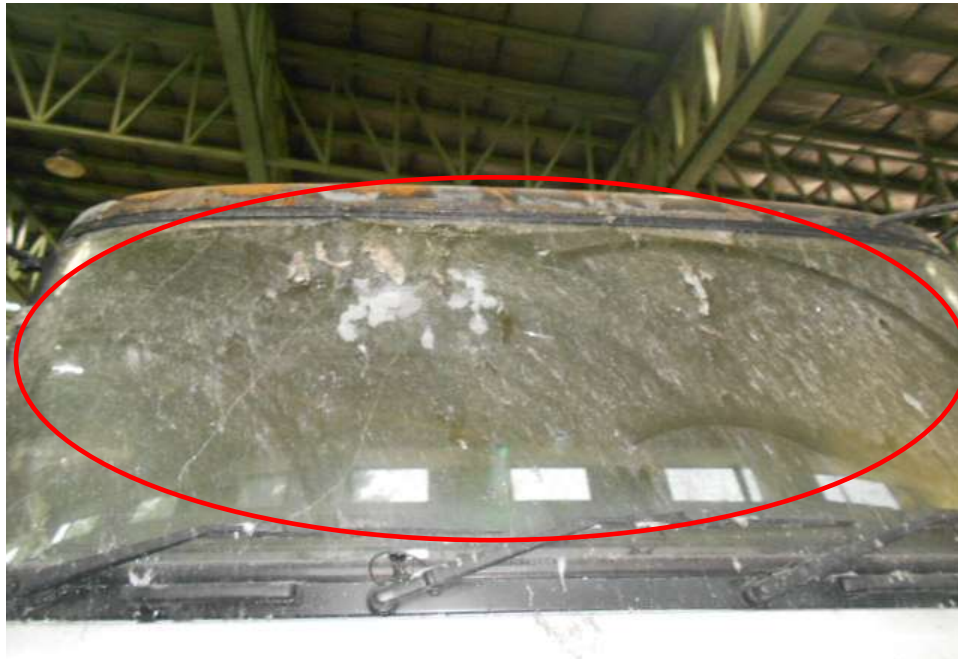
**Photo 2** shows the close up view of the Insured Vehicle's cabin windscreen at the time of our inspection. The front windscreen of the Insured Vehicle had sustained heat and smoke damaged as a result of the fire (circled).

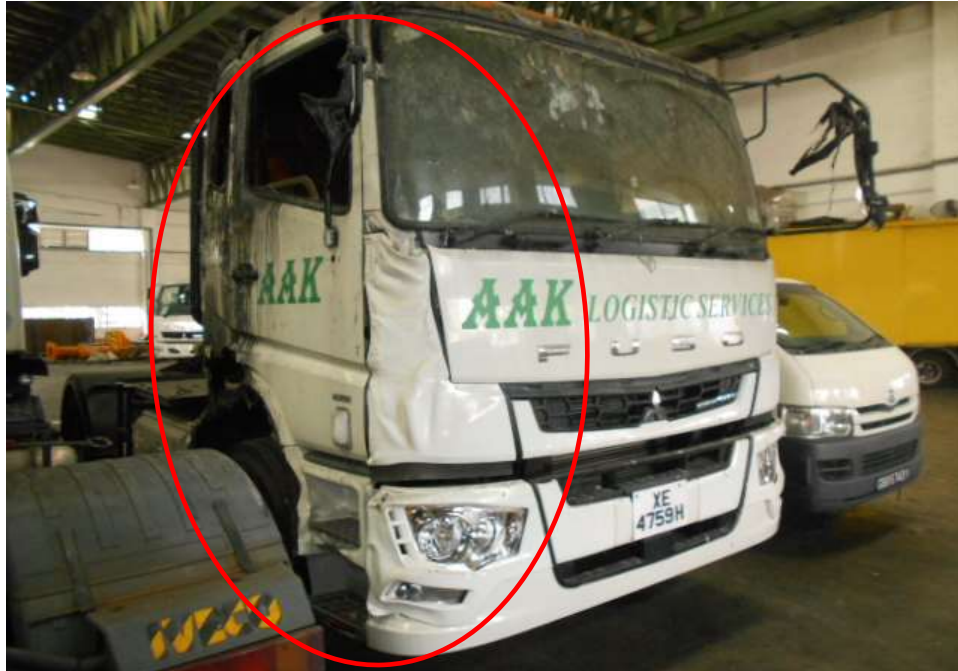
**Photo 3** shows the right side view of the Insured Vehicle at the time of our inspection. The exterior body of the Insured Vehicle was affected by the heat. The body and door panels had sustained heat and smoke damage as a result of the fire (circled).

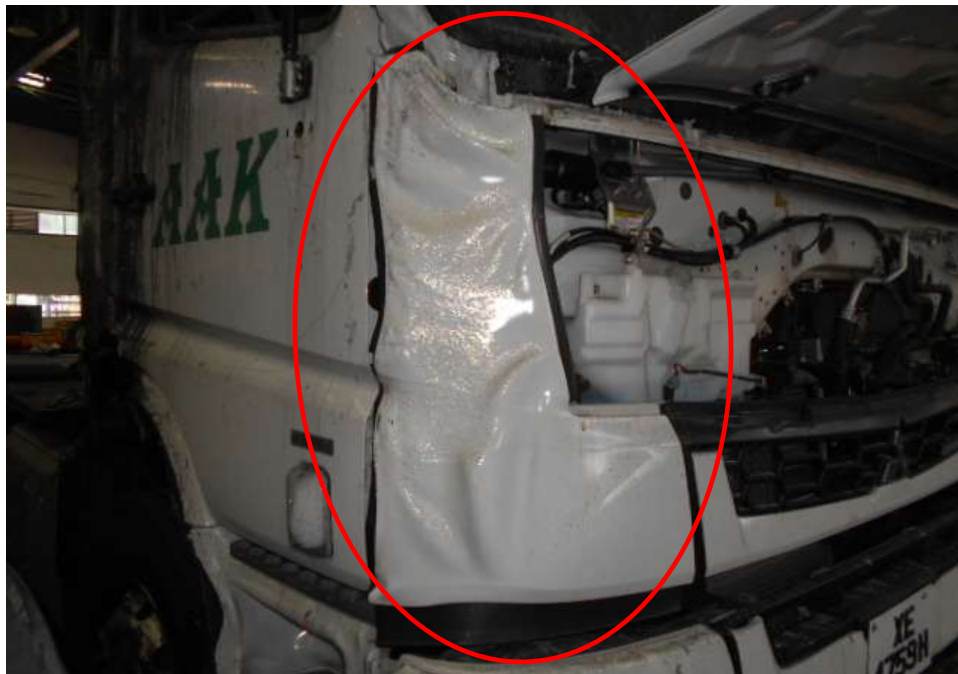
**Photo 4** shows the close up view of the right side of the Insured Vehicle at the time of our inspection. The body panel had sustained heat damage and melted as a result of the fire (circled).

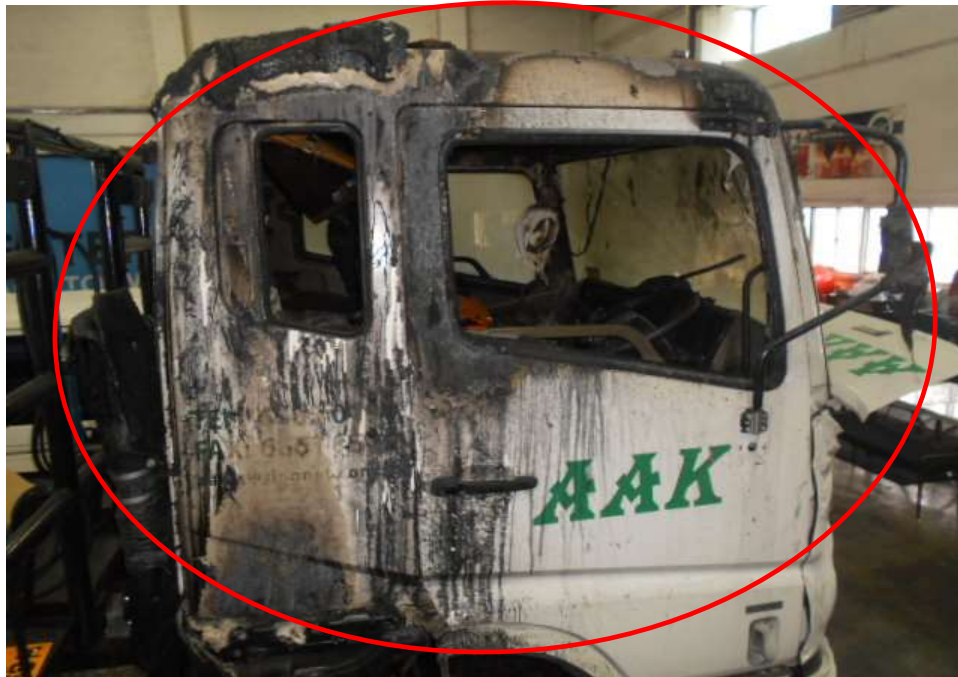
**Photo 5** shows the general view of the right side of the Insured Vehicle at the time of our inspection. The door panel, air filter box and side mirror had sustained fire damage, smoke damage and melted as a result of the fire (circled).

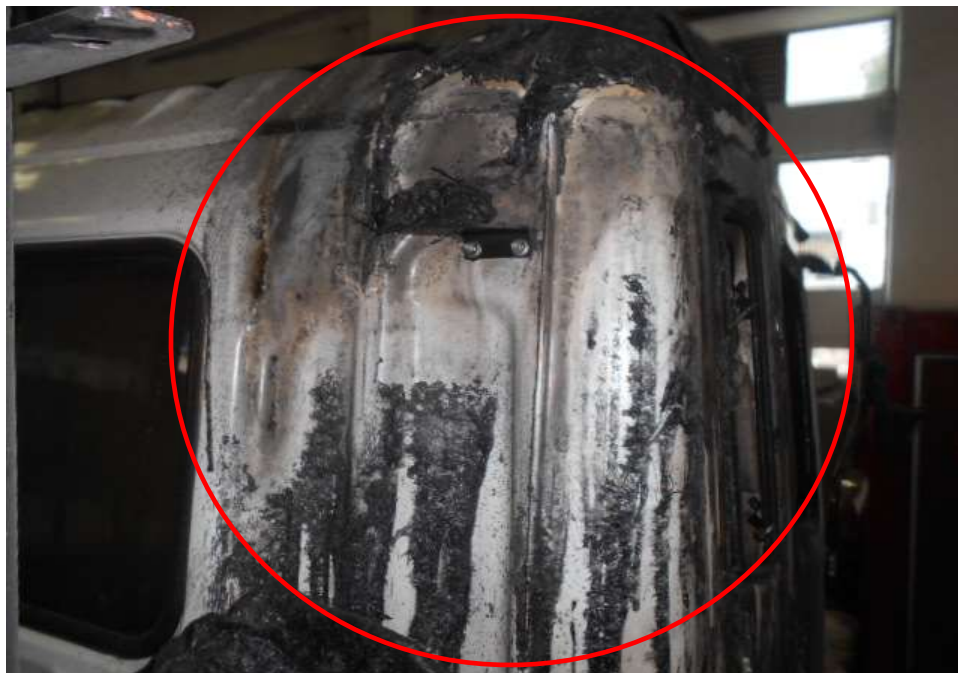
**Photo 6** shows the close up view of the right side of the Insured Vehicle at the time of our inspection. The air filter box had sustained fire damage, smoke damage and melted as a result of the fire (circled).

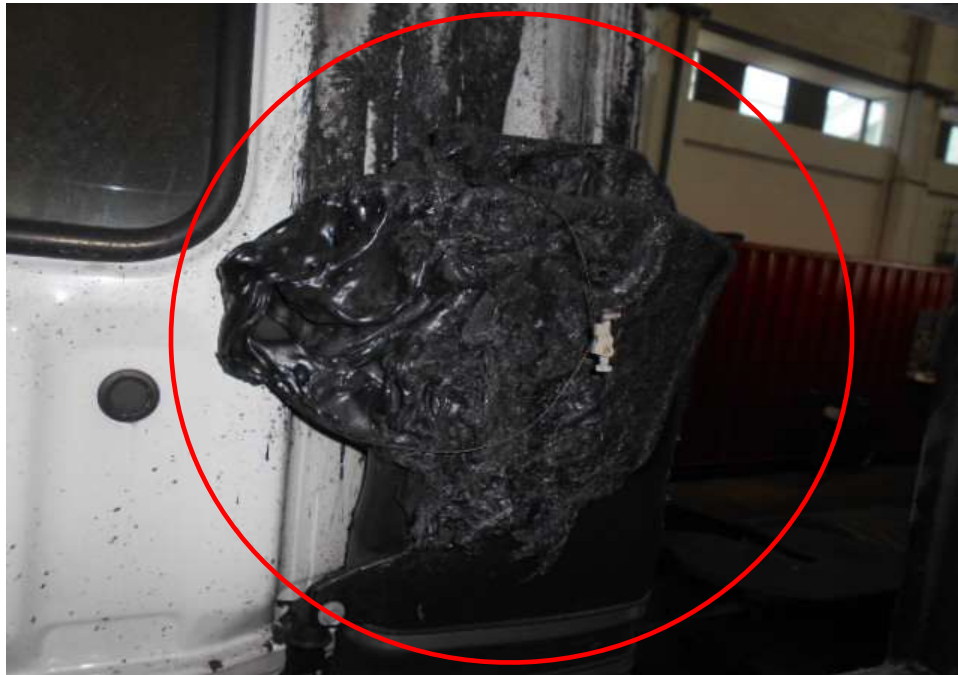
**Photo 7** shows the close up view of the right side of the Insured Vehicle at the time of our inspection. The air filter box had sustained fire damage, smoke damage, melted from the top and fallen downwards as a result of the fire (circled).

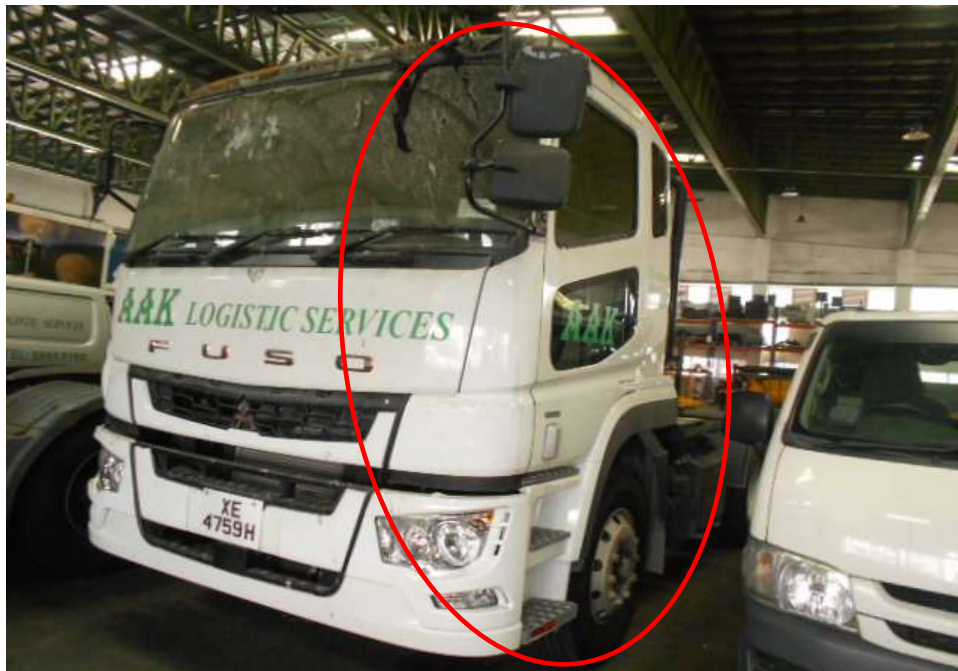
**Photo 8** shows the left side view of the Insured Vehicle at the time of our inspection. The exterior body of the Insured Vehicle was affected by the fire. The body, door panels and side mirror had sustained fire and smoke damage as a result of the fire (circled).

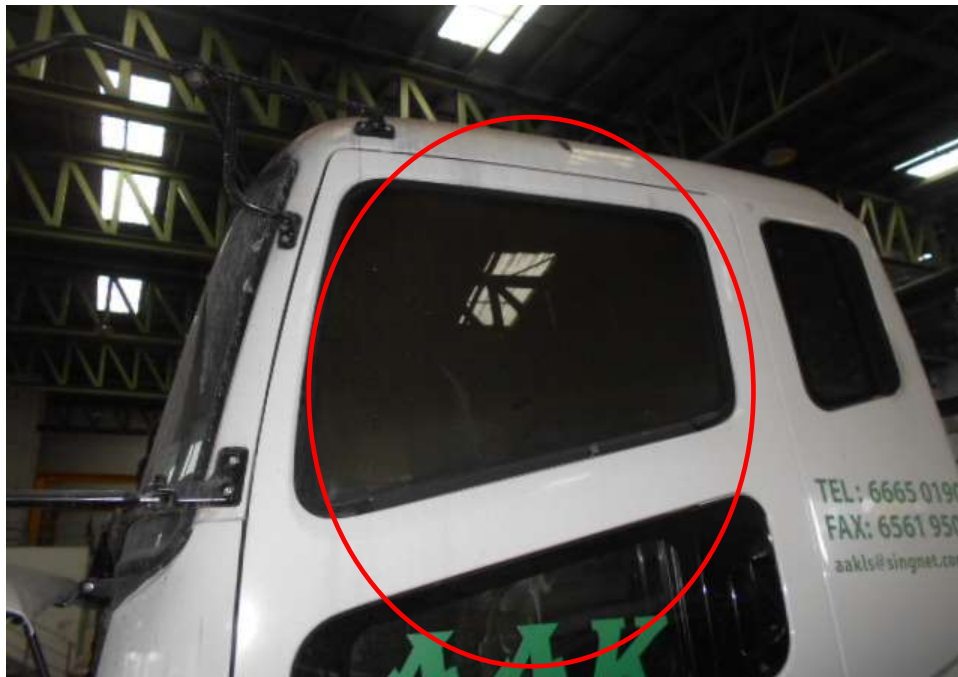
**Photo 9** shows the close up view of the left side of the Insured Vehicle at the time of our inspection. The exterior body of the Insured Vehicle was affected by the fire. The body, door panels and windscreen had sustained fire and smoke damage as a result of the fire (circled).

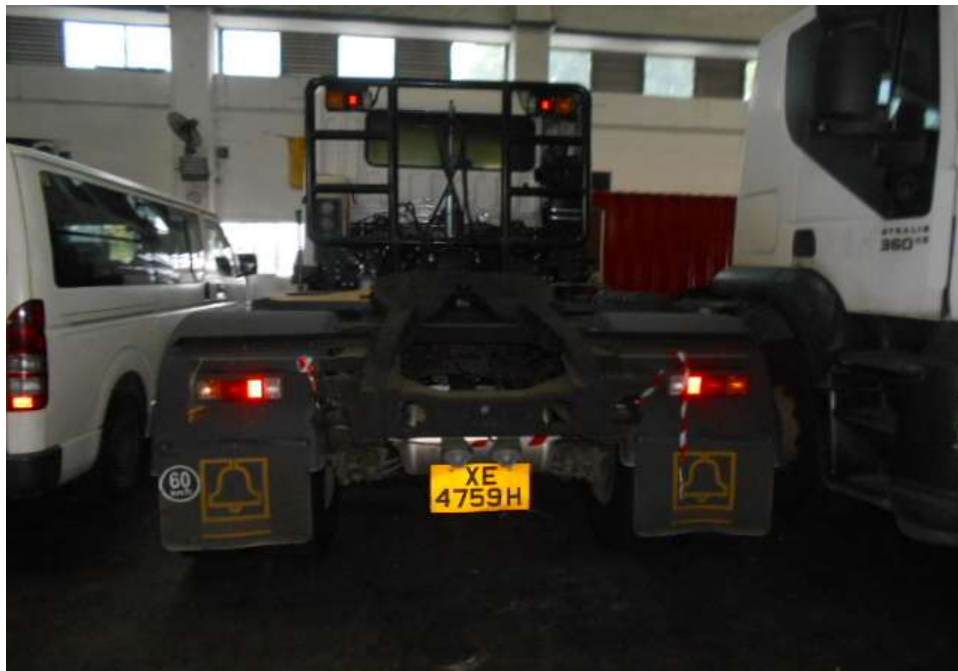
**Photo 10** shows the rear portion of the Insured at the time of our inspection. The rear portion of the Insured Vehicle was unaffected by the fire

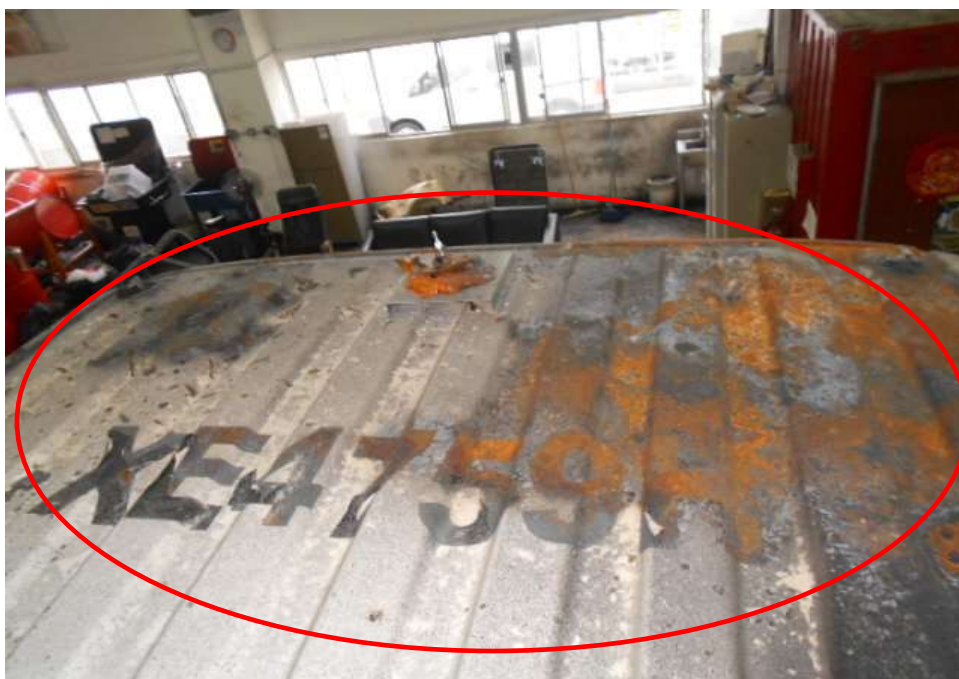
7. Based on the circumstances for this particular case, the fire appears to have originated from the exterior of the Insured Vehicle, somewhere around the front cabin portion. This can be determined basing on the area where the extent of fire damage was most severe, the circumstances of the fires' origin at the material time of incident and also the high heat intensity burn marks (whitish burn marks) that were found on the exterior surface of its cabin top.

8. These whitish burn marks are a result of exposure to prolong heat intensity. Rust would normally start to develop around these areas soon after a fire as the prolonged exposure to high heat intensity usually causes the bare steel/metal material of the body parts to be exposed to natural environmental condition. The rust that had developed on the cabin top, in the immediate vicinity of where these whitish burn marks were found, would also support our findings of where the fire had affected the Insured Vehicle. See photo 11-16 below.

**Photo 11** shows the fire damage at the exterior portion of the cabin top of the Insured Vehicle. The high heat intensity burn marks (whitish burn marks) found on the exterior surface of its cabin top as well as rust that had also developed on (circled) this indicates that the fire to the Insured Vehicle had originated from the exterior of the Insured Vehicle.

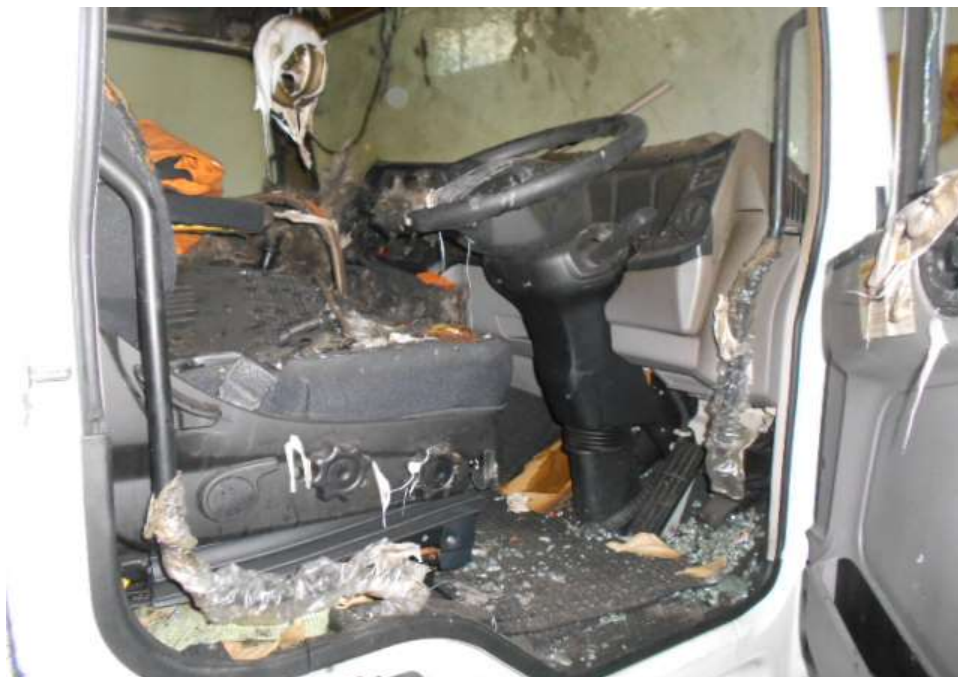
**Photo 12** shows the general view of the interior compartment of the Insured Vehicle at the time of our inspection. Its interior compartment had suffered heat, smoke damage and melted as a result of the fire.

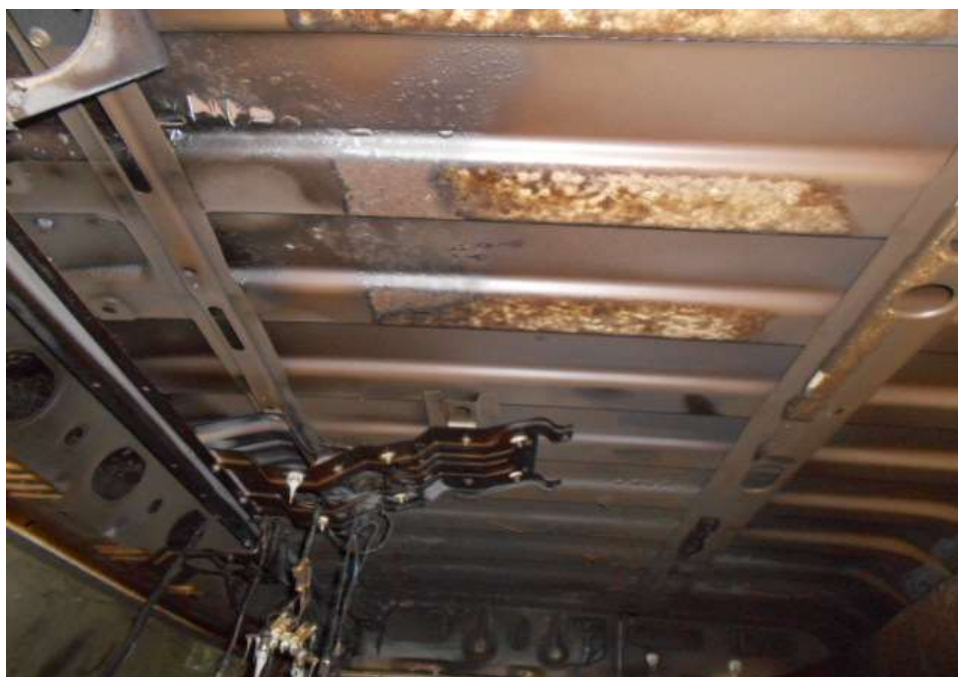
**Photo 13** shows the close up view of the interior compartment of the Insured Vehicle at the time of our inspection. Its roof lining material had suffered heat, smoke damage and fallen off as a result of the fire.

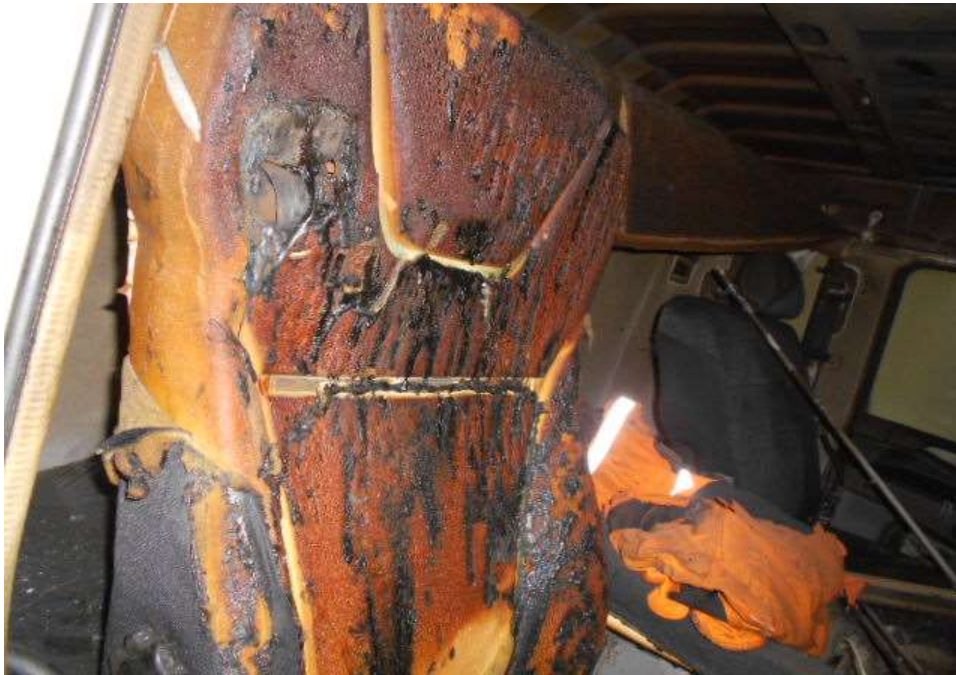
**Photo 14** shows the close up view of the interior compartment of the Insured Vehicle at the time of our inspection. Its driver's chair material had suffered heat, smoke damage and melted down as a result of the fire.

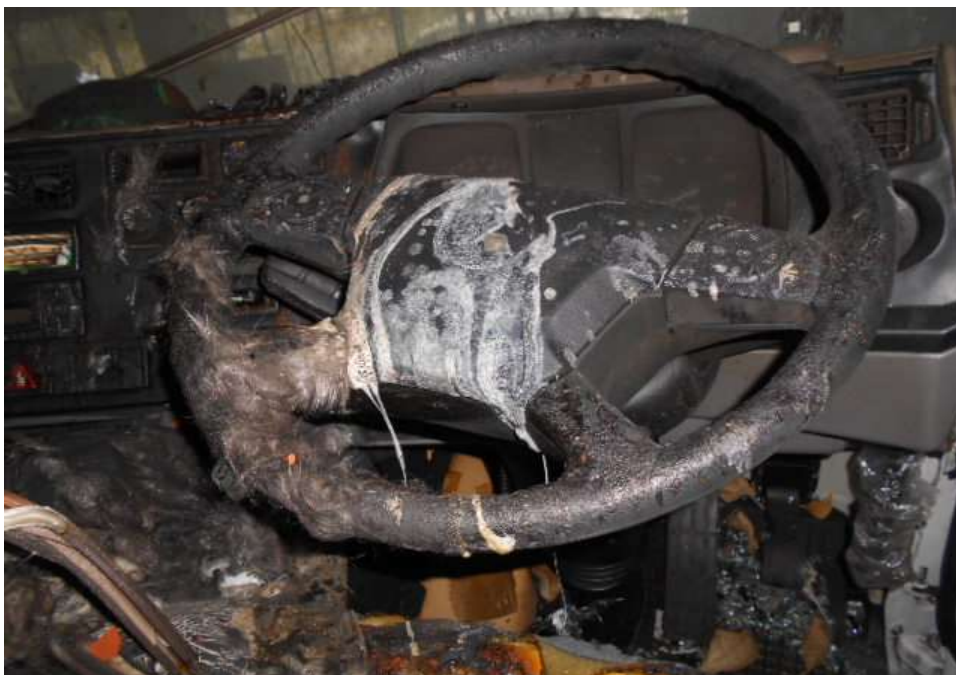
**Photo 15** shows the close up view of the interior compartment of the Insured Vehicle at the time of our inspection. Its driver's steering wheel and dashboard material had suffered heat, smoke damage and melted down as a result of the fire.

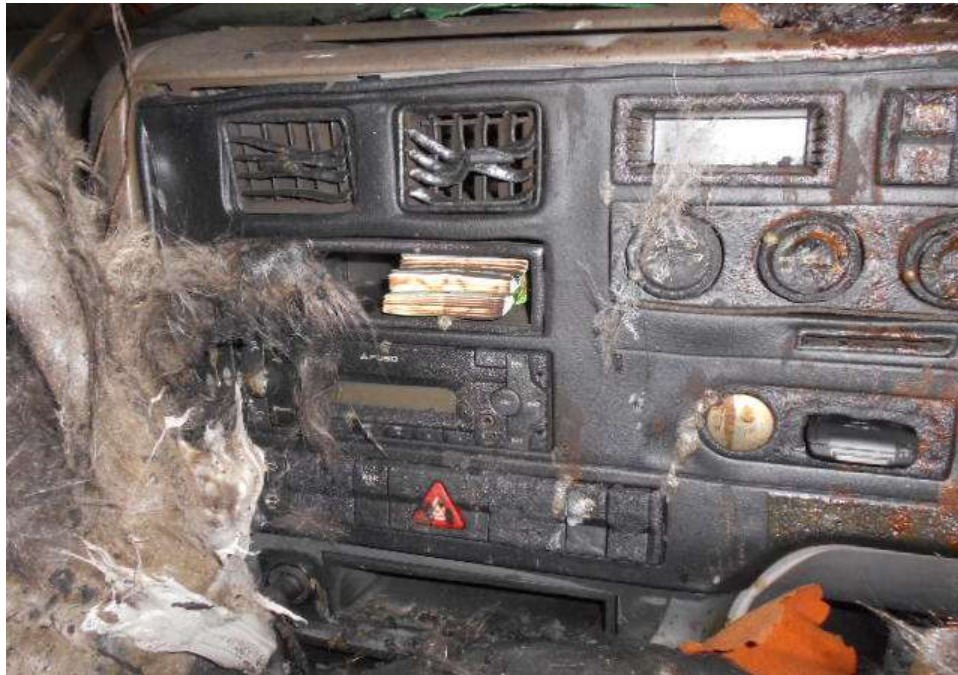
**Photo 16** shows the close up view of the interior compartment of the Insured Vehicle at the time of our inspection. Its cabin instrument panels and dashboard components had suffered heat, smoke damage and melted down as a result of the fire.

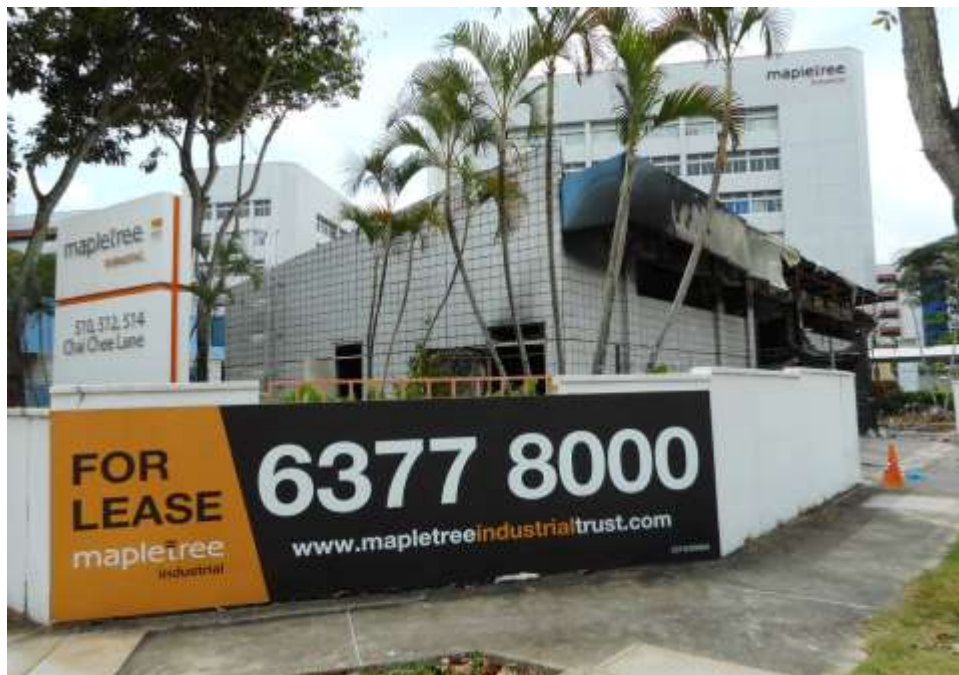
**Photo 17** shows the general view of the location where the fire incident had occurred. The Insured Vehicle was positioned at in front of the Rubbish Collection Centre at Chai Chee Lane Block 512. From our observations, there was no CCTV camera(s) located in the vicinity of the viaduct.

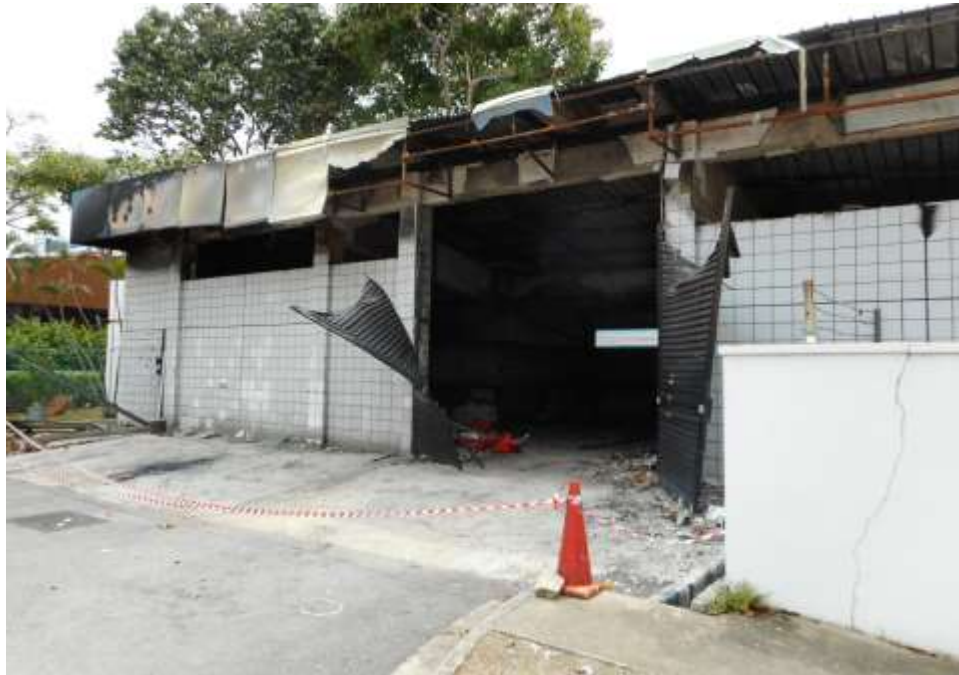
**Photo 18** shows the general view of the location where the fire incident had occurred. The Insured Vehicle was positioned head in at the front pouch of the Rubbish Collection Centre at Chai Chee Lane Block 512. From our observations, the roof panels, roof linings and surroundings were affected by the fire.

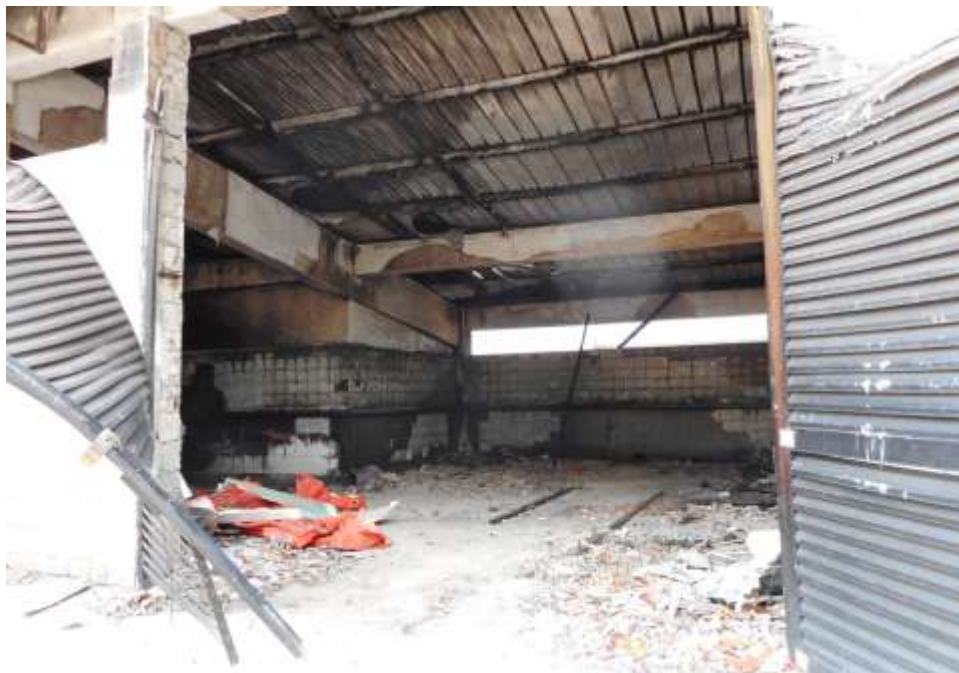
**Photo 19** shows the close up view of the inside of the Rubbish Collection Centre at Chai Chee Lane Block 512. From our observations, the doors, walls, roof and surroundings combustible materials were affected by the fire.

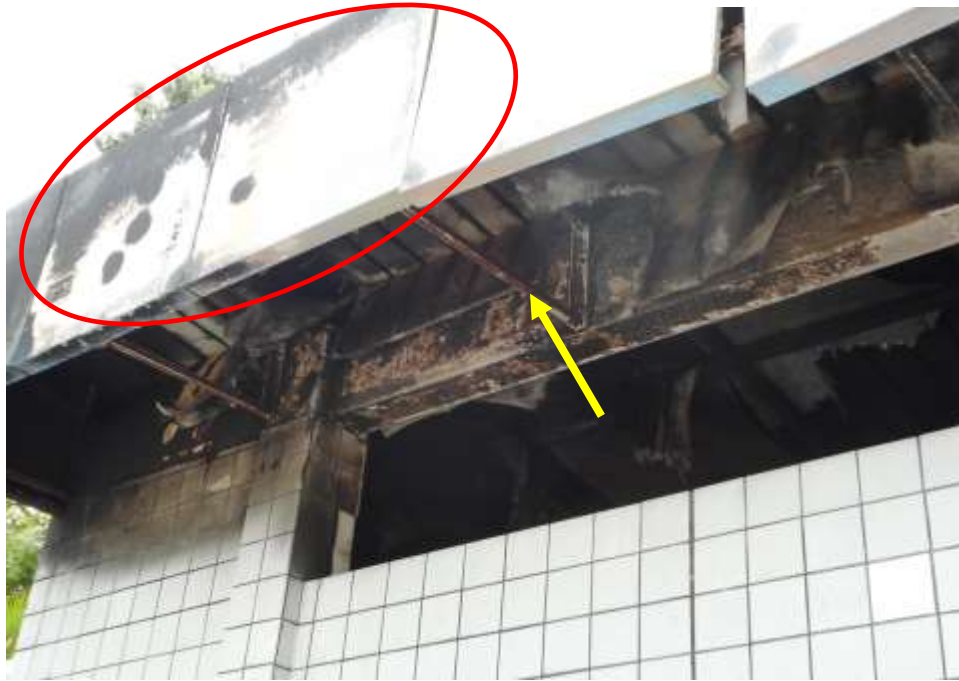
**Photo 20** shows the fire damage on the roof panels. From our observations, the high heat intensity burn marks (whitish burn marks) found on the exterior surface of its roofs panels (circled) and rust that had developed on the metal support brackets of the roof panels (yellow arrow) on the structure of the rubbish collection centre.

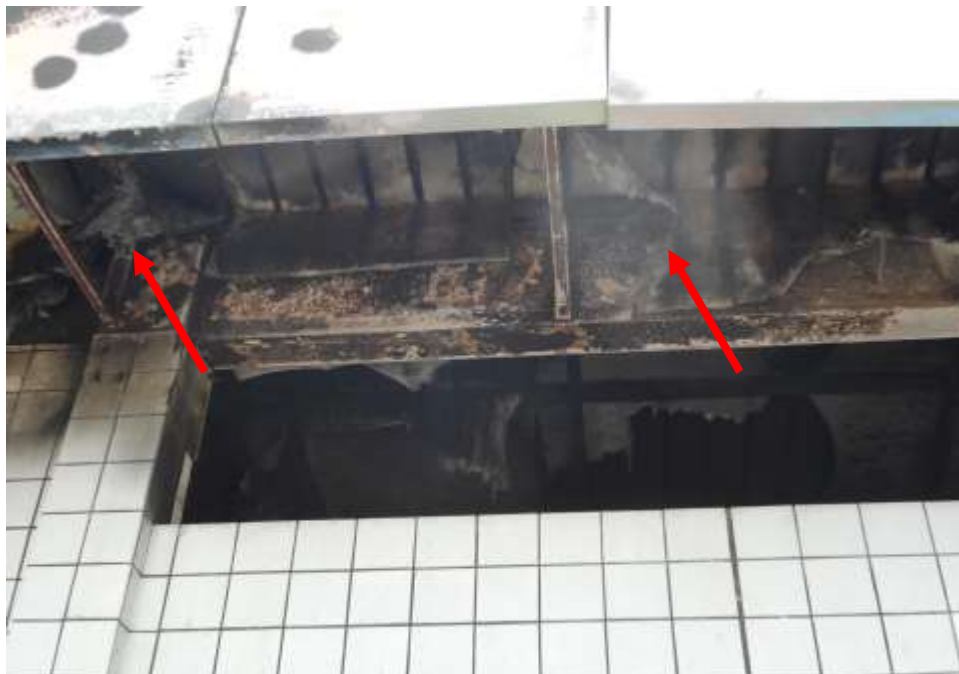
**Photo 21** shows the fire damage on the roof linings. From our observations, the roof linings materials (arrowed) had caught fire and fall off the roof structure and onto the Insured Vehicle resulting the heat and smoke damage on the cabin top, resulting in high heat intensity burn marks (whitish burn marks) found on the exterior surface of its cabin top as well as rust.

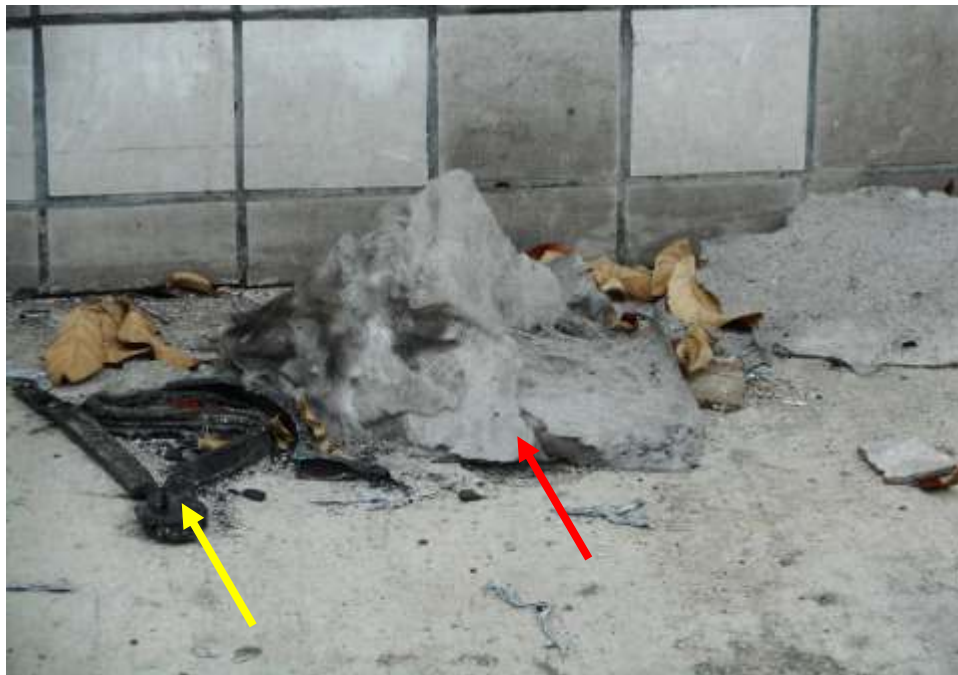
**Photo 22** shows the traces of residue materials of the roof linings and melted parts from the Insured Vehicle. The roof linings materials (red arrow) and parts of the Insured Vehicle (yellow arrow) had fallen off the roof onto the ground due to the intensity of the fire.

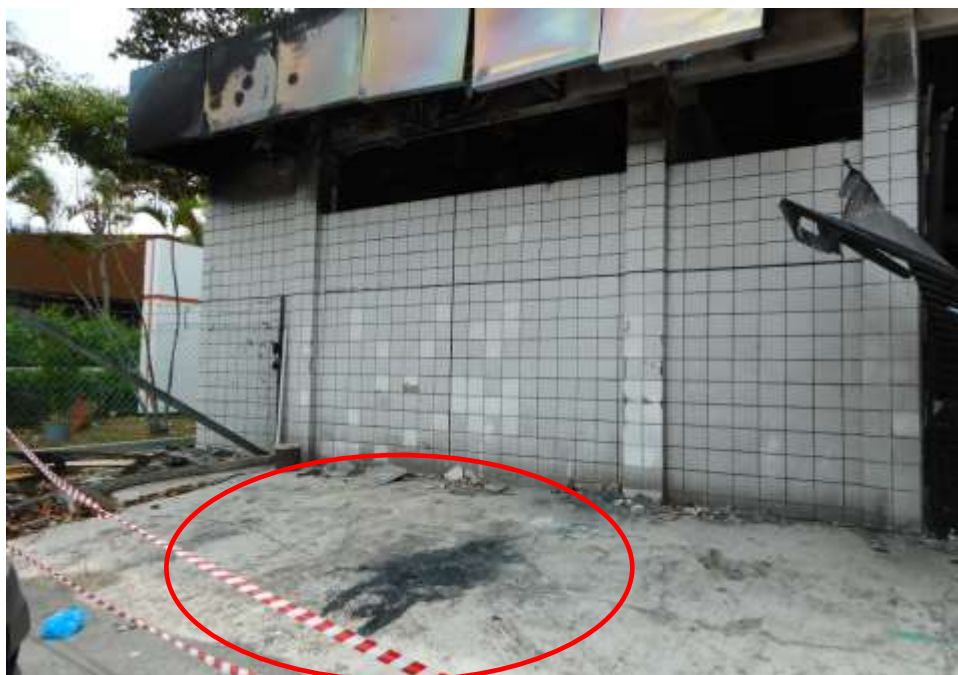
**Photo 23** shows the general view of the location where the fire incident had occurred. The Insured Vehicle was positioned head in at the front pouch of the Rubbish Collection Centre at Chai Chee Lane Block 512. From our observations, we see a melted leftover black residue of plastic on the ground which was the melted air filter box from the cabin top of the Insured Vehicle. (circled) Due to the burning roof lining landed on the air filter box and melting it onto the ground.
