Your Ref: TP/IP/39375/2019  
Our Ref : CI/TPD19017316/N

**Fatal Accident Investigation Team**

**INSPECTION REPORT OF MOTORCYCLE FBD 4157K**

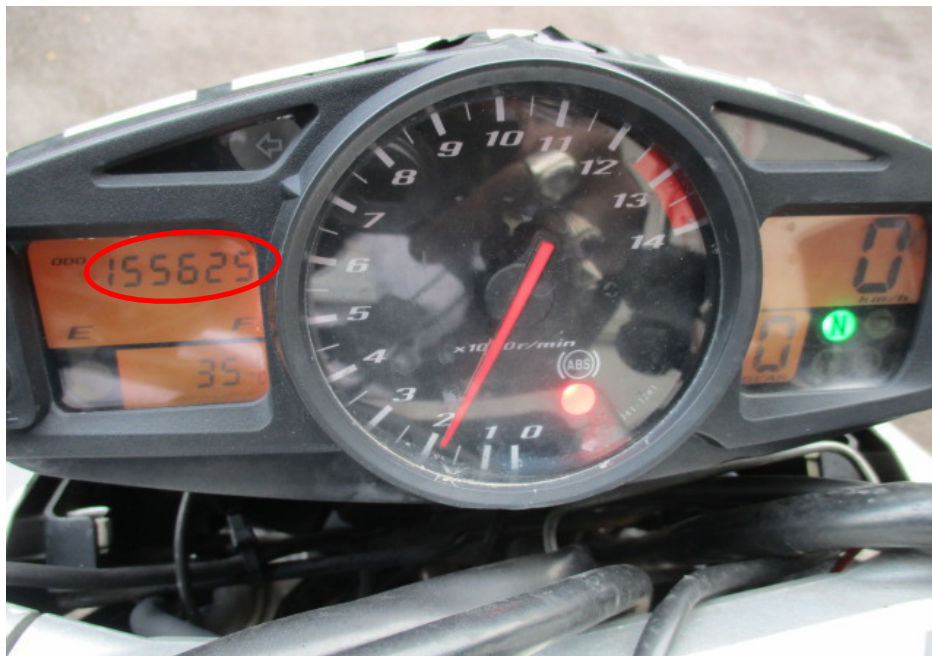
**Photo 1** shows the speedometer gauge of the Motorcycle where the mileage recorded at the time of our inspection was 155, 625km (circled).

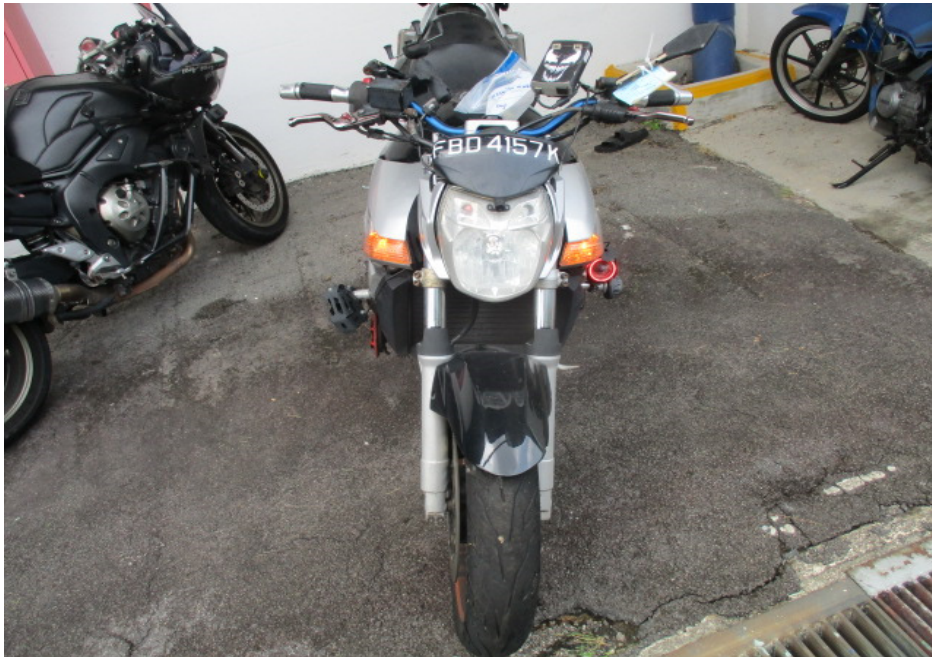
**Photo 2** shows a general view of the frontal portion of the Motorcycle at the time of our inspection. The Motorcycle was observed to have sustained damages at its frontal portion and right body.

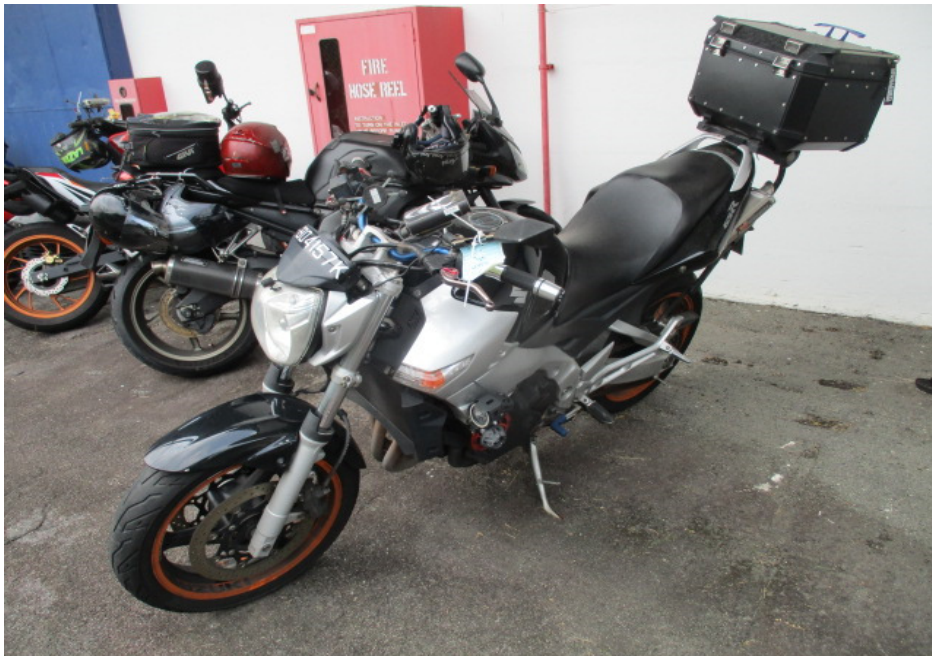
**Photo 3** shows a general view of the left body of the Motorcycle at the time of our inspection. The Motorcycle was observed to have sustained damages at its frontal portion and right body.

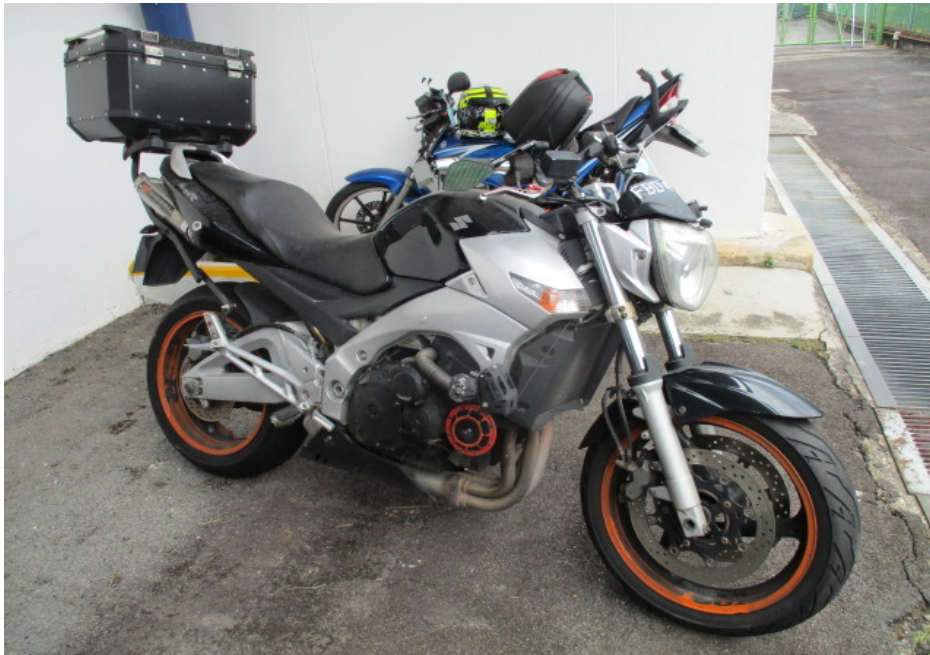
**Photo 4** shows a general view of the right body of the Motorcycle at the time of our inspection. The Motorcycle was observed to have sustained damages at its frontal portion and right body. Amongst the body parts that were found to have been damaged include its head cowl, right side cowl, right handlebar end, right side mirror, front brake lever, rear brake pedal, right front footrest, right rear side cover and exhaust muffler, amongst others.

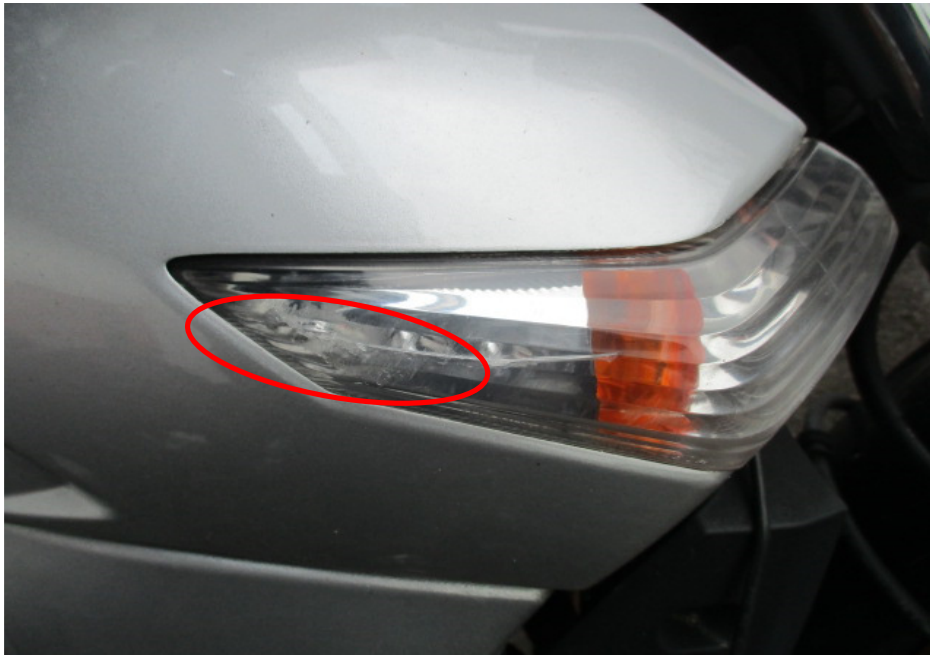
**Photo 5** shows a close up view of the right cowl and right front signal lamp which were amongst the body parts of the Motorcycle that had sustained damage as a result of the accident (circled).

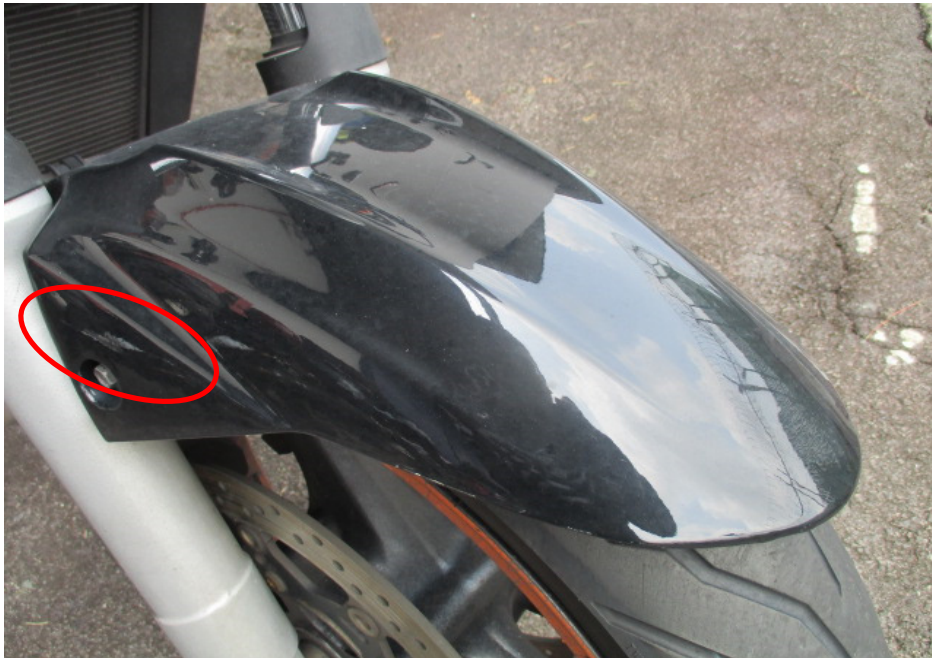
**Photo 6** shows a closer view of the front mudguard which was amongst the body parts at the front body of the Motorcycle that had sustained damage as a result of the accident (circled).

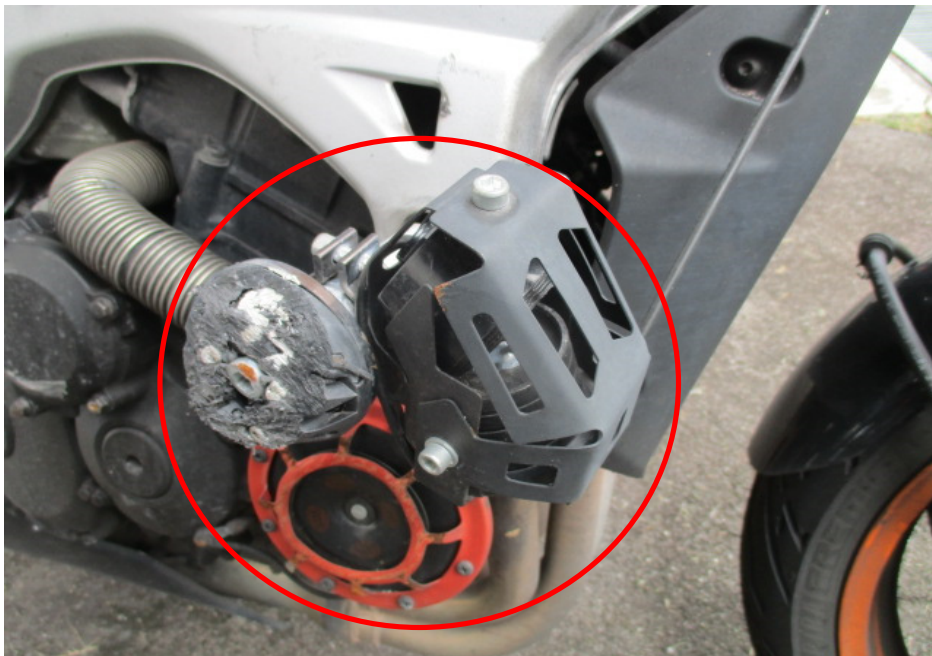
**Photo 7** shows a closer view of the right frame slider, horn and right fog light of the Motorcycle that had sustained damages of grazing nature as a result of the accident (circled).

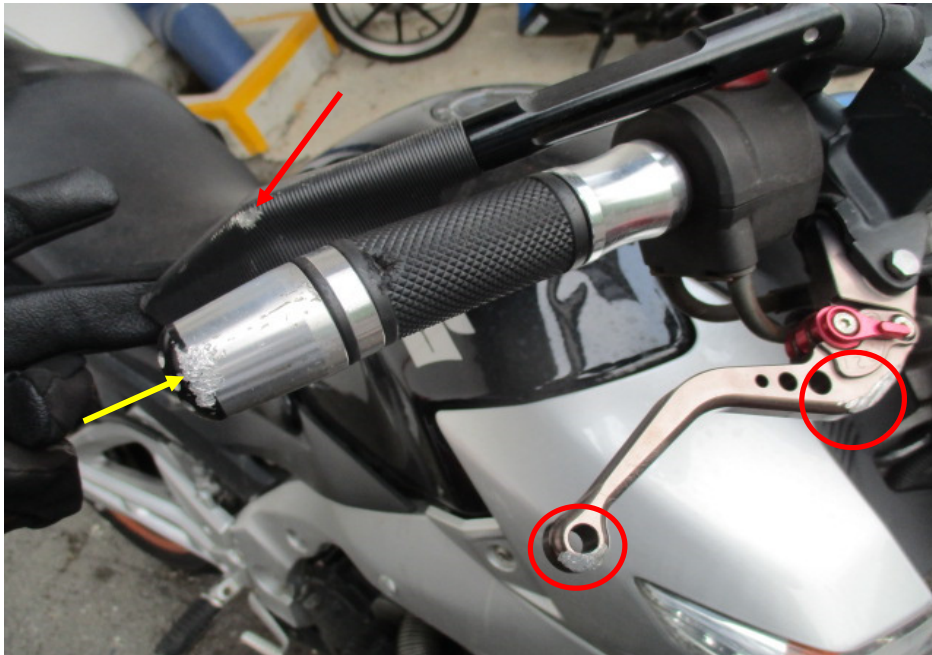
**Photo 8** shows a closer view of the right handlebar end (yellow arrow), right side mirror (red arrow) and front brake lever (circled) which were amongst the body parts of the Motorcycle that had sustained damage as a result of the accident.

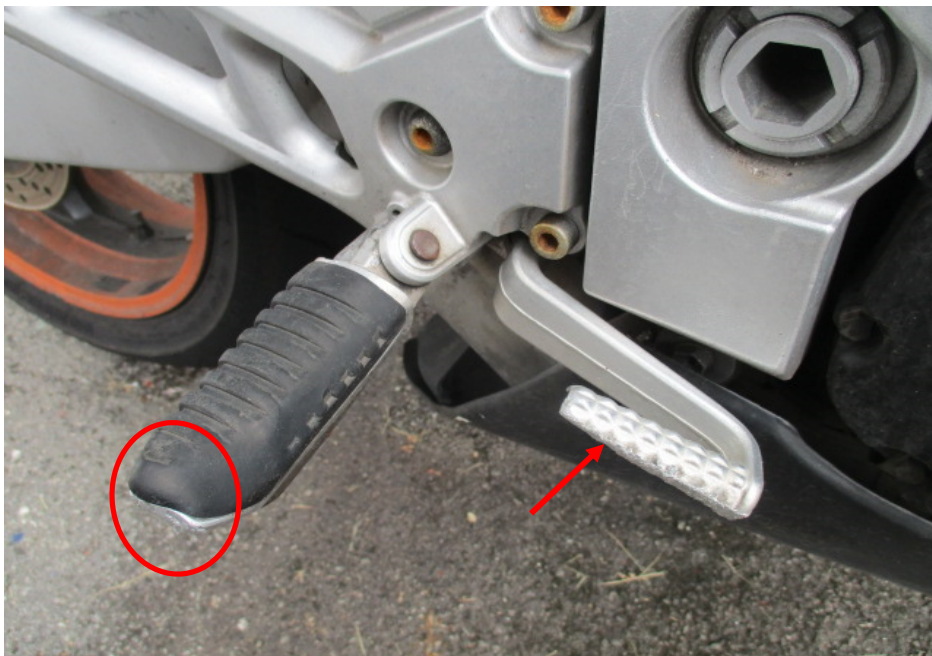
**Photo 9** shows a closer view of the rear brake pedal (arrowed) and right front footrest (circled) which were amongst the body parts of the Motorcycle that had sustained damage as a result of the accident.

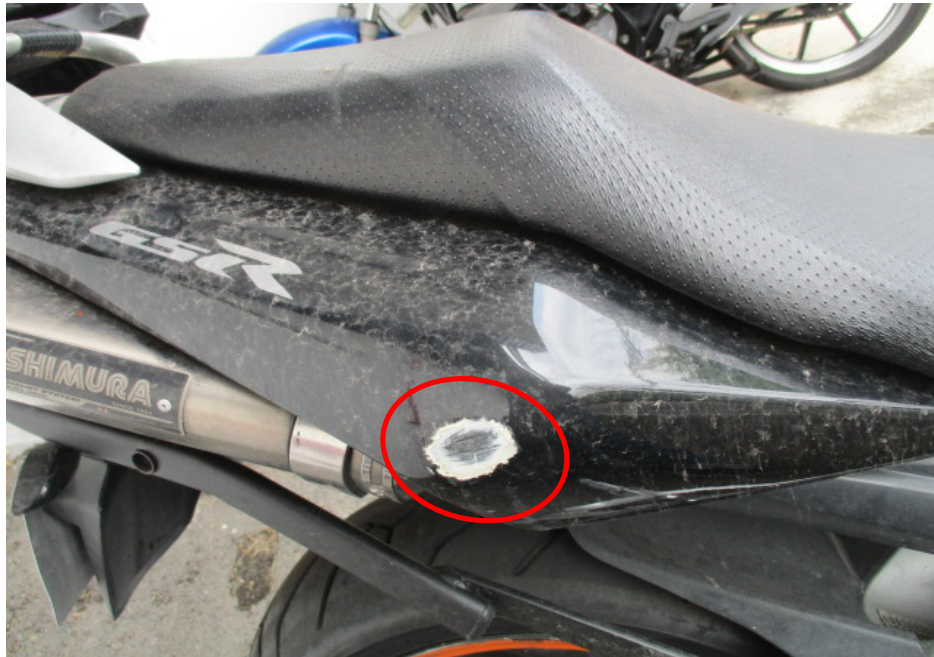
**Photo 10** shows a closer view of the right rear side cover which was amongst the body parts of the Motorcycle that had sustained damages of grazing nature as a result of the accident (circled).

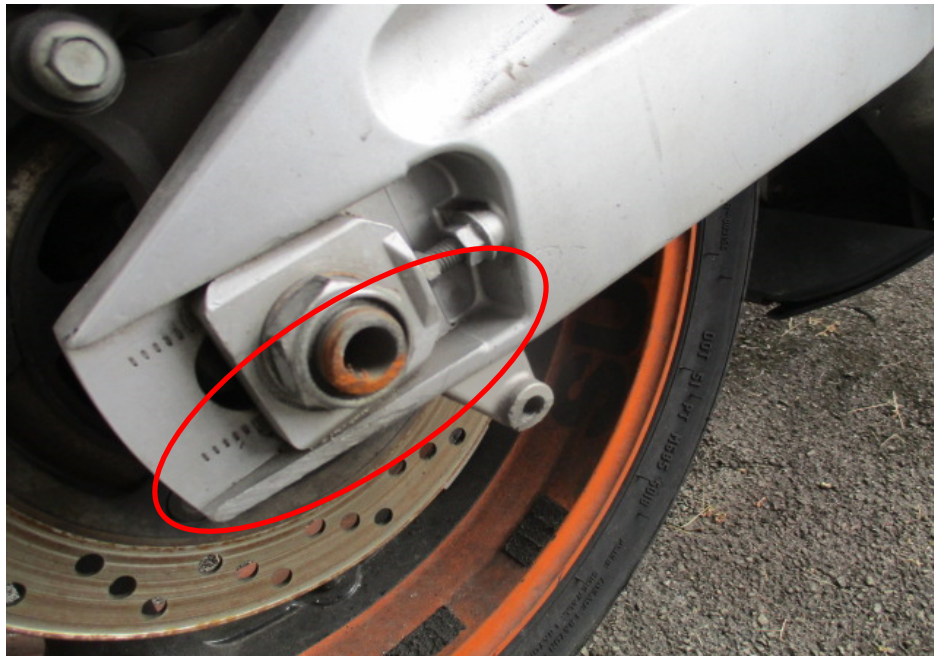
**Photo 11** shows a closer view of the swingarm and rear wheel axle nut which were amongst the body parts of the Motorcycle that had sustained damages of grazing nature as a result of the accident (circled).

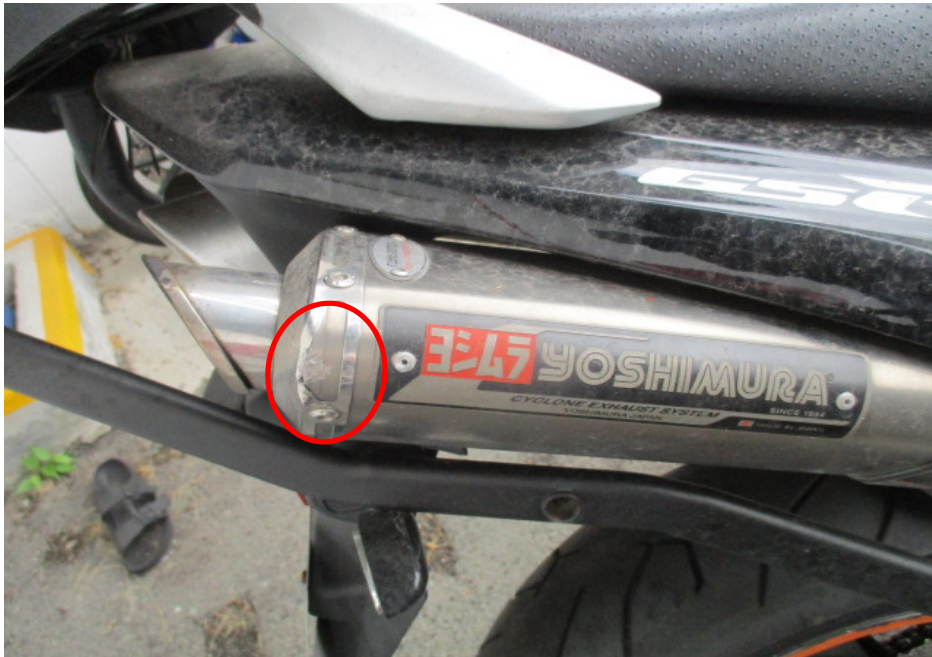
**Photo 12** shows a closer view of the right exhaust muffler of the Motorcycle that had sustained damages of grazing nature as a result of the accident (circled).

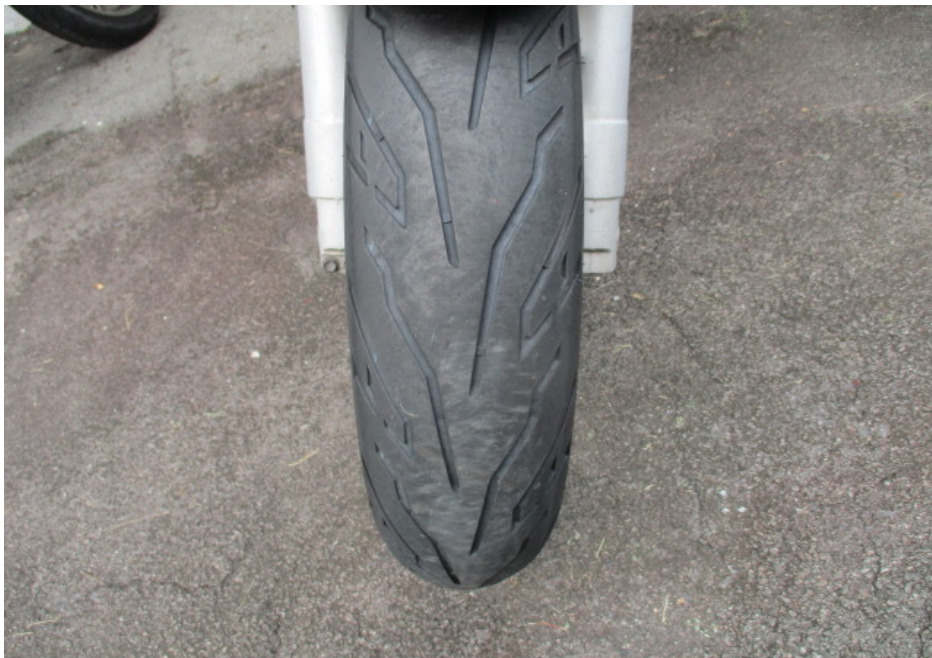
**Photo 13** shows the condition of the Motorcycle's front tyre. The front tyre was observed to be in serviceable condition with remaining tread depth of approximately 3mm. There was no tear, burst mark(s) and/or punctured hole(s) on the sidewalls as well as across the tread of the front tyre.

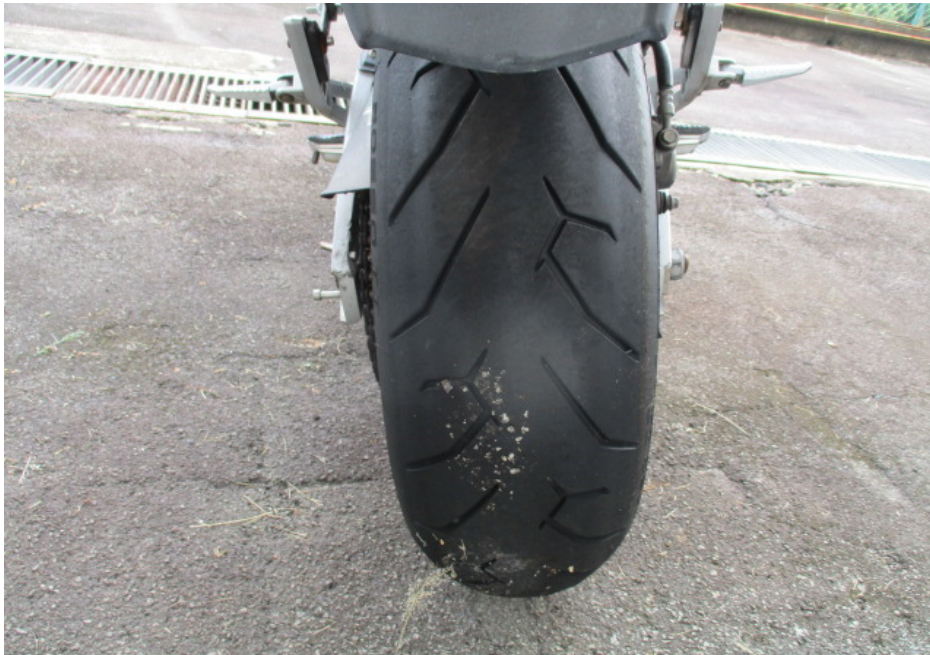
**Photo 14** shows the condition of the Motorcycle's rear tyre. The rear tyre was observed to be in serviceable condition with remaining tread depth of approximately 4mm. The tyre was also observed to be sufficiently inflated for vehicular operation. We did not observe any tear, burst mark(s) and/or punctured hole(s) on the sidewalls as well as across the tread of the rear tyre.

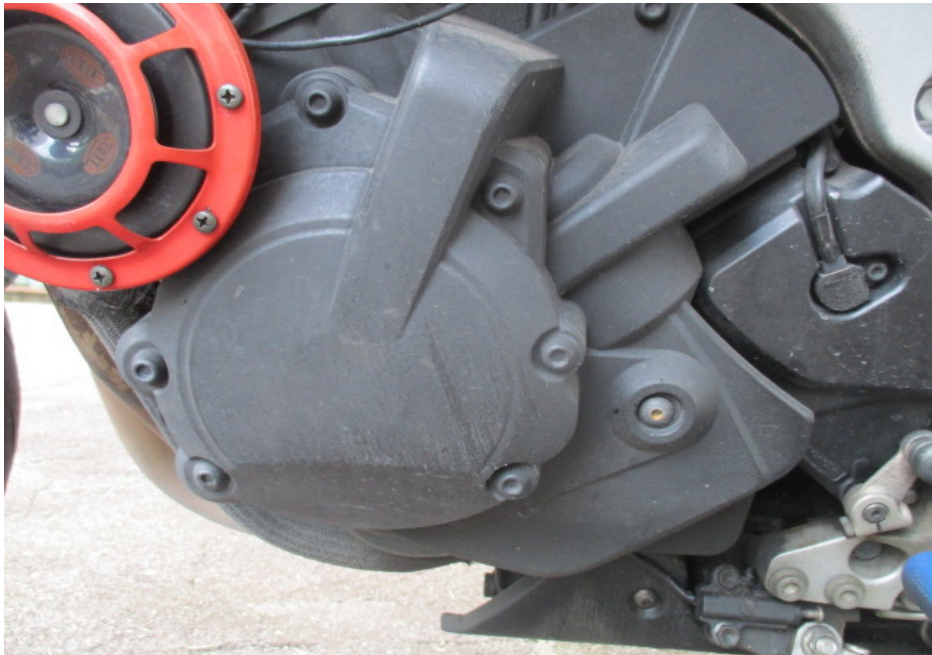
**Photo 15** shows the left side of the engine of the Motorcycle at the time of our inspection. The various engine related parts and components were found to be intact with no visible damage. There was also no sign(s) or indication(s) of fluid leak observed around the left engine area of the Motorcycle.

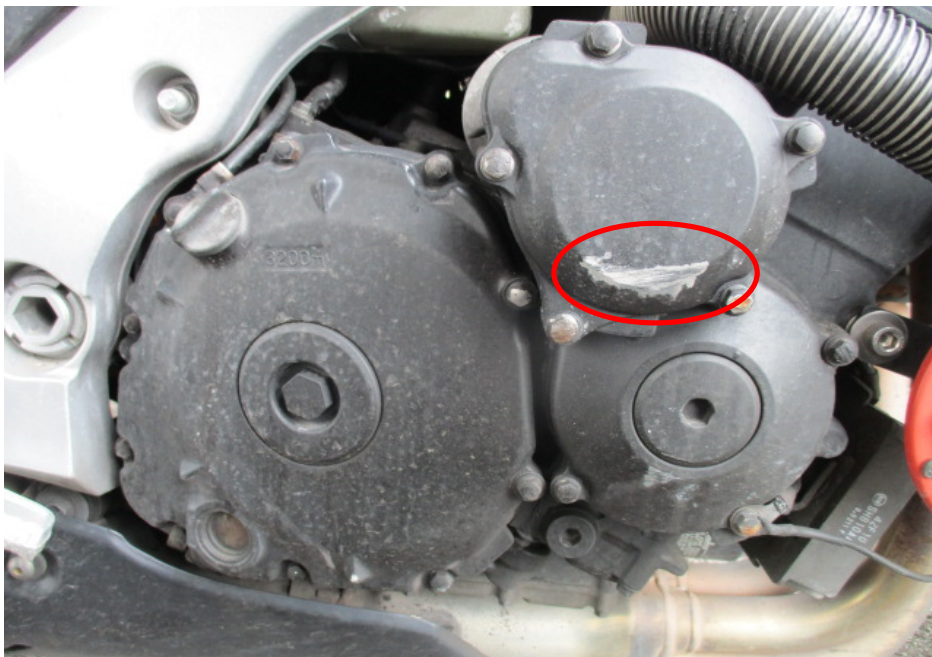
**Photo 16** shows the right side of the engine of the Motorcycle at the time of our inspection. The various right engine components had sustained damage of grazing nature as a result of the accident (circled) however the engine components were still intact. There was also no fluid leak and/or fluid stain found around the right engine area of the Motorcycle.

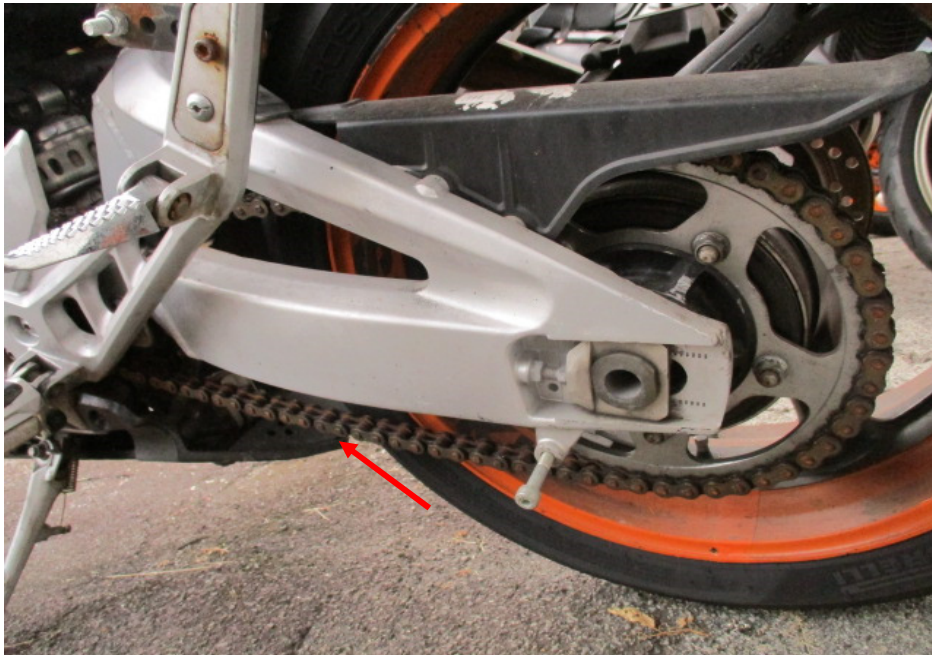
**Photo 17** shows the general view of the gear train (arrowed) of the Motorcycle, which was observed to be intact with no misalignment. It was also adequately lubricated for operating purposes.

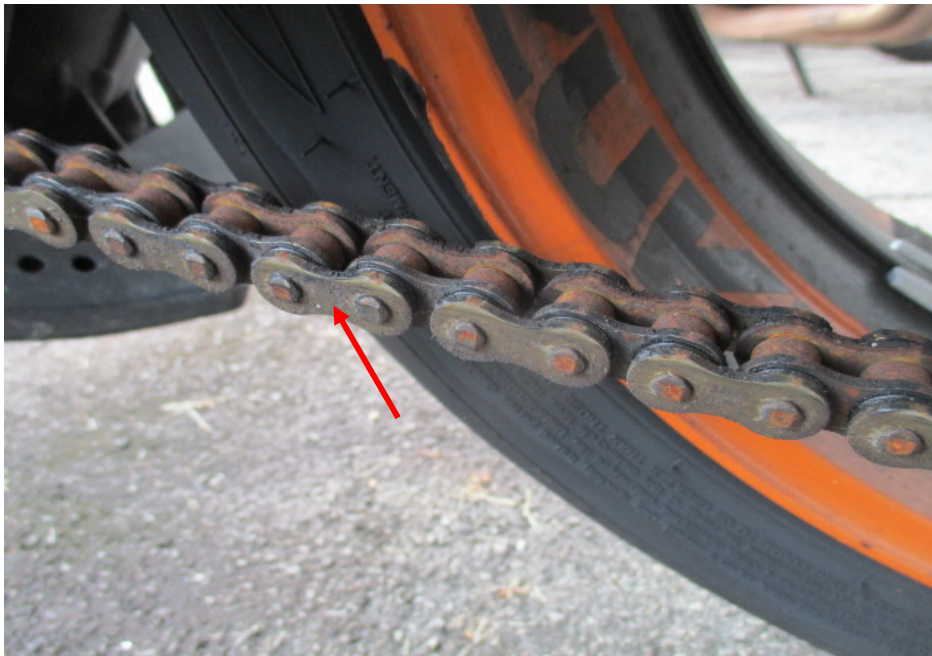
**Photo 18** shows a closer view of the gear train (arrowed) of the Motorcycle, which was observed to be intact with no misalignment. It was also adequately lubricated for operating purposes.

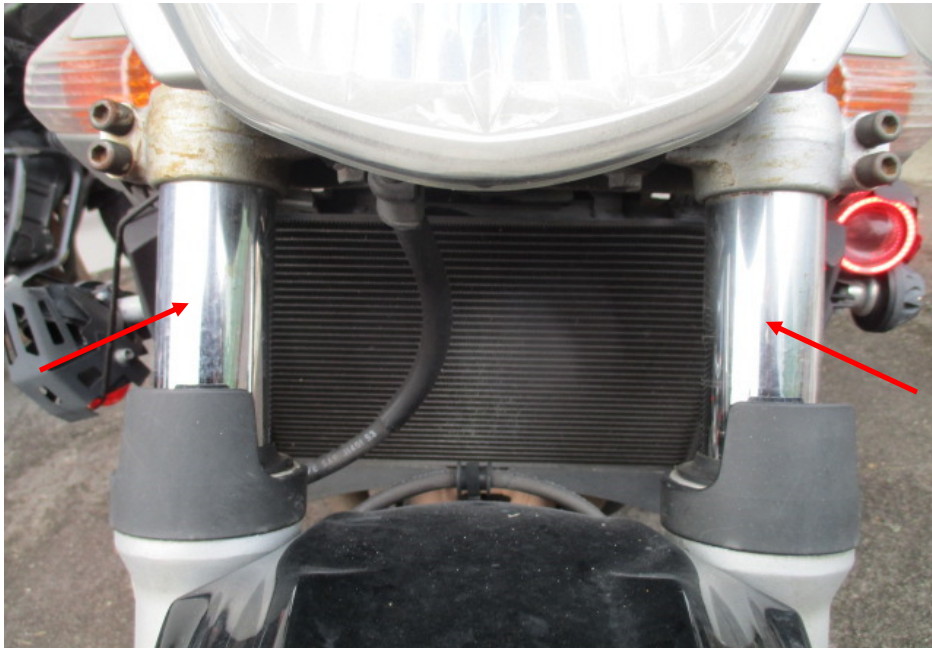
**Photo 19** shows the front fork (arrowed) of the Motorcycle. The front fork and fork bracket of the Motorcycle were both found to be intact and undamaged. Turning the Motorcycle's handle bar towards the left and right did not produce any abnormal free play and/or resistance. The steering system of the Motorcycle was in serviceable condition at the time of our inspection.

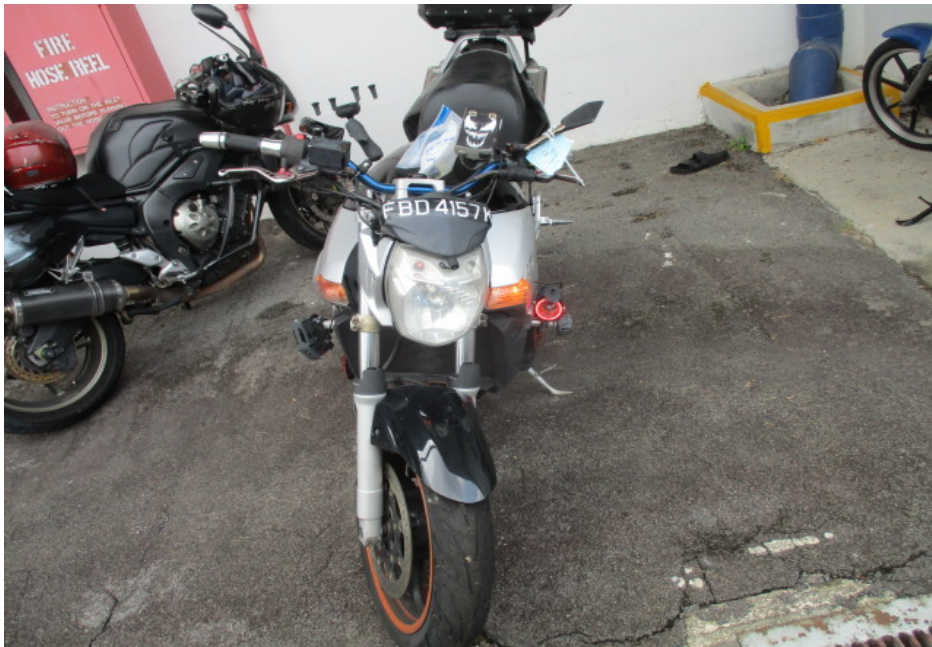
**Photo 20** shows the front wheel of the Motorcycle turned towards its full left. Turning the Motorcycle's handle bar towards the left and right did not produce any abnormal free play and/or resistance. This would indicate that the steering system of the Motorcycle was in serviceable condition at the time of our inspection.

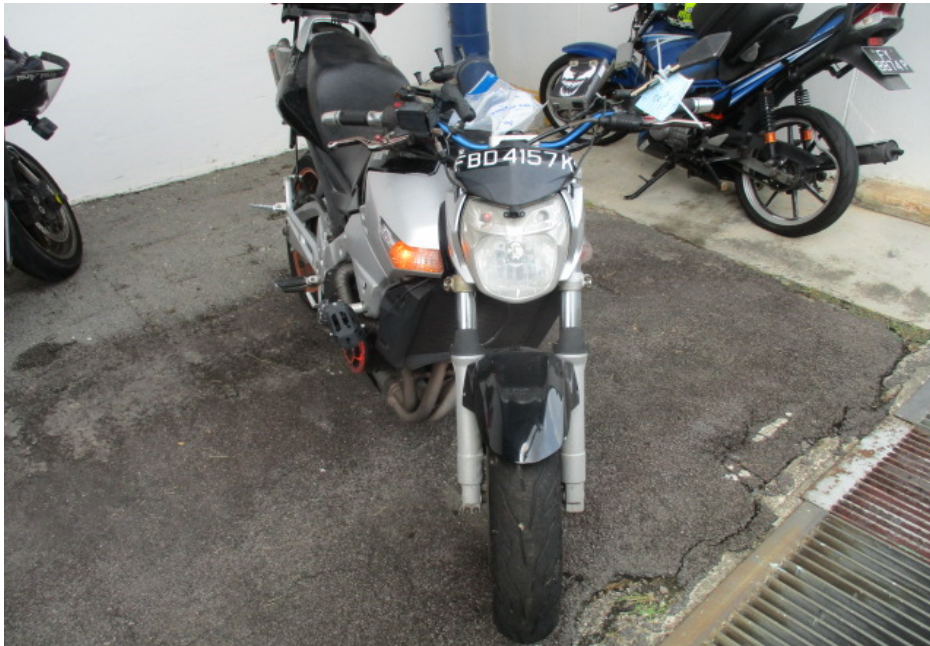
**Photo 21** shows the front wheel of the Motorcycle turned towards its full right. Turning the Motorcycle's handle bar towards the left and right did not produce any abnormal free play and/or resistance. This would indicate that the steering system of the Motorcycle was in serviceable condition at the time of our inspection.

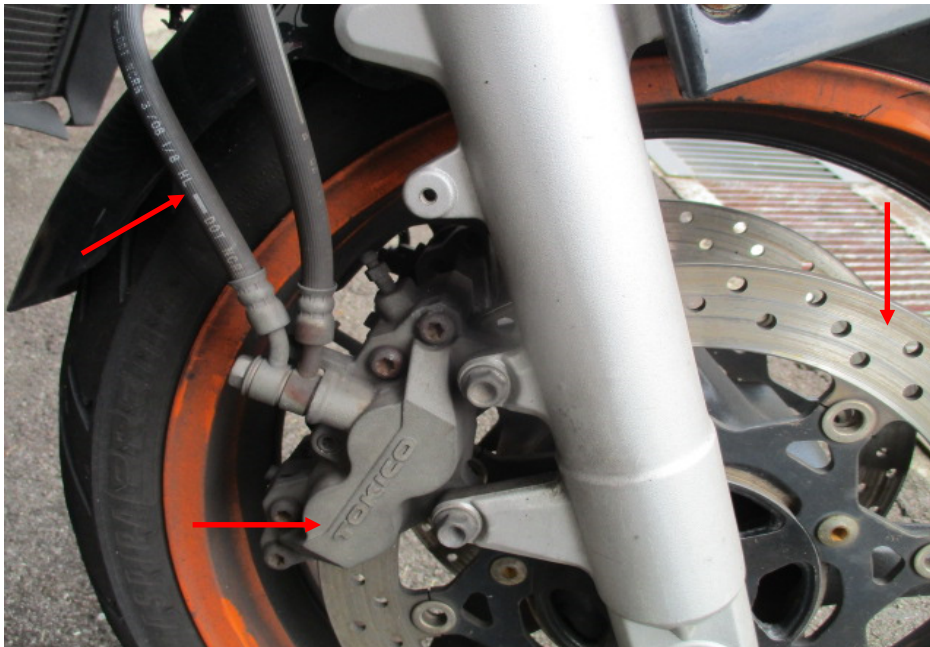
**Photo 22** shows a close up view of the front brake caliper, front brake disc and front brake hose (arrowed) at the right side of the Motorcycle's front wheel, which are all part of the components in the hydraulic front brake system of the Motorcycle. Our visual checks of these various components had revealed all to be intact with no visible damage. No leakage of brake fluid was also observed.

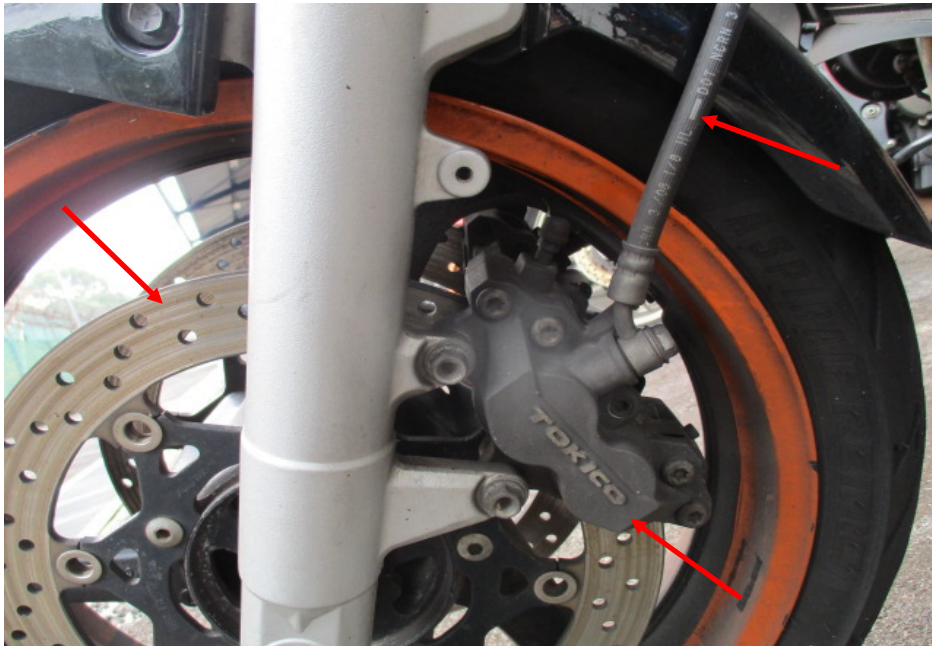
**Photo 23** shows a close up view of the front brake caliper, front brake disc and front brake hose (arrowed) at the left side of the Motorcycle's front wheel, which are all part of the components in the hydraulic front brake system of the Motorcycle. Our visual checks of these various components had revealed all to be intact with no visible damage. No leakage of brake fluid was also observed.

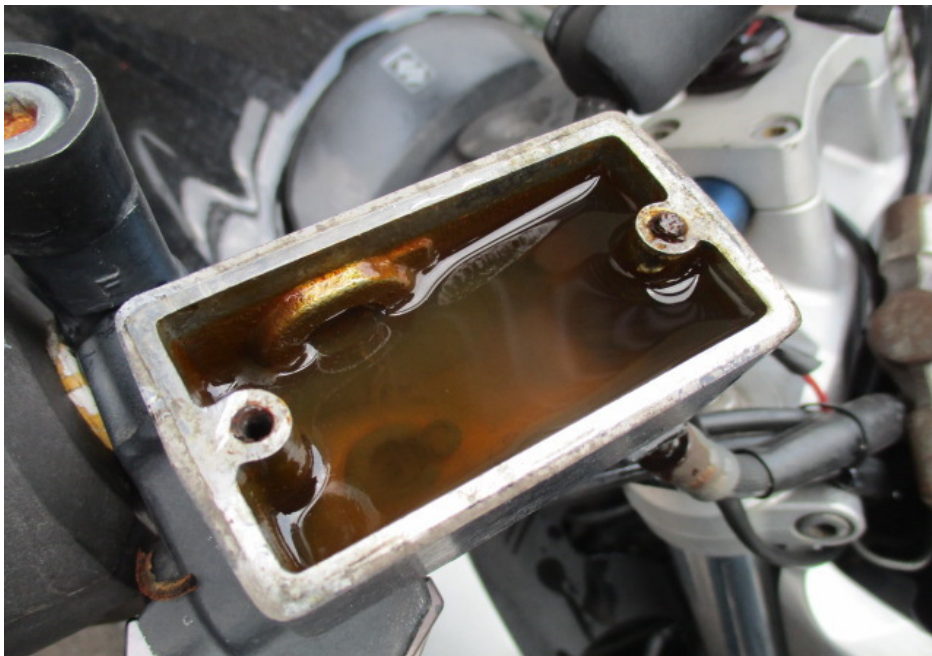
**Photo 24** shows the brake fluid reservoir for the front brake of the Motorcycle. The brake fluid was observed to be of sufficient level and without contamination for operational purposes.

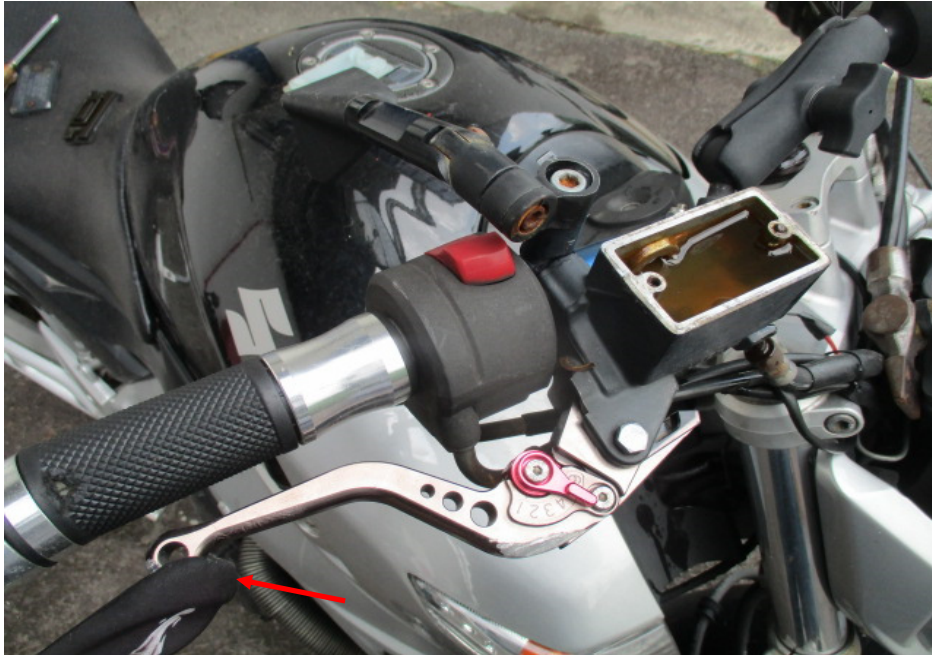
**Photo 25** shows the front brake lever being depressed. There was some resistance felt (spongy like feel) upon pressing the front brake lever (arrowed). This would indicate that there is no leakage of pressure/vacuum in the brake system.

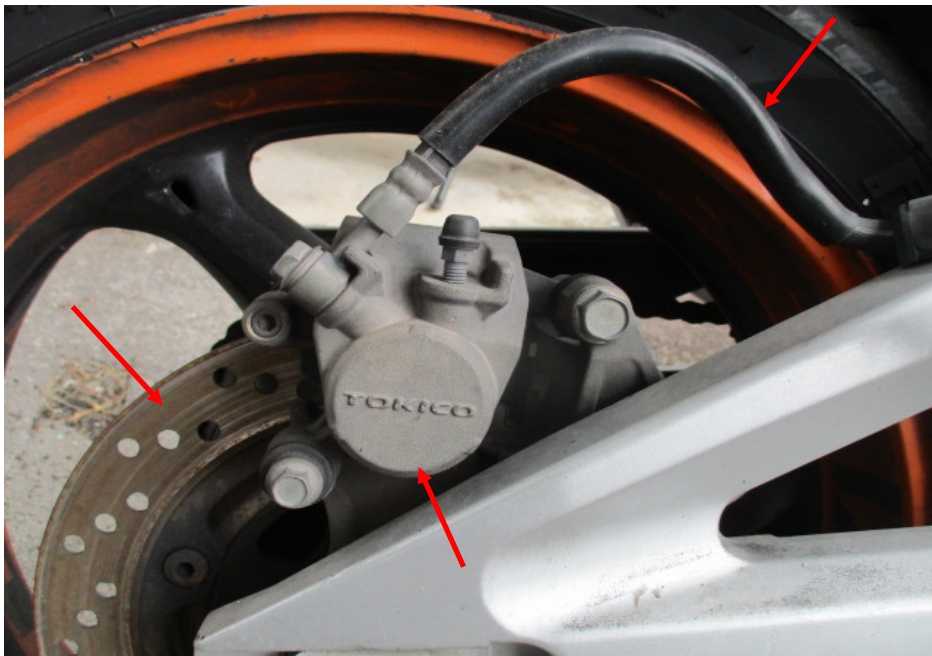
**Photo 26** shows a close up view of the rear brake caliper, rear brake disc and rear brake hose (arrowed) of the Motorcycle, which are all part of the components in the hydraulic rear brake system of the Motorcycle. Our visual checks of these various components had revealed all to be intact with no visible damage. No leakage of brake fluid was also observed.
