Your Ref: 8567853436SG
Our Ref : CI/AIG19017385/D

04 October 2019

TECHNICAL INVESTIGATION REPORT OF FIRE INCIDENT INVOLVING THE INSURED VEHICLE SKP 7717E ON 20 SEPTEMBER 2019

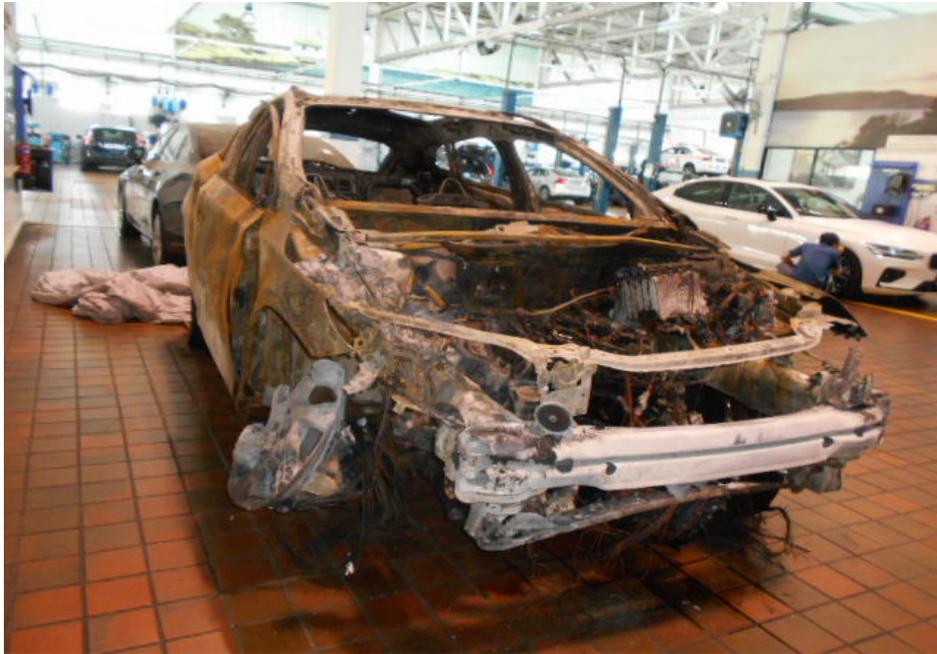
Photo 1 shows a general view of the front right body of the Insured Vehicle at the time of my inspection. The Insured Vehicle was observed to have been extensively burnt, leaving skeletal char remains. The entire Insured Vehicle was affected as a result of the fire.

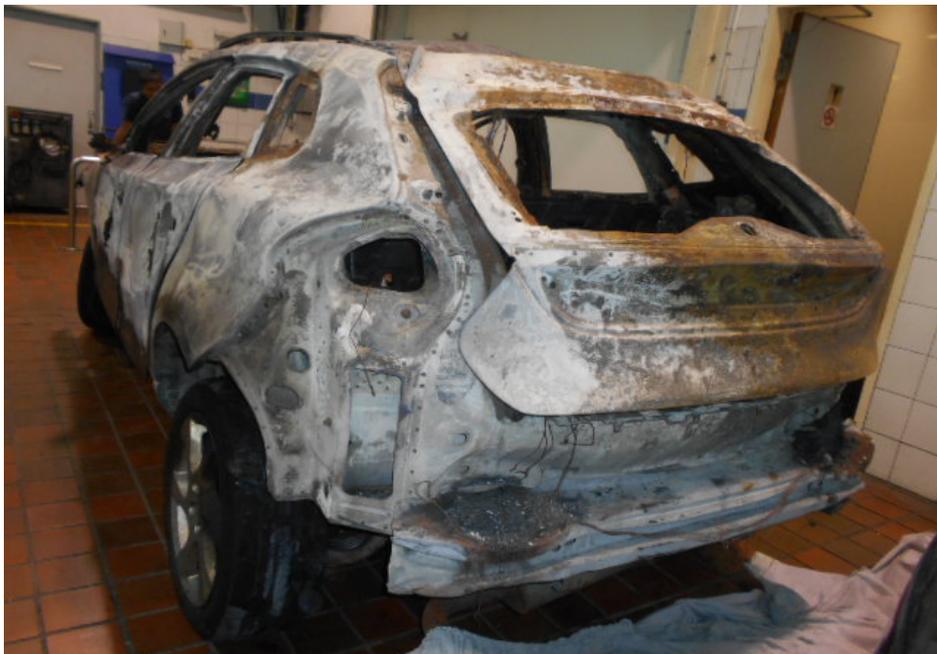
Photo 2 shows a general view of the rear left body of the Insured Vehicle at the time of my inspection. The Insured Vehicle was observed to have been extensively burnt, leaving skeletal char remains. The entire Insured Vehicle was affected as a result of the fire.

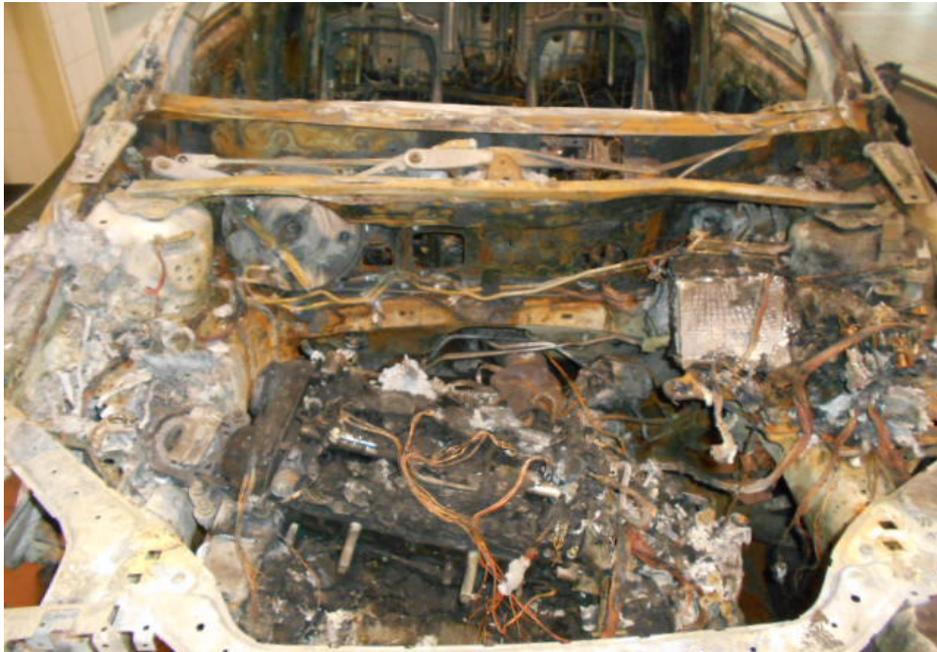
Photo 3 shows a general view of the engine compartment of the insured vehicle. All the parts inside the engine compartment were burned to char as a result of the fire. From what can be observed, there was no modification(s) and/or additional electrical and/or electronic component(s) fitted on the Insured Vehicle.

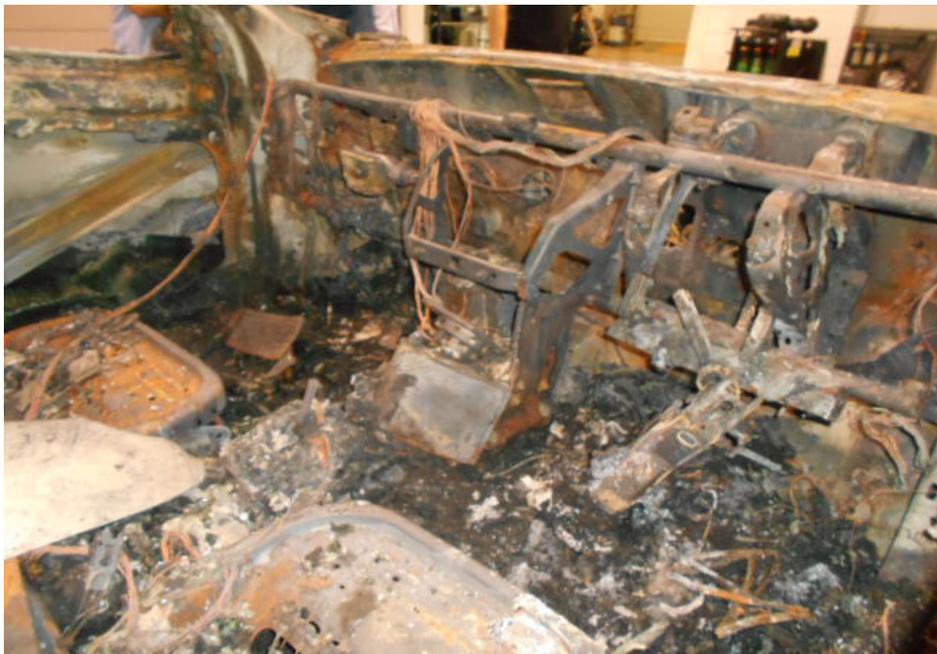
Photo 4 shows a general view of the interior compartment of the insured vehicle. All the parts inside the interior compartment were burned to char as a result of the fire. From what can be observed, there was no modification(s) and/or additional electrical and/or electronic component(s) fitted on the Insured Vehicle.

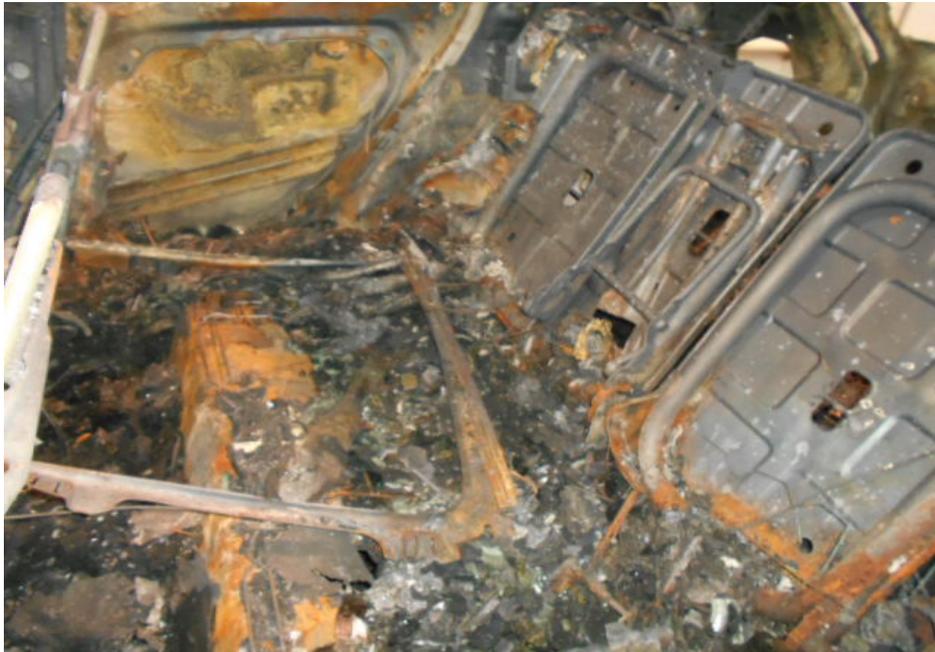
Photo 5 shows the rear of the Insured Vehicle's interior compartment. All the parts inside the interior compartment were burned to char leaving skeletal remains.

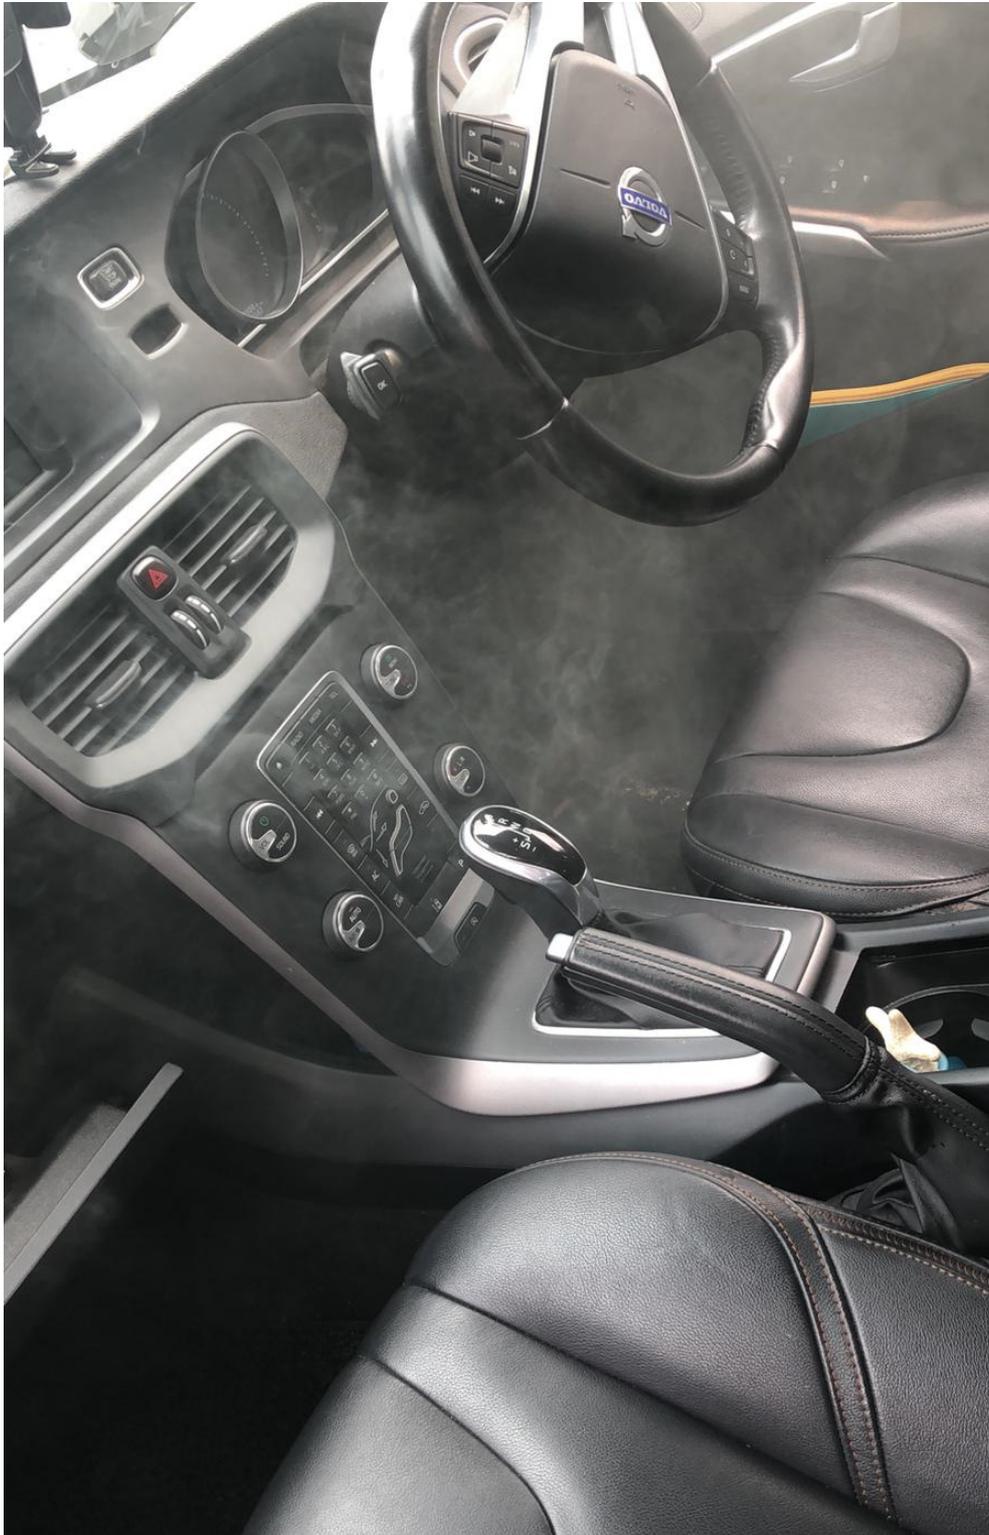
Photo 6 shows white coloured smoke inside the interior compartment of the Insured Vehicle, at the centre console/centre of front dashboard area (photograph provided by Ms Suzana). According to Ms Suzana, smoke was coming out from the air-conditioning vents of the Insured Vehicle as she was driving along CTE.

19. As seen in photograph 6 above, smoke was gathered at the centre console/centre of front dashboard area of the Insured Vehicle before the fire. The subsequent outbreak of fire was also inside the interior compartment, at the bottom of the left side centre console, at the foot well area of the front left passenger side (seen by Ms Suzana). Given these factors, the origin of fire can be established to be from within the interior compartment of the Insured Vehicle. This was also supported by flame subsequently coming out from the front left passenger door window and front right passenger door window first before spreading to the front and rear of the Insured Vehicle, as seen in photograph 7 and 10 above.

21. For this case, the first sight of flame was at the bottom of the left side centre console of the Insured Vehicle. A number of wiring harnesses are fitted behind the front dashboard area, which gives rise to the suggestion of an electrical short circuit to the wirings located behind the front dashboard of the Insured Vehicle. Since the wirings are located behind the front dashboard, smoke from an electrical short circuit would disperse through the air-conditioning vents amongst other gaps surrounding the front dashboard. This would correspond to the observation of smoke initially coming out from the air-conditioning vents of the Insured Vehicle. Hence, if following the information gathered for this case through my interview with Ms Suzana, and my examination of the available photographs that were taken at the incident scene, the cause of fire to the Insured Vehicle was due to electrical nature to the wiring harness behind the front dashboard area.

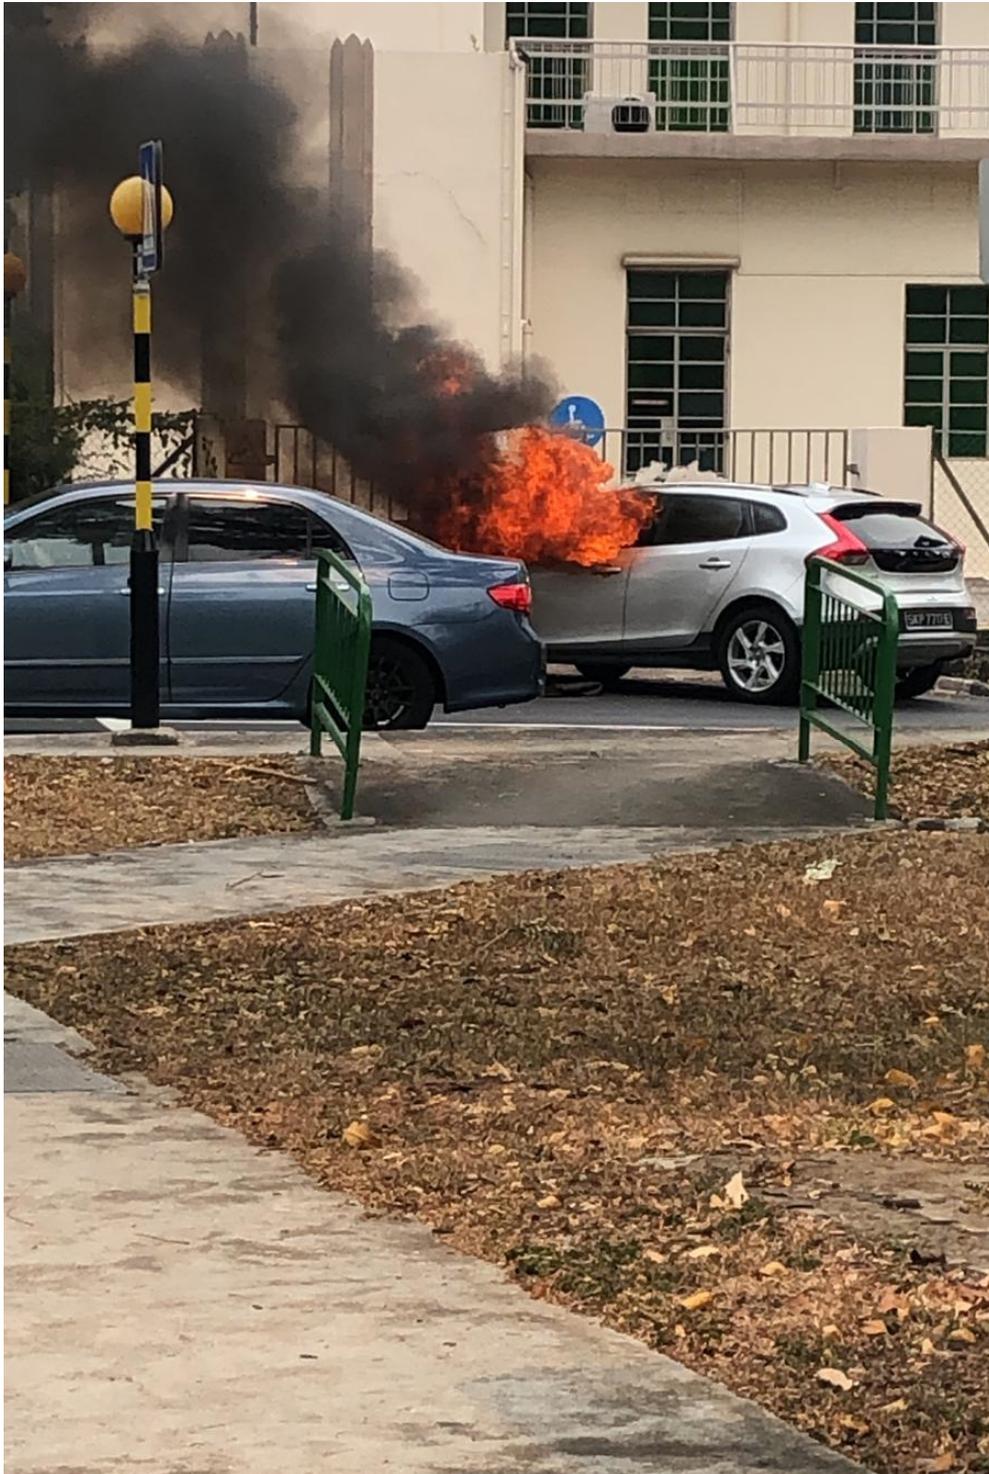
Photo 7 shows flame coming out from the front left passenger door window of the Insured Vehicle before spreading to the front and rear of the Insured Vehicle. This would indicate that the fire had originated from within the interior compartment of the Insured Vehicle, which corresponds to Ms Suzana's observation of a palm size flame inside the interior compartment (photograph provided by Ms Suzana).

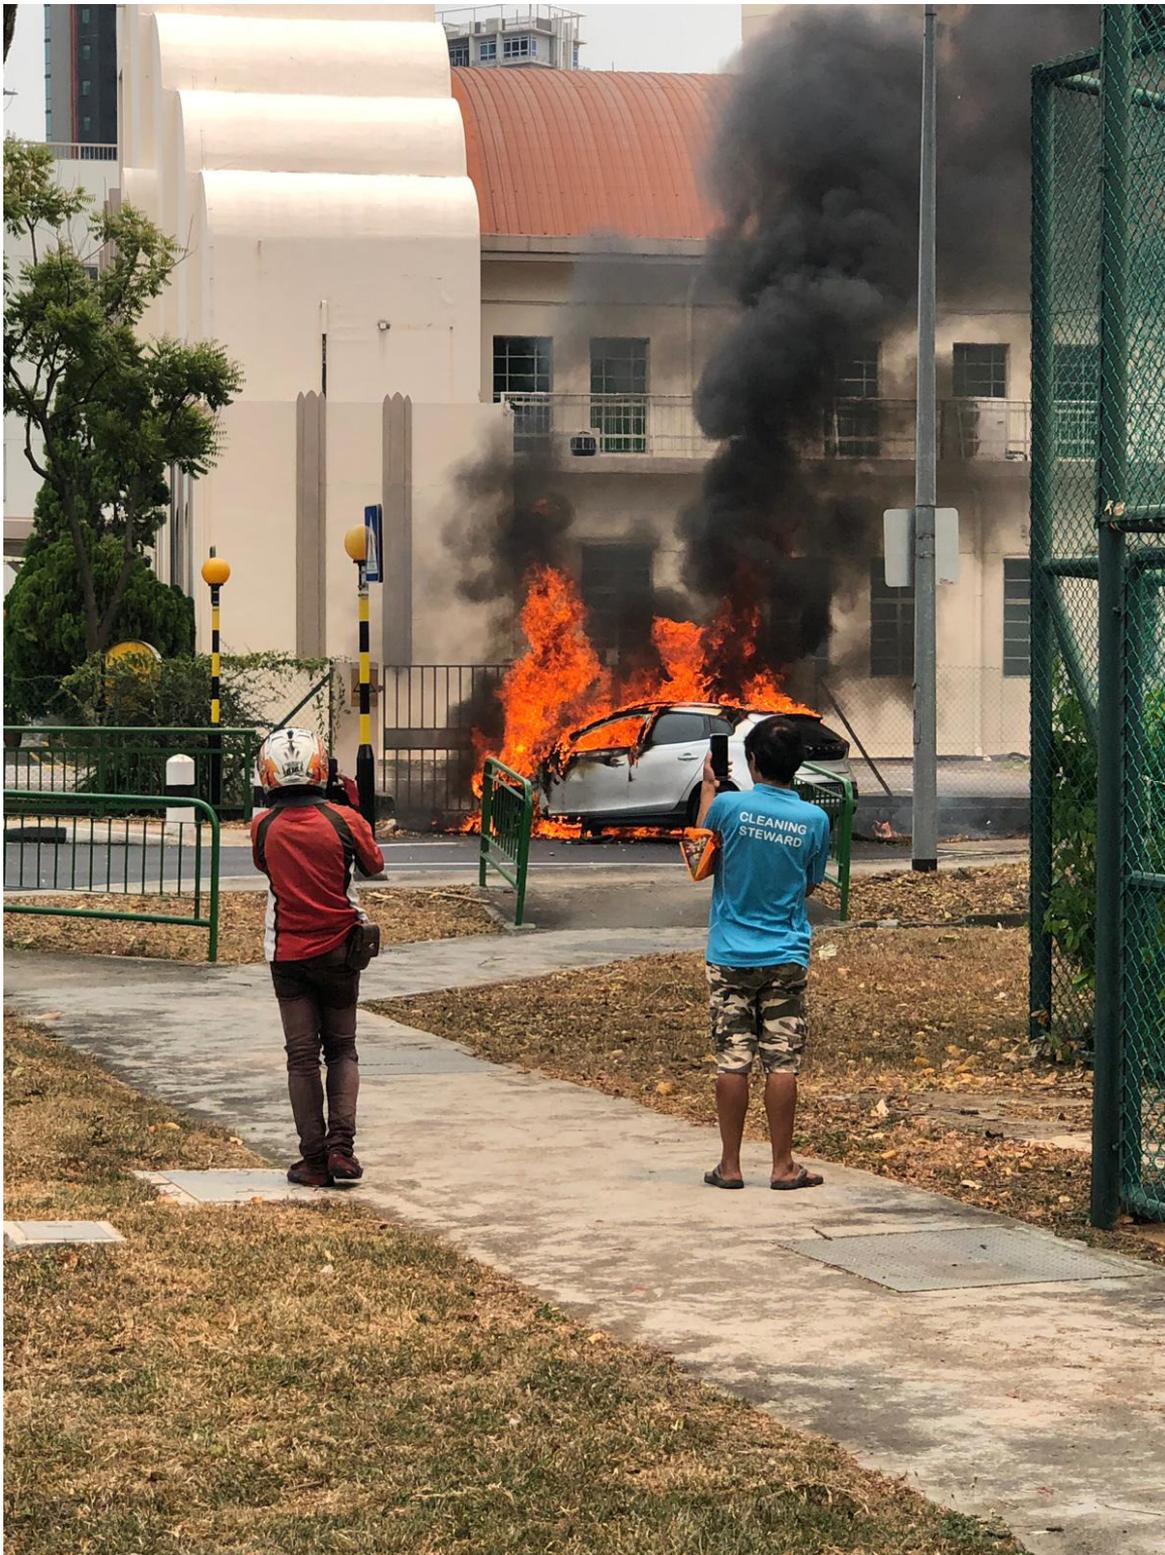
Photo 8 shows the Insured Vehicle at the incident scene engulfed in flame. From the interior compartment of the Insured Vehicle, the flame spread to the front and rear of the Insured Vehicle before SCDF arrival (photograph provided by Ms Suzana).

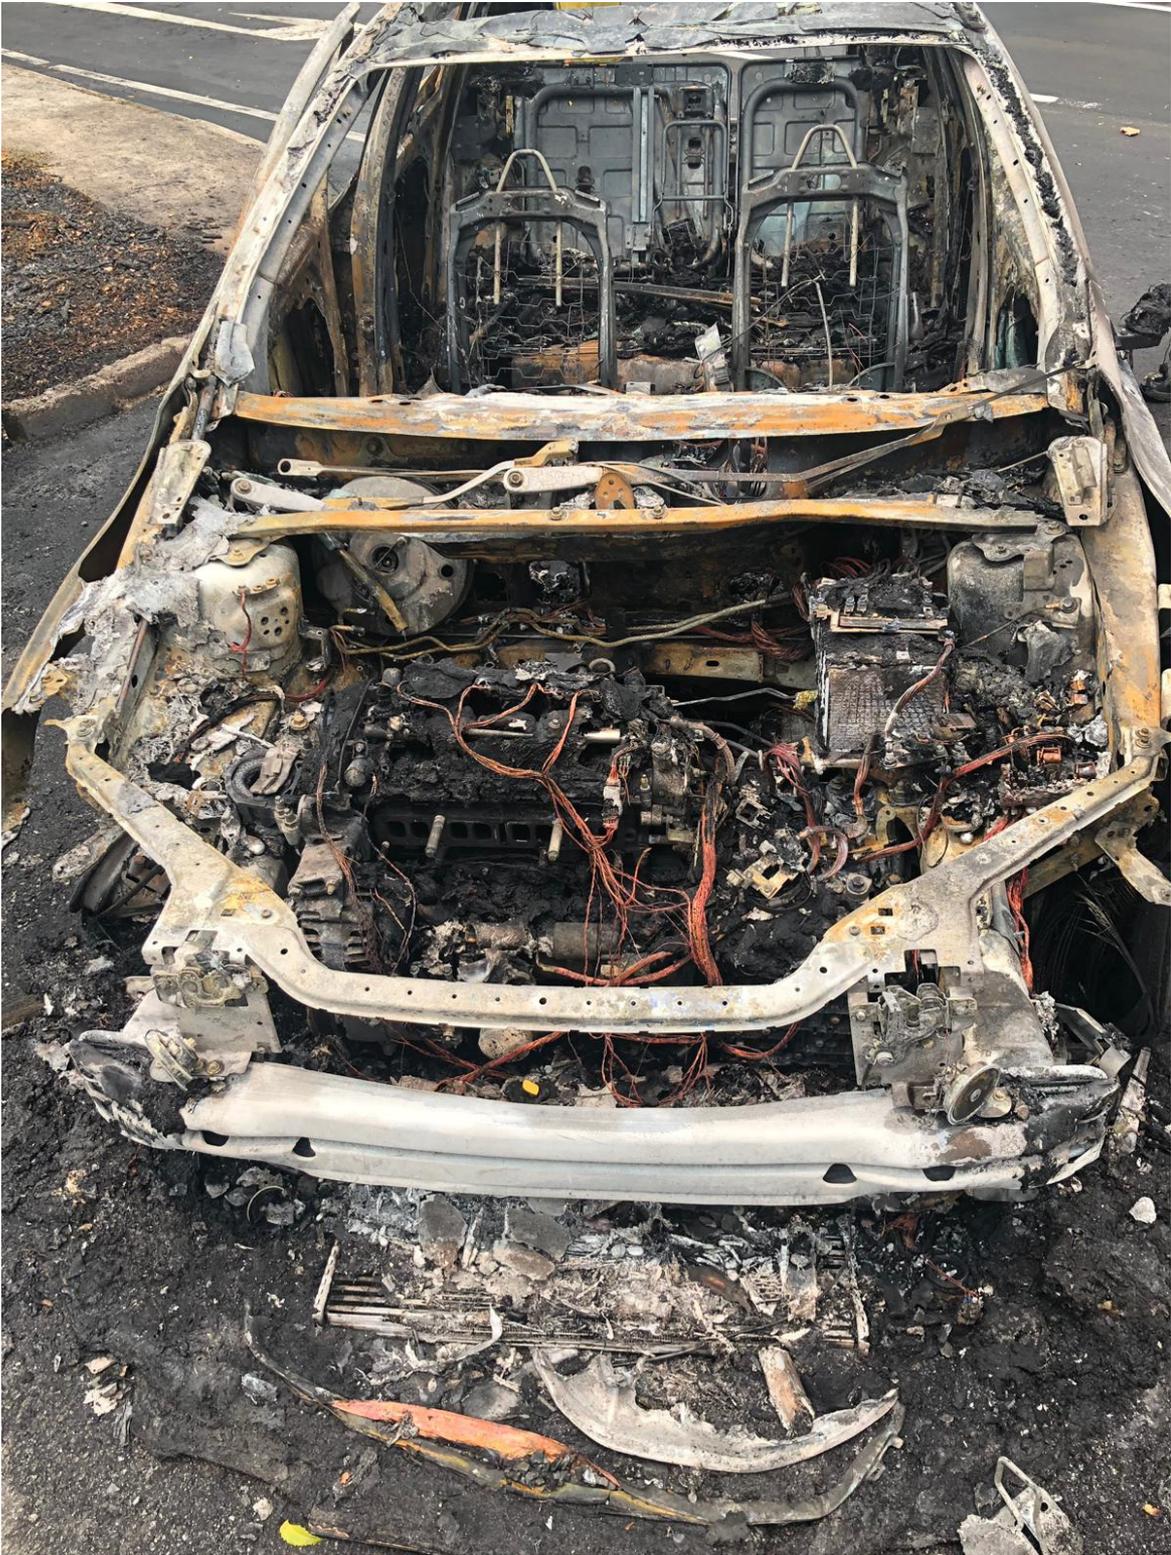
Photo 9 shows the Insured Vehicle at the incident scene after the fire was extinguished. The Insured Vehicle was burned to skeletal char as a result of the fire (photograph provided by Ms Suzana).

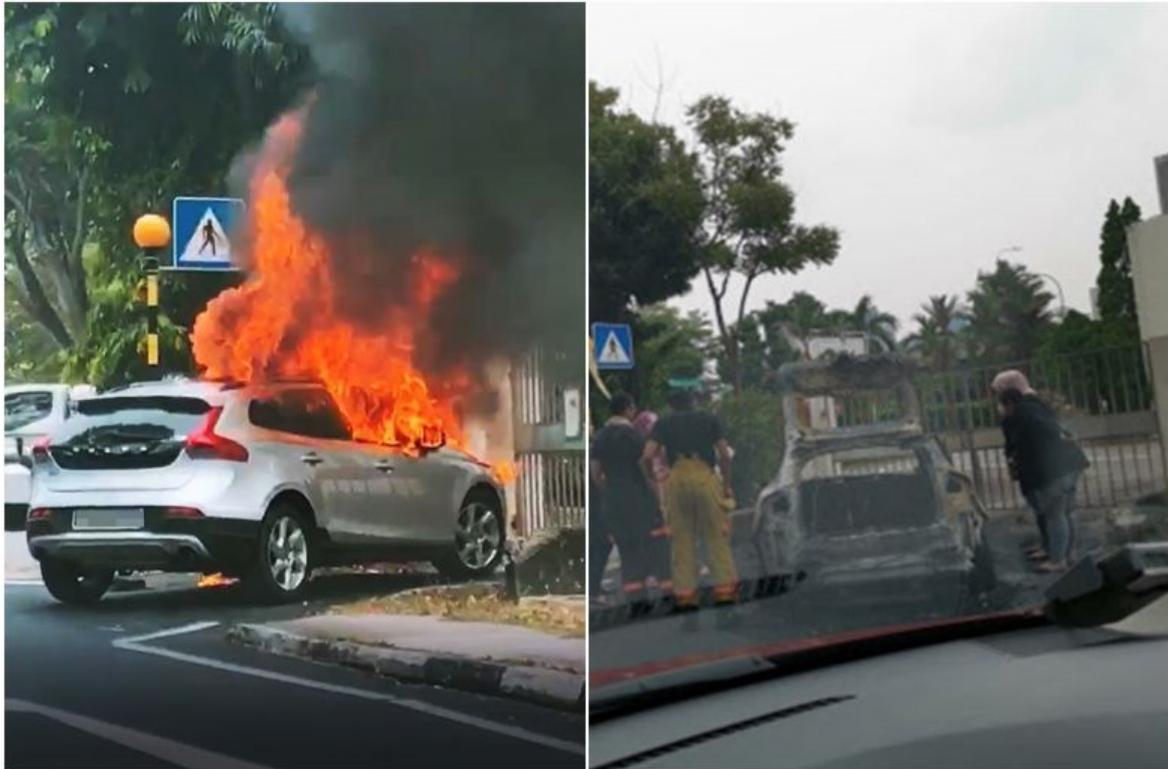
Photo 10 shows the Insured Vehicle at the incident scene (photograph obtained from social media website STOMP). Flame coming out from the interior compartment of the Insured Vehicle first before spreading to the front and rear of the Insured Vehicle.
