Your Ref: TP/IP/39437/2019  
Our Ref : CI/TPD19017390/N

**Fatal Accident Investigation Team**

**MECHANICAL INSPECTION REPORT OF MOTORCYCLE FY 8874P**

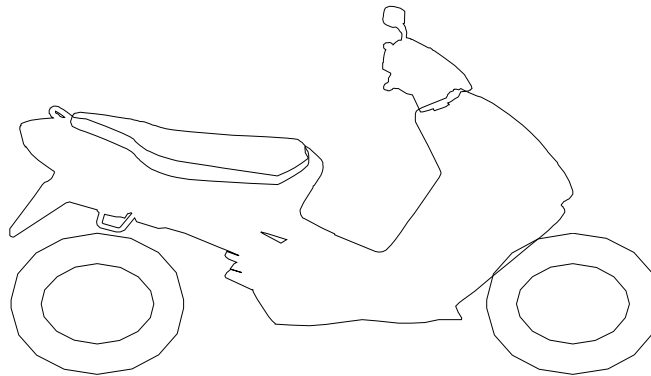
6. The condition of the 2 tyres of the Motorcycle was observed to be in serviceable condition. We did not observe any tear, burst mark(s) and/or punctured hole(s) on the sidewalls as well as across the tread of the 2 tyres. The front tyre was observed to be sufficiently inflated for vehicular operation. However the rear tyre was observed to be deflated. The tyre brand, tyre size and remaining tread depth of the 2 tyres of the Motorcycle were recorded as follows:-

Zeneos 90/80 R17 (4mm)  
(Deflated)

Zeneos 80/80 R17 (3mm)

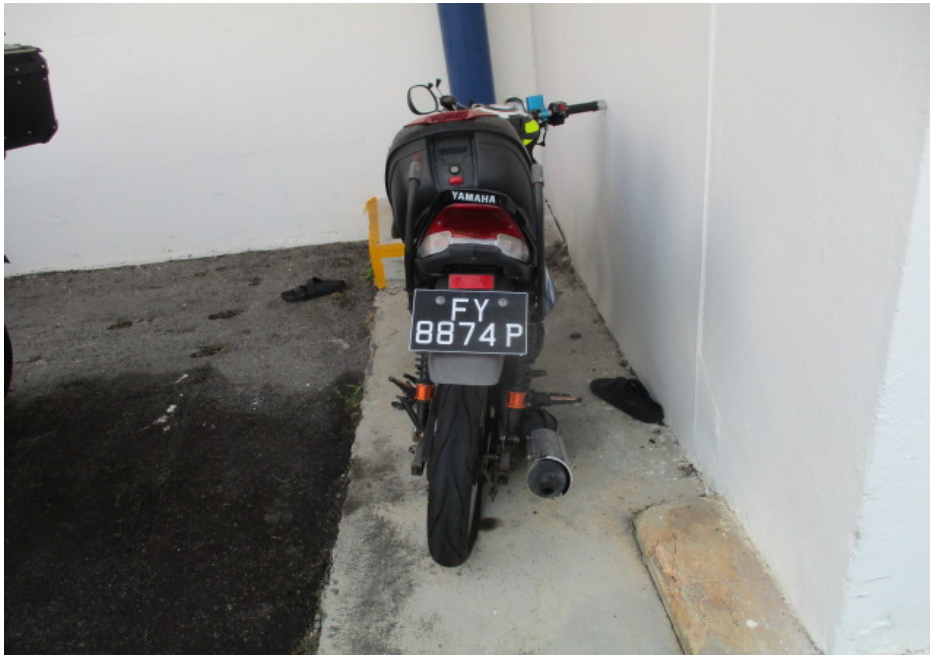
**Photo 1** shows a general view of the rear body of the Motorcycle at the time of our inspection. The Motorcycle had sustained damages all around, significantly at its front and rear portion. The mileage of the Motorcycle recorded at the time of our inspection was 58, 177km.

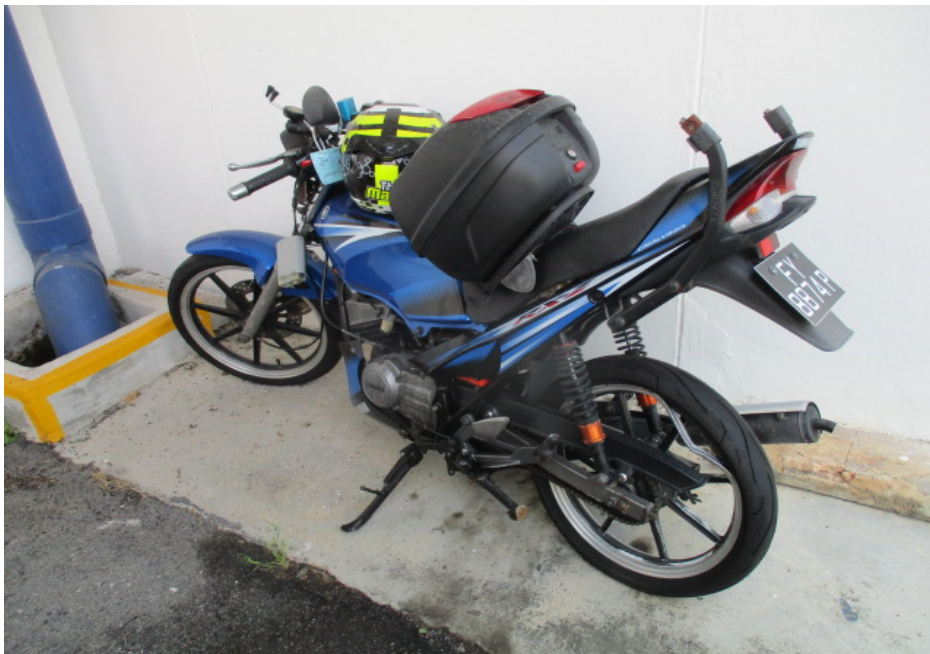
**Photo 2** shows a general view of the left body of the Motorcycle at the time of our inspection.

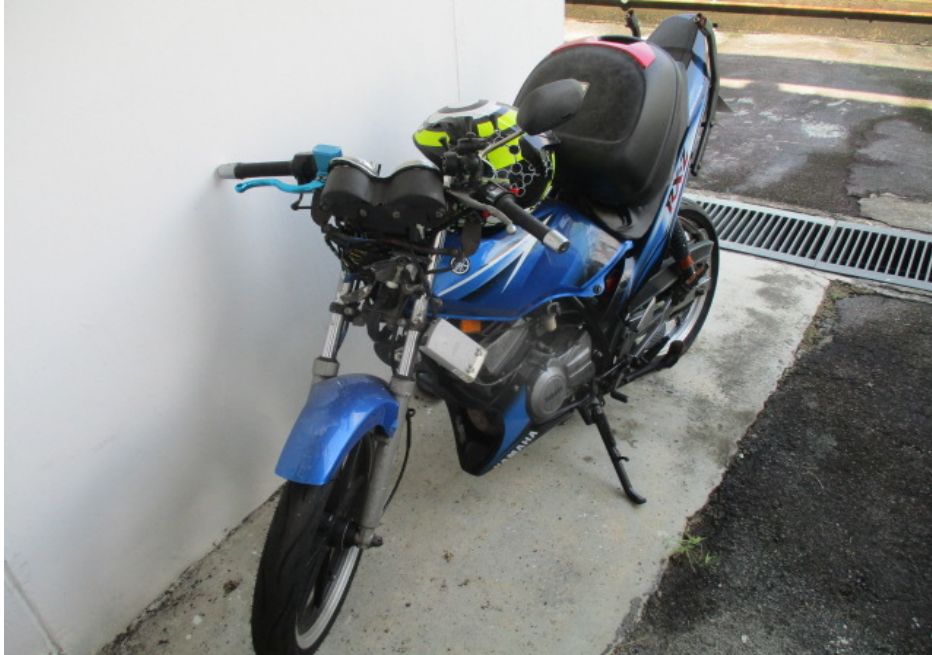
**Photo 3** shows a general view of the front body of the Motorcycle at the time of our inspection. The Motorcycle had sustained damages all around, significantly at its front and rear portion. Body parts that were found to have been damaged include its headlamp assembly, front fork assembly, speedometer gauge, left side mirror, clutch lever, petrol tank, seat, rear side covers, rear wheel rim and top box rack, amongst others.

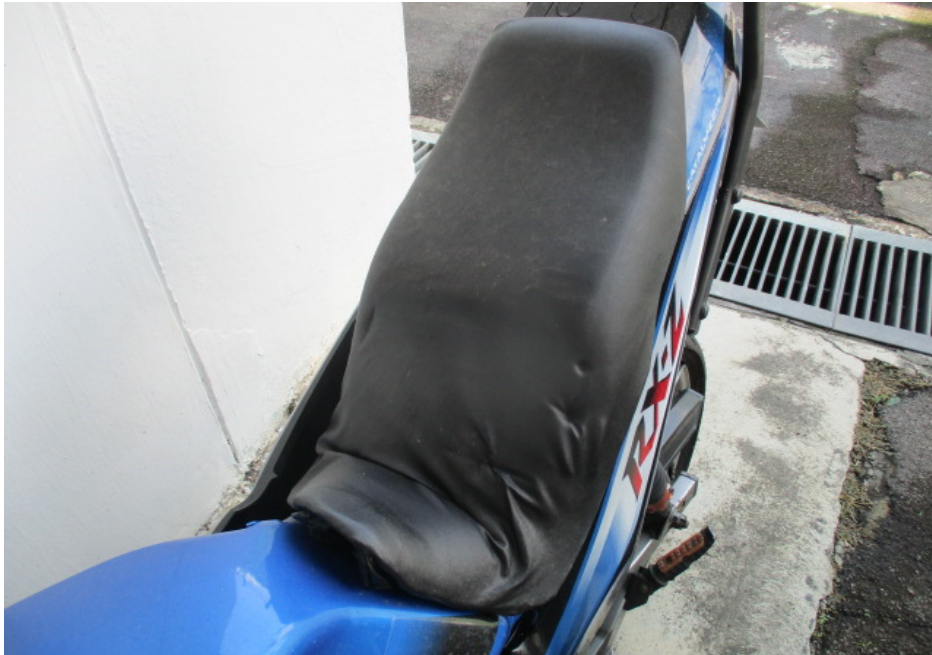
**Photo 4** shows the closer view of the rear body of the Motorcycle at the time of our inspection. Body parts that were found to have been damaged include the seat and rear side covers, amongst others.

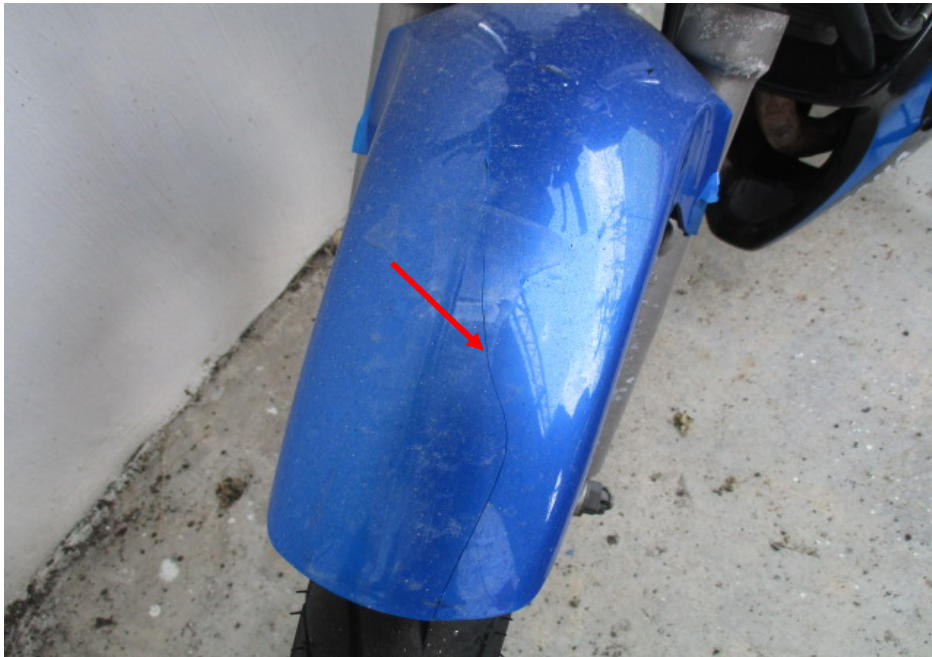
**Photo 5** shows the general view of the cracked front mudguard (arrowed) of the Motorcycle as a result of the accident.

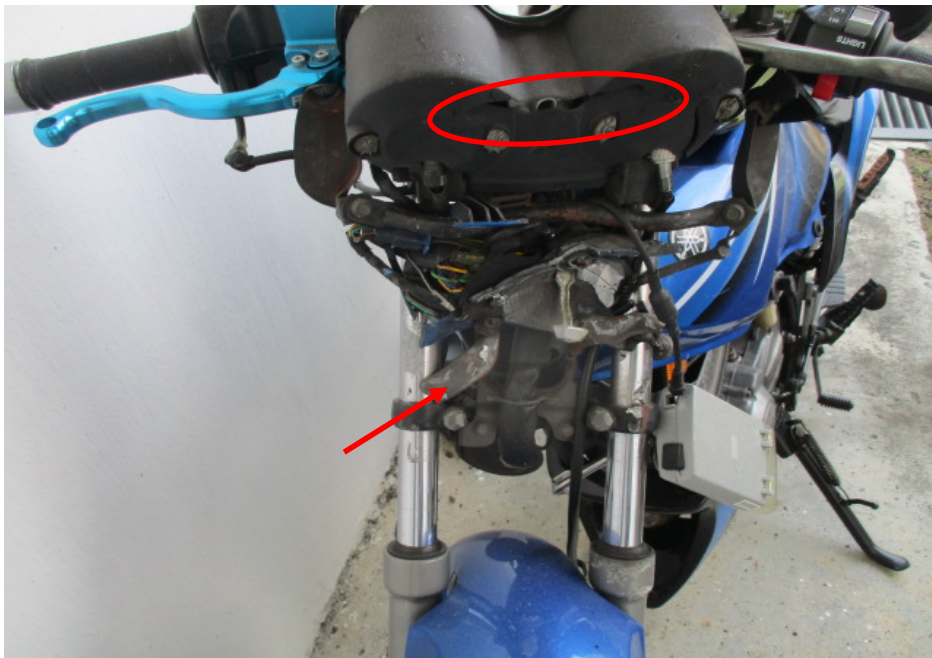
**Photo 6** shows a close up view of the headlamp assembly (arrowed) and speedometer cover (circled) of the Motorcycle. These parts were amongst the body parts of the Motorcycle which were damaged as a result of the accident.

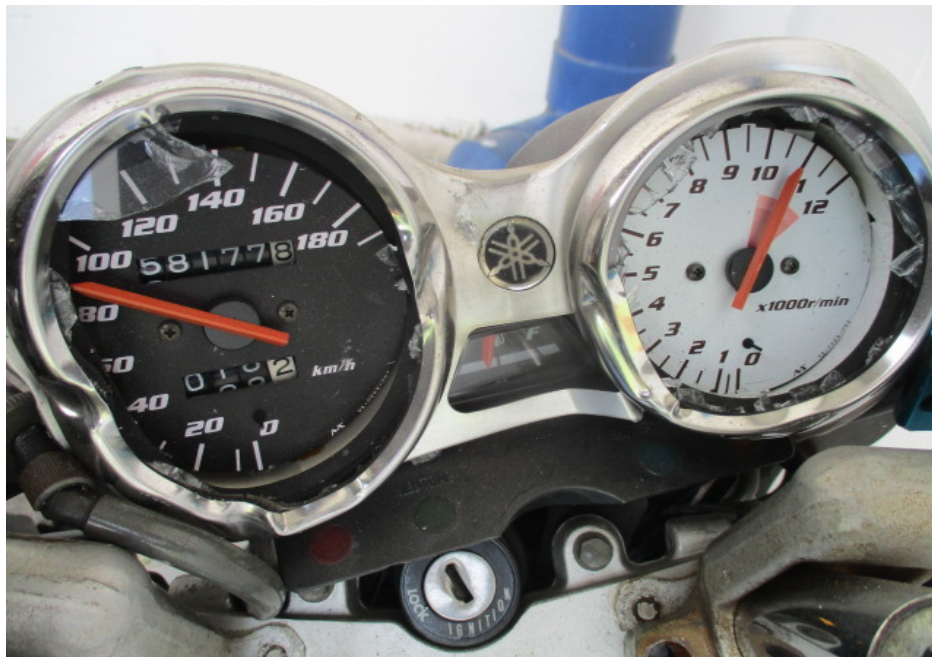
**Photo 7** shows a close up view of the broken speedometer gauge of the Motorcycle as a result of the accident.

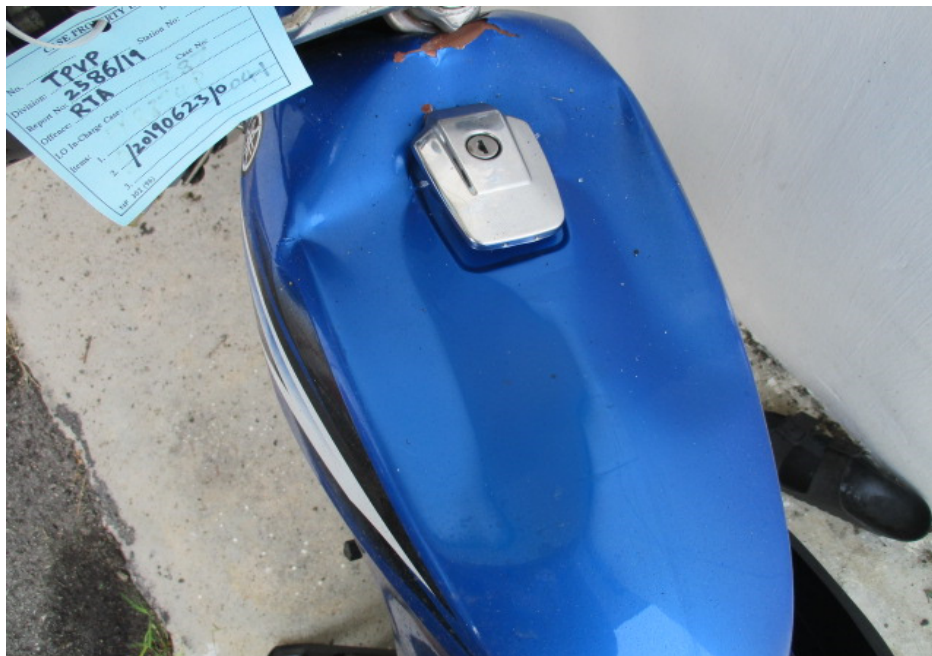
**Photo 8** shows a closer view of the dented petrol tank, which was amongst the body parts of the Motorcycle that had sustained damage as a result of the accident.

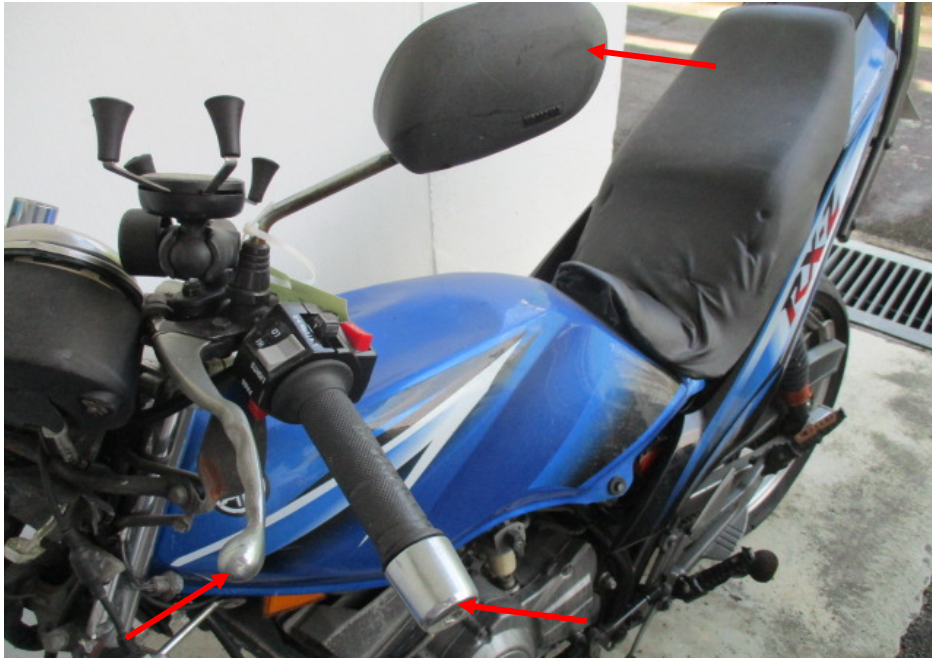
**Photo 9** shows the clutch lever, left handlebar end and left side mirror which were amongst the body parts of the Motorcycle that had sustained damages of grazing nature as a result of the accident (arrowed).

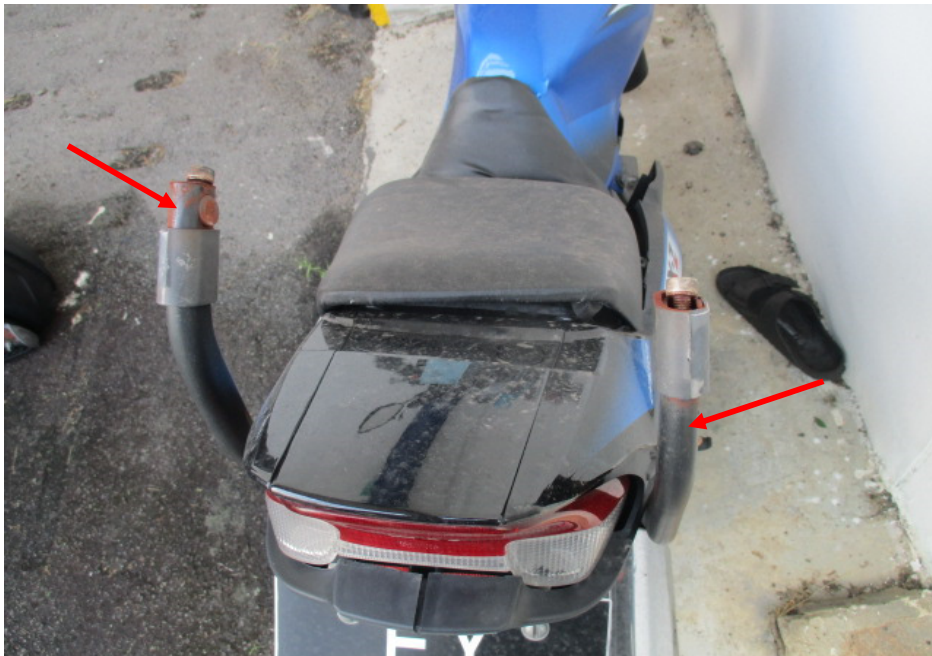
**Photo 10** shows the bent top box rack (arrowed) of the Motorcycle as a result of the accident.

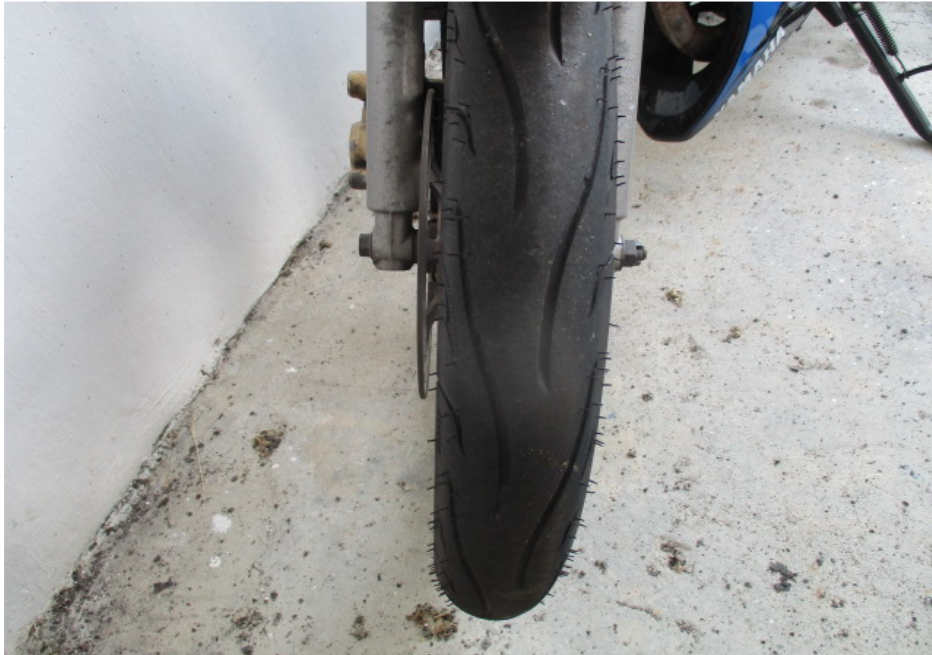
**Photo 11** shows the condition of the Motorcycle's front tyre. The front tyre was observed to be in serviceable condition with remaining tread depth of approximately 3mm. The tyre was also observed to be sufficiently inflated for vehicular operation. We did not observe any tear, burst mark(s) and/or punctured hole(s) on the sidewalls as well as across the tread of the front tyre.

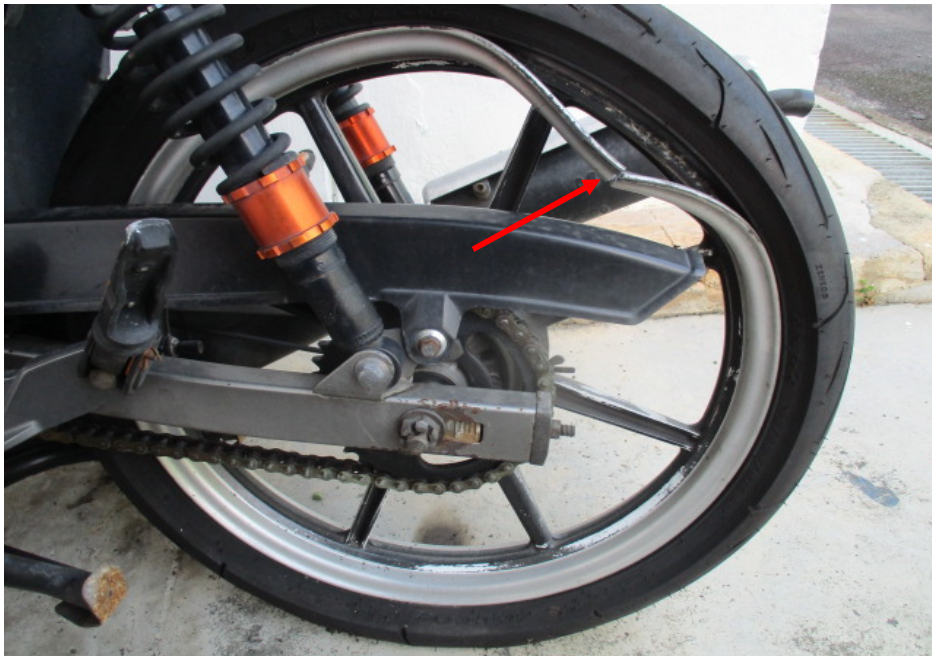
7. The 2 tyres were wrapped around alloy wheel rims. At the time of our inspection, we did not observe any visible damage on the front wheel rim of the Motorcycle. However we did observe that the rear wheel rim was broken. See photos 1 – 13 below.

**Photo 12** shows the broken rear wheel rim (arrowed) of the Motorcycle at the time of our inspection.

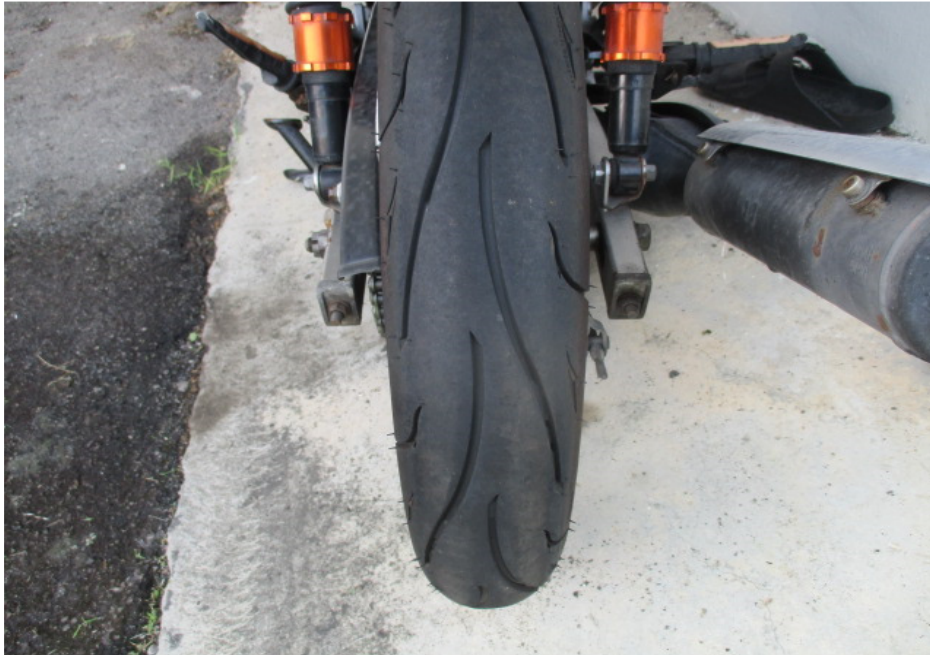
**Photo 13** shows the condition of the Motorcycle's rear tyre. The rear tyre was observed to be in serviceable condition with remaining tread depth of approximately 4mm. However the rear tyre was observed to be deflated as a result of the broken rear wheel rim. We did not observe any tear, burst mark(s) and/or punctured hole(s) on the sidewalls as well as across the tread of the rear tyre.

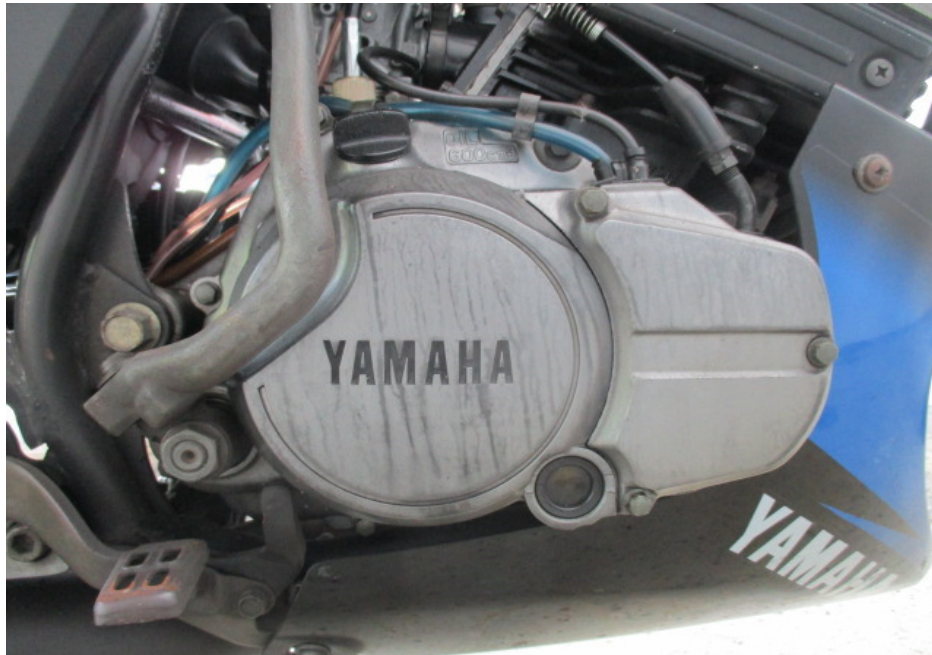
**Photo 14** shows the right side of the engine of the Motorcycle at the time of our inspection. The various engine related parts and components were found to be intact with no visible damage. There was also no sign(s) or indication(s) of fluid leak observed around the right engine area of the Motorcycle.

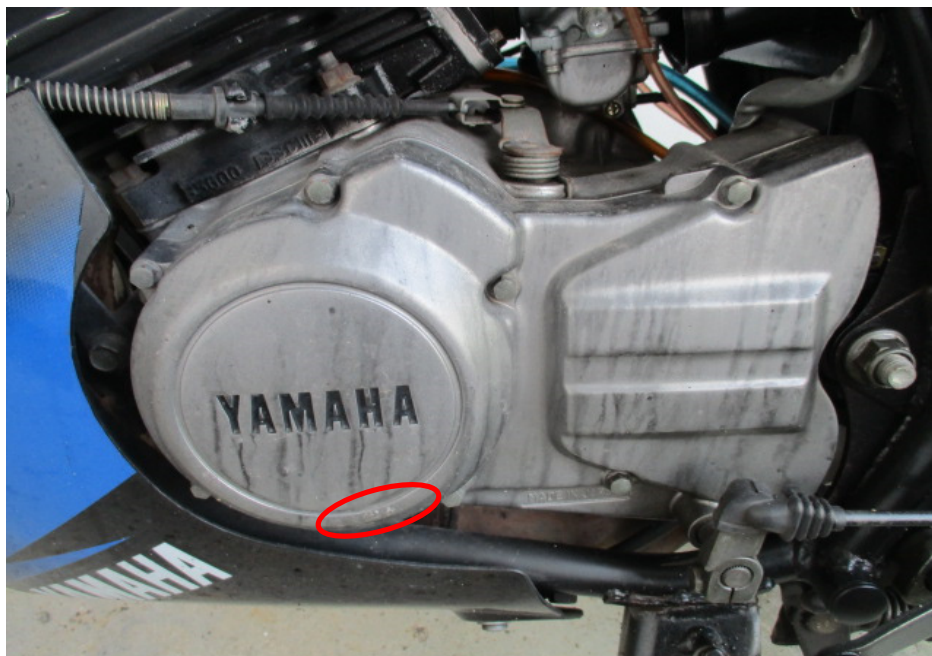
**Photo 15** shows the left side of the engine of the Motorcycle at the time of our inspection. The various left engine components had sustained damage of grazing nature as a result of the accident (circled) however the engine components were still intact. There was also no fluid leak and/or fluid stain found around the left engine area of the Motorcycle.

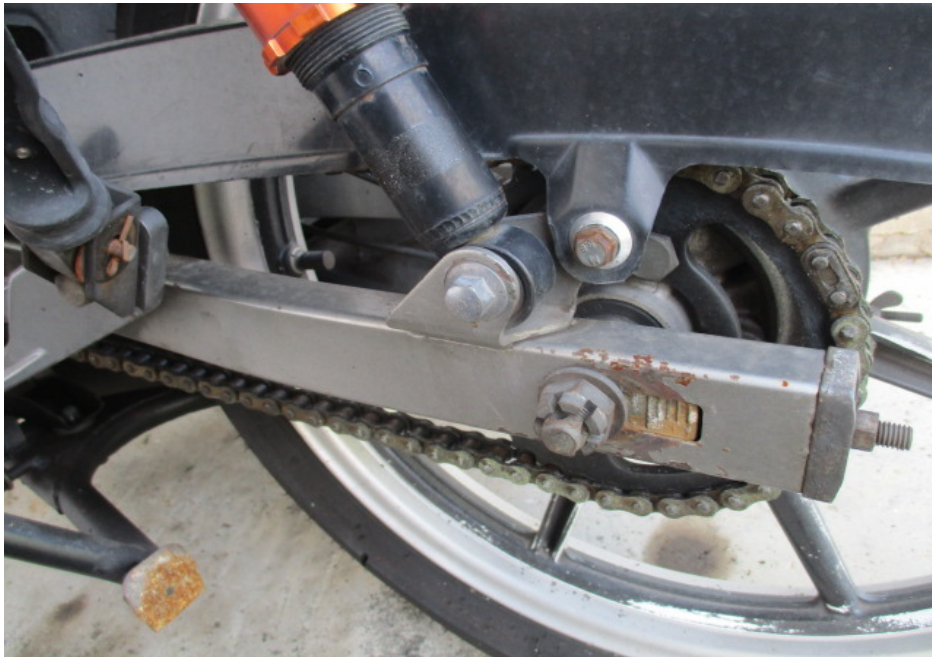
**Photo 16** shows the general view of the gear train of the Motorcycle, which was observed to be intact with no misalignment. It was also adequately lubricated for operating purposes.

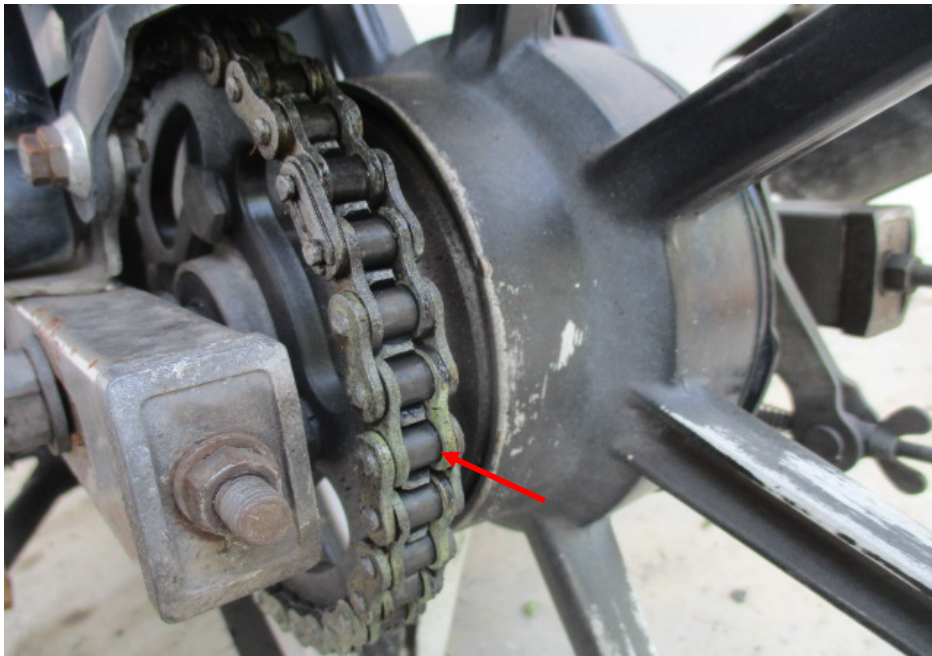
**Photo 17** shows a closer view of the gear train (arrowed) of the Motorcycle, which was observed to be intact with no misalignment. It was also adequately lubricated for operating purposes.

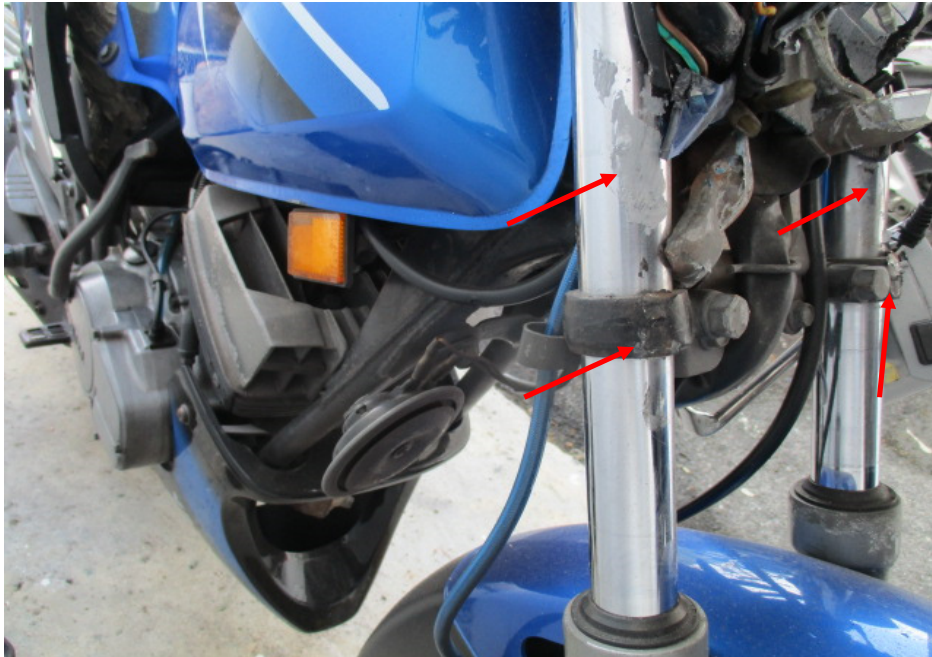
10. For this case, we were not able to conduct any test(s) on the steering system of the Motorcycle due to the damage to its front forks. The inner tube of the front forks and fork brackets were damaged as a result of the accident. The impact of the accident had also caused the petrol tank to be pushed towards the front fork stem. Hence we were unable to turn the handle bar towards the left or right.

**Photo 18** shows the front forks of the Motorcycle. The inner tube of the front forks and fork brackets were damaged as a result of the accident (arrowed). We were hence not able to conduct any tests on the steering system of the Motorcycle.

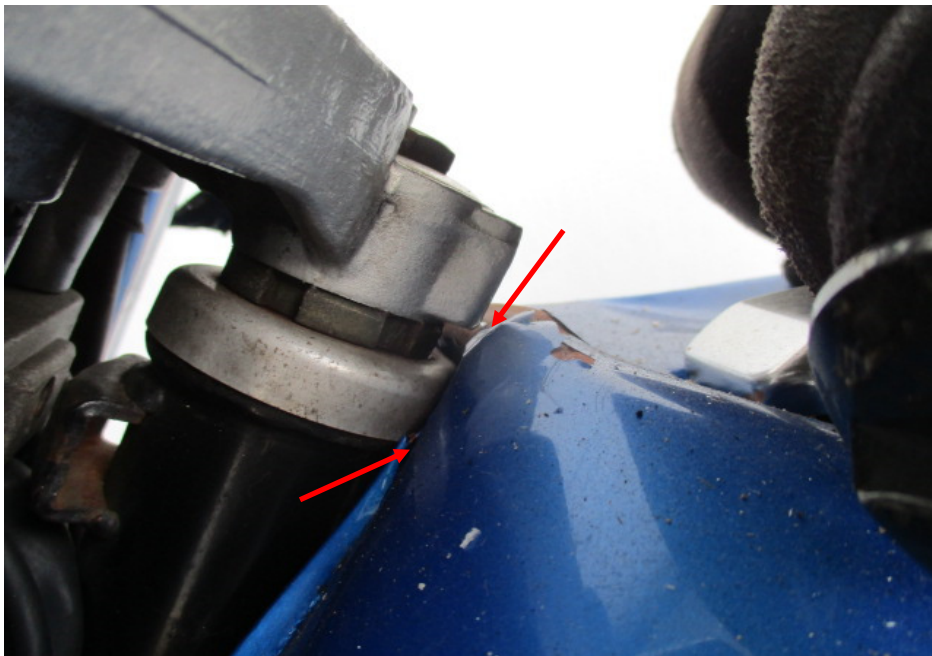
**Photo 19** shows the front fork stem of the Motorcycle. The petrol tank had been pushed towards the front fork stem as a result of the accident (arrowed). We were hence not able to turn the handle bar of the Motorcycle towards the left or right.

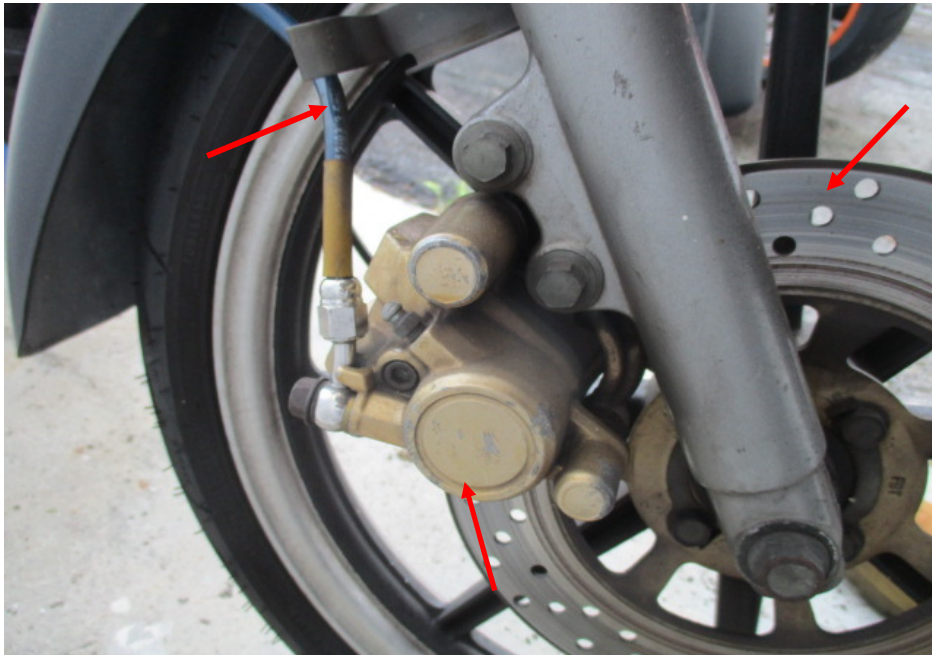
**Photo 20** shows a close up view of the front brake caliper, front brake disc and front brake hose (arrowed) of the Motorcycle, which are all part of the components in the hydraulic front brake system of the Motorcycle. Our visual checks of these various components had revealed all to be intact with no visible damage. No leakage of brake fluid was also observed.

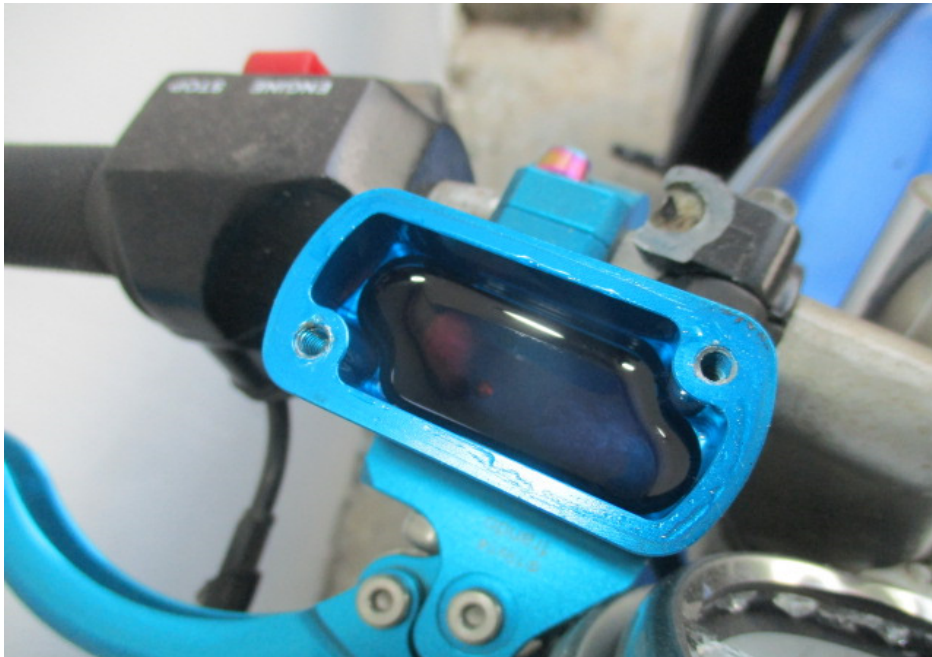
**Photo 21** shows the brake fluid reservoir for the front brake of the Motorcycle. The brake fluid was observed to be of sufficient level and without contamination for operational purposes.

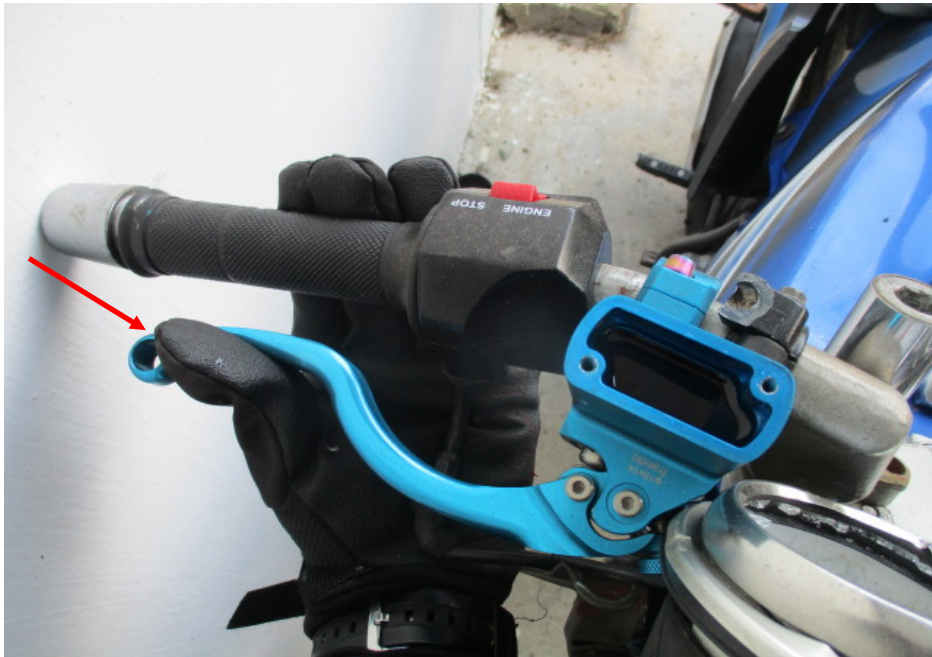
12. Static brake tests conducted on the Motorcycle had appear to indicate that the front braking system of the Motorcycle was in serviceable condition. There was some resistance felt (spongy like feel) upon pressing the brake lever. This would indicate that there was no leakage of pressure/vacuum in the front brake system.

**Photo 22** shows the front brake lever being depressed. There was some resistance felt (spongy like feel) upon pressing the front brake lever (arrowed). This would indicate that there is no leakage of pressure/vacuum in the brake system.

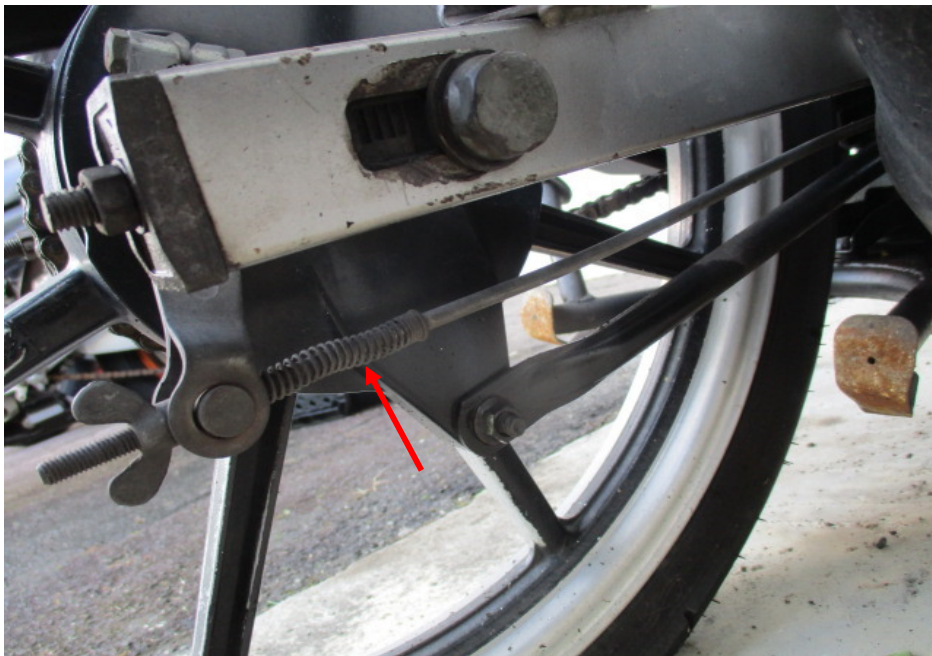
**Photo 23** shows the rear wheel of the Motorcycle. The type of brake system for the rear wheel was of a mechanical type, controlled by the brake foot pedal of the Motorcycle. Our checks of the cable (arrowed), spring and drum which are all part of the components in the rear brake system of the Motorcycle reveal all to be intact and without damage.
