VEHICLE REGISTRATION NO : YN 6635 J
VEHICLE MAKE /MODEL : Mitsubishi Canter 3.0

**Re : Third Party Claim
Vehicle Registration No. YN 6635 J**

VEHICLE INSPECTION REPORT

VEHICLE DAMAGE INSPECTION REPORT

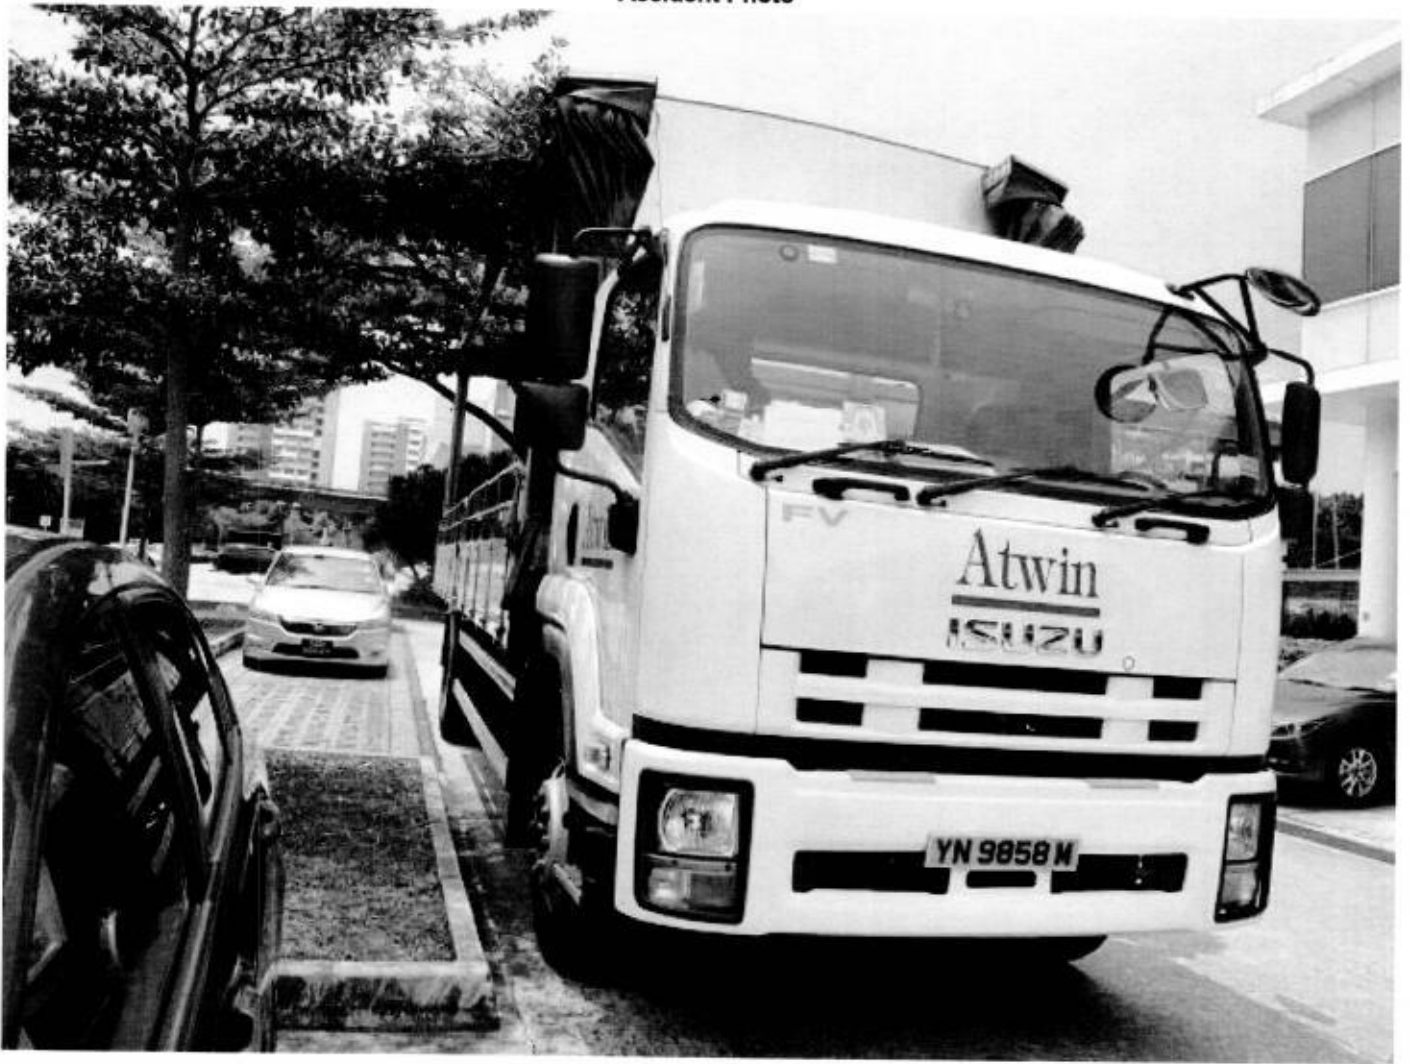
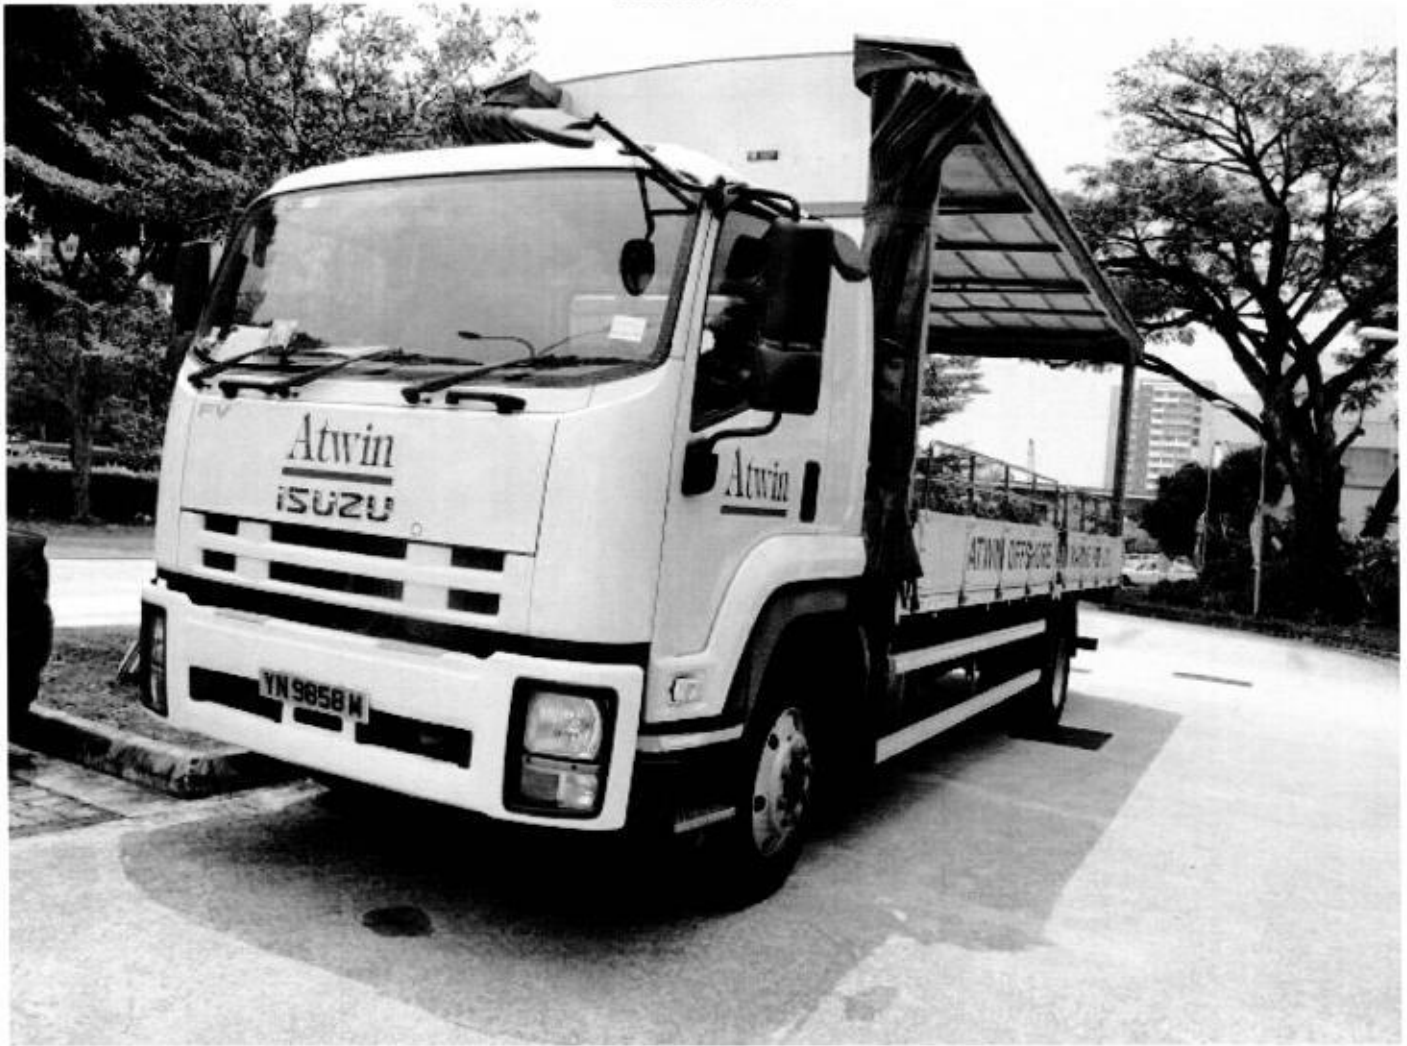
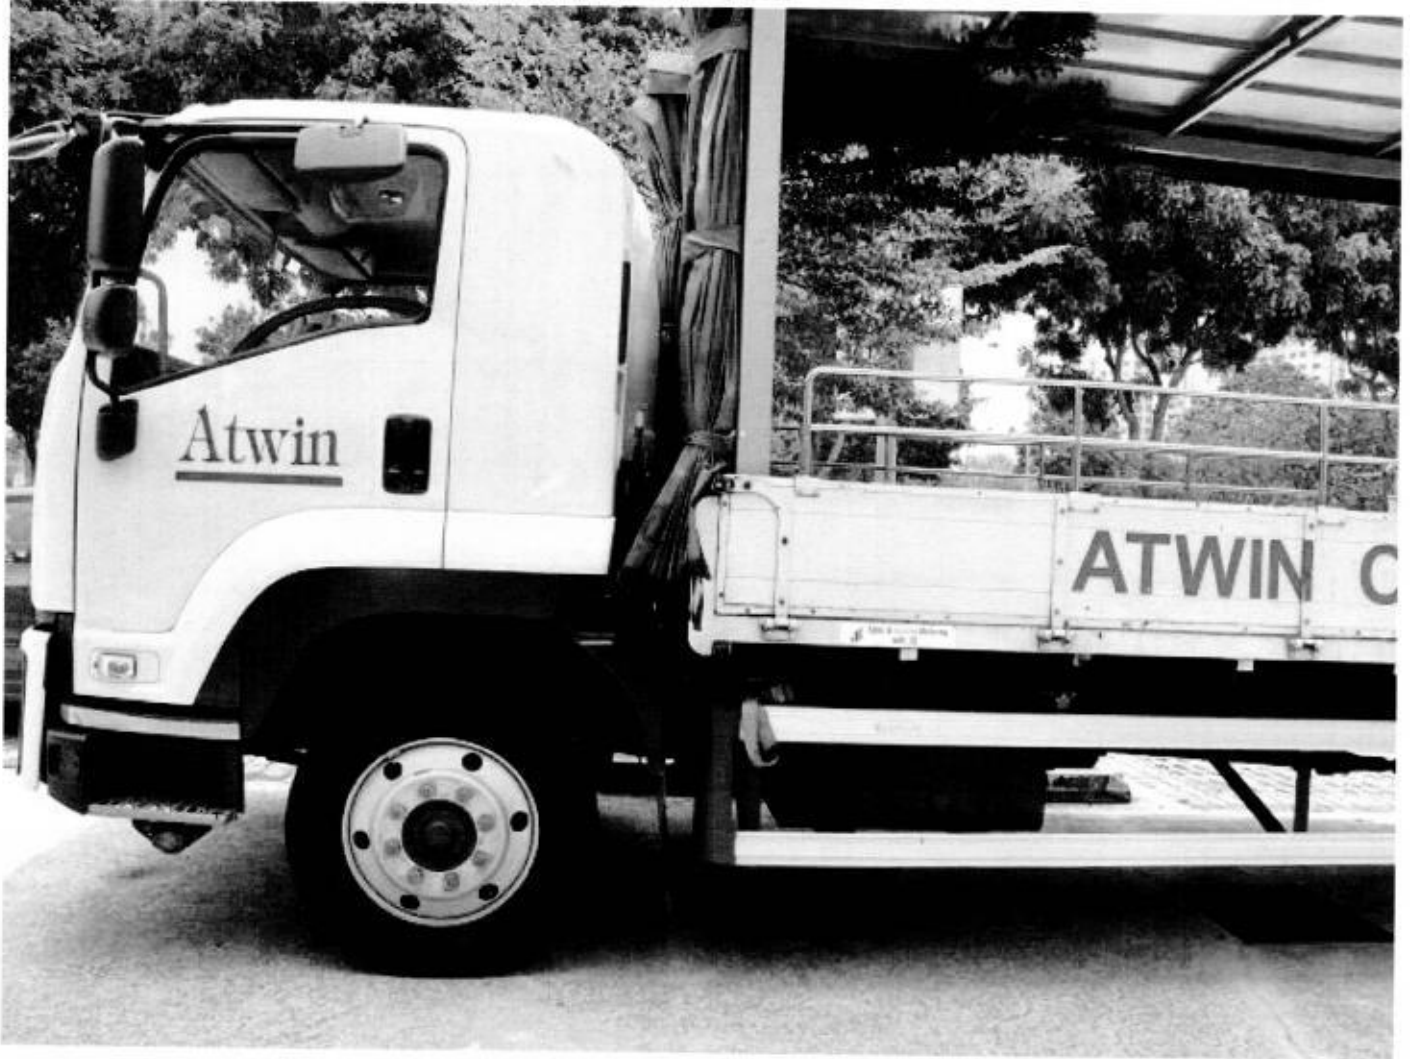
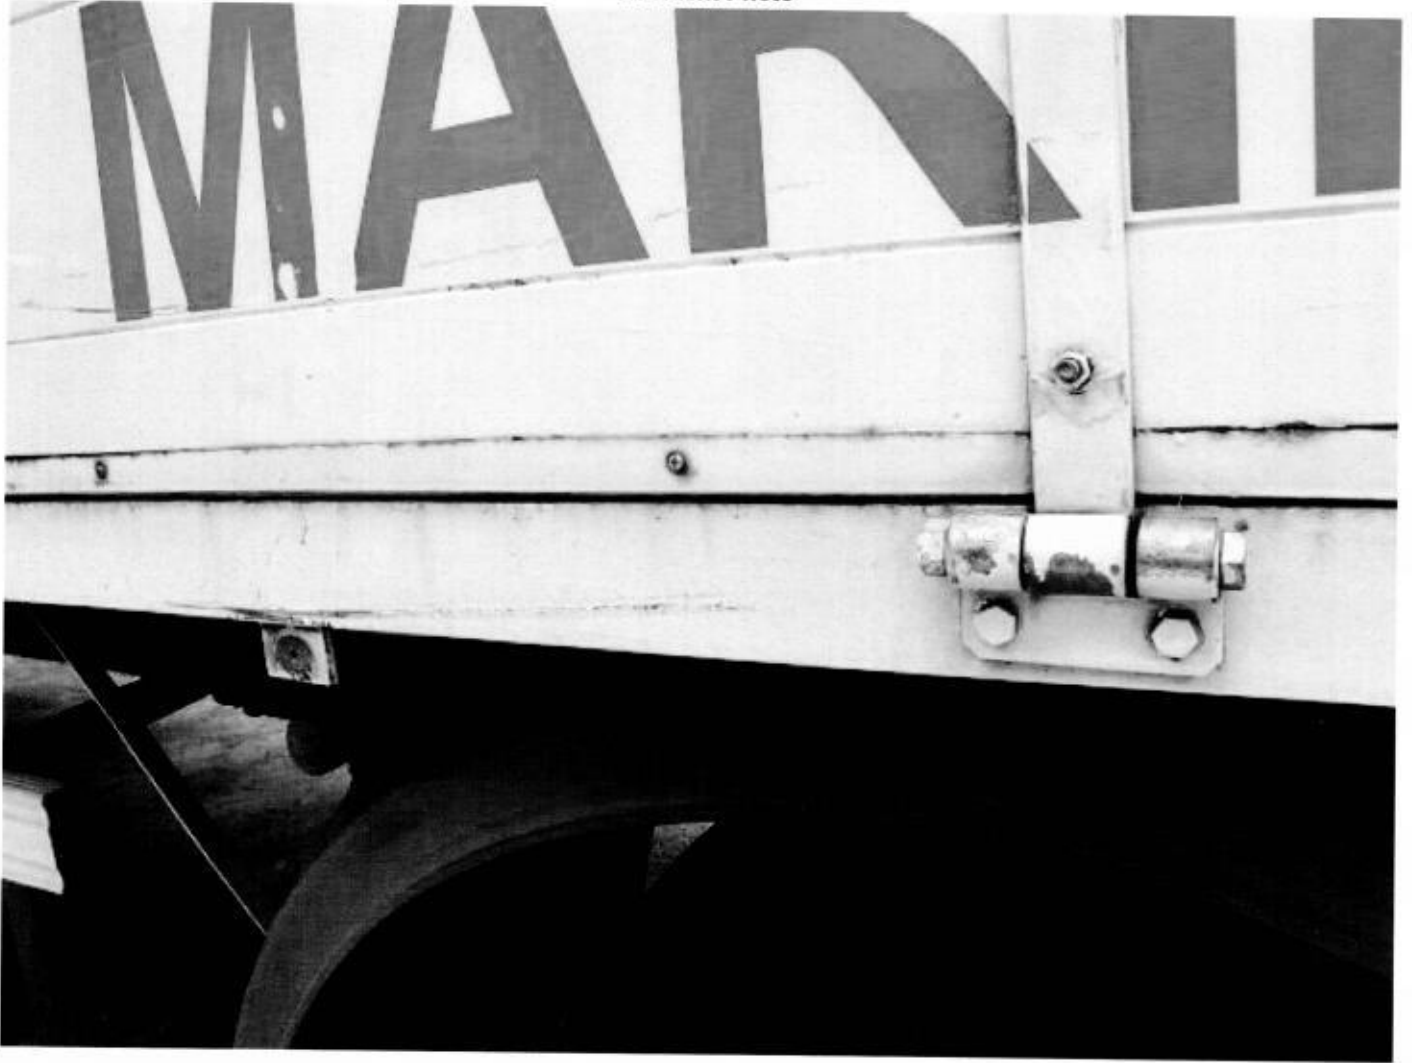
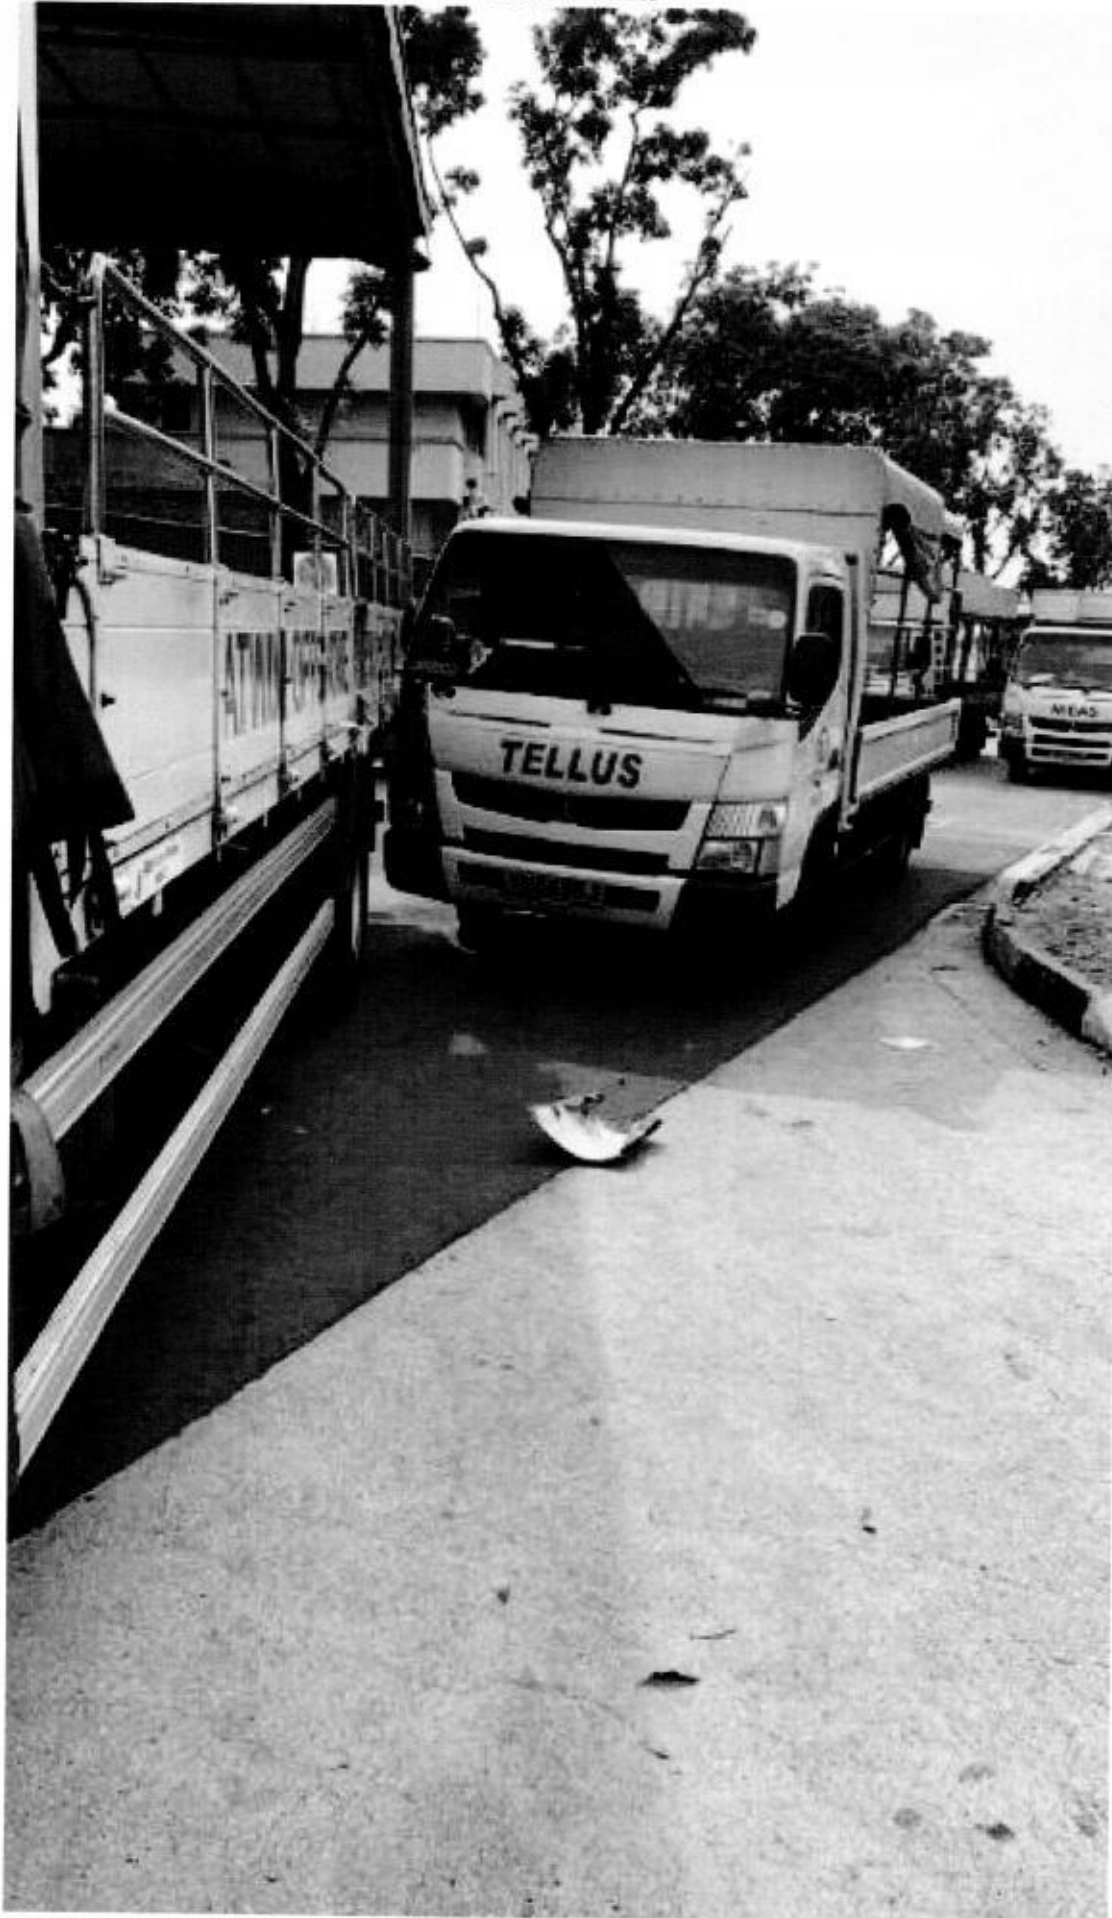
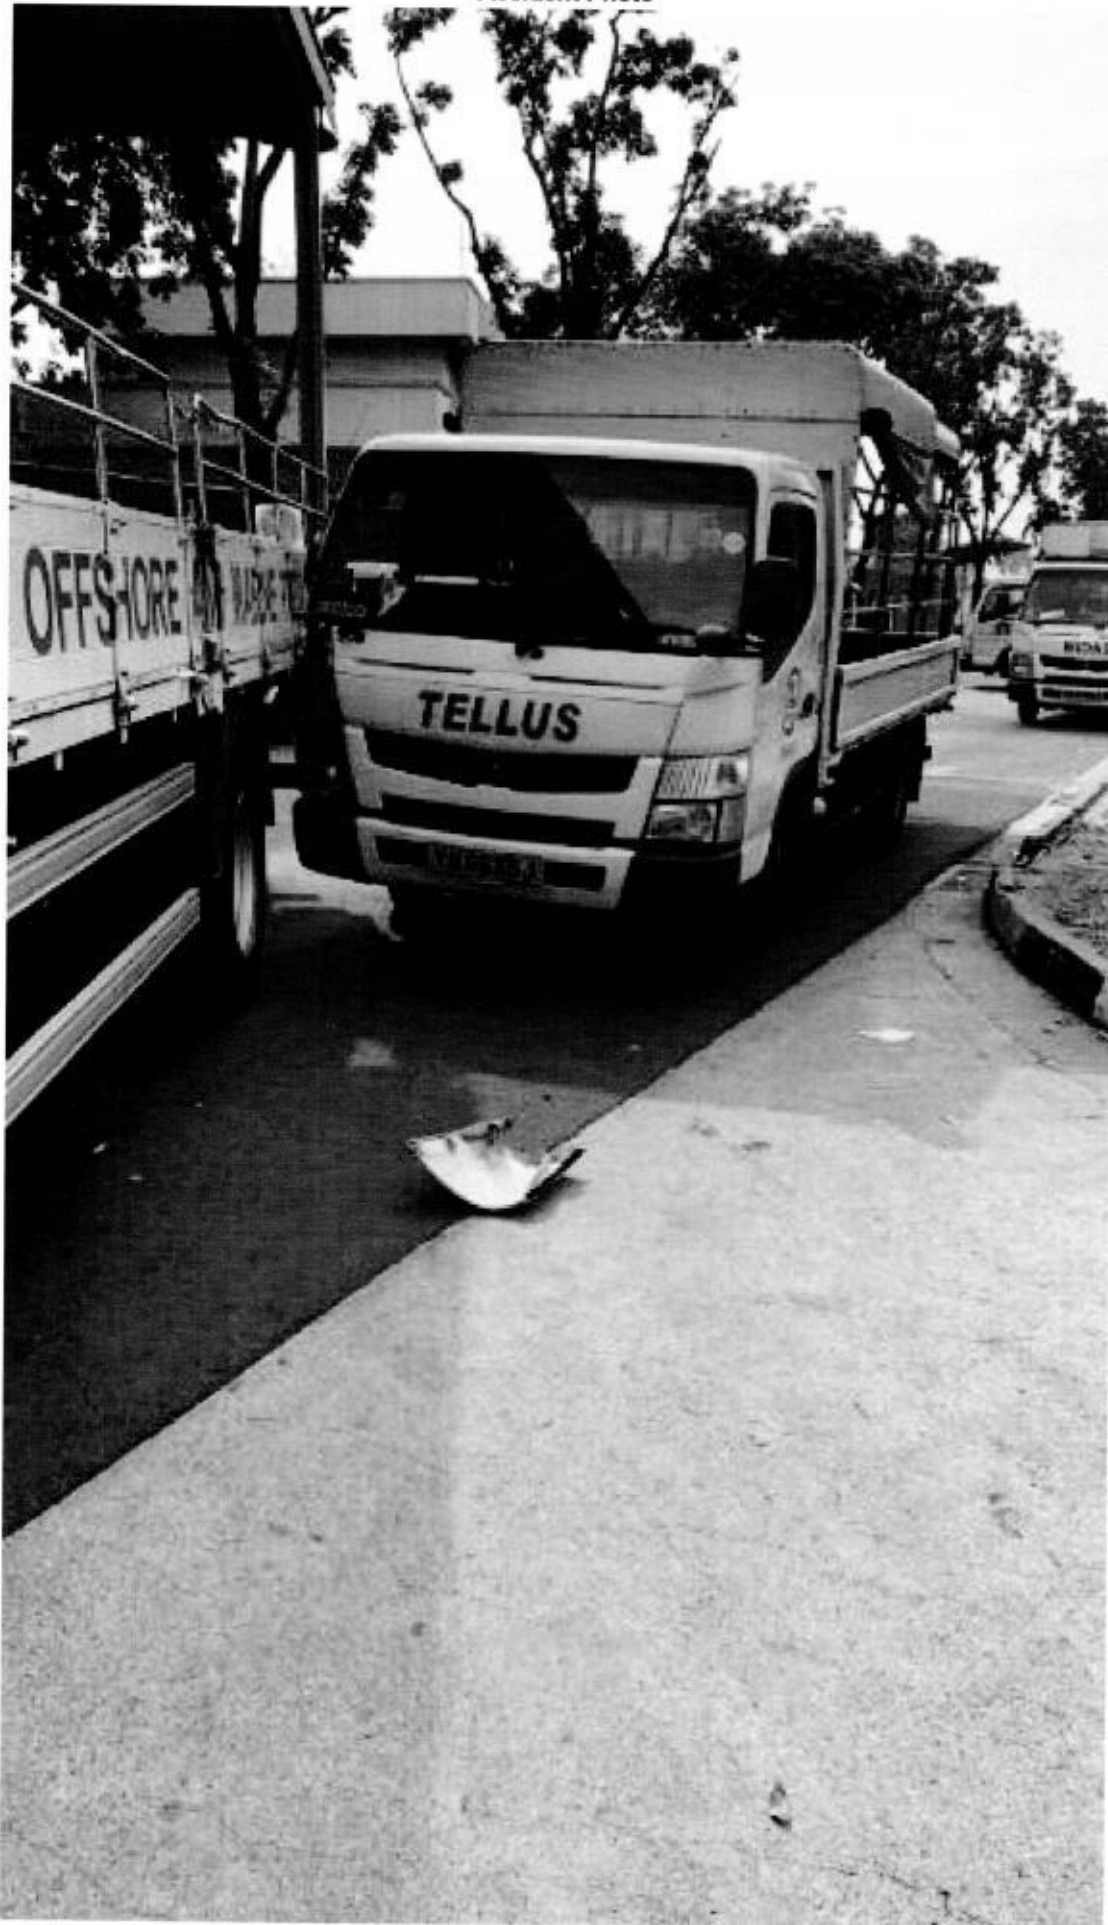
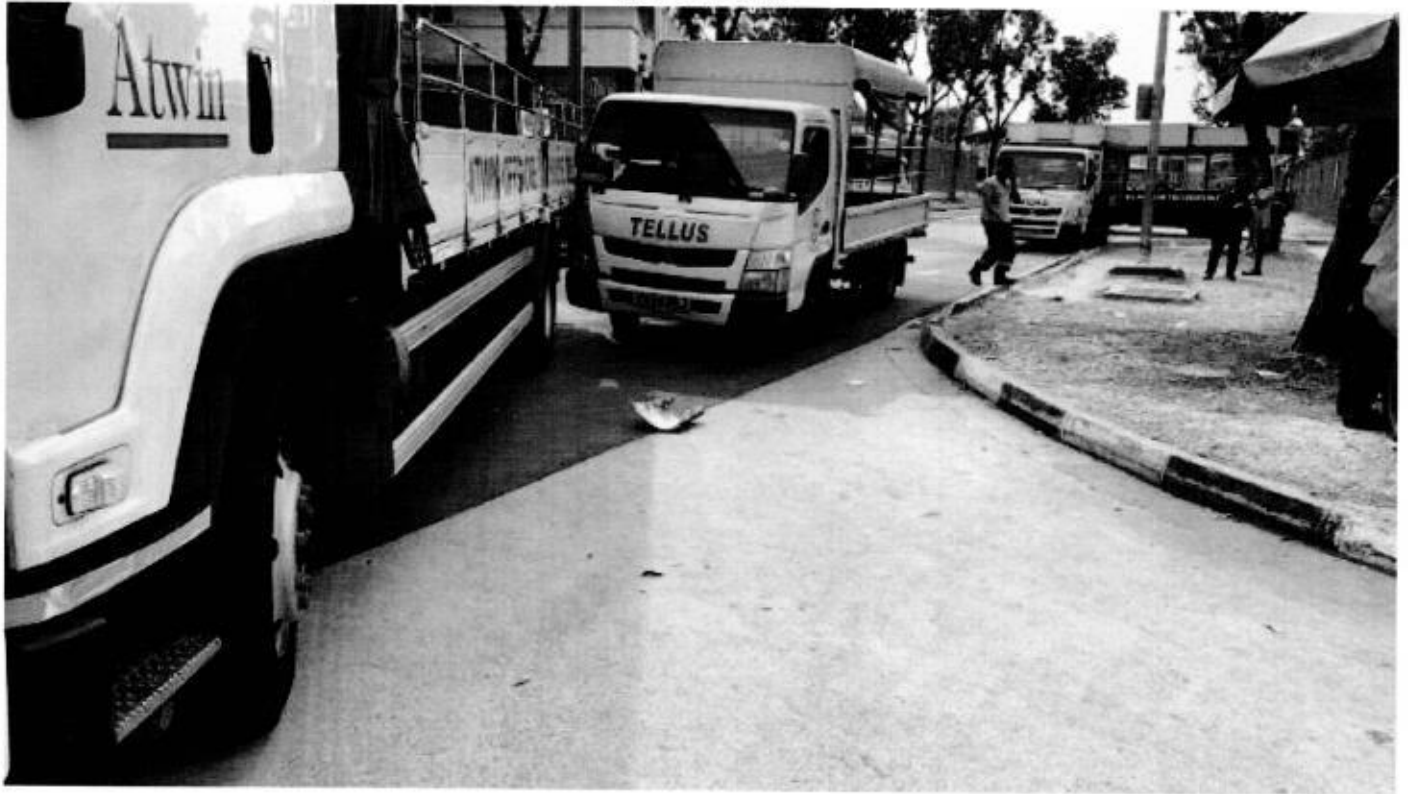
Accident Photo

Damages sustained were the front windscreen- cracked, front corner panel o/s- dented/buckled, front bumper assembly, front door pillar o/s- buckled o/s front door & its inner reinforcement- dented/buckled/torn etc. -----

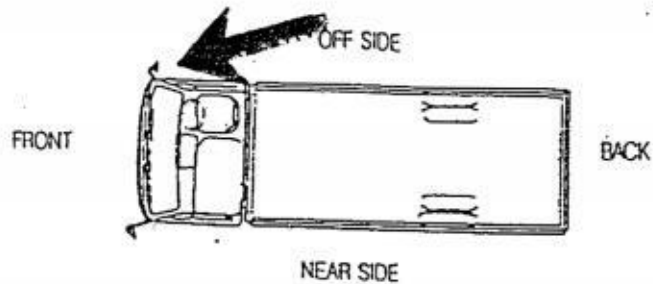
Damages sustained were consistent with the subject vehicle being involved in a collision with another vehicle and the impact was delivered onto the o/s front portion of the vehicle.
