## LKK Auto Consultants Pte Ltd

### 1. Policy Particulars :- THIRD PARTY CLAIM

## ADJUSTMENT ON REPAIR COST FOR VEHICLE NO. SKU 2916D

PHOTOGRAPHS FOR VEHICLE NO. SKU 2916D

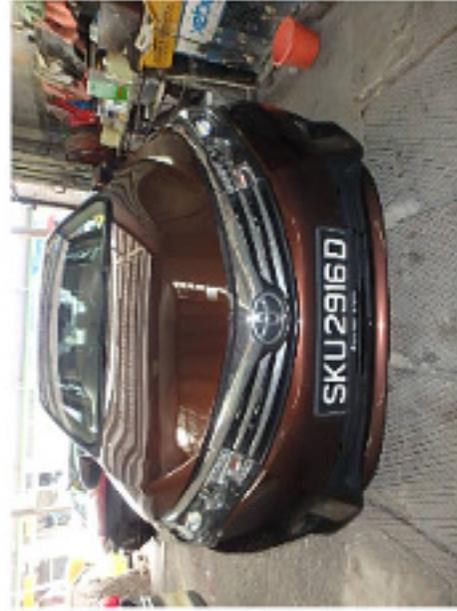
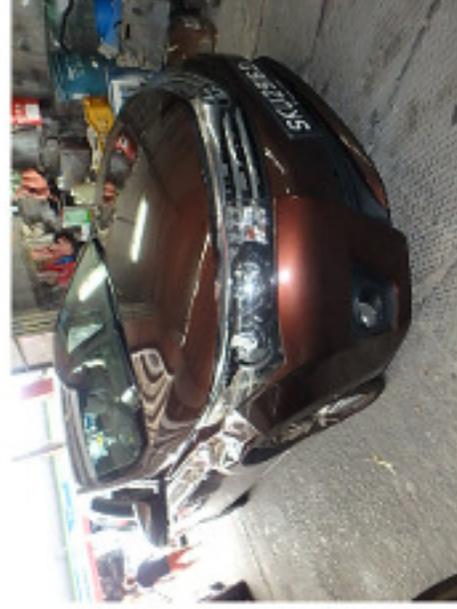
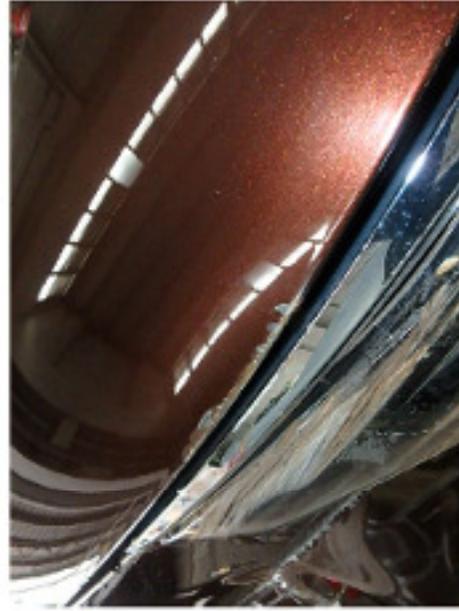
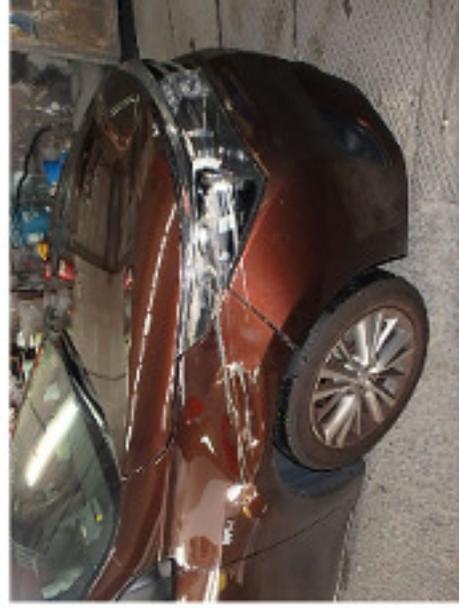
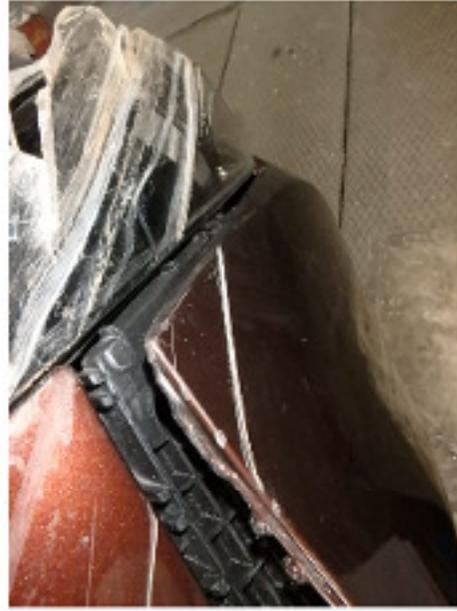
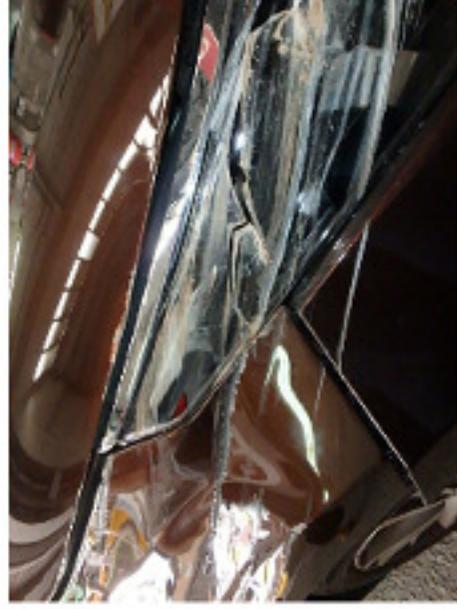
INSPECTION

THE VEHICLE SUSTAINED DAMAGES AT THE O/S FRONT PORTION. DAMAGES SEE DETAILS.
--	---------------------------------------------------------------------------------
