Your Ref: DF19HO00066
Our Ref : CI/EQI19017794/D

07 October 2019

**TECHNICAL INVESTIGATION REPORT OF FIRE INCIDENT INVOLVING THE
MOTOR CAR SJW 2052Y ON 28 AUGUST 2019**

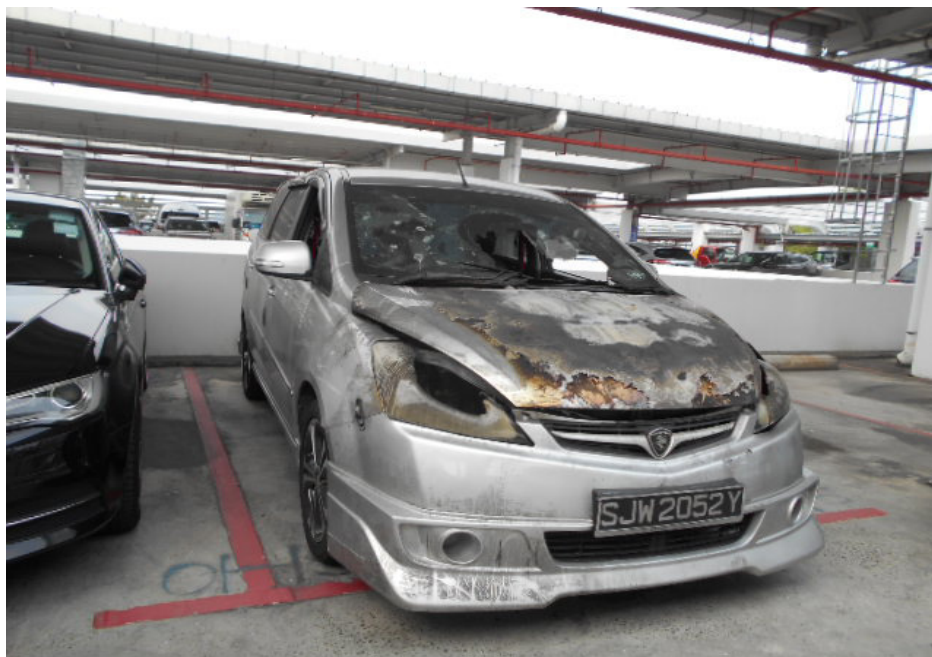
Photo 1 shows a general view of the front right body of the Motor Car at the time of my inspection. The fire damage to the Motor Car was confined to its frontal portion. Its engine compartment and interior compartment had sustained damage of burnt nature whilst its rear portion was unaffected. Its front bumper, front bonnet, front grille and front right headlamp were amongst the body parts that were found to have been affected as a result of the fire.

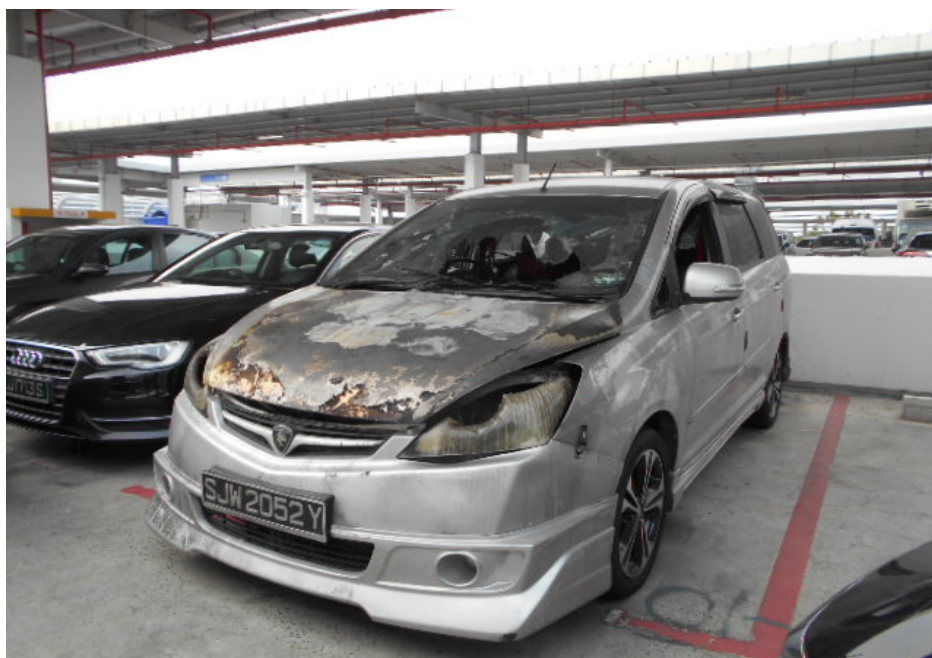
Photo 2 shows a general view of the front left body of the Motor Car at the time of my inspection. The fire damage to the Motor Car was observed to be confined to its frontal portion. Its front bumper, front bonnet, front left headlamp and front left fender were amongst the body parts that were found to have been affected as a result of the fire.

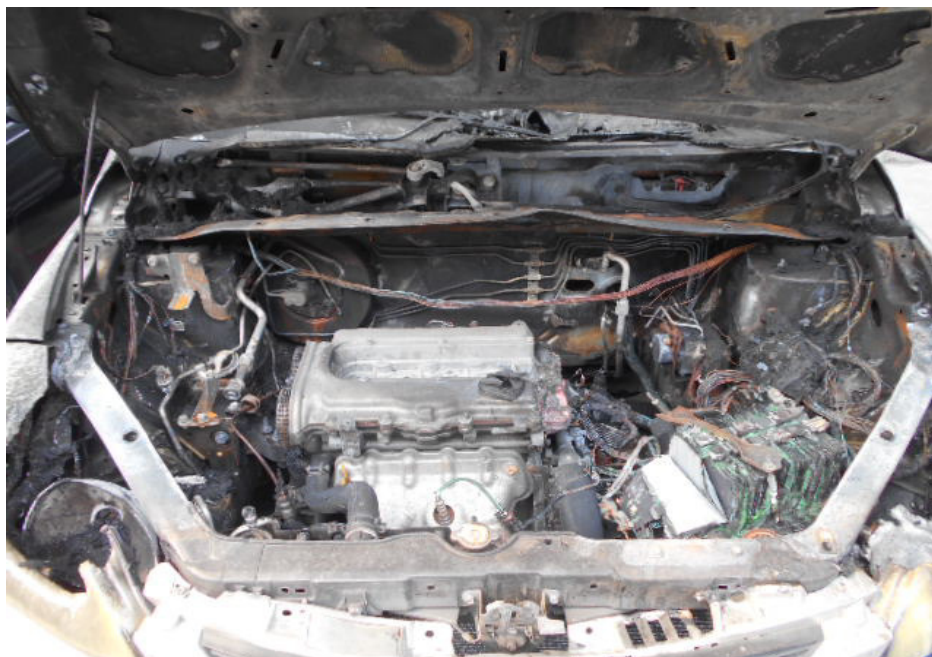
Photo 3 shows the engine compartment of the Motor Car at the time of my inspection. The engine compartment of the Motor Car was observed to have sustained moderate damage of burnt nature. The battery, fuse box, air intake, various piping and hoses were amongst the parts within the engine compartment that were burnt and/or melted as a result of the fire.

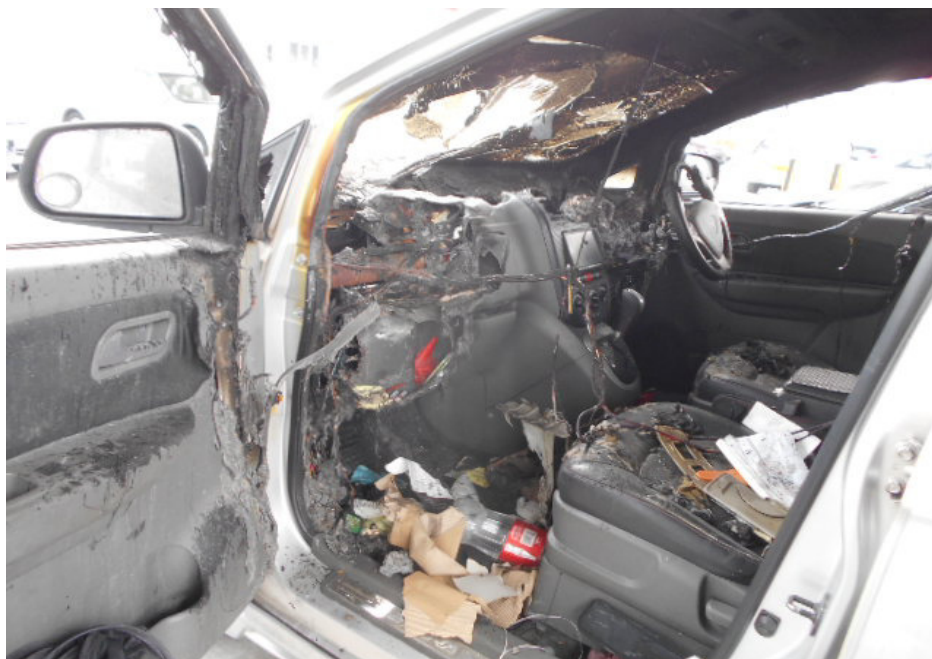
Photo 4 shows the interior compartment of the Motor Car, which was observed to be partially burnt and/or melted at the front area. The front windscreen, front dashboard, plastic trims and roof upholstery were amongst the parts that were found to have been burnt and/or melted as a result of the fire.

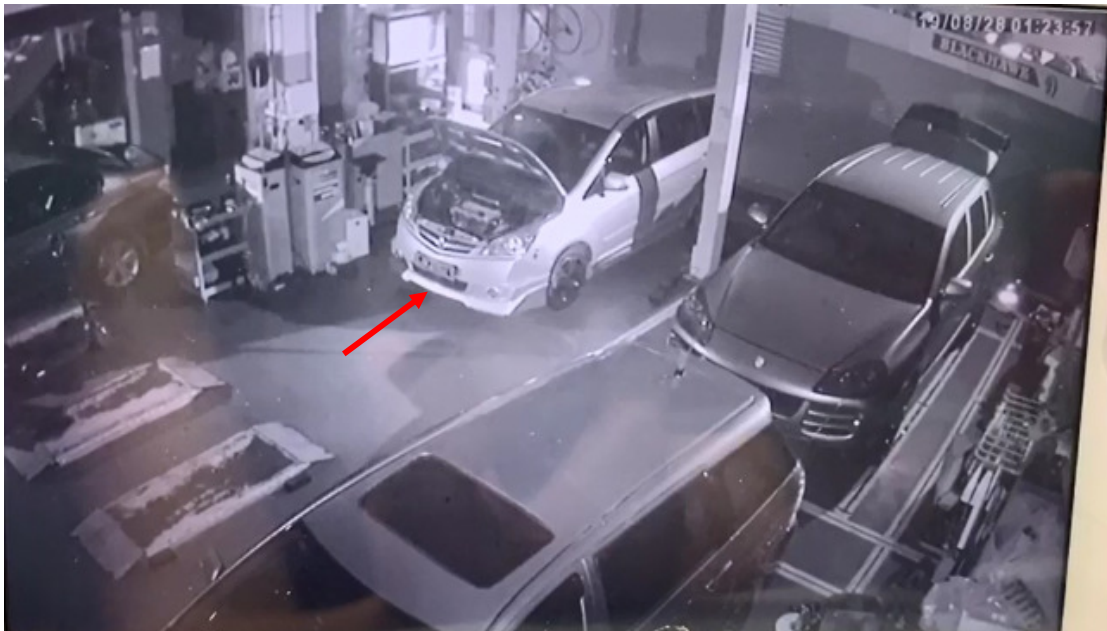
Photo 5 shows the premise of Hup Soon Batteries (screenshot from video footage retrieved from a CCTV camera inside the premise of Hup Soon Batteries). The Motor Car (arrowed) could be seen parked inside the premise of Hup Soon Batteries with its front bonnet lifted, before the fire. There was also no one inside the premise just before the fire. This was on 28 August 2019 at about 0123hrs.

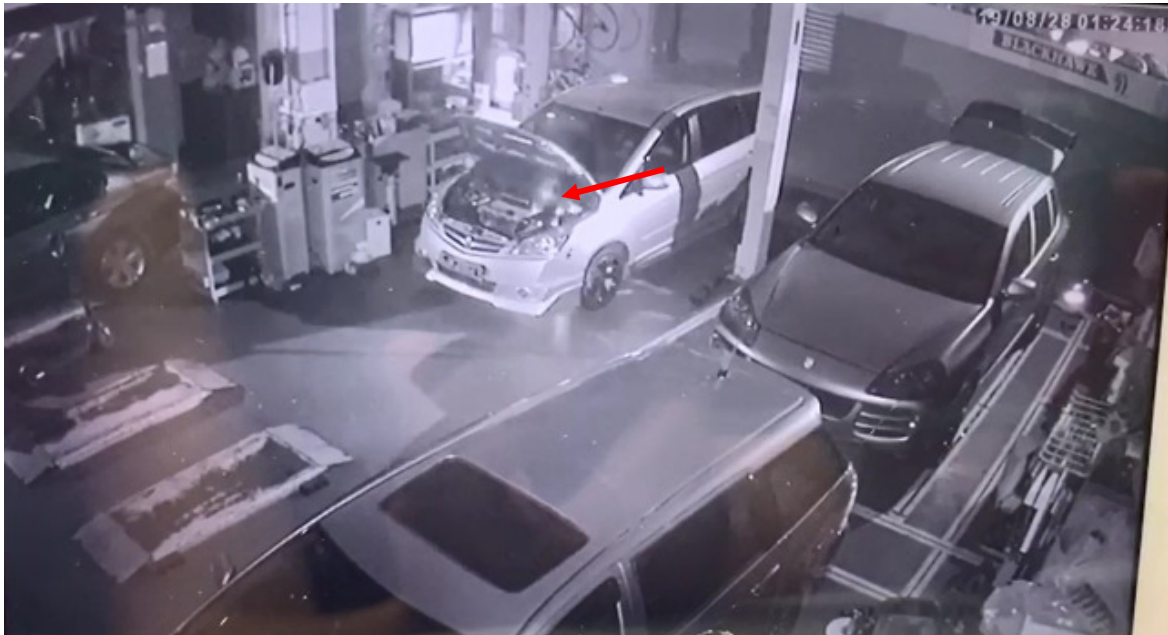
Photo 6 shows the premise of Hup Soon Batteries (screenshot from video footage retrieved from a CCTV camera inside the premise of Hup Soon Batteries). At about 0124hrs, a flame (arrowed) was first seen at the rear of the Motor Car's engine compartment, slightly towards the left from the rear centre. At this point in time, there was no one inside the premise. This would indicate that the flame at the rear of the Motor Car's engine compartment had self-ignite.

18. Firstly, the fire was observed to have self-ignited from within the engine compartment of the Motor Car. This was determined from the first sight of flame on the Motor Car that was seen from the video footage. Refer to photograph 6 above.

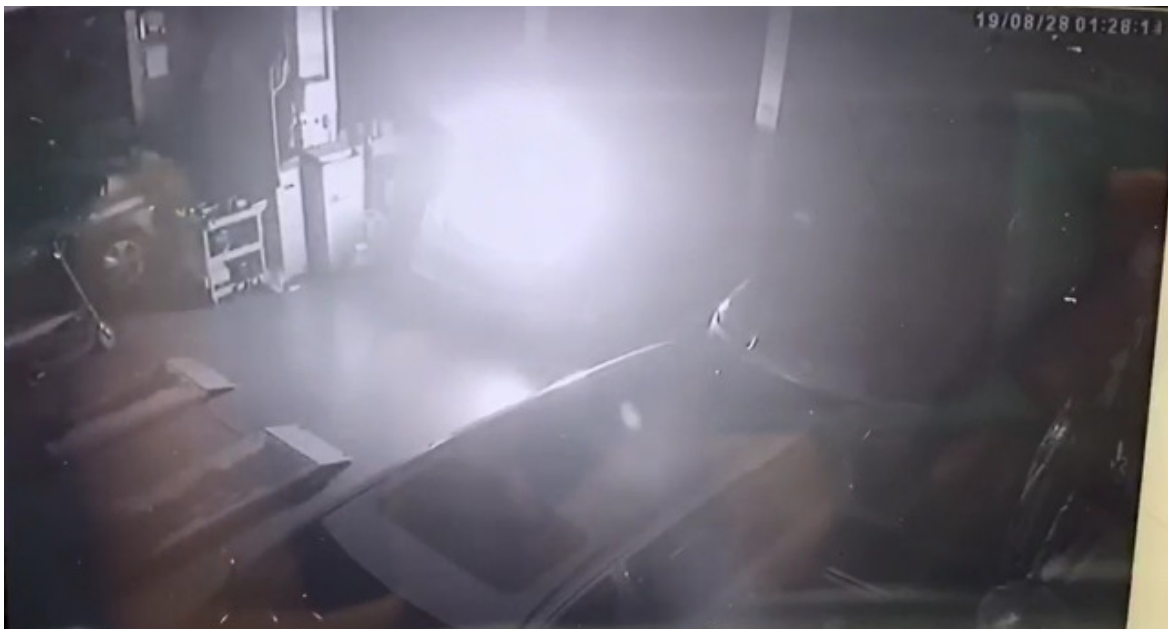
Photo 7 shows the premise of Hup Soon Batteries (screenshot from video footage retrieved from a CCTV camera inside the premise of Hup Soon Batteries). It was observed that the flame that was first seen at the rear of the Motor Car's engine compartment had turned into a fire and engulfed the entire engine compartment of the Motor Car but did not spread to the immediate surroundings of the Motor Car.

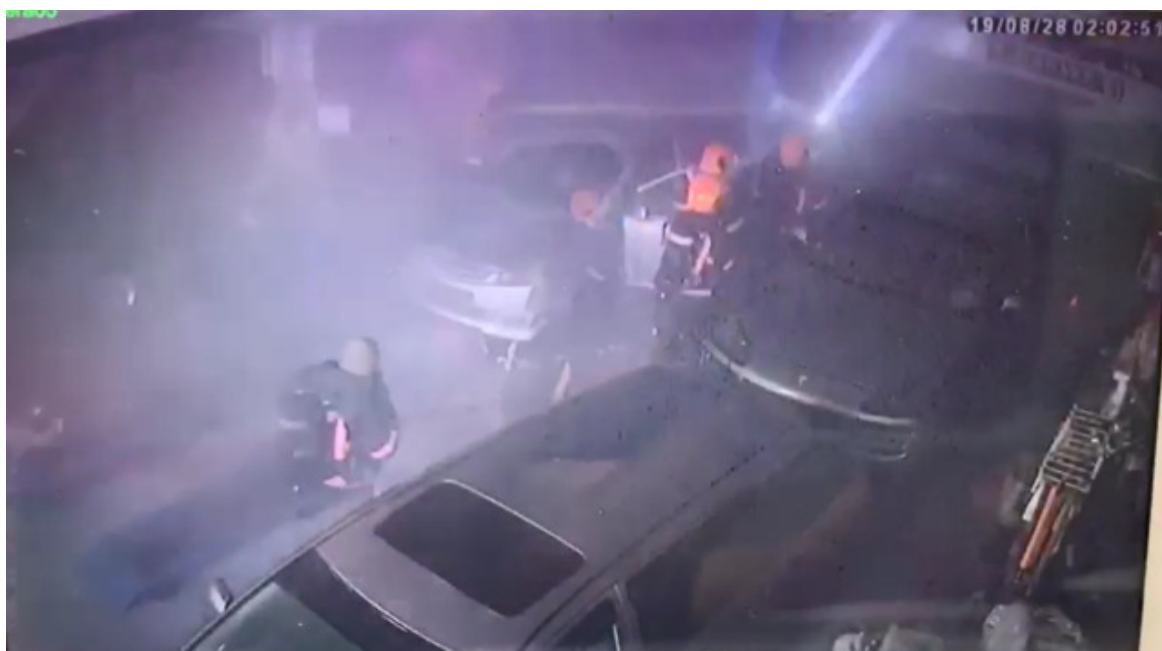
Photo 8 shows the premise of Hup Soon Batteries (screenshot from video footage retrieved from a CCTV camera inside the premise of Hup Soon Batteries). SCDF officers attending and putting out the fire before it could spread to the surroundings.

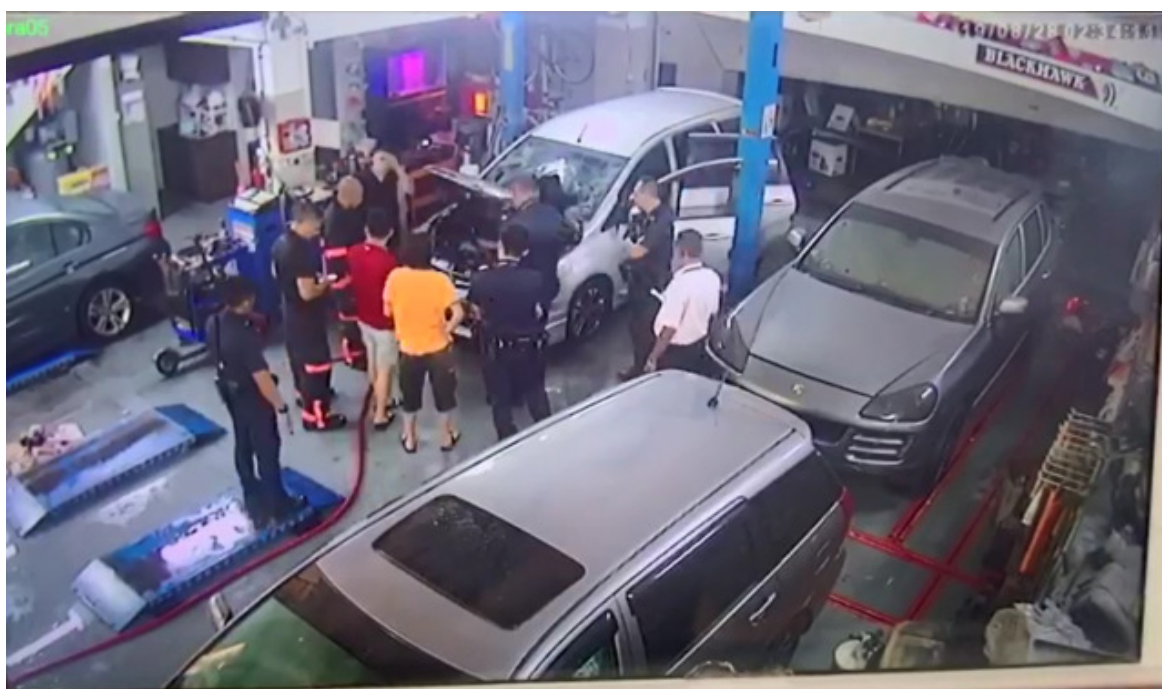
Photo 9 shows the premise of Hup Soon Batteries (screenshot from video footage retrieved from a CCTV camera inside the premise of Hup Soon Batteries). From the video footage, there appears to be no damage to other motor vehicle(s) that were parked inside the premise and/or to other property/equipment inside Hup Soon Batteries at that time.

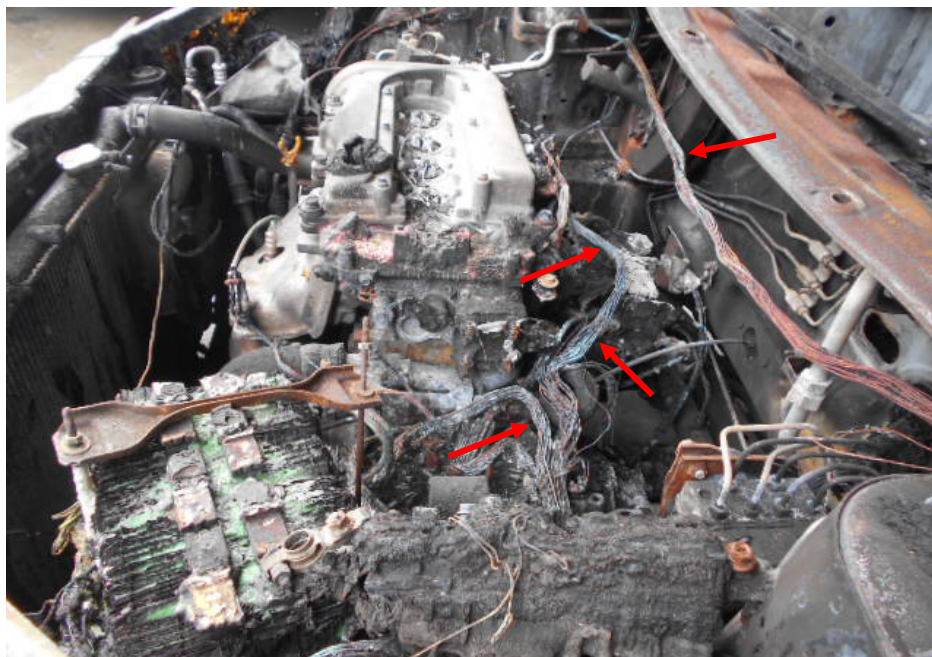
19. Upon my examination of the rear of the Motor Car's engine compartment, , which was where the flame was first seen, I had found greenish residue on several stretches of original factory fitted wirings. The presence of greenish residue indicates internal heating of copper wires, a sign of an electrical short circuit occurring. The greenish residue is normally left behind from oxidation as a result of chemical reaction involving the copper wires. This physical evidence indicates that the cause of fire to the Motor Car was due to electrical in nature. See photo 10 – 12 below.

Photo 10 shows the wirings inside the engine compartment of the Motor Car. Upon my examination of the rear of the engine compartment, which was where the flame was first seen, I had observed greenish residue on several stretches of wirings (arrowed). These wirings were originally fitted wirings. The presence of such greenish residue suggests occurrence of an electrical short circuit.

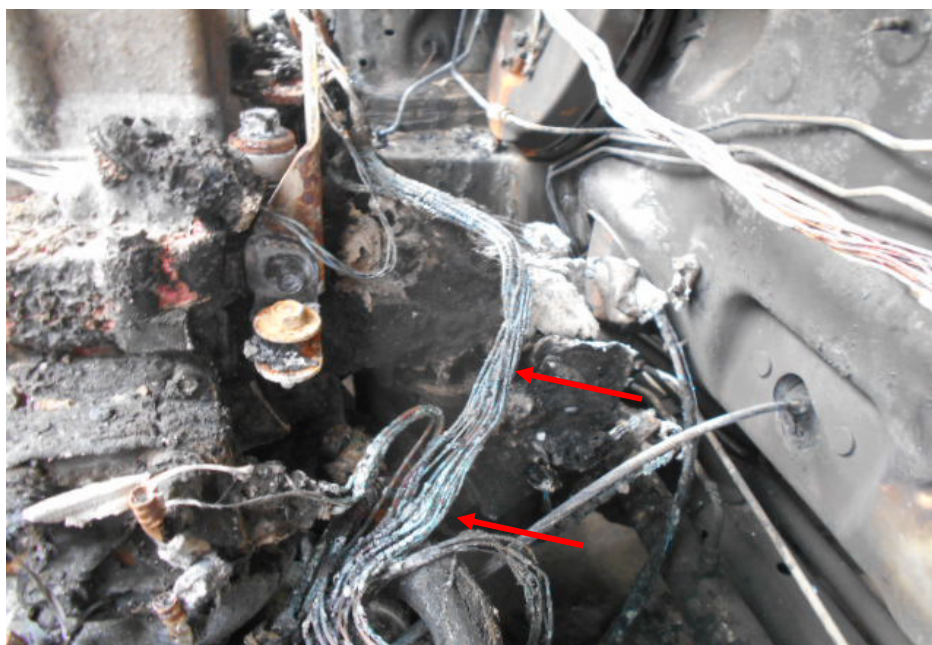
Photo 11 shows a closer view of the stretch of wirings with greenish residue (arrowed). The wirings were originally fitted wirings located at the rear of the Motor Car's engine compartment. The greenish residue indicates internal heating of copper wires, a sign of an electrical short circuit occurring. The greenish residue is normally left behind from oxidation as a result of chemical reaction involving the copper wires.

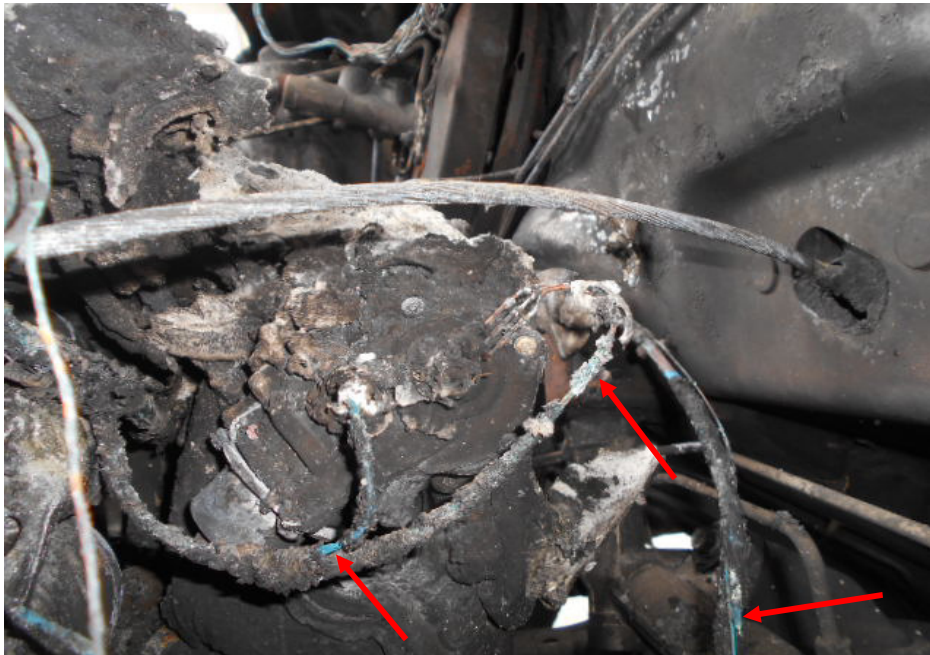
Photo 12 shows a closer view of another stretch of wirings with greenish residue (arrowed). The wirings were originally fitted wirings. The presence of such greenish residue suggests occurrence of an electrical short circuit.

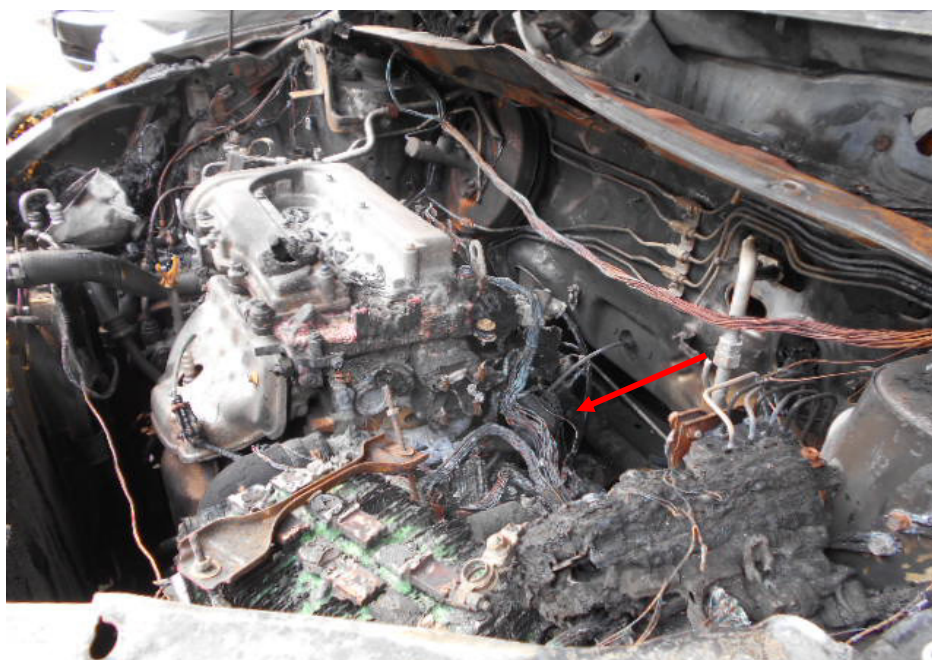
21. From the information gathered during the course of my investigations, the Motor Car was initially sent to Hup Soon Batteries for repair due to engine starting issue. Technicians from Hup Soon Batteries checked and diagnosed the issue as starter motor malfunction. The starter motor was subsequently removed, repaired and re-fitted on the Motor Car. The starter motor was located at the rear of the engine compartment, in the vicinity of where the flame was first seen on the Motor Car (refer to photograph 13 below). Factoring these into consideration, together with my technical analysis of the fire being of electrical in nature, it would appear that the fire could have possibly arisen from an electrical malfunction of the Motor Car's starter motor.

Photo 13 shows a general view of where the starter motor of the Motor Car is located. This was at the rear of the engine compartment (arrowed), in the vicinity of where the flame was first seen on the Motor Car.
