LKK Auto Consultants Pte Ltd

1. Policy Particulars :- THIRD PARTY CLAIM				
Insured Veh.	SLN 848E	Veh. Inspected	SHC 5020Z	
Policy No.	DMPCSN1936911900	Coverage (\$)	0.00	
Claim No.	SNM19D204711C02/8	Excess (\$)	0.00	
Assign From		Assign Date	08/10/2019

ADJUSTMENT ON REPAIR COST FOR VEHICLE NO. SHC 5020Z

PHOTOGRAPHS FOR VEHICLE NO. SHC 5020Z

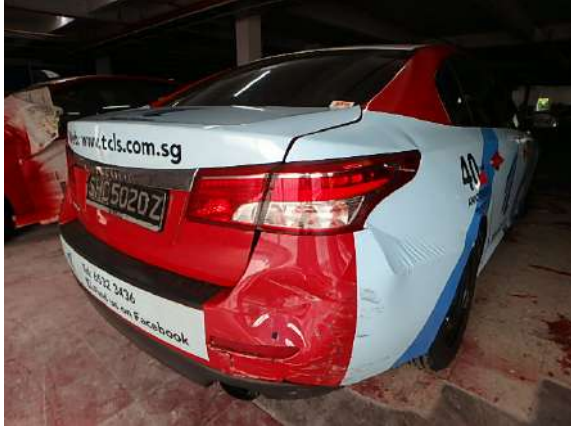
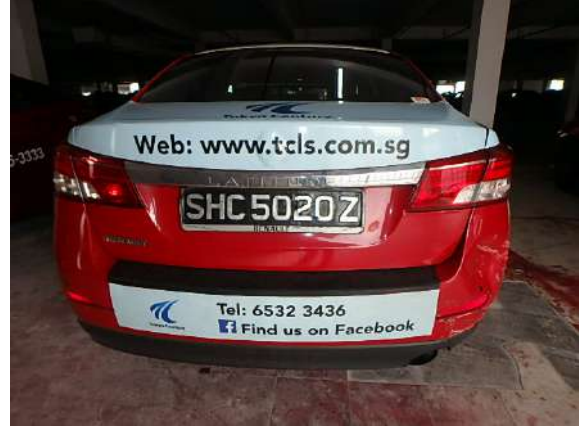
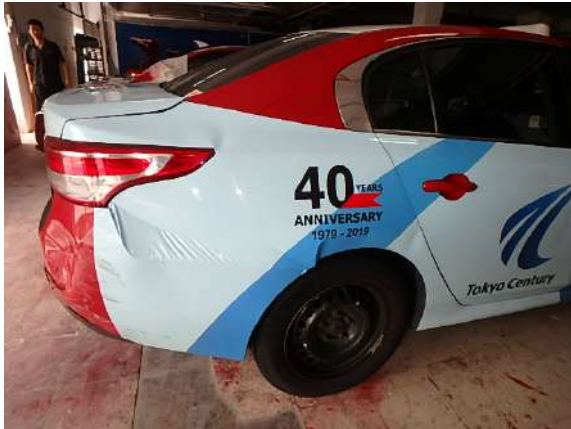
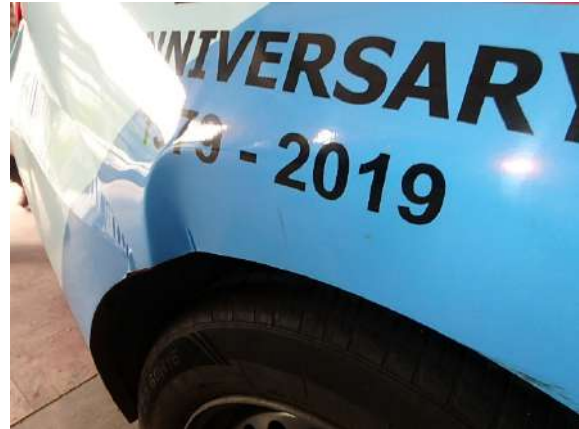
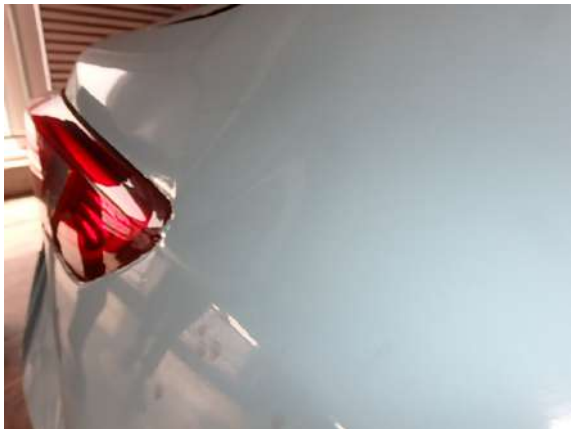
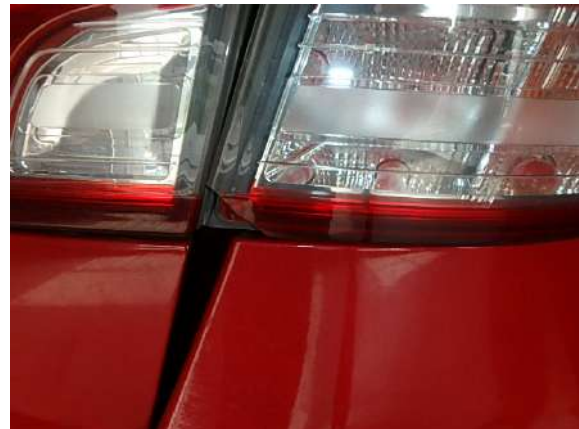
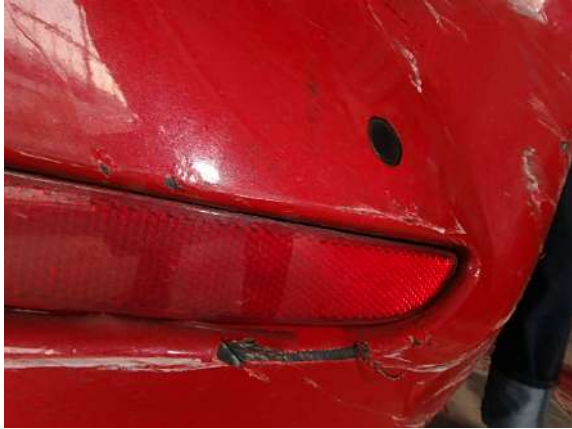
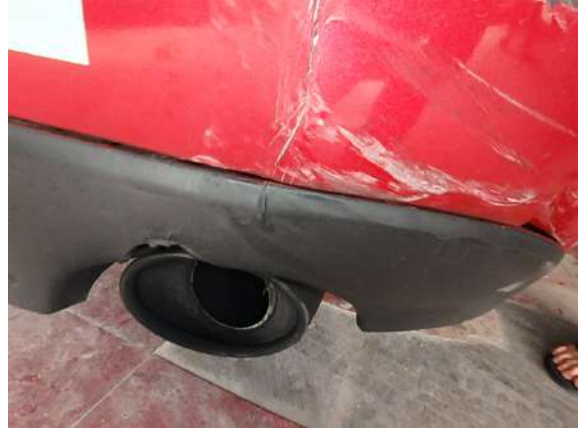
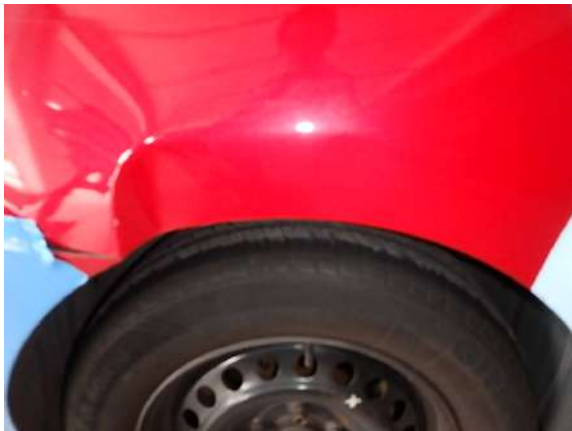
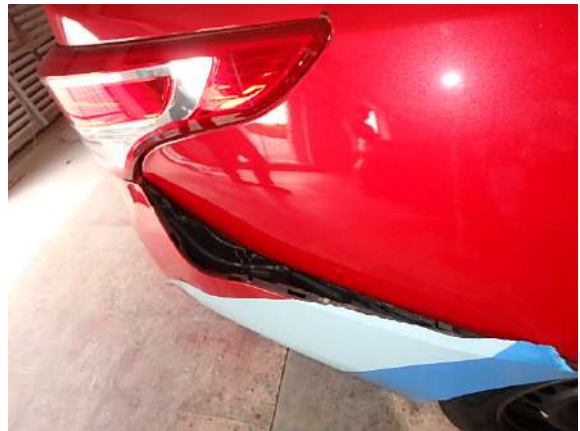
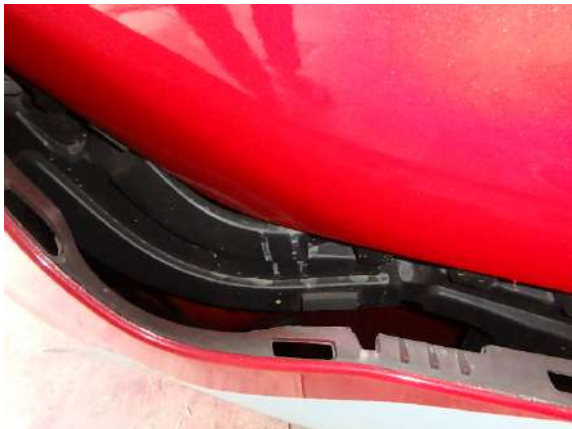
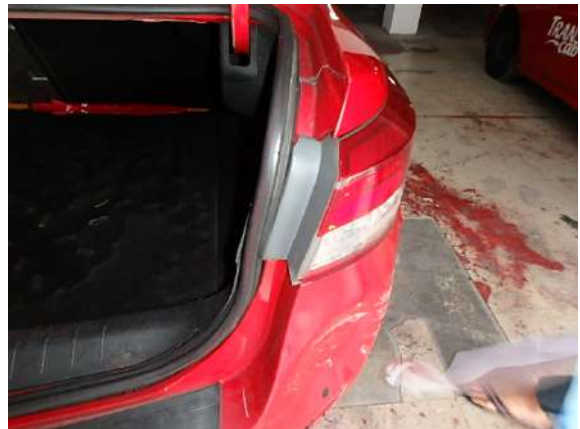
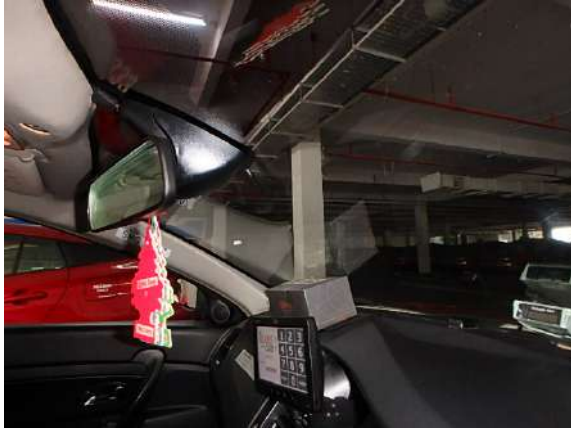
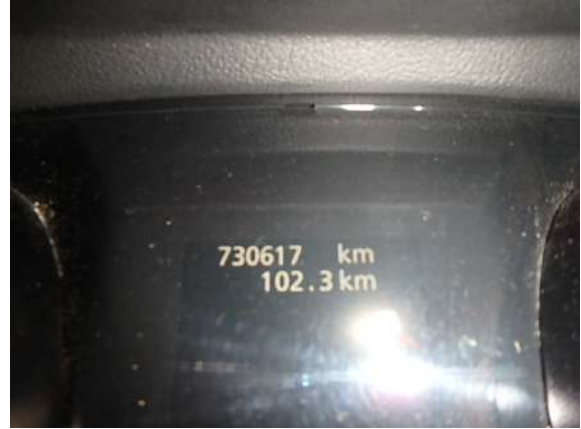
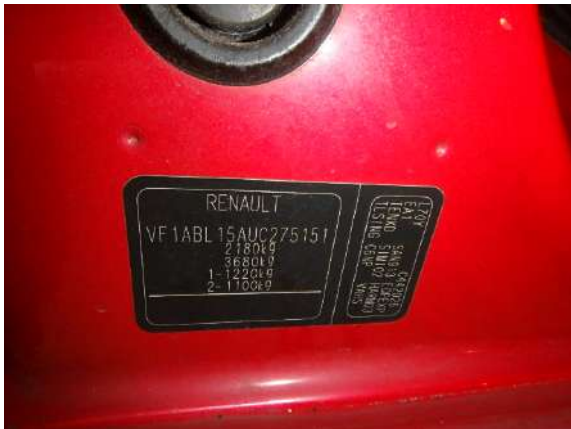
4. Description of Damages				
THE VEHICLE SUSTAINED DAMAGES AT THE REAR O/S PORTION. DAMAGES SEE DETAILS.				
5. General Information				
Accident Date	06/10/2019	Inspection Date	08/10/2019	
Survey held at	TRANS-CAB AUTO SERVICES PTE LTD NO.2 ANG MO KIO ST 63 SINGAPORE 569111			
5a. Remarks				
A)THE INSPECTION WAS CONDUCTED ON A"WITHOUT PREJUDICE" BASIS. B)IN ACCORDANCE TO YOUR INSTRUCTIONS, WE HAVE NOT AUTHORISED REPAIRS.				
5b. Estimate Days of Repair				
ESTIMATED NORMAL PERIOD FOR REPAIR:			5 Working Days
