Report Reference : TP / 19011-09/AY / 2019  
Date of Report : 24 Sep 2019

**THIRD PARTY SURVEY**  
**ACCIDENT HAPPENED ON 7 Sep 2019**

## VEHICLE DAMAGE INSPECTION REPORT

**Our File No:** CS3/SMO19016045/UVF3S2-1  
**Date:** 18/10/2019

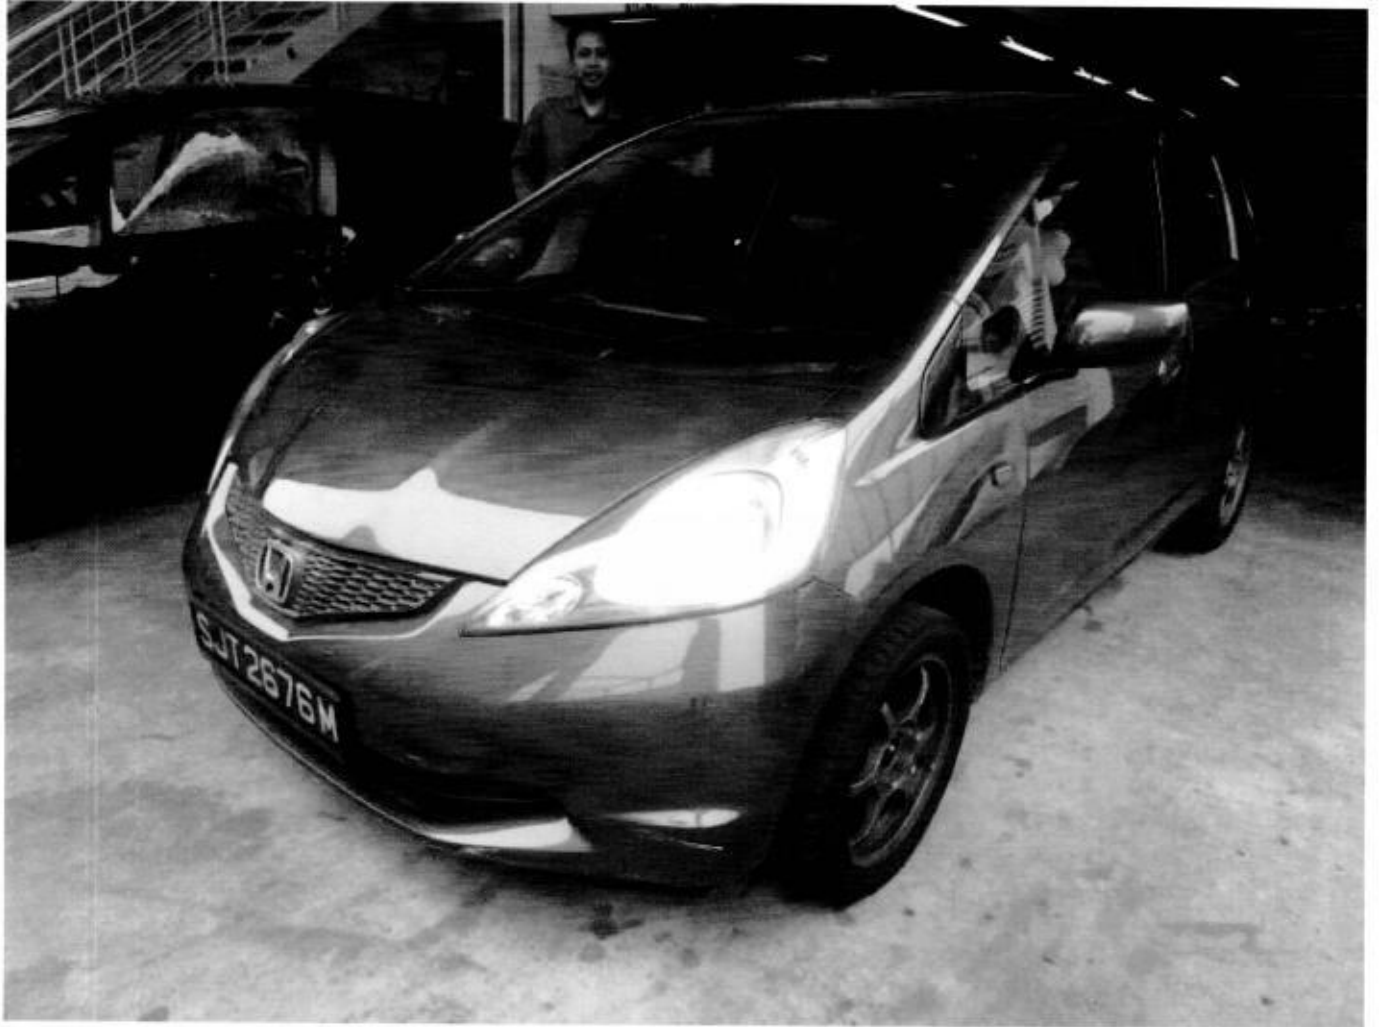
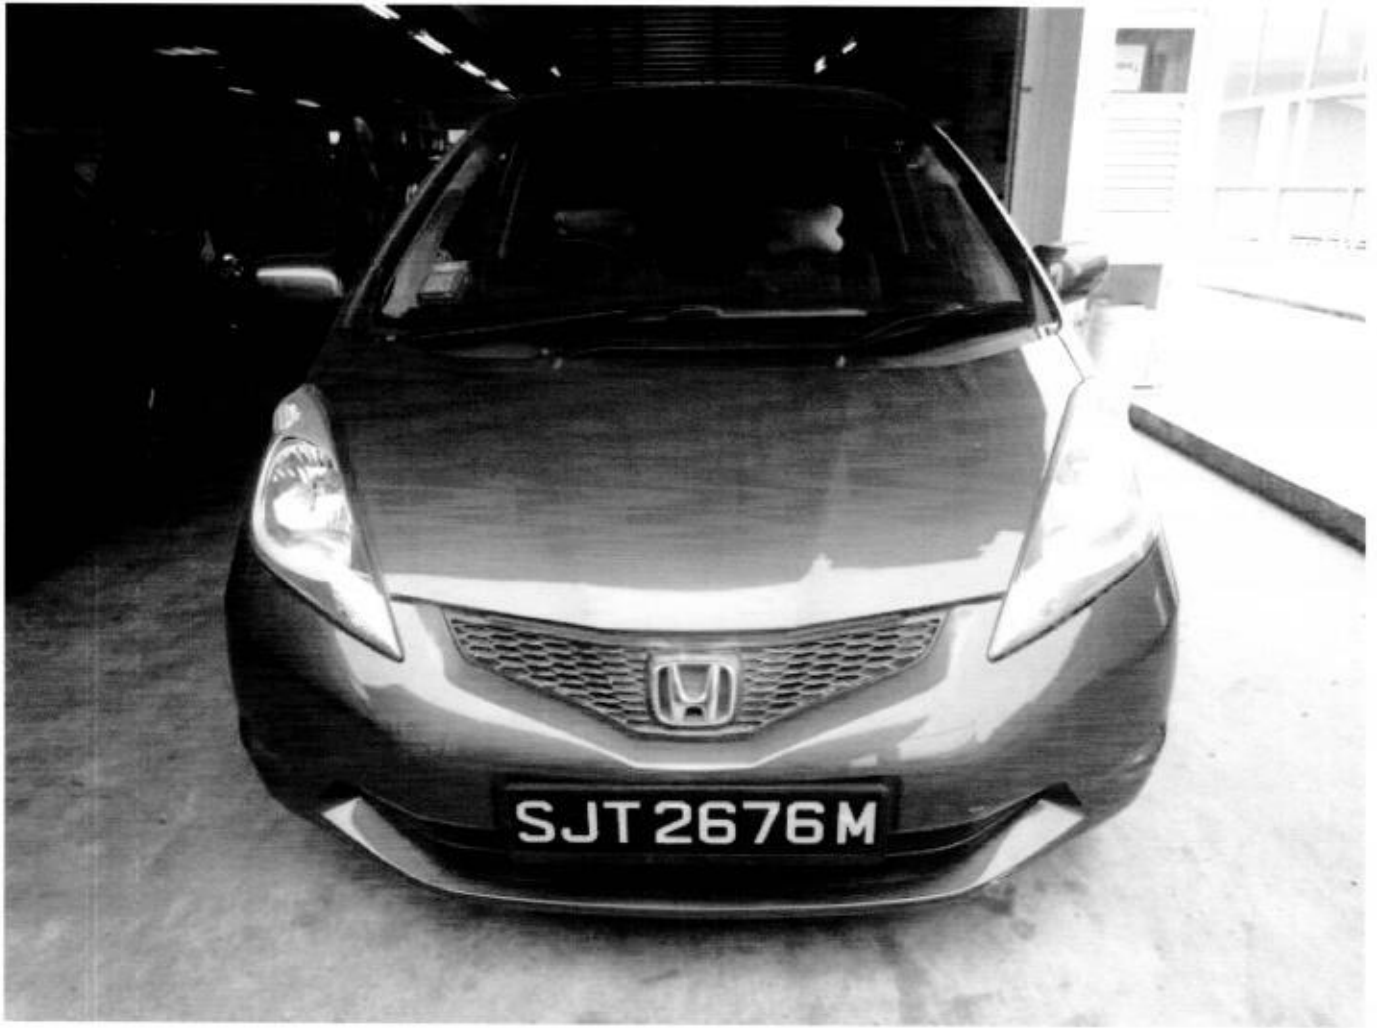
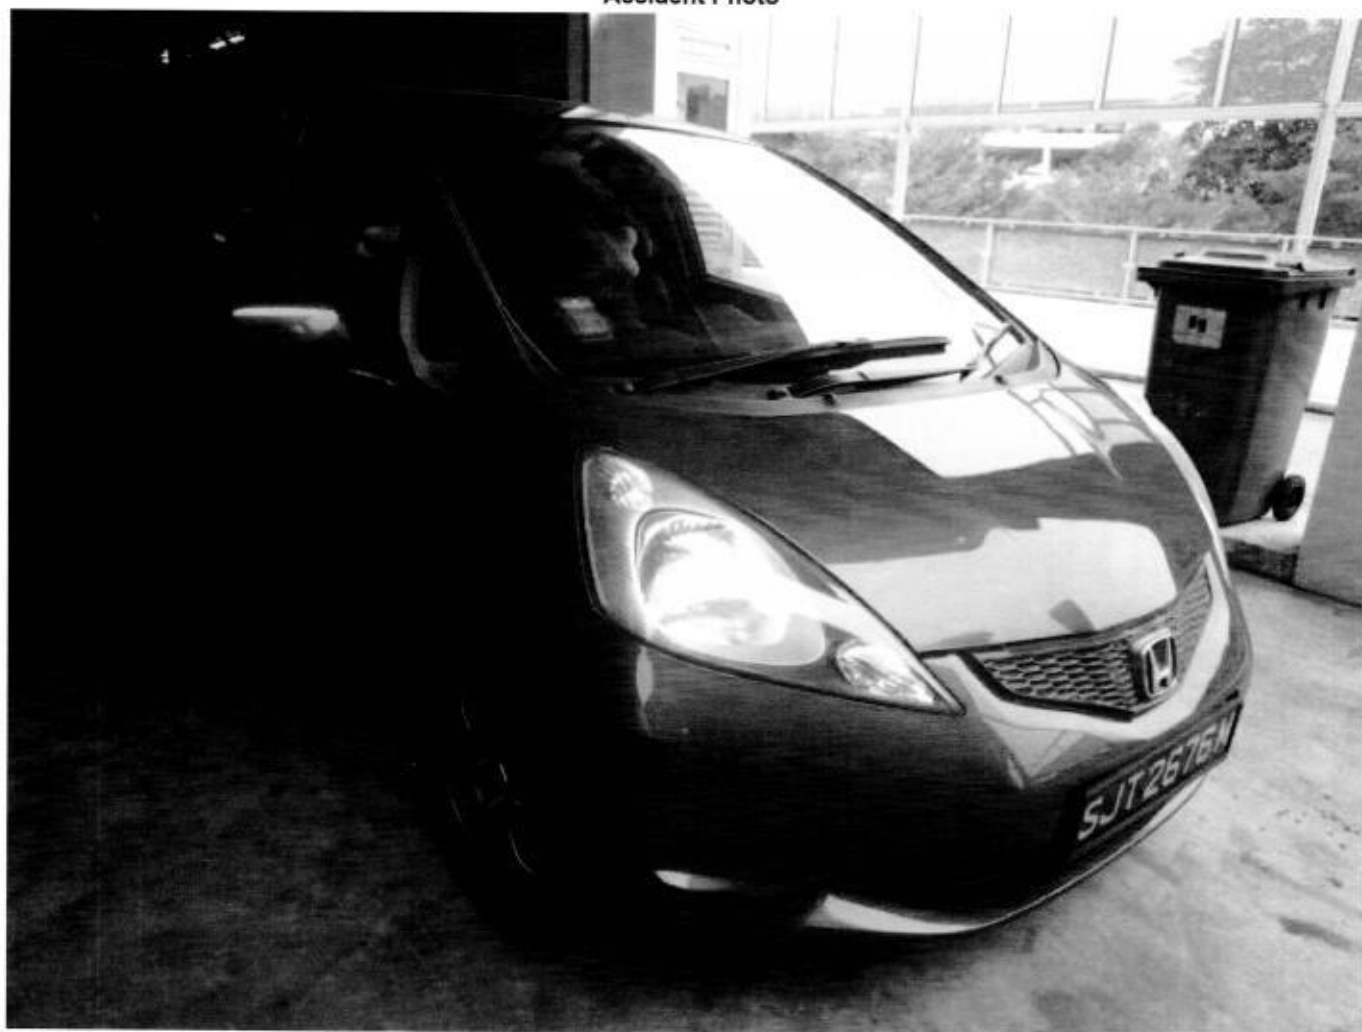
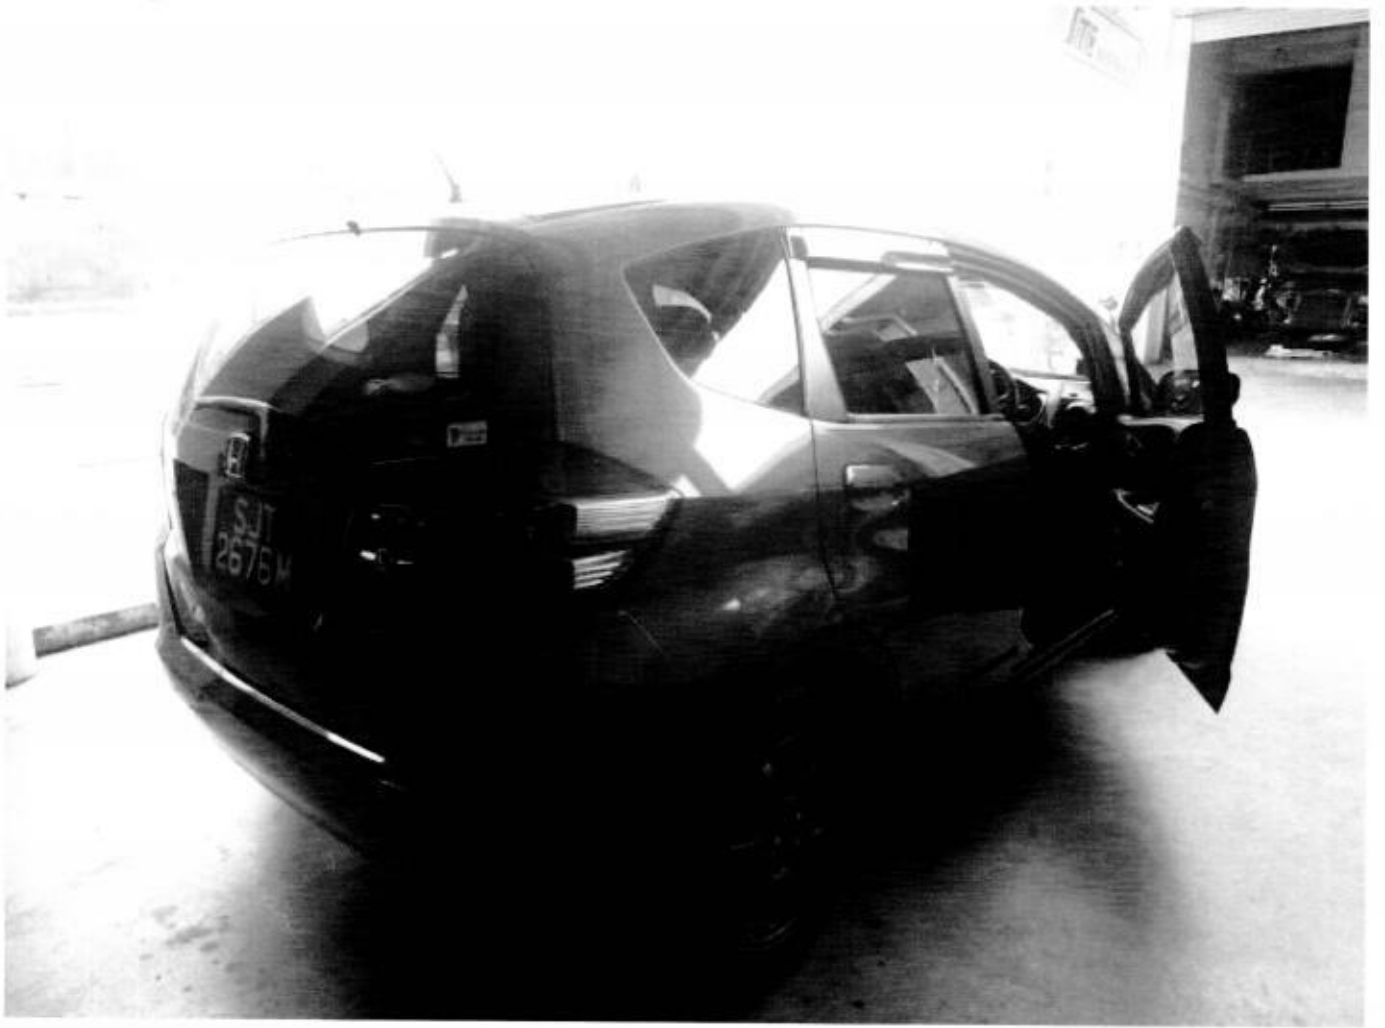
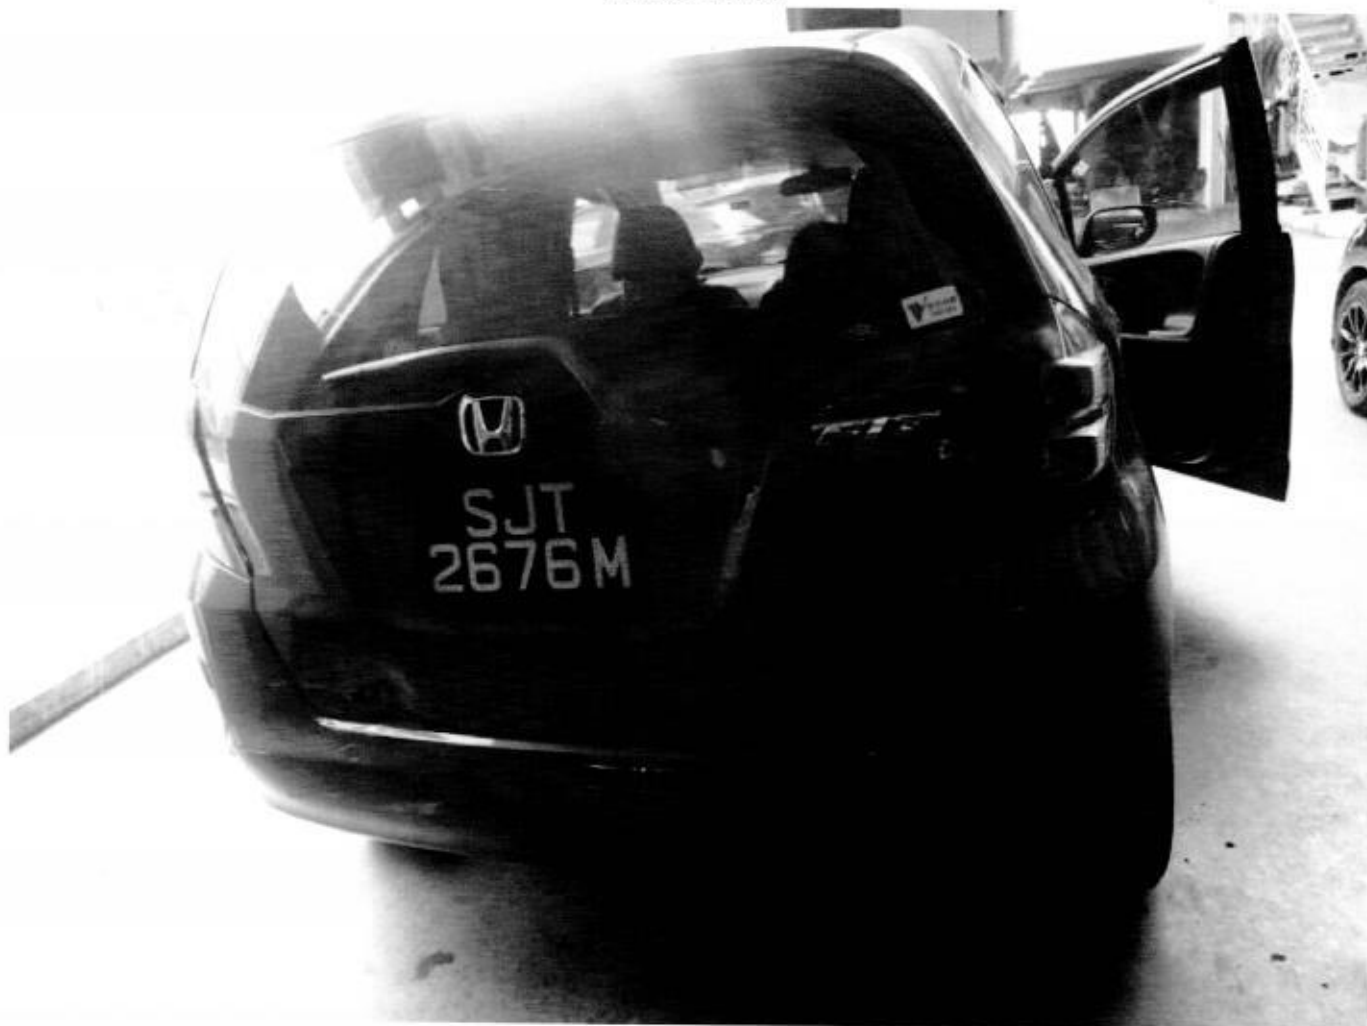
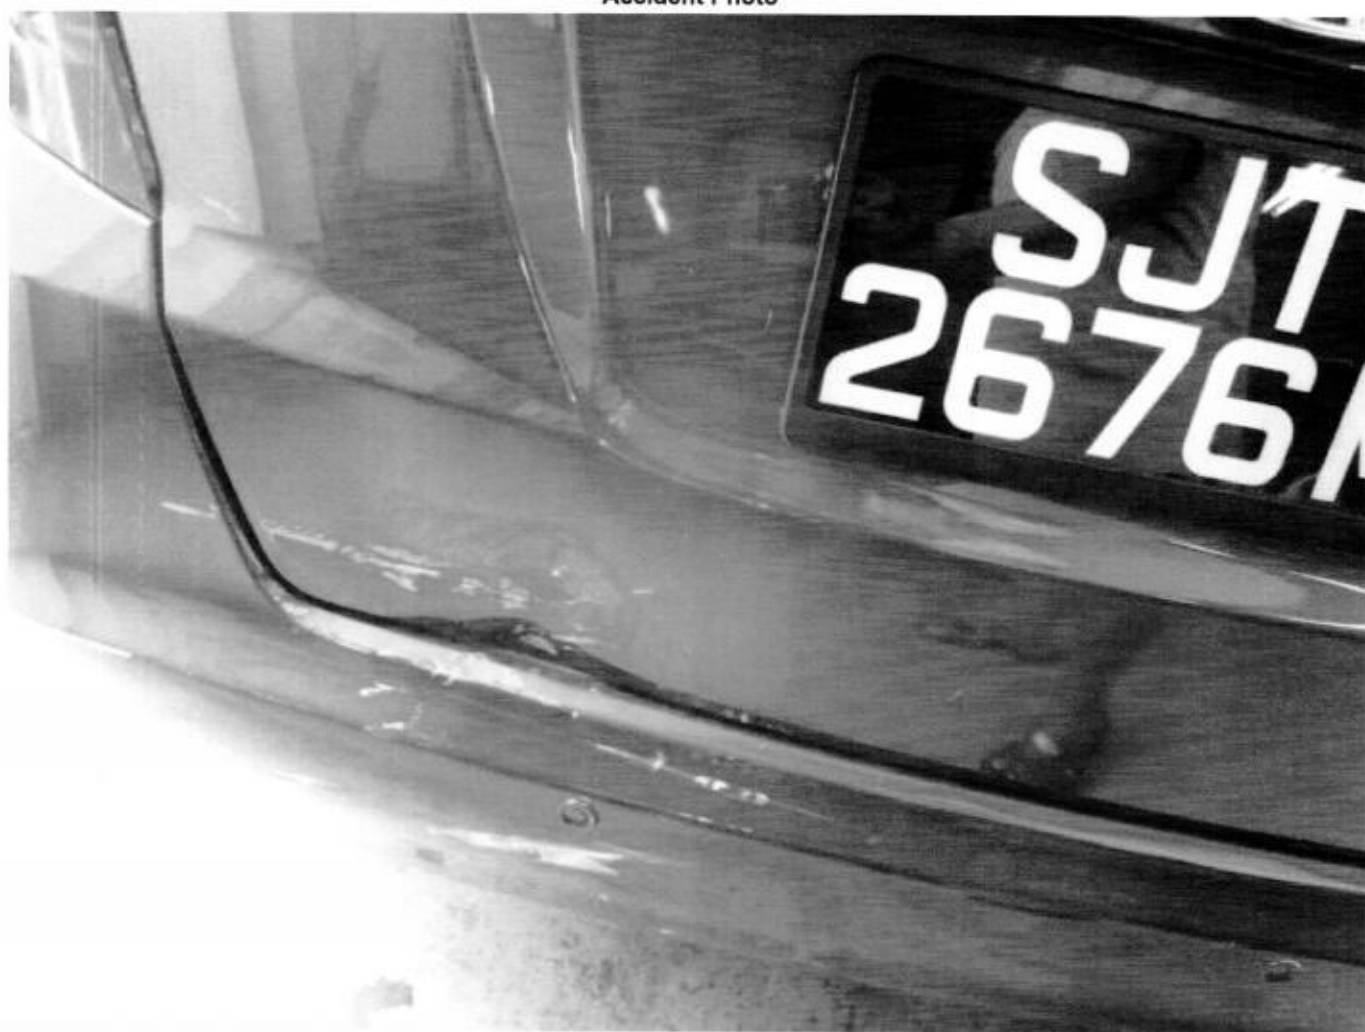
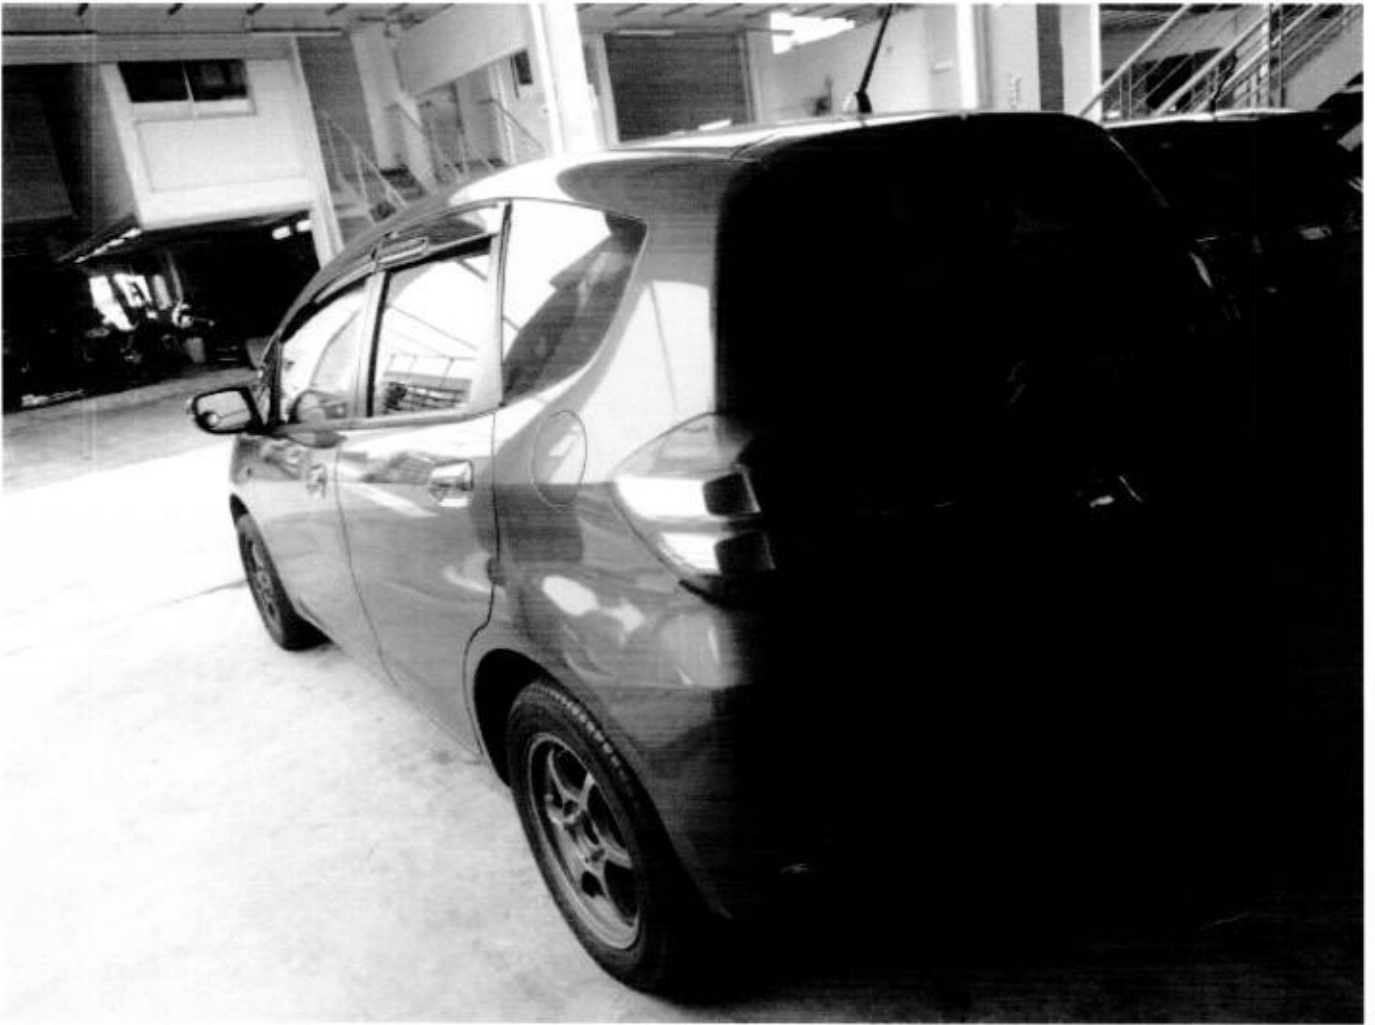
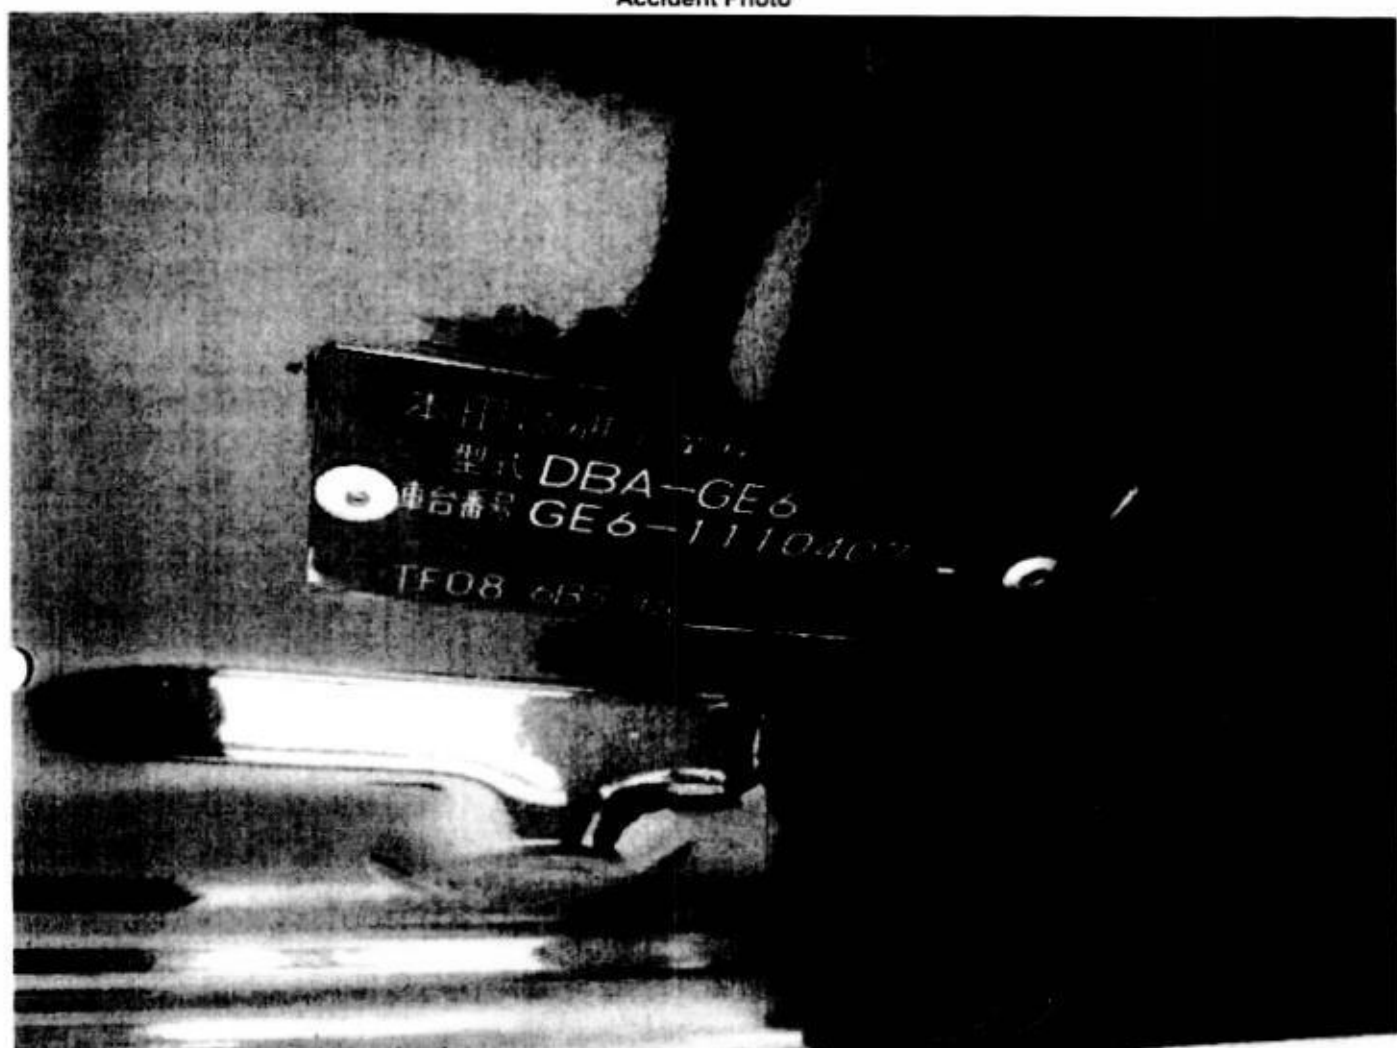
At the time of inspection, we noted that the vehicle has sustained an impact damages on the front portion(s). For more detail of the damages, please see photograph attached.
