Your Ref: DMPC1900268H
Our Ref : CS/ICS19018236/D

24 October 2019

TECHNICAL INVESTIGATION REPORT OF FIRE INCIDENT INVOLVING THE INSURED VEHICLE SGL 2506Z ON 12 OCTOBER 2019

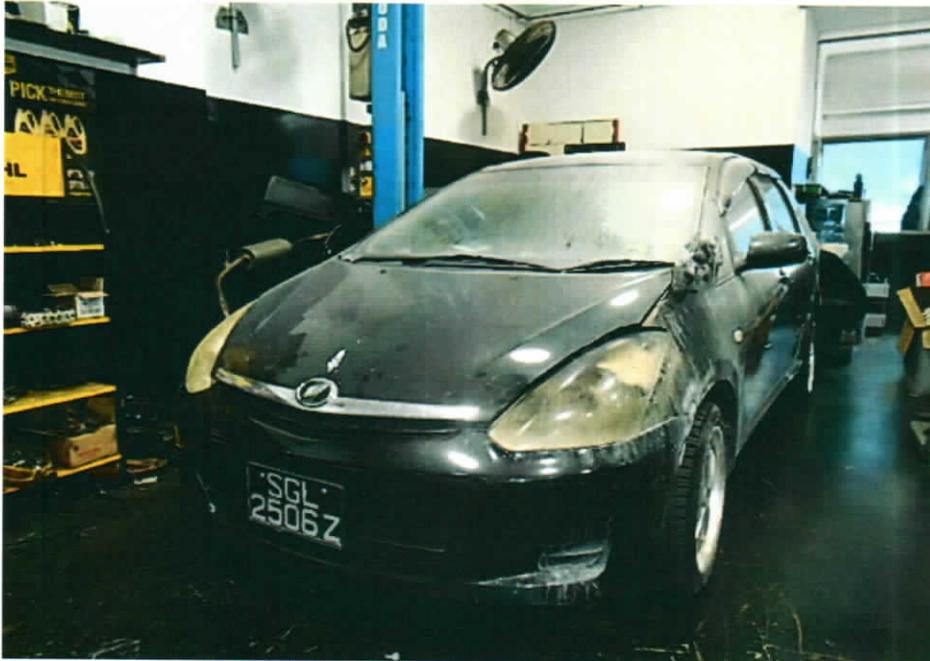
Photo 1 shows a general view of the front left body of the Insured Vehicle at the time of my inspection. The fire damage was confined to the left side of the Insured Vehicle's engine compartment. The interior compartment and the rear portion of the Insured Vehicle were unaffected. Exteriously, the front bumper, front bonnet, front left headlamp and front left fender were affected by the incident.

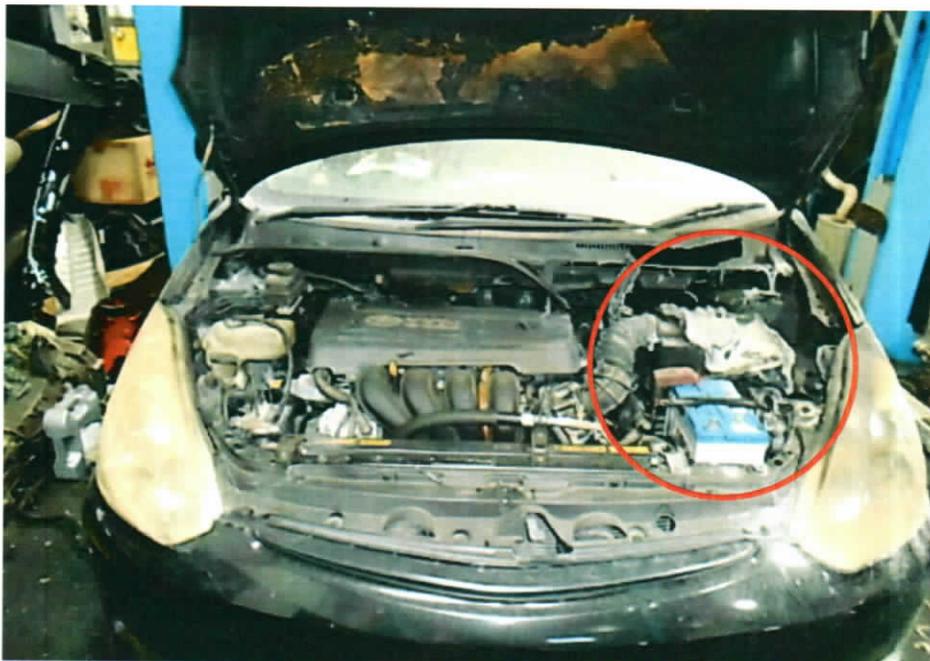
Photo 2 shows a general view of the engine compartment of the Insured Vehicle. The fire damage was confined to the left side (circled) of the engine compartment. Parts like the air intake housing, battery, fuse box, wiper panel garnish amongst others were observed to have been burnt and/or partially melted.

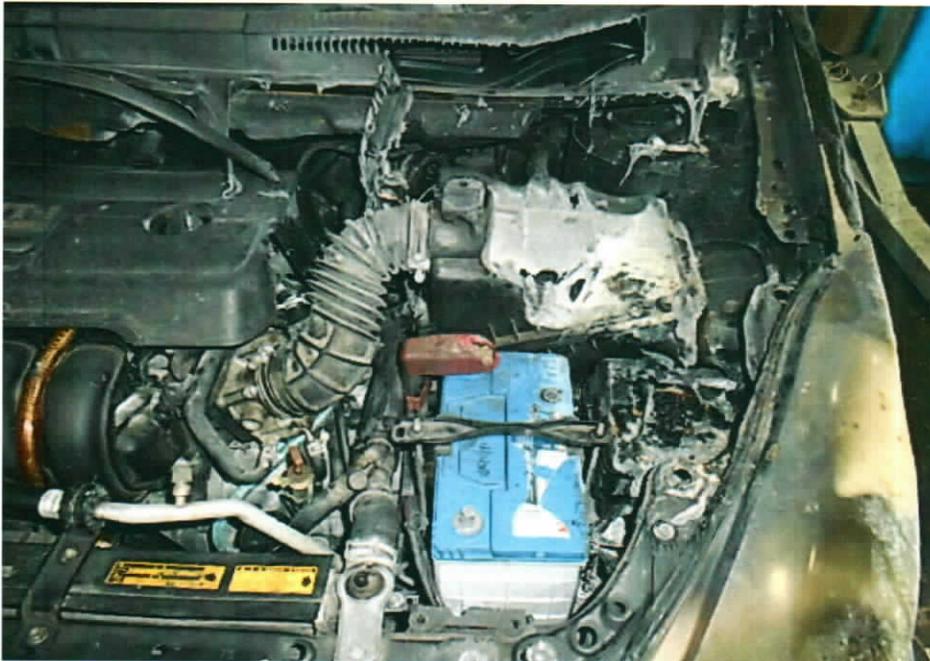
Photo 3 shows a closer view of the burnt and/or partially melted parts that were located at the left side of the engine compartment. This had included the air intake housing, battery, fuse box, wiper panel garnish amongst.

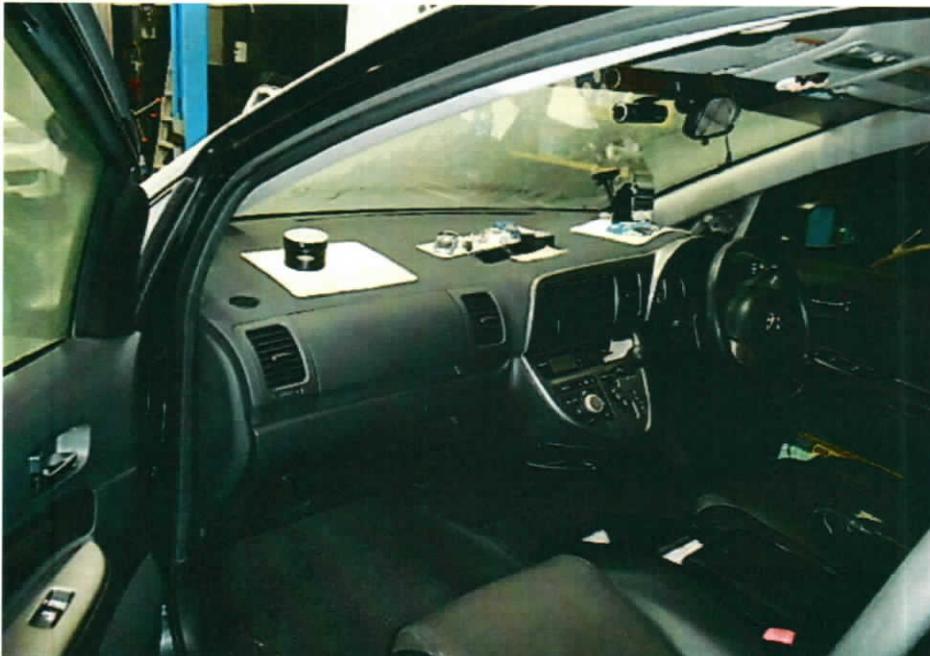
Photo 4 shows the interior compartment of the Insured Vehicle, which was unaffected by the incident. The rear portion of the Insured Vehicle was also similarly unaffected by the incident.

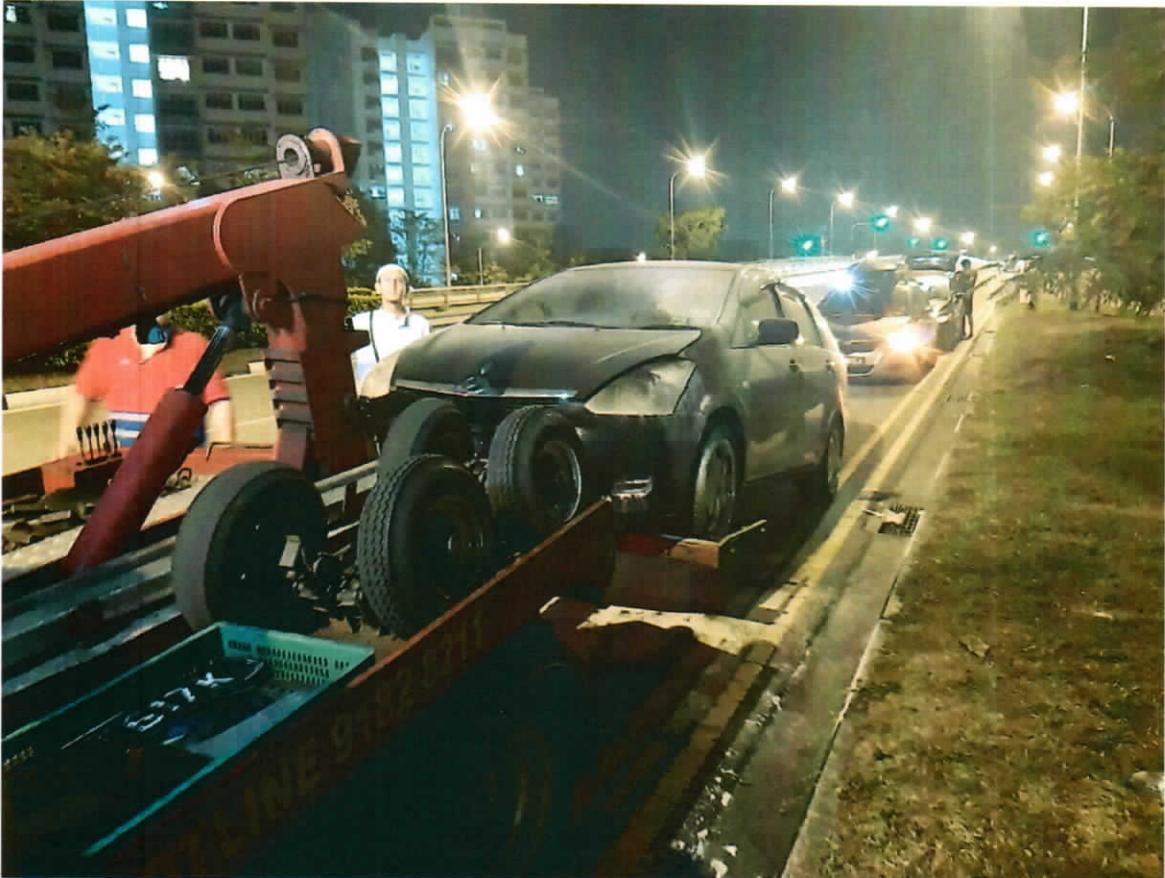
Photo 5 shows a general view of the Insured Vehicle at the incident location with the fire already extinguished, and just as it was about to be towed away. Generally, there was no notable information that could be gathered upon reviewing the photographs provided by Mr Yunos.

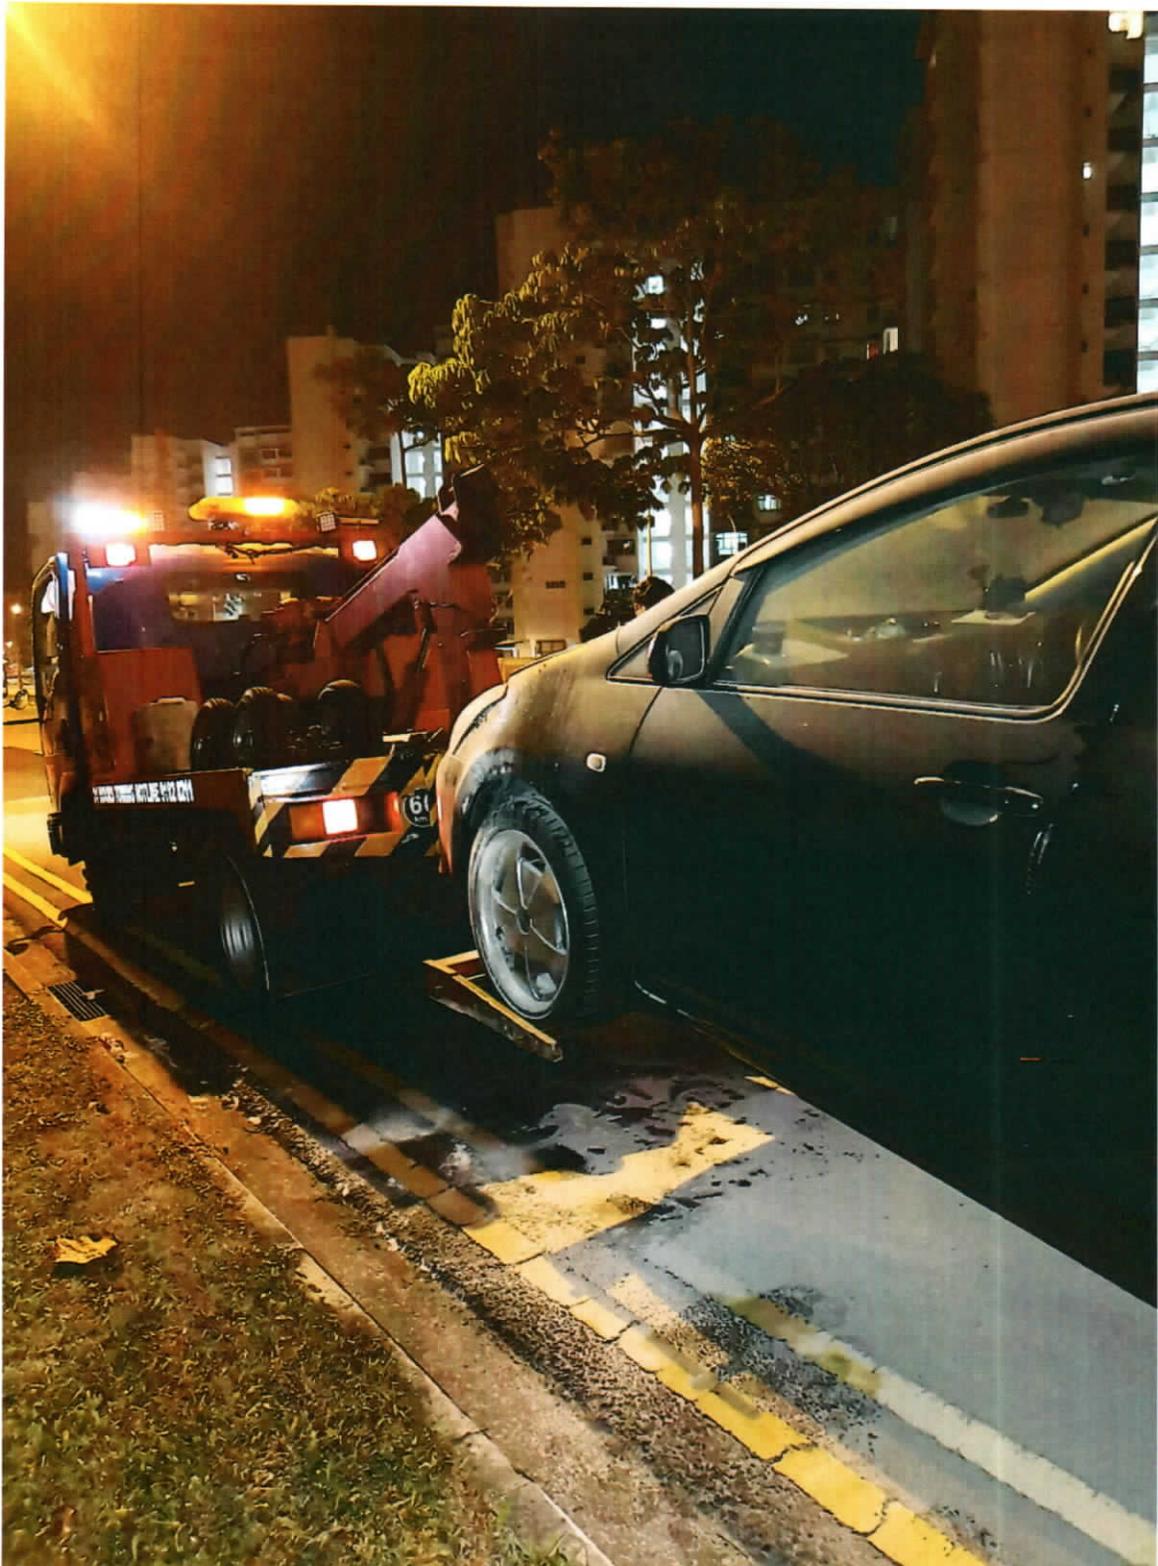
Photo 6 shows a general view of the Insured Vehicle at the incident location with the fire already extinguished, and just as it was about to be towed away. Generally, there was no notable information that could be gathered upon reviewing the photographs provided by Mr Yunos.

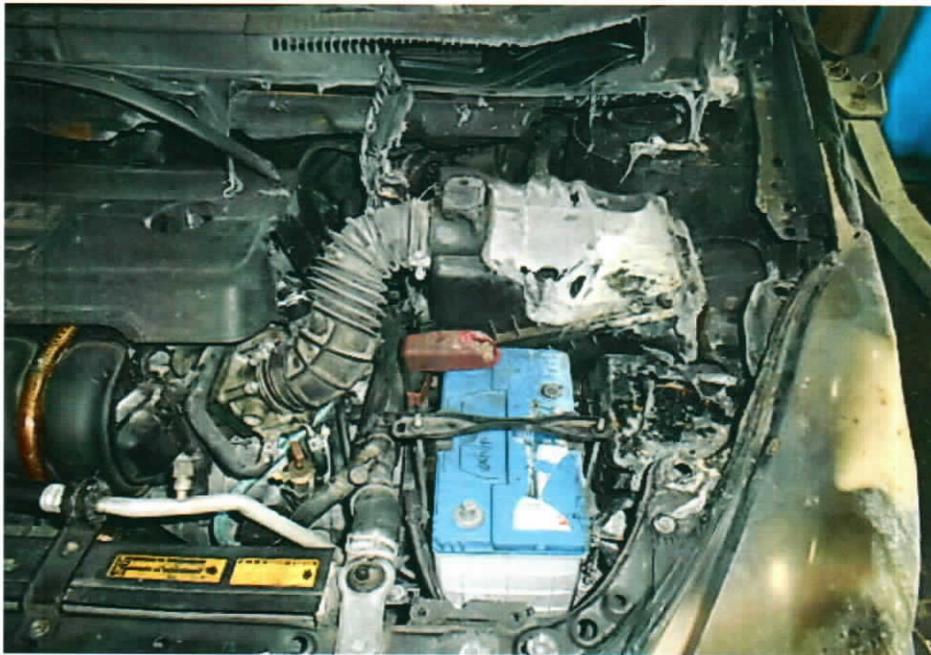
18. Firstly, it was observed during my inspection that the Insured Vehicle had sustained fire damage only at the left side of its engine compartment. Based on this single area of fire damage that the Insured Vehicle had sustained (interior compartment and rear portion also unaffected), the fire is established to have originated at the left side of the Insured Vehicle's engine compartment.

Photo 7 shows the left side of the Insured Vehicle's engine compartment. Basing on the single area of fire damage that the Insured Vehicle had sustained, the fire can be determined to have occurred within the engine compartment of the Insured Vehicle, at the left side.

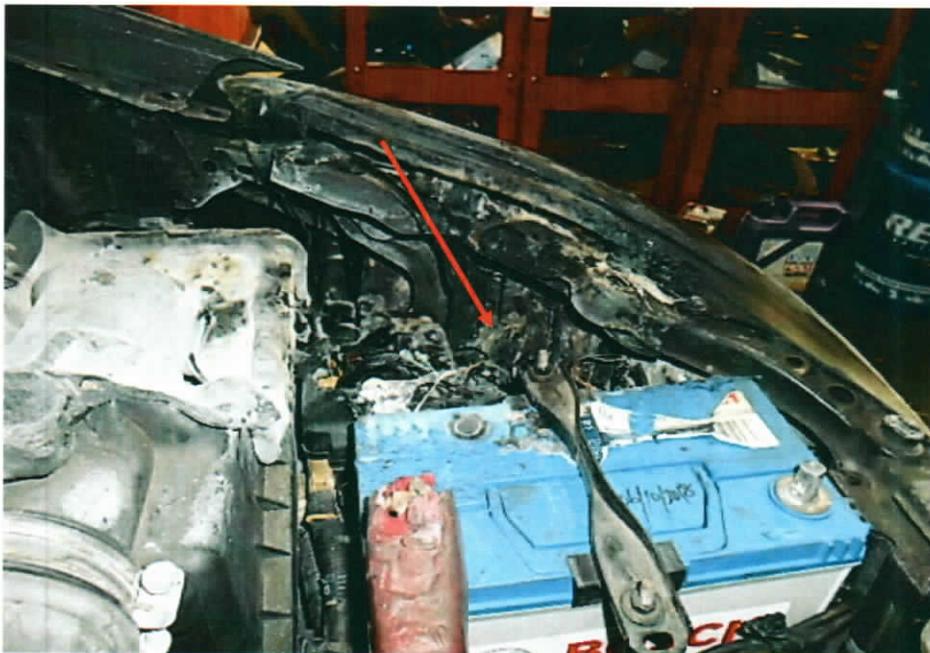
Photo 8 shows a closer view of the left side of the engine compartment. Upon my closer examination, I had found greenish residue on an original factory fitted wiring at the area (arrowed) directly behind the front left headlamp of the Insured Vehicle.

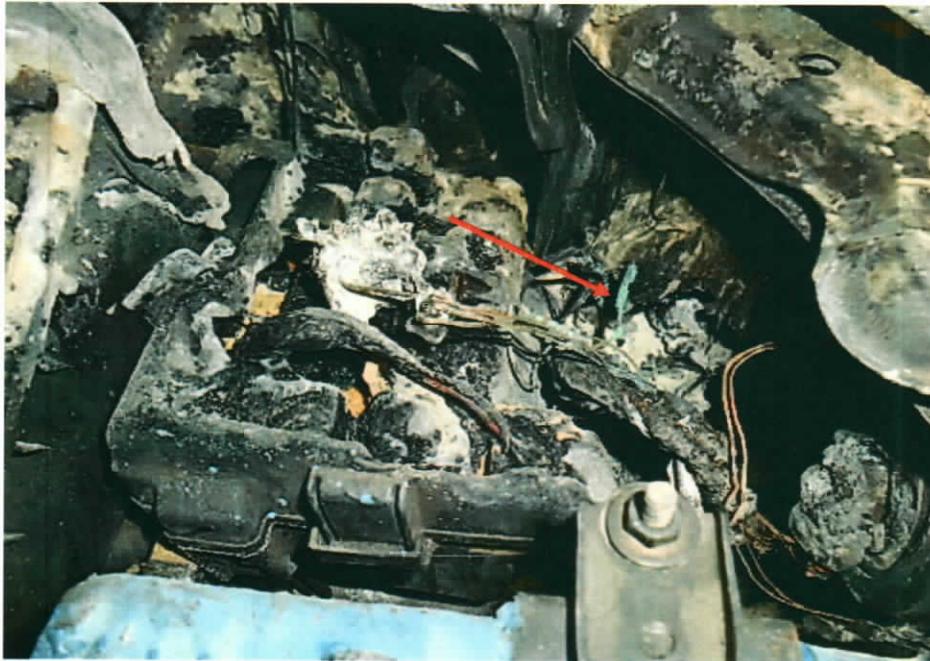
19. Upon my close examination of the left side of the engine compartment, I had found greenish residue on an original factory fitted wiring. The wiring was observed to be for the front left headlamp of the Insured Vehicle. The presence of greenish residue indicates internal heating of copper wires, a sign of an electrical short circuit occurring. Such greenish residue is normally left behind from oxidation as result of chemical reaction involving copper wires. This physical evidence indicates that the cause of fire to the Insured Vehicle was due to electrical in nature. See photo 7 - 10 below.

Photo 9 shows the greenish residue (arrowed) that was found on an original factory fitted wiring. The wiring was observed to be for the front left headlamp of the Insured Vehicle. The presence of greenish residue indicates internal heating of copper wires, a sign of an electrical short circuit occurring. Such greenish residue is normally left behind from oxidation as result of chemical reaction involving copper wires.

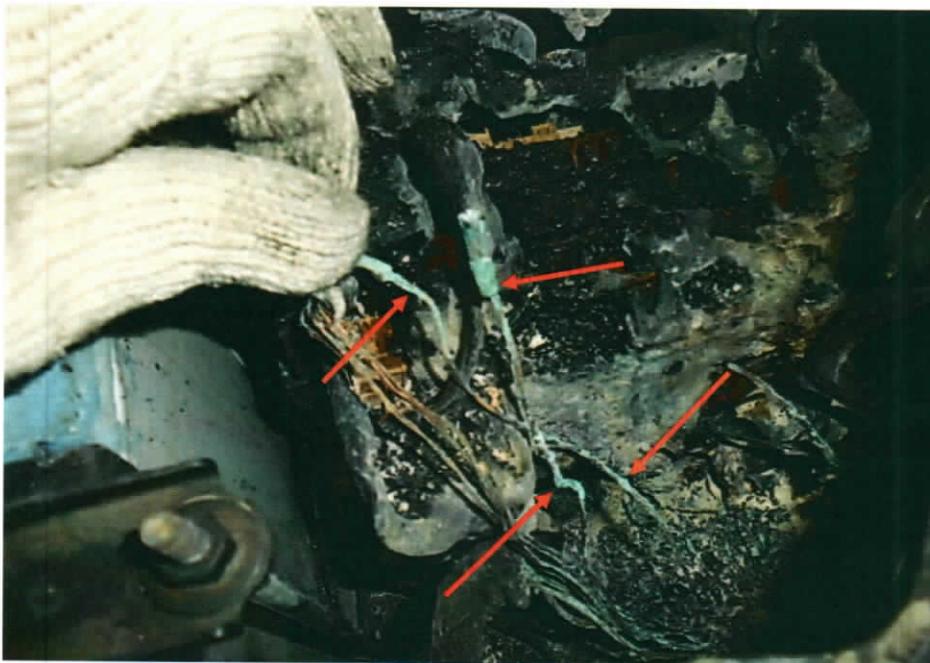
Photo 10 shows a closer view of the greenish residue (arrowed) that was found on the wiring for the front left headlamp of the Insured Vehicle. The presence of greenish residue indicates internal heating of copper wires, a sign of an electrical short circuit occurring. This physical evidence indicates that the cause of fire to the Insured Vehicle was due to electrical in nature.

20. During my conversation with Mr Yunos, he had mentioned that the blub for the front left headlamp had blown just before the fire incident. He further mentioned that the bulb(s) for the front left headlamp and/or the front right headlamp would blow quite frequently, about 2 to 3 months once. From this information, it can be gathered that there was abnormality with the wirings for the front headlamps of the Insured Vehicle.

21. Under normal circumstance, typical cause(s) of bulb blowing includes an overload of electrical current flowing through the wirings and/or an abnormal travel path of electrical current triggering high heat that could blow the bulb. Since there were several past occasions of bulb blown experienced by the Insured Vehicle, the issue of bulb blowing experienced by the Insured Vehicle can then be considered to be a recurring issue. If thorough check(s) were to be carried out previously (especially after there were several occurrences of bulb blown), the fire incident to the Insured Vehicle could possibly have been prevented.

23. Having investigated and technically analysed the damages of burnt nature to the Insured Vehicle, I am of the view that the cause of fire to the Insured Vehicle was of electrical in nature. For this particular case, the fire had originated along the originally fitted wiring for the front left headlamp of the Insured Vehicle.
