Your Ref: DMPC1900268H
Our Ref : CS/ICS19018236/D

24 October 2019

TECHNICAL INVESTIGATION REPORT OF FIRE INCIDENT INVOLVING THE INSURED VEHICLE SGL 2506Z ON 12 OCTOBER 2019

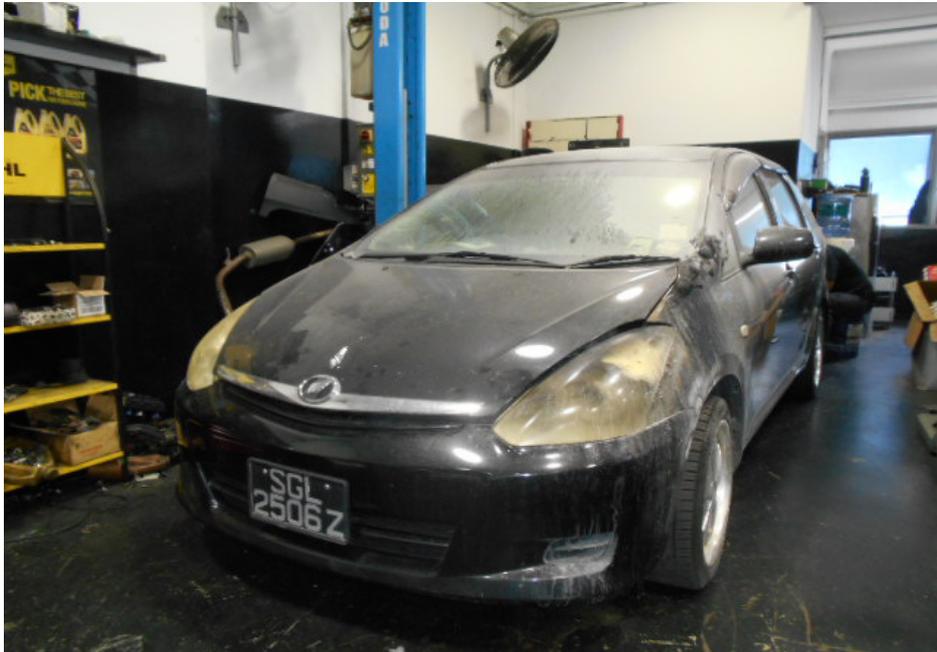
Photo 1 shows a general view of the front left body of the Insured Vehicle at the time of my inspection. The fire damage was confined to the left side of the Insured Vehicle's engine compartment. The interior compartment and the rear portion of the Insured Vehicle were unaffected. Exterially, the front bumper, front bonnet, front left headlamp and front left fender were affected by the incident.

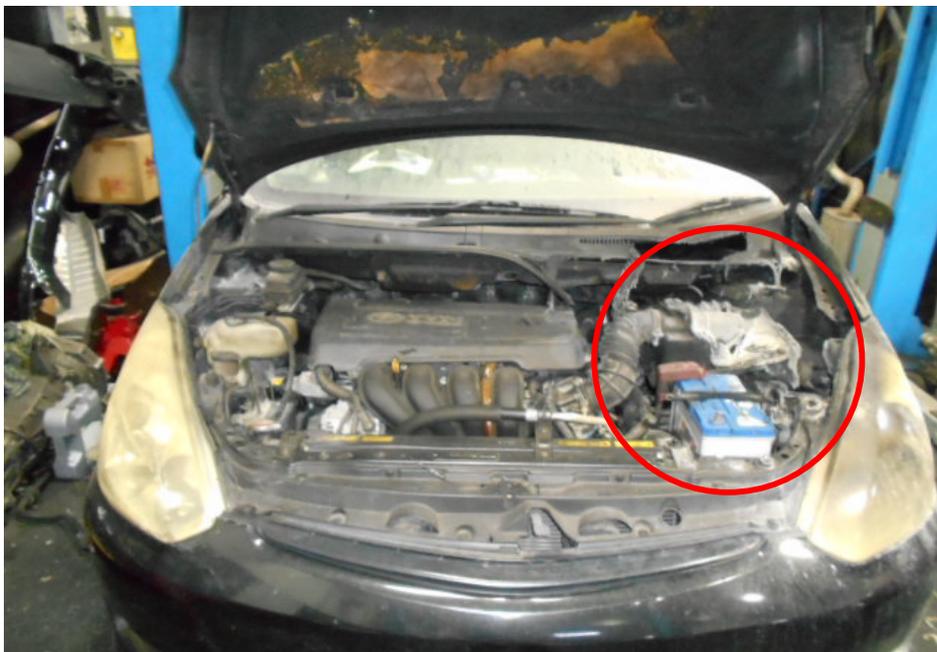
Photo 2 shows a general view of the engine compartment of the Insured Vehicle. The fire damage was confined to the left side (circled) of the engine compartment. Parts like the air intake housing, battery, fuse box, wiper panel garnish amongst others were observed to have been burnt and/or partially melted.

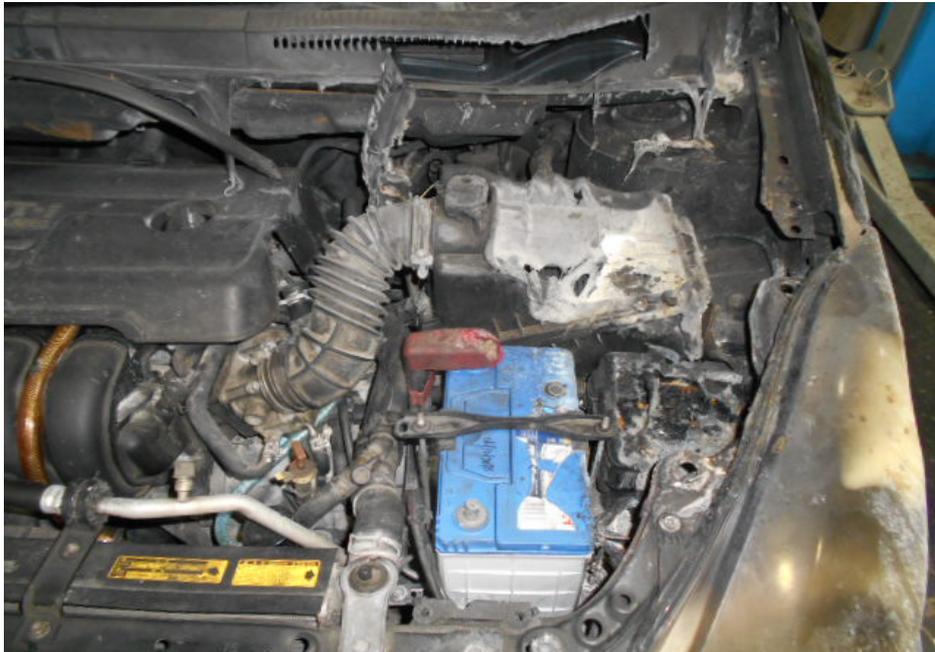
Photo 3 shows a closer view of the burnt and/or partially melted parts that were located at the left side of the engine compartment. This had included the air intake housing, battery, fuse box, wiper panel garnish amongst.

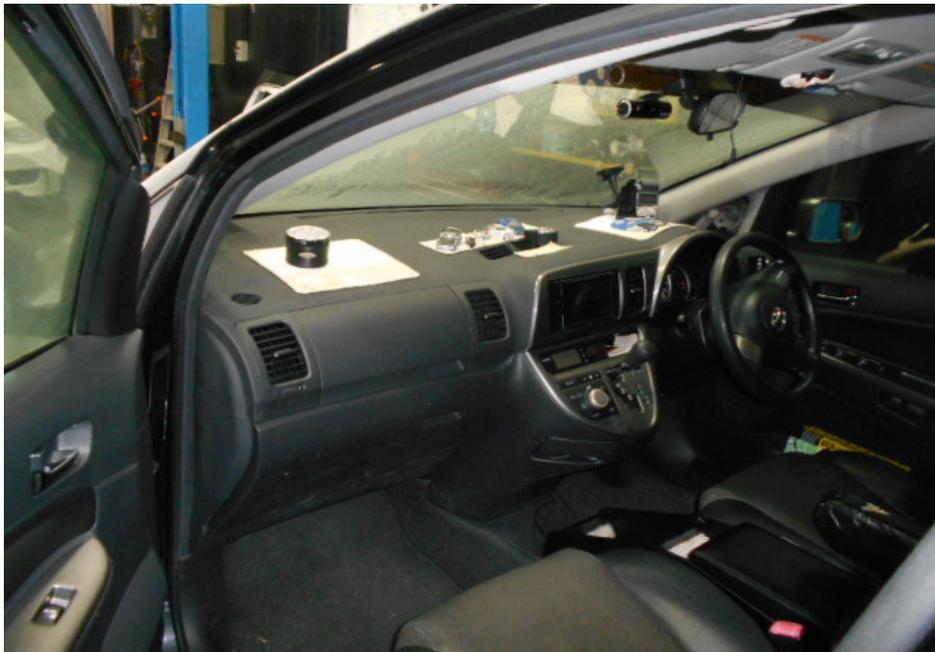
Photo 4 shows the interior compartment of the Insured Vehicle, which was unaffected by the incident. The rear portion of the Insured Vehicle was also similarly unaffected by the incident.

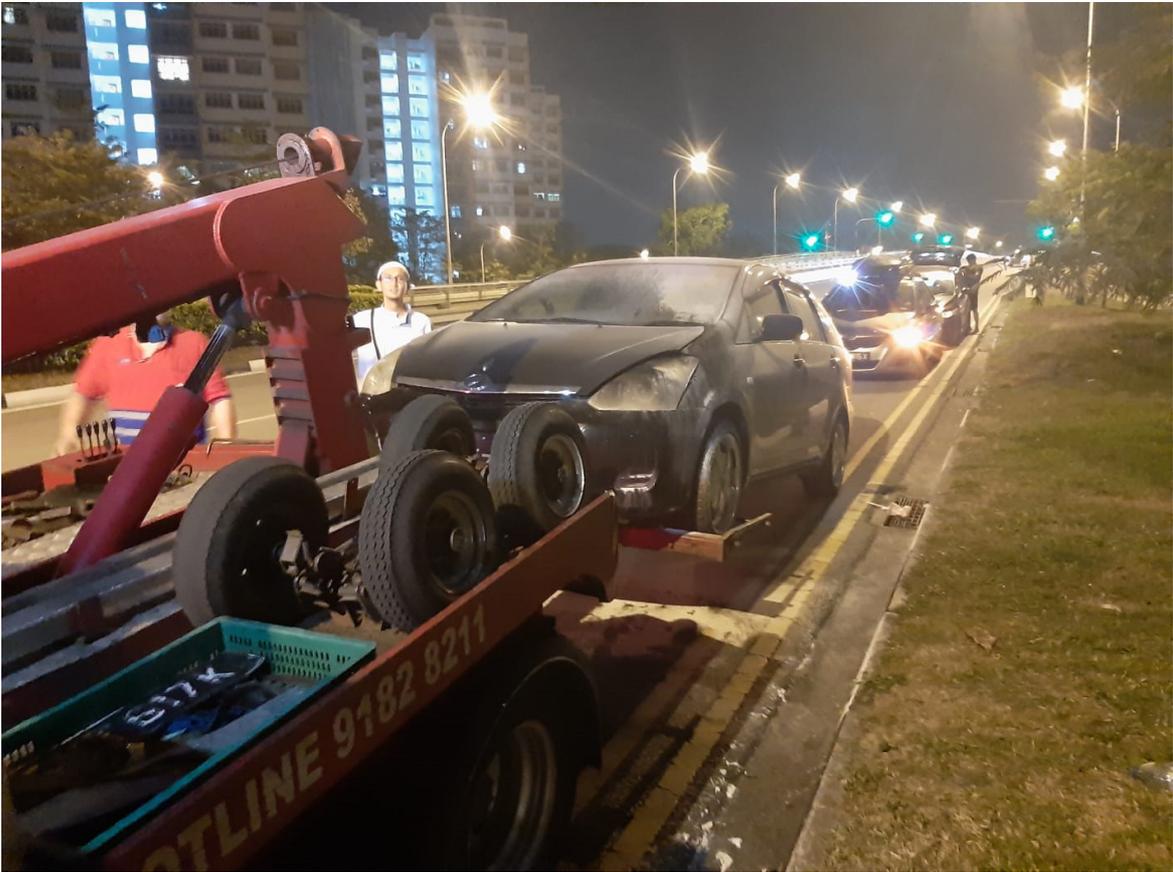
Photo 5 shows a general view of the Insured Vehicle at the incident location with the fire already extinguished, and just as it was about to be towed away. Generally, there was no notable information that could be gathered upon reviewing the photographs provided by Mr Yunos.

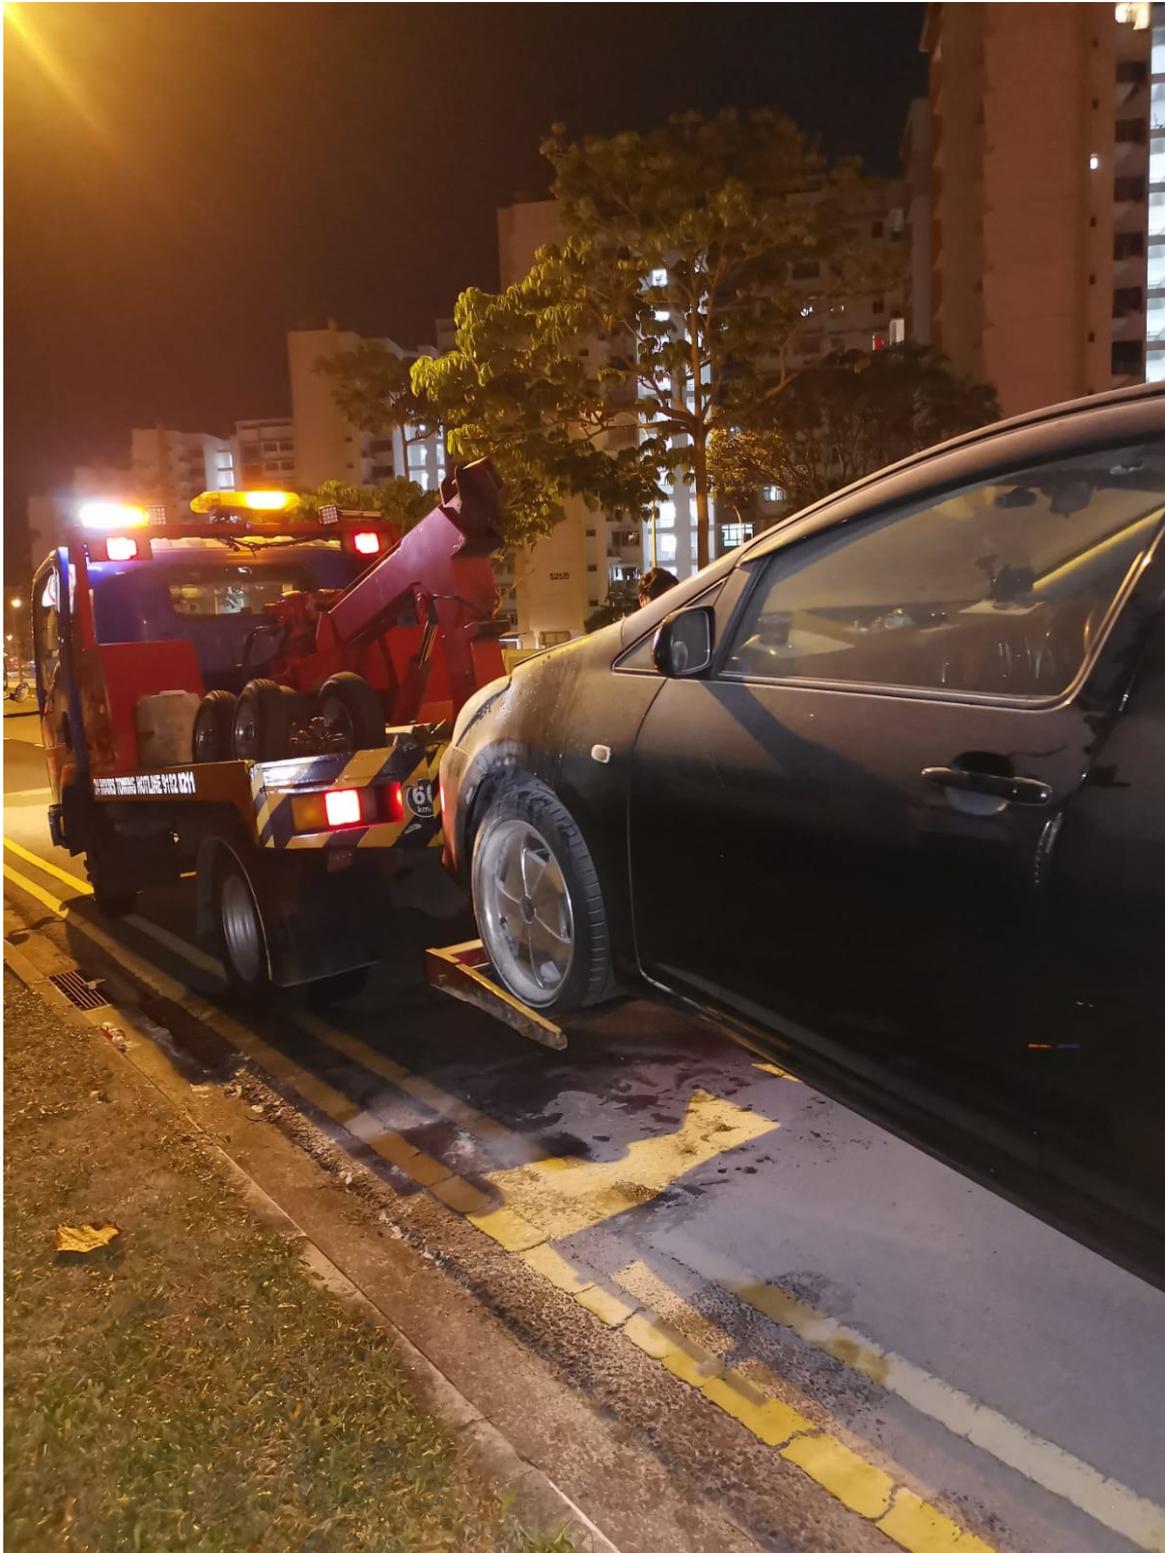
Photo 6 shows a general view of the Insured Vehicle at the incident location with the fire already extinguished, and just as it was about to be towed away. Generally, there was no notable information that could be gathered upon reviewing the photographs provided by Mr Yunos.

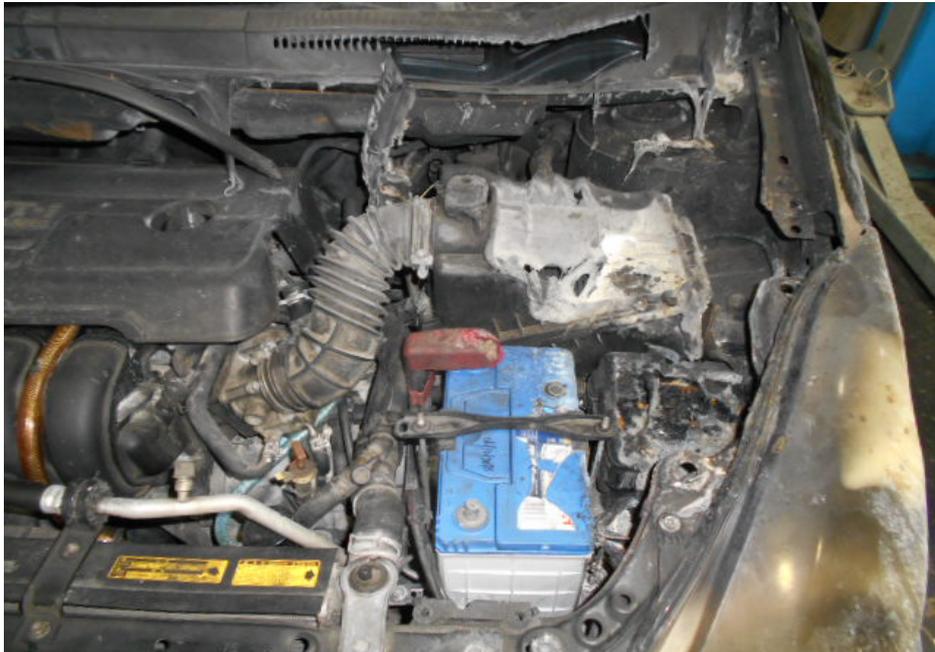
18. Firstly, it was observed during my inspection that the Insured Vehicle had sustained fire damage only at the left side of its engine compartment. Based on this single area of fire damage that the Insured Vehicle had sustained (interior compartment and rear portion also unaffected), the fire is established to have originated at the left side of the Insured Vehicle's engine compartment.

Photo 7 shows the left side of the Insured Vehicle's engine compartment. Basing on the single area of fire damage that the Insured Vehicle had sustained, the fire can be determined to have occurred within the engine compartment of the Insured Vehicle, at the left side.

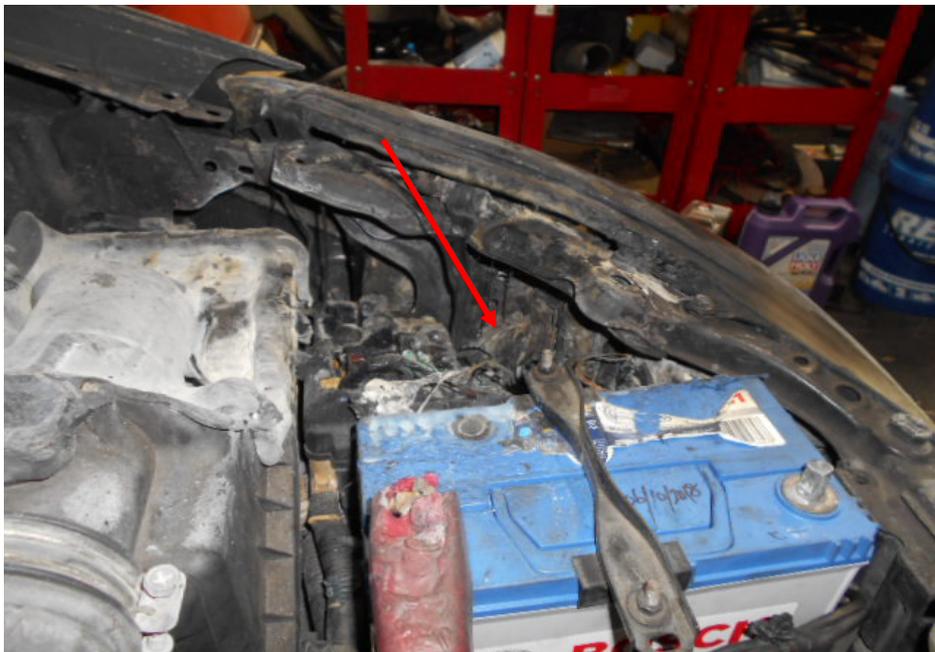
Photo 8 shows a closer view of the left side of the engine compartment. Upon my closer examination, I had found greenish residue on an original factory fitted wiring at the area (arrowed) directly behind the front left headlamp of the Insured Vehicle.

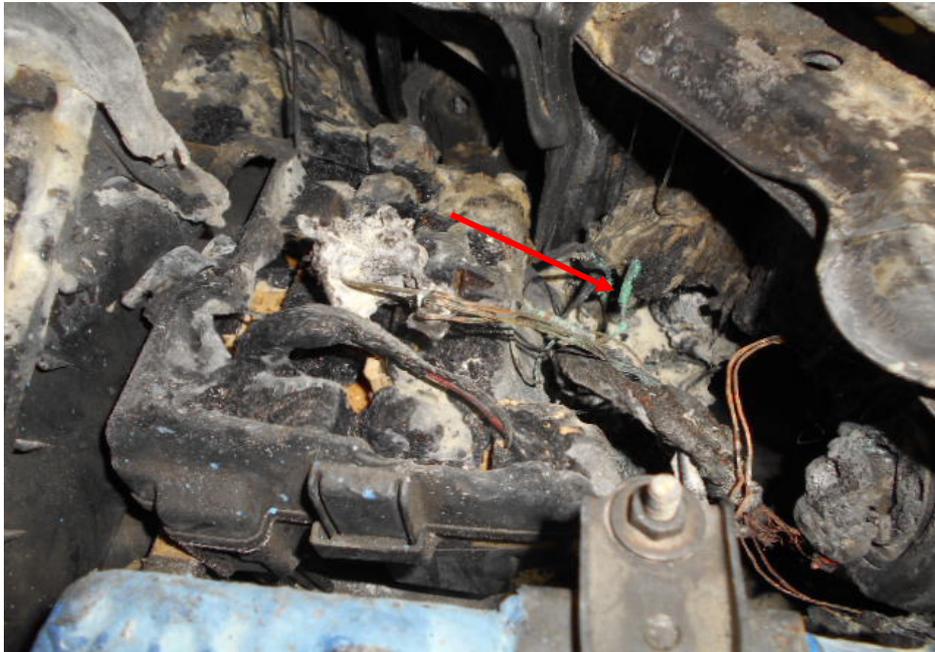
19. Upon my close examination of the left side of the engine compartment, I had found greenish residue on an original factory fitted wiring. The wiring was observed to be for the front left headlamp of the Insured Vehicle. The presence of greenish residue indicates internal heating of copper wires, a sign of an electrical short circuit occurring. Such greenish residue is normally left behind from oxidation as result of chemical reaction involving copper wires. This physical evidence indicates that the cause of fire to the Insured Vehicle was due to electrical in nature. See photo 7 - 10 below.

Photo 9 shows the greenish residue (arrowed) that was found on an original factory fitted wiring. The wiring was observed to be for the front left headlamp of the Insured Vehicle. The presence of greenish residue indicates internal heating of copper wires, a sign of an electrical short circuit occurring. Such greenish residue is normally left behind from oxidation as result of chemical reaction involving copper wires.

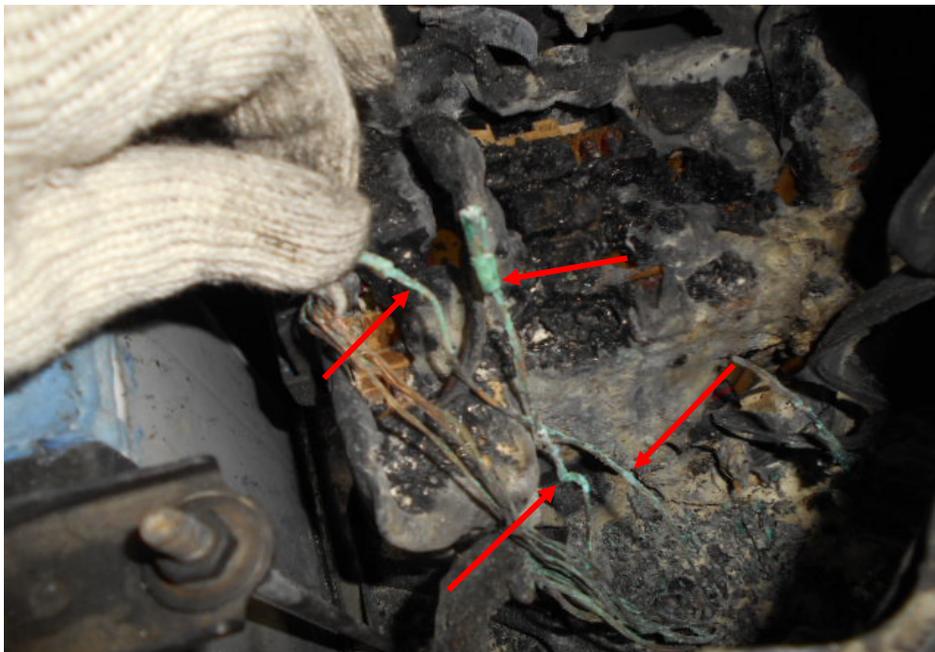
Photo 10 shows a closer view of the greenish residue (arrowed) that was found on the wiring for the front left headlamp of the Insured Vehicle. The presence of greenish residue indicates internal heating of copper wires, a sign of an electrical short circuit occurring. This physical evidence indicates that the cause of fire to the Insured Vehicle was due to electrical in nature.

23. Having investigated and technically analysed the damages of burnt nature to the Insured Vehicle, I am of the view that the cause of fire to the Insured Vehicle was of electrical in nature. For this particular case, the fire had originated along the originally fitted wiring for the front left headlamp of the Insured Vehicle.
