VEHICLE DAMAGE INSPECTION REPORT

Our File No: CS/CT119018608/KVF3E2

Handling Insurer:	China Taiping Insurance (Singapore) Pte. Ltd.	Policy No:	DMPCSN3042131900		
Claimant Vehicle No :	SLK2959X	Insured Vehicle No :	SLP5933Z		
Date of Loss:	17/10/2019	Nature of Claim:	TP	Claim No:	SNM19D204942-SLP5933Z-TKL

Reg No:	SLK2959X		Engine No:	2ZRR985740
Make & Model:	TOYOTA PRIUS HYBRID, 1.8 CVT (A)		Chassis No:	JTDKB3FU403542277
Reg. Date:	12/01/2017 (Man. Year: 2016)		Odometer:	176753 km
Colour:	Metallic Silver			
Engine Capacity:	1798 cc			
Market Value/New Car Price:	N/A			
Sum Insured (S\$):	Market Value/New Car Price

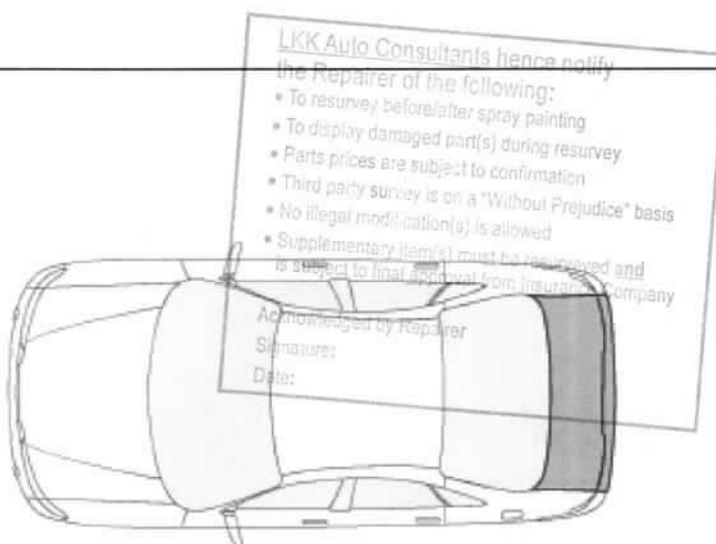
Damage Areas

Code	Description	WU	Price SGD
B290	RENEW REAR END PANEL	39.0	195.00
B420	RENEW REAR BUMPER INCLUDES: REAR BUMPER AND REQUIRED ATTACHED PARTS R + R	12.0	60.00
B410)	R + R REAR BUMPER REINFORCEMENT	1.0	5.00
B450	R + R REAR SEAT CUSHION CPL	2.0	10.00
Labour Cost		Hrs	WU
Panel / Mechanical Labour		5.40	54.0
Total of Labour			270.00

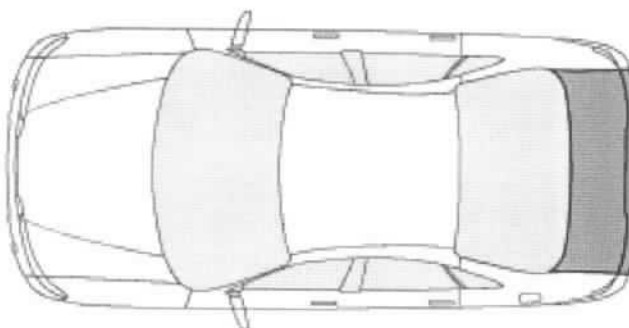
Damage Areas

Code	Description	Time Base 10 WU/h	Price = 50.00 SGD/h WU Price SGD	
B420	RENEW REAR BUMPER INCLUDES: REAR BUMPER AND REQUIRED ATTACHED PARTS R + R		12.0	60.00
B410)	R + R REAR BUMPER REINFORCEMENT		1.0	5.00
2711	REAR PANEL REPAIR		15.0*	75.00
Labour Cost		Hrs	WU	
Panel / Mechanical Labour		2.80	28.0	140.00
Total of Labour				140.00
