Your Ref: TP/IP/37585/2019
Our Ref : CI/TPD19018767/P

Fatal Accident Investigation Team

MECHANICAL INSPECTION REPORT OF MOTOR TAXI SHC 5516K

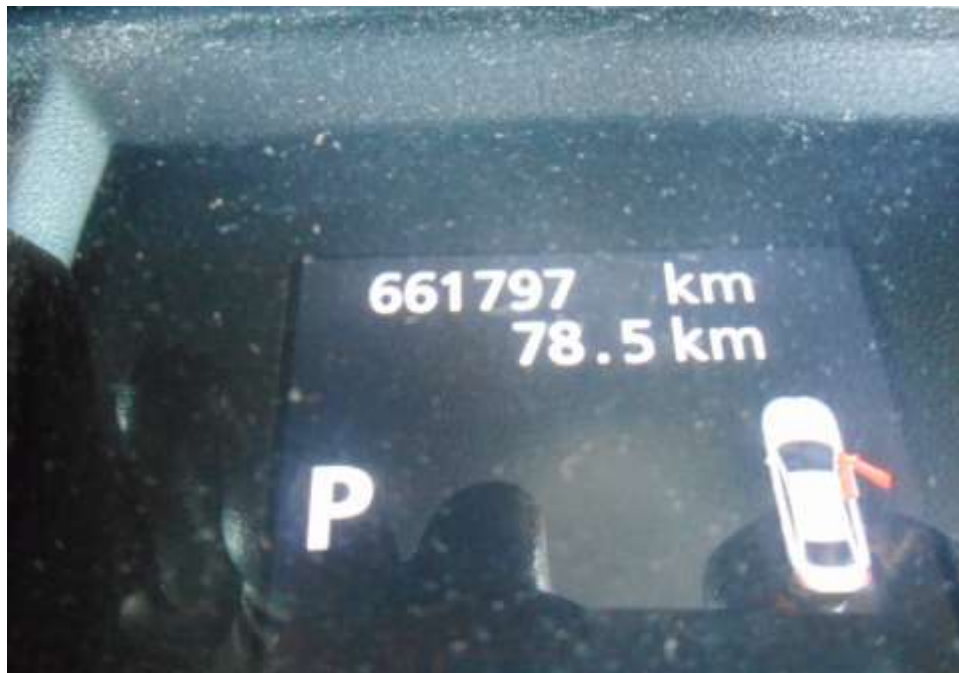
4. The mileage of the Motor Taxi at the time of my inspection was 661,797km.
5. The Motor Taxi was observed to have sustained damage at its front portion. Its front bumper and front left headlamp were amongst the body parts that were damaged as a result of the accident.

Photo 1 shows the mileage of the Motor Taxi at the time of my inspection. The mileage observed was 661,797km.

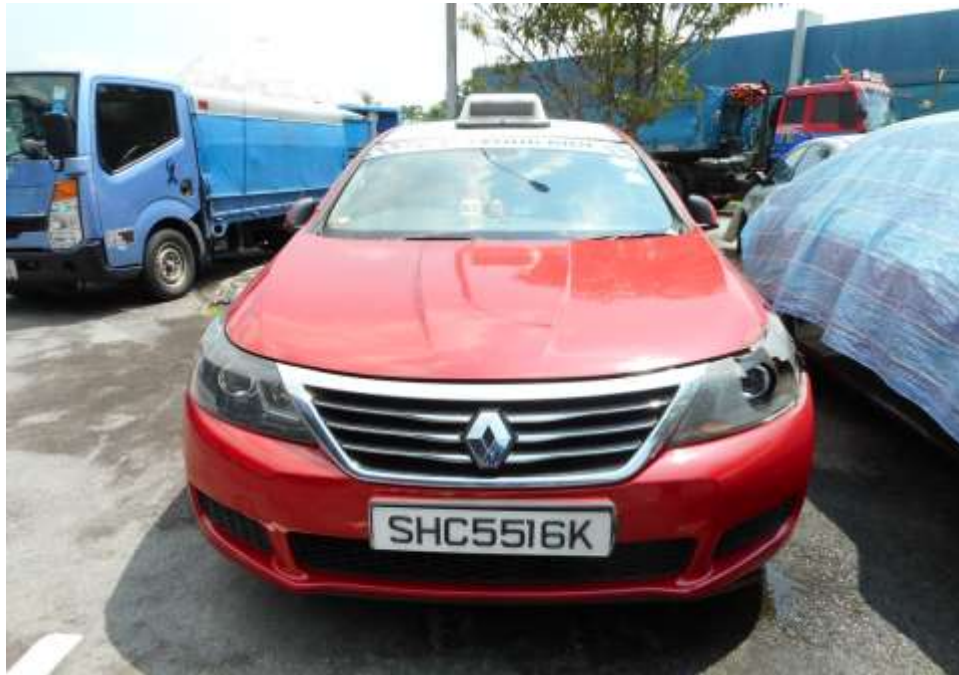
Photo 2 shows a general view of the Motor Taxi's front body at the time of my inspection. The Motor Taxi was observed to have sustained damage at its frontal portion. Its front bumper and front left headlamp were amongst the body parts that were damaged as a result of the accident.

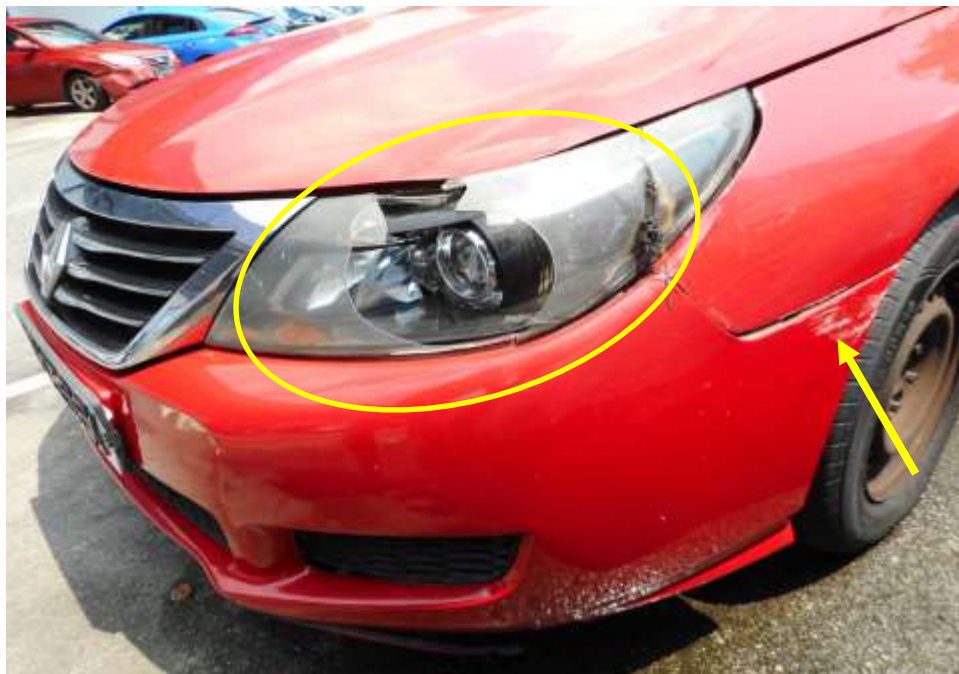
Photo 3 shows the close up view of the Motor Taxi's front body at the time of my inspection. The Motor Taxi was observed to have sustained damage at its front bumper (arrowed) and front left headlamp (circled) as a result of the accident.

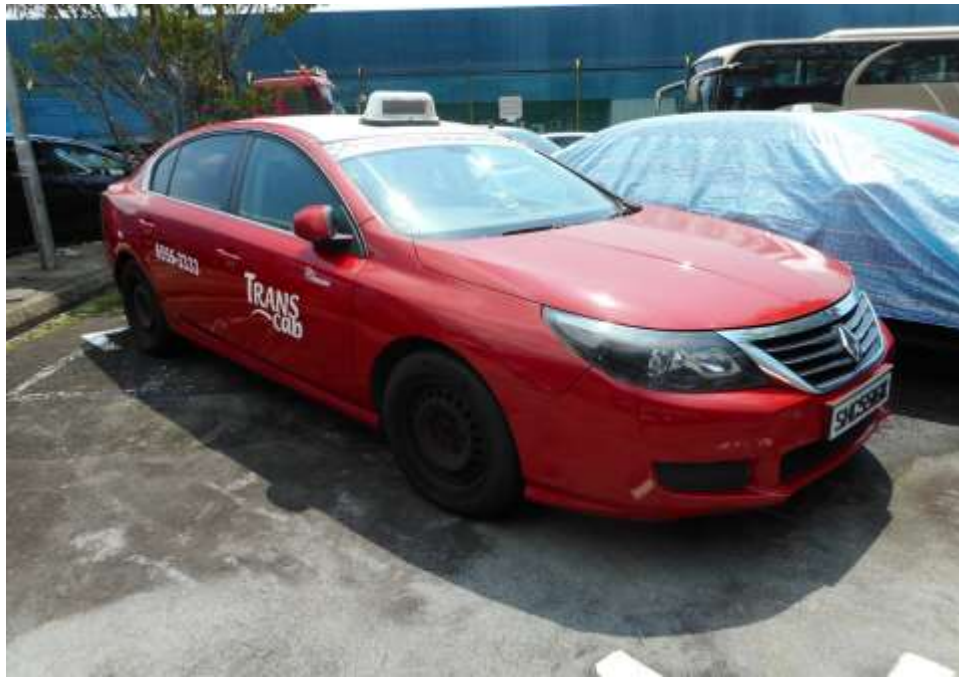
Photo 4 shows a general view of the Motor Taxi's right body at the time of my inspection. The right portion of the Motor Taxi was observed to have been unaffected by the accident.

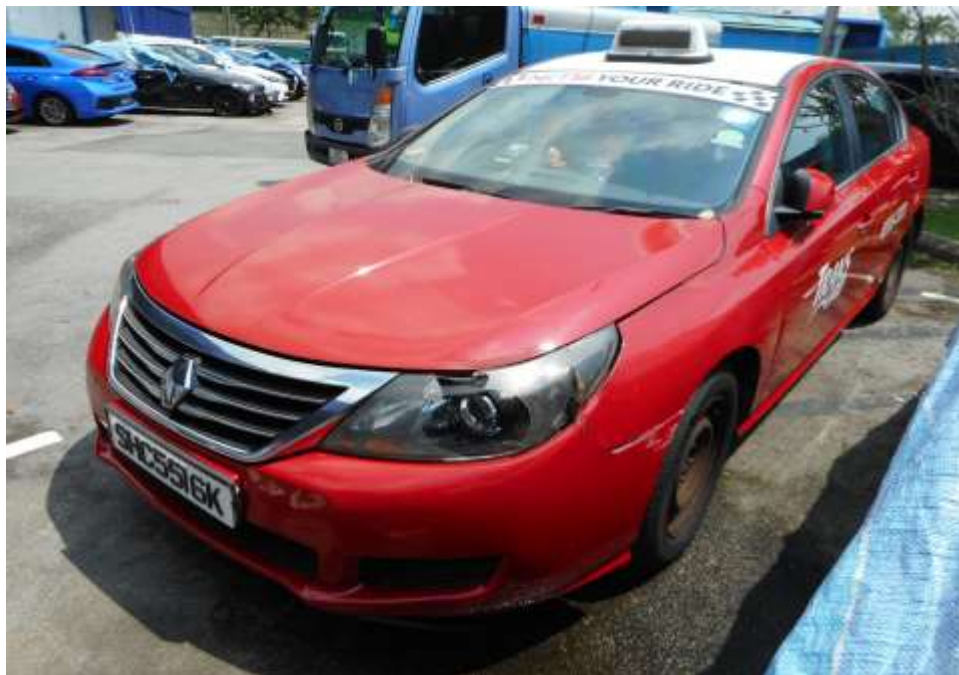
Photo 5 shows a general view of the Motor Taxi's left body at the time of my inspection. The left portion of the Motor Taxi was observed to have been unaffected by the accident.

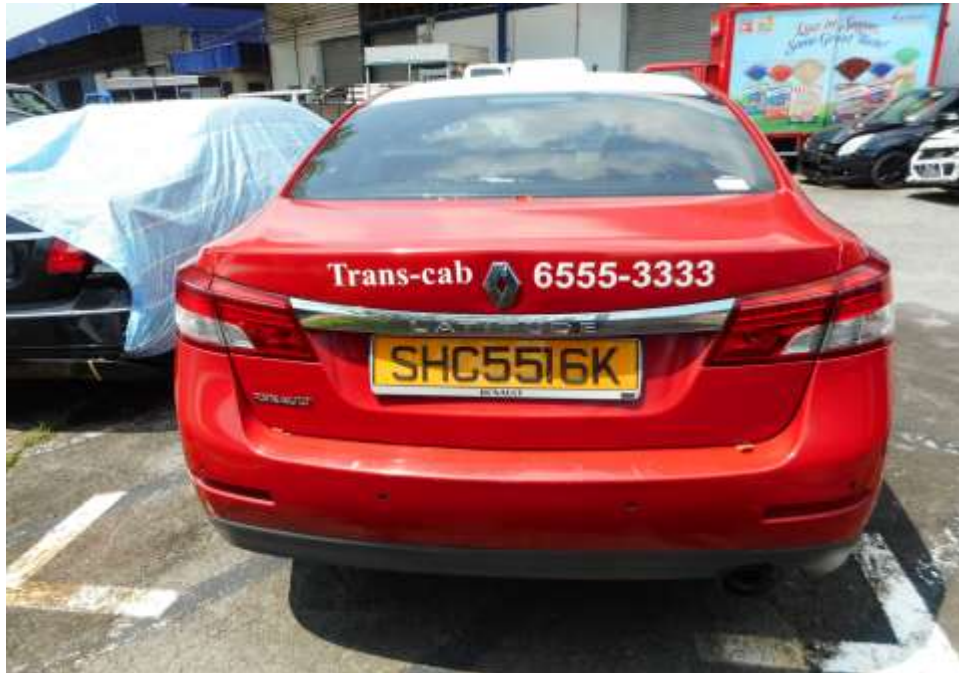
Photo 6 shows the general view of the Motor Taxi's rear body at the time of my inspection. The Motor Taxi rear was observed to be unaffected by the accident.

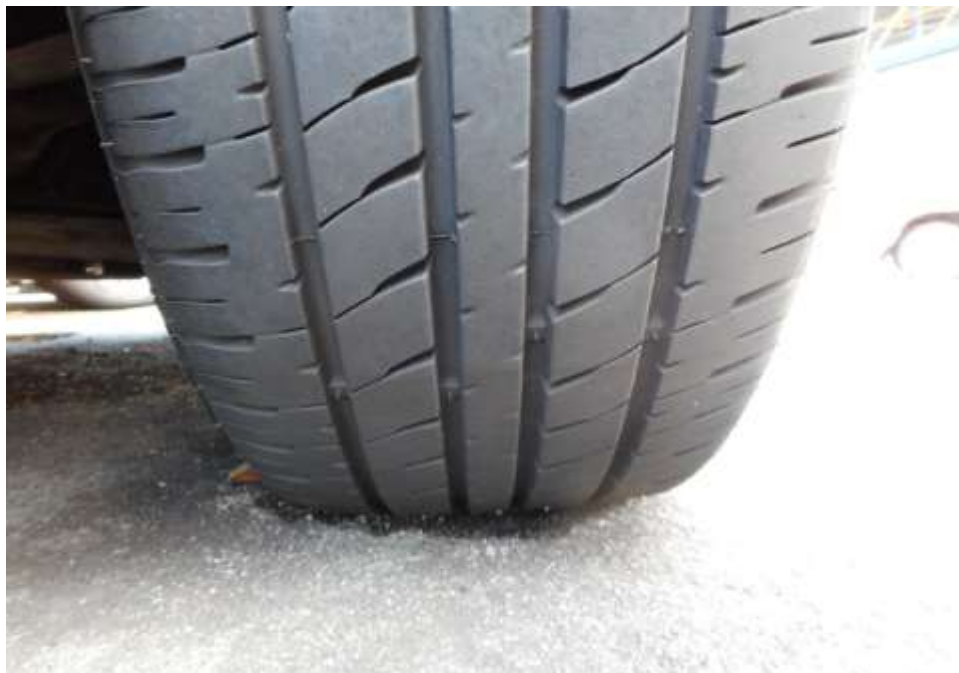
Photo 7 shows the condition of the front right tyre of the Motor Taxi, which was observed to be in serviceable condition with remaining tread depth of approximately 6mm. The tyre was sufficiently inflated for vehicular operation with no tear, cut or burst mark(s) on the outer and the inner sidewalls as well as across the tread. The 4 tyres of the Motor Taxi were wrapped around standard steel wheel rims without any damage.

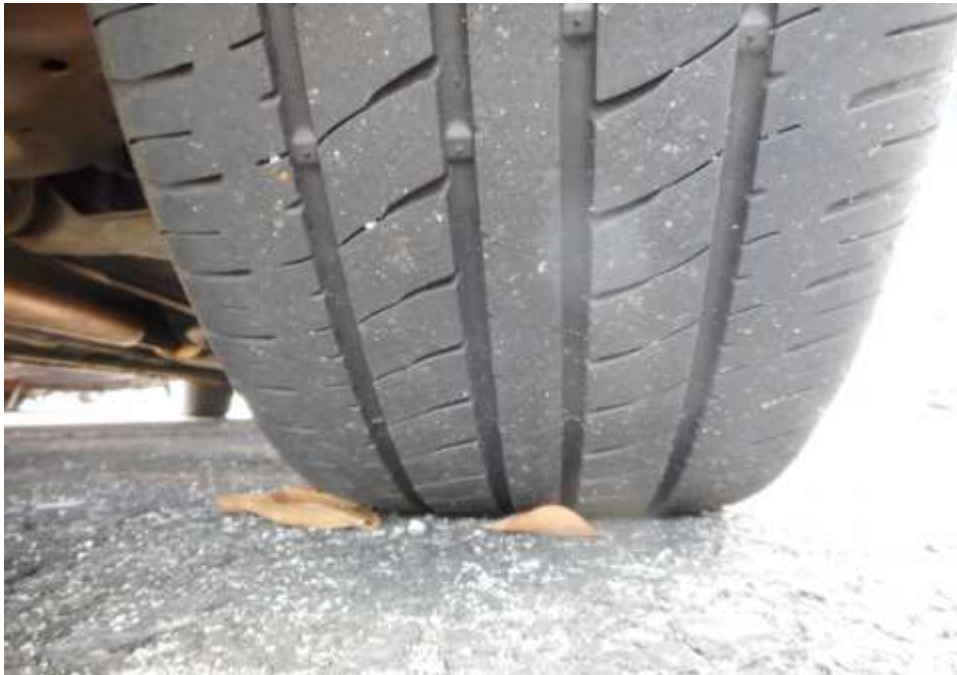
Photo 8 shows the condition of the rear right tyre of the Motor Taxi, which was observed to be in serviceable condition with remaining tread depth of approximately 4.8mm. The tyre was also observed to be sufficiently inflated for vehicular operation with no tear, cut or burst mark(s).

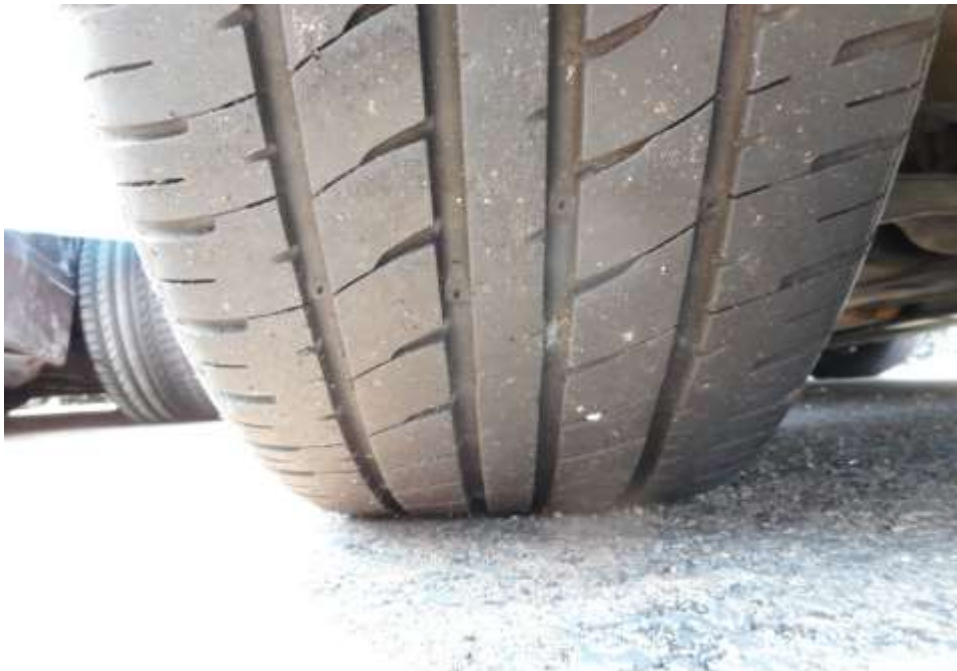
Photo 9 shows the condition of the rear left tyre of the Motor Taxi, which was observed to be in serviceable condition with remaining tread depth of approximately 6.1mm. The tyre, which was wrapped around steel wheel rim, was also observed to be sufficiently inflated for vehicular operation. The 4 tyres of the Motor Taxi were wrapped around standard steel wheel rims.

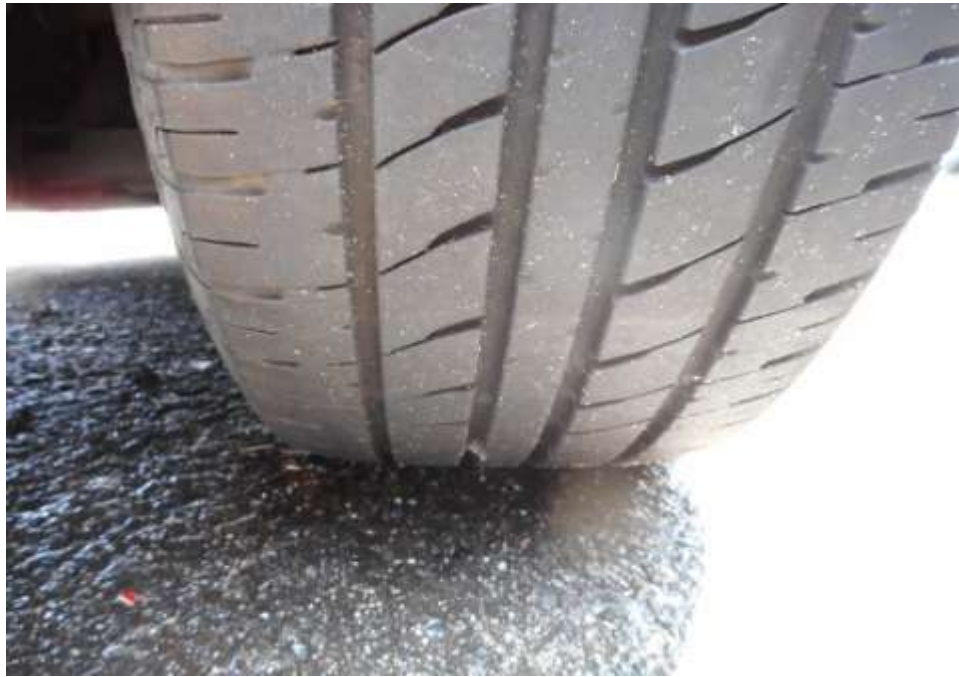
Photo 10 shows the condition of the front left tyre of the Motor Taxi, which was observed to be in serviceable condition with remaining tread depth of approximately 6mm. There was also no tear, cut or burst mark(s) on the outer and the inner sidewalls as well as across the tread of the Motor Taxi's 4 tyres.

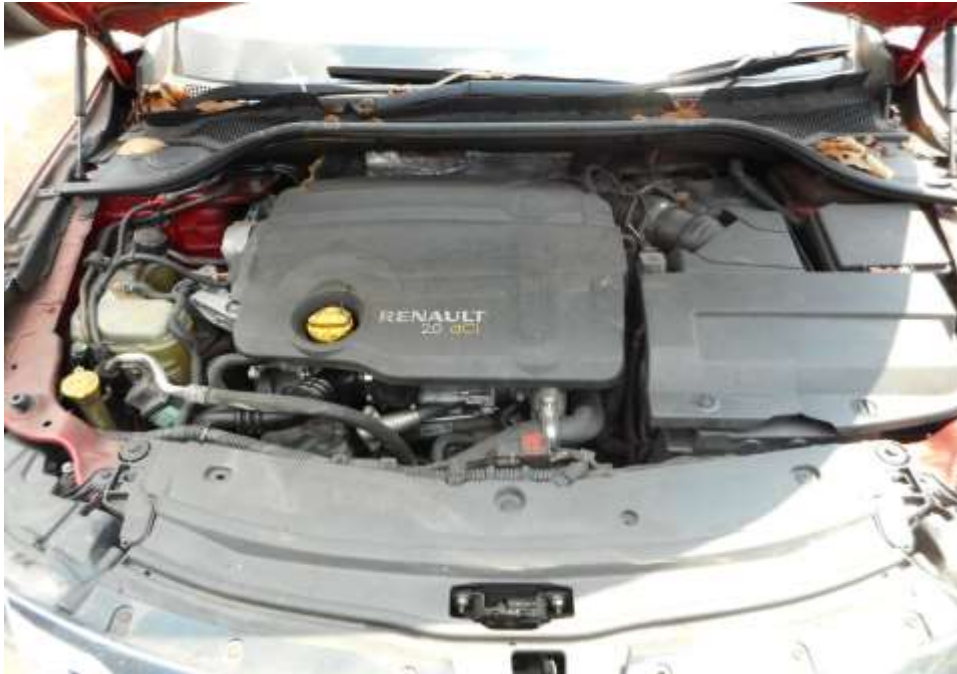
Photo 11 shows a general view of the Motor Taxi's engine compartment. The various parts and components inside the engine compartment were unaffected by the accident. There was also no sign(s) or indication(s) of fluid leakage and/or fluid stain within the engine compartment.

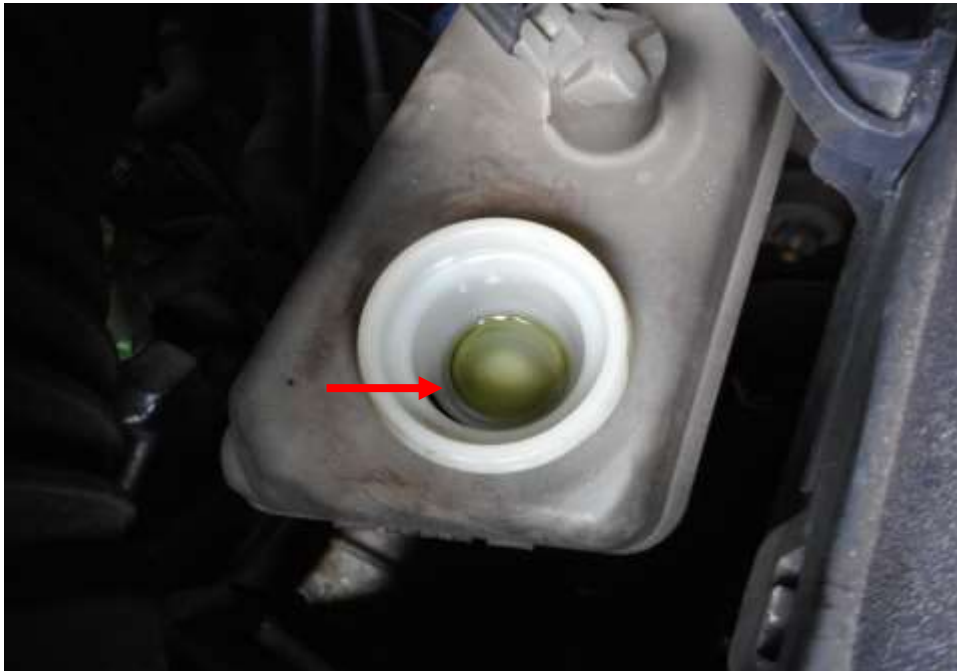
Photo 12 shows the brake fluid reservoir of the Motor Taxi at the time of my inspection. The brake fluid was observed to be of sufficient level (arrowed) and without any visible contamination.

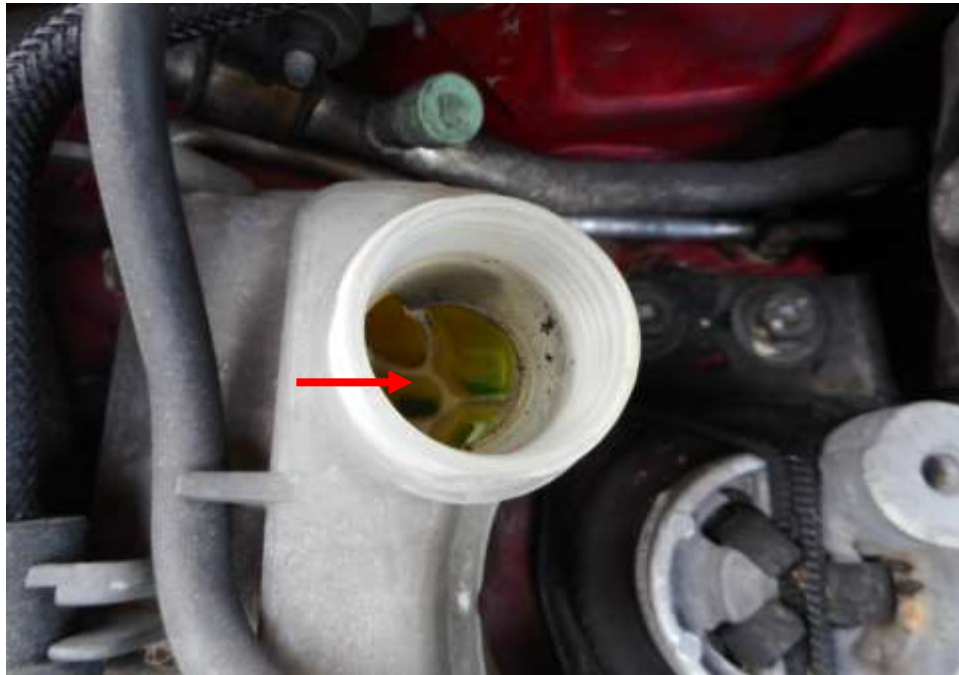
Photo 13 shows checks being carried out to the engine coolant of the Motor Taxi at the time of my inspection. The engine coolant was observed to be of sufficient level (arrowed) and without any visible contamination.

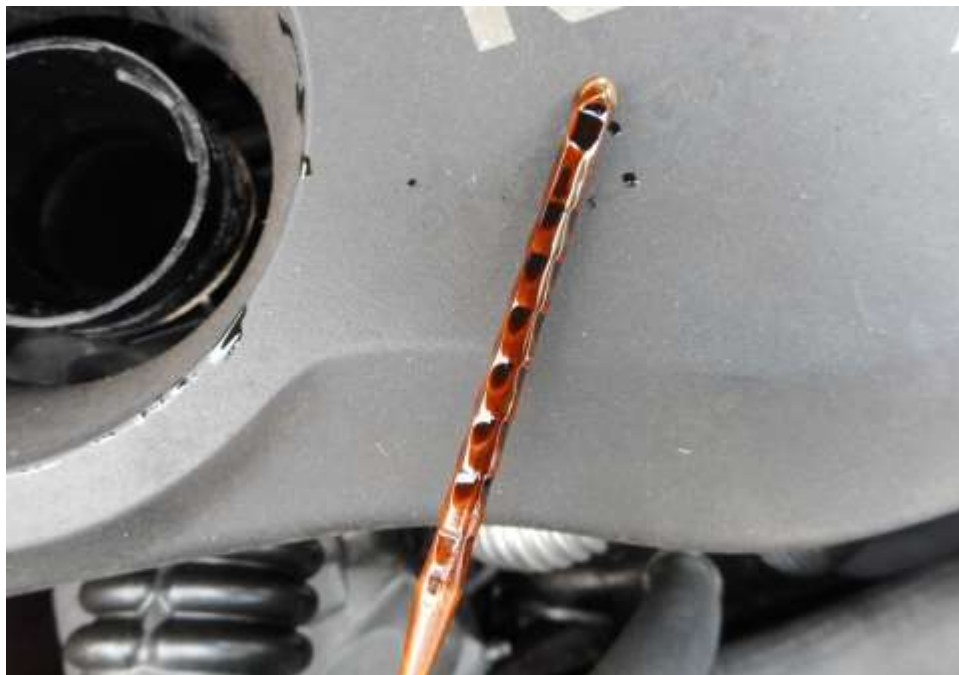
Photo 14 shows the engine oil dip stick of the Motor Taxi at the time of my inspection. The engine oil was observed to be of sufficient level and without any visible contamination.

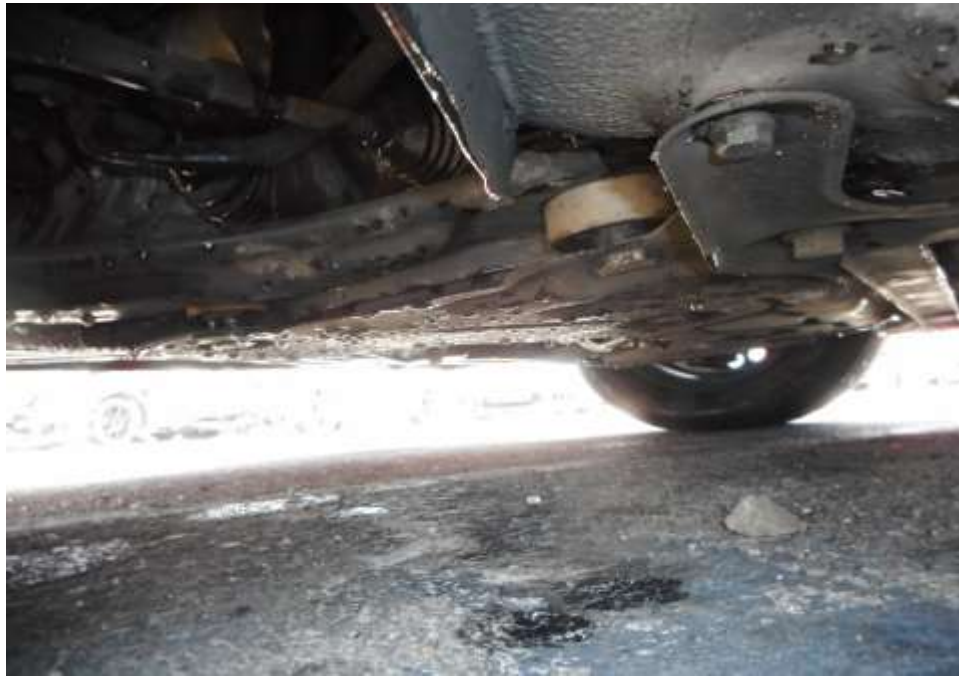
Photo 15 shows the undercarriage of the Motor Taxi, at the area where the engine housing and transmission housing are located. I did not find any sign(s) or indication(s) of fluid leak and/or fluid stain(s) on the underside of the Motor Taxi.

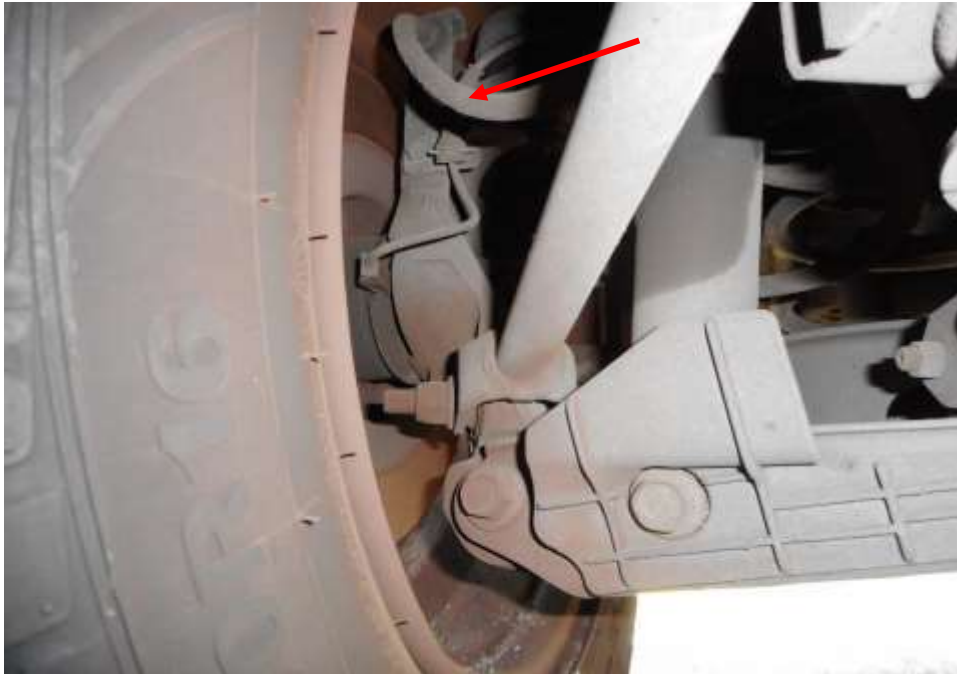
Photo 16 shows the brake hose/pipe (arrowed) at the rear left wheel of the Motor Taxi. I did not observe any leakage of brake fluid at the time of my inspection of the Motor Taxi. Static tests of the Motor Taxi's braking system had indicated that there was no internal leakage of pressure/vacuum. The undercarriage components of the Motor Taxi were also all found to be intact and without any visible damage.

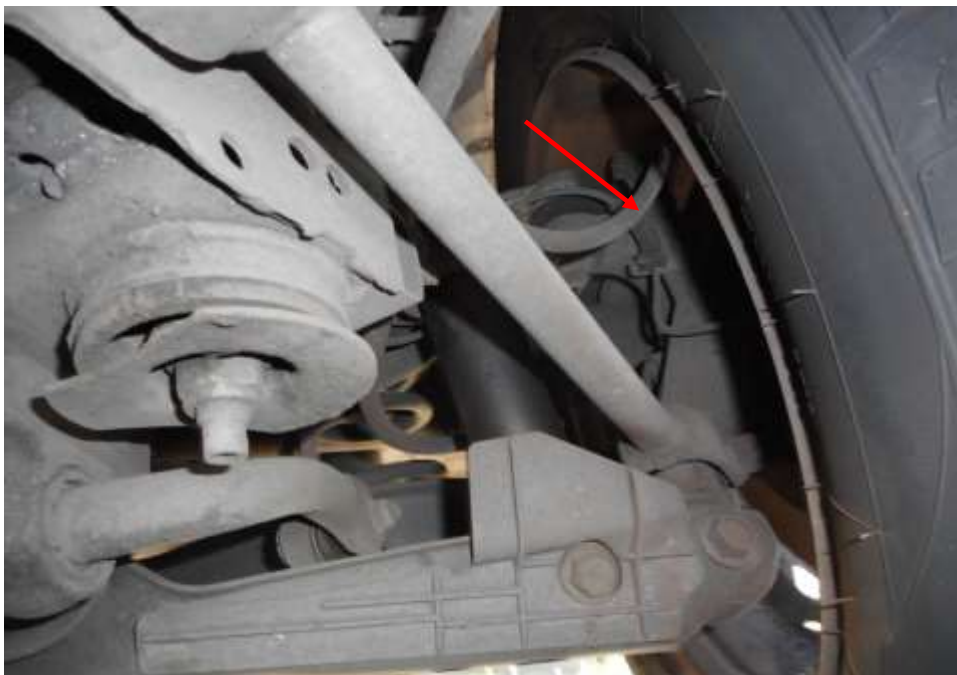
Photo 17 shows the brake hose/pipe (arrowed) at the rear right wheel of the Motor Taxi. No leakage of brake fluid was observed. Visual examination of the various components of the braking system like the drum brake, brake booster, brake pedal etc had revealed all to be intact and without visible damage.

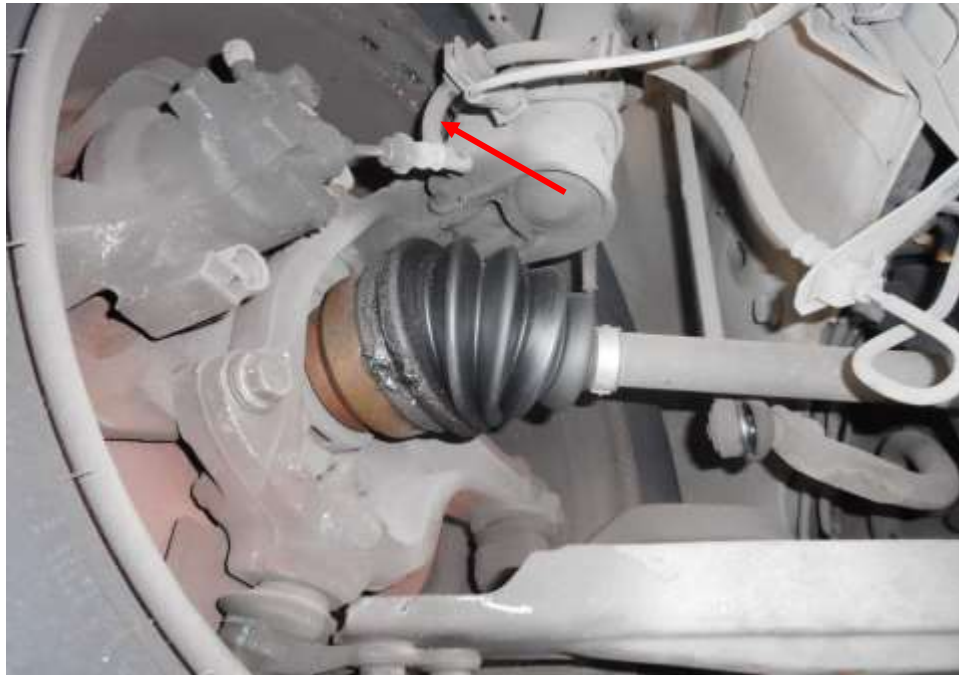
Photo 18 shows the brake hose/pipe (arrowed) at the front right wheel of the Motor Taxi. I did not observe any leakage of brake fluid at the time of my inspection of the Motor Taxi. Static tests of the Motor Taxi's braking system had indicated that there was no internal leakage of pressure/vacuum. The undercarriage components of the Motor Taxi were also all found to be intact and without any visible damage.

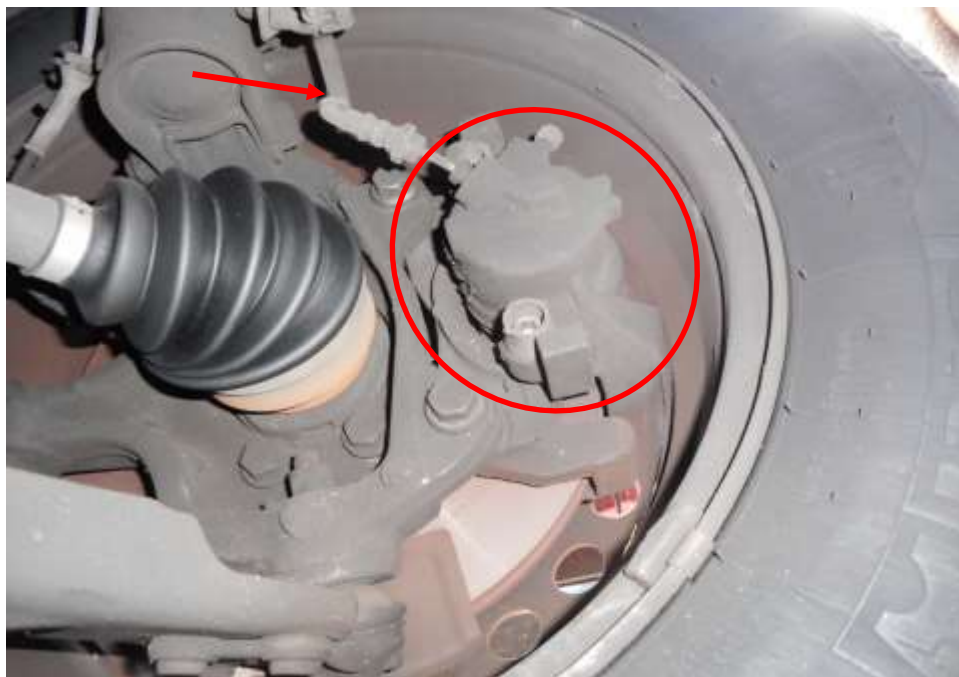
Photo 19 shows the brake hose/pipe (arrowed) at the front left wheel of the Motor Taxi. No leakage of brake fluid was observed. Visual examination of the various components of the braking system like the brake caliper (circled), brake booster, brake pedal etc had revealed all to be intact and without visible damage.

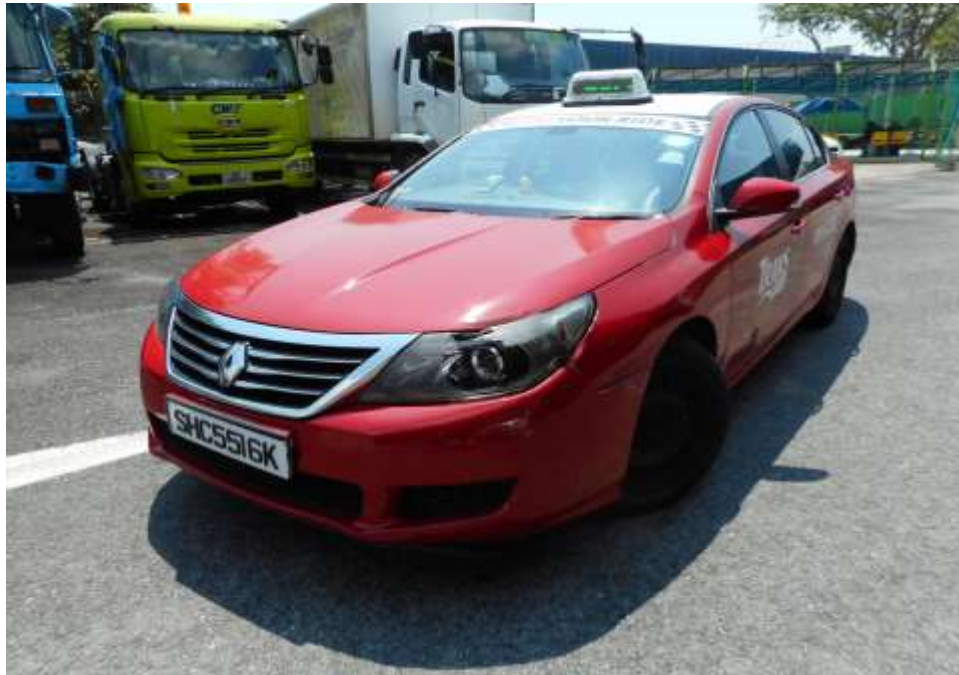
Photo 20 shows the front left wheel of the Motor Taxi turned to its full right. During my steering system test, I did not experience any abnormal free play and/or resistance when I had turned the steering wheel towards the left and right. This would suggest that the steering system of the Motor Taxi was likely to be in serviceable condition at the material time of accident.

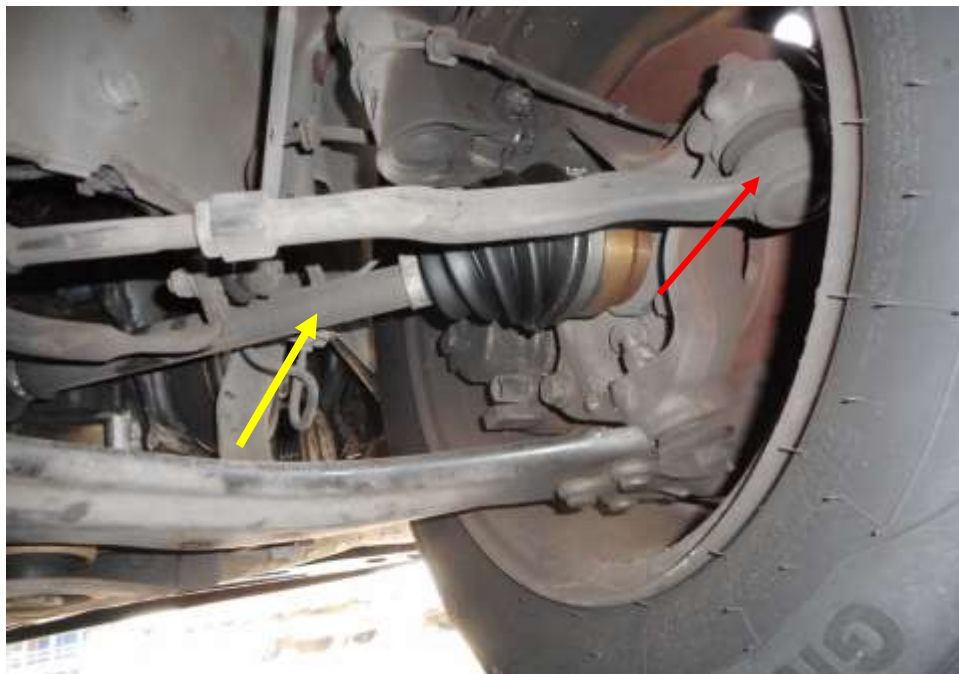
Photo 21 shows the various undercarriage components at the front right wheel of the Motor Taxi, in particular the steering tie rod (red arrow) and drive shaft (yellow arrow). The various steering components were all found to be intact, suggesting that the steering system of the Motor Taxi was likely to be in serviceable condition at the material time of accident. There was also no sign of fluid stain observed on the various undercarriage components at the front right wheel of the Motor Taxi.

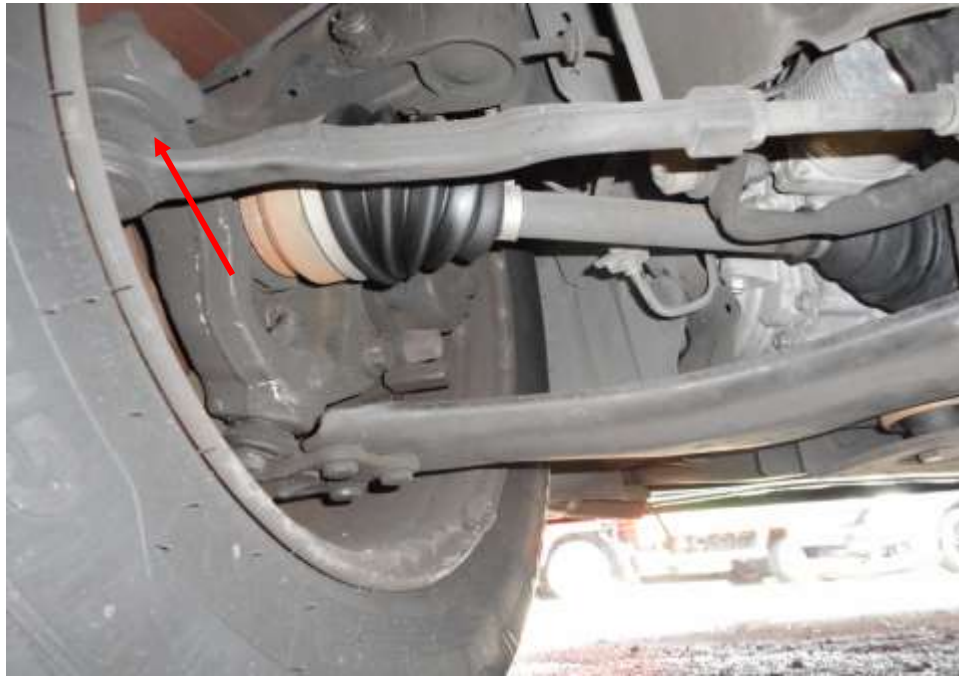
Photo 22 shows the various undercarriage components at the front left wheel of the Motor Taxi, which had included the steering tie rod (red arrow). The various undercarriage components of the Motor Taxi were all found to be intact without any visible damage.

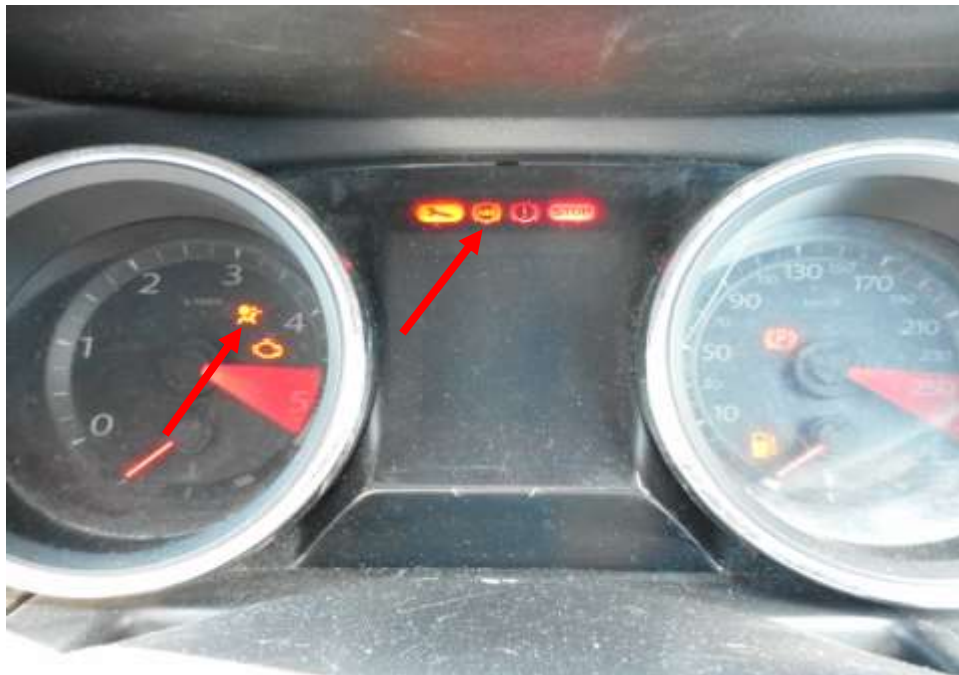
Photo 23 shows the warning light for Anti-Lock Brake System (ABS) and Supplemental Restraint System (SRS) appearing on the instrument panel of the Motor Taxi during the self-test of its various electronic operating systems when its engine was cranked.

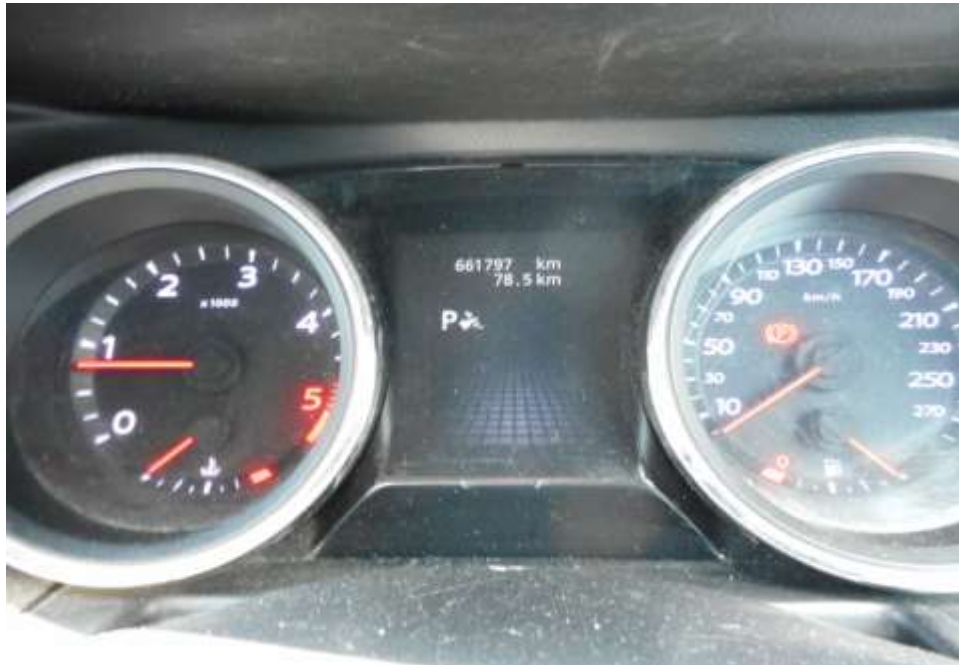
Photo 24 shows no warning lights illuminated on the instrument panel of the Motor Taxi after the engine was cranked. This would suggest that there was no abnormality to the various electronic operating systems of the Motor Taxi, like the ABS and SRS etc.
