Your Ref: TP/IP/60999/2019
Our Ref : CI/TPD19018770/P

14th November 2019

MECHANICAL INSPECTION REPORT OF MOTOR TRAILER VR 3460

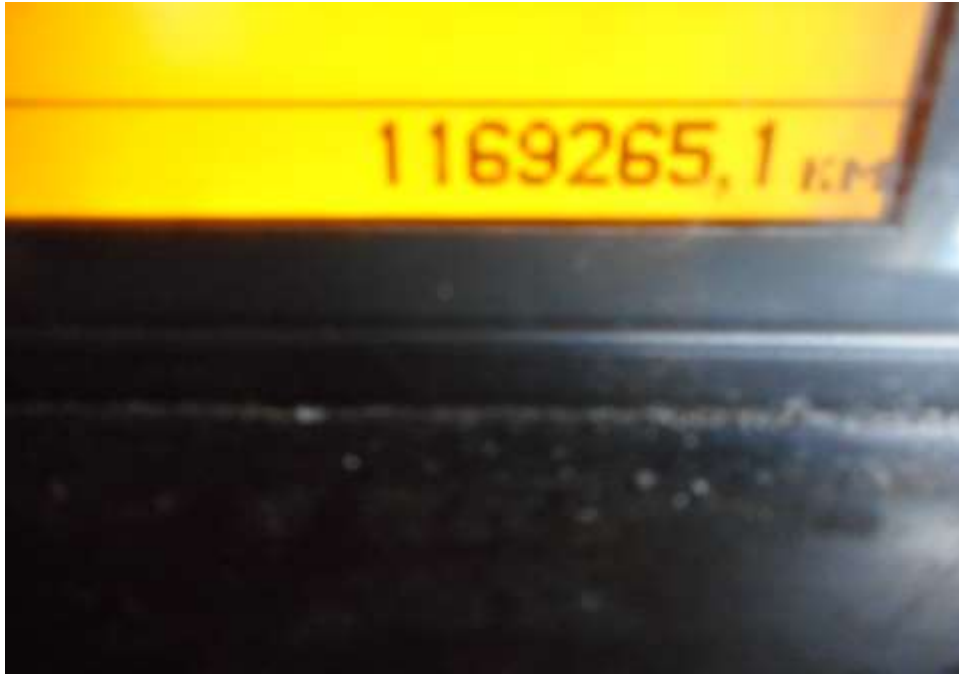
4. The mileage of the Motor Trailer at the time of my inspection was 1169265 km.
5. There was no visible damage observed on the Motor Trailer at the time of my inspection.

Photo 1 shows a general view of the instrument cluster of the Motor Trailer at the time of my inspection. The mileage of the Motor Trailer was 1169265km

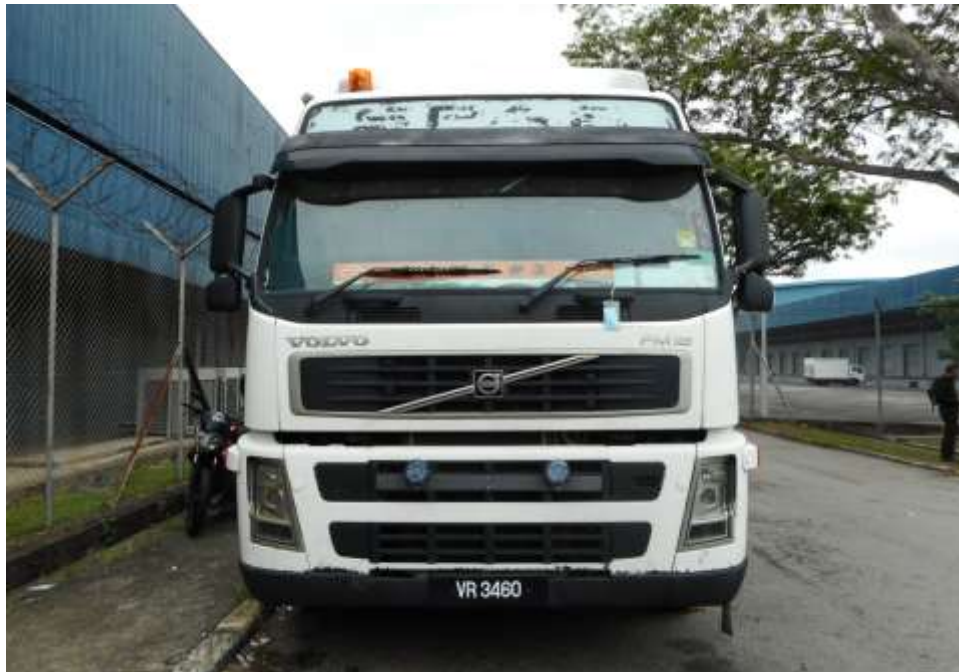
Photo 2 shows a general view of the front body of the Motor Trailer at the time of my inspection. There was no visible damage observed on the Motor Trailer.

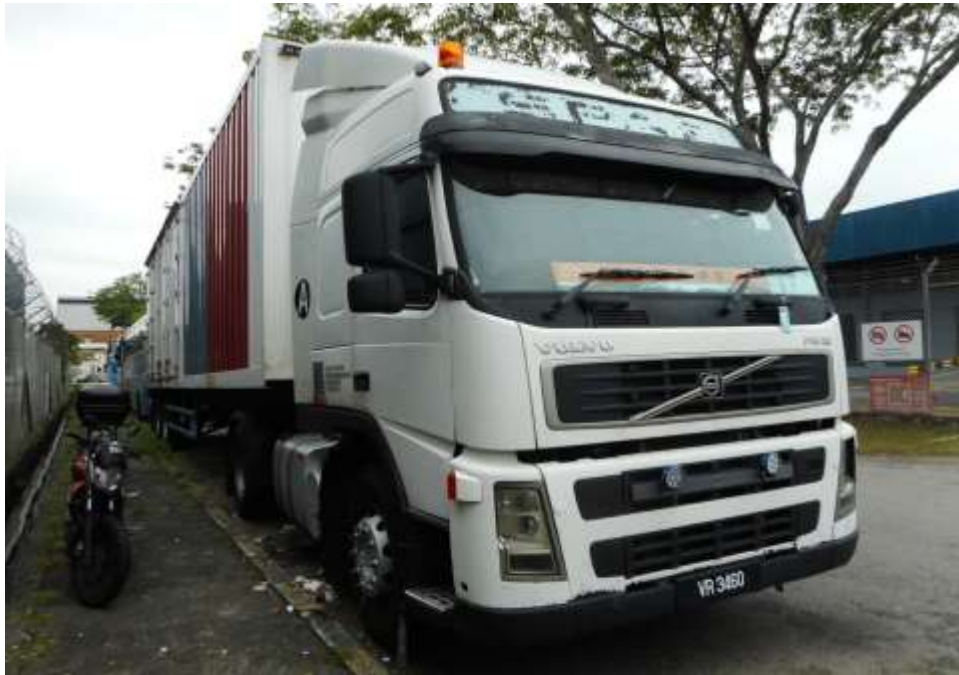
Photo 3 shows a general view of the front right body of the Motor Trailer at the time of my inspection, observed to have been unaffected by the accident.

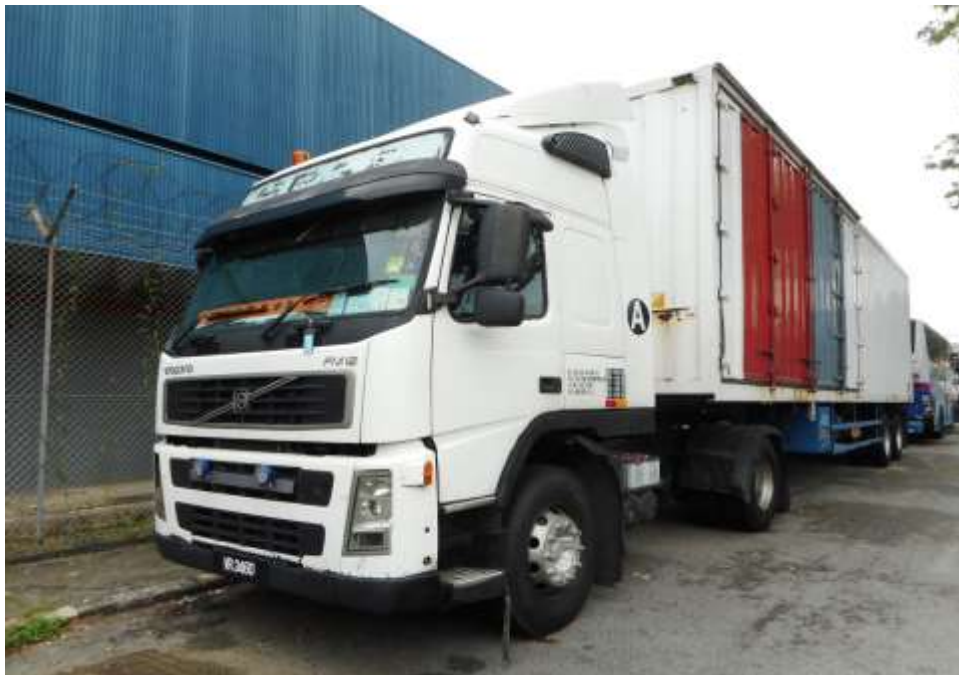
Photo 4 shows a general view of the front left body of the Motor Trailer at the time of my inspection, observed to have been unaffected by the accident.

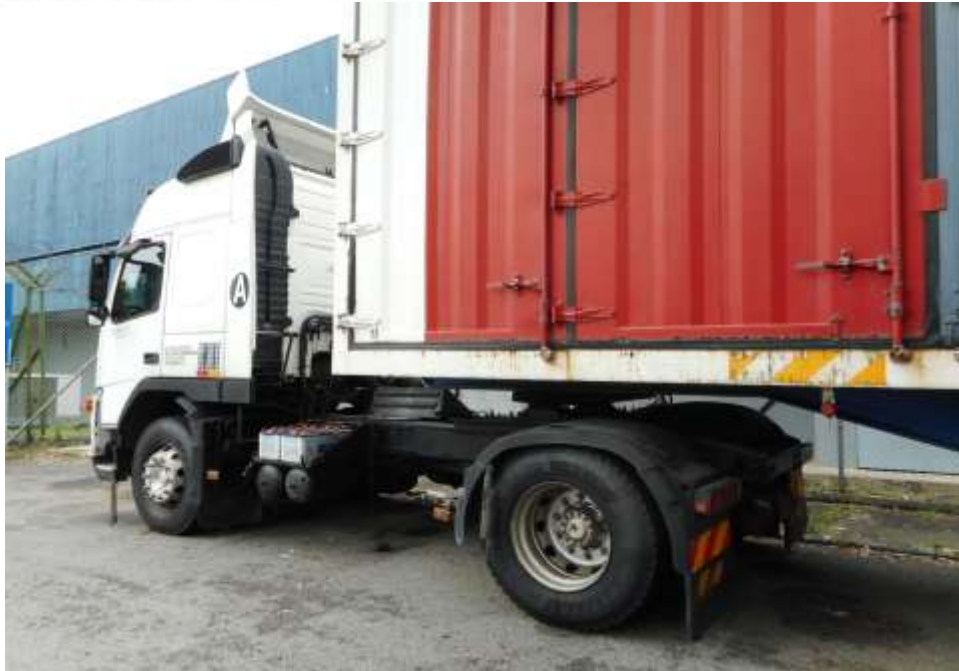
Photo 5 shows a general view of the Motor Trailer's rear body at the time of my inspection. There was no damage observed to the rear portion of the Motor Trailer.

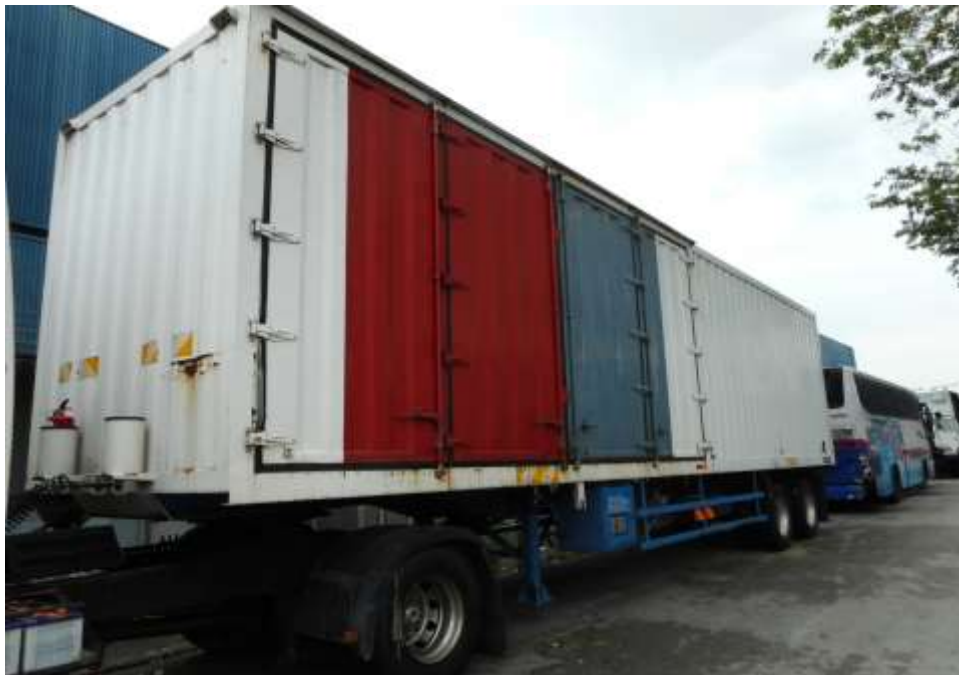
Photo 6 shows a general view of the trailer's left body at the time of my inspection. There was no damage found to the body portion of the trailer.

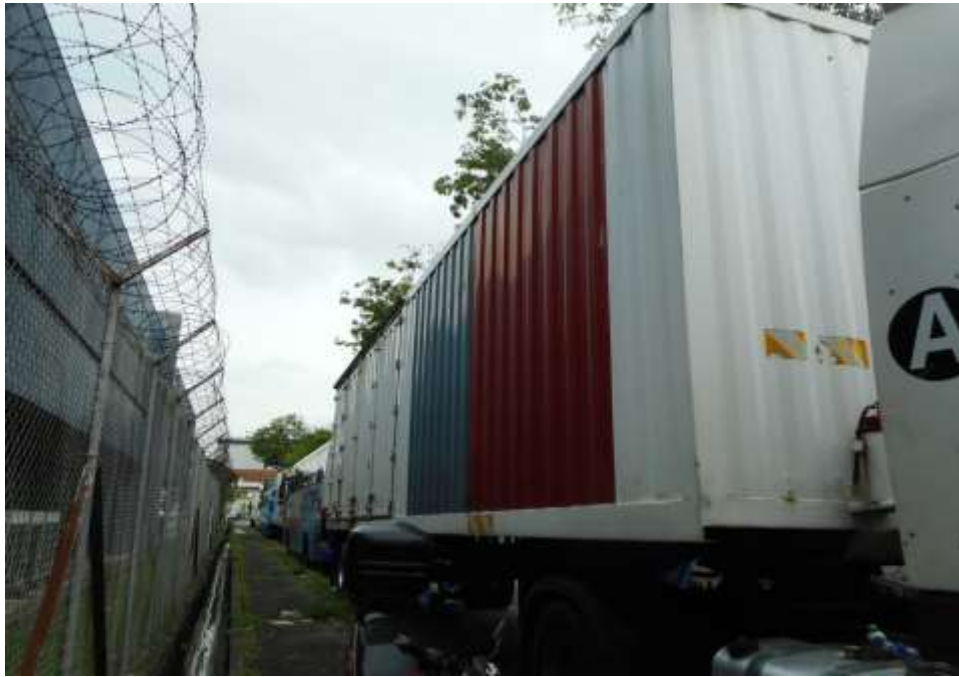
Photo 7 shows a general view of the trailer's right body at the time of my inspection. There was no damage found to the body portion of the trailer.

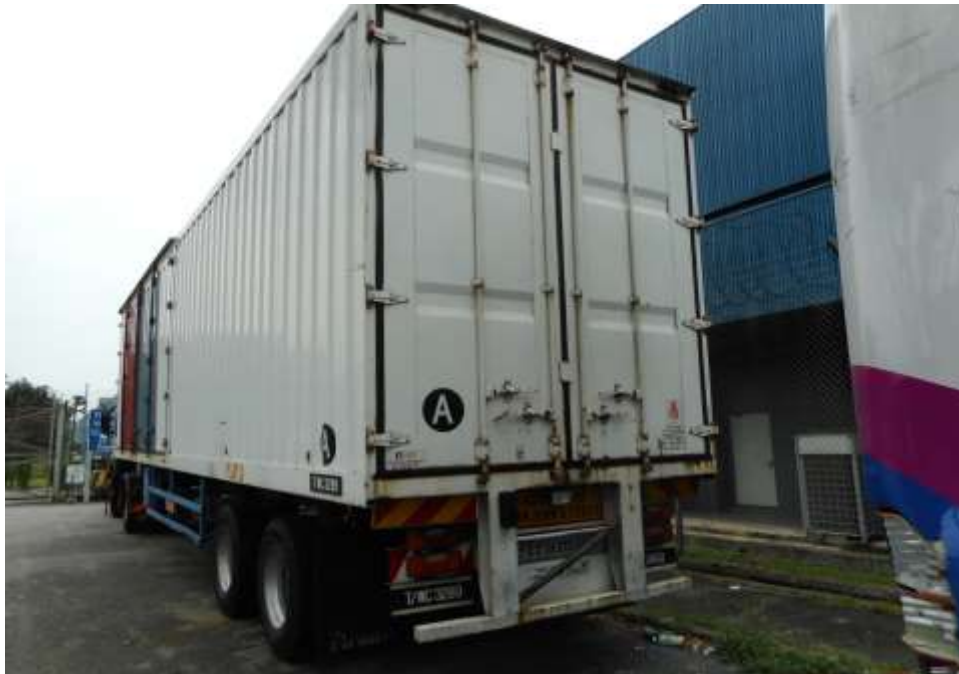
Photo 8 shows a general view of the trailer's rear body at the time of my inspection. There was no damage found to the rear portion of the trailer.

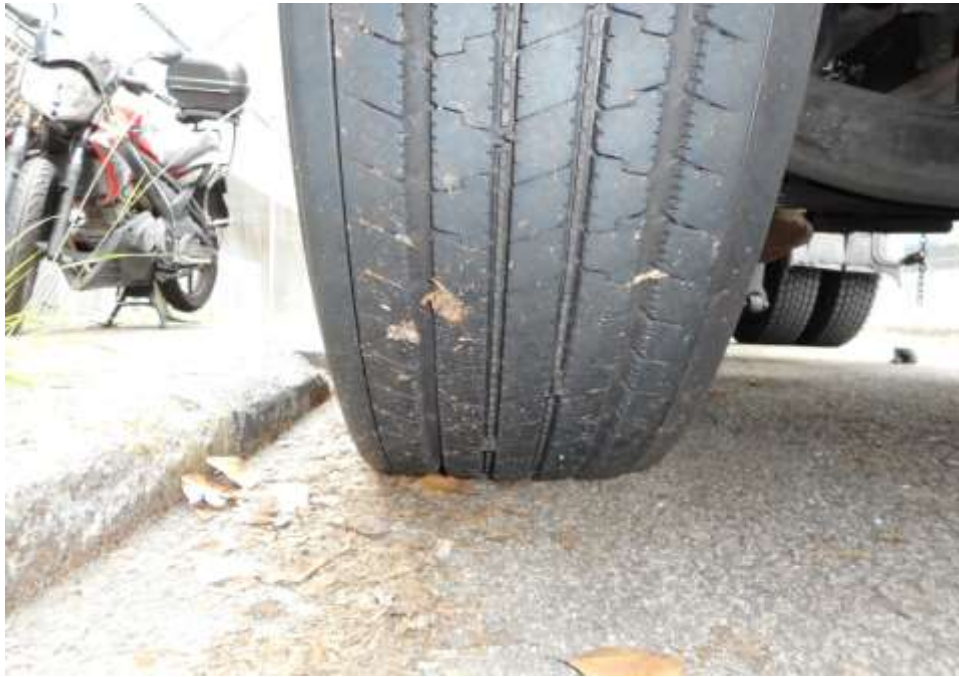
Photo 9 shows the condition of the front right tyre of the Motor Trailer, which was observed to be in serviceable condition with remaining tread depth of approximately 11.7 mm. The tyre, which was wrapped around standard steel wheel rim, was also observed to be sufficiently inflated for vehicular operation. There was no tear, cut or burst mark(s) on the outer and the inner sidewalls as well as across the tread of the 10 tyres that were fitted on the Motor Trailer.

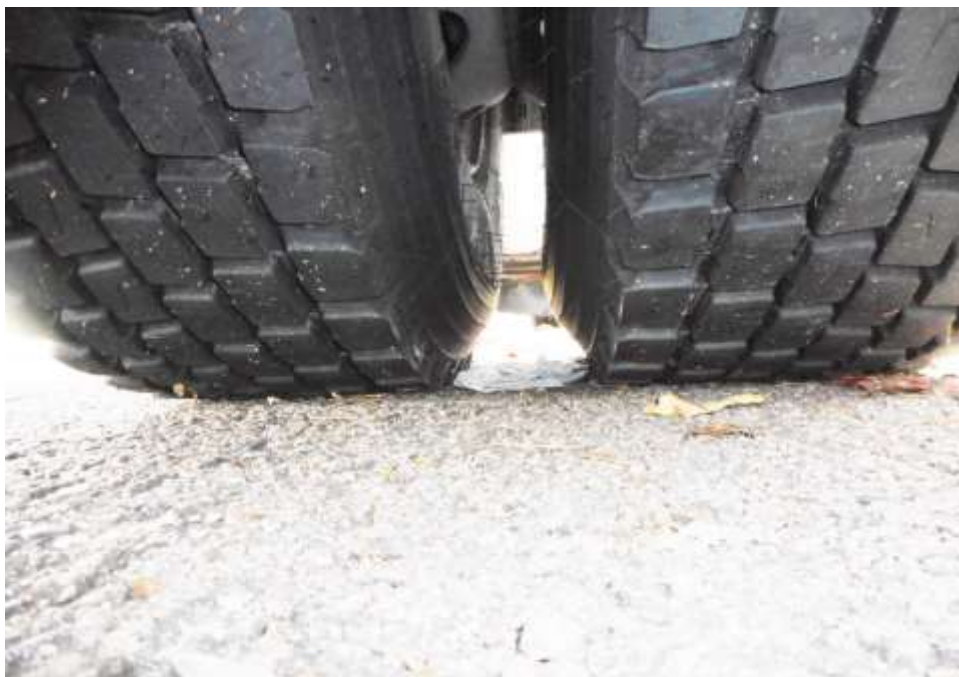
Photo 10 shows the condition of the rear right tyre of the Motor Trailer, which was observed to be in serviceable condition with remaining tread depth of approximately 11mm. The tyre, which was wrapped around standard steel wheel rim, was also observed to be sufficiently inflated for vehicular operation.

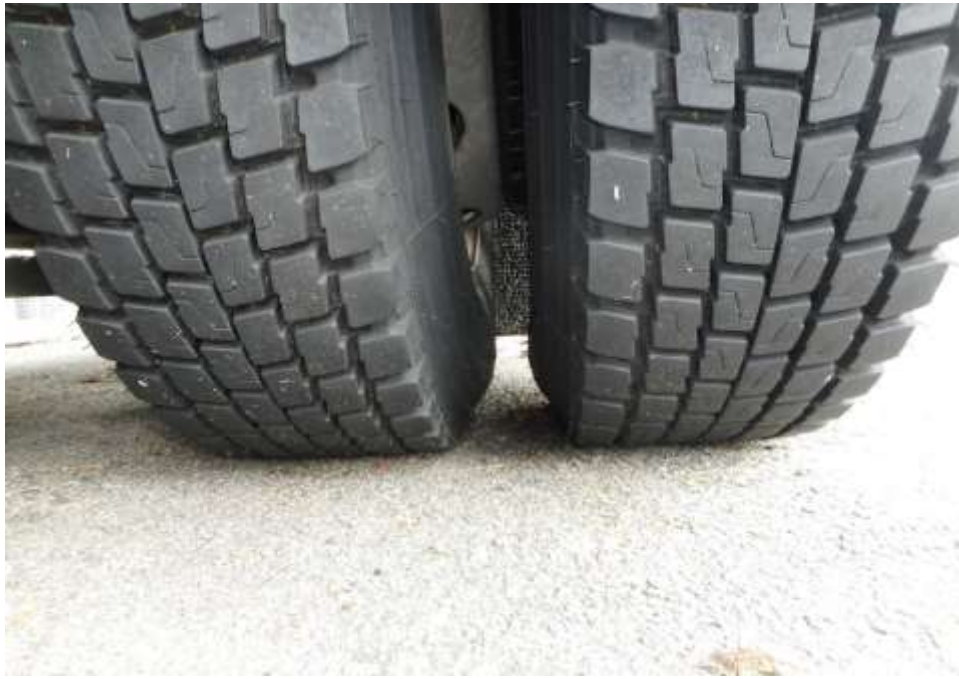
Photo 11 shows the condition of the rear left tyres of the Motor Trailer, which was observed to be in serviceable condition with remaining tread depth of approximately 12.8mm. The tyres, which were wrapped around standard steel wheel rim, were also observed to be sufficiently inflated for vehicular operation. There was also no damage found on all 10 steel wheel rims of the Motor Trailer.

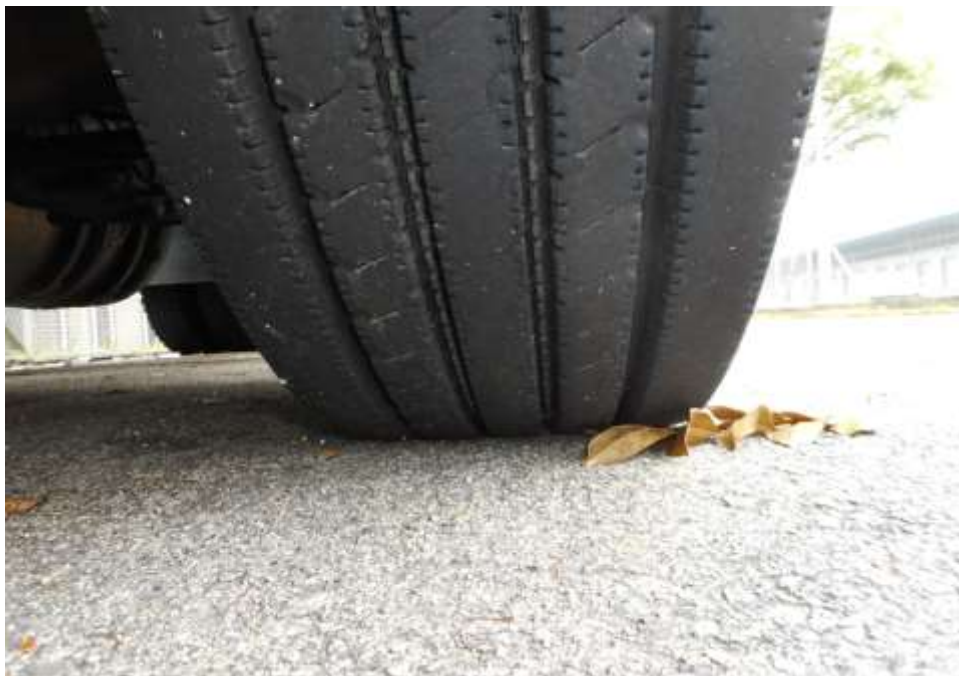
Photo 12 shows the condition of the front left tyres of the Motor Trailer, which were observed to be in serviceable condition with remaining tread depth of approximately 12.4mm. There was also no tear, cut or burst mark(s) on the outer and the inner sidewalls as well as across the tread of the 10 tyres that were fitted on the Motor Trailer.

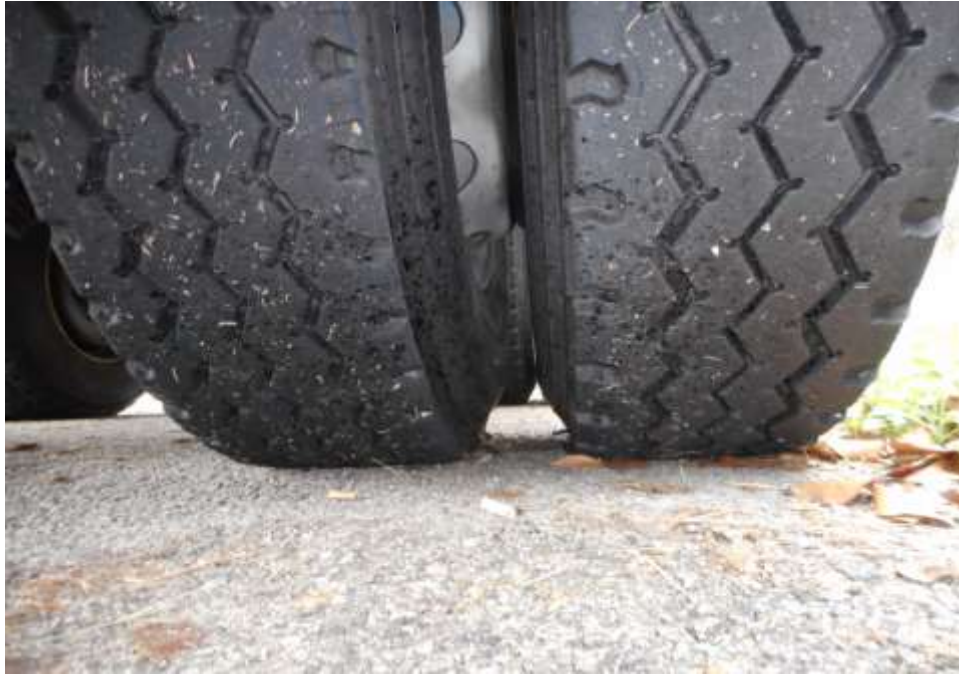
Photo 13 shows the condition of the right tyres of the trailer, which was observed to be in serviceable condition with remaining tread depth of approximately 12.1mm. The tyre, which was wrapped around standard steel wheel rim, was also observed to be sufficiently inflated for vehicular operation.

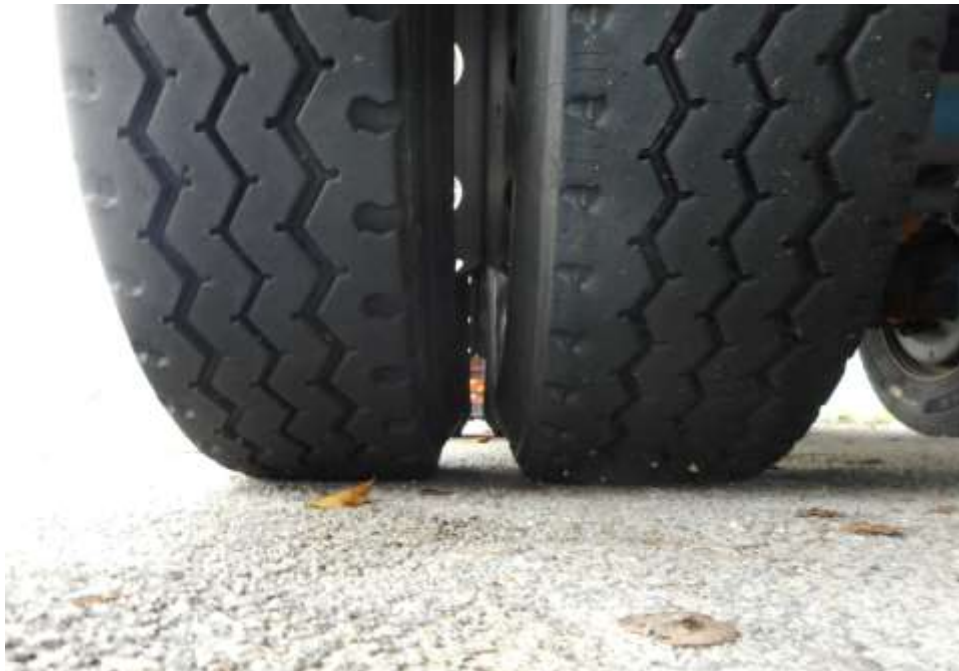
Photo 14 shows the condition of the left tyres of the trailer, which was observed to be in serviceable condition with remaining tread depth of approximately 10.6mm. The tyres, which were wrapped around standard steel wheel rim, were also observed to be sufficiently inflated for vehicular operation. There was also no damage found on all 12 steel wheel rims of the Motor Trailer.

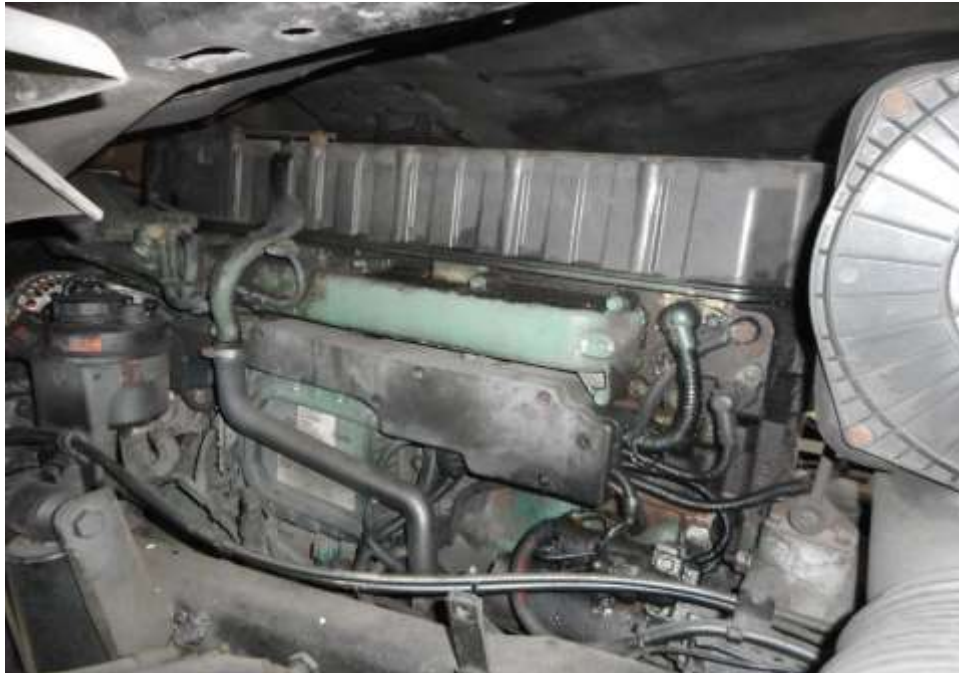
Photo 15 shows a general view of the Motor Trailer's engine compartment, which was accessed by lifting the front cabin of the Motor Trailer. The various parts and components inside the engine compartment were unaffected by the accident. There was also no sign(s) or indication(s) of fresh fluid leakage and/or fluid stain within the engine compartment

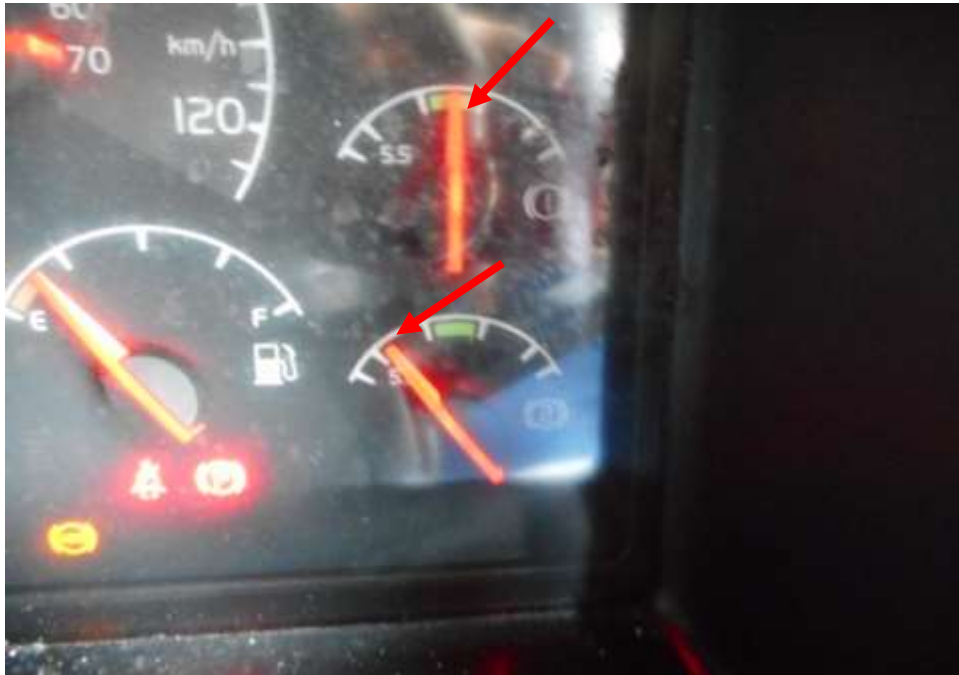
Photo 16 shows the air in the air brake cylinders of the Motor Trailer at the time of my inspection. The air in the cylinder was observed to be of sufficient level & serviceable at the time of the accident.

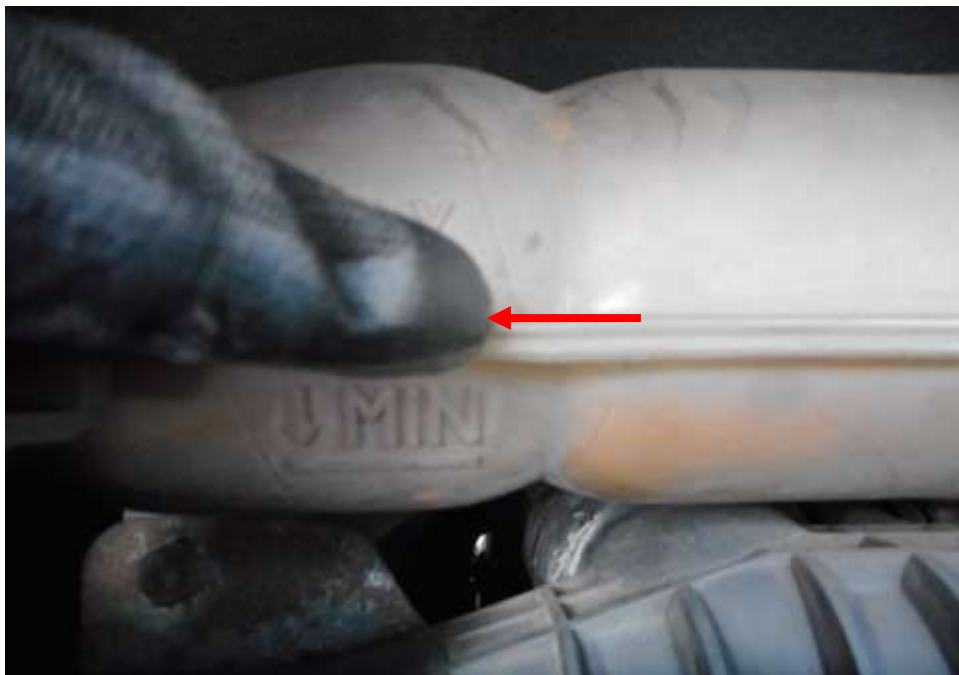
Photo 17 shows the engine coolant reservoir of the Motor Trailer at the time of my inspection. The engine coolant was observed to be of sufficient level (arrowed) and without any visible contamination.

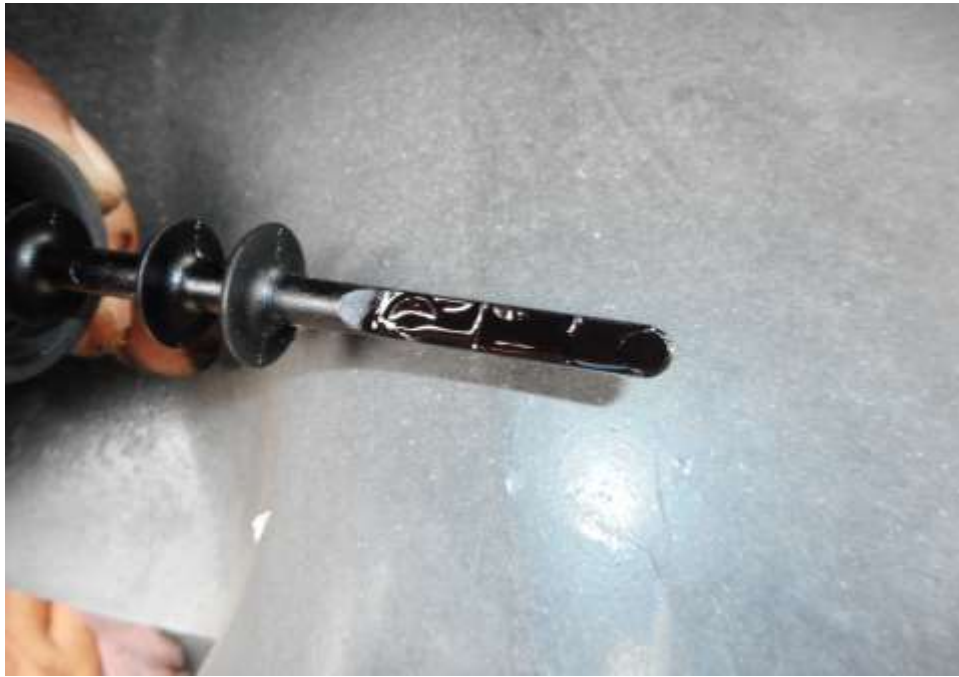
Photo 18 shows the power steering fluid reservoir of the Motor Trailer at the time of my inspection. The power steering fluid was observed to be of sufficient level and without any visible contamination.

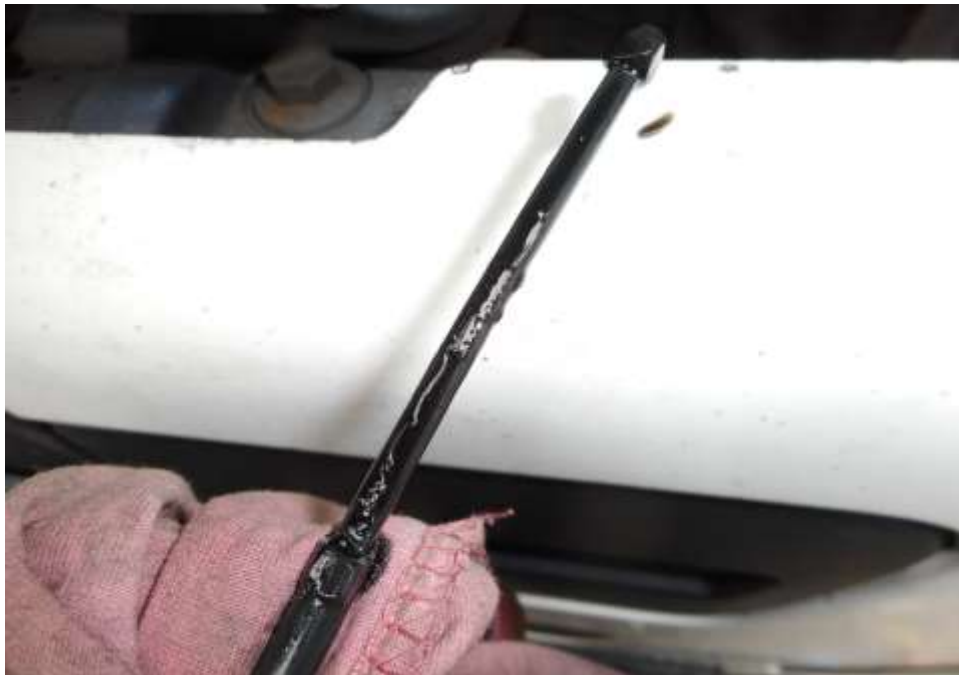
Photo 19 shows the engine oil dip stick of the Motor Trailer at the time of my inspection. The engine oil was observed to be of sufficient level and without any visible contamination.

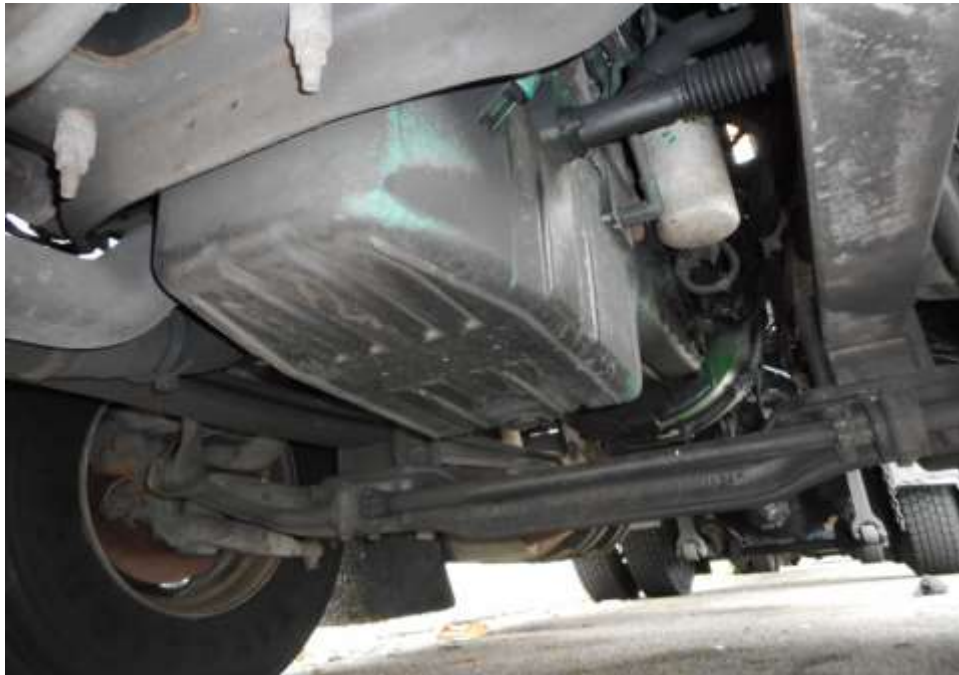
Photo 20 shows the undercarriage of the Motor Trailer, at the area where the engine housing located. I did not find any sign(s) or indication(s) of fluid leak and/or fluid stain(s) on the underside of the Motor Trailer.

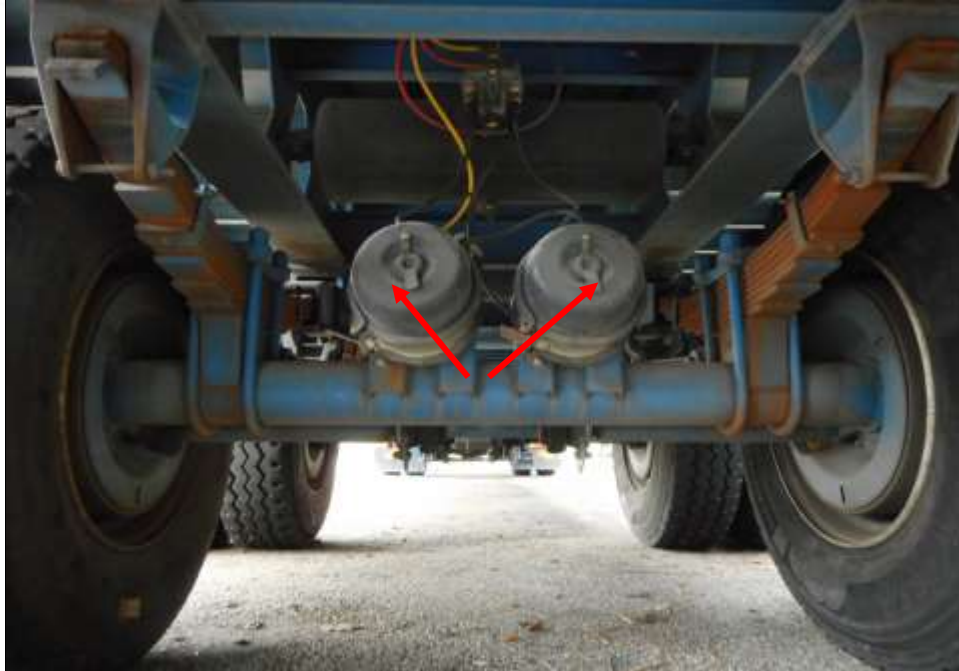
Photo 21 shows the brake pipe (arrowed) at the rear left and right wheel of the Motor Trailer. I did not observe any leakage of brake fluid at the time of my inspection of the Motor Trailer. My static tests of the Motor Trailer's braking system, along with my visual examination of the various mechanical components in the braking system, had indicated that there was no internal leakage of pressure/vacuum. Hence the braking system of the Motor Trailer was likely to be in serviceable condition at the material time of accident.

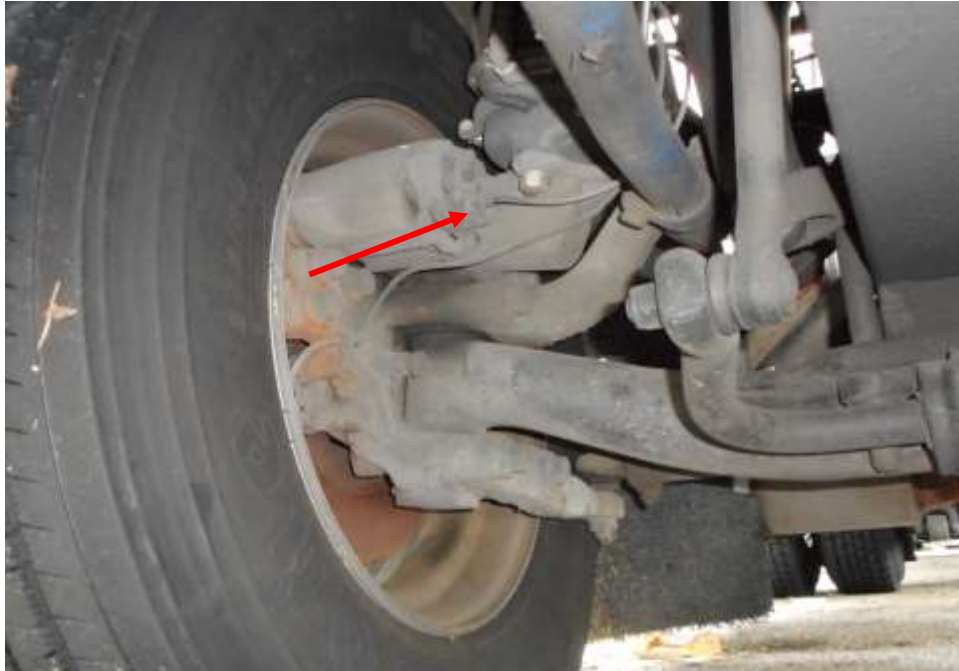
Photo 22 shows the brake pipe (arrowed) at the front right wheel of the Motor Trailer. I did not observe any leakage of brake fluid at the time of my inspection of the Motor Trailer. My static tests of the Motor Trailer's braking system, along with my visual examination of the various mechanical components in the braking system, had indicated that there was no internal leakage of pressure/vacuum. Hence the braking system of the Motor Trailer was likely to be in serviceable condition at the material time of accident.

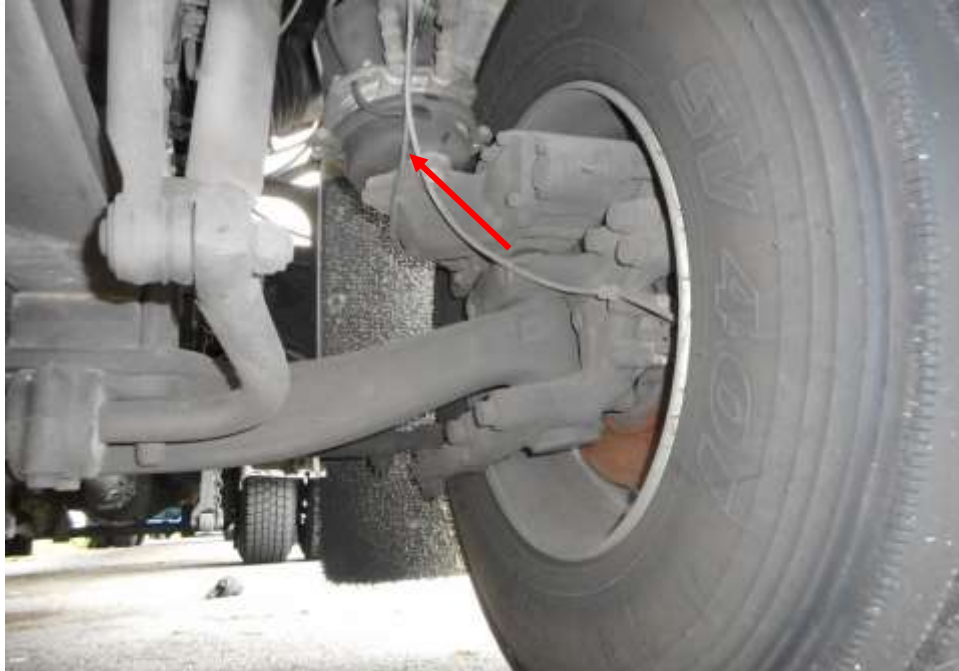
Photo 23 shows the brake pipe (arrowed) at the front left wheel of the Motor Trailer. I did not observe any leakage of brake fluid at the time of my inspection of the Motor Trailer. My static tests of the Motor Trailer's braking system, along with my visual examination of the various mechanical components in the braking system had indicated that there was no internal leakage of pressure/vacuum. Hence the braking system of the Motor Trailer was likely to be in serviceable condition at the material time of accident.

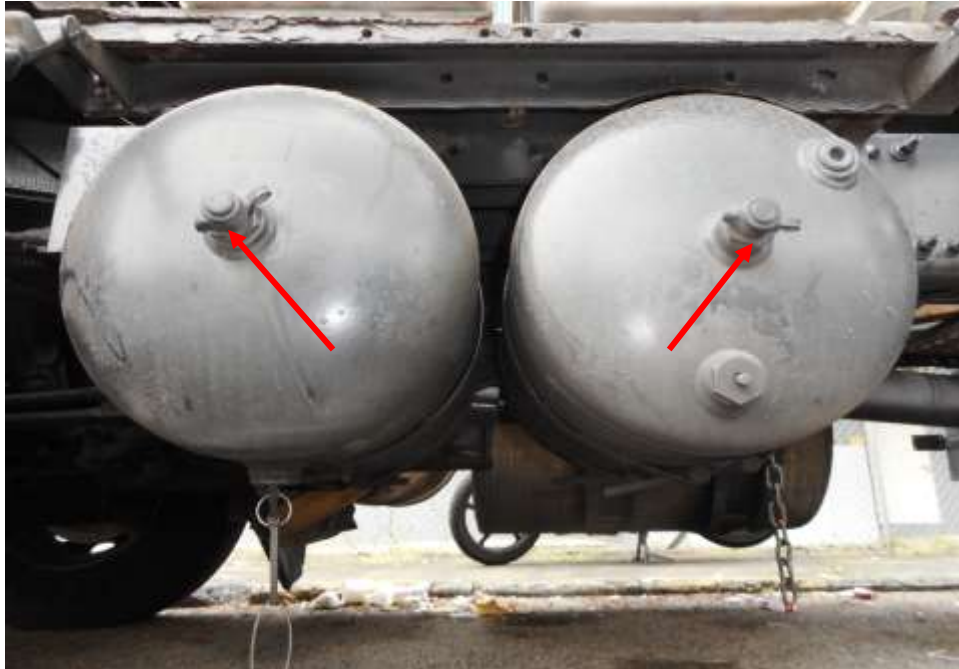
Photo 24 shows the air brake cylinders (arrowed) at the undercarriage of the Motor Trailer. I did not observe any leakage of air brake fluid at the time of my inspection of the Motor Trailer. My static tests of the Motor Trailer's braking system, along with my visual examination of the various mechanical components in the braking system had indicated that there was no internal leakage of pressure/vacuum. Hence the braking system of the Motor Trailer was likely to be in serviceable condition at the material time of accident.

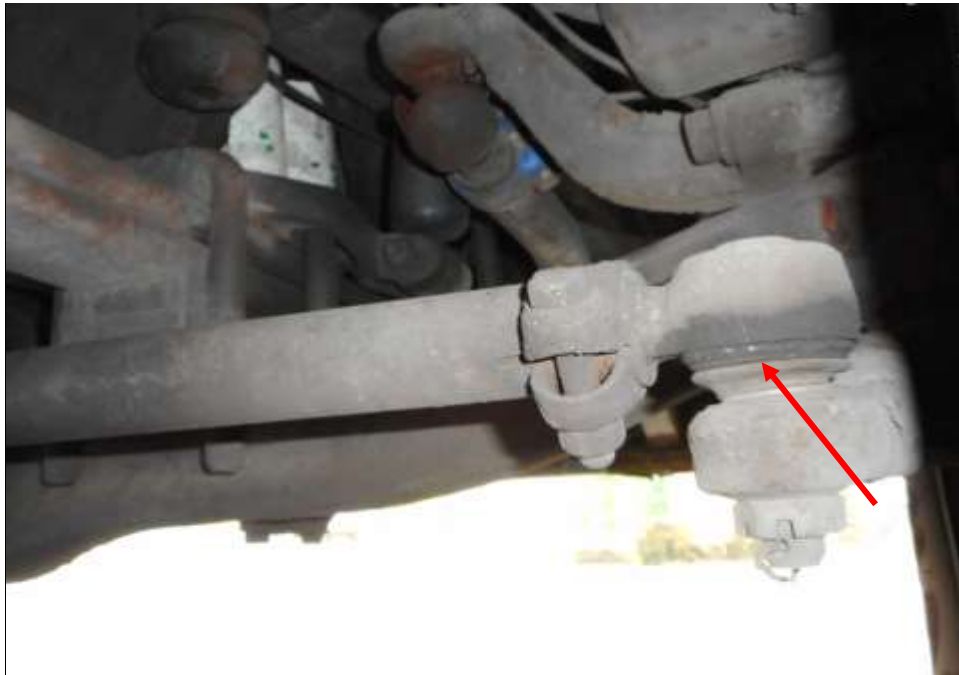
Photo 25 shows the various undercarriage components at the front right wheel of the Motor Trailer, in particular the steering tie rod end (arrowed). The various steering components were all found to be intact, suggesting that the steering system of the Motor Trailer was likely to be in serviceable condition at the material time of accident. There was also no sign of fluid stain(s) observed on the various undercarriage components.

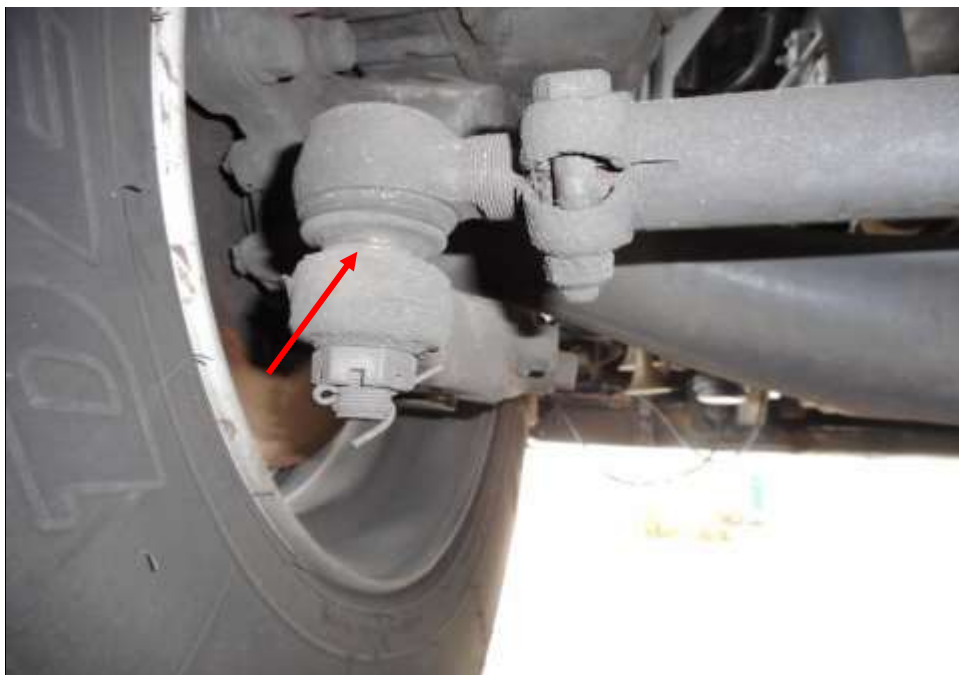
Photo 26 shows the various undercarriage components at the front left wheel of the Motor Trailer, in particular the steering tie rod end (arrowed). The various undercarriage components of the Motor Trailer were all found to be intact without any visible damage. There was also no sign of fluid stain(s) observed on the various undercarriage components.

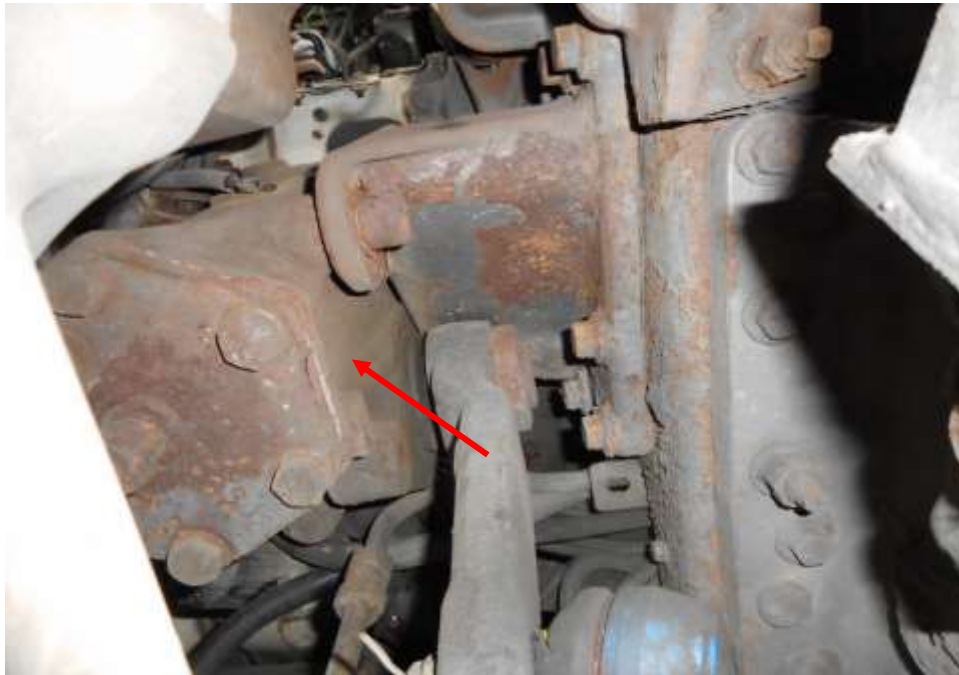
Photo 27 shows the steering box component (arrowed) at the undercarriage of the Motor Trailer was found to be intact without any visible damage. There was also no sign of fluid stain(s) observed on the various undercarriage components.

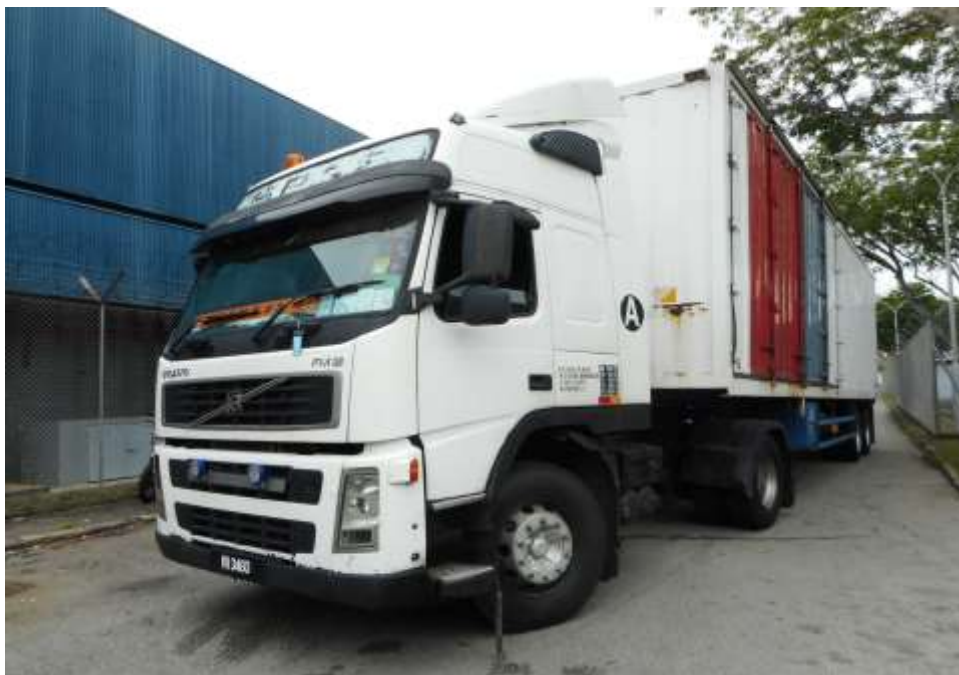
Photo 28 shows the front left wheel of the Motor Trailer turned to its full right. During my steering system test, I did not experience any abnormal free play and/or resistance when I had turned the steering wheel towards full left and full right. This would suggest that the steering system of the Motor Trailer was likely to be in serviceable condition at the material time of accident.

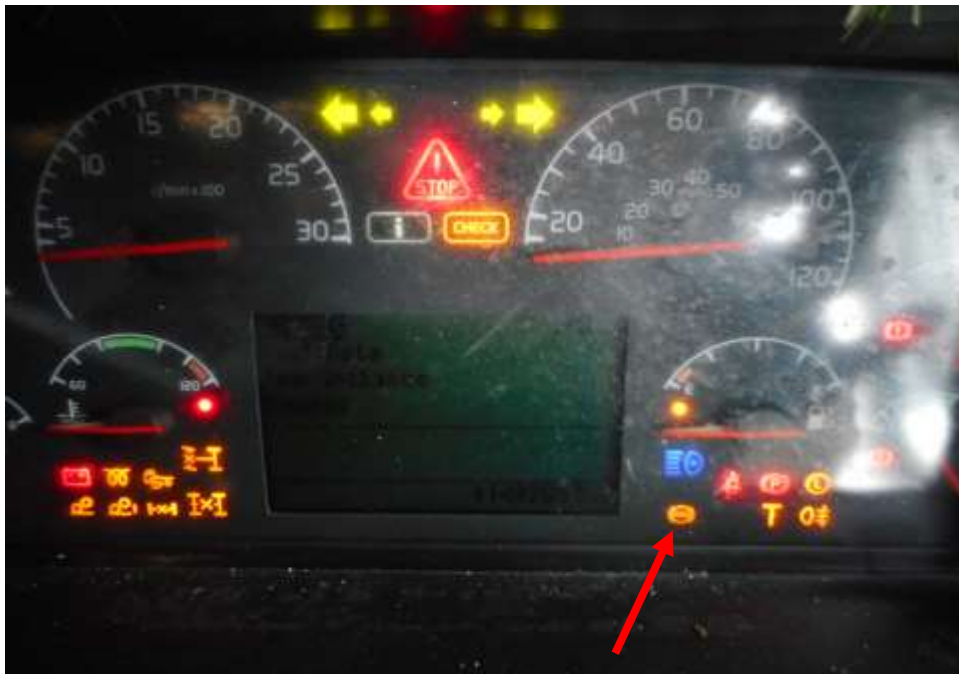
Photo 29 shows the warning light for Anti-Lock Brake System (ABS) (arrowed) appearing on the instrument panel of the Motor Trailer during the self-test of its various electronic operating systems when its engine was cranked.

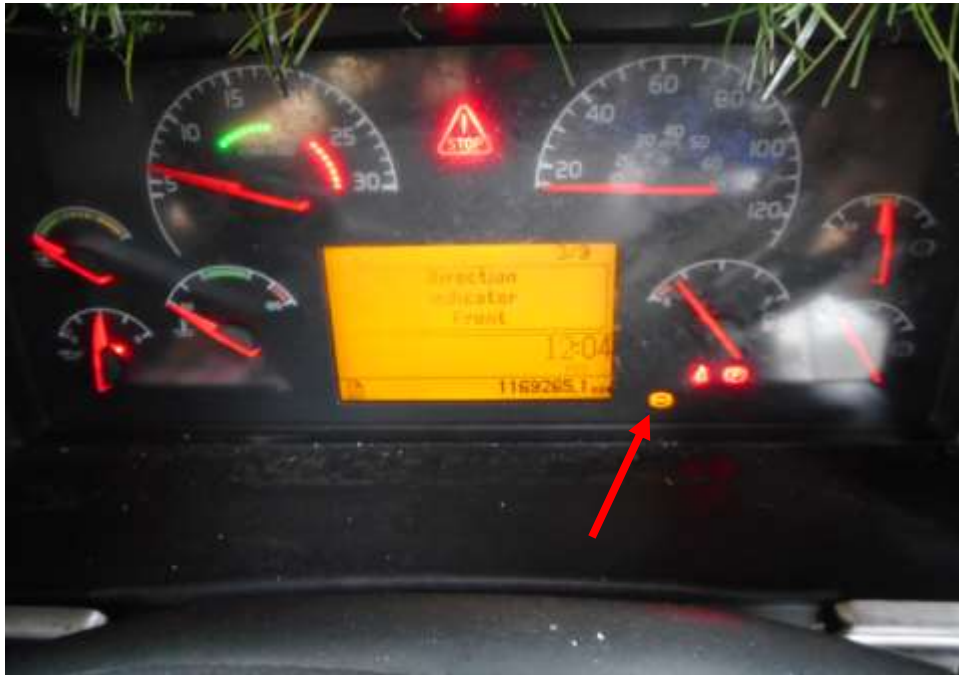
Photo 30 shows the ABS warning lights illuminated on the instrument panel of the Motor Trailer after the engine was cranked. This would suggest that there was an electrical fault to the ABS systems of the Motor Trailer.
