Your Ref: TP/IP/33001/2019
Our Ref : CI/TPD19018895/N

25 October 2019

INSPECTION REPORT OF MOTORCYCLE VAL 1344

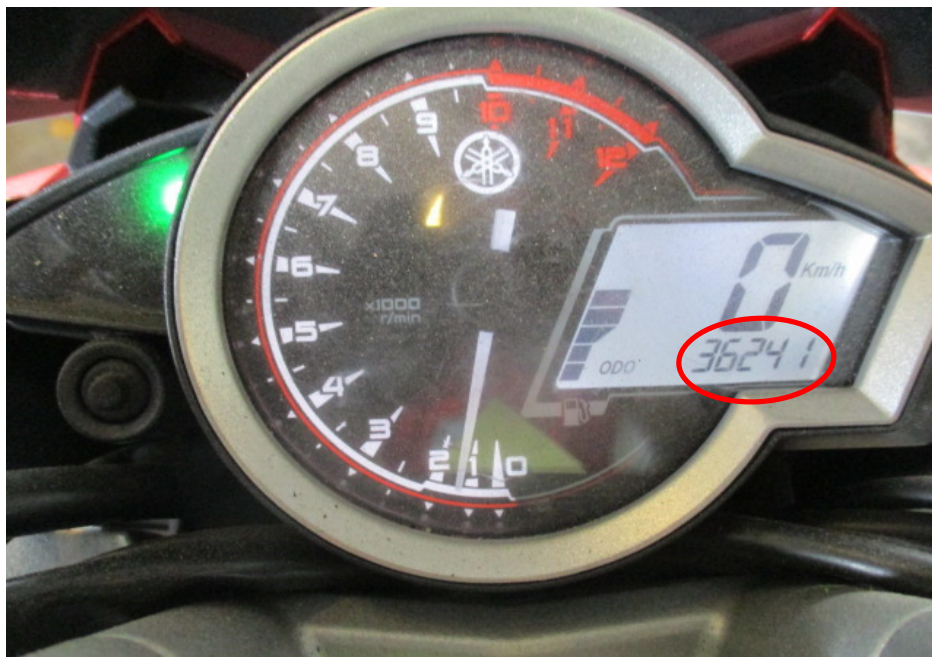
Photo 1 shows the speedometer gauge of the Motorcycle. The mileage of the Motorcycle at the time of our inspection was 36, 241km (circled).

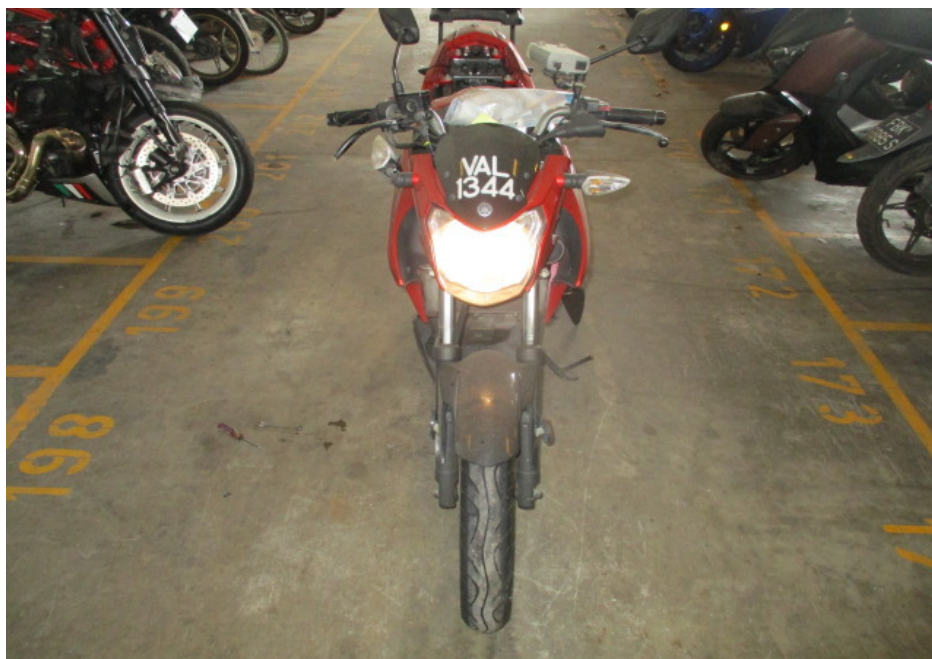
Photo 2 shows a general view of the front body of the Motorcycle at the time of our inspection. The Motorcycle was observed to have sustained damages along its frontal portion and right body.

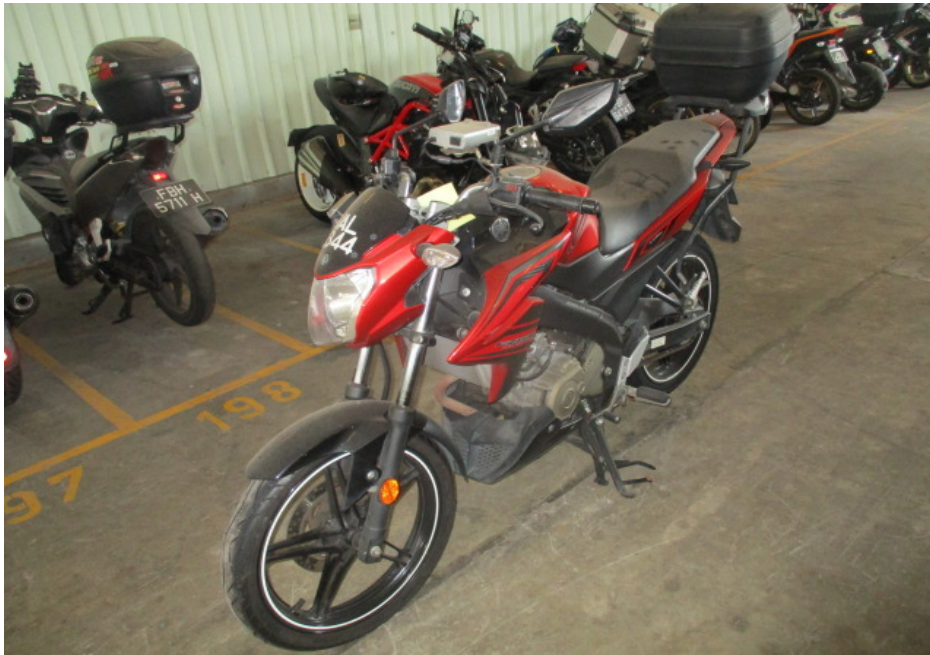
Photo 3 shows a general view of the left body of the Motorcycle at the time of our inspection. The Motorcycle was observed to have sustained damages along its frontal portion and right body.

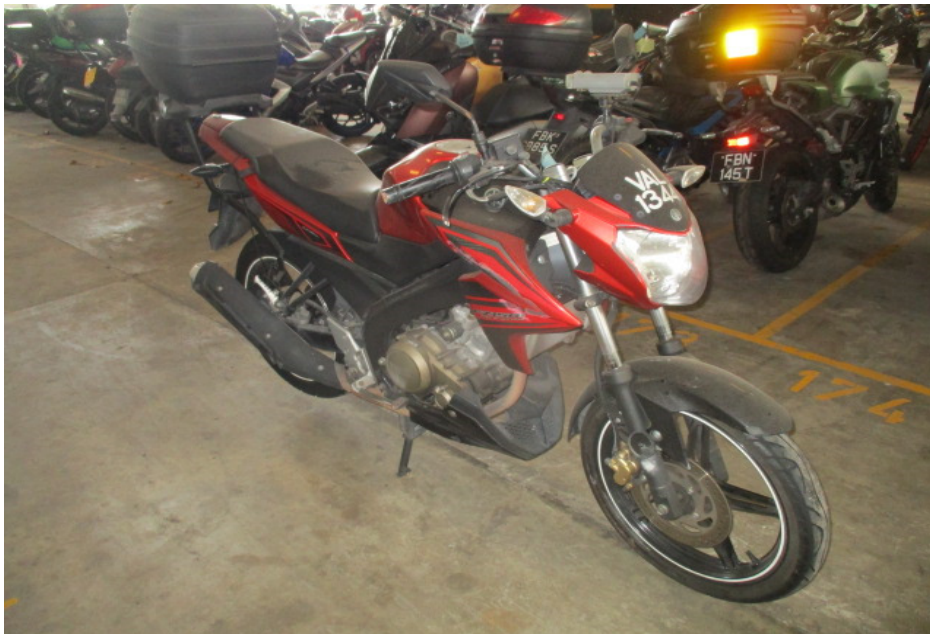
Photo 4 shows a general view of the right body of the Motorcycle at the time of our inspection. The Motorcycle was observed to have sustained damages along its frontal portion and right body. Amongst the body parts that were found to have been damaged include its headlamp assembly, right cowling, right front signal lamp, front mudguard, right outer fork tube, front brake lever, right side mirror, petrol tank, rear brake pedal, right front footrest, right rear side cover, exhaust muffler heat shield and top box, amongst others.

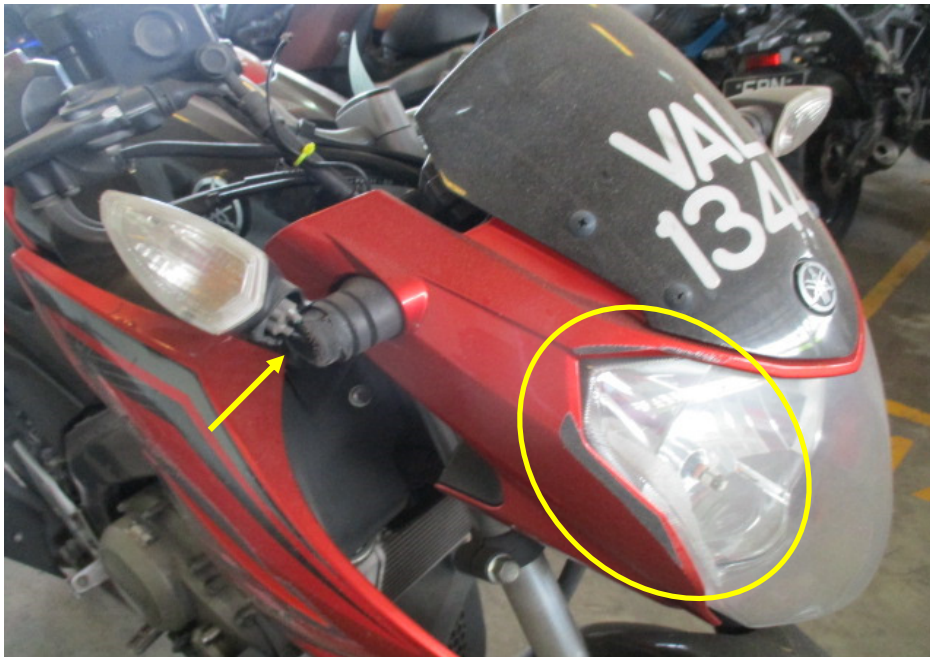
Photo 5 shows a closer view of the headlamp assembly (circled) and right front signal lamp (arrowed) which were amongst the body parts at the front body of the Motorcycle that had sustained damage as a result of the accident.

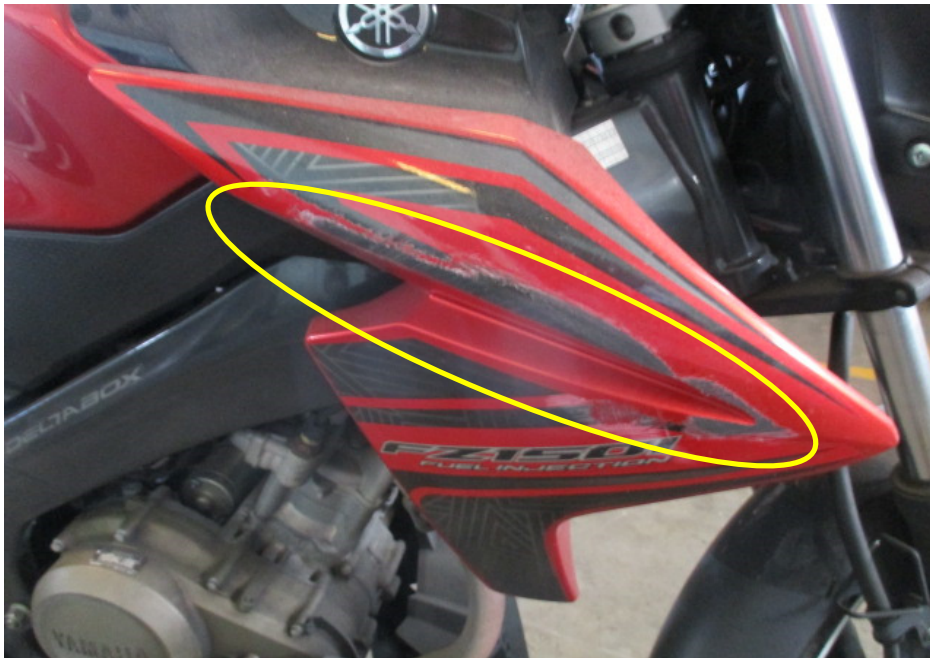
Photo 6 shows a close up view of the right side cowling (circled) which was amongst the body parts of the Motorcycle that had sustained damage as a result of the accident.

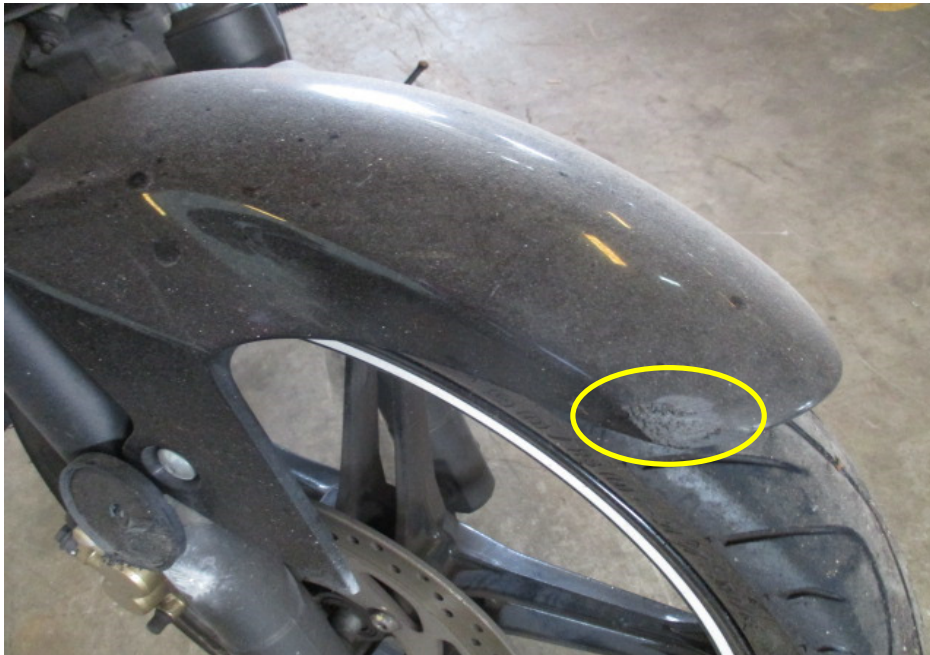
Photo 7 shows a closer view of the front mudguard (circled) which was amongst the body parts at the front body of the Motorcycle that had sustained damage as a result of the accident.

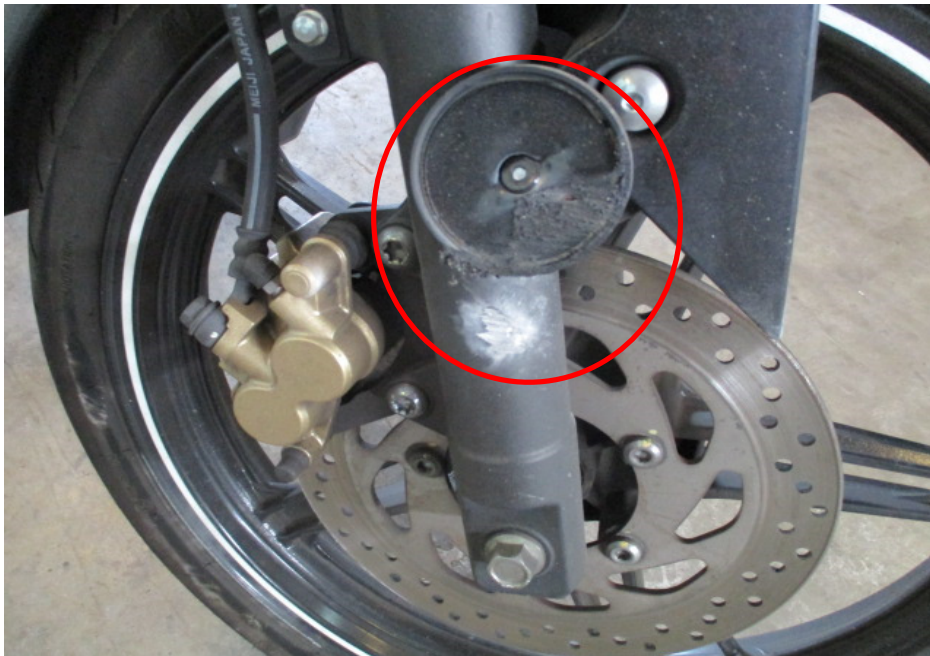
Photo 8 shows a closer view of the right outer fork tube and right reflector cover (circled) which were amongst the body parts of the Motorcycle that had sustained damages of grazing nature as a result of the accident.

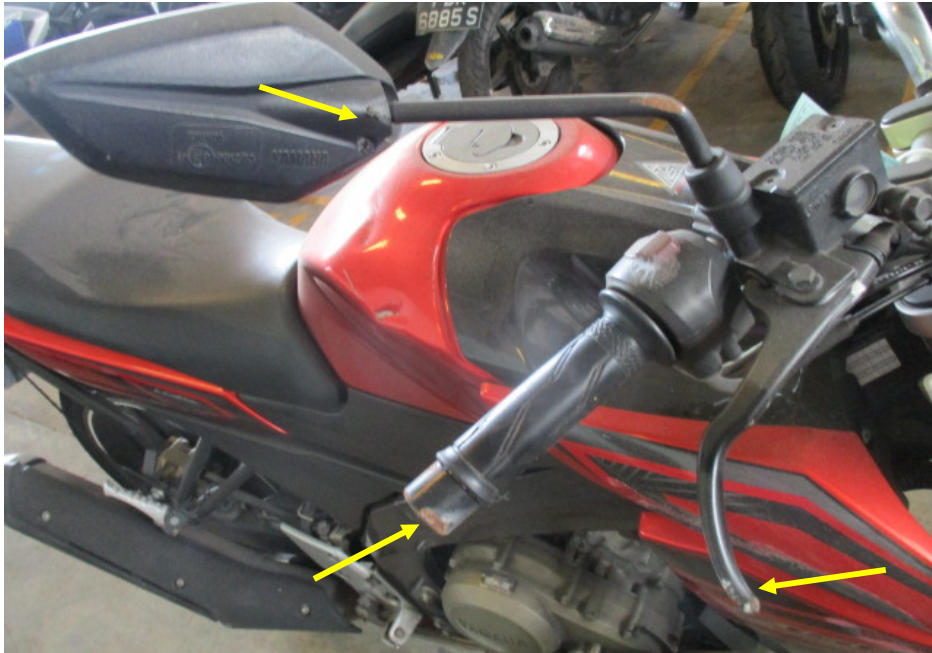
Photo 9 shows the front brake lever, right handlebar end and right side mirror (arrowed), which were amongst the body parts of the Motorcycle that had sustained damage as a result of the accident.

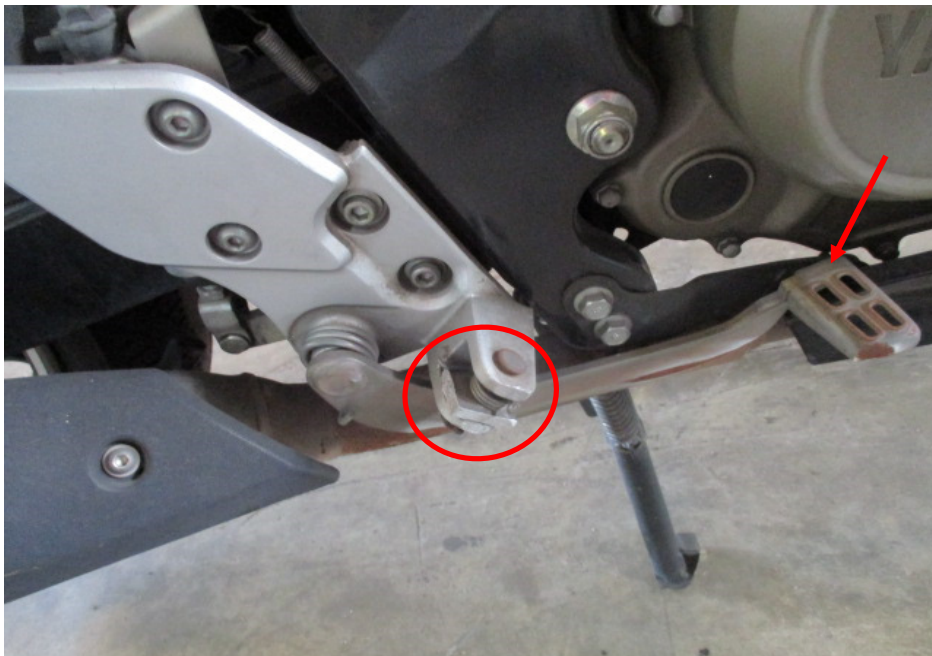
Photo 10 shows a closer view of the broken right front footrest (circled) and bent rear brake pedal (arrowed), which were amongst the body parts of the Motorcycle that had sustained damage as a result of the accident.

14. Our visual examination of the various components in the Motorcycle's rear braking system like the brake disc, brake caliper and rear brake hose revealed all to be intact and without damage. There was also no leakage of brake fluid observed along the rear brake hose. This was from the respective rear brake fluid reservoir to the rear brake caliper of the Motorcycle. The brake fluid for the rear brake was also found to be of sufficiently level and without any contamination. However, we observed that the impact of the accident had resulted in the rear brake pedal to be bent inwards, jamming it. Hence we were unable to depress the brake pedal. Refer to photo 10 above.

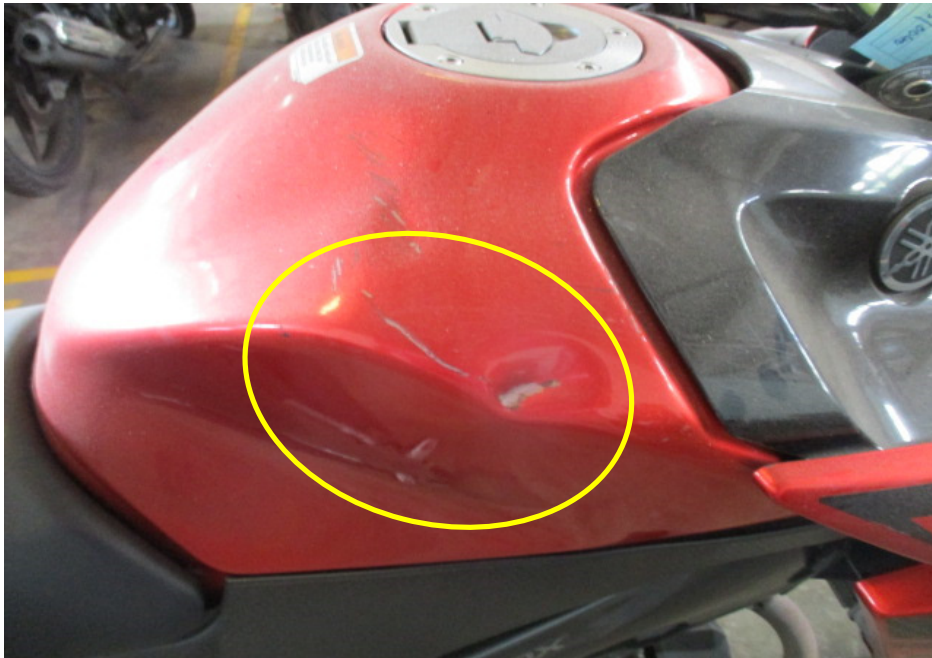
Photo 11 shows a closer view of the petrol tank (circled) which was amongst the body parts of the Motorcycle that had sustained damage as a result of the accident.

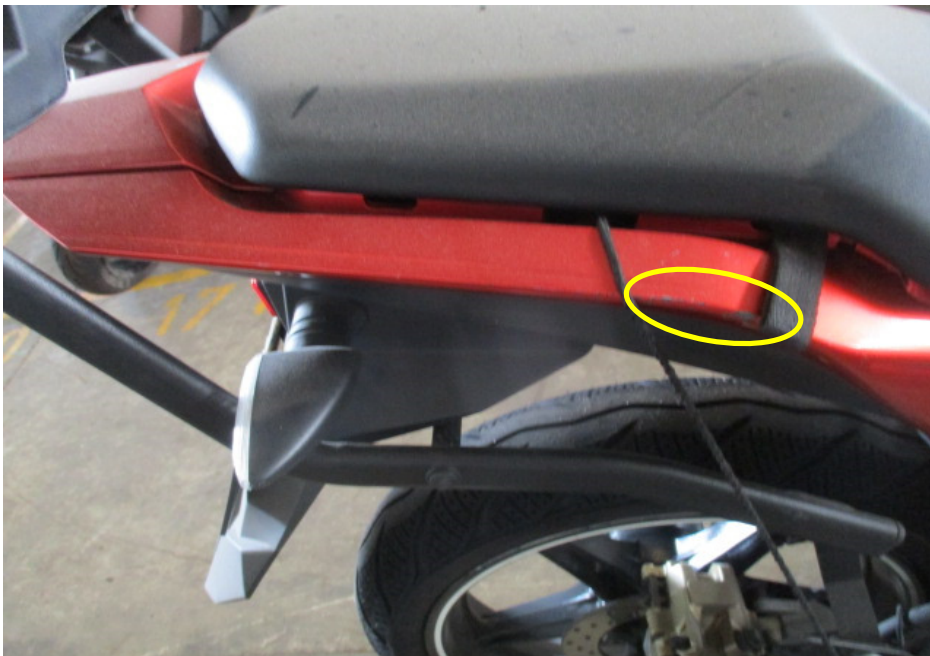
Photo 12 shows the damaged right rear side cover of the Motorcycle as a result of the accident (circled).

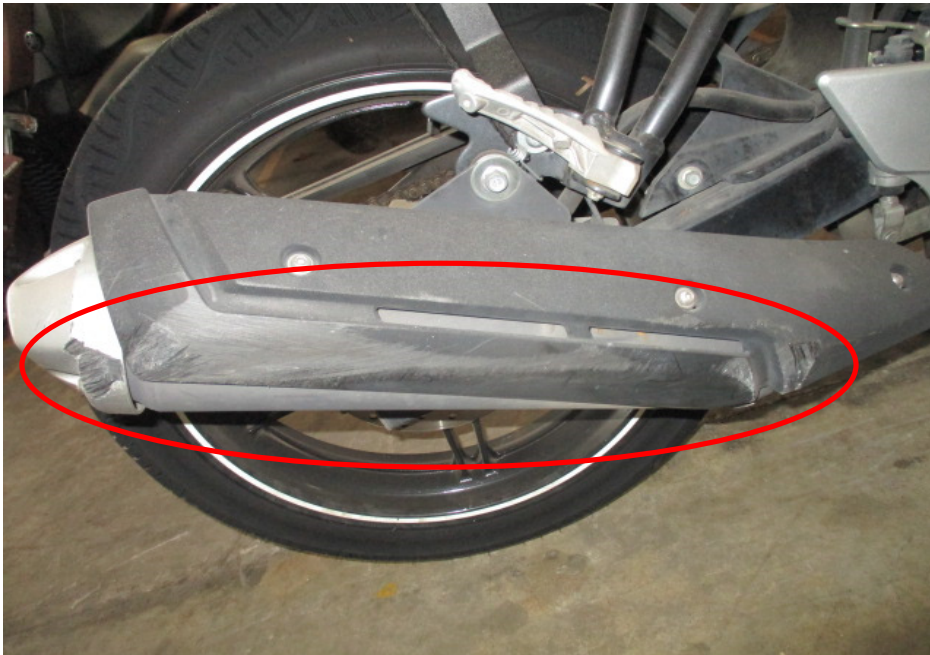
Photo 13 shows a closer view of the exhaust muffler and exhaust muffler heat shield which was amongst the body parts of the Motorcycle that had sustained damages of grazing nature as a result of the accident (circled).

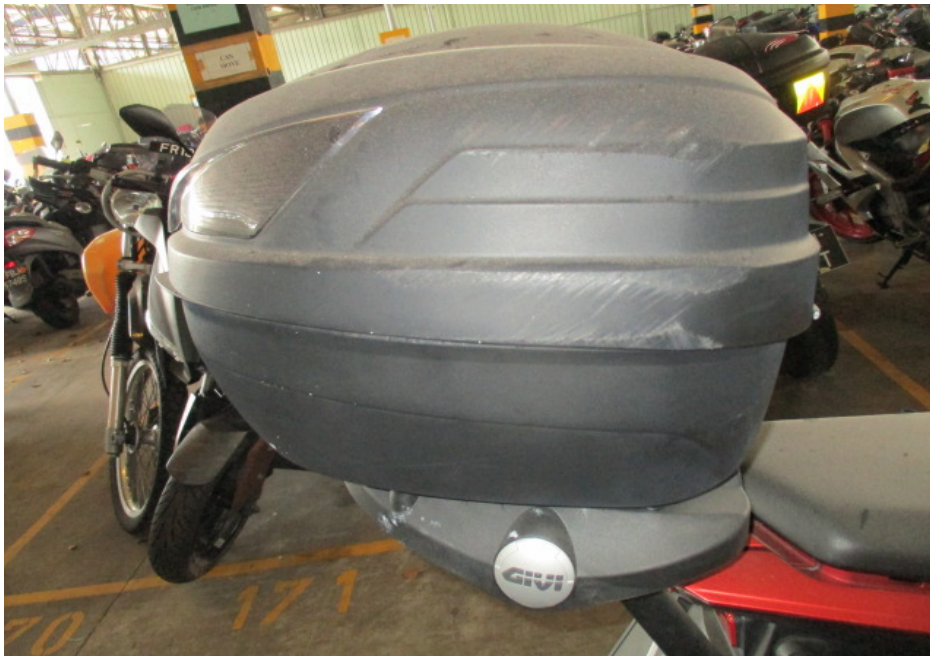
Photo 14 shows a closer view of the top box rack and top box which were amongst the body parts of the Motorcycle that had sustained damages of grazing nature as a result of the accident.

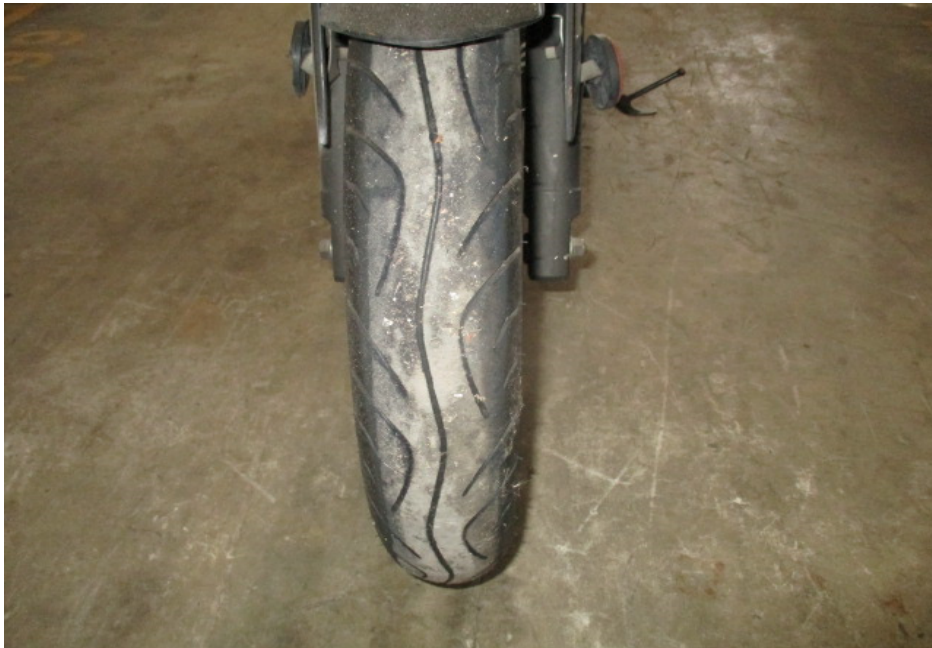
Photo 15 shows the condition of the Motorcycle's front tyre. The front tyre was observed to be in serviceable condition with remaining tread depth of approximately 3mm. The tyre was also observed to be sufficiently inflated for vehicular operation. We did not observe any tear, burst mark(s) and/or punctured hole(s) on the sidewalls as well as across the tread of the front tyre.

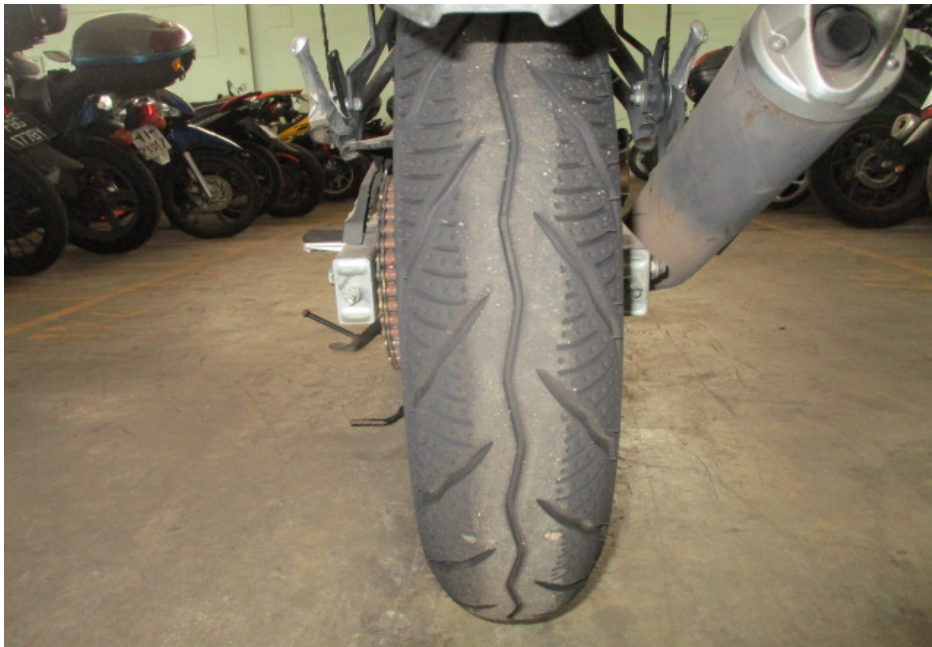
Photo 16 shows the condition of the Motorcycle's rear tyre. The rear tyre was observed to be in serviceable condition with remaining tread depth of approximately 4mm. The tyre was also observed to be sufficiently inflated for vehicular operation. We did not observe any tear, burst mark(s) and/or punctured hole(s) on the sidewalls as well as across the tread of the rear tyre.

17. Basing on our physical inspection of the Motorcycle, it appears that the steering system and front braking system of the Motorcycle were all in serviceable condition. We did not find any evidence(s) to suggest that there was possible mechanical failure to the Motorcycle. The rear braking system of the Motorcycle could not be tested due to damage as a result of the accident.
18. The 2 tyres of the Motorcycle were found to be in serviceable condition with remaining tread depth of approximately 3mm and 4mm each. This had included the rear tyre where a cut/tear on its tread area was observed. This cut/tear was a result of the accident which caused the rear tyre to be punctured.

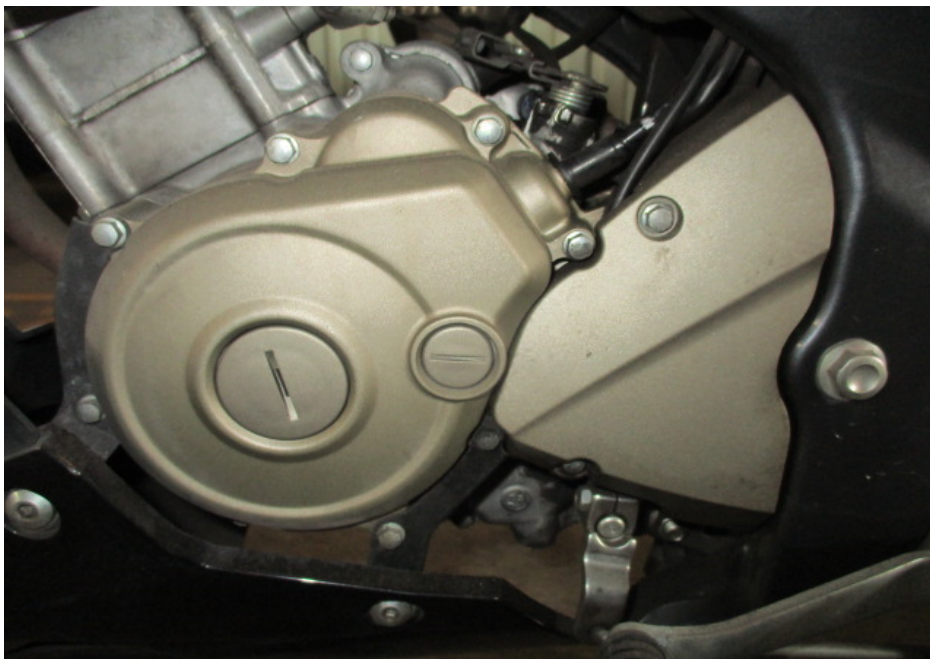
Photo 17 shows the left side of the engine of the Motorcycle at the time of our inspection. The various engine related parts and components were found to be intact with no visible damage. There was also no sign(s) or indication(s) of fluid leak observed around the left engine area of the Motorcycle.

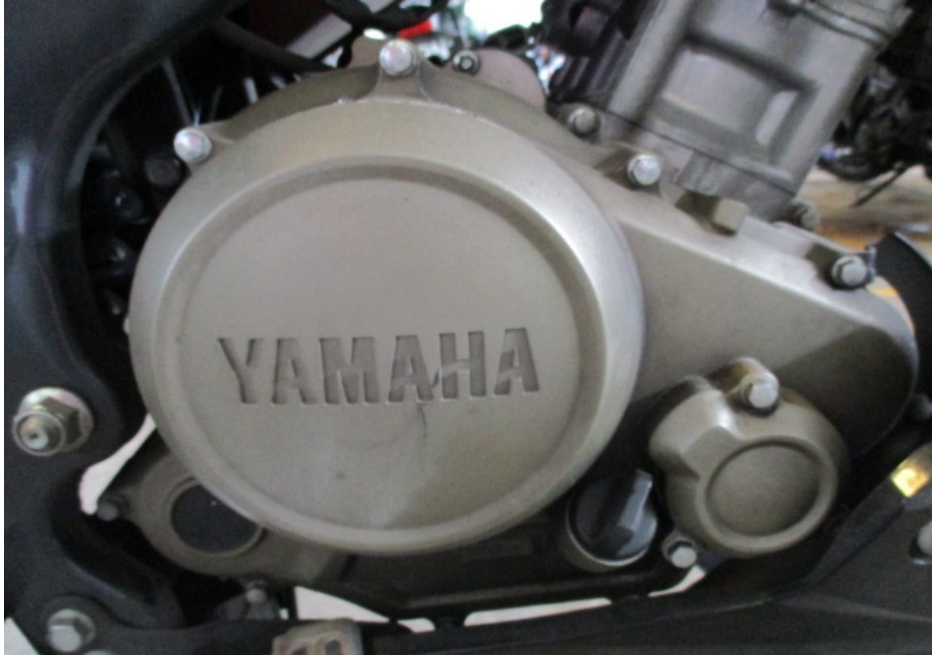
Photo 18 shows the right side of the engine of the Motorcycle at the time of our inspection. The various engine related parts and components were found to be intact with no visible damage. There was also no sign(s) or indication(s) of fluid leak observed around the right engine area of the Motorcycle.

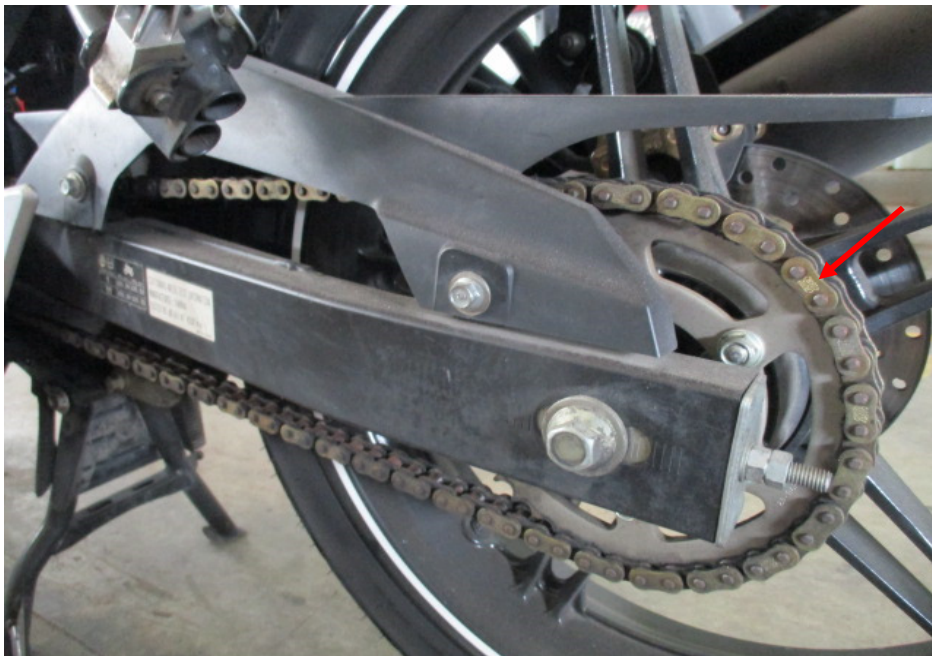
Photo 19 shows the general view of the gear train (arrowed) of the Motorcycle, which was observed to be intact with no misalignment. It was also adequately lubricated for operating purposes.

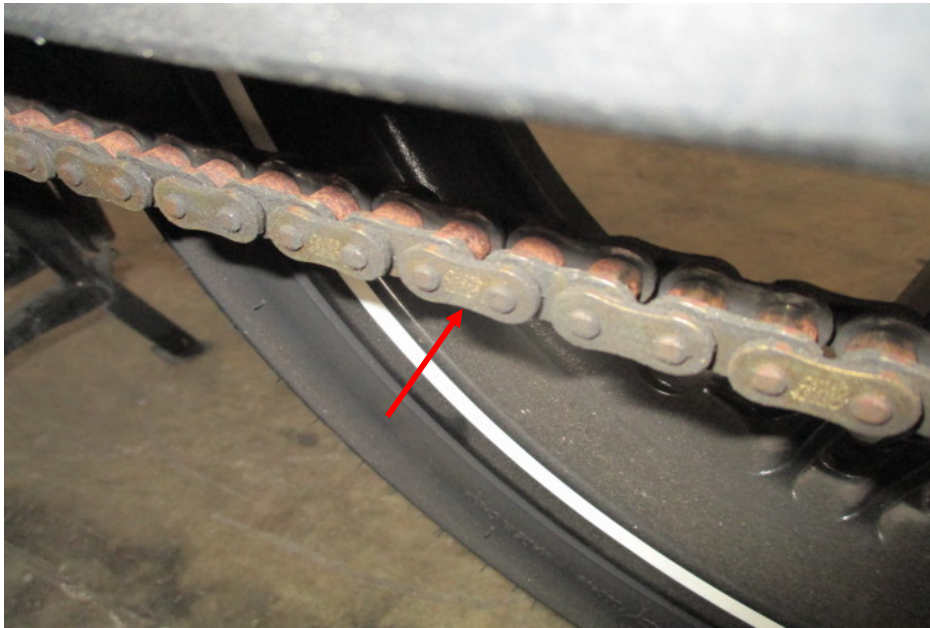
Photo 20 shows a closer view of the gear train (arrowed) of the Motorcycle, which was observed to be intact with no misalignment. It was also adequately lubricated for operating purposes.

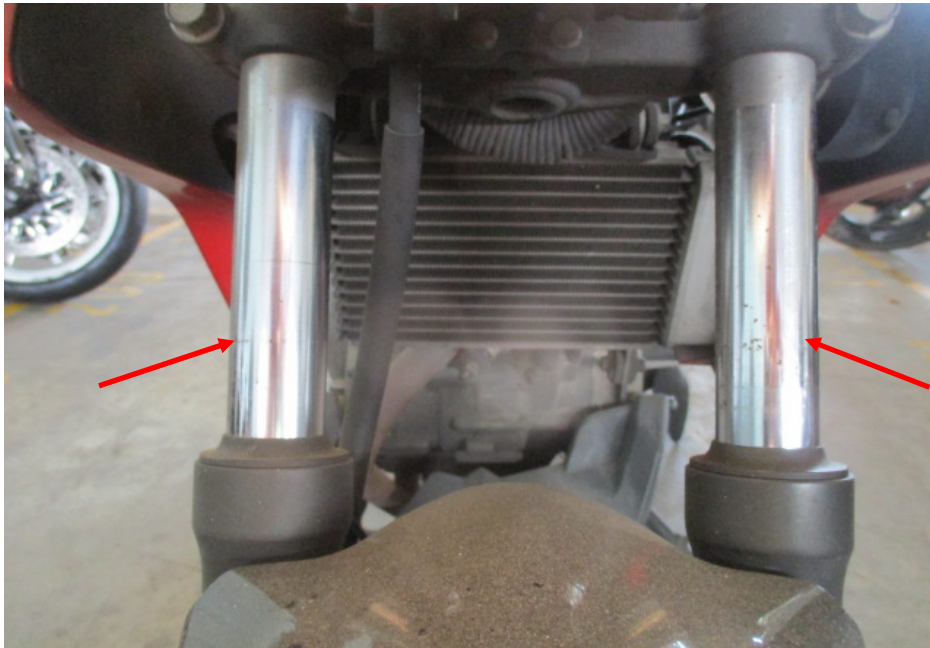
Photo 21 shows the front fork (arrowed) of the Motorcycle. The front fork and fork bracket of the Motorcycle were both found to be intact and undamaged. Turning the Motorcycle's handle bar towards the left and right did not produce any abnormal free play. The steering system of the Motorcycle was in serviceable condition at the time of our inspection.

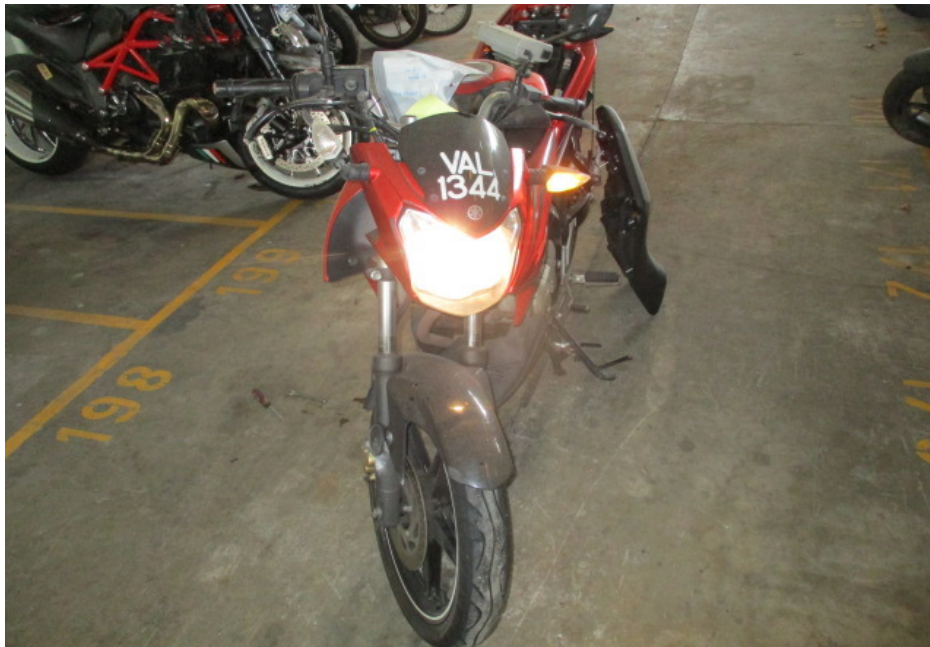
Photo 22 shows the front wheel of the Motorcycle turned towards its full left. Turning the Motorcycle's handle bar towards the left did not produce any abnormal free play and/or resistance. This would indicate that the steering system of the Motorcycle was in serviceable condition at the time of our inspection.

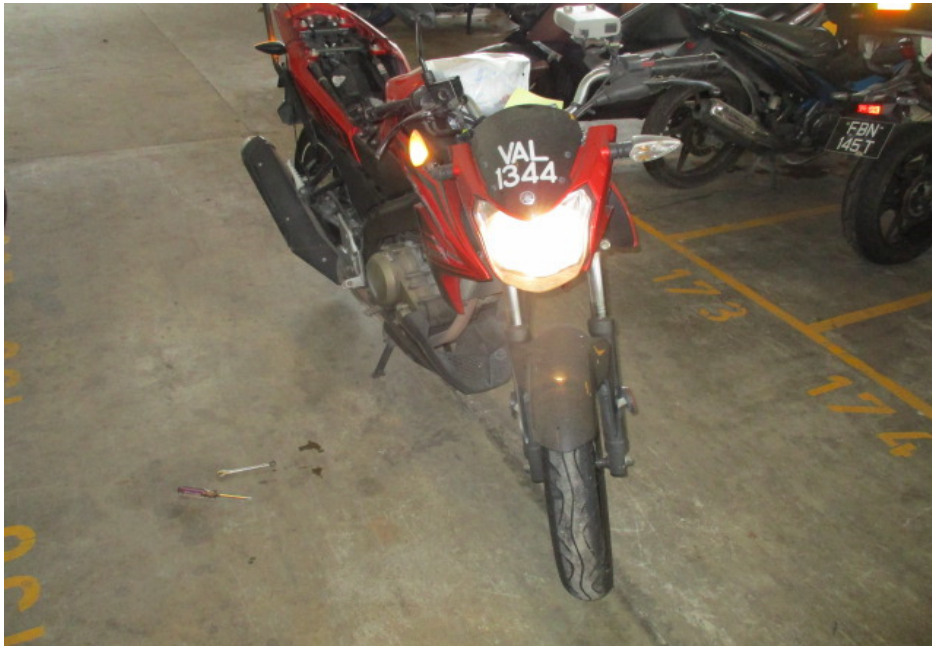
Photo 23 shows the front wheel of the Motorcycle turned towards its full right. Turning the Motorcycle's handle bar towards the right did not produce any abnormal free play and/or resistance. This would indicate that the steering system of the Motorcycle was in serviceable condition at the time of our inspection.

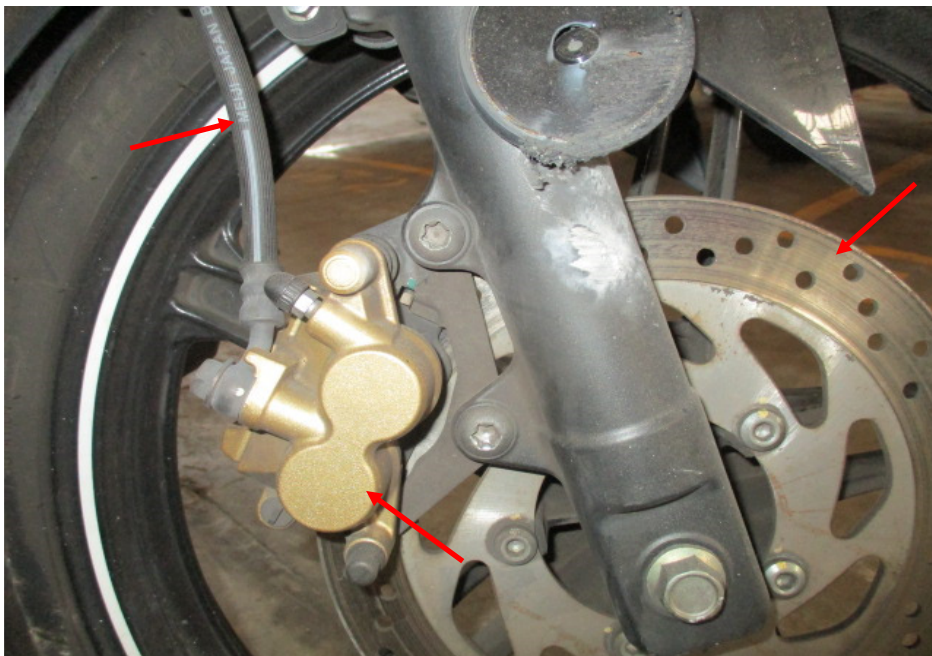
Photo 24 shows a close up view of the front brake caliper, front brake disc and front brake hose (arrowed) of the Motorcycle, which are all part of the components in the hydraulic front brake system of the Motorcycle. Our visual checks of these various components had revealed all to be intact with no visible damage. No leakage of brake fluid was also observed.

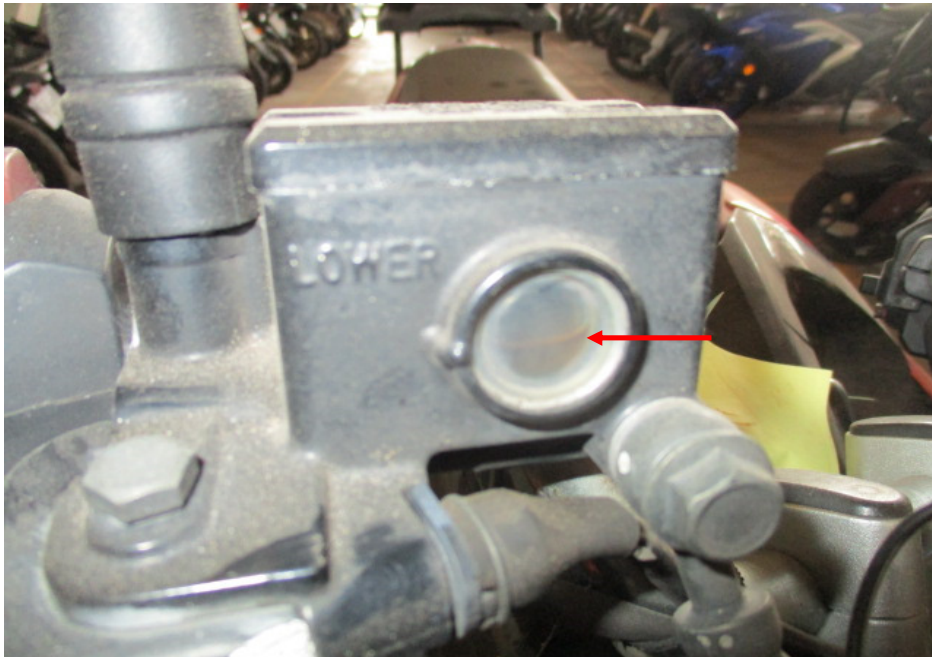
Photo 25 shows the brake fluid reservoir for the front brake of the Motorcycle. The brake fluid was observed to be of sufficient level and without contamination for operational purposes (arrowed).

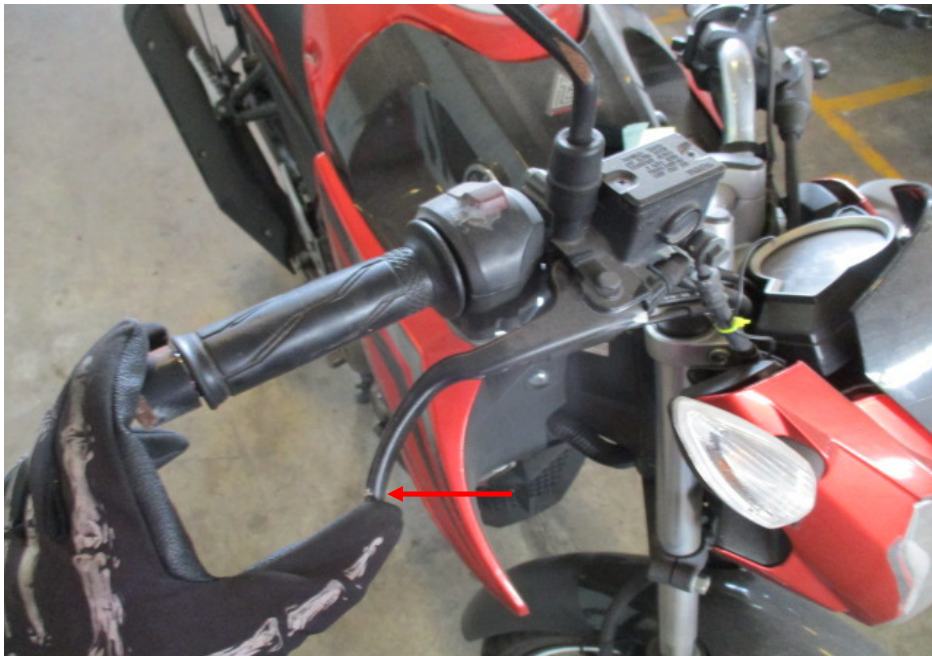
Photo 26 shows the front brake lever being depressed. There was some resistance felt (spongy like feel) upon pressing the front brake lever (arrowed). This would indicate that there is no leakage of pressure/vacuum in the brake system.

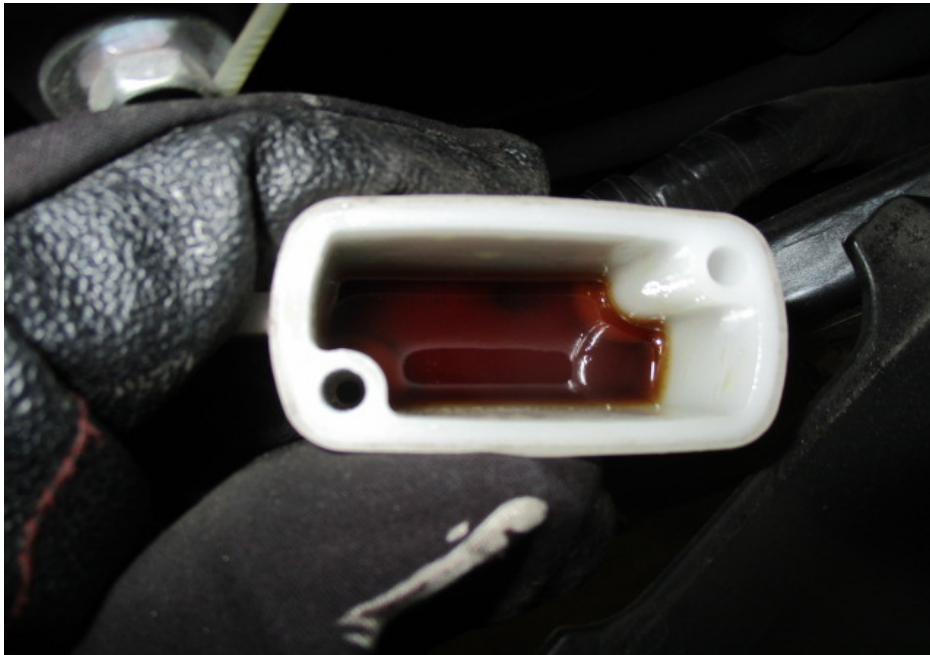
Photo 27 shows the brake fluid reservoir for the rear brake of the Motorcycle. The brake fluid was observed to be of sufficient level and without contamination for operational purposes.

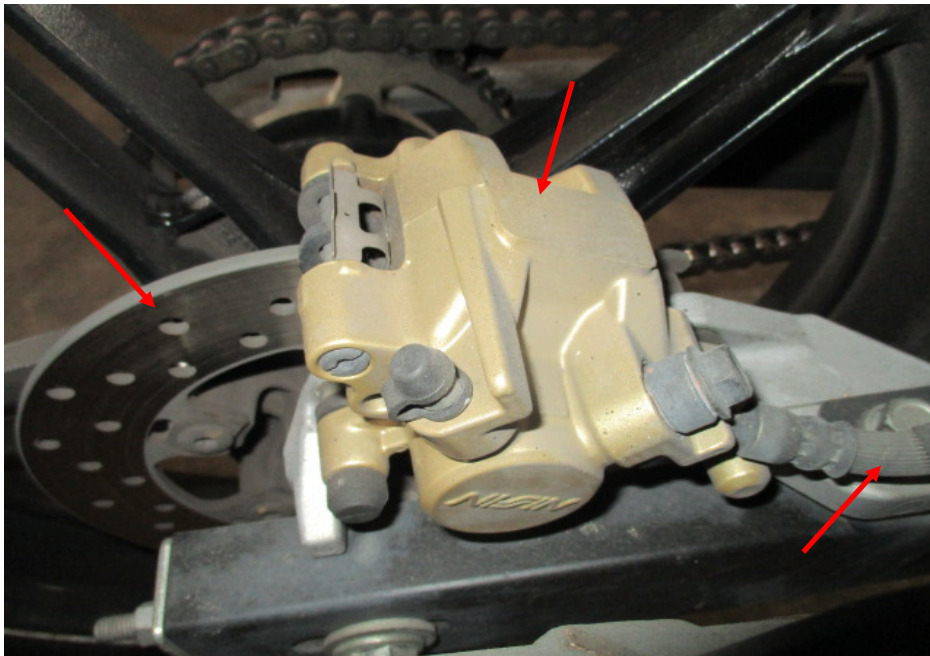
Photo 28 shows a close up view of the rear brake caliper, rear brake disc and rear brake hose (arrowed) of the Motorcycle, which are all part of the components in the hydraulic rear brake system of the Motorcycle. Our visual checks of these various components had revealed all to be intact with no visible damage. No leakage of brake fluid was also observed.
