Your Ref: TP/IP/32037/2019
Our Ref : CI/TPD19018897/P

Fatal Accident Investigation Team

MECHANICAL INSPECTION REPORT OF MOTOR BUS NCK 9059

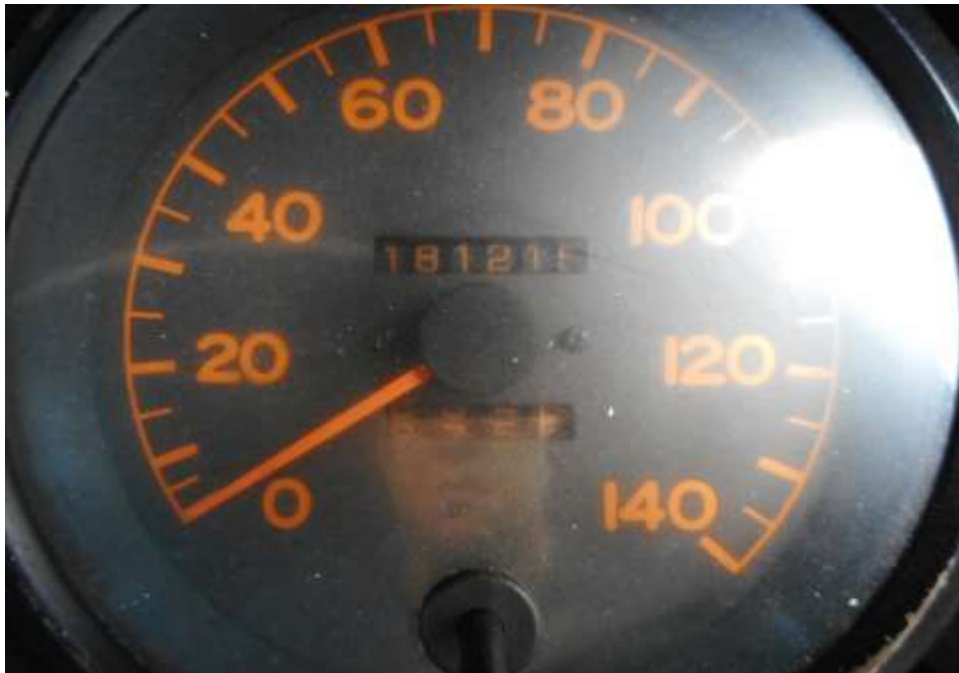
Photo 1 shows a general view of the instrument cluster of the Motor Bus at the time of my inspection. The mileage of the Motor Bus was 181,215km

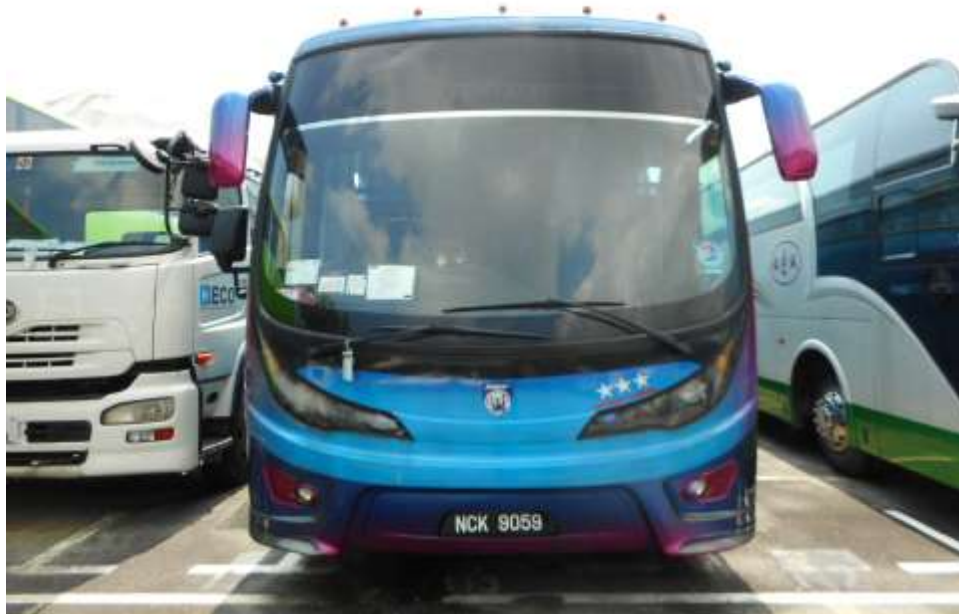
Photo 2 shows a general view of the front body of the Motor Bus at the time of my inspection. The Motor Bus was observed to be in good general condition and unaffected by the accident.

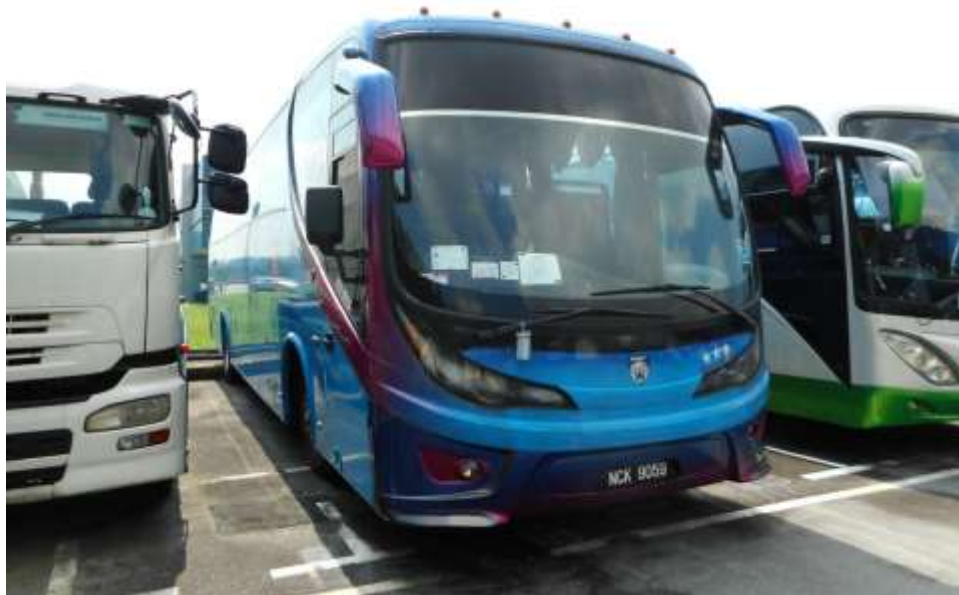
Photo 3 shows a general view of the right body of the Motor Bus at the time of my inspection. The Motor Bus was observed to be in good general condition and unaffected by the accident.

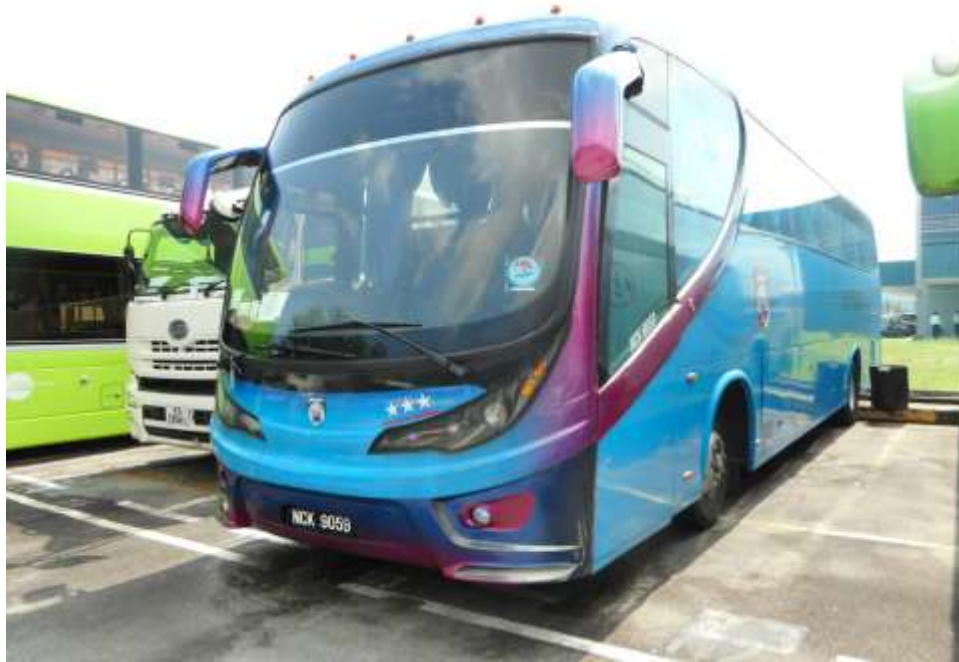
Photo 4 shows a general view of the left body of the Motor Bus at the time of my inspection. The Motor Bus was observed to be in good general condition and unaffected by the accident.

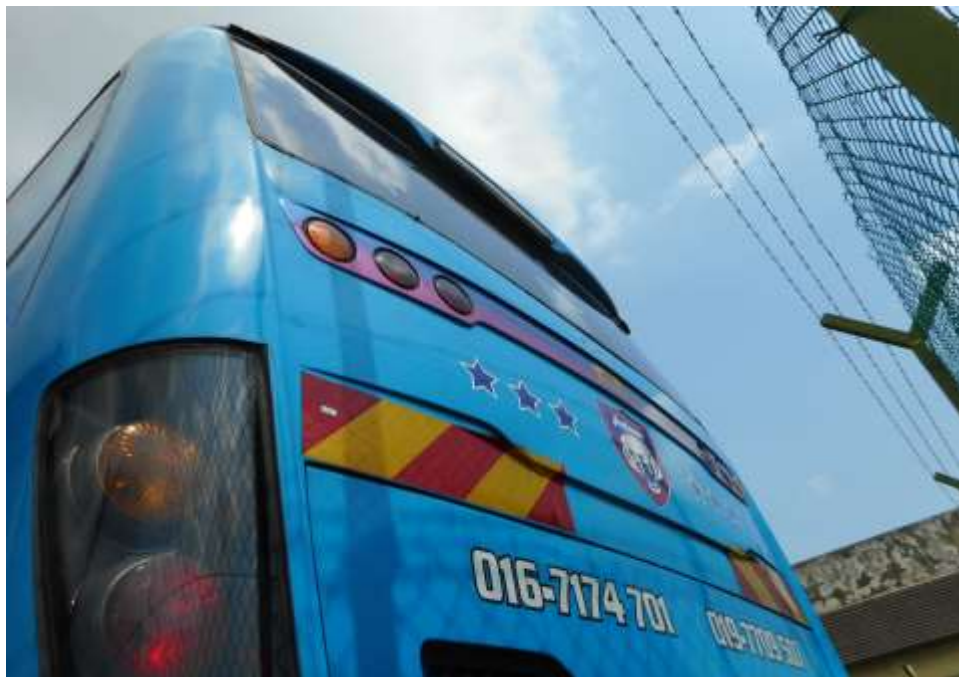
Photo 5 shows a general view of the rear top half body of the Motor Bus at the time of my inspection. The Motor Bus was observed to be in good general condition and unaffected by the accident.

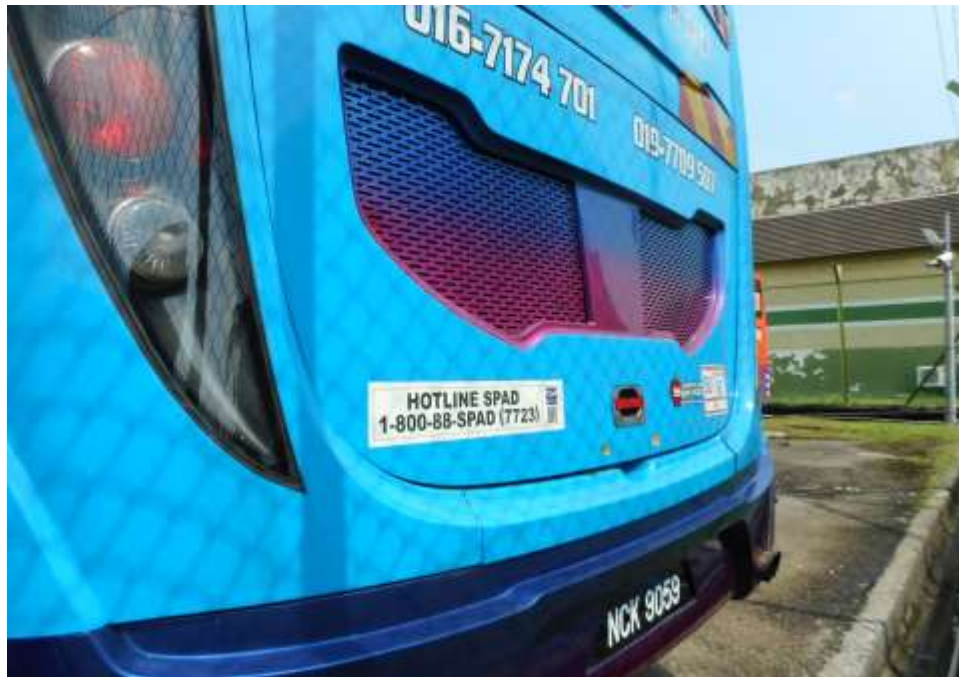
Photo 6 shows a general view of the rear bottom half body of the Motor Bus at the time of my inspection. The Motor Bus was observed to be in good general condition and unaffected by the accident.

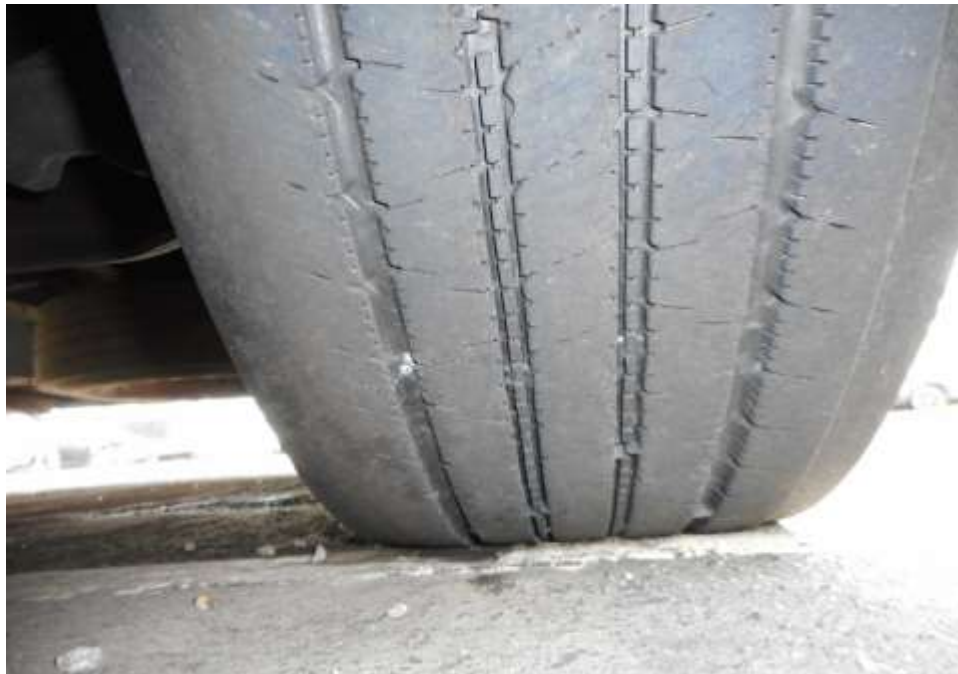
Photo 7 shows the condition of the front right tyre of the Motor Bus, which was observed to be in serviceable condition with remaining tread depth of approximately 6.1mm. The tyre, which was wrapped around standard steel wheel rim, was also observed to be sufficiently inflated for vehicular operation. There was no tear, cut or burst mark(s) on the outer and the inner sidewalls as well as across the tread of the 6 tyres that were fitted on the Motor Bus.

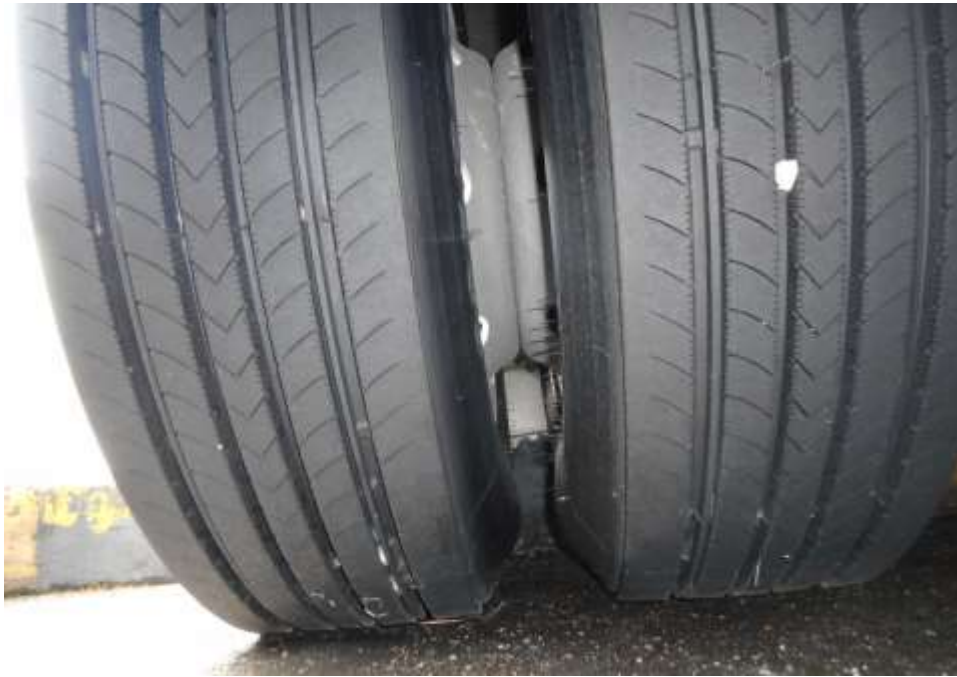
Photo 8 shows the condition of the rear right tyre of the Motor Bus, which was observed to be in serviceable condition with remaining tread depth of approximately 13.3mm. The tyre, which was wrapped around standard steel wheel rim, was also observed to be sufficiently inflated for vehicular operation.

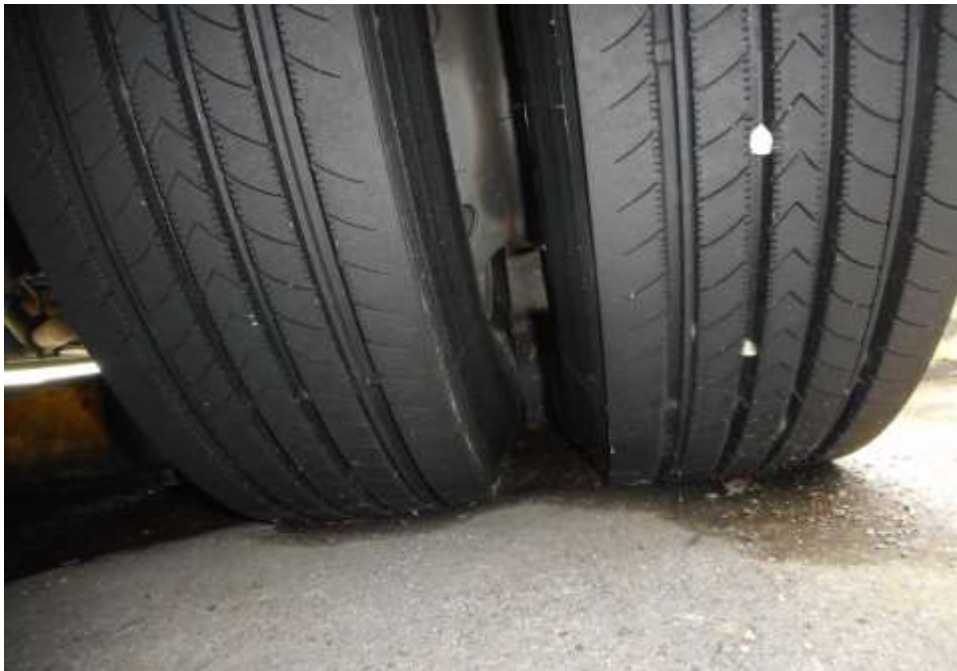
Photo 9 shows the condition of the rear left tyres of the Motor Bus, which was observed to be in serviceable condition with remaining tread depth of approximately 13.3mm. The tyres, which were wrapped around standard steel wheel rim, were also observed to be sufficiently inflated for vehicular operation. There was also no damage found on all 6 steel wheel rims of the Motor Bus.

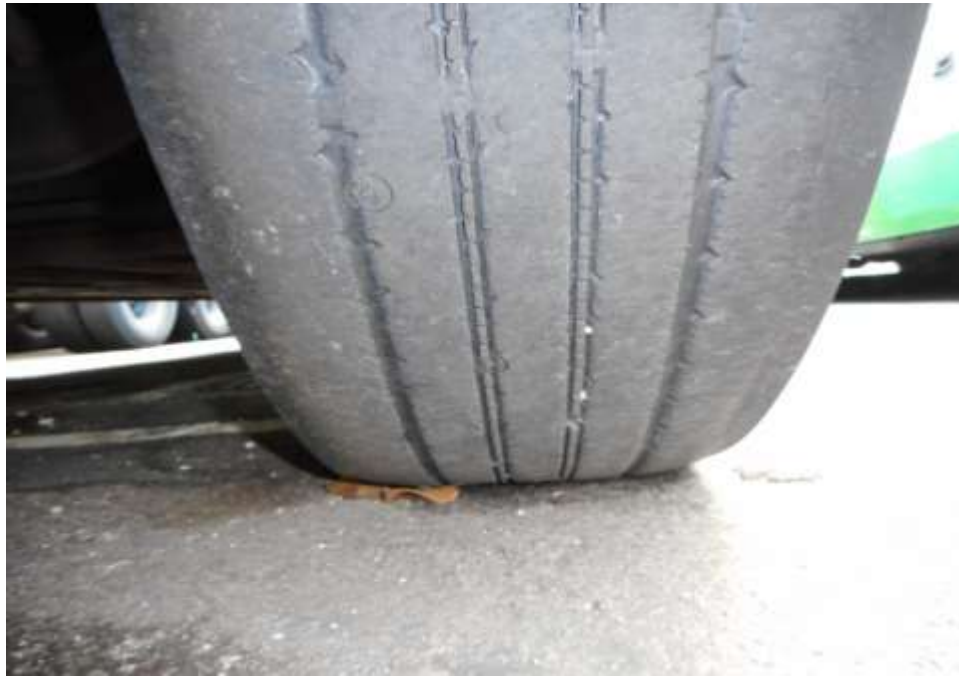
Photo 10 shows the condition of the front left tyres of the Motor Bus, which were observed to be in serviceable condition with remaining tread depth of approximately 2.7mm. There was also no tear, cut or burst mark(s) on the outer and the inner sidewalls as well as across the tread of the 6 tyres that were fitted on the Motor Bus.

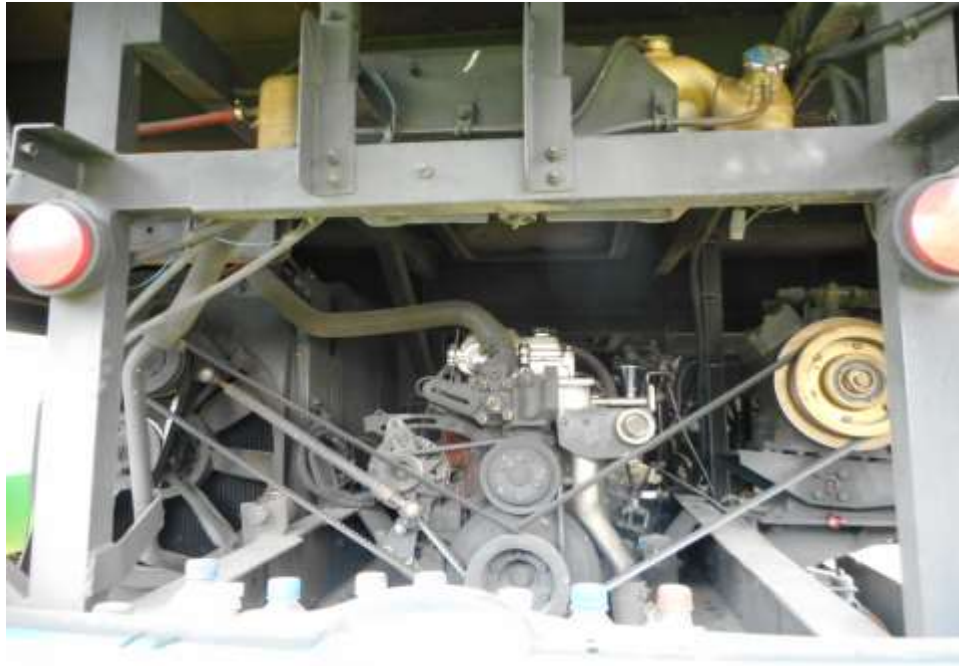
Photo 11 shows a general view of the Motor Bus's engine compartment, which was accessed by lifting the rear cabin of the Motor Bus. The various parts and components inside the engine compartment were unaffected by the accident. There was also no sign(s) or indication(s) of fresh fluid leakage and/or fluid stain within the engine compartment

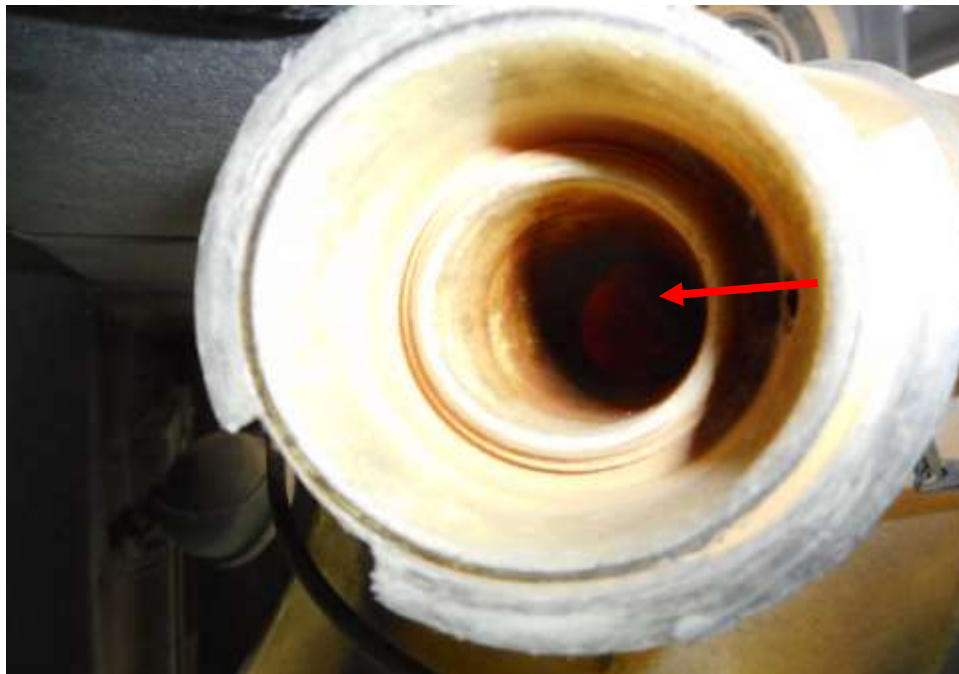
Photo 12 shows the engine coolant reservoir of the Motor Bus at the time of my inspection. The engine coolant was observed to be of sufficient level (arrowed) and without any visible contamination.

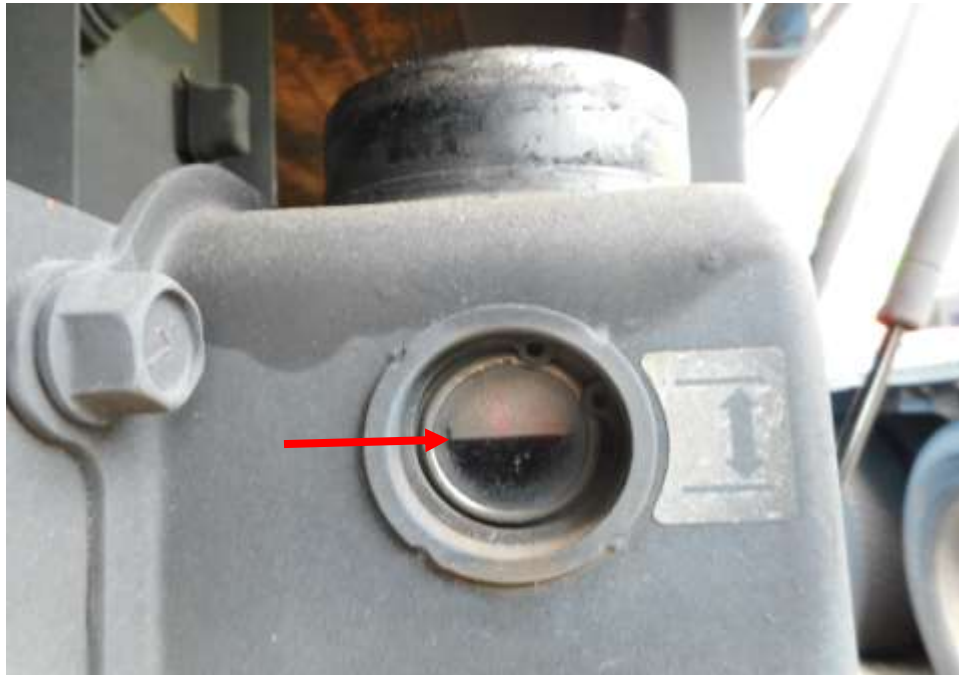
Photo 13 shows the power steering fluid reservoir of the Motor Bus at the time of my inspection. The power steering fluid was observed to be of sufficient level (arrowed) and without any visible contamination.

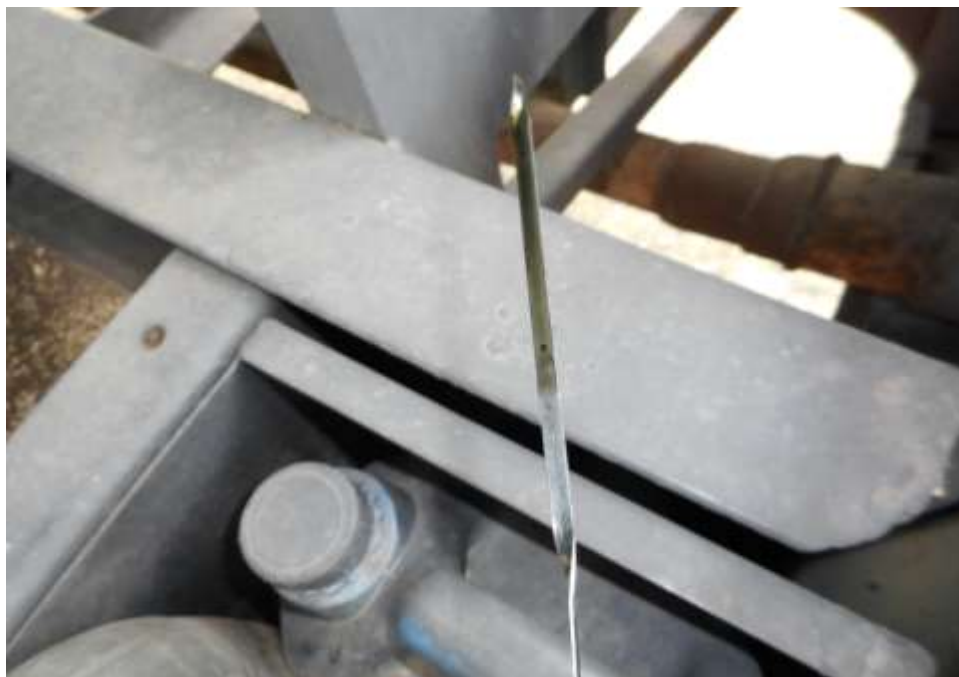
Photo 14 shows the engine oil dip stick of the Motor Bus at the time of my inspection. The engine oil was observed to be sufficient level for operation and without any visible contamination.

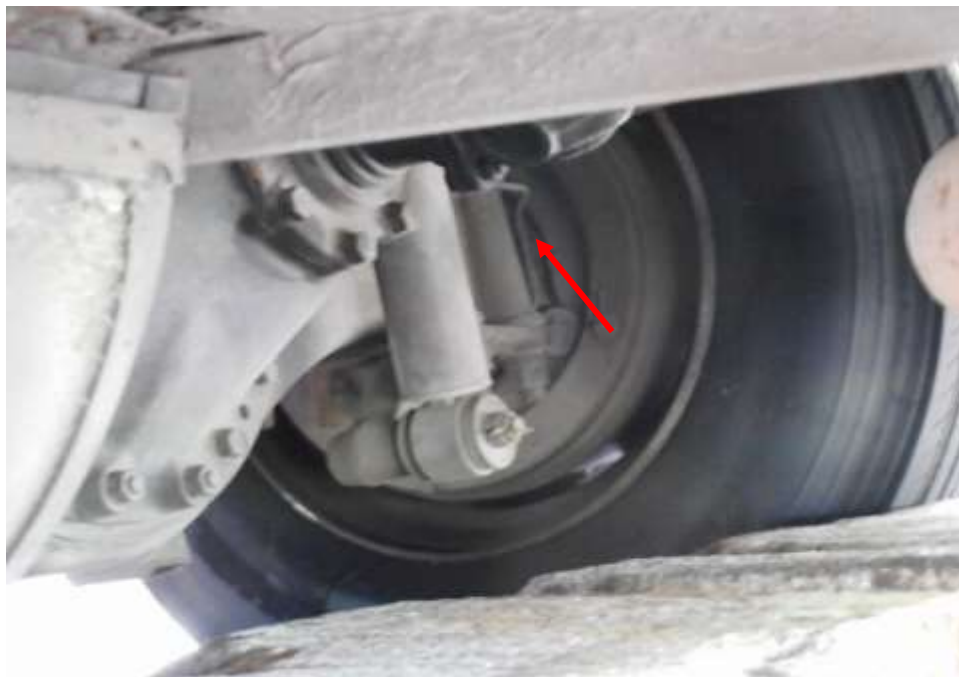
Photo 15 shows the brake pipe (arrowed) at the rear right wheel of the Motor Bus. I did not observe any leakage of brake fluid at the time of my inspection of the Motor Bus. My static tests of the Motor Bus's braking system, along with my visual examination of the various mechanical components in the braking system, had indicated that there was no internal leakage of pressure/vacuum. Hence the braking system of the Motor Bus was likely to be in serviceable condition at the material time of accident.

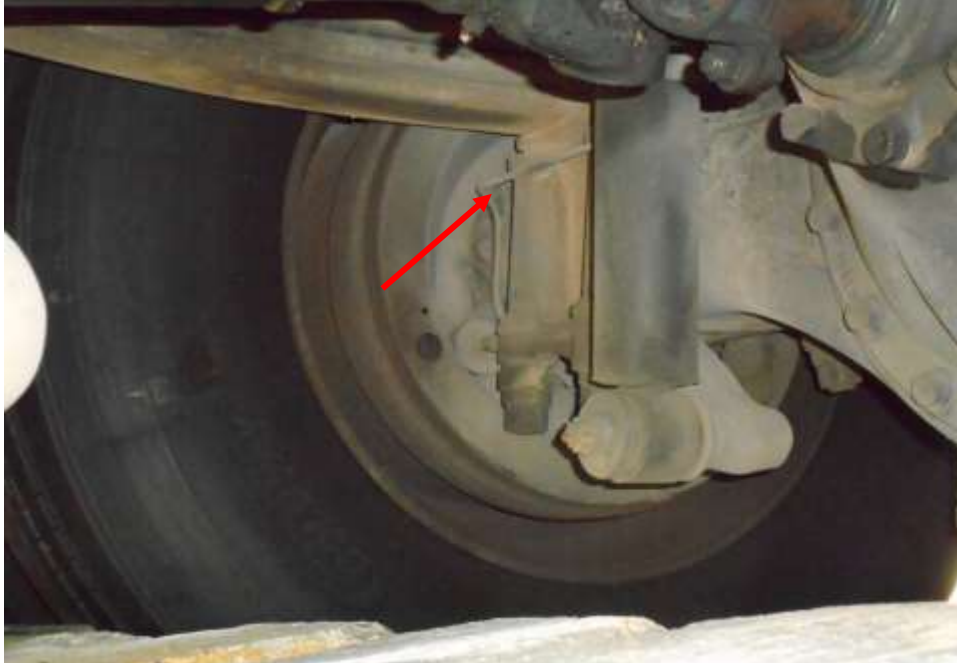
Photo 16 shows the brake pipe (arrowed) at the rear left wheel of the Motor Bus. I did not observe any leakage of brake fluid at the time of my inspection of the Motor Bus. My static tests of the Motor Bus's braking system, along with my visual examination of the various mechanical components in the braking system, had indicated that there was no internal leakage of pressure/vacuum. Hence the braking system of the Motor Bus was likely to be in serviceable condition at the material time of accident.

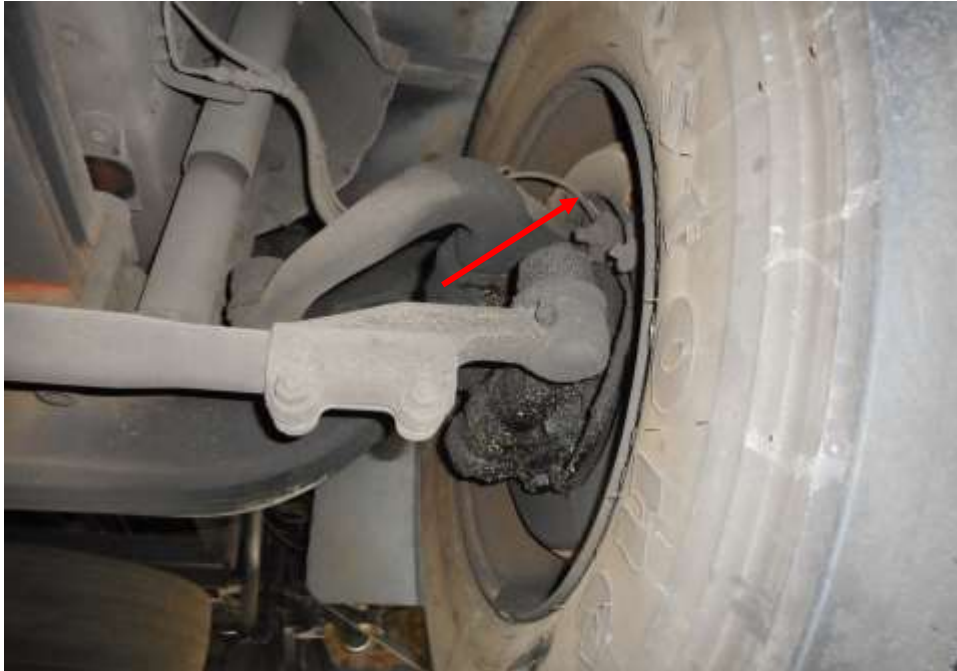
Photo 17 shows the brake pipe (arrowed) at the front right wheel of the Motor Bus. I did not observe any leakage of brake fluid at the time of my inspection of the Motor Bus. My static tests of the Motor Bus's braking system, along with my visual examination of the various mechanical components in the braking system, had indicated that there was no internal leakage of pressure/vacuum. Hence the braking system of the Motor Bus was likely to be in serviceable condition at the material time of accident.

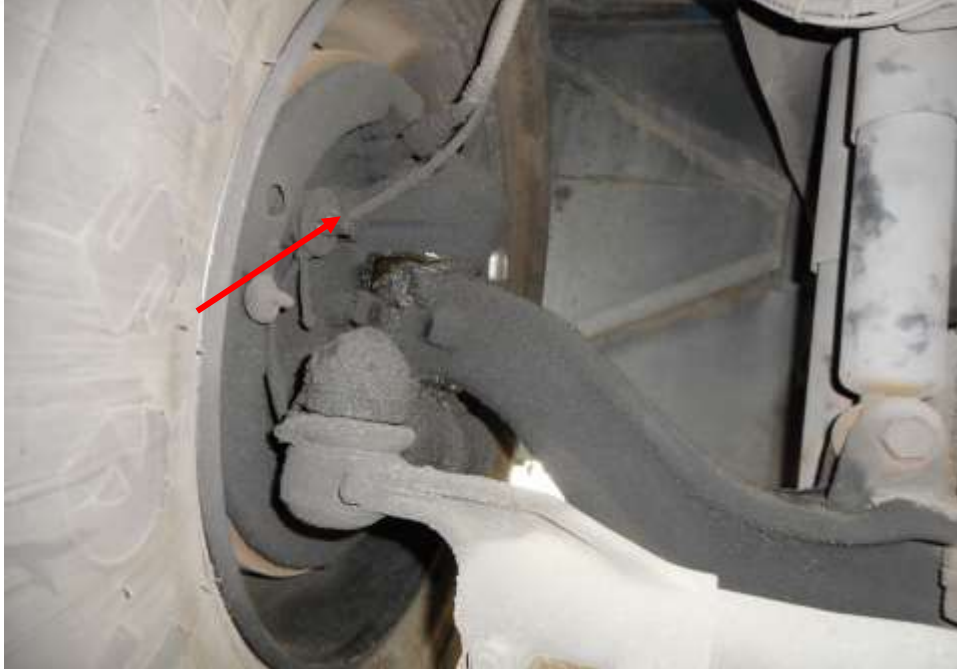
Photo 18 shows the brake pipe (arrowed) at the front left wheel of the Motor Bus. I did not observe any leakage of brake fluid at the time of my inspection of the Motor Bus. My static tests of the Motor Bus's braking system, along with my visual examination of the various mechanical components in the braking system had indicated that there was no internal leakage of pressure/vacuum. Hence the braking system of the Motor Bus was likely to be in serviceable condition at the material time of accident.

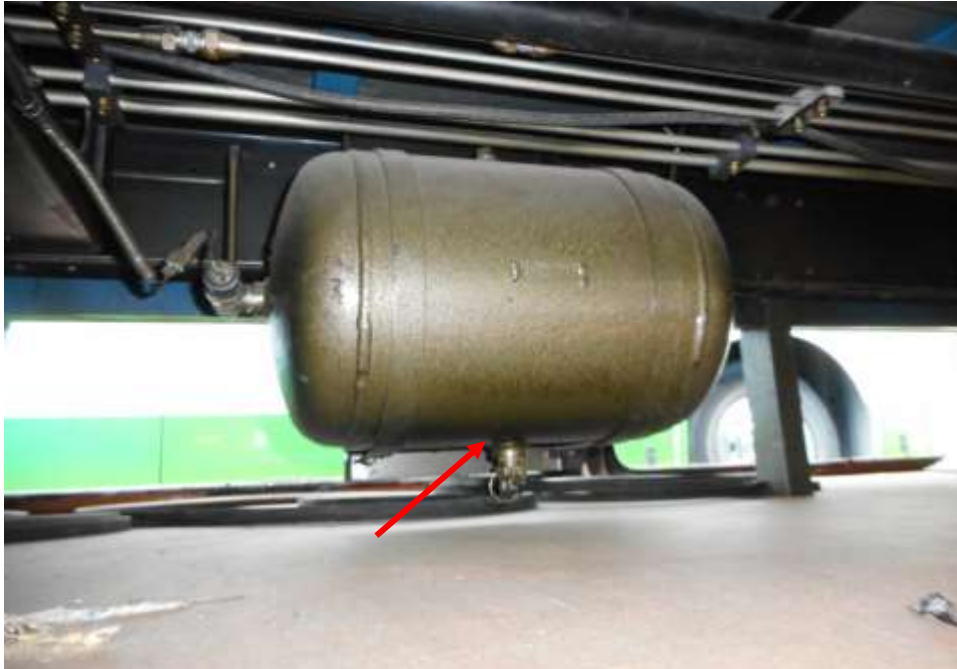
Photo 19 shows the air brake cylinder (arrowed) at the undercarriage of the Motor Bus. I did not observe any leakage of air brake fluid at the time of my inspection of the Motor Bus. My static tests of the Motor Bus's braking system, along with my visual examination of the various mechanical components in the braking system had indicated that there was no internal leakage of pressure/vacuum. Hence the braking system of the Motor Bus was likely to be in serviceable condition at the material time of accident.

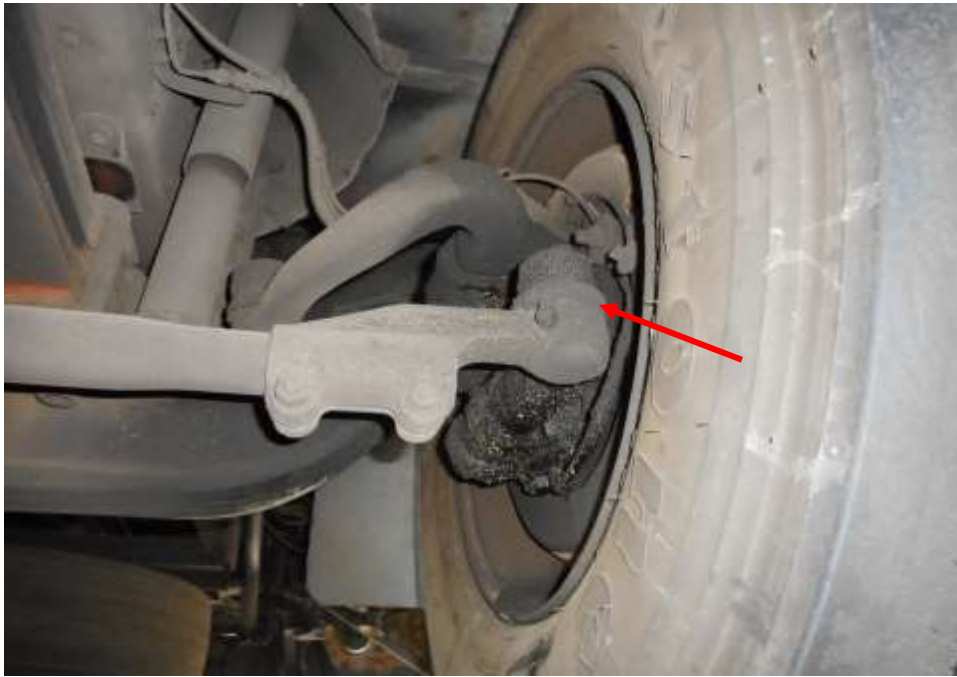
Photo 20 shows the various undercarriage components at the front right wheel of the Motor Bus, in particular the steering tie rod end (arrowed). The various steering components were all found to be intact, suggesting that the steering system of the Motor Bus was likely to be in serviceable condition at the material time of accident. There was also no sign of fluid stain(s) observed on the various undercarriage components.

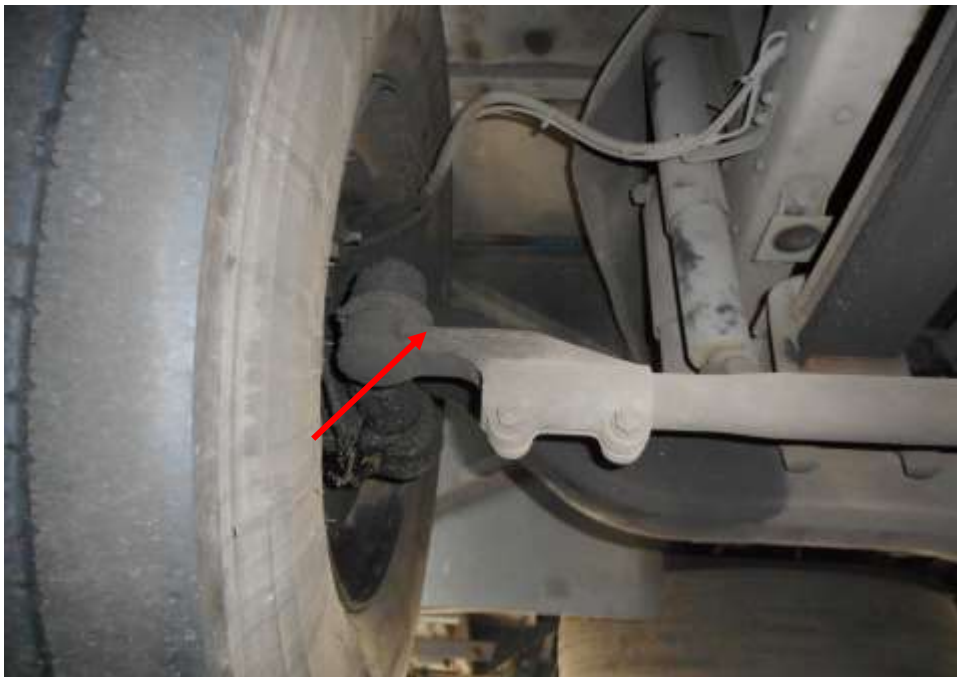
Photo 21 shows the various undercarriage components at the front left wheel of the Motor Bus, in particular the steering tie rod end (arrowed). The various undercarriage components of the Motor Bus were all found to be intact without any visible damage. There was also no sign of fluid stain(s) observed on the various undercarriage components.

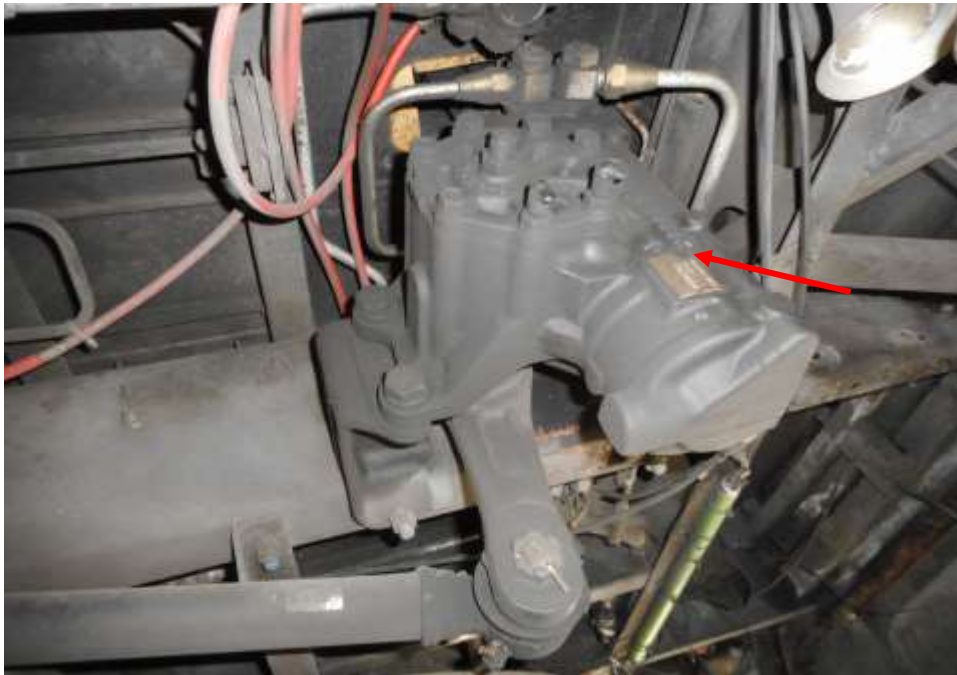
Photo 22 shows the steering box component (arrowed) at the undercarriage of the Motor Bus was found to be intact without any visible damage. There was also no sign of fluid stain(s) observed on the various undercarriage components.

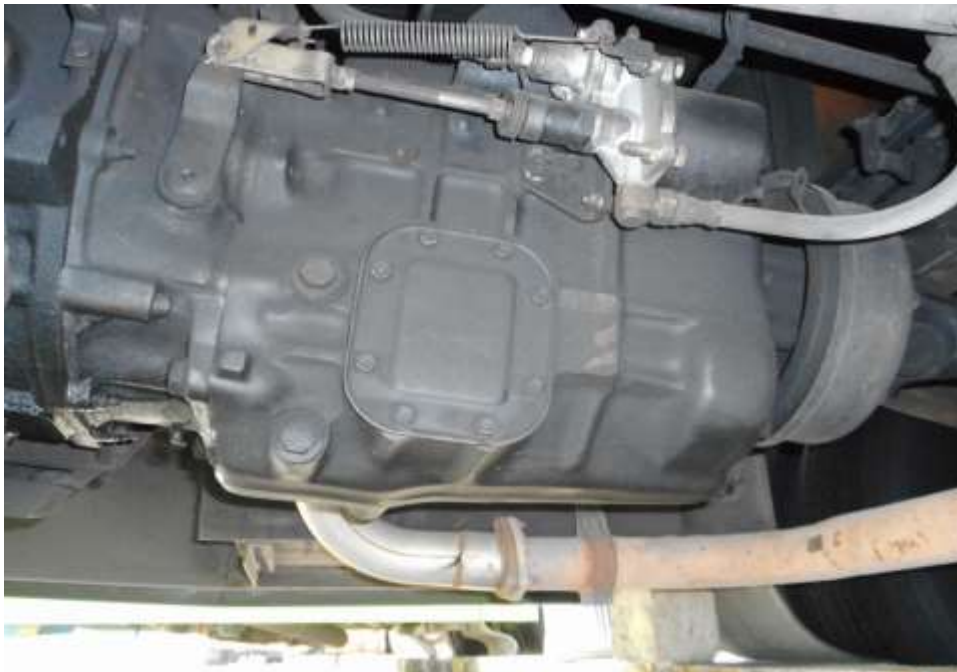
Photo 23 shows the undercarriage of the Motor Bus, at the area where the engine housing located. We observed minor fresh fluid stains on the surface of the engine oil sump. However the Motor Bus is still in serviceable condition.
