REF: CS/FCI 19019157/UVf3n2

Our ref: CS/FCI19019157/Uvf3

**INITIAL INSPECTION REPORT OF VEHICLE NO SFW 59P**

## ADJUSTMENT ON REPAIR COST FOR VEHICLE NO. SFW 59P

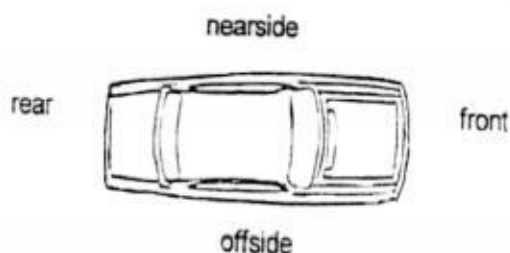
**Description of Damage:**

The vehicle sustained damages at the n/s rear portion. The undercarriage affected due to collision

Damages Consistent

| Revised Estimate Amount | : S\$7,900.00 (LUMP SUM) |
