Vehicle No. SLC 752E
Insured Veh. SBL 1181S
Claim No. 19/19/19/VP05/022575
Policy No. Z19VP05024785
Accident Date 27/10/2019
Inspection Date 31/10/2019

LKK Auto Consultants Pte Ltd

ADJUSTMENT ON REPAIR COST FOR VEHICLE NO. SLC 752E

PHOTOGRAPHS FOR VEHICLE NO. SLC 752E

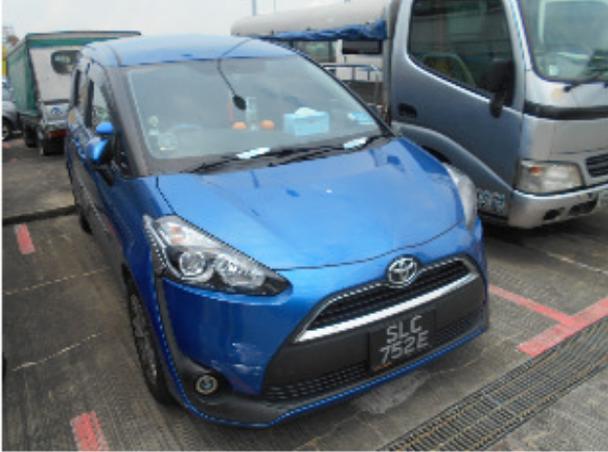
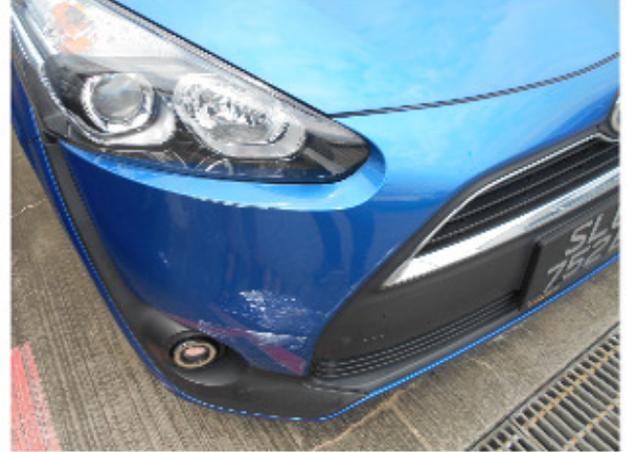
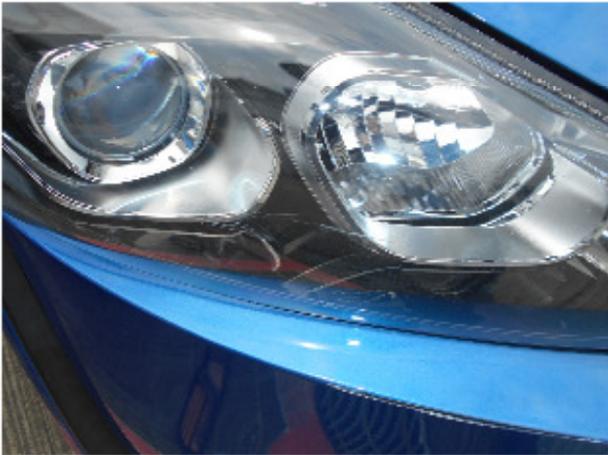
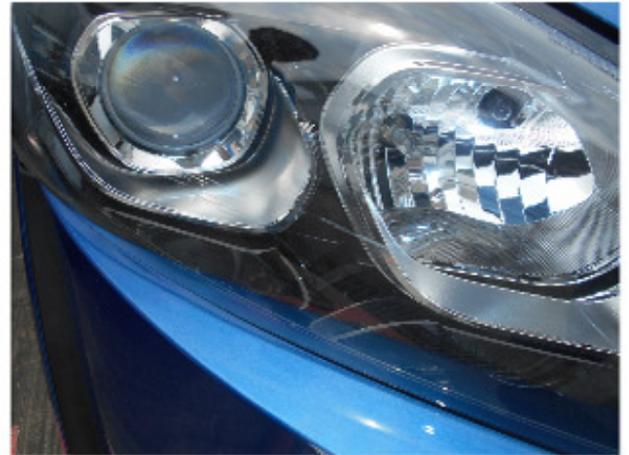
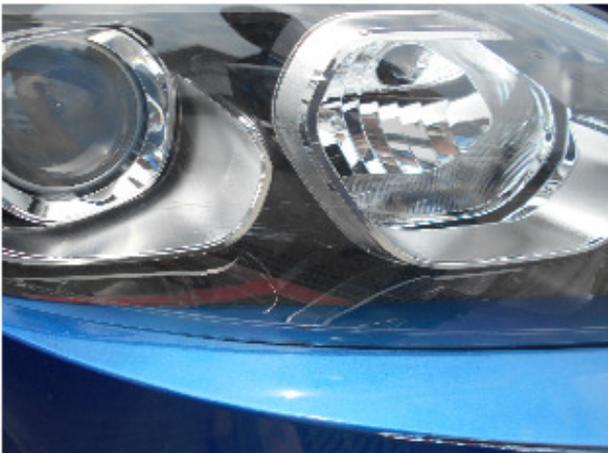
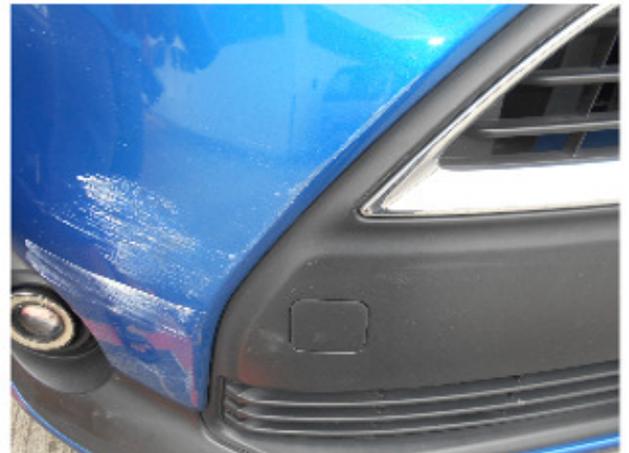
INSPECTION

THE VEHICLE SUSTAINED DAMAGES AT THE FRONT PORTION.
DAMAGES SEE DETAILS.
