Our Ref : CS/FWD19019268/N

4 November 2019

**TECHNICAL INVESTIGATION REPORT OF FIRE INCIDENT INVOLVING THE  
INSURED VEHICLE SJK 7251U ON 29 OCTOBER 2019**

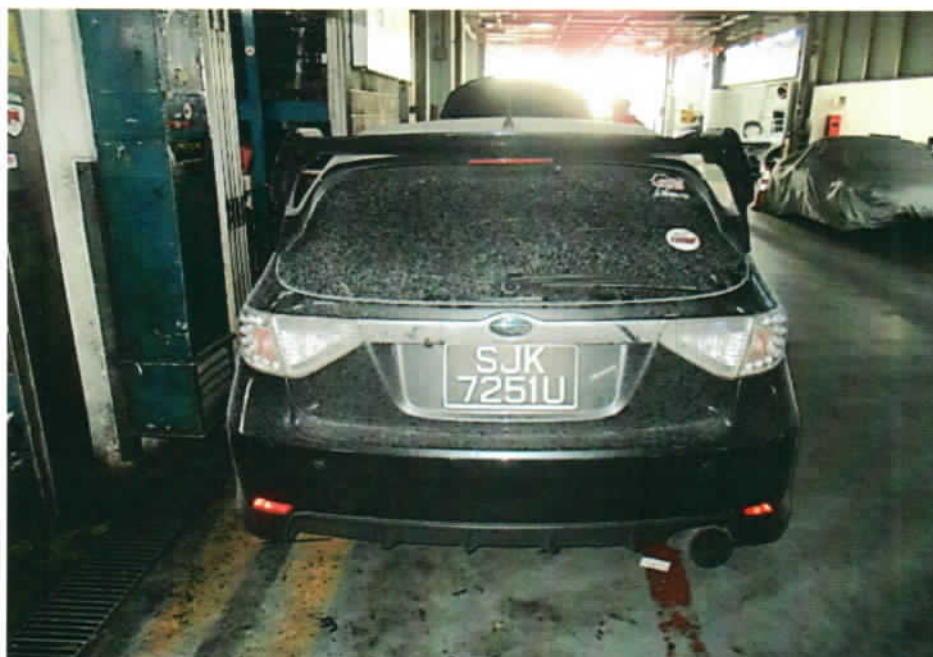
**Photo 1** shows the general view of the rear body of the Insured Vehicle at the time of our inspection. The rear portion of the Insured Vehicle was observed to be unaffected by the fire.

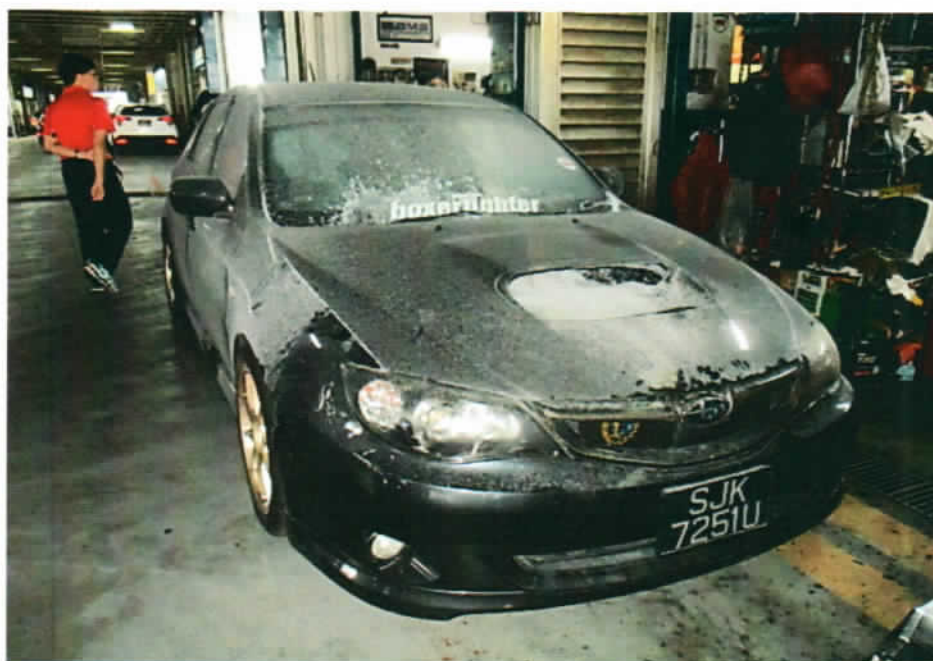
**Photo 2** shows the general view of the front portion of the Insured Vehicle at the time of our inspection. The exterior body of the Insured Vehicle had sustained visible fire damage. This included its front windscreen, front bonnet, headlights, front bumper and side panels.

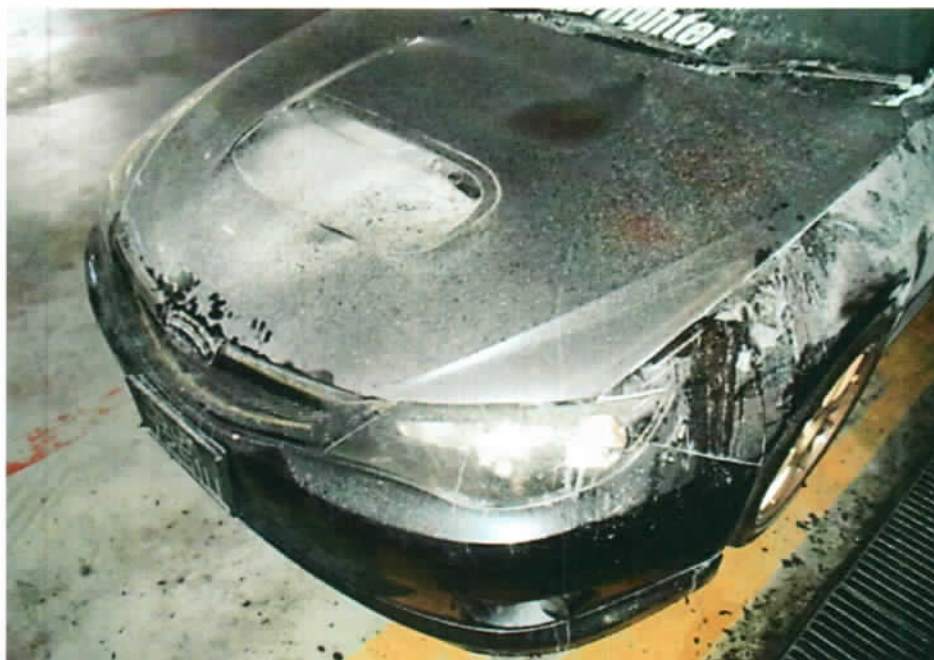
**Photo 3** shows the general view of the left frontal portion of the Insured Vehicle at the time of our inspection. The exterior body of the Insured Vehicle had sustained visible fire damage. This included its front windscreen, front bonnet, left headlight, front bumper and left side panel.

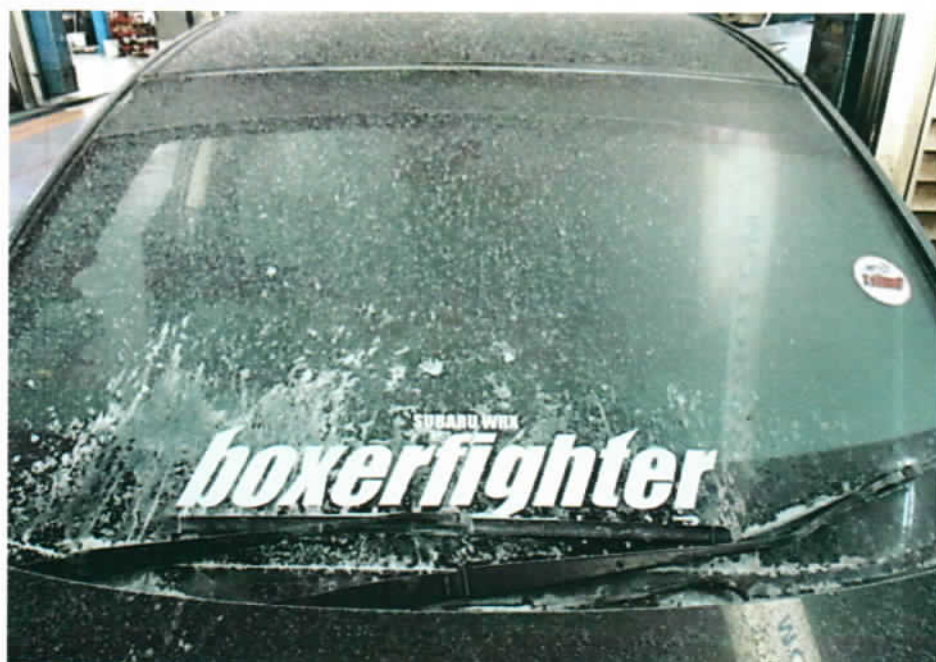
**Photo 4** shows a closer view of the front windscreen of the Insured Vehicle at the time of our inspection. The front windscreen had sustained minimal fire damage.

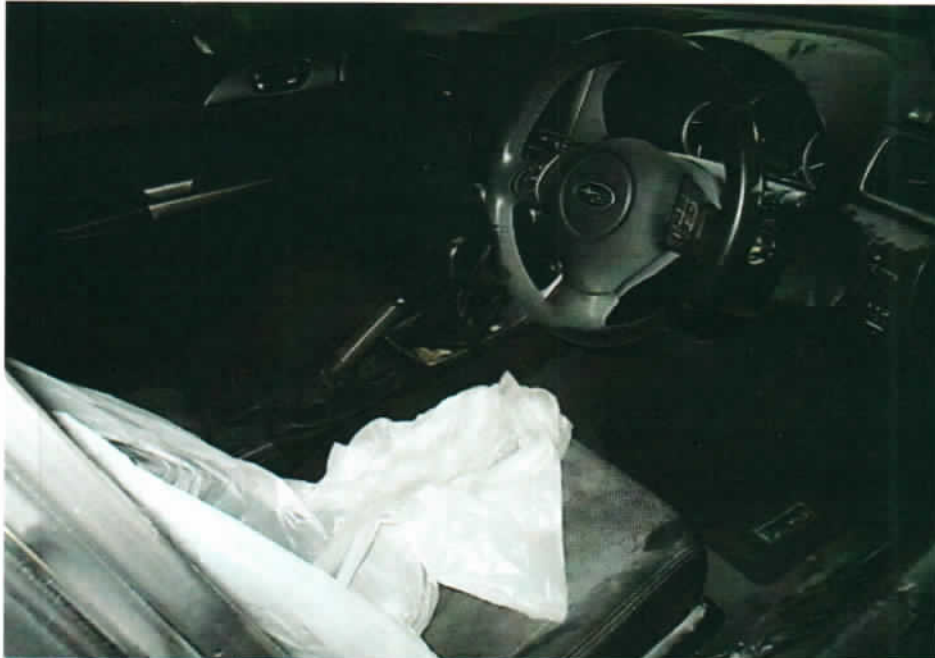
**Photo 5** shows the interior compartment of the Insured Vehicle at the time of our inspection. The interior compartment of the Insured Vehicle was relatively unaffected by the fire.

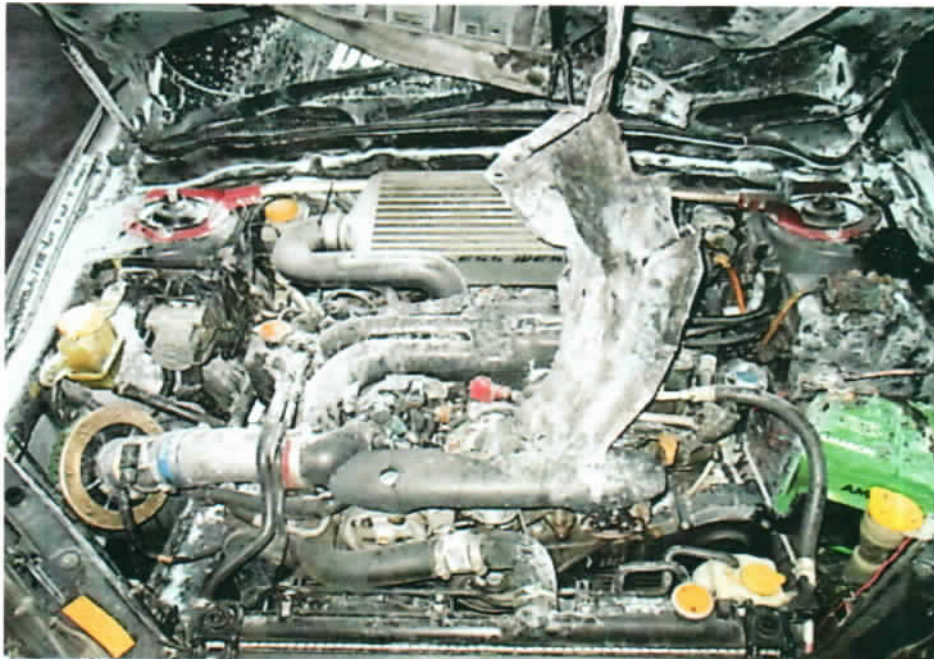
**Photo 6** shows a general view of the engine compartment of the Insured Vehicle at the time of our inspection. Most of the components inside the engine compartment were found to be severely burnt and/or melted as a result of the fire.

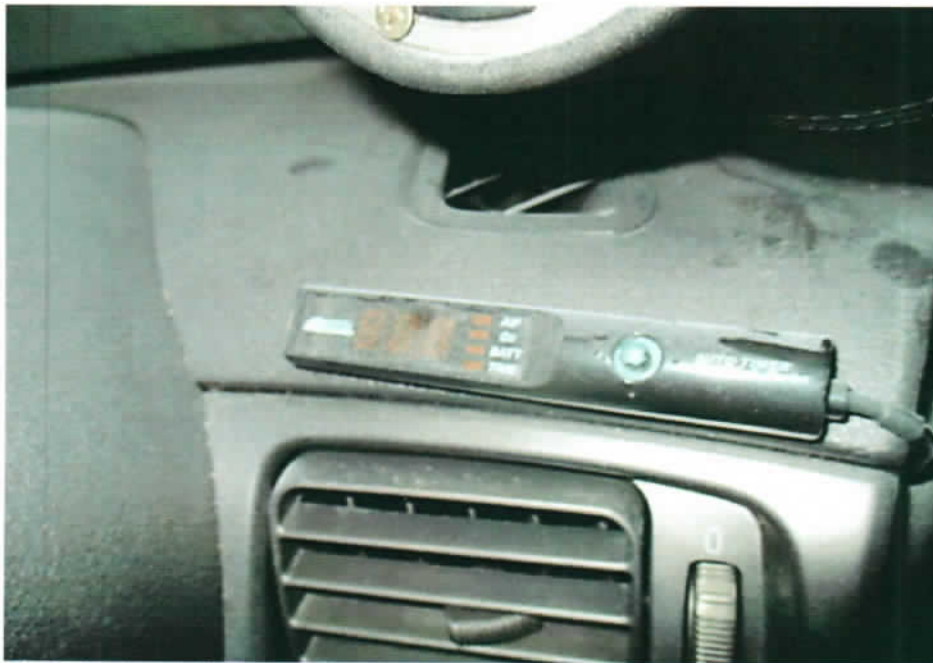
**Photo 7** shows the auto timer that was found to be additionally fitted onto the Insured Vehicle upon our inspection.

31. We are further of the opinion that the additionally fitted electrical/electronic components found on the Insured Vehicle could have possibly caused overloading to the electrical system of the Insured Vehicle. These components had included an auto timer, an aftermarket amplifier, an aftermarket subwoofer, 2 aftermarket twitters, 2 aftermarket speakers and an aftermarket in-car DVD player which are all LTA compliant. However considering that the installation was carried out for a period of time prior to the fire incident, the overloading was likely to be minimal.

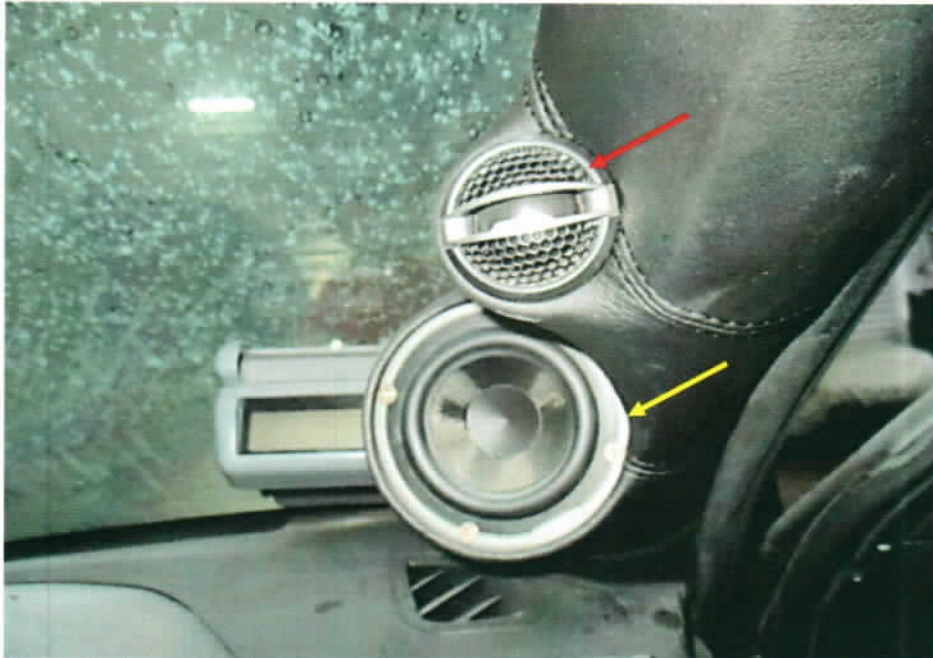
**Photo 8** shows the 1st aftermarket twitter fitted (red arrow) and speaker (yellow arrow) onto the right 'A' pillar of the Insured Vehicle upon our inspection.

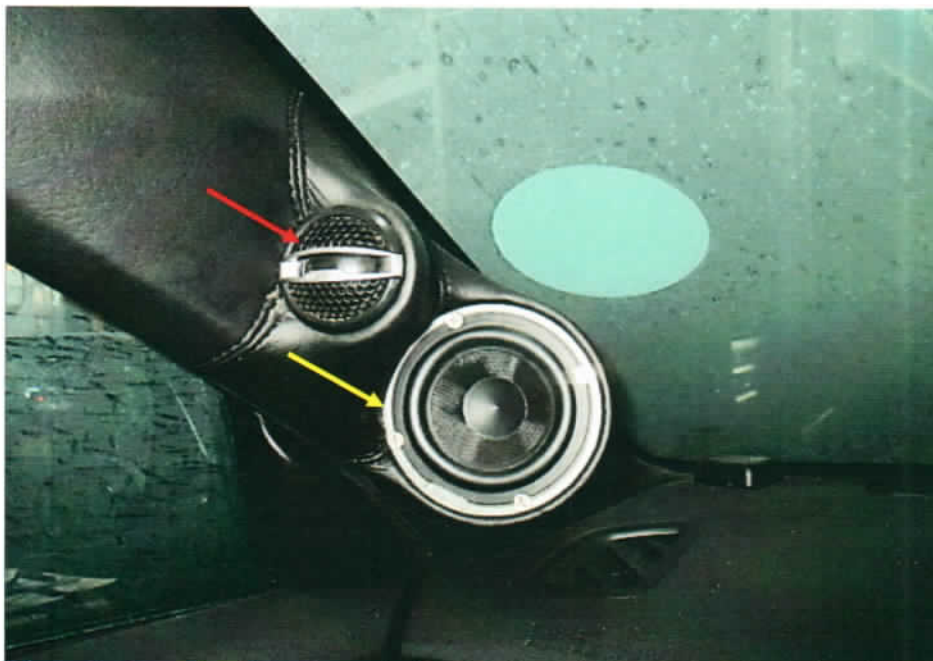
**Photo 9** shows the 2nd aftermarket twitter fitted (red arrow) and speaker (yellow arrow) onto the left 'A' pillar of the Insured Vehicle upon our inspection.

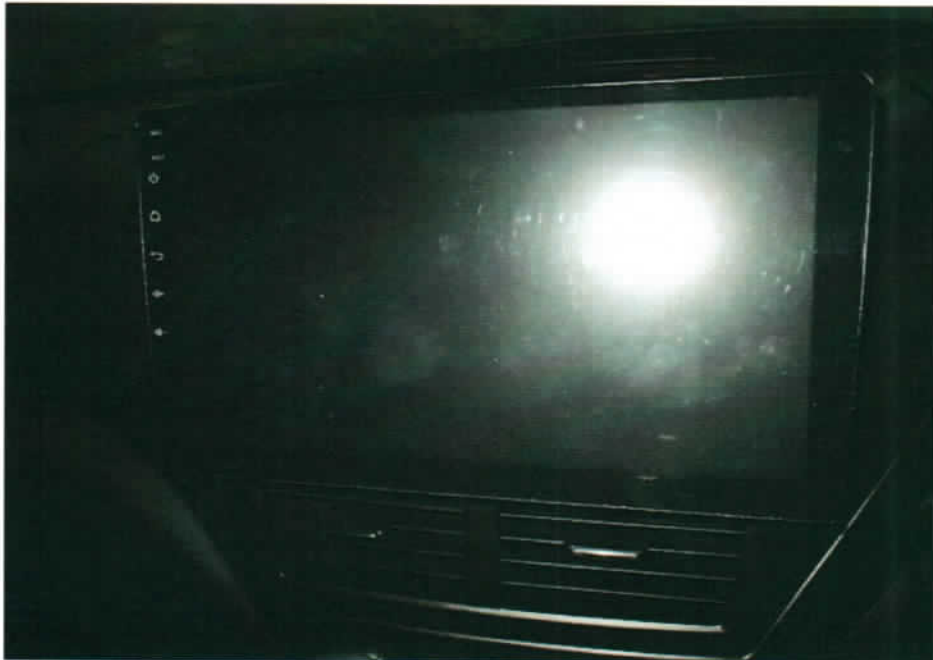
**Photo 10** shows the aftermarket in-car DVD player that was fitted at the centre portion of the front dashboard of the Insured Vehicle.

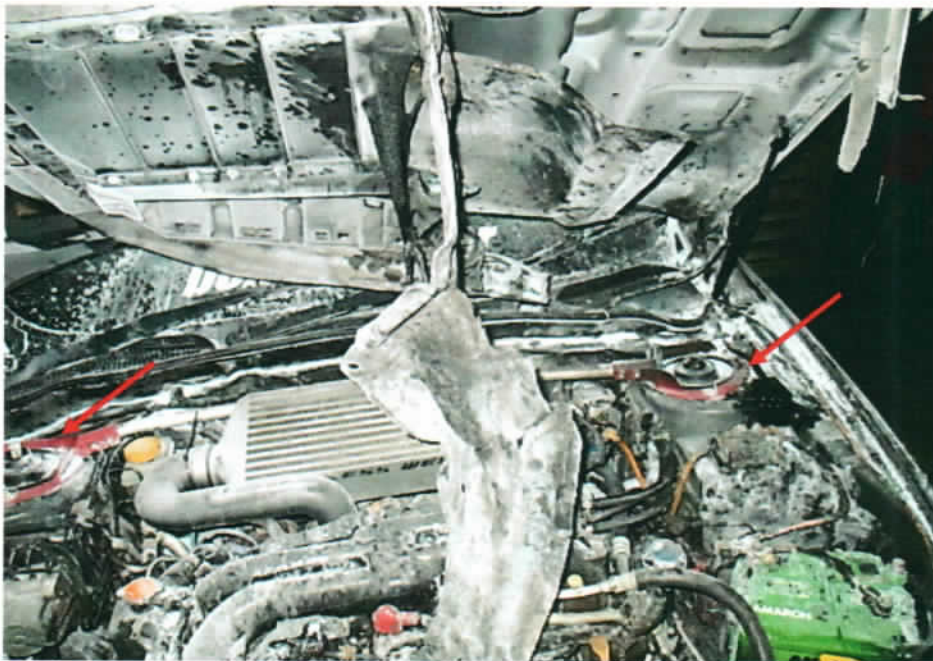
**Photo 11** shows the engine strut bar (arrowed) fitted on the Insured Vehicle. However it had sustained minor fire damage.

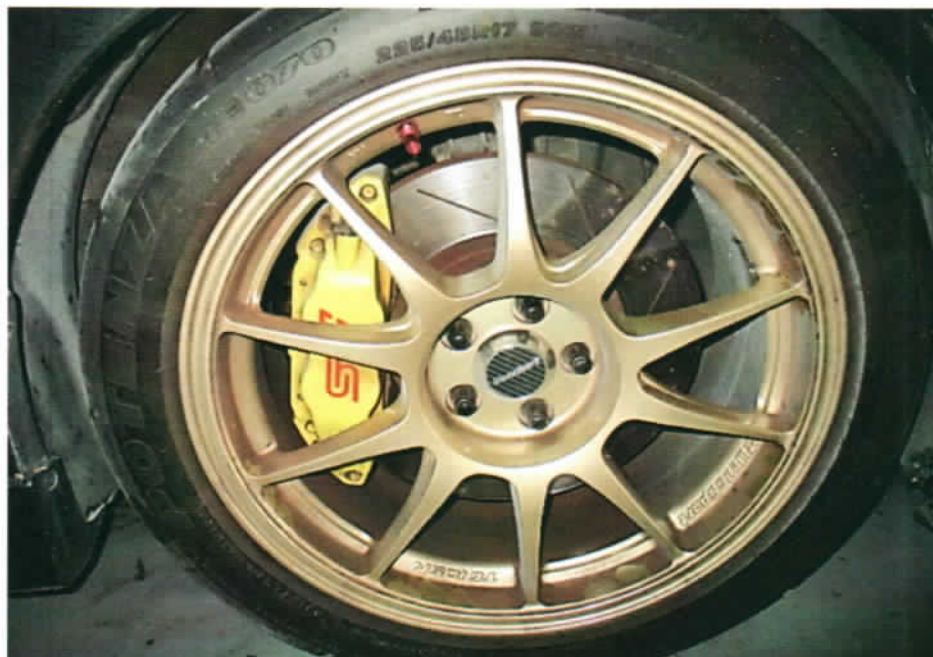
**Photo 12** shows the non-standard rim found to be fitted on the Insured Vehicle at the time of our inspection. The 17- inch alloy rims fitted on the Insured Vehicle were not the standard type for the Insured Vehicle.

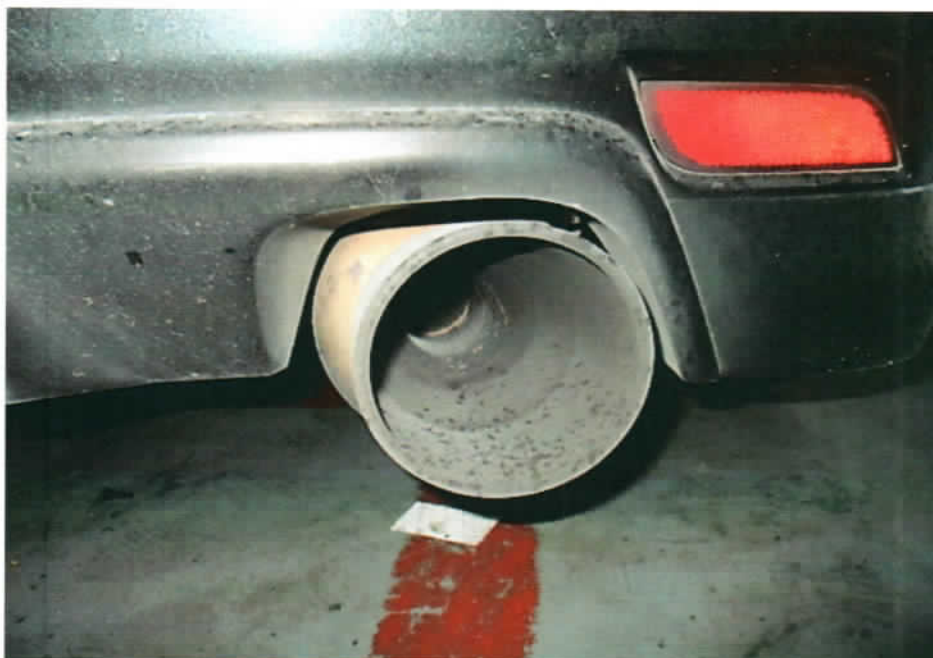
**Photo 13** shows a front view of the non-standard rear exhaust muffler that was found to be fitted on the Insured Vehicle at the time of our inspection.

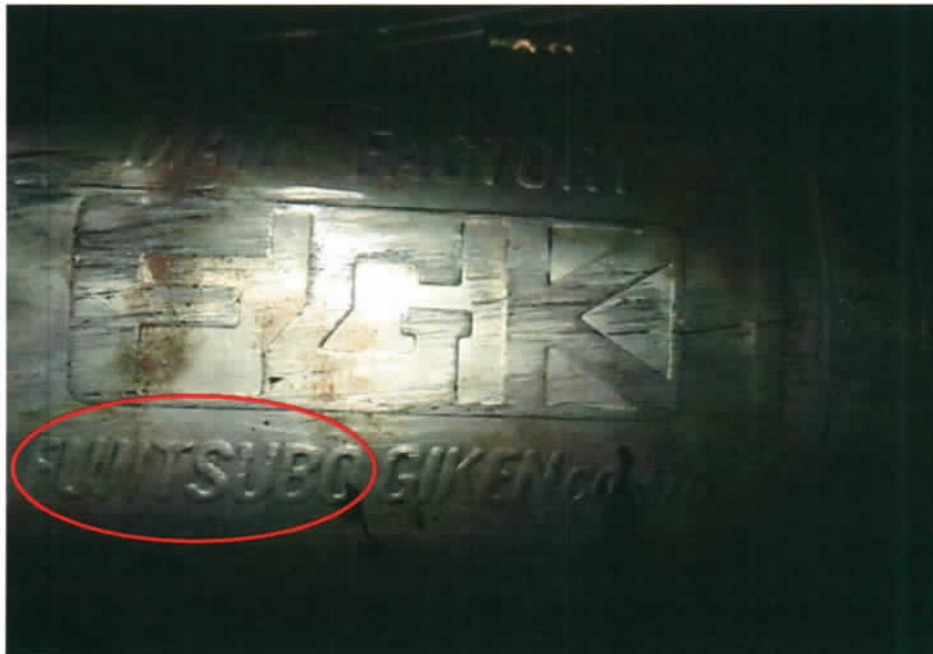
**Photo 14** shows a close up side view of the non-standard rear exhaust muffler that was found to be fitted on the Insured Vehicle at the time of our inspection. The brand of the rear exhaust muffler was 'Fujitsubo' (circled).

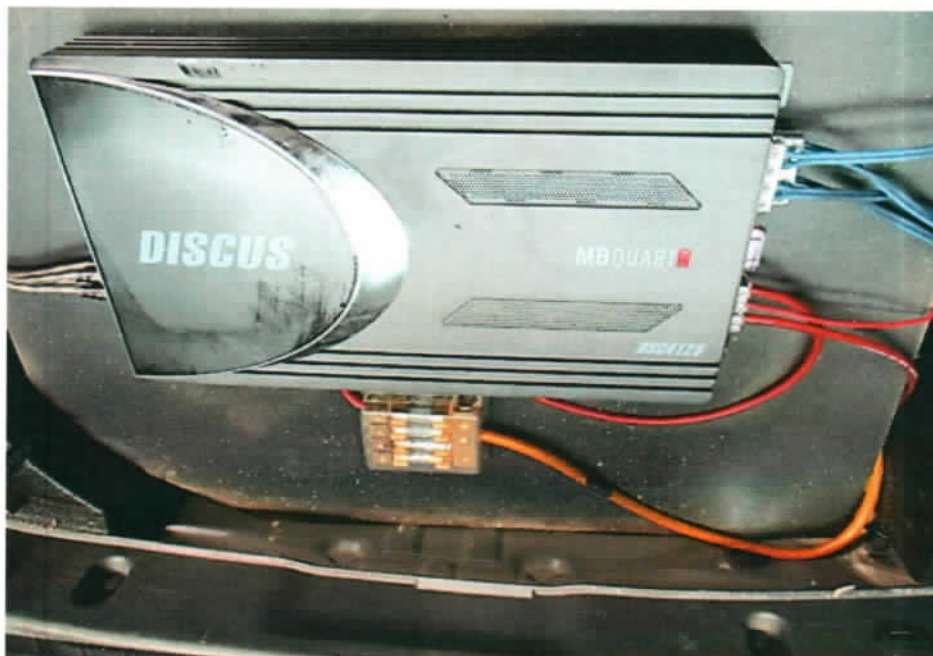
**Photo 15** shows the aftermarket amplifier that was found to be additionally fitted onto the Insured Vehicle upon our inspection.

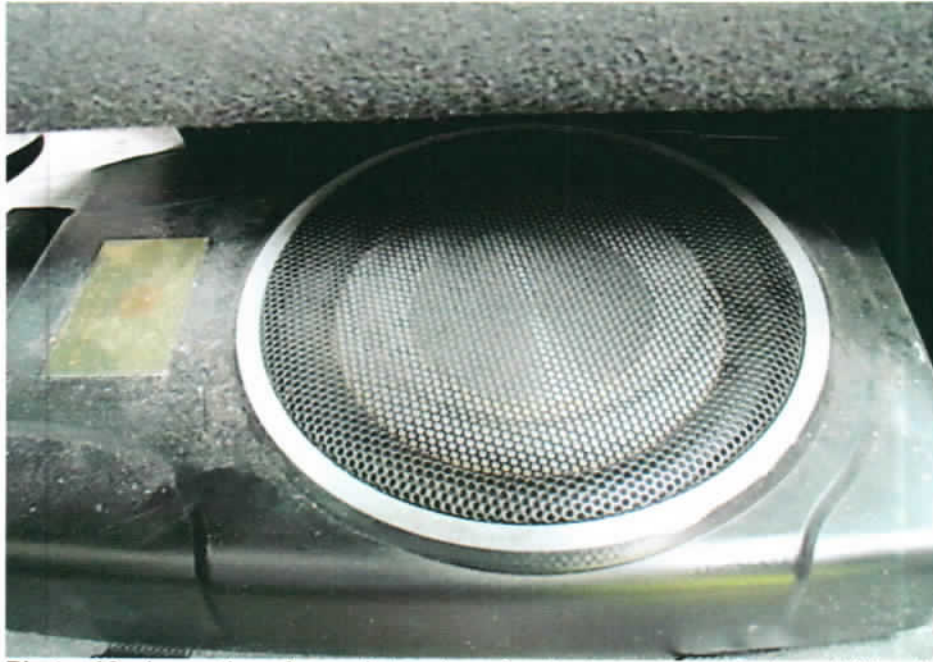
**Photo 16** shows the aftermarket subwoofer that was found to be additionally fitted onto the Insured Vehicle upon our inspection.

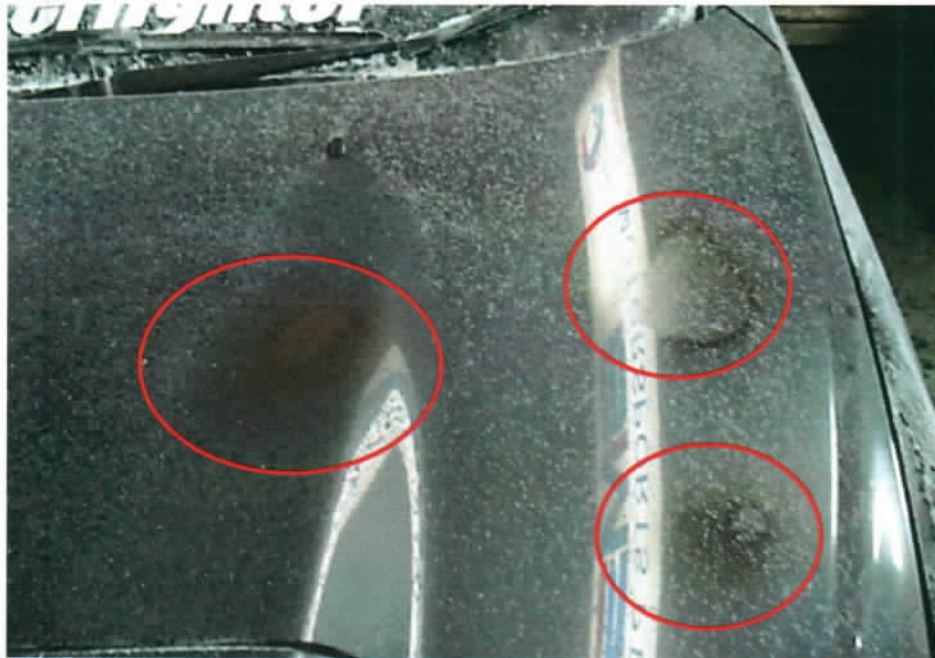
8. For this particular case, the fire appears to have originated within the engine compartment of the Insured Vehicle, somewhere around the left portion of the engine compartment due to the nature of the fire damage which was more extensive at the left portion. This can also be determined from the burn pattern and the high heat intensity burn marks (whitish burn marks) found on the left portion of the bonnet of the Insured Vehicle. The whitish burn marks are a result of exposure to prolonged heat intensity. See photos 17 - 19 below.

**Photo 17** shows the burn pattern that was found on the left portion of the front bonnet of the Insured Vehicle (circled).

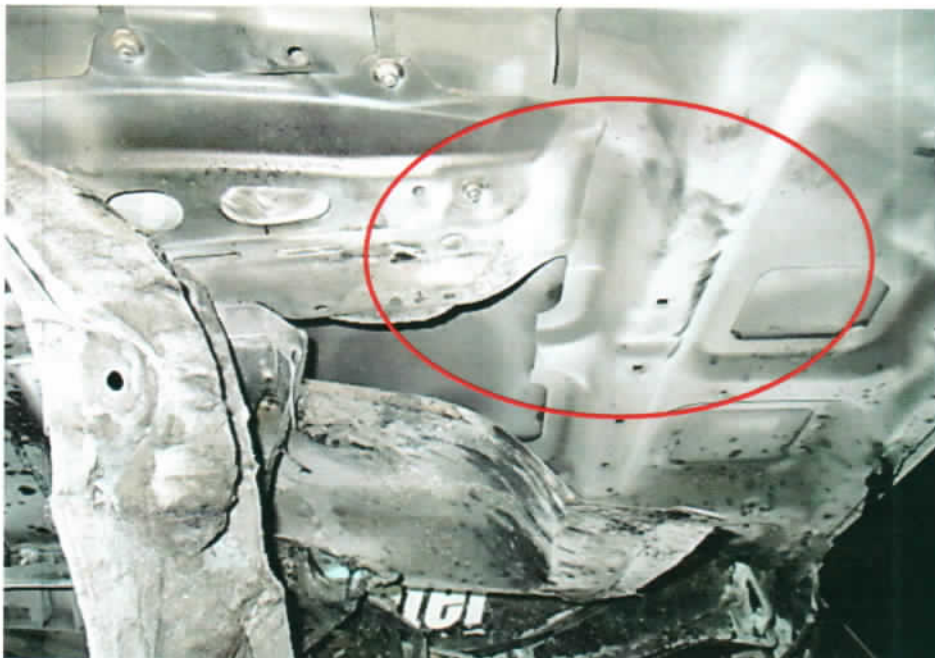
**Photo 18** shows the whitish burn marks that were found on the left portion of the underside of the front bonnet of the Insured Vehicle (circled). Such whitish burn marks are a result of exposure to prolonged heat intensity, which may indicate where the fire had started. Hence the fire to the Insured Vehicle can be determined to have originated towards the left portion of the engine compartment.

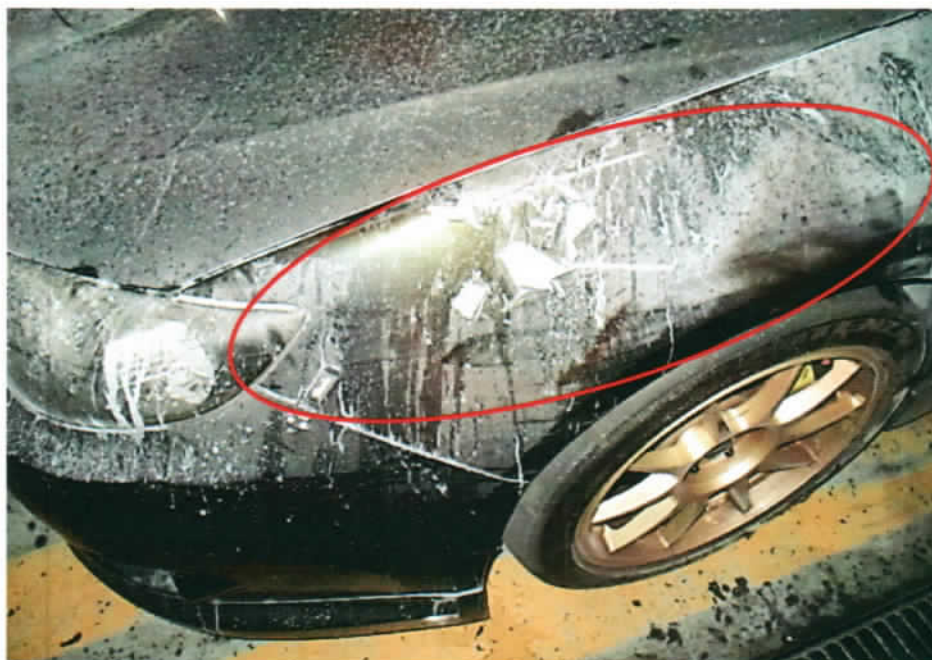
**Photo 19** shows the burn pattern and whitish burn marks that were found on the left front fender of the Insured Vehicle (circled). Such whitish burn marks are a result of exposure to prolonged heat intensity, which may indicate where the fire had started.

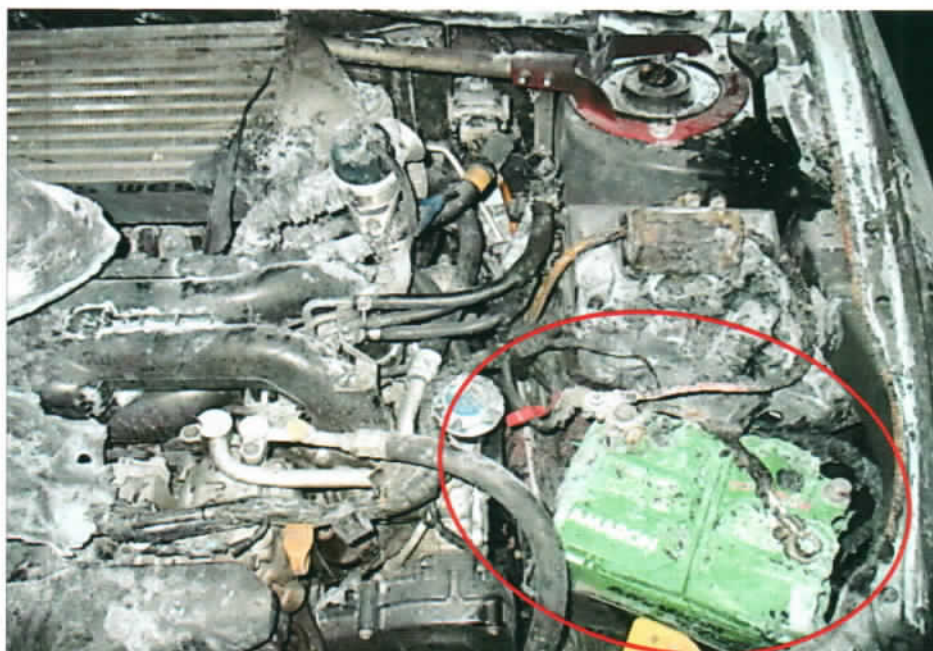
9. Upon closer examination of the left portion of the engine compartment which was where the fire to the Insured Vehicle had likely started, we had found several stretches of wirings with greenish residue. These wirings were original factory fitted wirings leading from the battery of the Insured Vehicle. The presence of greenish residue indicates internal heating of copper wires, a sign of an electrical short circuit occurring. The greenish residue is normally left behind from oxidation as a result of chemical reaction involving the copper wires. This physical evidence would appear to suggest that the cause of fire to the Insured Vehicle could have possibly been due to electrical in nature. See photos 20 – 23 below.

**Photo 20** shows the wirings around the left portion of the engine compartment which is near to the vicinity where the fire to the Insured Vehicle had likely started. We observed greenish residue on the wirings leading from the battery of the Insured Vehicle (circled). The presence of greenish residue indicates internal heating of copper wires, a sign of an electrical short circuit occurring. The greenish residue is normally left behind from oxidation as a result of chemical reaction involving the copper wires.

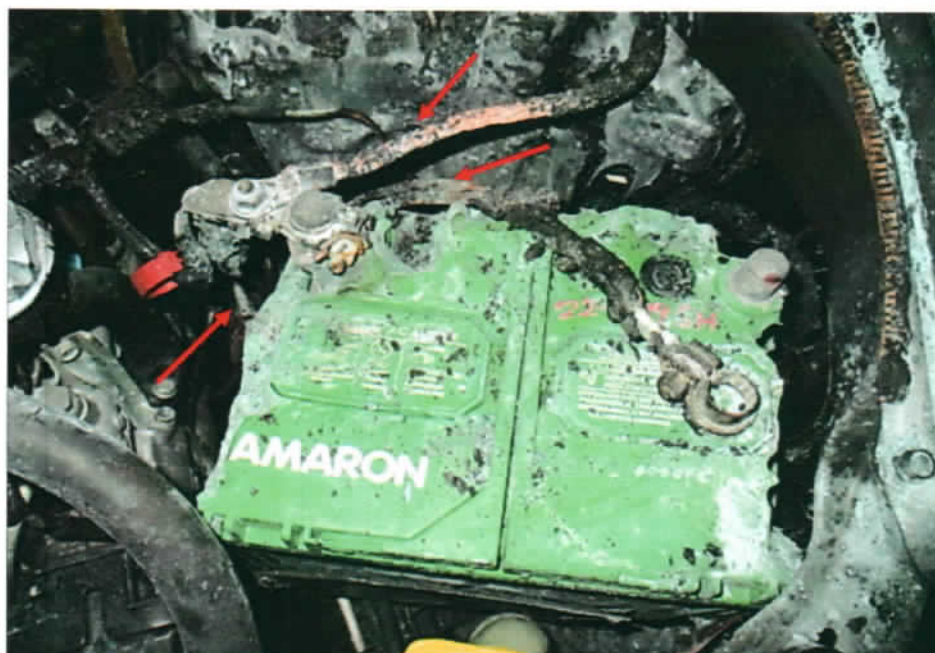
**Photo 21** shows a closer view the greenish residue on the wirings at the left portion of the engine compartment (red arrows). The presence of such greenish residue suggests occurrence of an electrical short circuit.

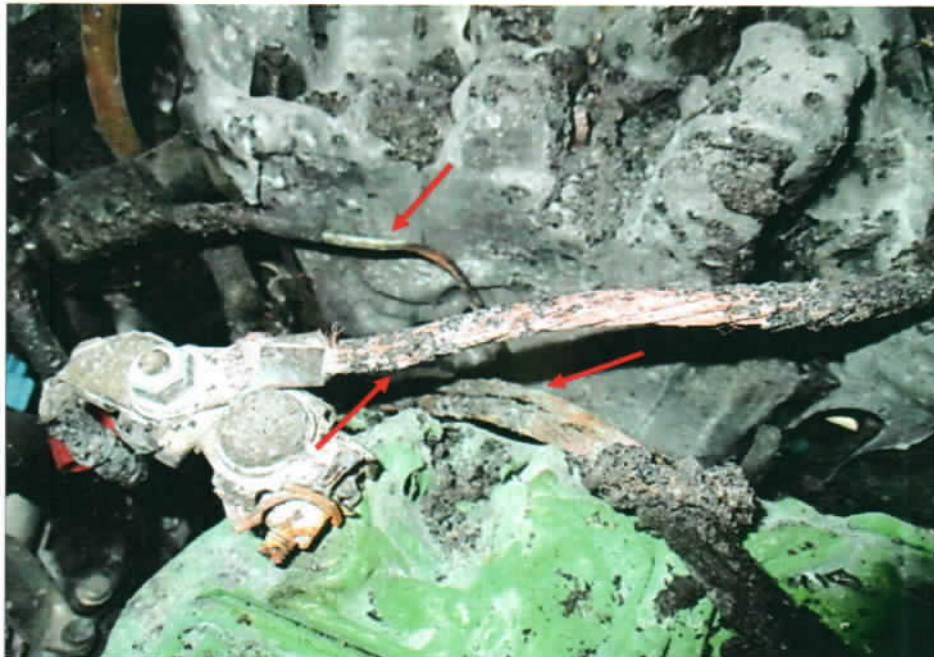
**Photo 22** shows a close up view of the greenish residue on the wirings leading from the battery of the Insured Vehicle (red arrows). The presence of such greenish residue suggests occurrence of an electrical short circuit.

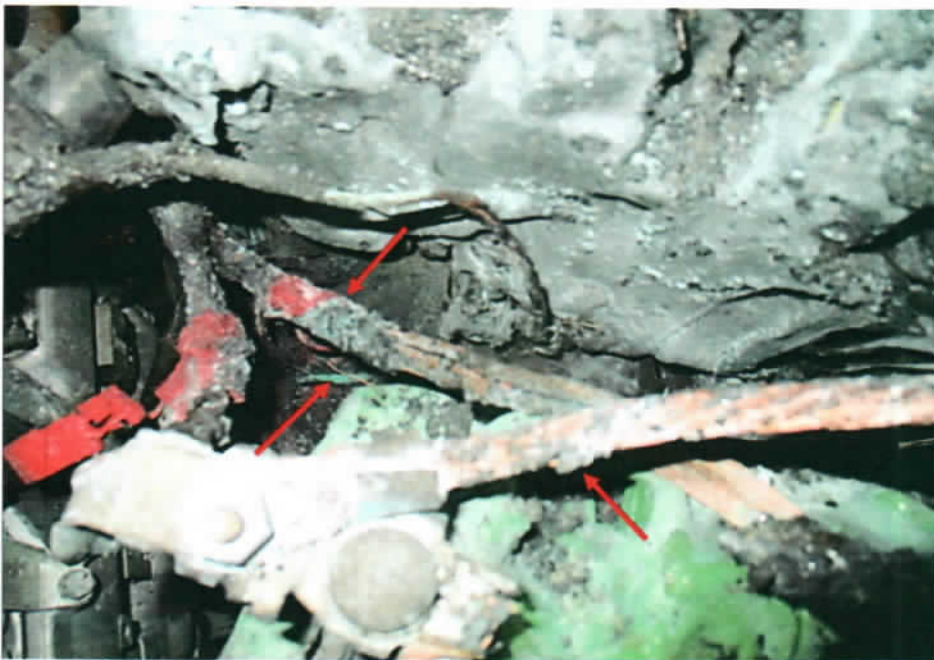
**Photo 23** shows a close up view of the greenish residue on the wirings leading from the battery of the Insured Vehicle (red arrows). The presence of such greenish residue suggests occurrence of an electrical short circuit.

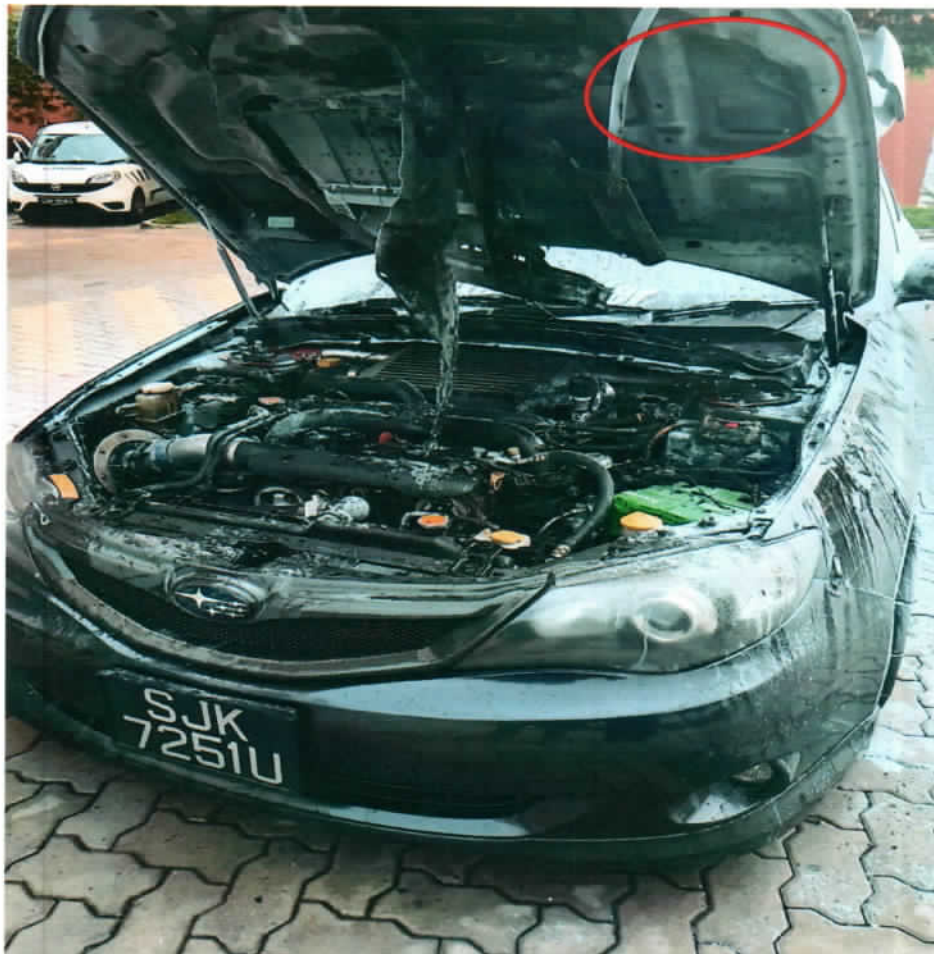
**Photo 26** shows the Insured Vehicle at the incident location after the fire was extinguished. In general, the information that could be gathered from this photograph had corresponded to the events that were related to us by Mr Kwek. Whitish burn marks were observed on the underside of the front bonnet, at the left portion (circled) which indicates that the fire had started in the left portion of the engine compartment.
