Our Ref : CS/FWD19019268/N

**M/s FWD Singapore Pte. Ltd.**

**TECHNICAL INVESTIGATION REPORT OF FIRE INCIDENT INVOLVING THE INSURED VEHICLE SJK 7251 V ON 29 OCTOBER 2019**

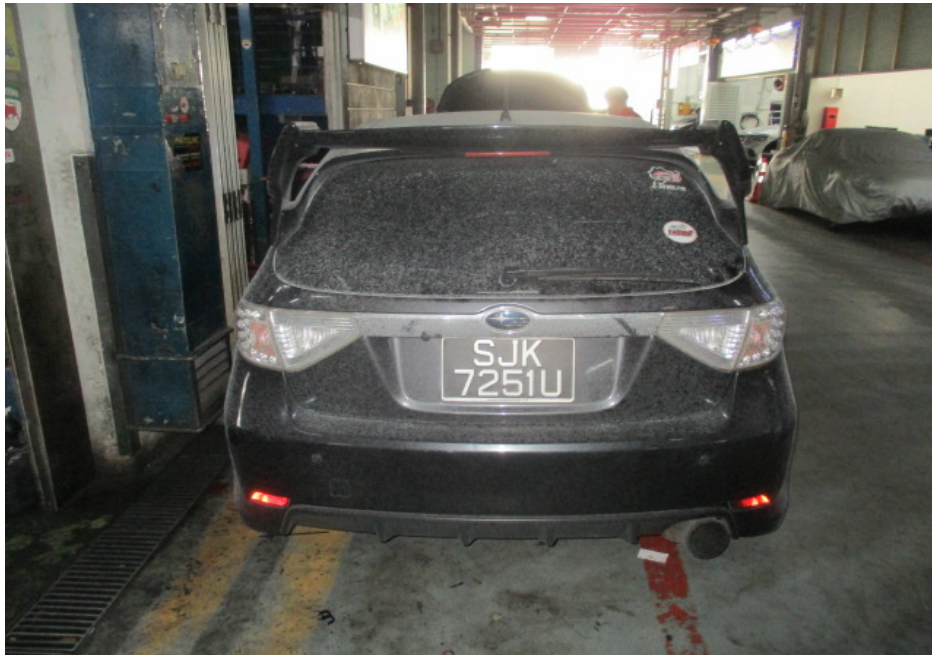
**Photo 1** shows the general view of the rear body of the Insured Vehicle at the time of our inspection. The rear portion of the Insured Vehicle was observed to be unaffected by the fire.

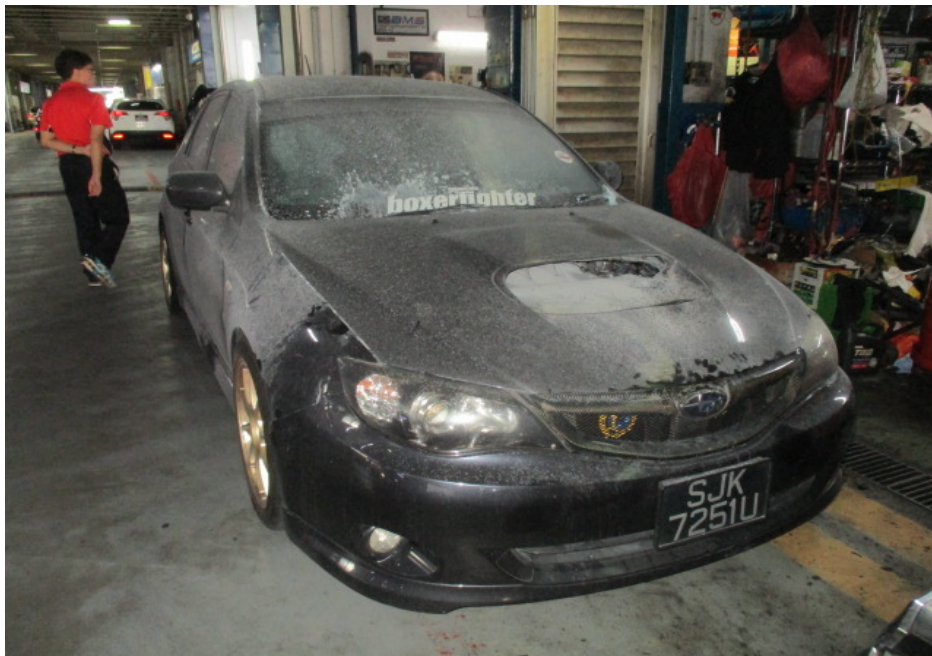
**Photo 2** shows the general view of the front portion of the Insured Vehicle at the time of our inspection. The exterior body of the Insured Vehicle had sustained visible fire damage. This included its front windscreen, front bonnet, headlights, front bumper and side panels.

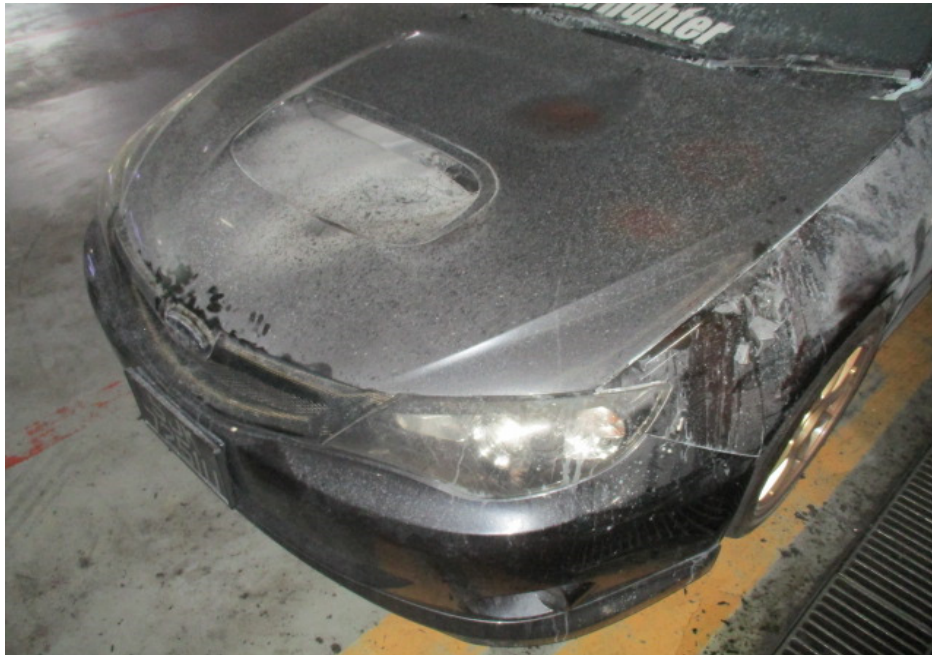
**Photo 3** shows the general view of the left frontal portion of the Insured Vehicle at the time of our inspection. The exterior body of the Insured Vehicle had sustained visible fire damage. This included its front windscreen, front bonnet, left headlight, front bumper and left side panel.

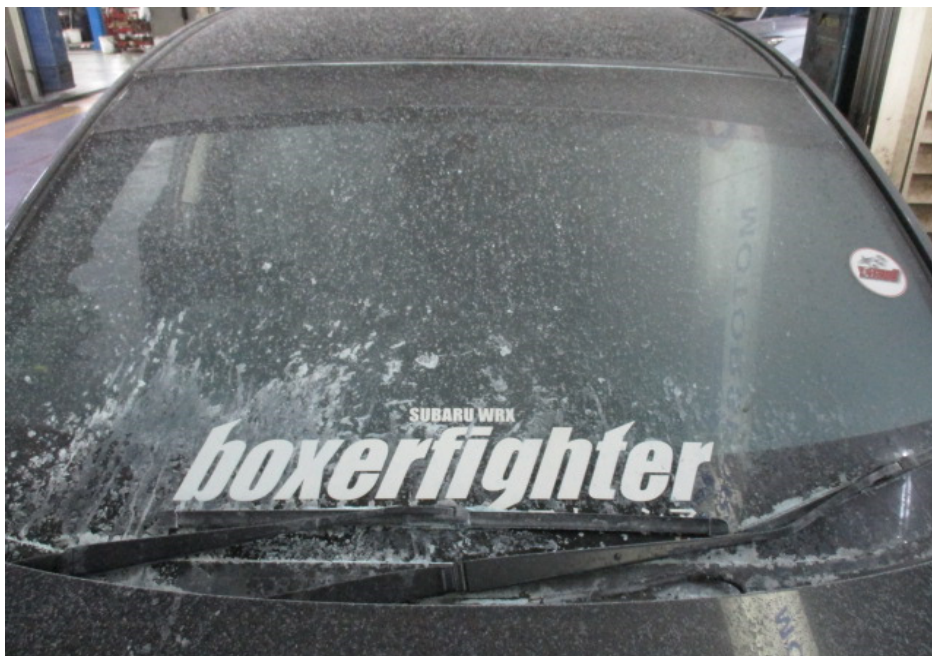
**Photo 4** shows a closer view of the front windscreen of the Insured Vehicle at the time of our inspection. The front windscreen had sustained minimal fire damage.

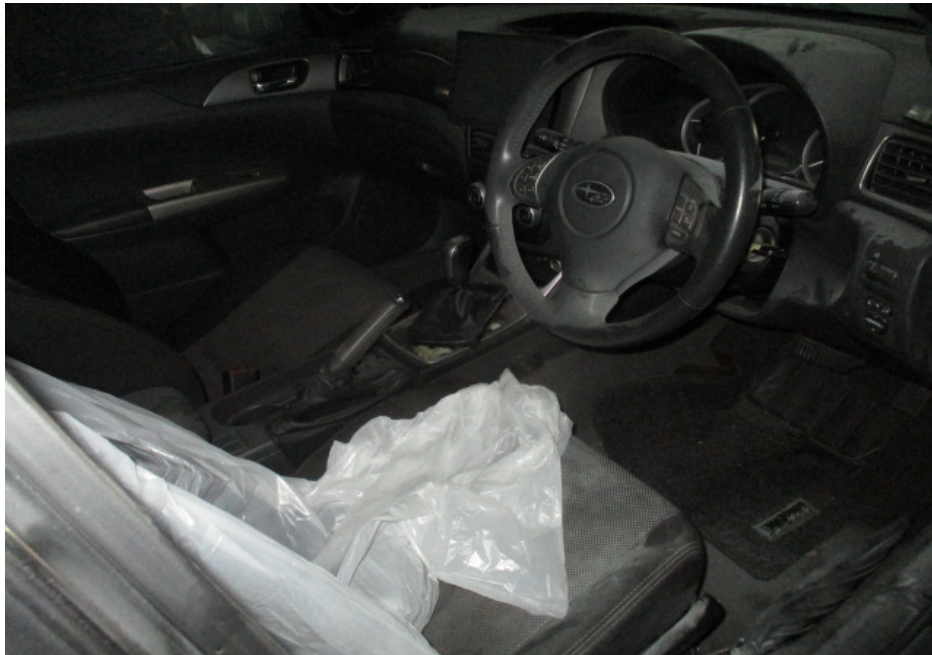
**Photo 5** shows the interior compartment of the Insured Vehicle at the time of our inspection. The interior compartment of the Insured Vehicle was relatively unaffected by the fire.

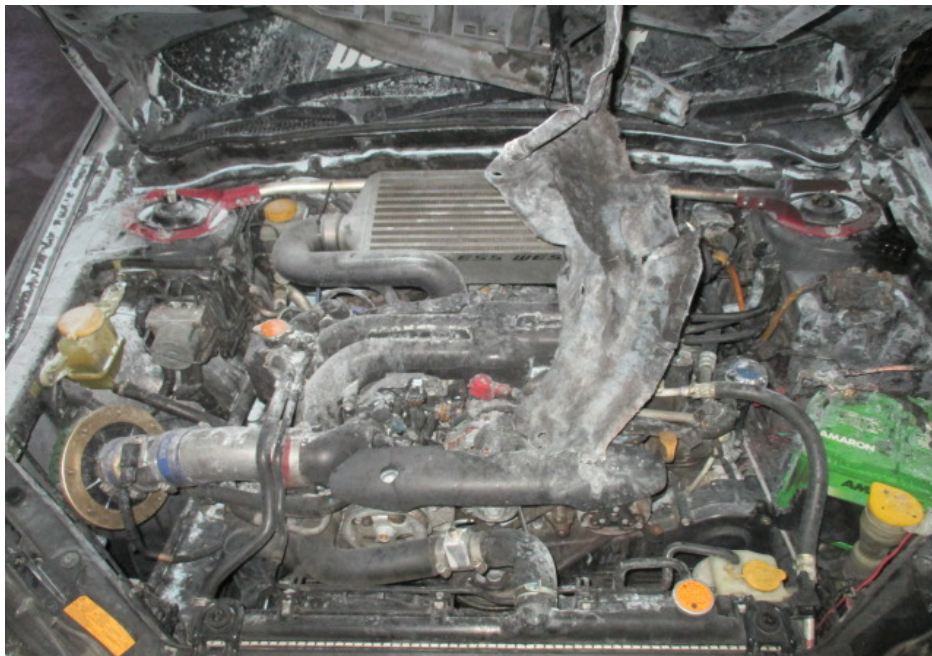
**Photo 6** shows a general view of the engine compartment of the Insured Vehicle at the time of our inspection. Most of the components inside the engine compartment were found to be severely burnt and/or melted as a result of the fire.

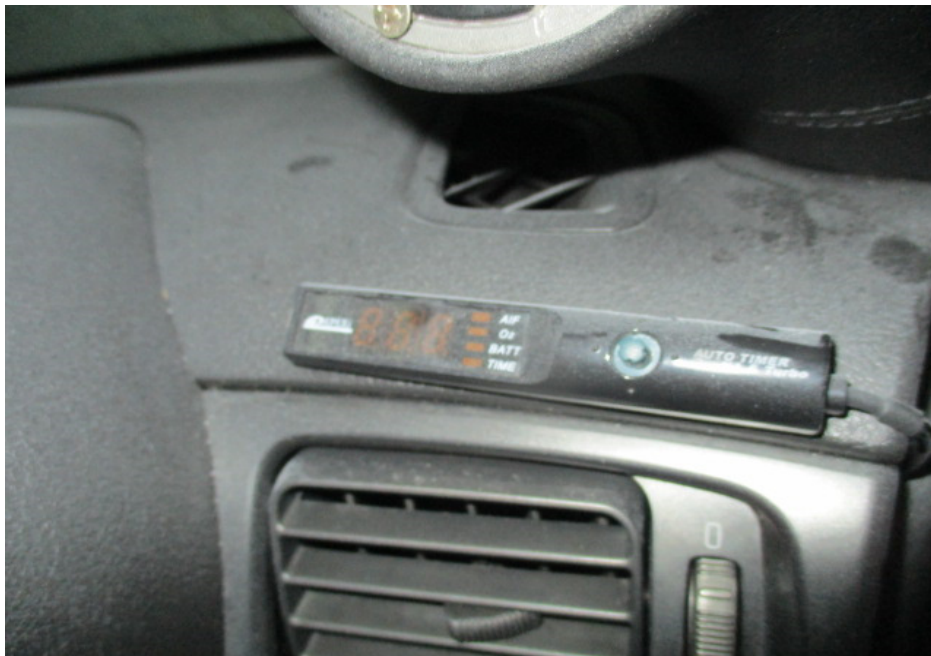
**Photo 7** shows the auto timer that was found to be additionally fitted onto the Insured Vehicle upon our inspection.

31. We are further of the opinion that the additionally fitted electrical/electronic components found on the Insured Vehicle could have possibly caused overloading to the electrical system of the Insured Vehicle. These components had included an auto timer, an aftermarket amplifier, an aftermarket subwoofer, 2 aftermarket twitters, 2 aftermarket speakers and an aftermarket in-car DVD player which are all LTA compliant. However considering that the installation was carried out for a period of time prior to the fire incident, the overloading was likely to be minimal.

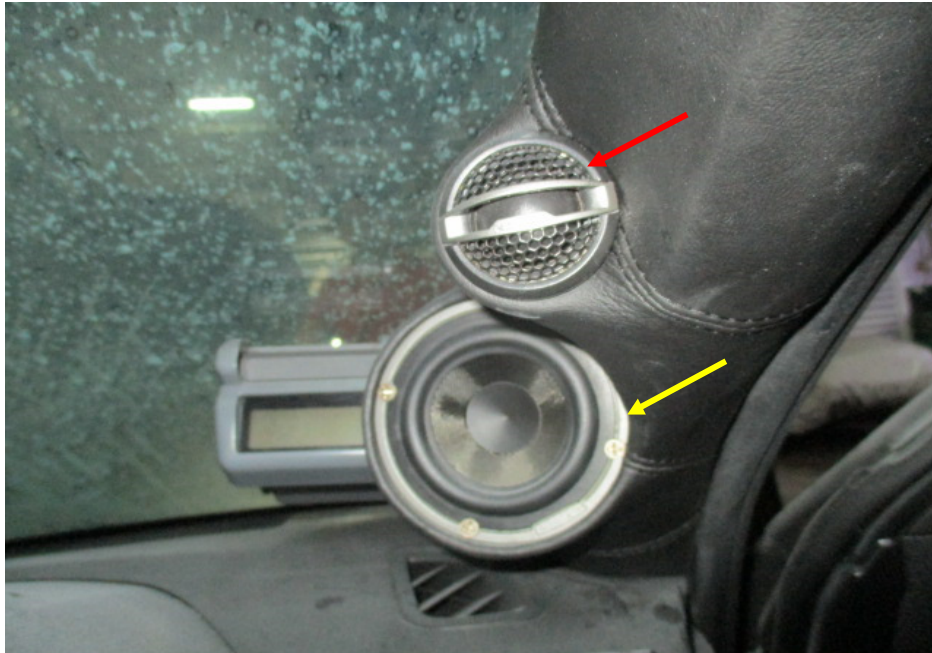
**Photo 8** shows the 1st aftermarket twitter fitted (red arrow) and speaker (yellow arrow) onto the right 'A' pillar of the Insured Vehicle upon our inspection.

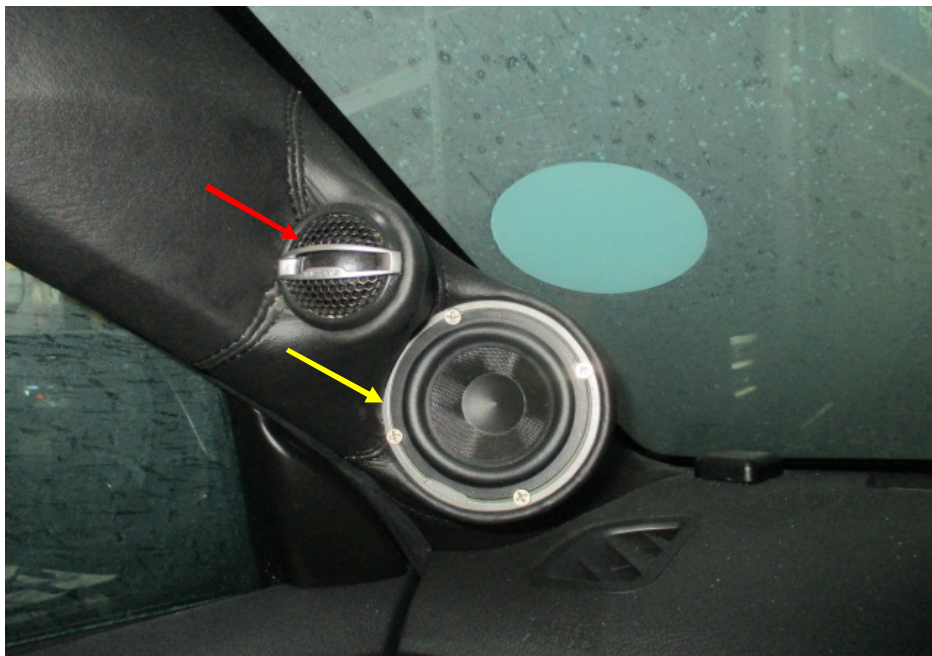
**Photo 9** shows the 2nd aftermarket twitter fitted (red arrow) and speaker (yellow arrow) onto the left 'A' pillar of the Insured Vehicle upon our inspection.

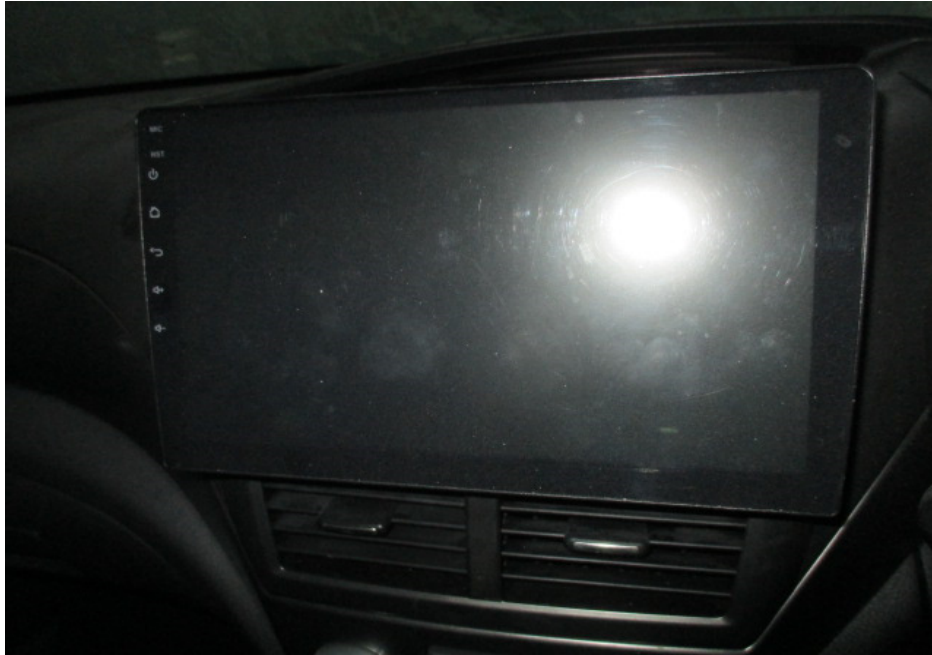
**Photo 10** shows the aftermarket in-car DVD player that was fitted at the centre portion of the front dashboard of the Insured Vehicle.

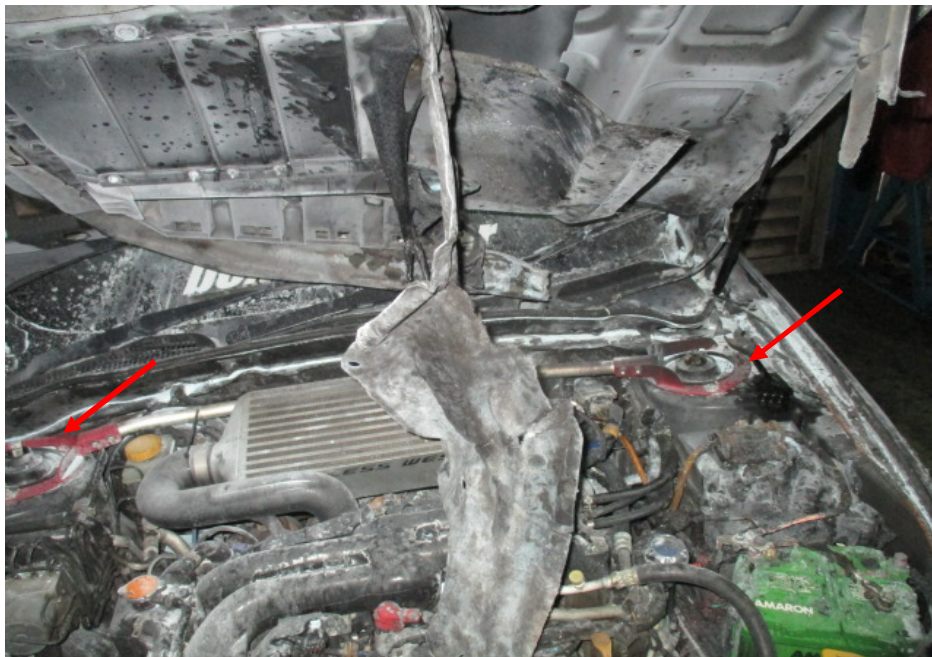
**Photo 11** shows the engine strut bar (arrowed) fitted on the Insured Vehicle. However it had sustained minor fire damage.

33. Although the engine strut bar, aftermarket alloy rims and rear exhaust muffler fitted on the Insured Vehicle were not the standard type for the Insured Vehicle, we are of the view that these parts did not cause and/or contribute to the fire incident.

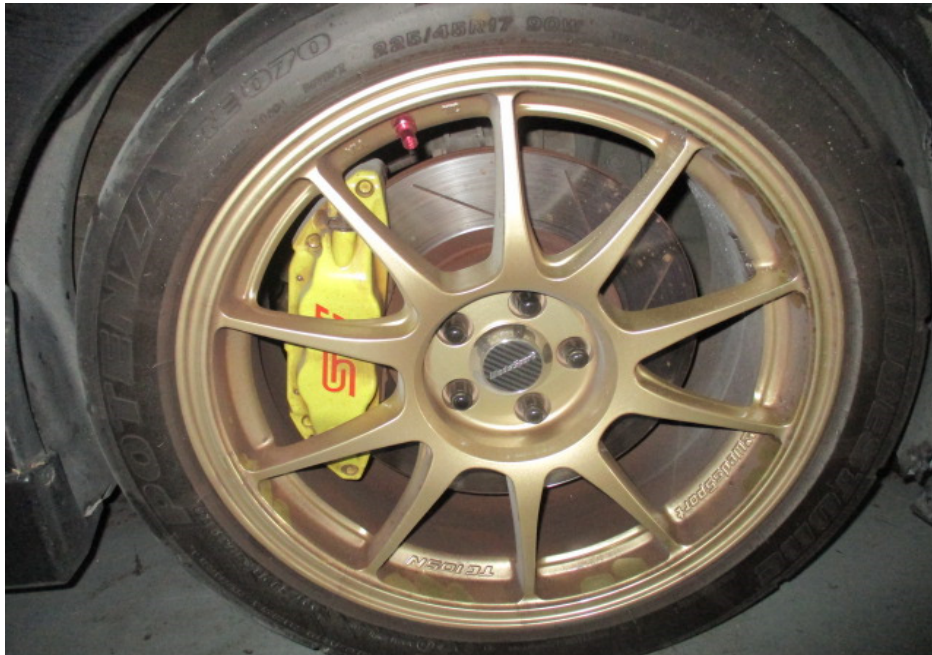
**Photo 12** shows the non-standard rim found to be fitted on the Insured Vehicle at the time of our inspection. The 17- inch alloy rims fitted on the Insured Vehicle were not the standard type for the Insured Vehicle.

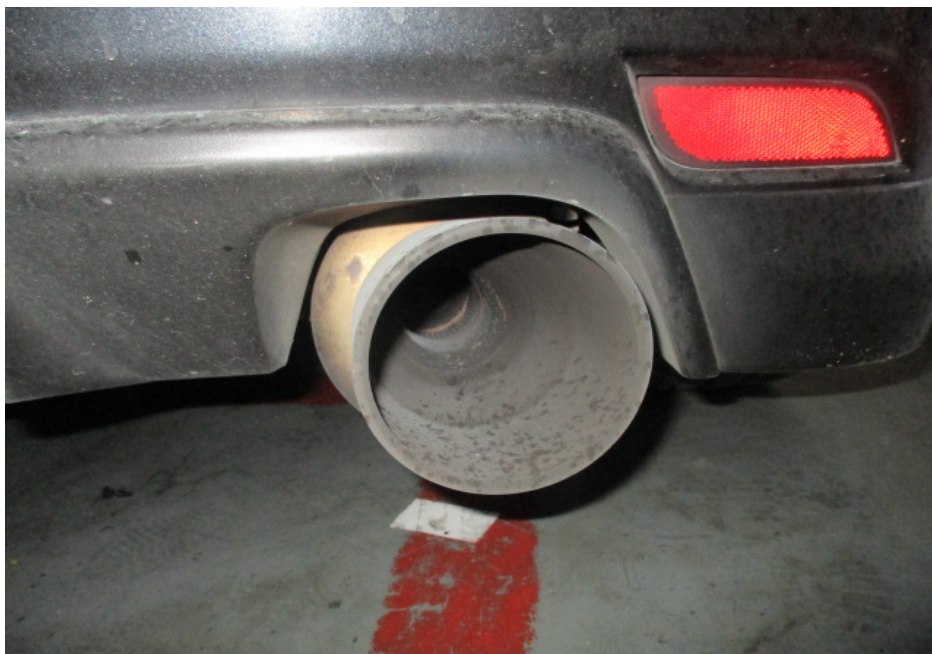
**Photo 13** shows a front view of the non-standard rear exhaust muffler that was found to be fitted on the Insured Vehicle at the time of our inspection.

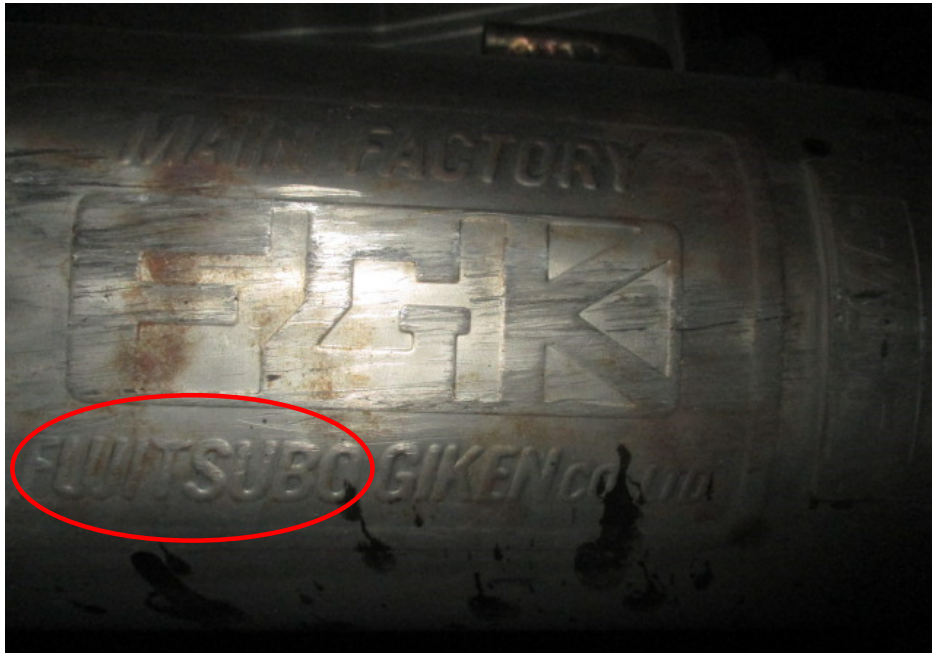
**Photo 14** shows a close up side view of the non-standard rear exhaust muffler that was found to be fitted on the Insured Vehicle at the time of our inspection. The brand of the rear exhaust muffler was 'Fujitsubo' (circled).

32. We found the Insured Vehicle to be fitted with a non- standard engine strut bar, aftermarket 17- inch alloy rims and a non- standard rear exhaust muffler. The engine strut bar and tyre rims fitted do not require prior approval from LTA however the non-standard rear exhaust muffler would require prior approval from LTA. Mr Kwek has provided documents to prove that the non-standard rear exhaust muffler has been approved by the LTA.

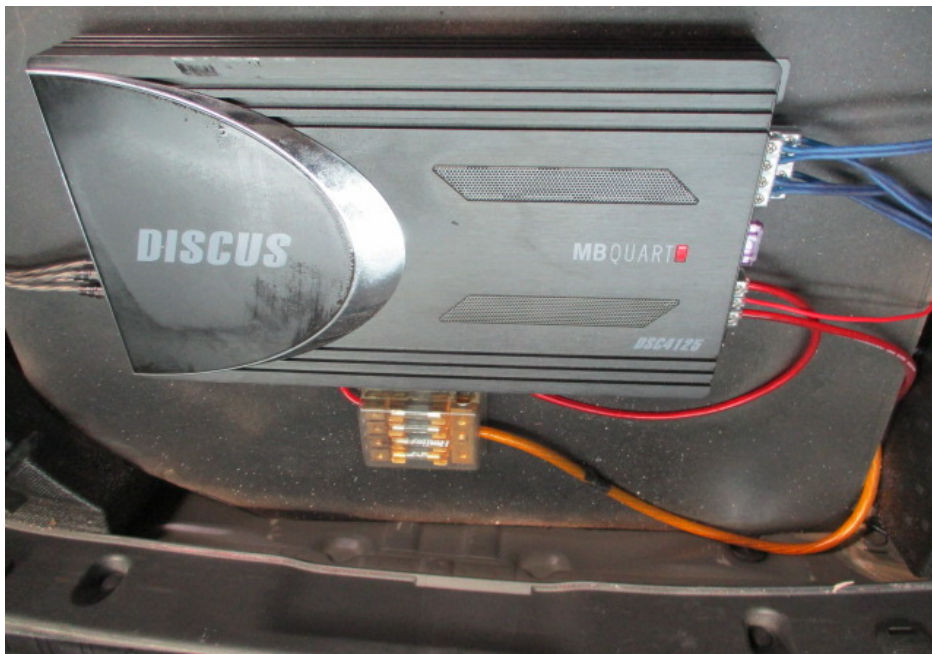
**Photo 15** shows the aftermarket amplifier that was found to be additionally fitted onto the Insured Vehicle upon our inspection.

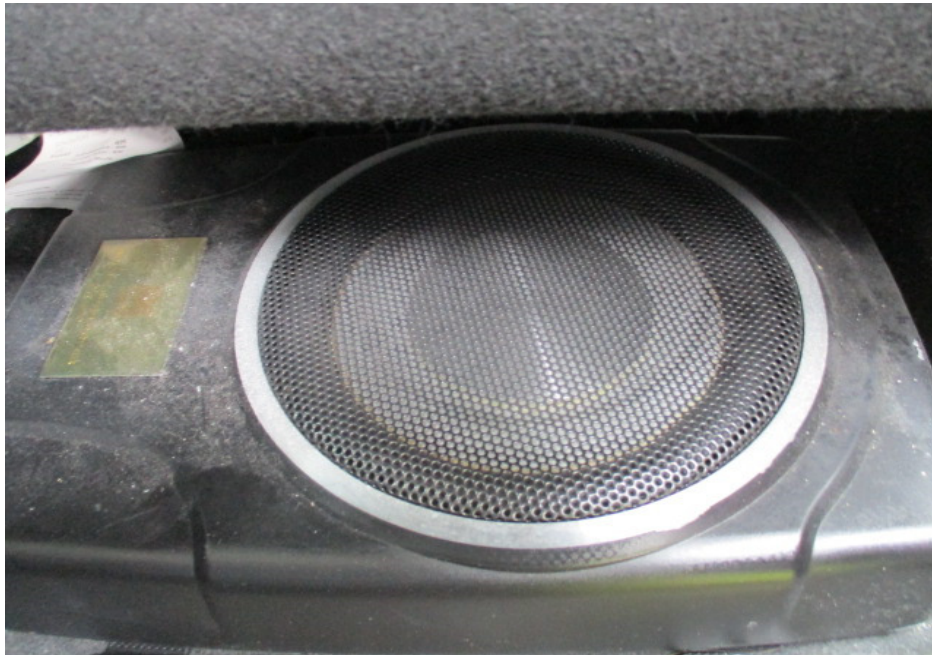
**Photo 16** shows the aftermarket subwoofer that was found to be additionally fitted onto the Insured Vehicle upon our inspection.

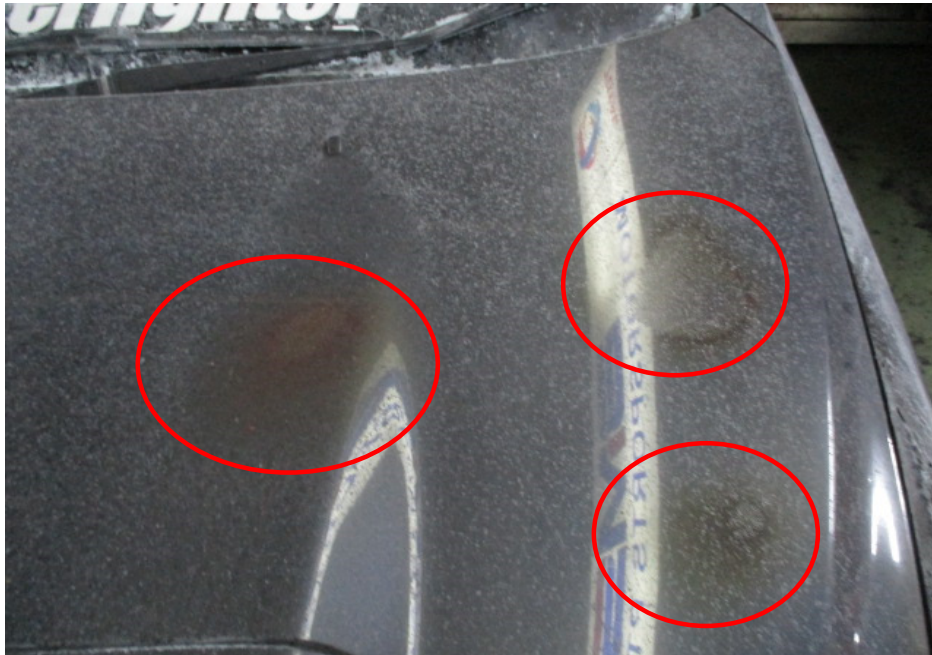
8. For this particular case, the fire appears to have originated within the engine compartment of the Insured Vehicle, somewhere around the left portion of the engine compartment due to the nature of the fire damage which was more extensive at the left portion. This can also be determined from the burn pattern and the high heat intensity burn marks (whitish burn marks) found on the left portion of the bonnet of the Insured Vehicle. The whitish burn marks are a result of exposure to prolonged heat intensity. See photos 17 - 19 below.

**Photo 17** shows the burn pattern that was found on the left portion of the front bonnet of the Insured Vehicle (circled).

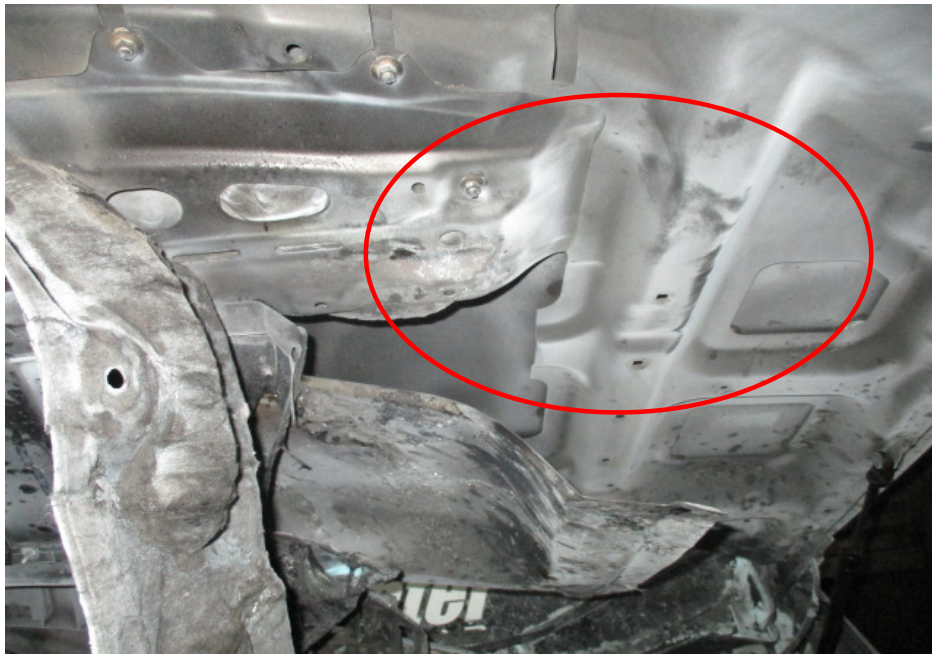
**Photo 18** shows the whitish burn marks that were found on the left portion of the underside of the front bonnet of the Insured Vehicle (circled). Such whitish burn marks are a result of exposure to prolonged heat intensity, which may indicate where the fire had started. Hence the fire to the Insured Vehicle can be determined to have originated towards the left portion of the engine compartment.

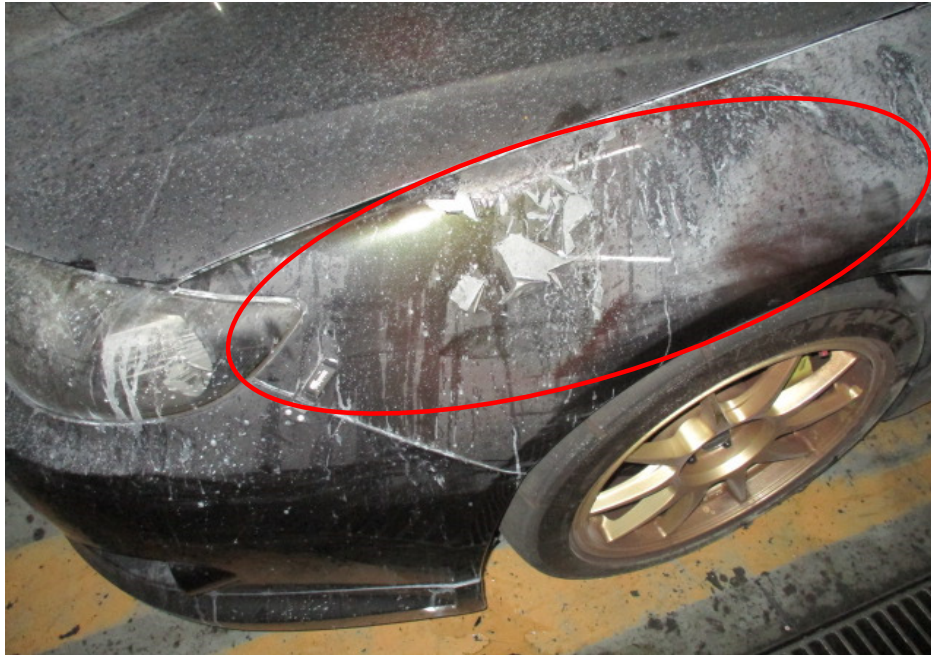
**Photo 19** shows the burn pattern and whitish burn marks that were found on the left front fender of the Insured Vehicle (circled). Such whitish burn marks are a result of exposure to prolonged heat intensity, which may indicate where the fire had started.

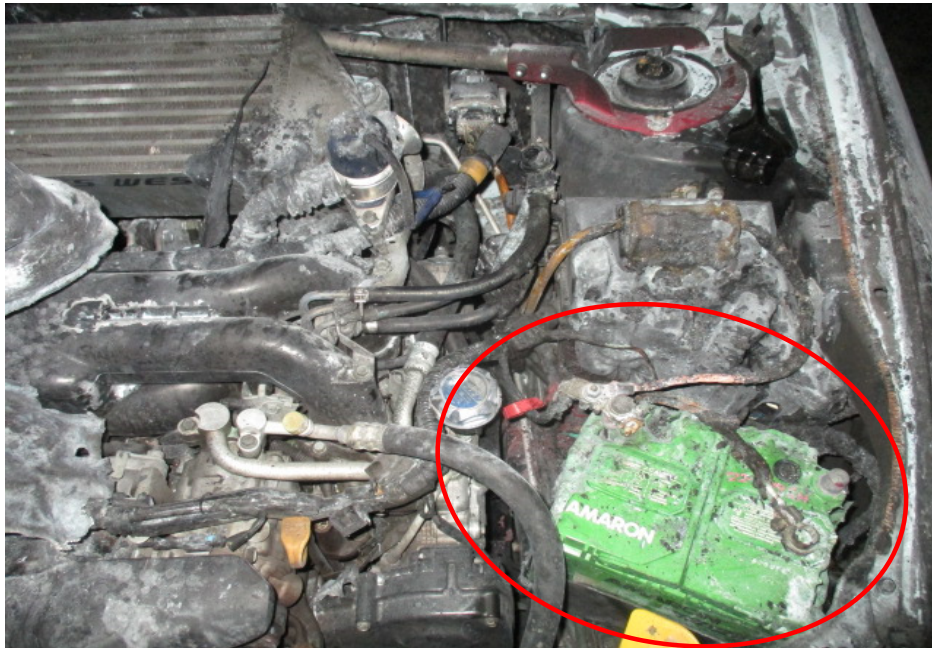
9. Upon closer examination of the left portion of the engine compartment which was where the fire to the Insured Vehicle had likely started, we had found several stretches of wirings with greenish residue. These wirings were original factory fitted wirings leading from the battery of the Insured Vehicle. The presence of greenish residue indicates internal heating of copper wires, a sign of an electrical short circuit occurring. The greenish residue is normally left behind from oxidation as a result of chemical reaction involving the copper wires. This physical evidence would appear to suggest that the cause of fire to the Insured Vehicle could have possibly been due to electrical in nature. See photos 20 – 23 below.

**Photo 20** shows the wirings around the left portion of the engine compartment which is near to the vicinity where the fire to the Insured Vehicle had likely started. We observed greenish residue on the wirings leading from the battery of the Insured Vehicle (circled). The presence of greenish residue indicates internal heating of copper wires, a sign of an electrical short circuit occurring. The greenish residue is normally left behind from oxidation as a result of chemical reaction involving the copper wires.

28. Having investigated and technically analysed the damages of burnt nature to the Insured Vehicle, we are of the view that the cause of fire to the Insured Vehicle was of electrical in nature. For this particular case, the fire had originated along the wirings inside the engine compartment, somewhere around the left portion of the engine compartment. The wirings were original factory wirings of the Insured Vehicle.

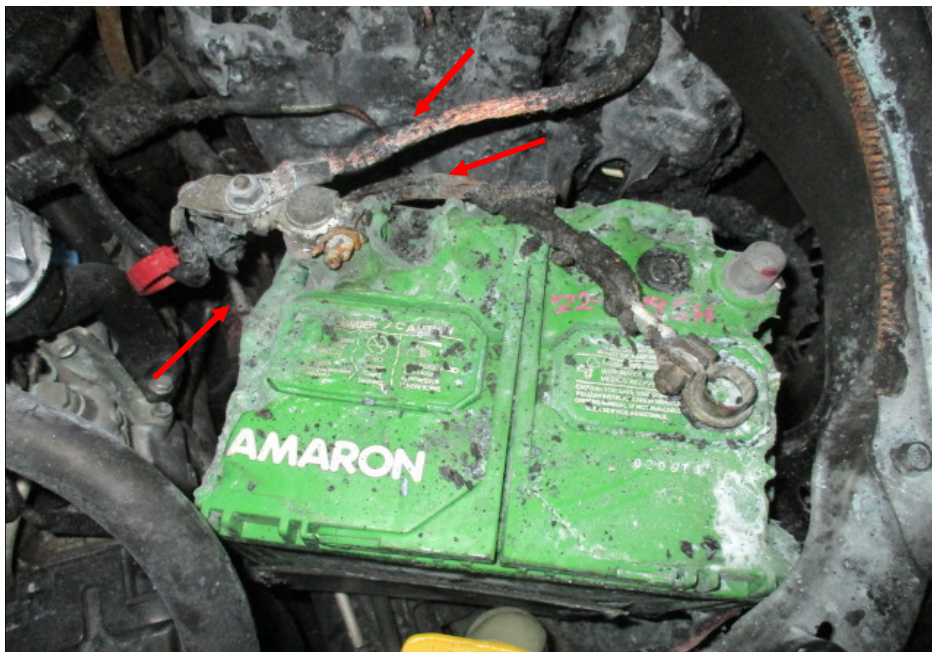
**Photo 21** shows a closer view the greenish residue on the wirings at the left portion of the engine compartment (red arrows). The presence of such greenish residue suggests occurrence of an electrical short circuit.

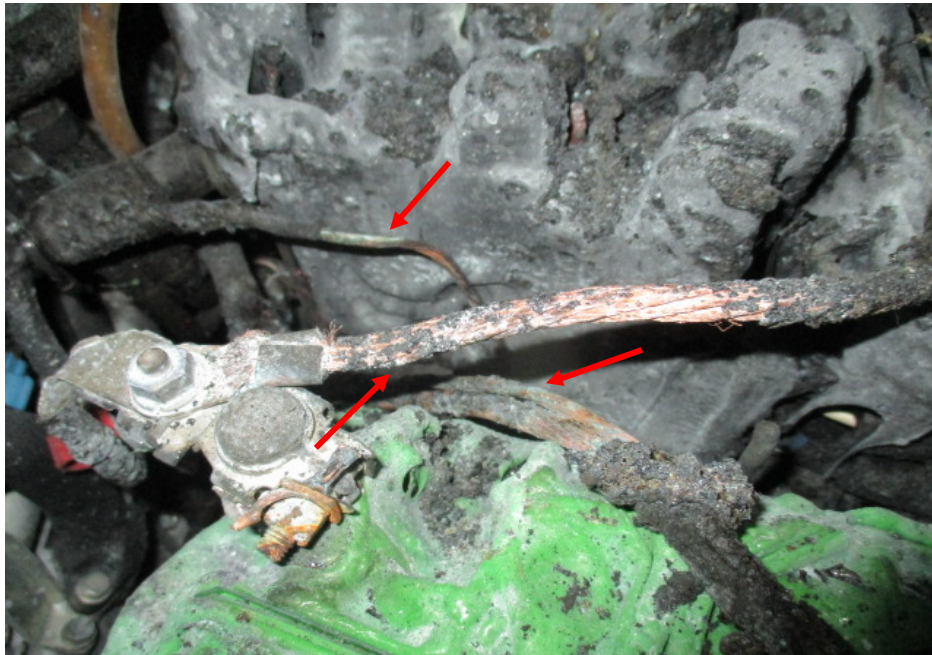
**Photo 22** shows a close up view of the greenish residue on the wirings leading from the battery of the Insured Vehicle (red arrows). The presence of such greenish residue suggests occurrence of an electrical short circuit.

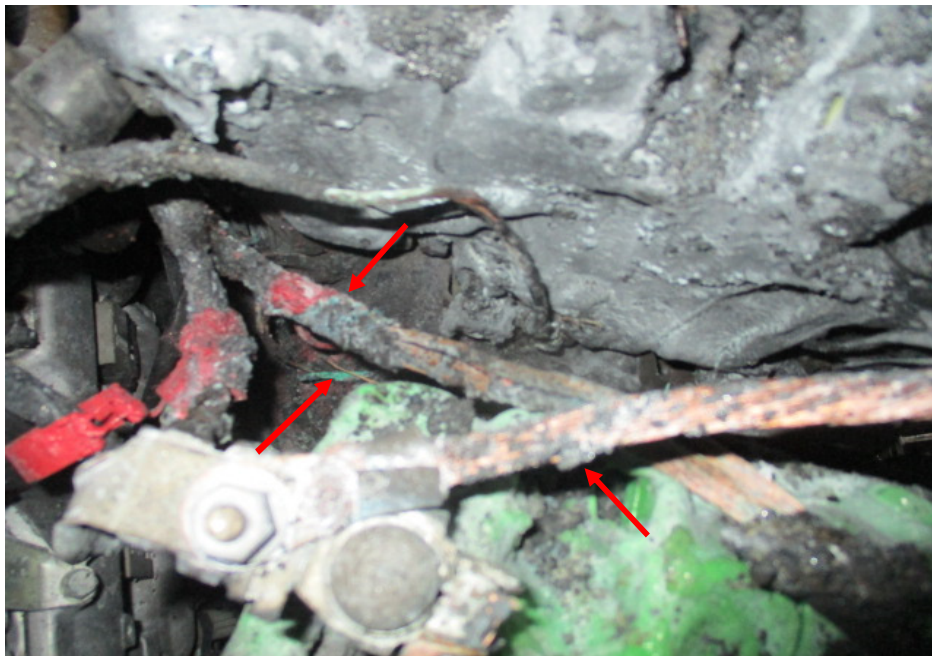
**Photo 23** shows a close up view of the greenish residue on the wirings leading from the battery of the Insured Vehicle (red arrows). The presence of such greenish residue suggests occurrence of an electrical short circuit.

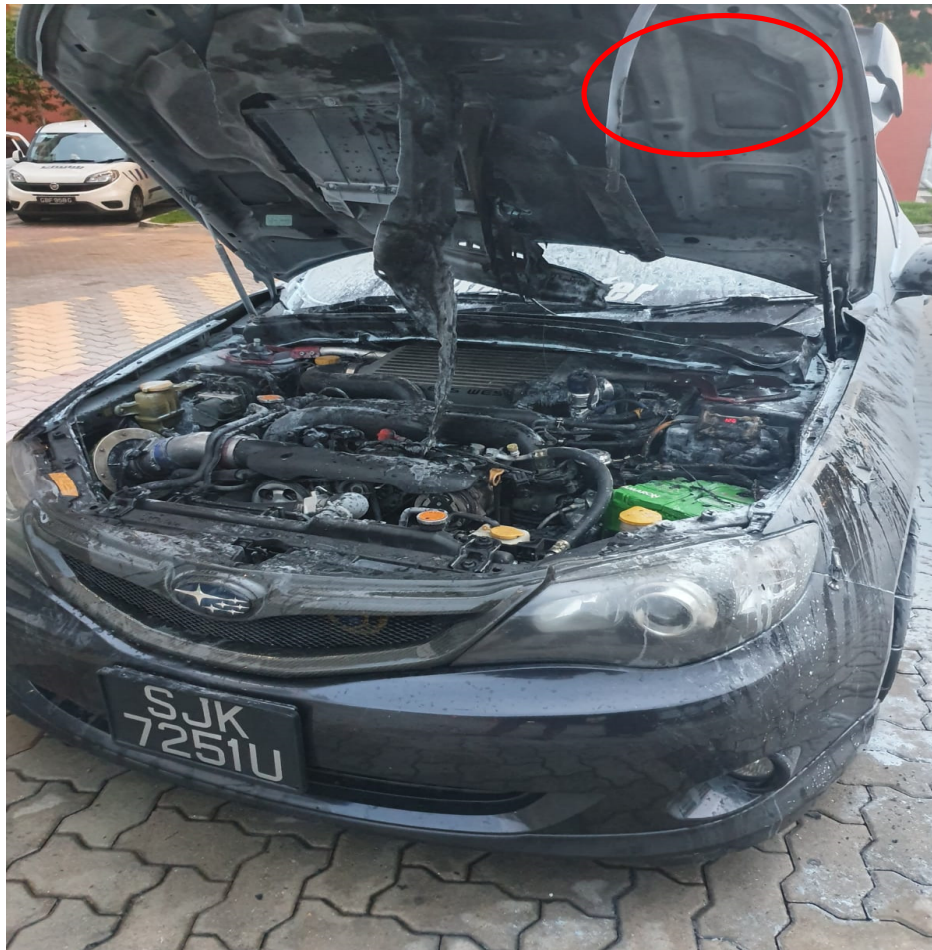
**Photo 26** shows the Insured Vehicle at the incident location after the fire was extinguished. In general, the information that could be gathered from this photograph had corresponded to the events that were related to us by Mr Kwek. Whitish burn marks were observed on the underside of the front bonnet, at the left portion (circled) which indicates that the fire had started in the left portion of the engine compartment.
