Bicycle Damaged Assessment Report

For Mr. Steven Lim
by Soon Watt & Co. (23rd Oct 2019)
Business registration no.: 06167900c
Prepared by Nigel Ng

1. Policy Particulars :- THIRD PARTY CLAIM

ADJUSTMENT ON REPAIR COST FOR VEHICLE NO. BICYCLE

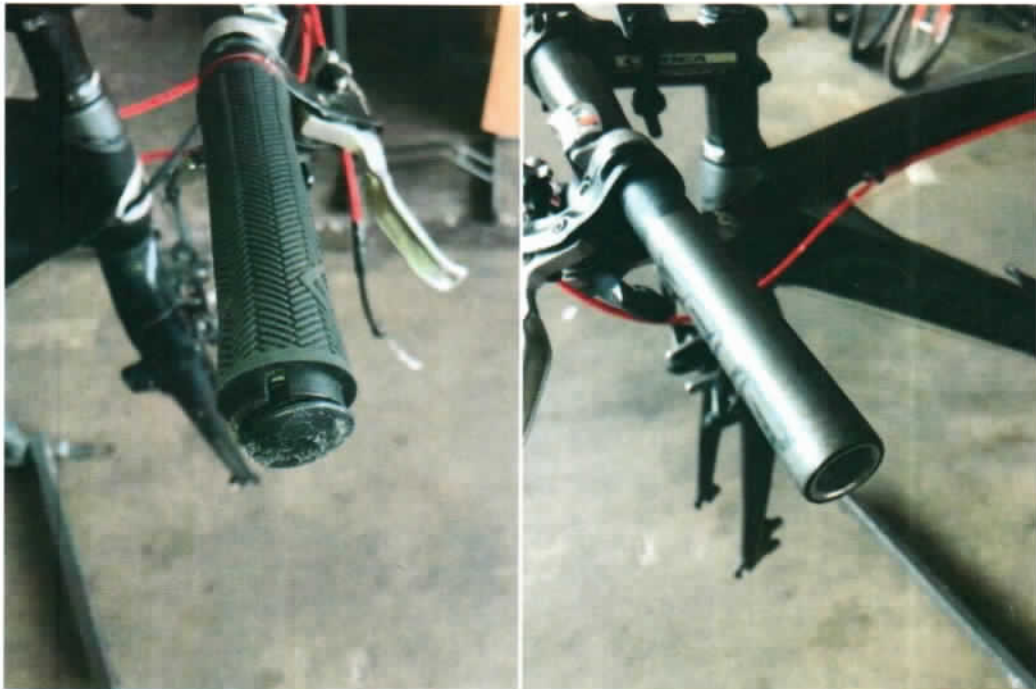
1. Cockpit area

- a. Right handlebar grip's Lock-on hardware is missing. This is possibly knocked off due to the impact against the floor. Replacement recommended.

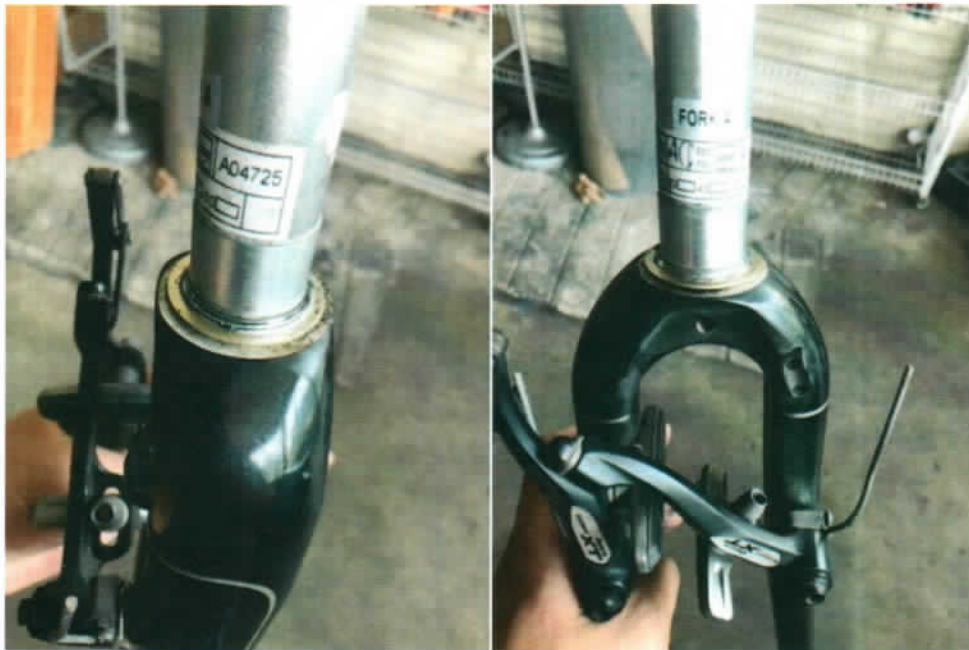
- b. No signs of damaged was found on the bar

- c. Stem has been taken out to inspect handlebar's bore area and the fork's steerer. No signs of damages were found on both bar and fork steerer.

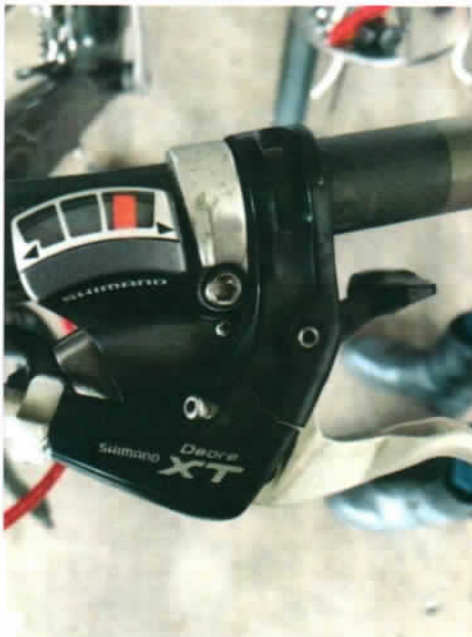
- d. Brake Lever. Left side lever has serious cracked and it's beyond repair. Replacement recommended.

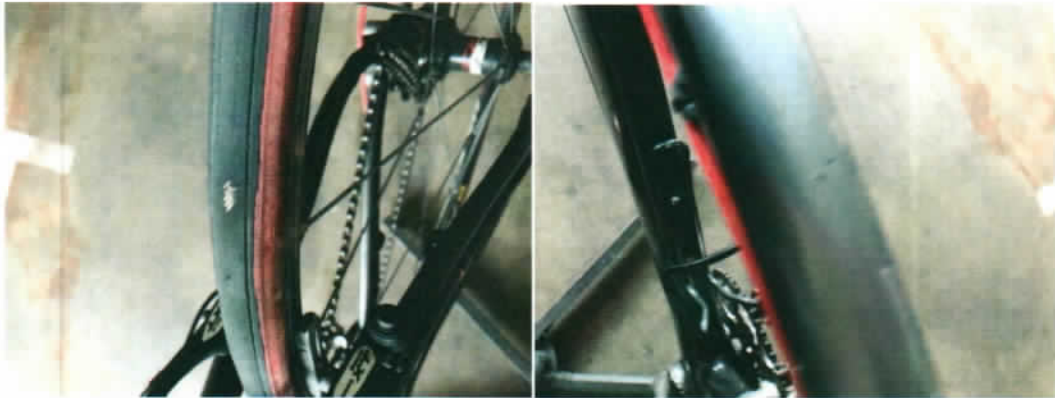
2. Wheels

- a. Both front and rear tyres showing a hole exposing the inner layer of the tyres. This is largely due to sudden braking and skiing of the tyres against the rough road surface. Replacement recommended.
- b. Both wheels are no longer true and require wheel truing.
- c. Brake Pad has been worn out. Replacement recommended.

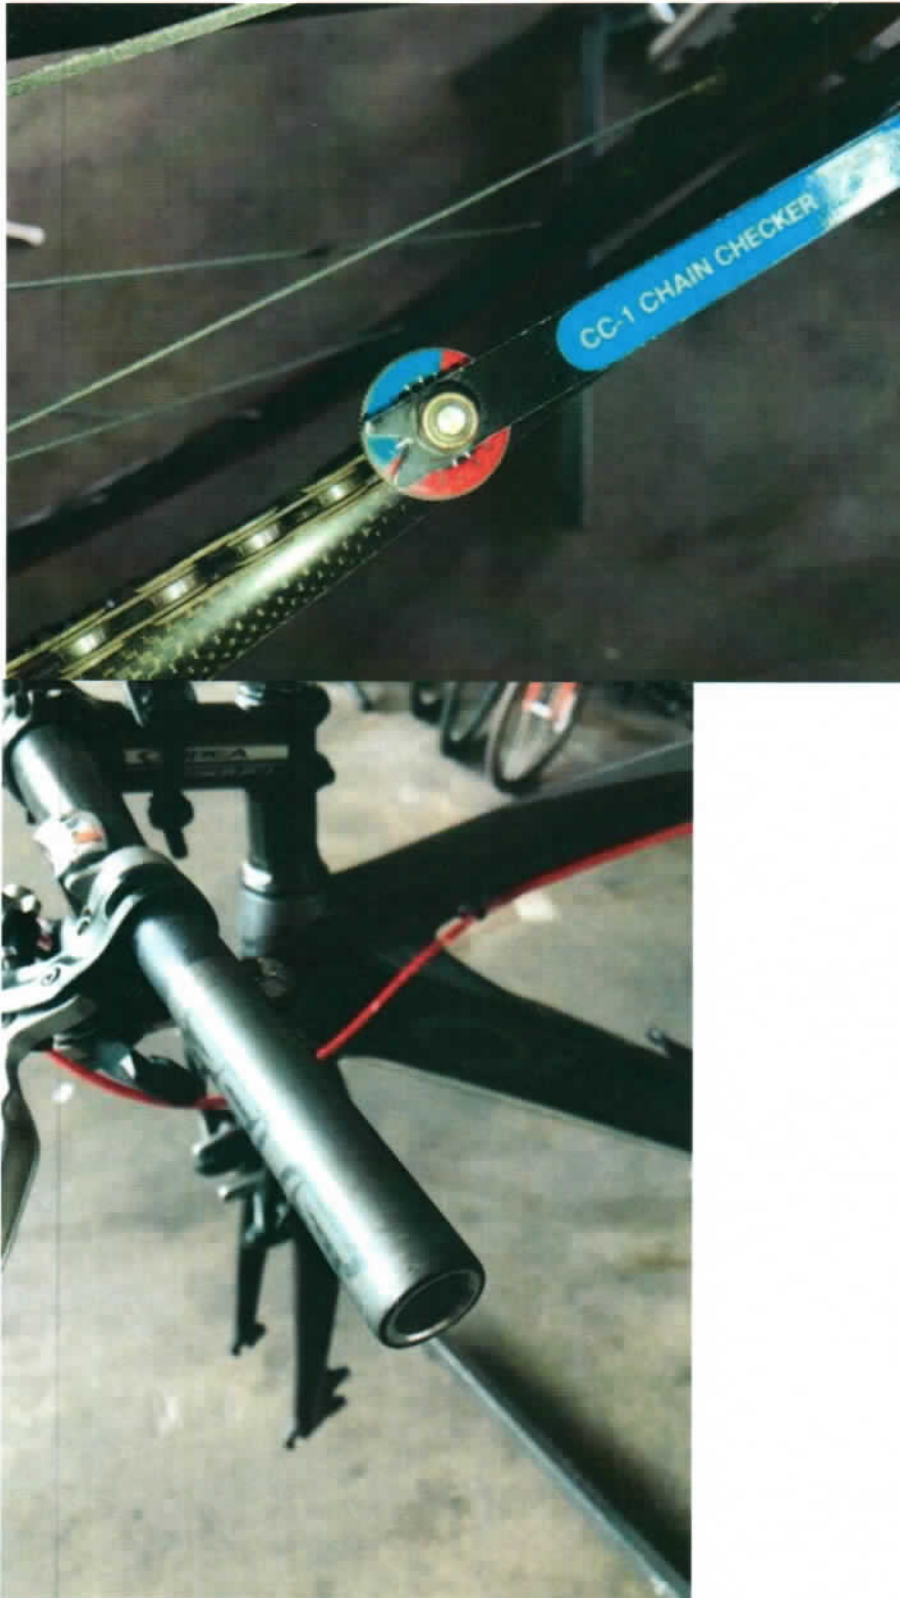
3. Chain

a. Chain is intact and not stretched

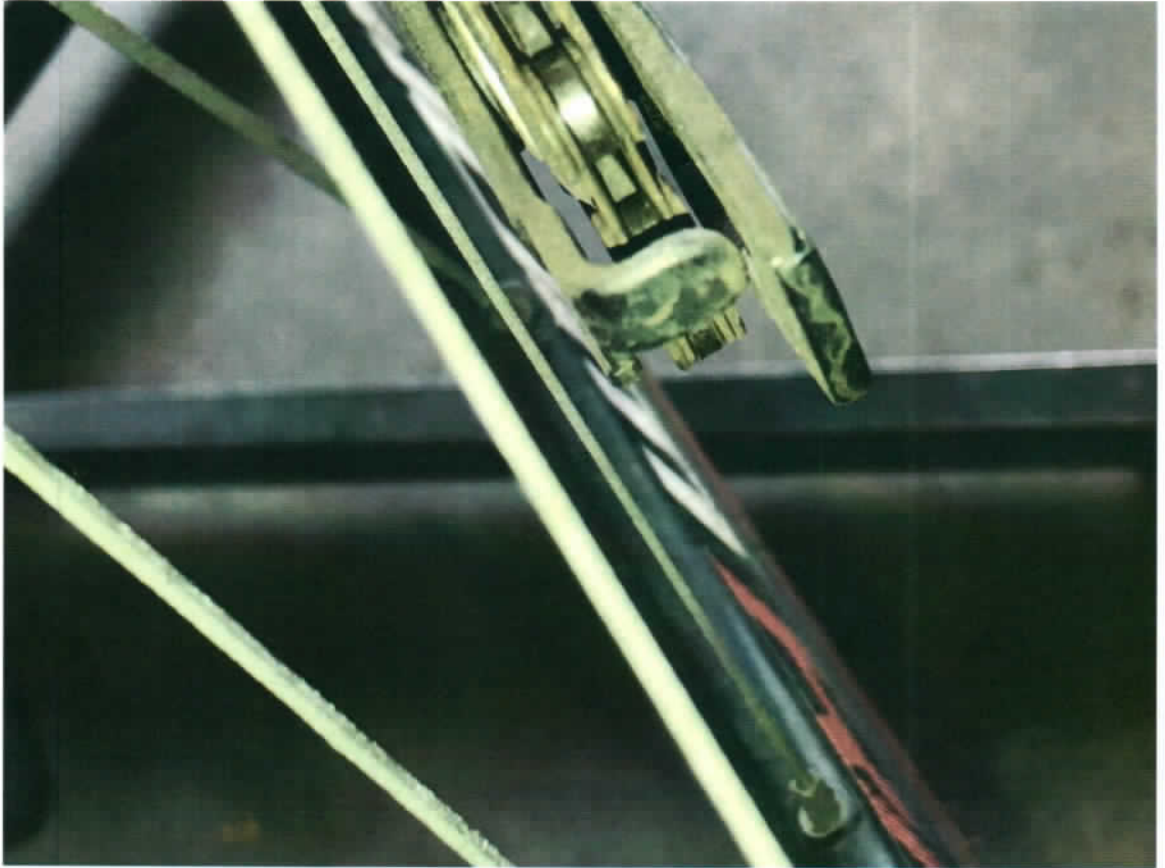
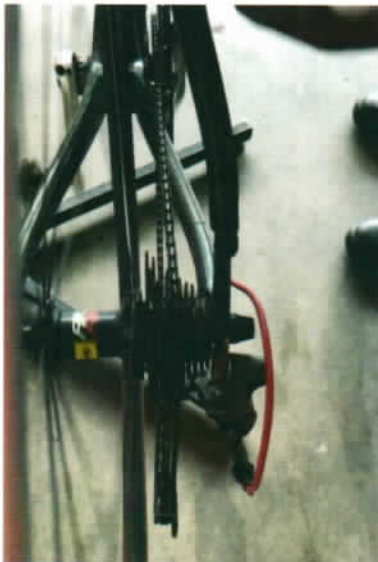
4. Rear Derailleur Hanger

- a. The hanger is slightly bent and requires servicing. Shifting is not functioning precisely and the derailleur cage is very closed to the wheel's spokes at the lowest gearing.

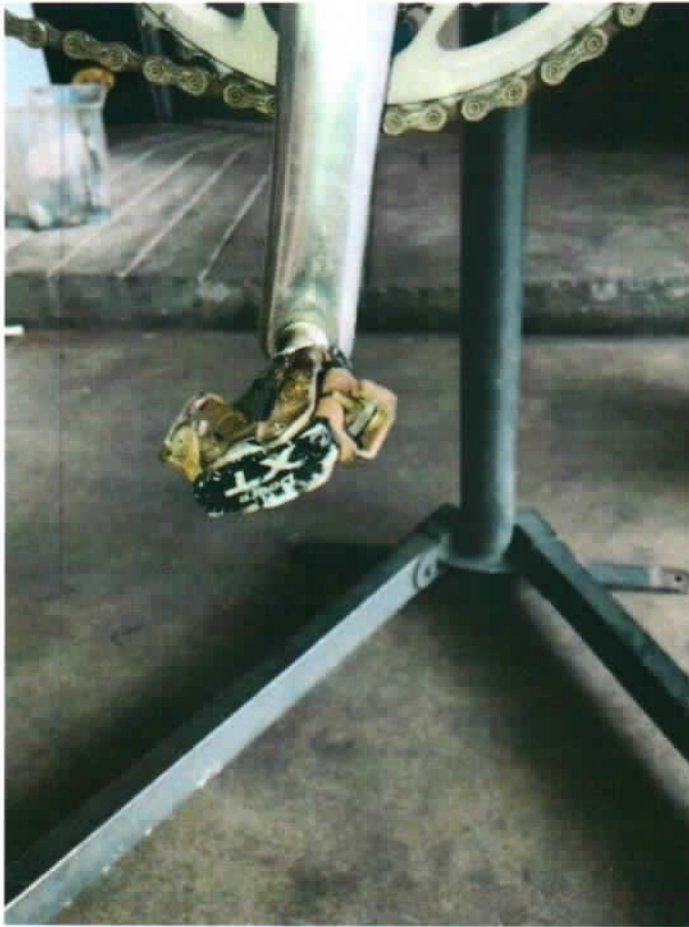
5. Pedal

- a. The pedal mounting and dismounting is no longer functioning as well as before. This could be due to the sudden impact causing urgent dismount or involuntarily dismount during the impact. Replacement is recommended.

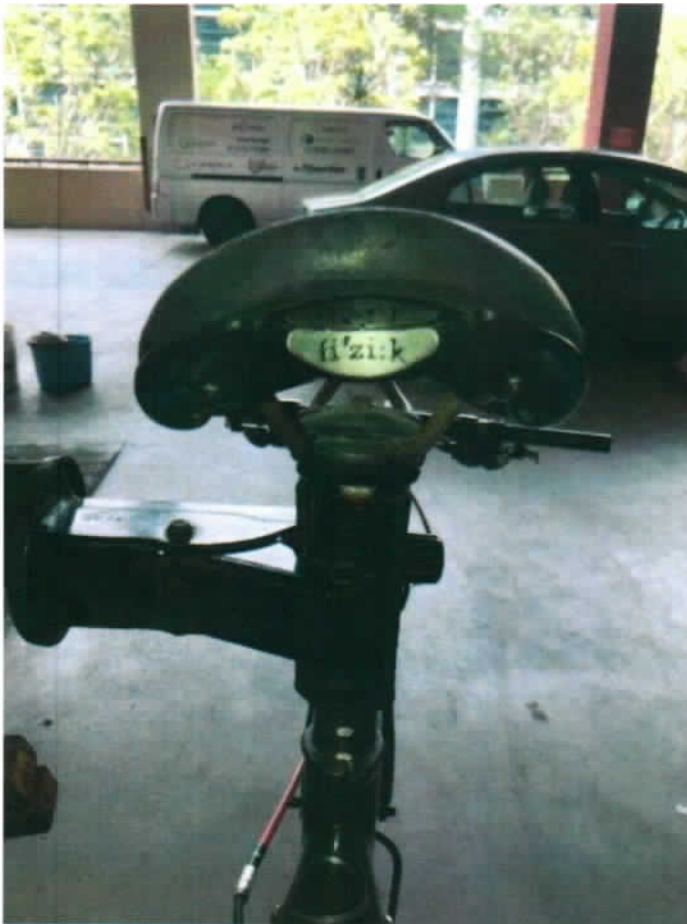
6. Saddle

- a. The saddle rails have twisted and are no longer balanced with one rail higher than the other. This cause the saddle to be lopsided and no longer support the rider with proper comfort and stress relieve. Continue usage may cause the rails to deform further. This is common and may occur during falls and accidents while riding. Saddle replacement is recommended.

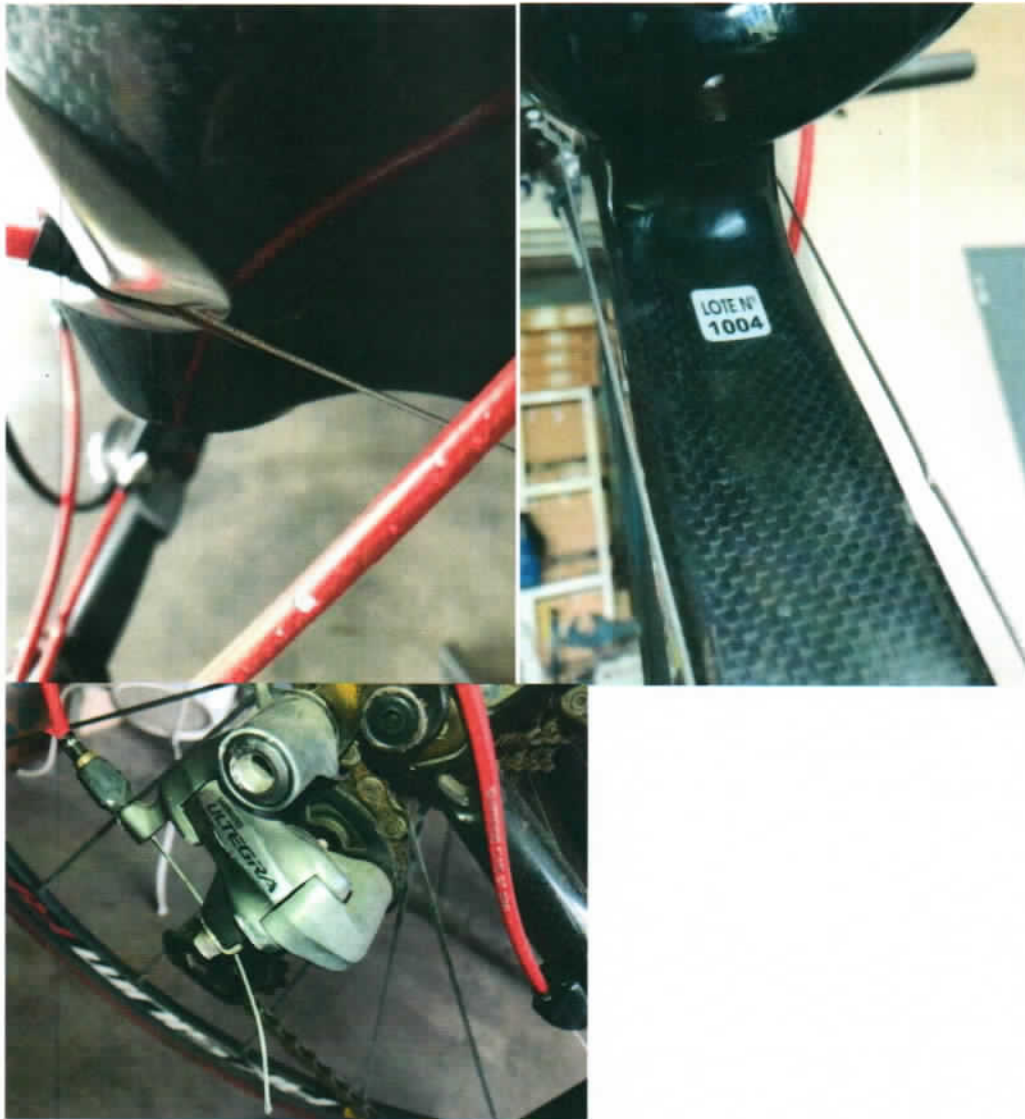
7. Cable Housing and Cables

- a. The cable housing has been damaged
- b. The cable has also been bent.

Overall cable and housing set has to be replaced.

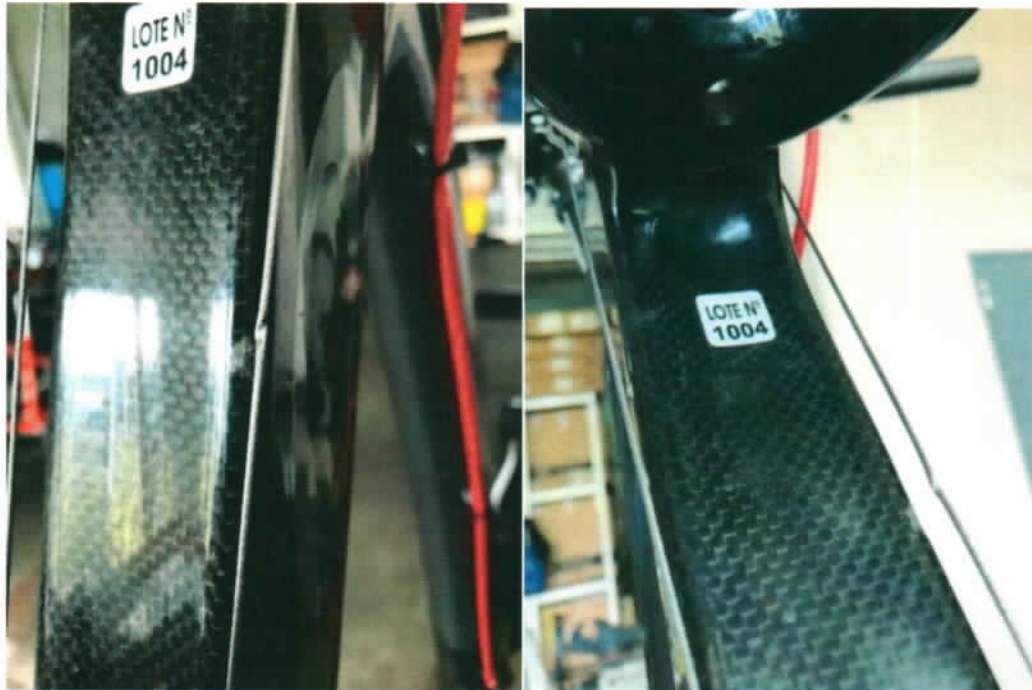
8. Frame

- a. Frame's down tube has a dent along at the part where the cable was damaged. The cable damaged is highly caused by external impact against an object with shape angle where the impact penetrates thru and caused the dent on the carbon frame.

The carbon frame will need to be sent for carbon frame repairer for further inspection for possible repair or be replaced if it is beyond repair. The dent is small but we do not have any equipment to verify the internal structure to understand the extent of the damage.
