Your Ref: TP/IP/67665/2019  
Our Ref : CI/TPD19019394/P

**Fatal Accident Investigation Team**

**MECHANICAL INSPECTION REPORT OF MOTOR LORRY XE 1531S**

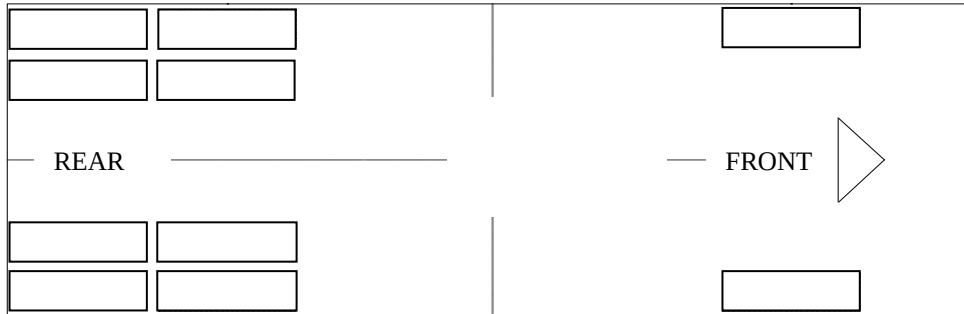
6. The 10 tyres of the Motor Lorry were observed to be in serviceable condition and sufficiently inflated for vehicular operation. I did not find any tear, cut or burst mark(s) on the outer and the inner sidewalls as well as across the tread of the 10 tyres of the Motor Lorry. The tyre brand, tyre size and remaining tread depth of the 10 tyres of the Motor Lorry were recorded as follows:-

Agate 315/80 R22.5 (5.6mm)

Hankook 315/80 R22.5 (9.6mm)

Agate 315/80 R22.5 (6.7mm)

Hankook 315/80 R22.5 (14mm)

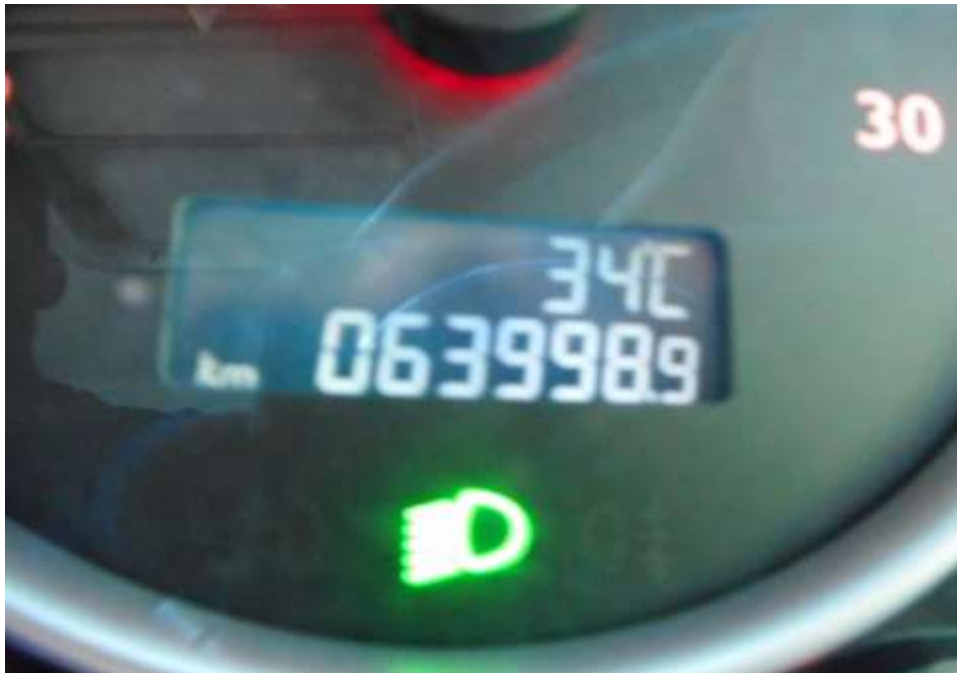
**Photo 1** shows a general view of the instrument cluster of the Motor Lorry at the time of my inspection. The mileage of the Motor Lorry was 63,998km

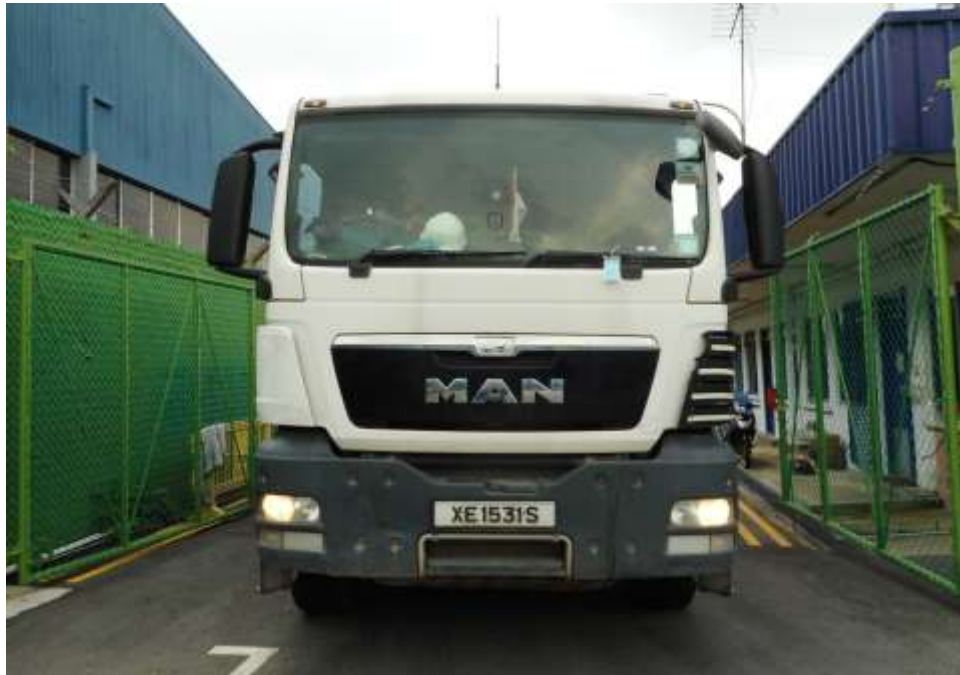
**Photo 2** shows a general view of the front body of the Motor Lorry at the time of my inspection. The Motor Lorry was observed to not sustain any damage

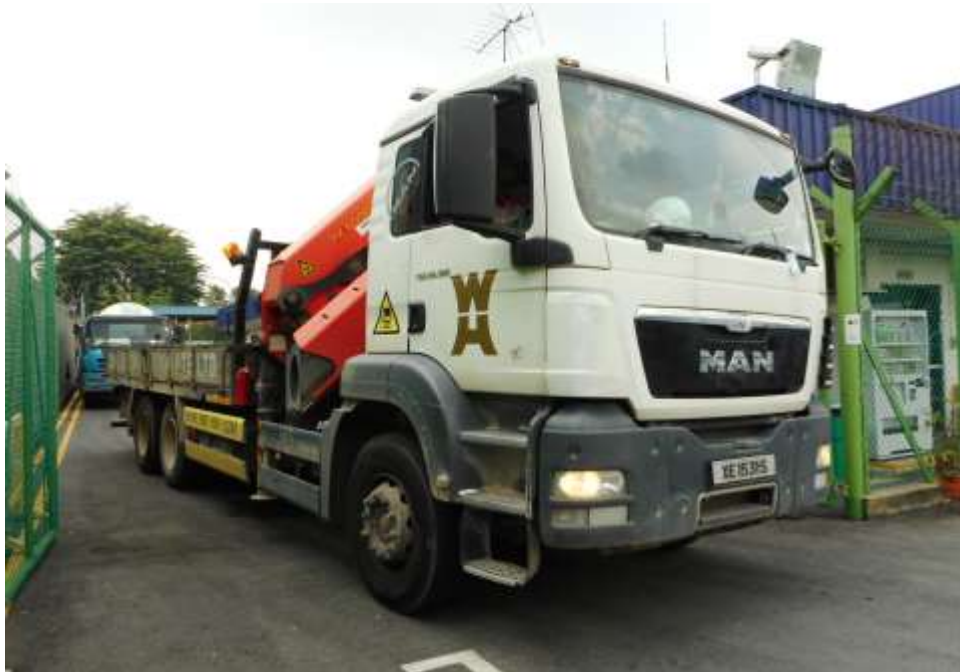
**Photo 3** shows a general view of the front right body of the Motor Lorry at the time of my inspection, observed to have been unaffected by the accident.

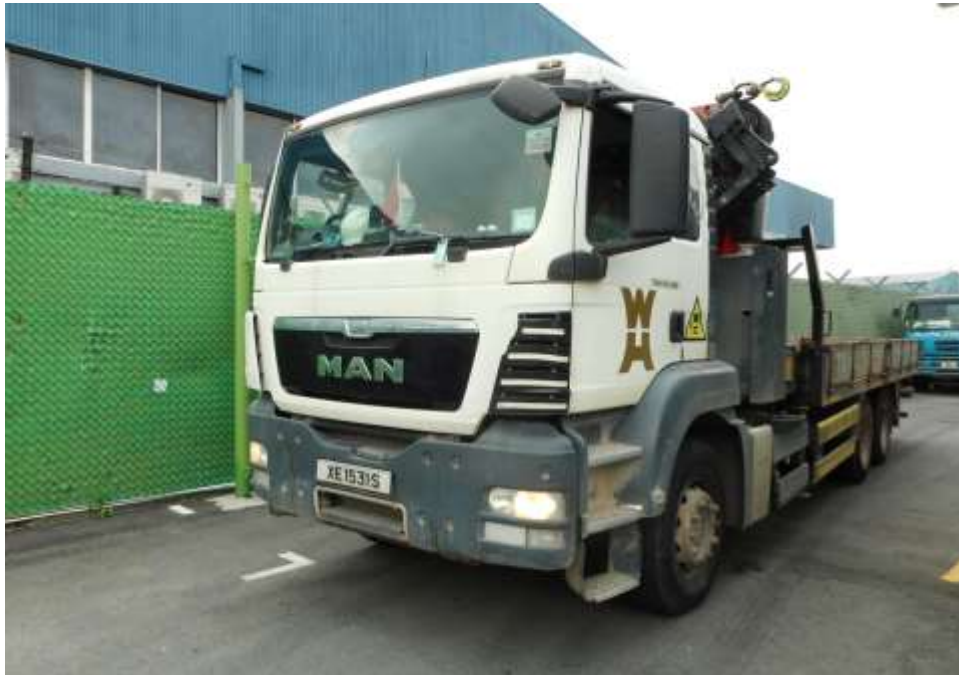
**Photo 4** shows a general view of the front right body of the Motor Lorry at the time of my inspection, observed to have been unaffected by the accident.

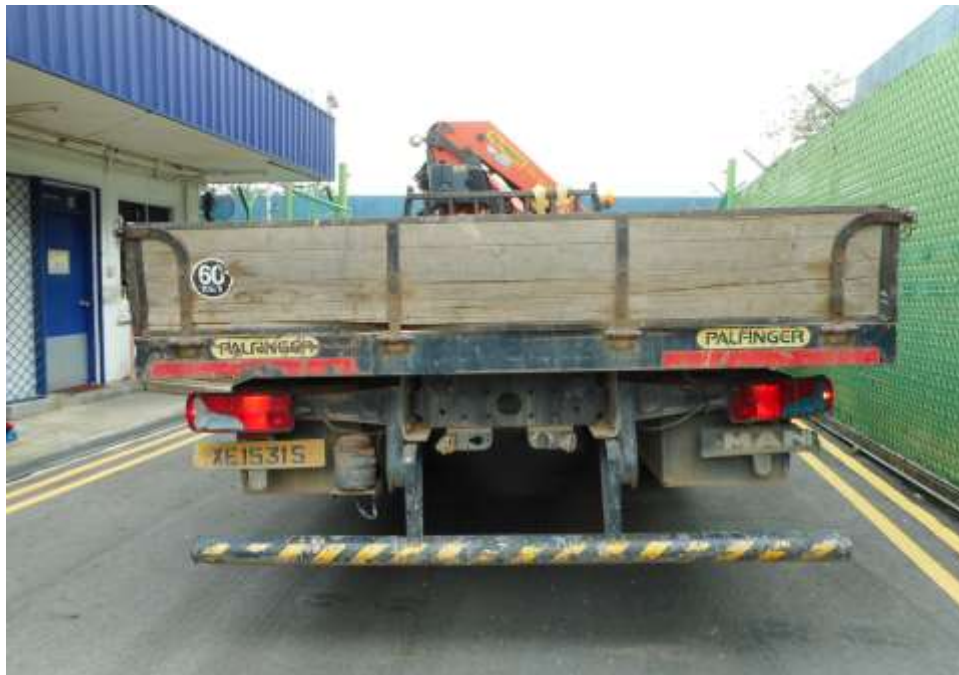
**Photo 5** shows a general view of the Motor Lorry's rear body at the time of my inspection. There was no damage found to the rear portion of the Motor Lorry.

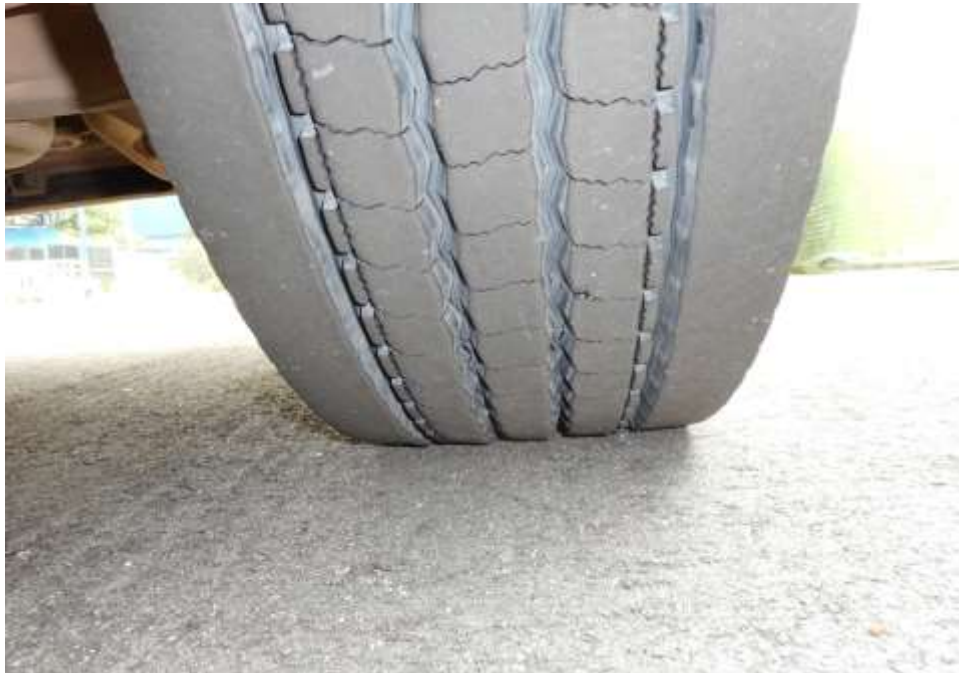
**Photo 6** shows the condition of the front right tyre of the Motor Lorry, which was observed to be in serviceable condition with remaining tread depth of approximately 14 mm. The tyre, which was wrapped around standard steel wheel rim, was also observed to be sufficiently inflated for vehicular operation. There was no tear, cut or burst mark(s) on the outer and the inner sidewalls as well as across the tread of the 10 tyres that were fitted on the Motor Lorry.

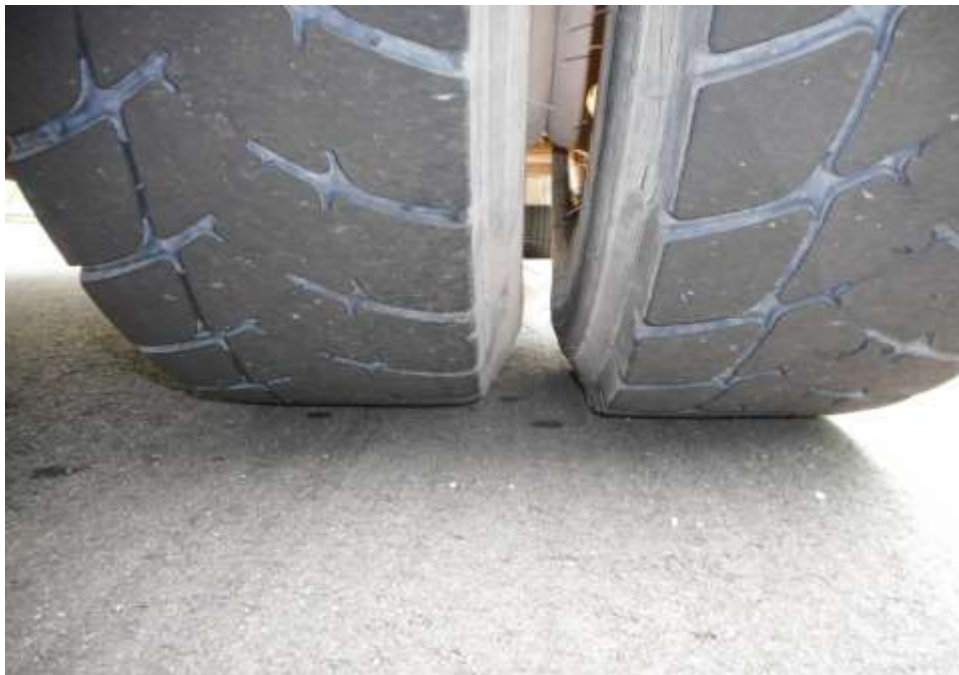
**Photo 7** shows the condition of the rear right tyre of the Motor Lorry, which was observed to be in serviceable condition with remaining tread depth of approximately 6.7mm. The tyre, which was wrapped around standard steel wheel rim, was also observed to be sufficiently inflated for vehicular operation.

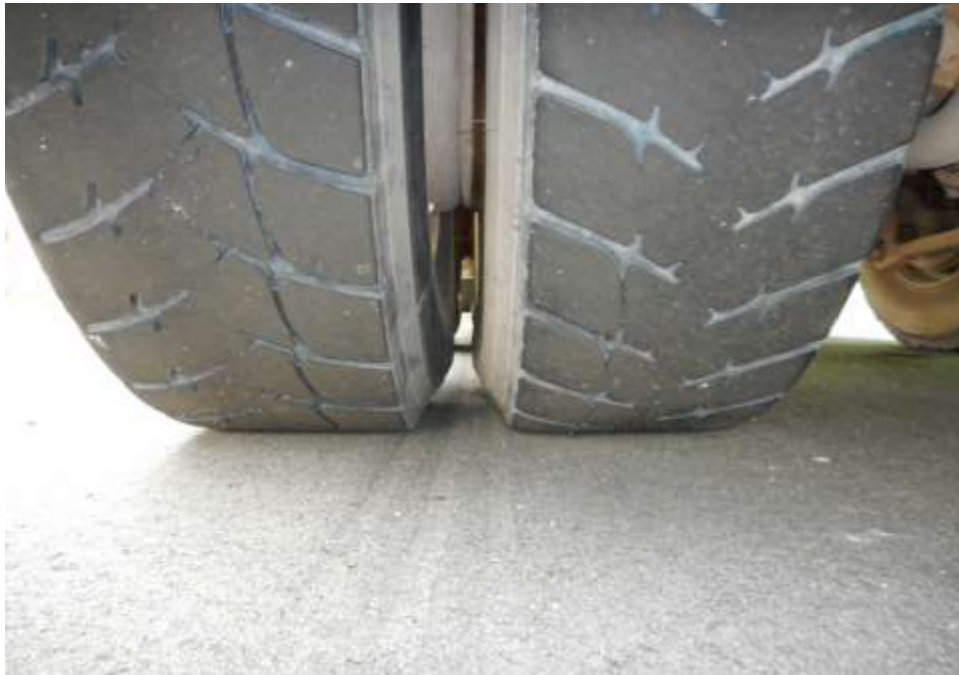
**Photo 8** shows the condition of the rear left tyres of the Motor Lorry, which was observed to be in serviceable condition with remaining tread depth of approximately 5.6mm. The tyres, which were wrapped around standard steel wheel rim, were also observed to be sufficiently inflated for vehicular operation. There was also no damage found on all 10 steel wheel rims of the Motor Lorry.

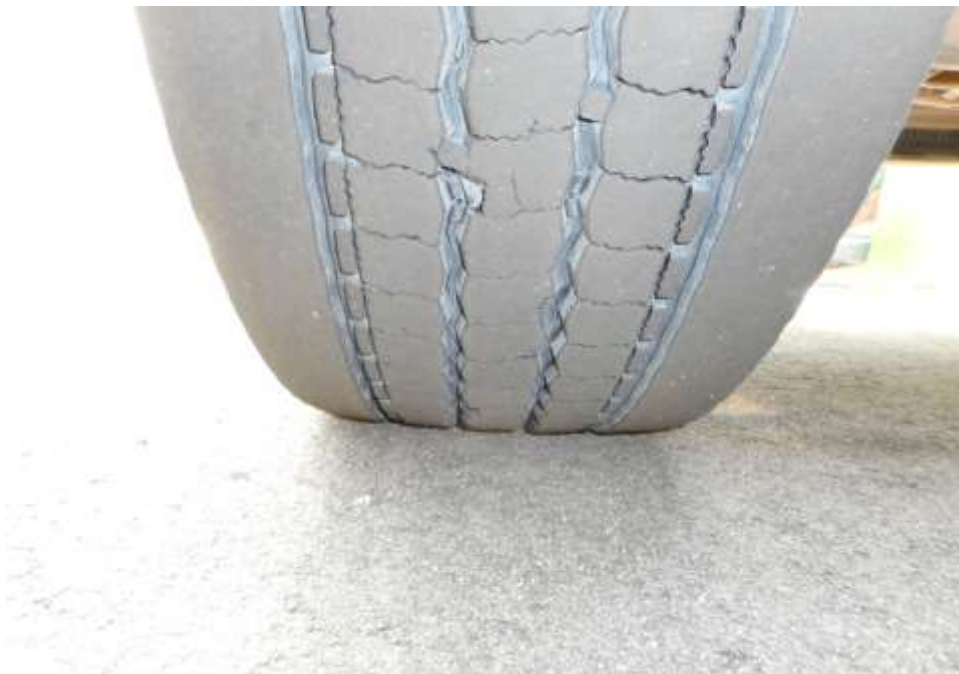
**Photo 9** shows the condition of the front left tyres of the Motor Lorry, which were observed to be in serviceable condition with remaining tread depth of approximately 9.6mm. There was also no tear, cut or burst mark(s) on the outer and the inner sidewalls as well as across the tread of the 10 tyres that were fitted on the Motor Lorry.

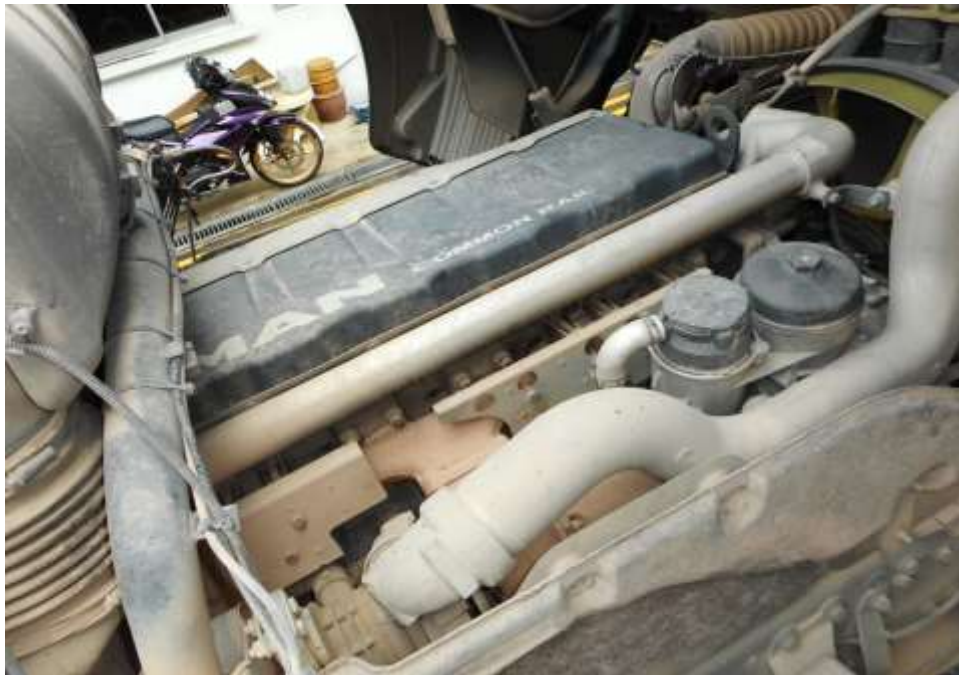
**Photo 10** shows a general view of the Motor Lorry's engine compartment, which was accessed by lifting the front cabin of the Motor Lorry. The various parts and components inside the engine compartment were unaffected by the accident. There was also no sign(s) or indication(s) of fresh fluid leakage and/or fluid stain within the engine compartment

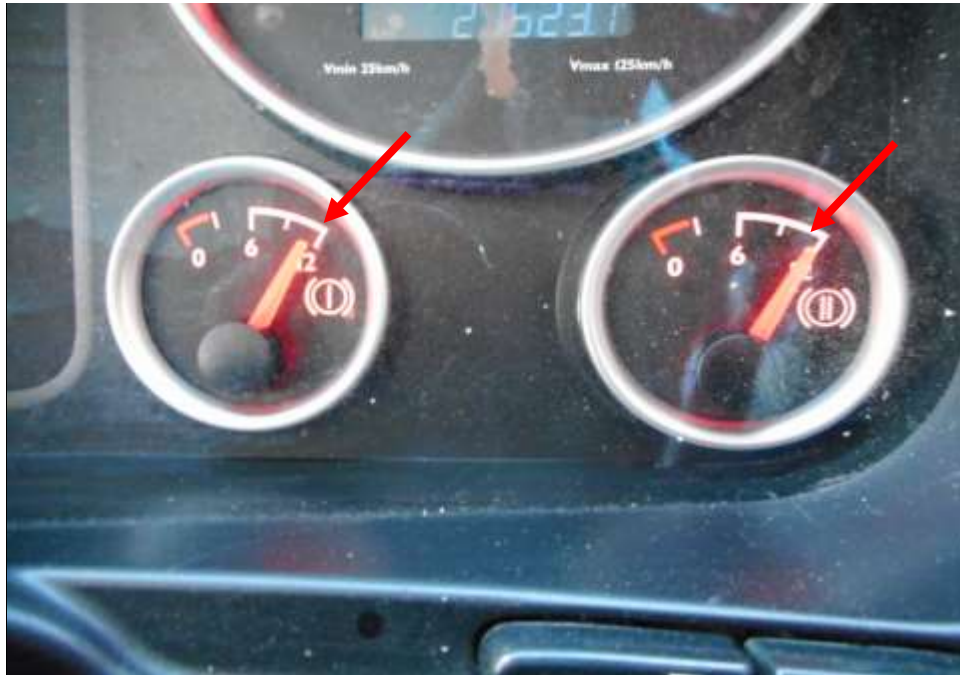
**Photo 11** shows the air in the air brake cylinders of the Motor Lorry at the time of my inspection. The air in the cylinder was observed to be of sufficient level & serviceable at the time of the accident.

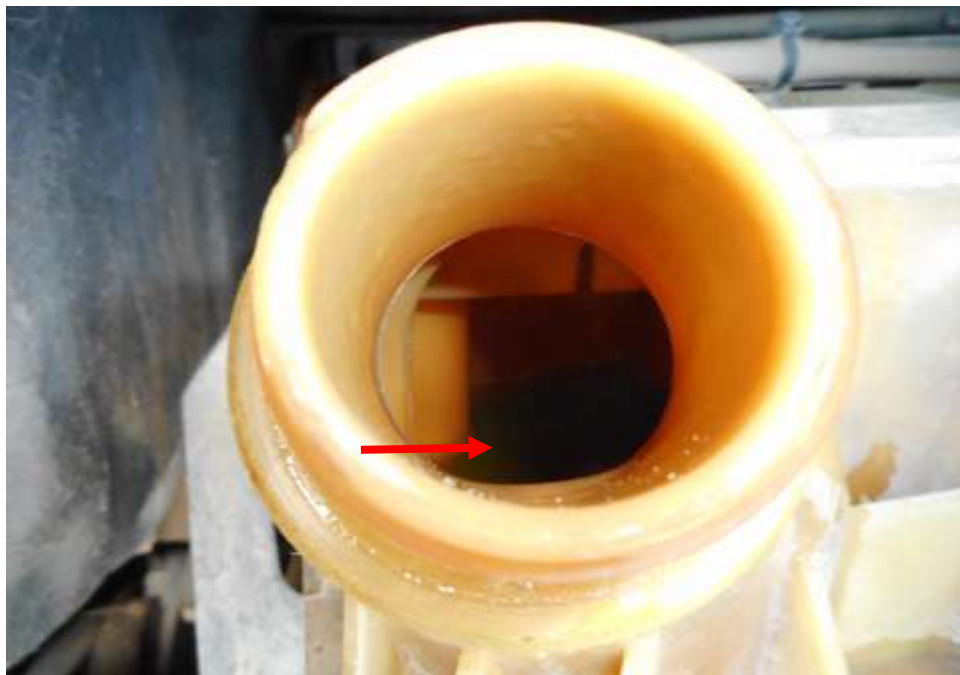
**Photo 12** shows the engine coolant reservoir of the Motor Lorry at the time of my inspection. The engine coolant was observed to be of sufficient level (arrowed) and without any visible contamination.

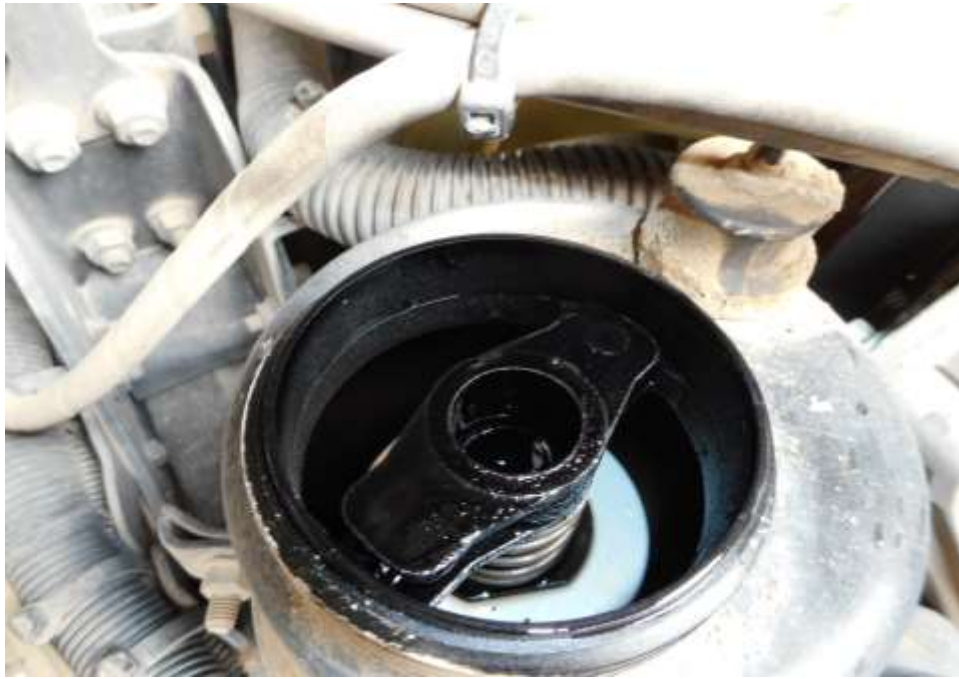
**Photo 13** shows the power steering fluid reservoir of the Motor Lorry at the time of my inspection. The power steering fluid was observed to be of sufficient level and without any visible contamination.

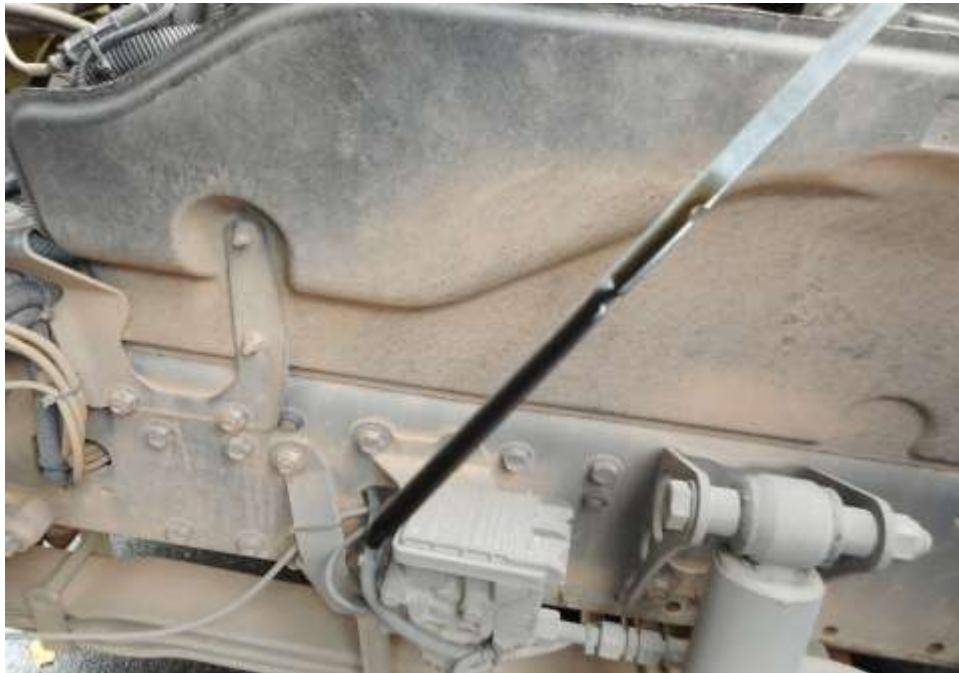
**Photo 14** shows the engine oil level display of the Motor Lorry at the time of my inspection. The engine oil was observed to be of sufficient level.

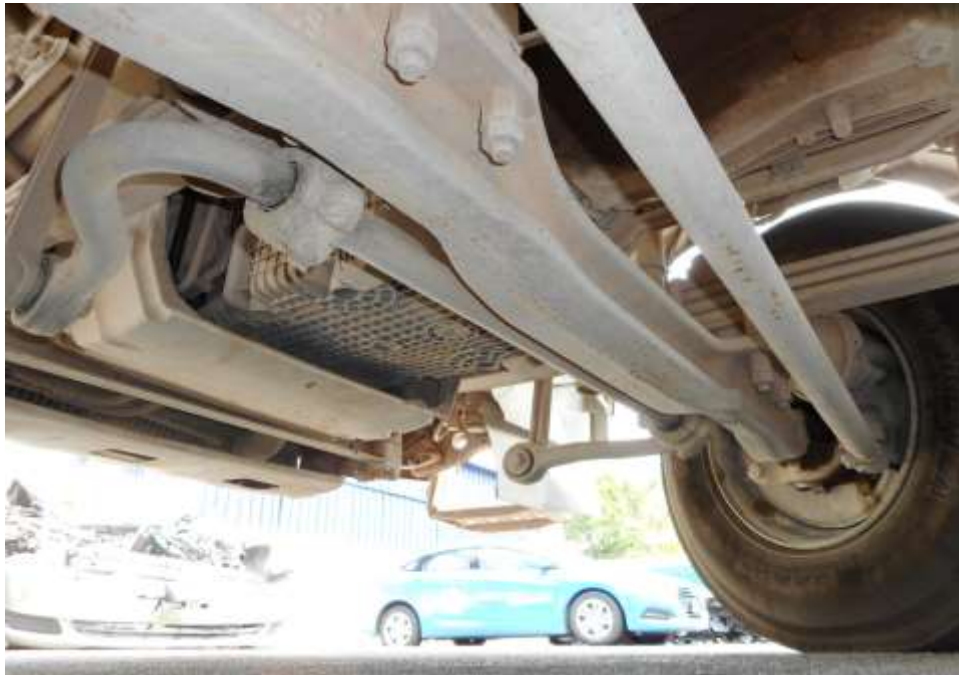
**Photo 15** shows the undercarriage of the Motor Lorry, at the area where the engine housing located. I did not find any sign(s) or indication(s) of fluid leak and/or fluid stain(s) on the underside of the Motor Lorry.

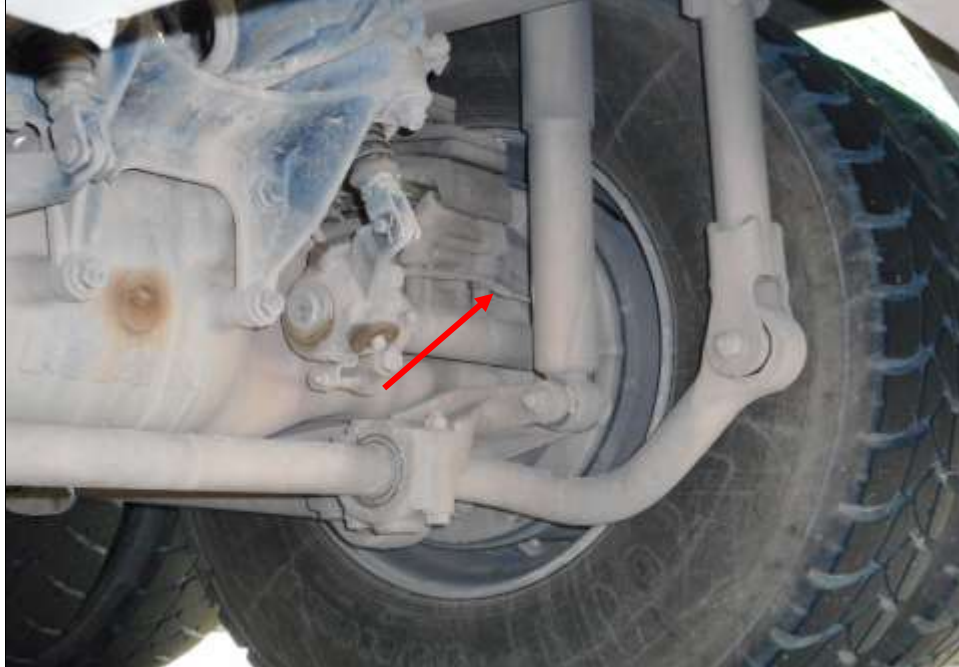
**Photo 16** shows the brake pipe (arrowed) at the rear right wheel of the Motor Lorry. I did not observe any leakage of brake fluid at the time of my inspection of the Motor Lorry. My static tests of the Motor Lorry's braking system, along with my visual examination of the various mechanical components in the braking system, had indicated that there was no internal leakage of pressure/vacuum. Hence the braking system of the Motor Lorry was likely to be in serviceable condition at the material time of accident.

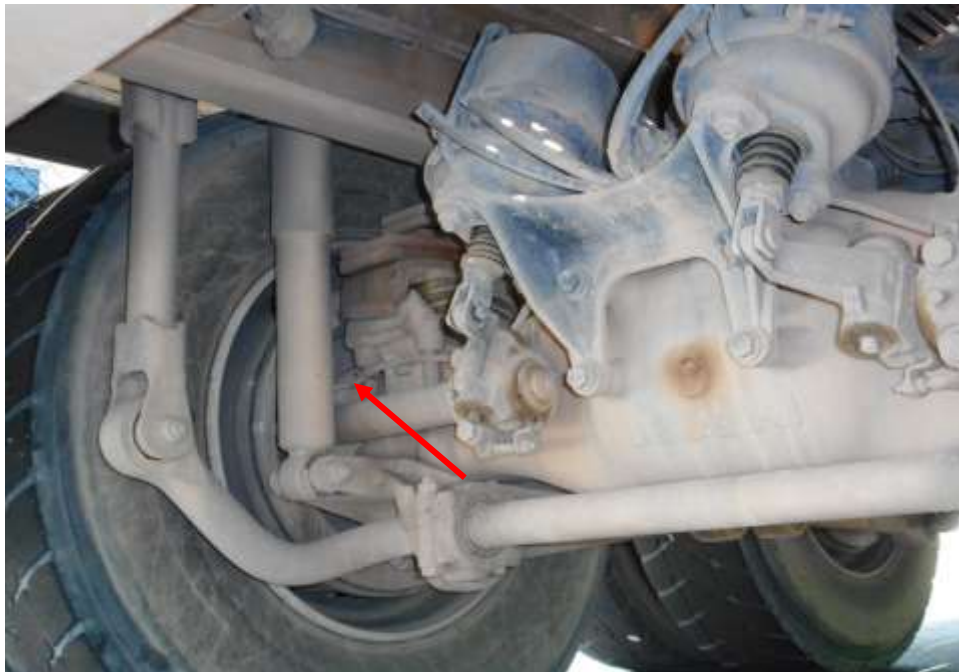
**Photo 17** shows the brake pipe (arrowed) at the rear left wheel of the Motor Lorry. I did not observe any leakage of brake fluid at the time of my inspection of the Motor Lorry. My static tests of the Motor Lorry's braking system, along with my visual examination of the various mechanical components in the braking system, had indicated that there was no internal leakage of pressure/vacuum. Hence the braking system of the Motor Lorry was likely to be in serviceable condition at the material time of accident.

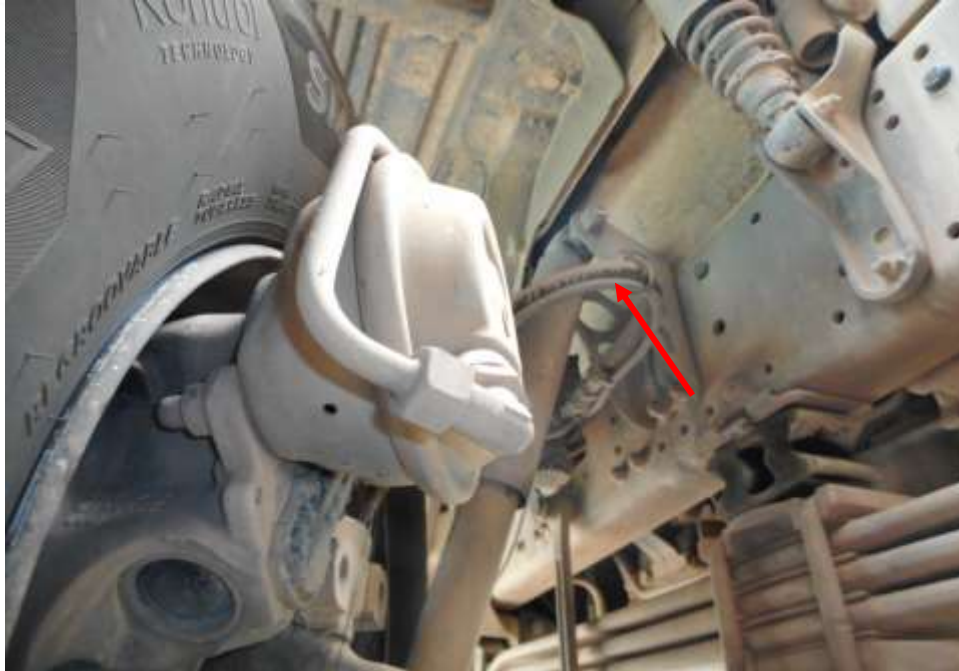
**Photo 18** shows the brake pipe (arrowed) at the front left wheel of the Motor Lorry. I did not observe any leakage of brake fluid at the time of my inspection of the Motor Lorry. My static tests of the Motor Lorry's braking system, along with my visual examination of the various mechanical components in the braking system, had indicated that there was no internal leakage of pressure/vacuum. Hence the braking system of the Motor Lorry was likely to be in serviceable condition at the material time of accident.

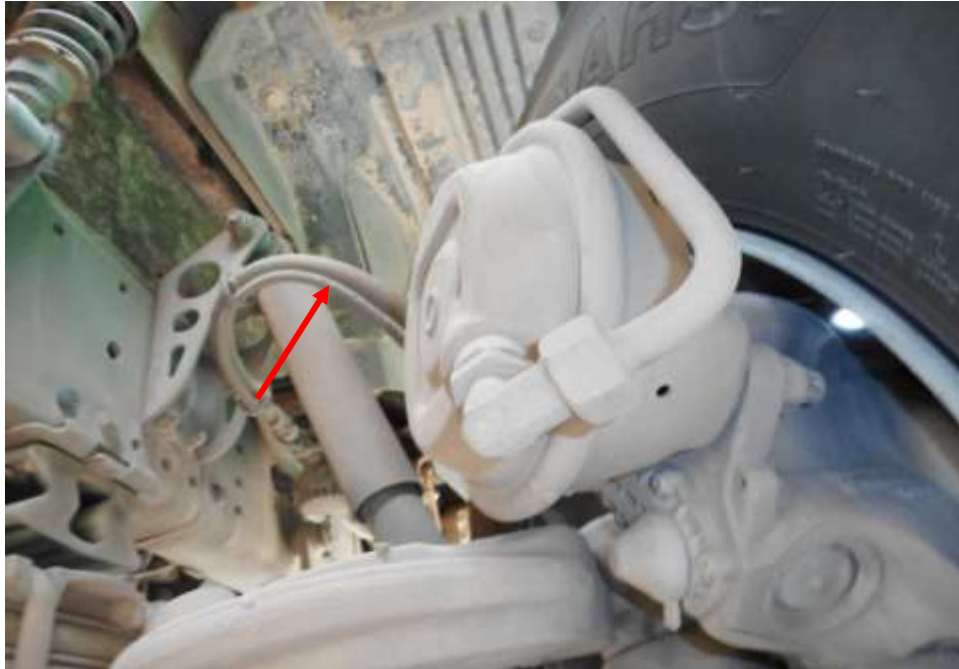
**Photo 19** shows the brake pipe (arrowed) at the front right wheel of the Motor Lorry. I did not observe any leakage of brake fluid at the time of my inspection of the Motor Lorry. My static tests of the Motor Lorry's braking system, along with my visual examination of the various mechanical components in the braking system had indicated that there was no internal leakage of pressure/vacuum. Hence the braking system of the Motor Lorry was likely to be in serviceable condition at the material time of accident.

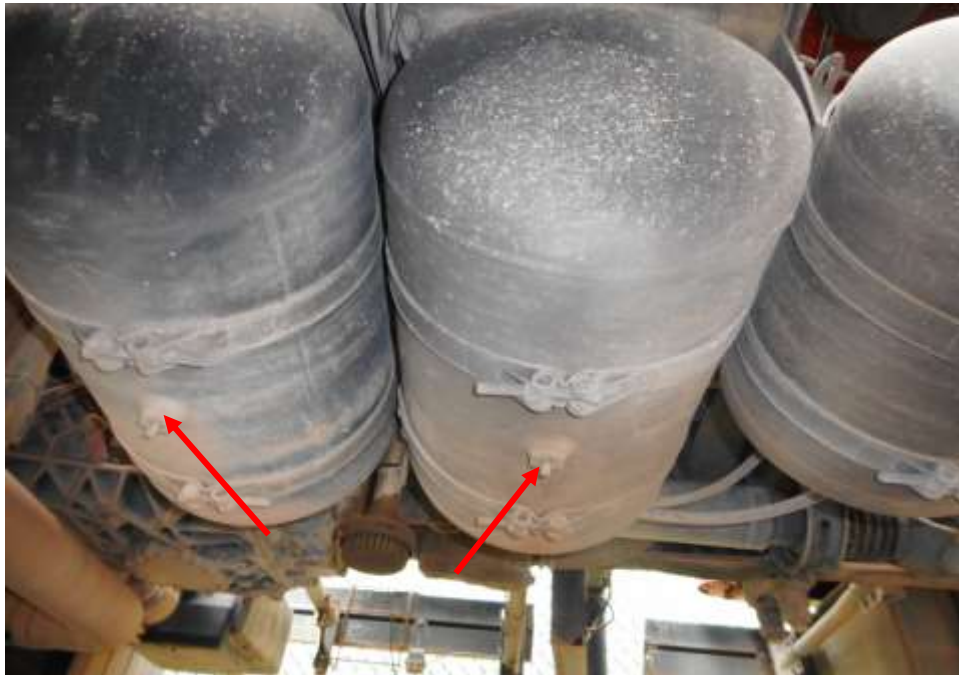
**Photo 20** shows the air brake cylinders (arrowed) at the undercarriage of the Motor Lorry. I did not observe any leakage of air brake fluid at the time of my inspection of the Motor Lorry. My static tests of the Motor Lorry's braking system, along with my visual examination of the various mechanical components in the braking system had indicated that there was no internal leakage of pressure/vacuum. Hence the braking system of the Motor Lorry was likely to be in serviceable condition at the material time of accident.

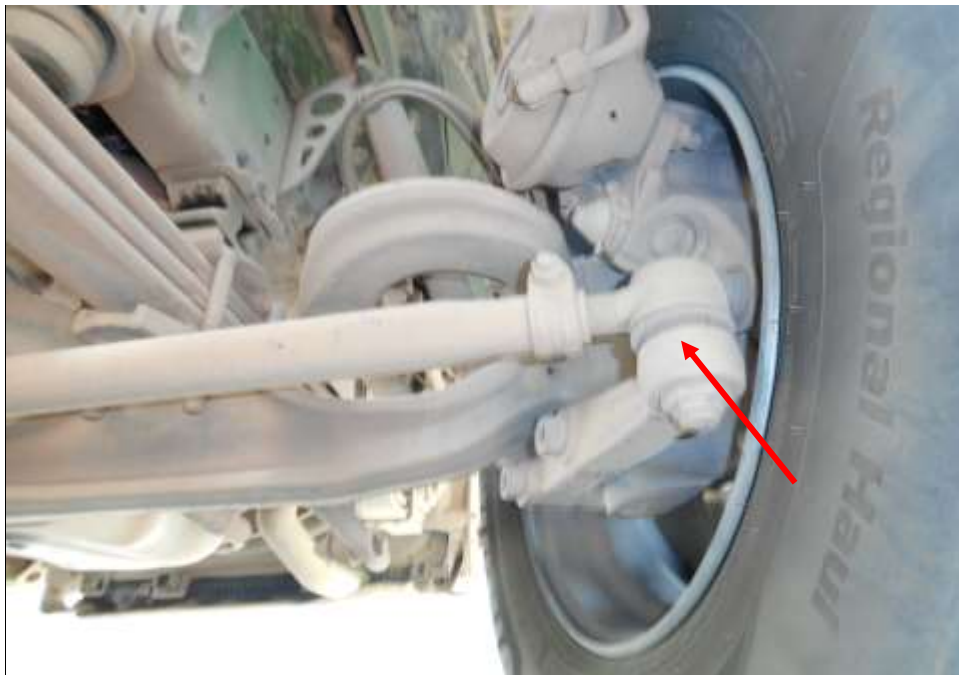
**Photo 21** shows the various undercarriage components at the front right wheel of the Motor Lorry, in particular the steering tie rod end (arrowed). The various steering components were all found to be intact, suggesting that the steering system of the Motor Lorry was likely to be in serviceable condition at the material time of accident. There was also no sign of fluid stain(s) observed on the various undercarriage components.

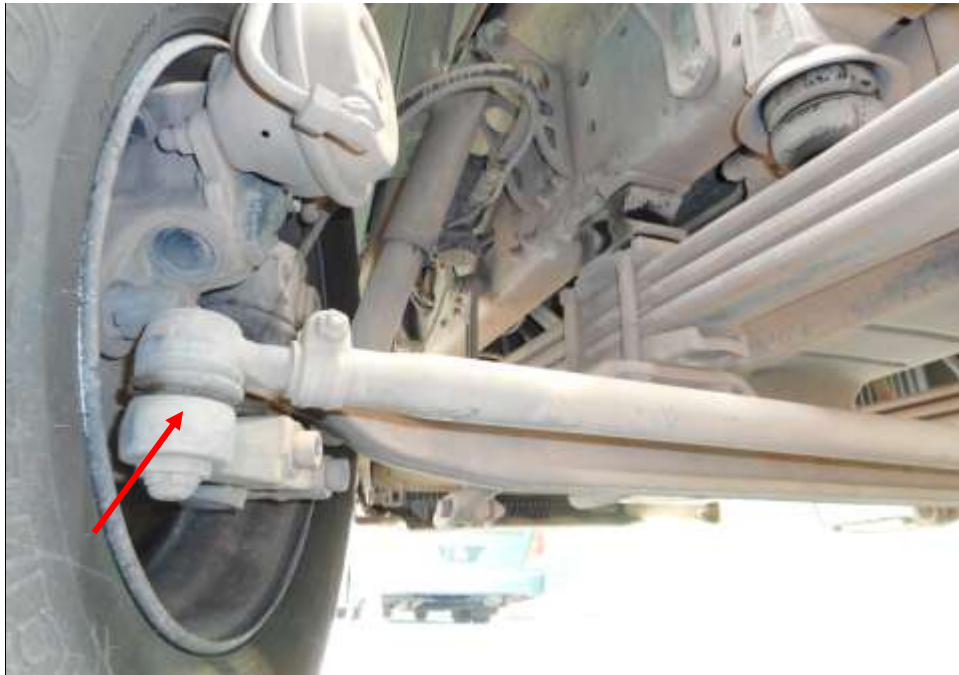
**Photo 22** shows the various undercarriage components at the front left wheel of the Motor Lorry, in particular the steering tie rod end (arrowed). The various undercarriage components of the Motor Lorry were all found to be intact without any visible damage. There was also no sign of fluid stain(s) observed on the various undercarriage components.

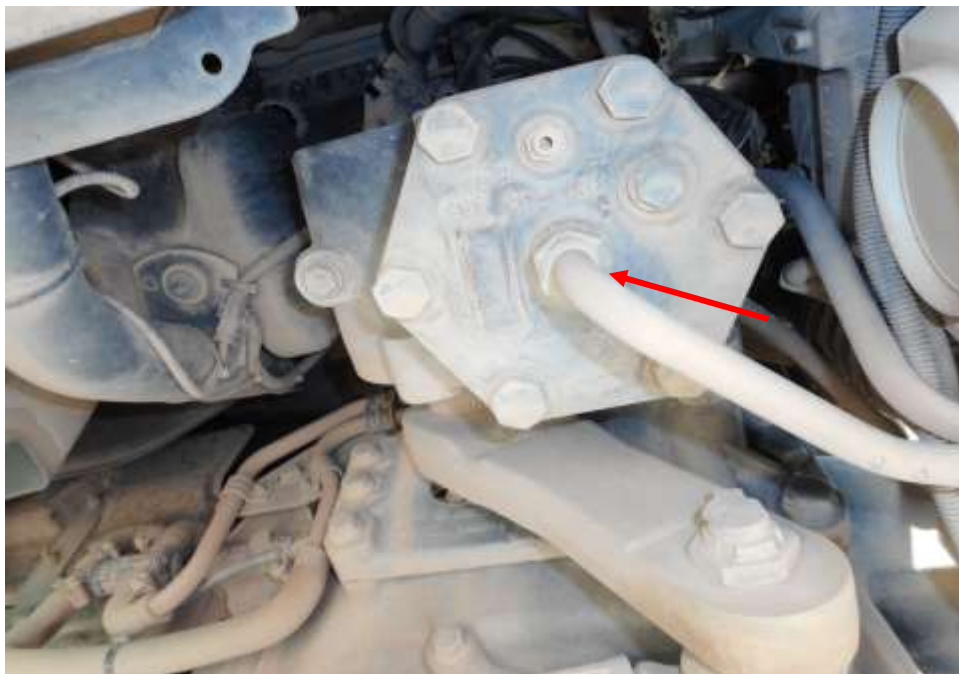
**Photo 23** shows the steering box component (arrowed) at the undercarriage of the Motor Lorry was found to be intact without any visible damage. There was also no sign of fluid stain(s) observed on the various undercarriage components.

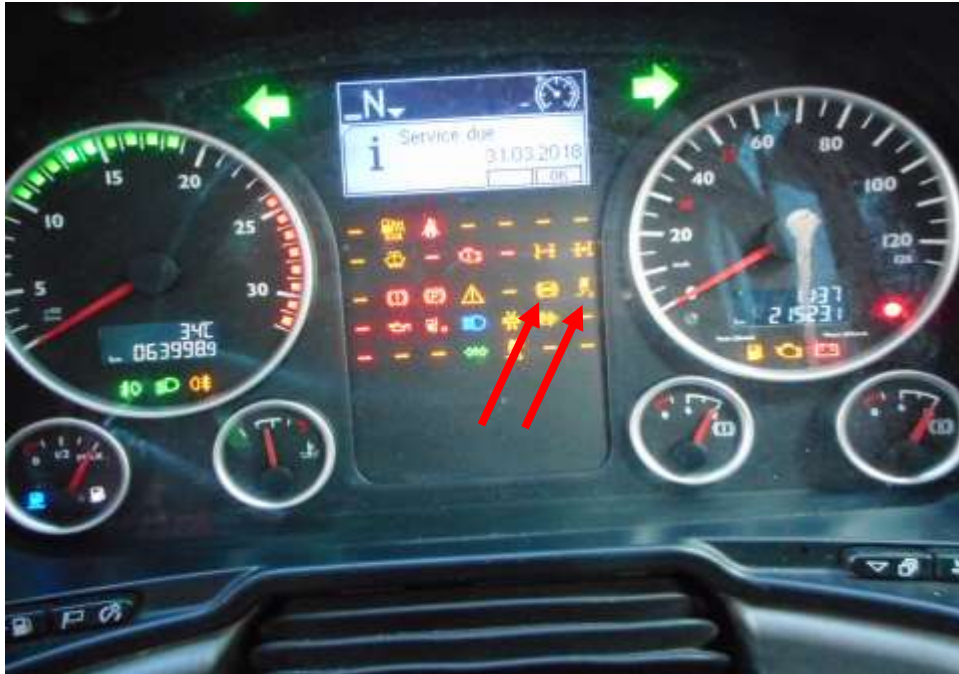
**Photo 25** shows the warning light for Anti-Lock Brake System (ABS) and Traction Control System (TC) (arrowed) appearing on the instrument panel of the Motor Lorry during the self-test of its various electronic operating systems when its engine was cranked.

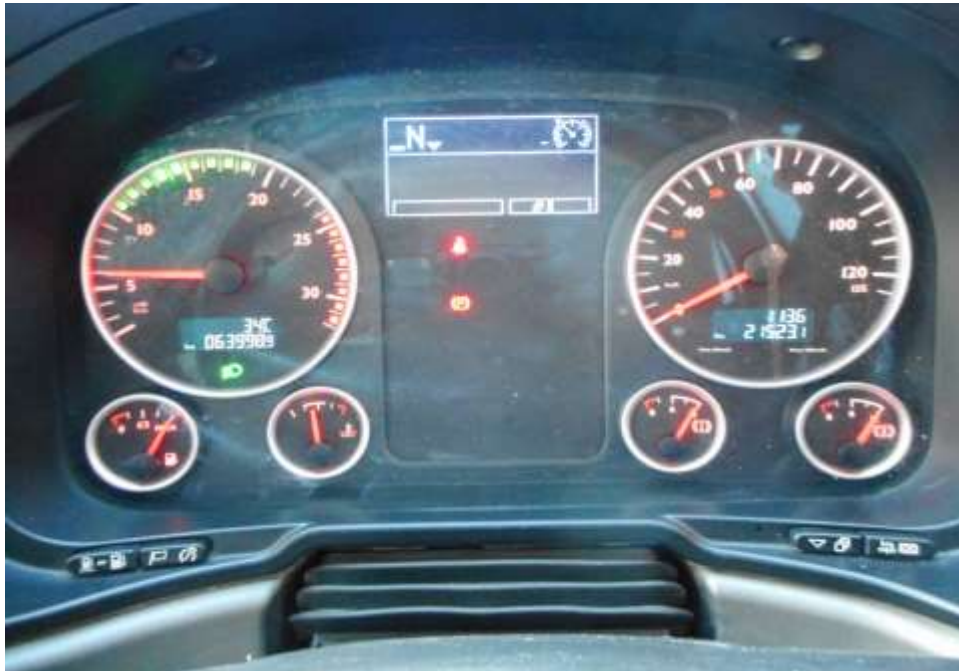
**Photo 26** shows no warning lights illuminated on the instrument panel of the Motor Lorry after the engine was cranked. This would suggest that there was no abnormality to the various electronic operating systems of the Motor Lorry, like the ABS etc.
