Your Ref: 603305
Our Ref : CI/MSG19019958/D

11 November 2019

AUTOMOBILE INSPECTION REPORT OF THE INSURED VEHICLE SMK 4105T

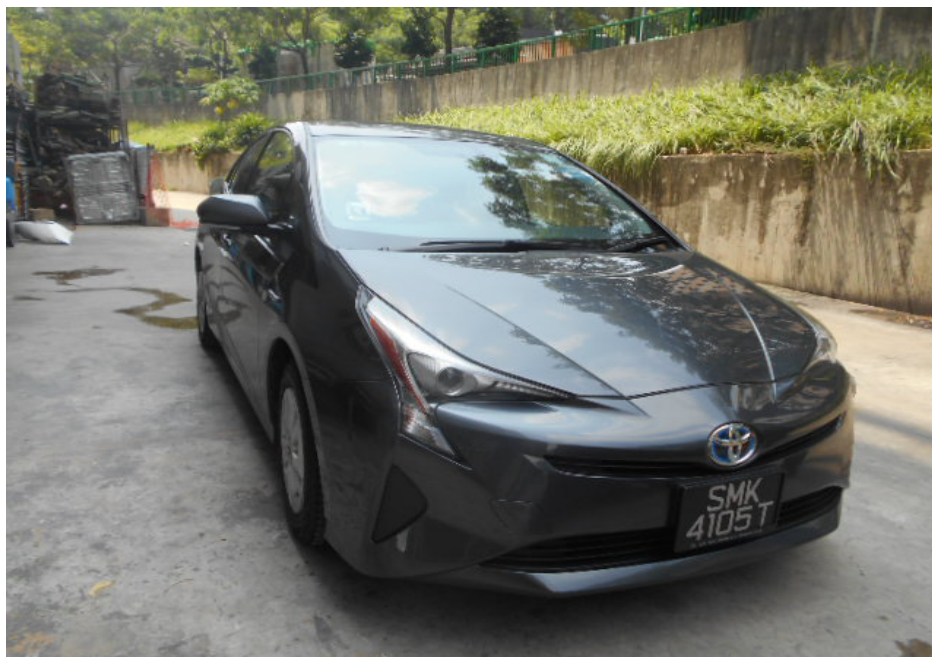
Photo 1 shows a general view of the Insured Vehicle at the time of my inspection on 06 November 2019. The repair to the Insured Vehicle for damages sustained as a result of the road traffic accident on 19 August 2019 was observed to have been completed. The mileage of the Insured Vehicle at the time of this inspection was 54,129km.

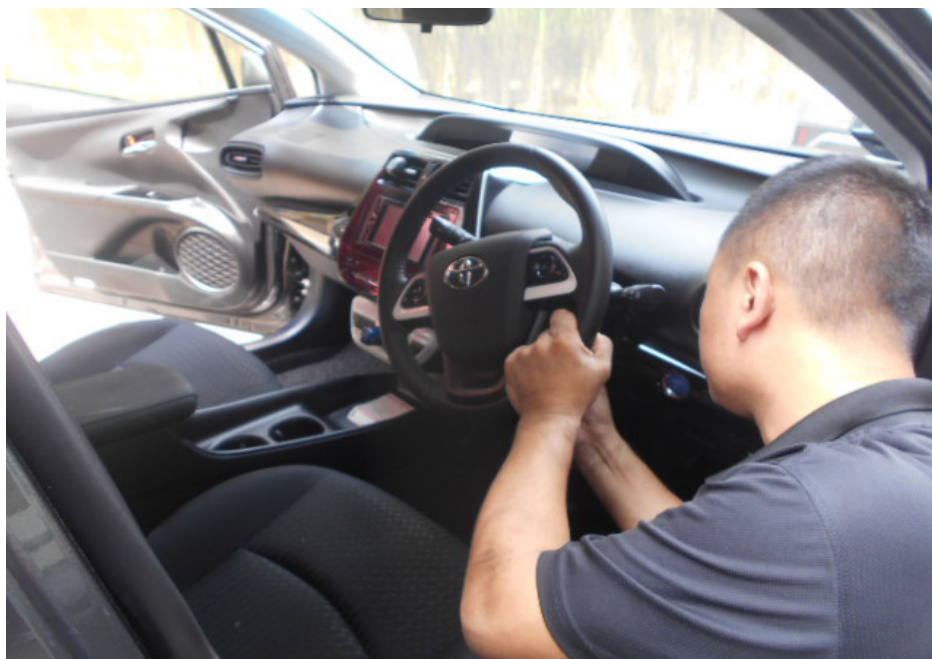
Photo 2 shows the driver's airbag of the Insured Vehicle being removed in my presence.

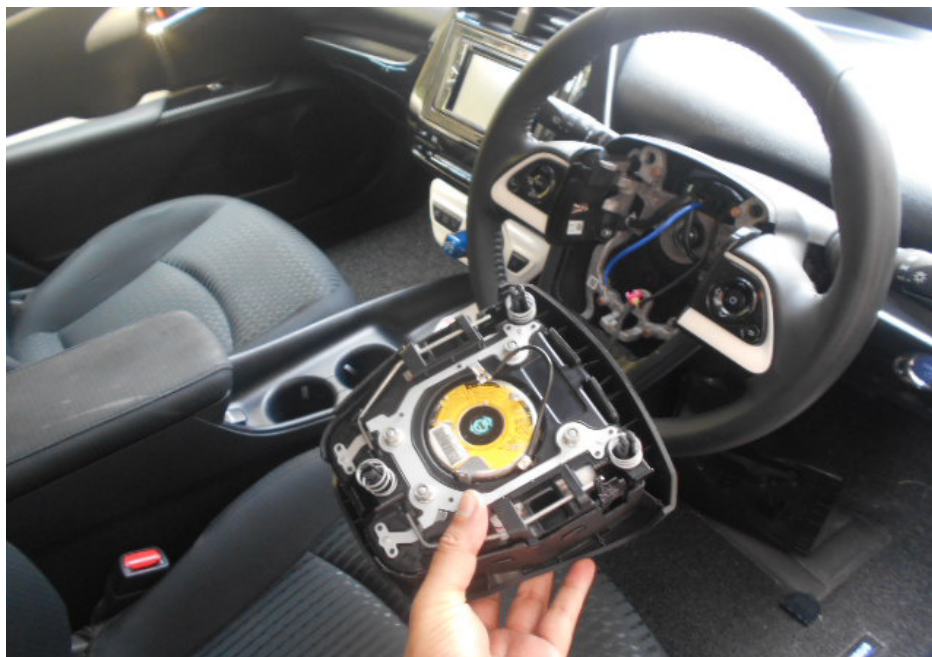
Photo 3 shows a back view of the driver's airbag of the Insured Vehicle after it was removed from the steering wheel of the Insured Vehicle.

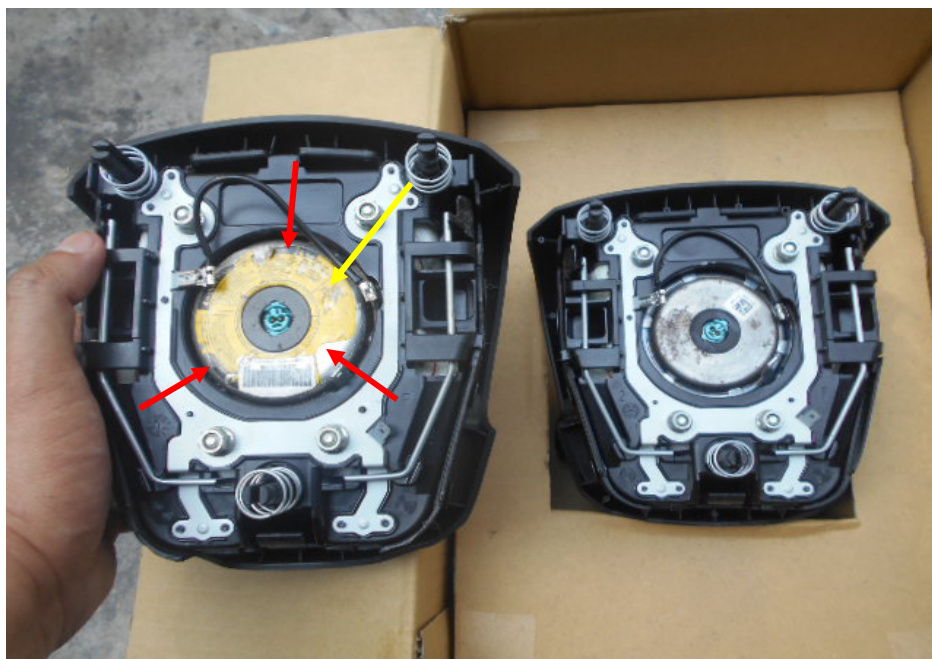
4. Upon comparing the removed driver's airbag of the Insured Vehicle with a new driver's airbag for a similar make and model vehicle, I had observed 2 differences on the exterior. The first difference was the partially torn off and relatively worn looking sticker label on the airbag propellant; the second difference was the size of the airbag propellant, which was bigger in size as compared to the driver's airbag for a similar make and model vehicle.

Photo 4 shows the driver's airbag of the Insured Vehicle in comparison with a new driver's airbag for a similar make and model vehicle. I had observed 2 differences on the exterior. The first difference was the partially torn off and relatively worn looking sticker label on the airbag propellant (red arrow); the second difference was the size of the airbag propellant (yellow arrow), which was bigger in size as compared to the driver's airbag for a similar make and model vehicle.

6. Basing on my observations, it would appear to me that the driver's airbag of the Insured Vehicle was a repaired part. The torn and worn looking sticker label, the bigger size airbag propellant, the dirty condition of the airbag and the incomplete sealing of the airbag propellant are all signs and indications to suggest that the driver's airbag of the Insured Vehicle was repaired and not a new part.

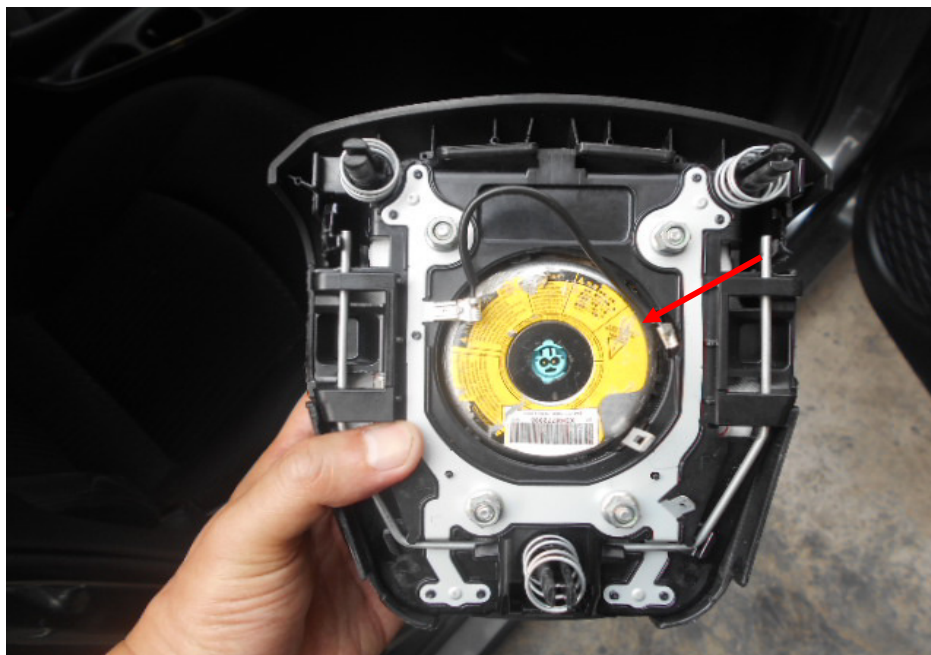
Photo 5 shows a closer view of the driver's airbag of the Insured Vehicle. The size of the airbag propellant (arrowed) was observed to be bigger when compared with a driver's airbag for a similar make and model vehicle. The sticker label on the propellant was also observed to be partially torn off and worn looking.

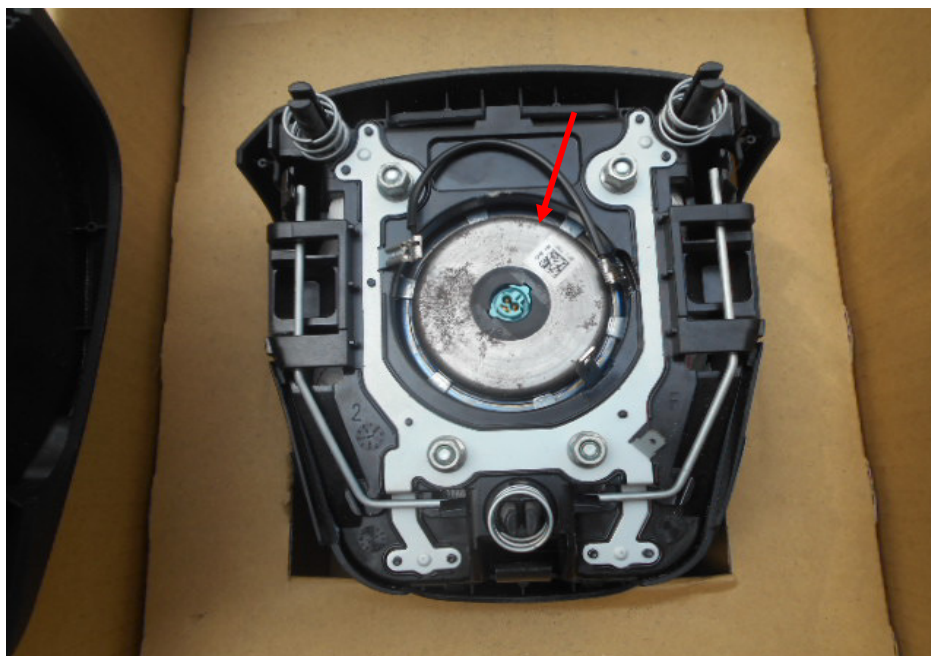
Photo 6 shows a closer view of the driver's airbag for a similar make and model vehicle. The airbag propellant (arrowed) was observed to be smaller in size as compared to the propellant for the driver's airbag of the Insured Vehicle. There was also no sticker label on the propellant for the driver's airbag for a similar make and model vehicle.

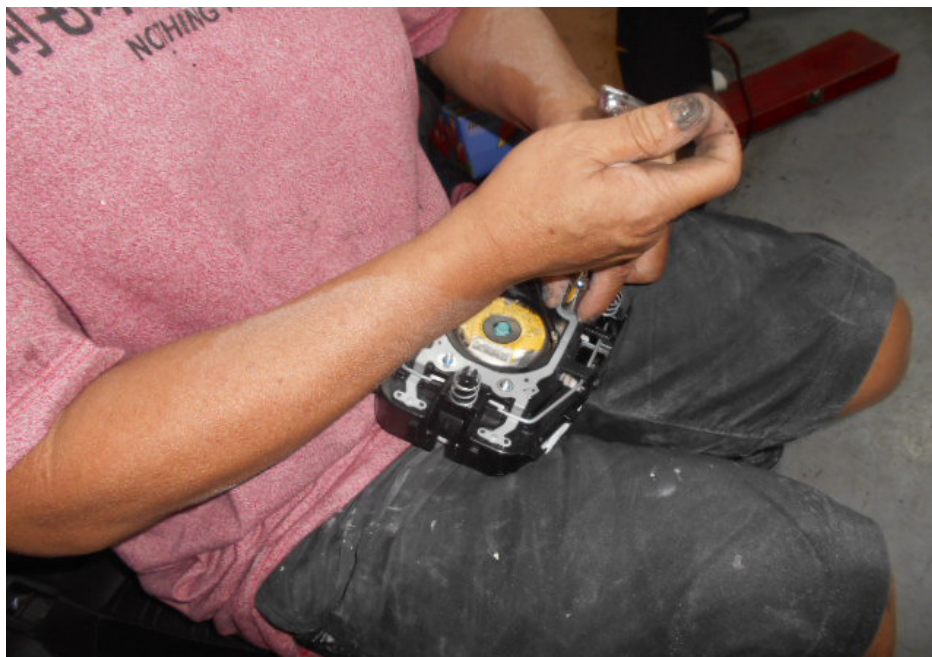
Photo 7 shows dismantling of the driver's airbag of the Insured Vehicle. This was carried out for the purpose of checking the interior of the driver's airbag of the Insured Vehicle. Dismantling was carried out by an airbag specialist in my presence.

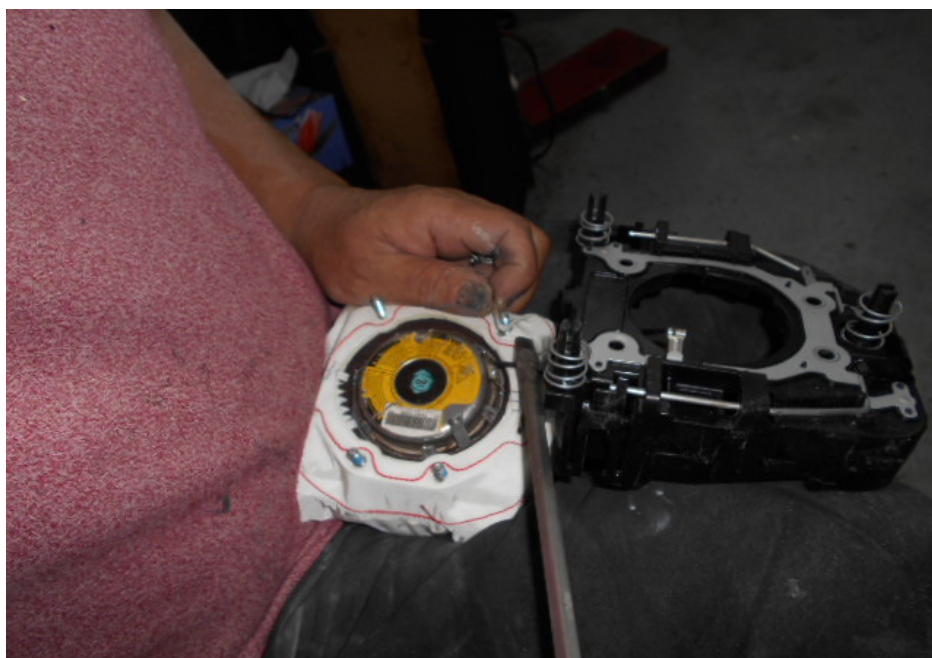
Photo 8 shows dismantling of the driver's airbag of the Insured Vehicle. This was carried out for the purpose of checking the interior of the driver's airbag of the Insured Vehicle. Dismantling was carried out by an airbag specialist in my presence.

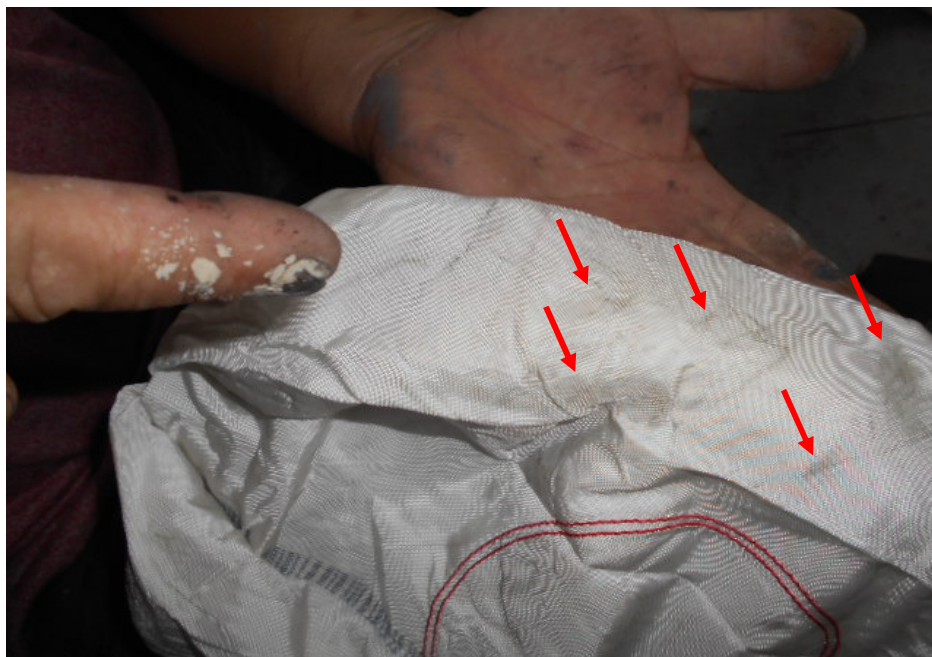
5. I then sought the assistance of an airbag specialist and upon my request, the driver's airbag of the Insured Vehicle was dismantled. Upon checking on the airbag, I had found the airbag to be dirty with black stain marks at multiple areas. The seal surrounding the airbag propellant also did not completely seal the airbag propellant at one area. See photo 1 – 13 below showing the photographs that were taken for the purpose this report.

Photo 9 shows the airbag after it was unfolded. The airbag was found to be dirty with black stain marks (arrowed) at multiple areas.

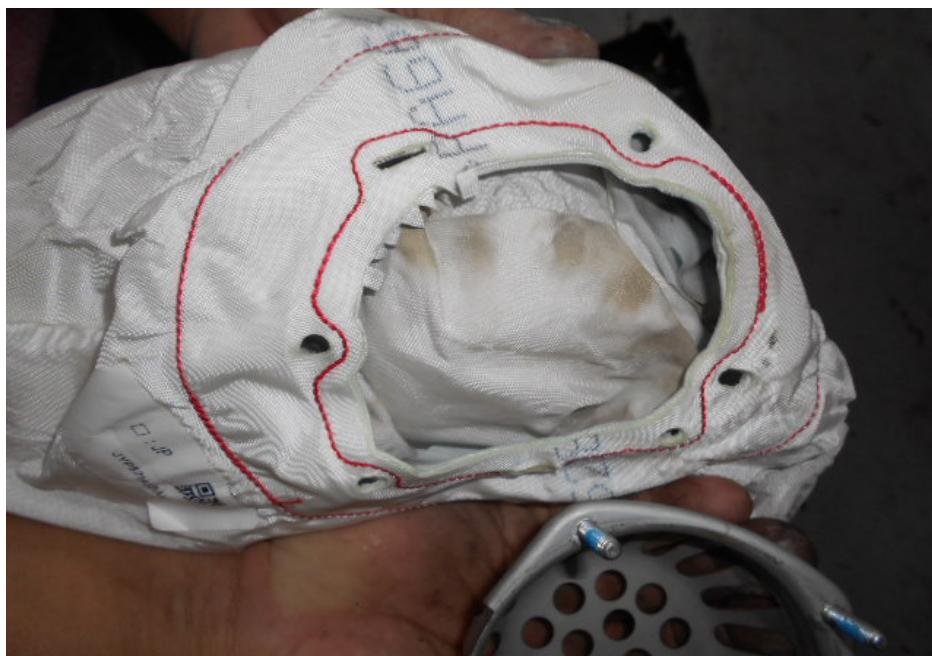
Photo 10 shows the airbag after it was unfolded. The airbag was found to be dirty with black stain marks at multiple areas.

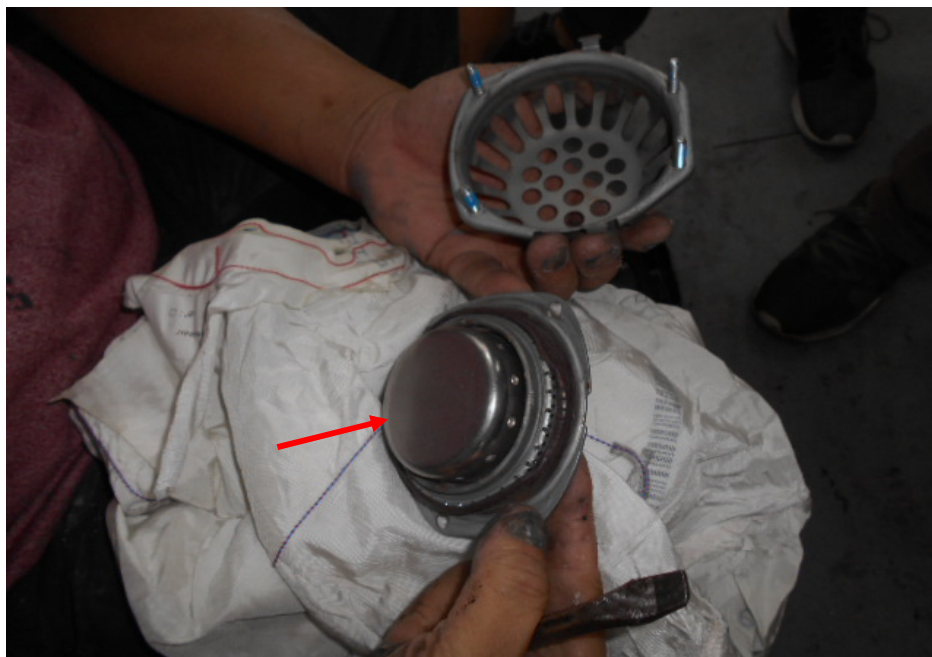
Photo 11 shows the bigger size airbag propellant (arrowed) for the driver's airbag of the Insured Vehicle after the airbag was removed.

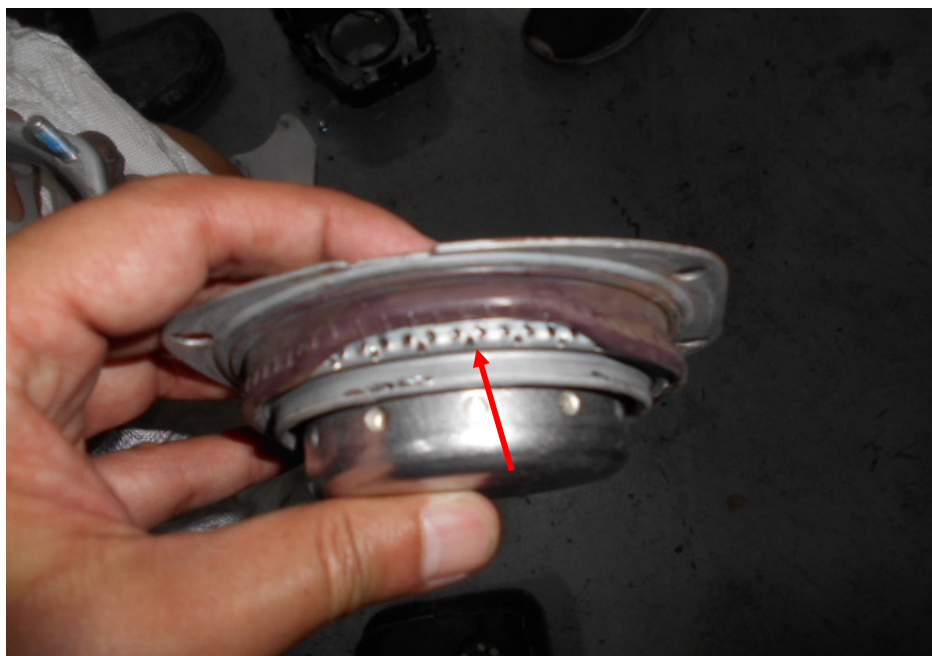
Photo 12 shows airbag propellant not completely sealed at one area, exposing the airbag propellant (arrowed).

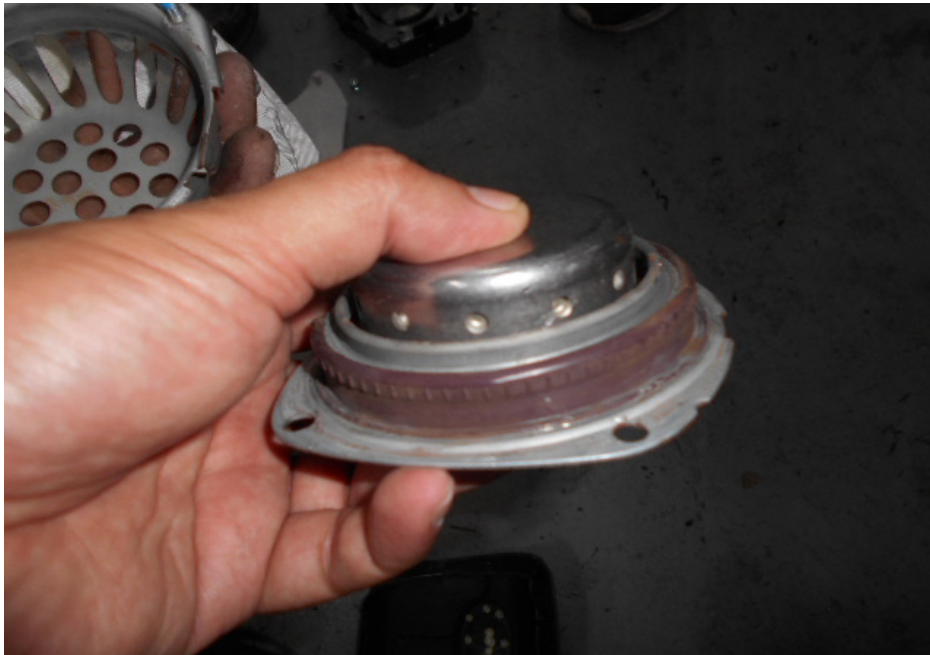
Photo 13 shows other areas of the airbag propellant for the driver's airbag of the Insured Vehicle. On comparison, the other areas of the propellant were observed to be completely sealed.
