Your Ref: 603305
Our Ref : CI/MSG19019958/D-1

SUPPLEMENTARY AUTOMOBILE INSPECTION REPORT OF THE INSURED VEHICLE SMK 4105T

1. This report serves as a supplementary report to a further physical inspection that was carried out to the insured vehicle SMK 4105T (herein referred to as "**Insured Vehicle**") on 13 February 2020.

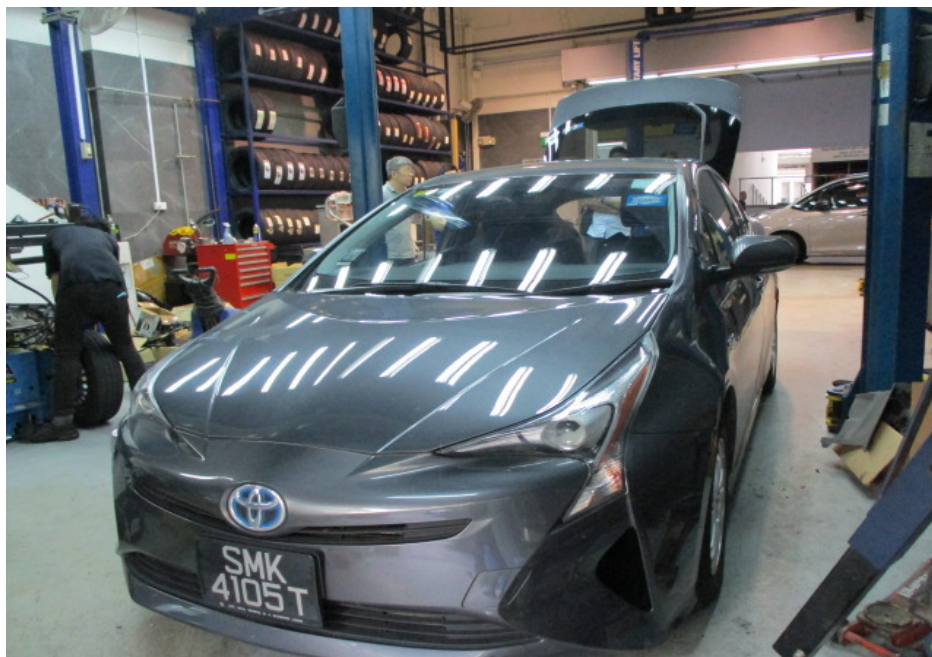
Photo 1 shows a general view of the Insured Vehicle at the time of my inspection on 13 February 2020. The mileage of the Insured Vehicle at the time of this inspection was 74,941km.

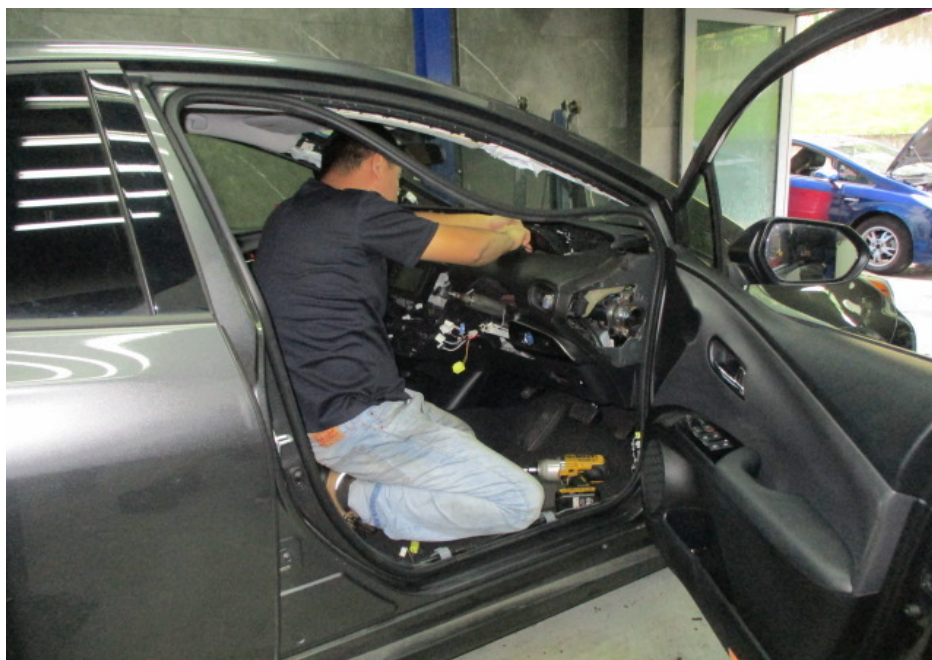
Photo 2 shows dismantling works being carried out to the Insured Vehicle in my presence. For this inspection, the driver's airbag, front left passenger airbag, driver's seat airbag, front left passenger seat airbag, left side curtain airbag, right side curtain airbag and front dashboard that were fitted on the Insured Vehicle were all dismantled and physically compared with new parts.

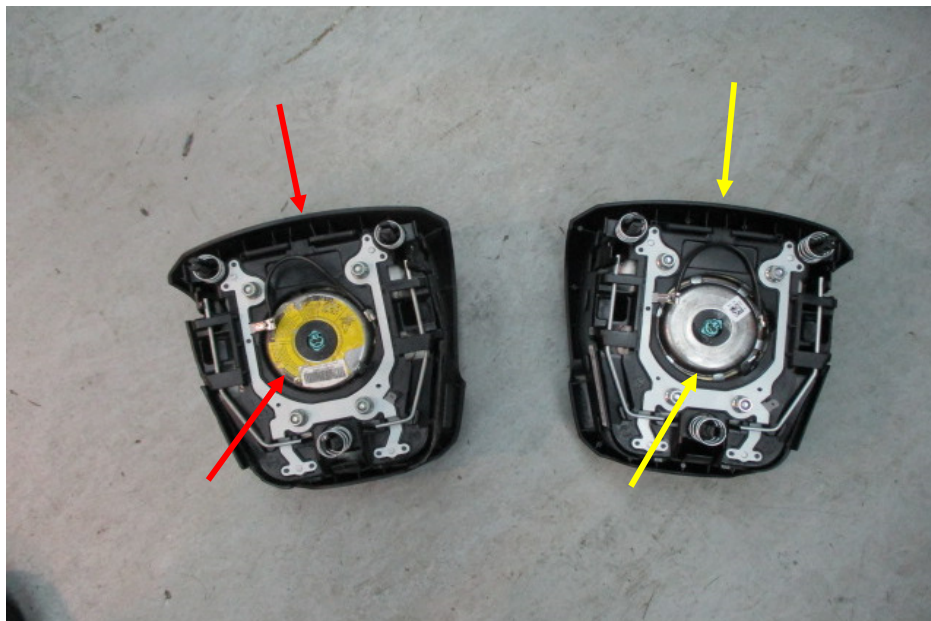
Photo 3 shows the driver's airbag (red arrow) that was fitted on the Insured Vehicle in comparison with a new driver's airbag (yellow arrow). As commented in LKK's First Report, I had observed 2 differences on the exterior. The first difference was the partially torn off and relatively worn looking sticker label on the airbag propellant (also indicated by the red arrow); the second difference was the size of the airbag propellant (also indicated by the red arrow), which was bigger in size as compared to the airbag propellant of a new driver's airbag (also indicated by the yellow arrow). For more photographs of the driver's airbag that was fitted on the Insured Vehicle, refer to LKK's First Report.

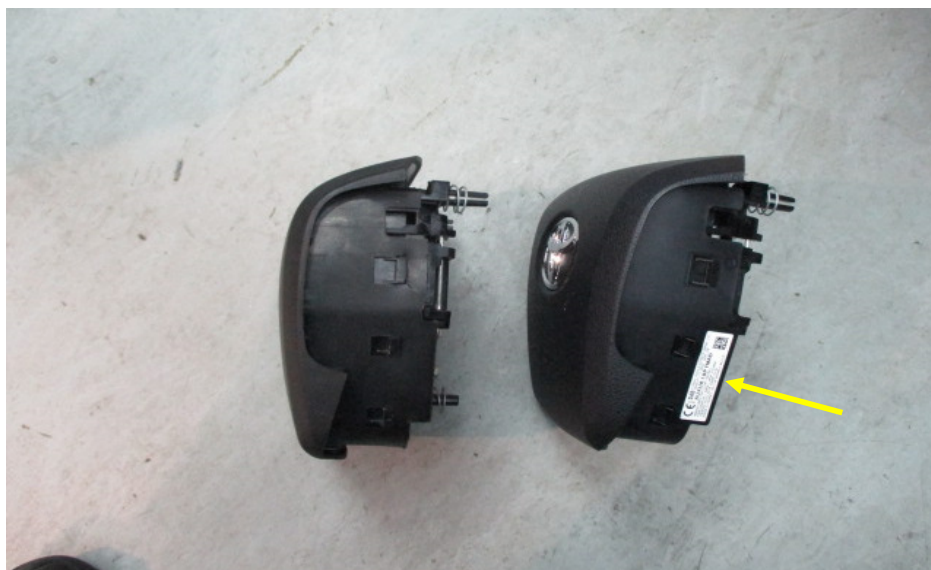
Photo 4 shows a sticker label (yellow arrowed) that was pasted on the side of a new driver's airbag cover, which was not found on the cover of the driver's airbag that was fitted on the Insured Vehicle.

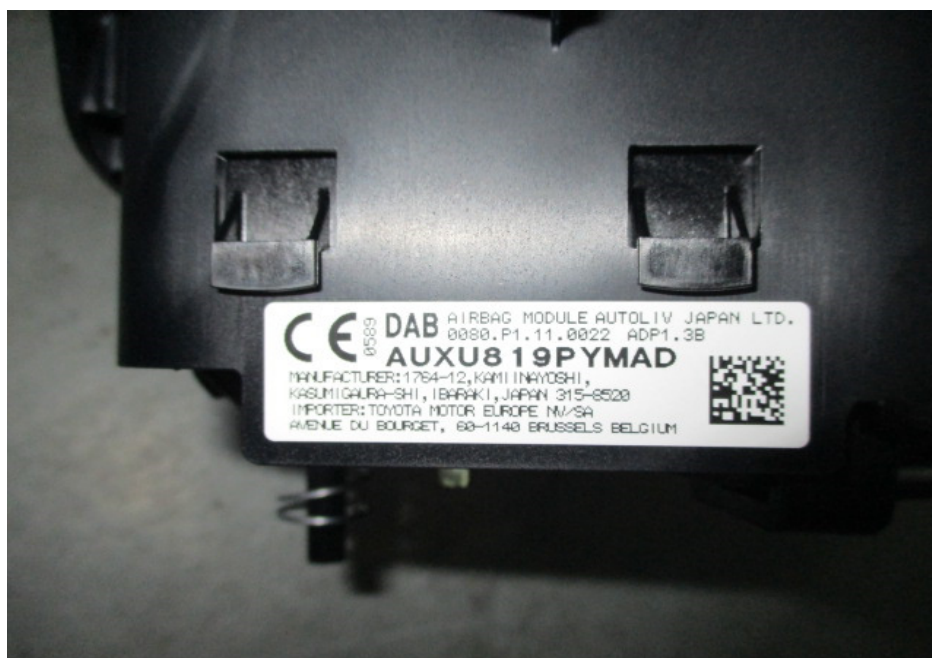
Photo 5 shows a closer view of the sticker label that was pasted on the cover of a new driver's airbag. The sticker label had indicated the manufacturer and importer of the driver's airbag.

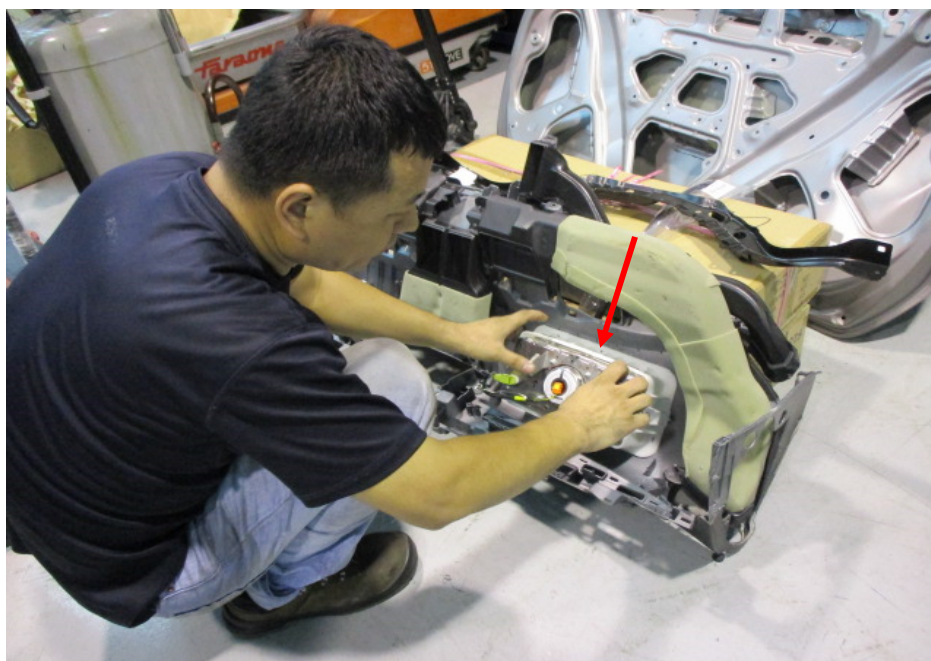
Photo 6 shows dismantling of the Insured Vehicle's front left passenger airbag (arrowed) after the front dashboard was dismantled.

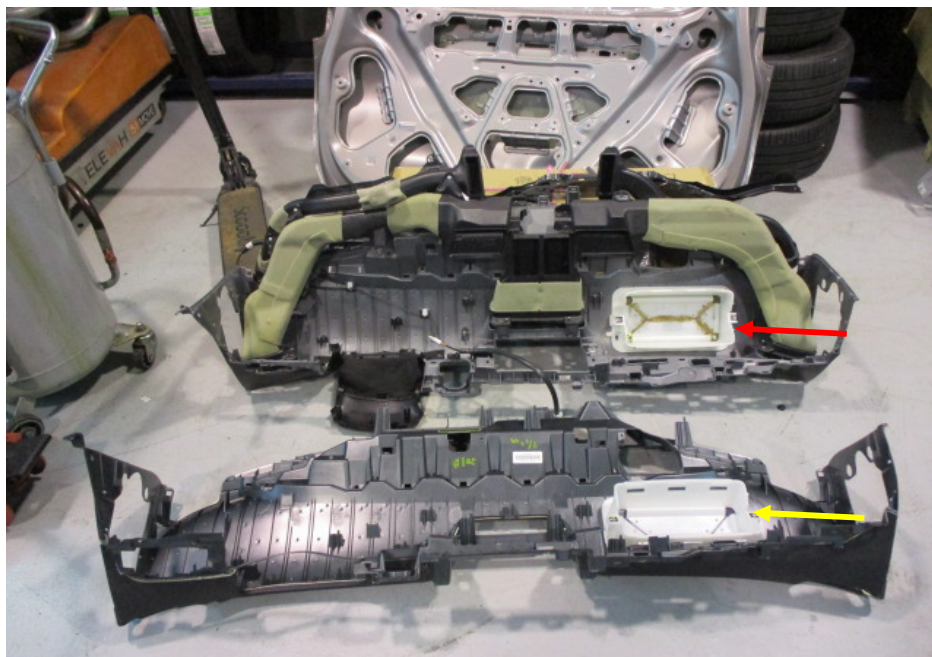
Photo 7 shows the comparison between the cover of the front left passenger airbag (red arrow) that was fitted on the Insured Vehicle and a new front left passenger airbag cover (yellow arrow). It was observed that the opening of the cover for the Insured Vehicle's front left passenger airbag was sealed with some saw dust like material.

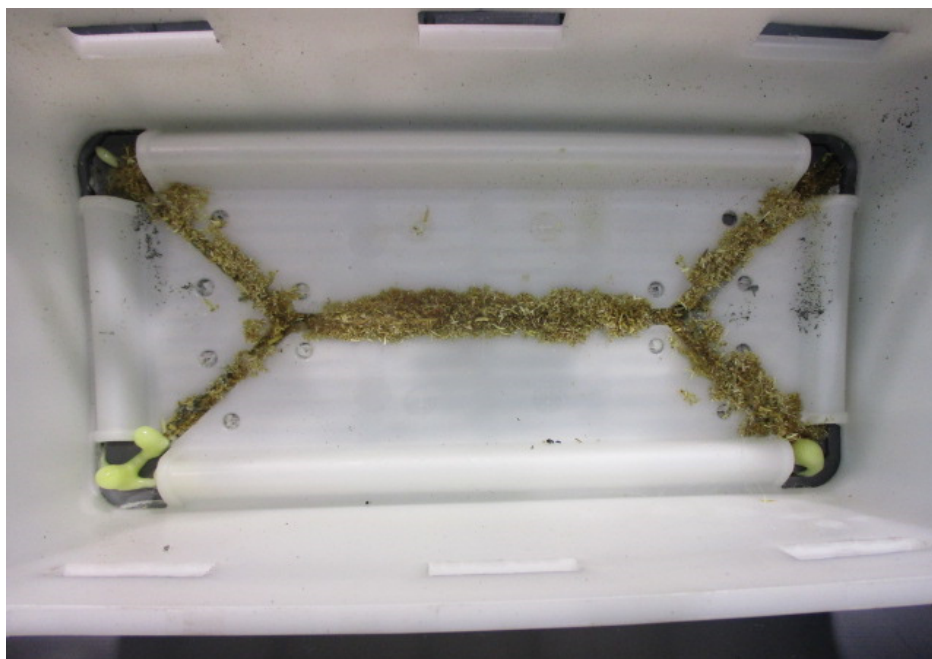
Photo 8 shows a closer view of the saw dust like material that was used to seal the opening of the cover for the Insured Vehicle's front left passenger airbag.

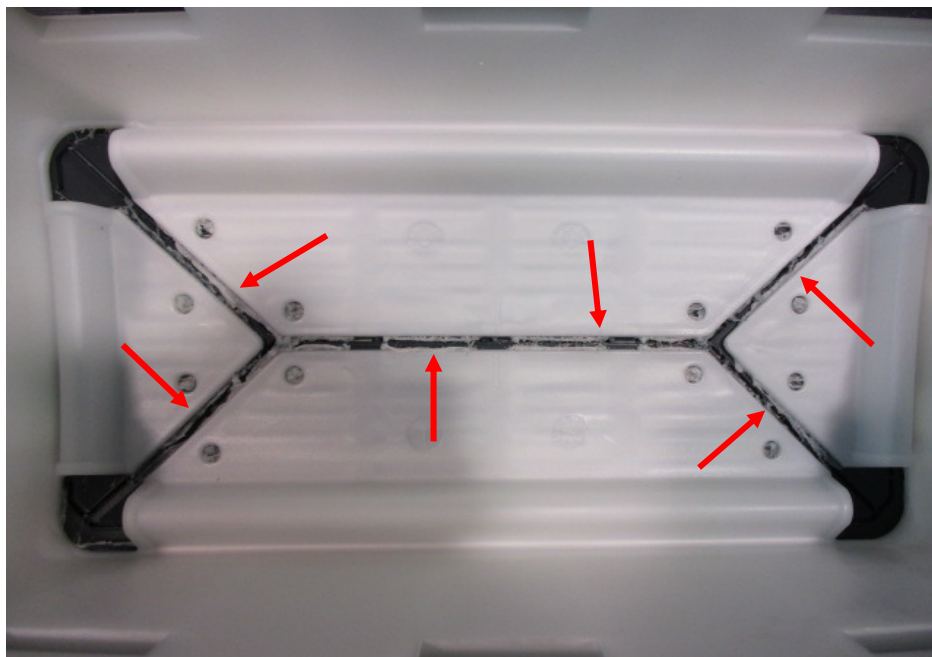
Photo 9 shows the sealing of the opening of a new front left passenger airbag cover. When the front left passenger airbag is activated, the airbag explodes outwards, breaking the seal at the opening (arrowed). The saw dust like material seen on the same part that was fitted on the Insured Vehicle was for the re-sealing of the opening. This would indicate that the cover for the front left passenger airbag that was fitted on the Insured Vehicle was a used part.

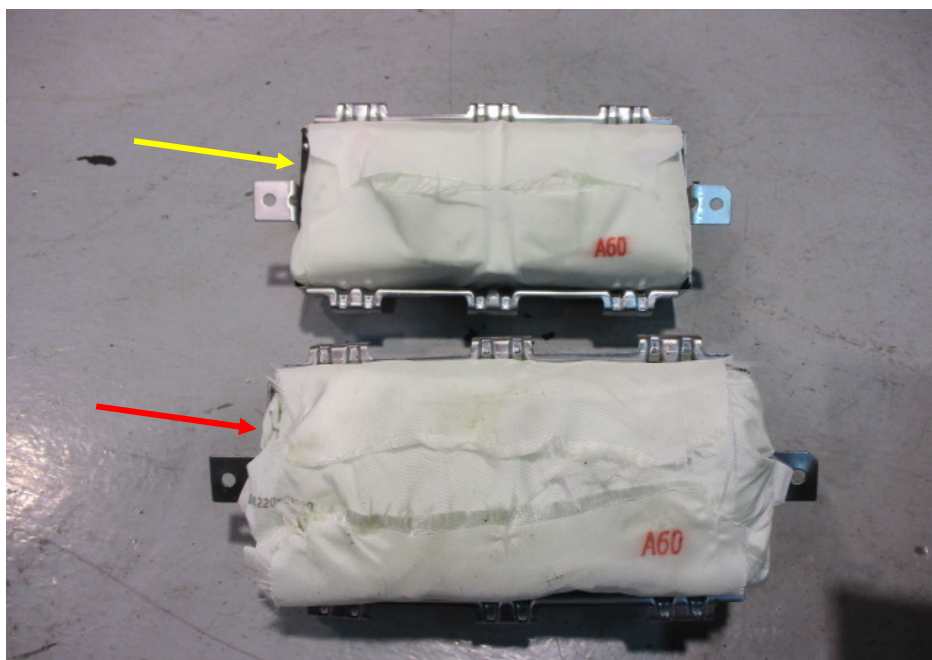
Photo 10 shows the front left passenger airbag (red arrow) that was fitted on the Insured Vehicle in comparison with a new front left passenger airbag (yellow arrow). The one fitted on the Insured Vehicle was observed to be in a dirty condition and not folded properly into its casing.

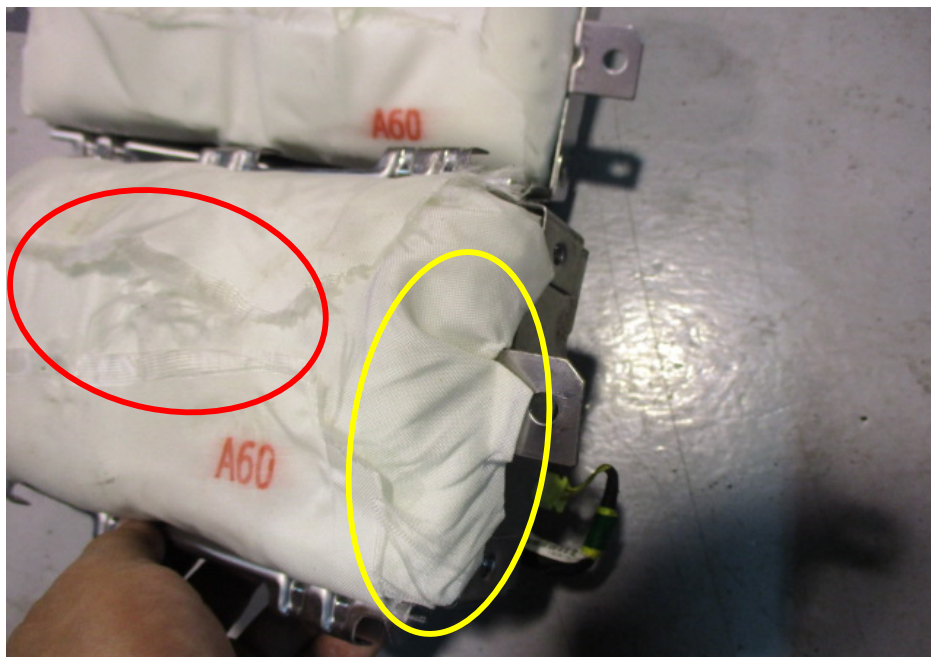
Photo 11 shows a closer view of the front left passenger airbag that was fitted on the Insured Vehicle. The front left passenger airbag was observed to be with dirty stain marks (red circle) and not folded properly (yellow circle) into its casing, which suggests that the front left passenger airbag was re-folded after activation; and is a re-used airbag.

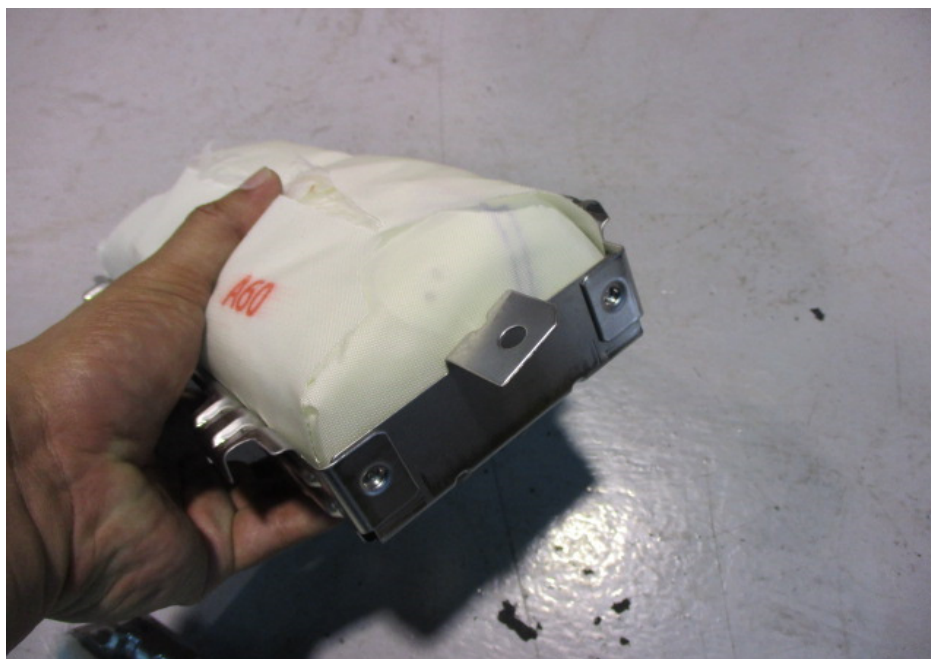
Photo 12 shows a closer view of a new front left passenger airbag, at the same area as shown in photograph 11 above. In comparison, the new front left passenger airbag was nicely folded into its casing and was in a clean condition with no dirty stain marks seen.

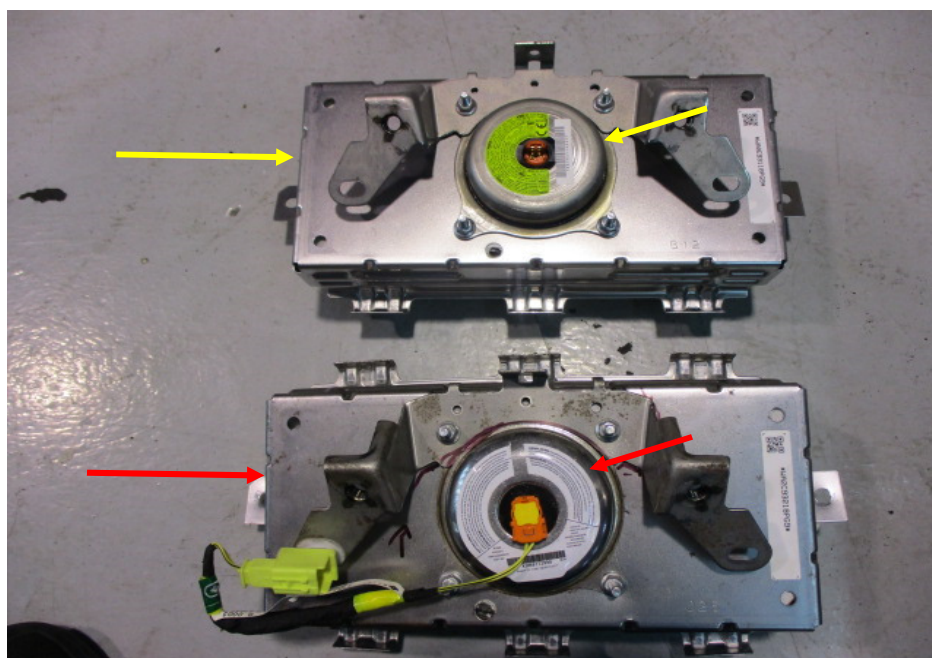
Photo 13 shows the back of the casing for the front left passenger airbag (red arrow) that was fitted on the Insured Vehicle in comparison with a new front left passenger airbag (yellow arrow). The sticker label for the airbag propellants (also indicated by the red and yellow arrows) for both were observed to be different.

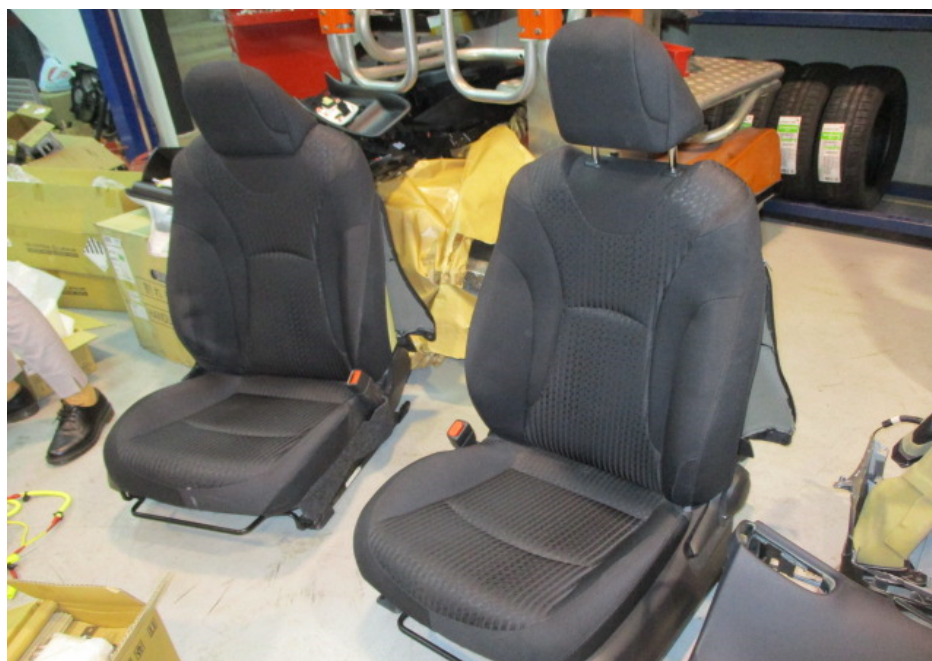
Photo 14 shows a general view of the driver's seat and front left passenger seat that were fitted on the Insured Vehicle. These seats, together with the respective airbag that was fitted on these seats, were removed from the Insured Vehicle in my presence.

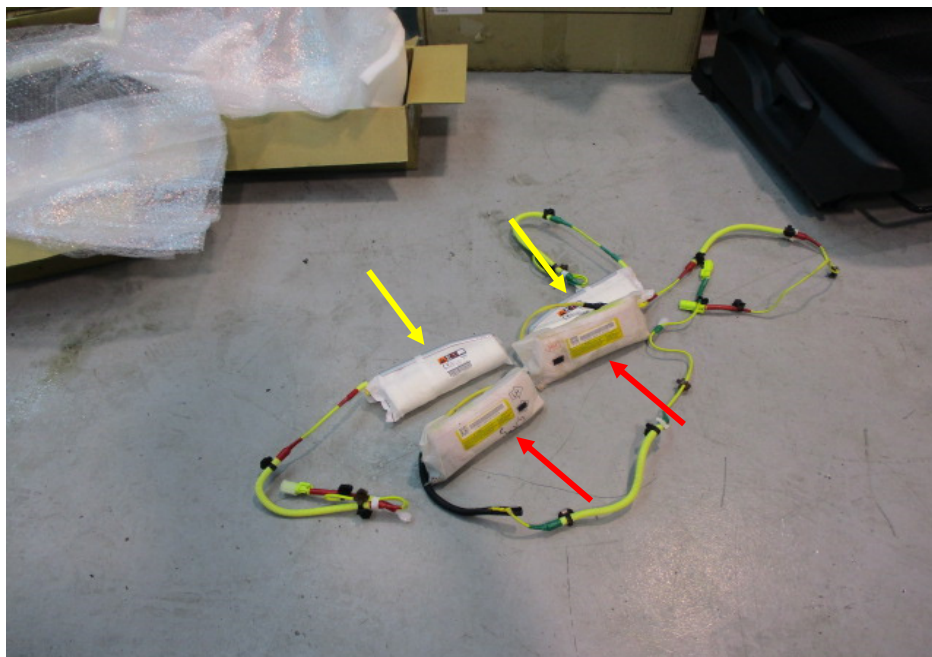
Photo 15 shows the airbags (red arrows) that were fitted for the driver's seat and front left passenger seat of the Insured Vehicle in comparison with a new driver's seat airbag and a new front left passenger seat airbag (yellow arrows).

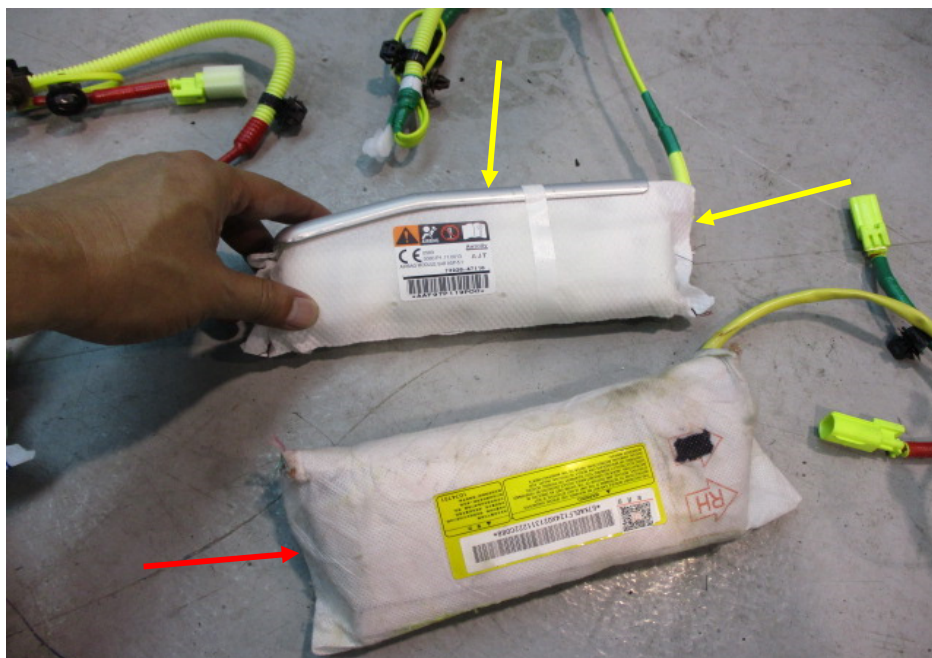
Photo 16 shows a closer view of the comparison between the driver's seat airbag (red arrow) that was fitted on the Insured Vehicle with a new driver's seat airbag (yellow arrow). Notably, the driver's seat airbag fitted on the Insured Vehicle was observed to be in a relatively dirty condition. A bracket (also indicated by the yellow arrow) on the exterior of the new driver's seat airbag was observed to be covered for the driver's seat airbag that was fitted on the Insured Vehicle.

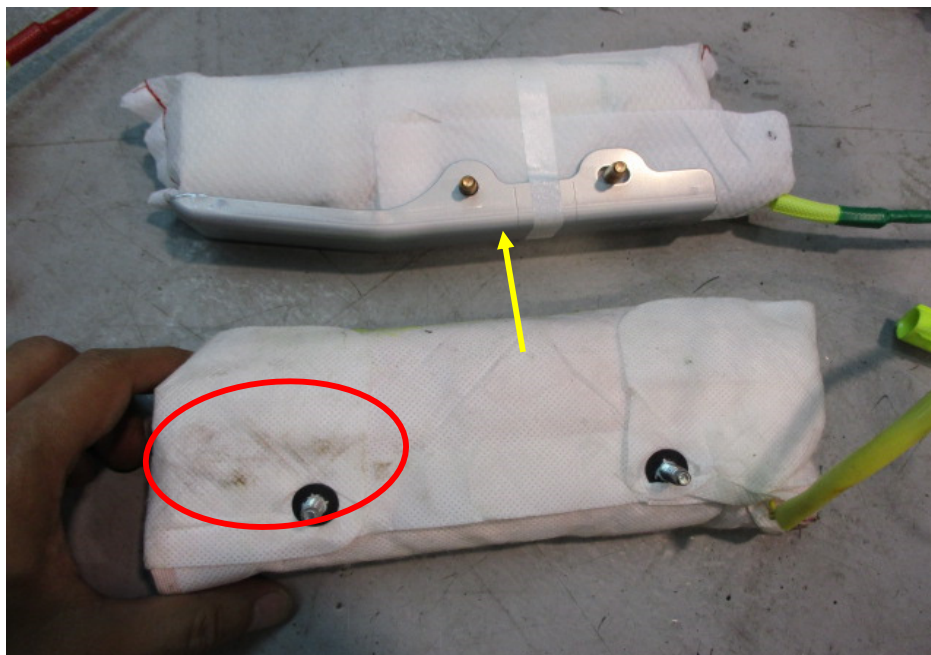
Photo 17 shows the back of the driver's seat airbag that was fitted on the Insured Vehicle in comparison with a new driver's seat airbag. Notably, the driver's seat airbag fitted on the Insured Vehicle was observed to be in a relatively dirty condition (red circle). A bracket (yellow arrow) on the exterior of the new driver's seat airbag was observed to be covered for the driver's seat airbag that was fitted on the Insured Vehicle. The covering of the bracket is an indication that the driver's airbag fitted on the Insured Vehicle was re-folded after activation; and is a re-used airbag.

Part fitted on the Insured Vehicle	Sign(s) / Indication(s)
Driver's airbag	<ol style="list-style-type: none"> 1. Partially torn and relatively worn looking sticker label on the airbag propellant. 2. Airbag propellant of different size. 3. The dirty condition of the airbag and the incomplete sealing of the airbag propellant (refer to LKK's First Report). 4. Manufacturer and importer sticker label not found on the cover of the airbag.
Front left passenger airbag	<ol style="list-style-type: none"> 1. Saw dust like material used to seal the opening of the cover for the airbag. 2. Airbag in a dirty condition and not folded properly into its casing. 3. Sticker label for the airbag propellant different.
Driver's seat Airbag	<ol style="list-style-type: none"> 1. Airbag in a relatively dirty condition. 2. Exterior bracket found to be wrapped and covered by the airbag, indication of re-folding of the airbag.

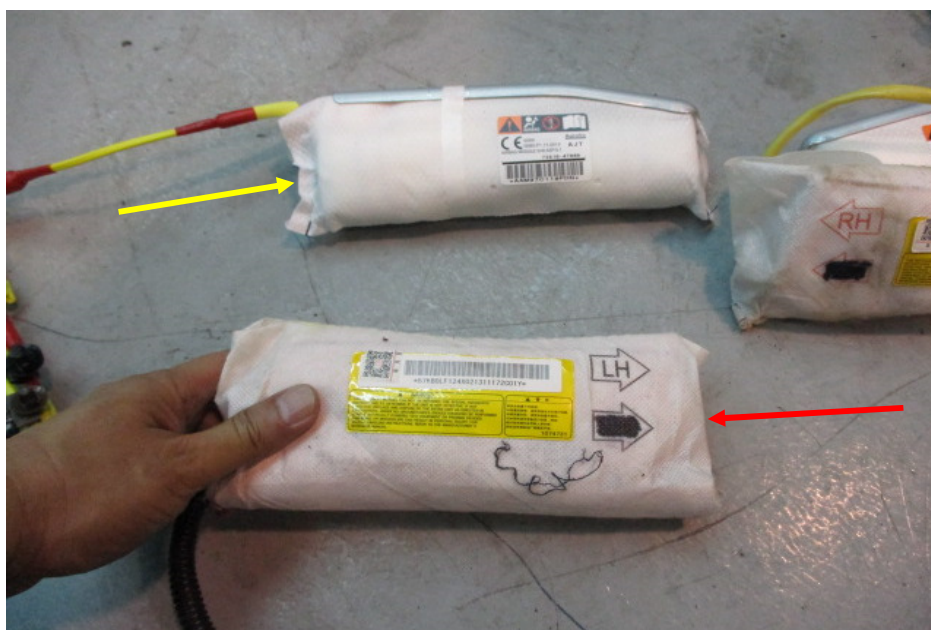
Photo 18 shows a closer view of the comparison between the front left passenger seat airbag (red arrow) that was fitted on the Insured Vehicle with a new front left passenger seat airbag (yellow arrow).

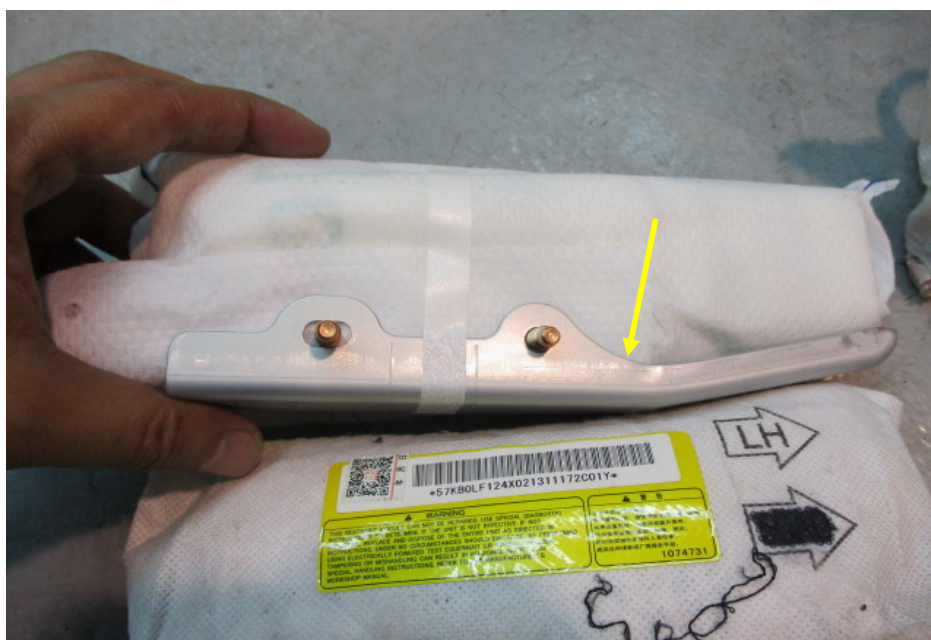
Photo 19 shows a closer view of the comparison between the front left passenger seat airbag that was fitted on the Insured Vehicle with a new front left passenger seat airbag. Like the driver's seat airbag, the bracket (yellow arrow) on the exterior of the new front left passenger seat airbag was found to be covered for the front left passenger airbag that was fitted on the Insured Vehicle. The covering of the bracket is an indication that the front left passenger airbag fitted on the Insured Vehicle was re-folded after activation; and a re-used airbag.

Front left passenger seat airbag	<ol style="list-style-type: none"> 1. Exterior bracket found to be wrapped and covered by the airbag, indication of re-folding of the airbag.

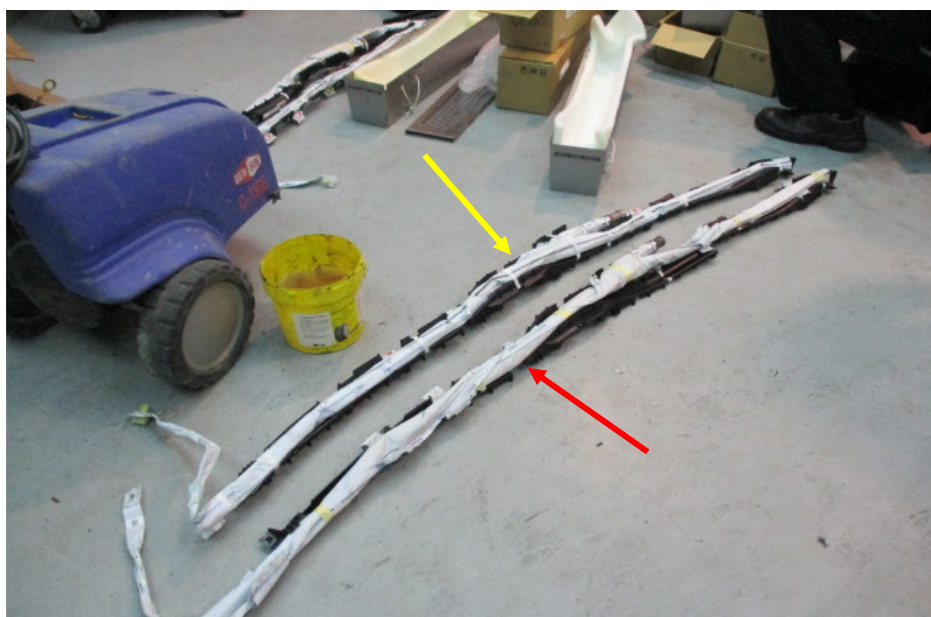
Photo 20 shows the comparison between the right side curtain airbag (red arrow) that was fitted on the Insured Vehicle with a new right side curtain airbag (yellow arrow).

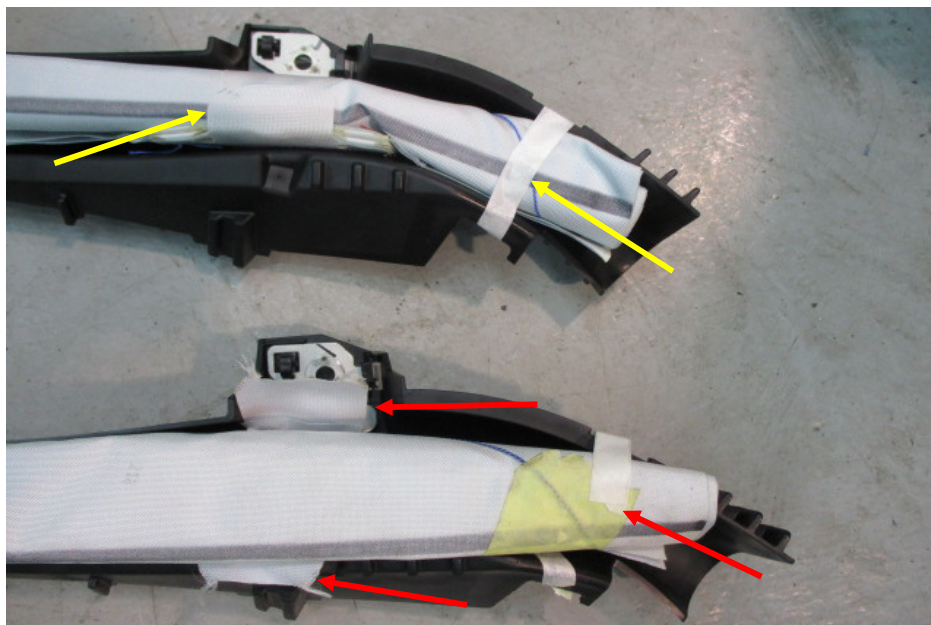
Photo 21 shows the comparison between the right side curtain airbag (red arrow) that was fitted on the Insured Vehicle with a new right side curtain airbag (yellow arrow). Notably, the tape holding the airbag in place for the right side curtain airbag that was fitted on the Insured Vehicle was found to be broken as compared to the tape at the same area for the new right side curtain airbag. This is an indication that the airbag for the Insured Vehicle was re-folded after activation; and a re-used airbag.

Right side curtain airbag	<ol style="list-style-type: none"> 1. Original tape broken and yellow masking tape used to secure the airbag, indication of re-folding of the airbag. 2. Airbag not taped around the back cover.
Left side curtain airbag	<ol style="list-style-type: none"> 1. Original tape broken and yellow masking tape used to secure the airbag, indication of re-folding of the airbag. 2. Airbag not taped around the back cover.
Front Dashboard	<ol style="list-style-type: none"> 1. Re-pasted front surface material onto the frame of the dashboard.

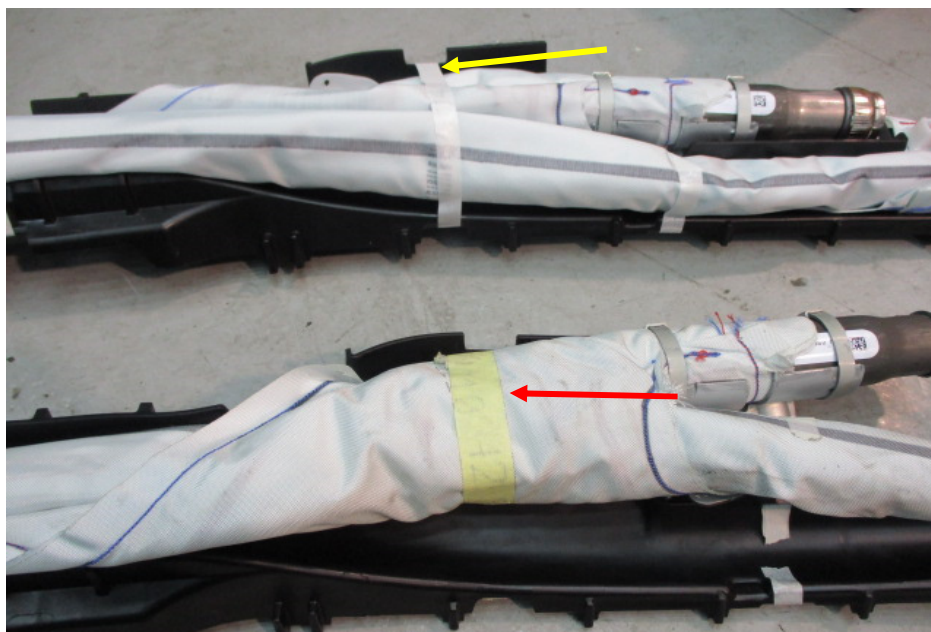
Photo 22 shows another section of the right side curtain airbag that was fitted on the Insured Vehicle in comparison to the same section of a new right side curtain airbag. Yellow masking tape (red arrow) was used to secure the right side curtain airbag for the Insured Vehicle. The right side curtain airbag was also not tape around the back cover (yellow arrow) as compared to the new right side curtain airbag.

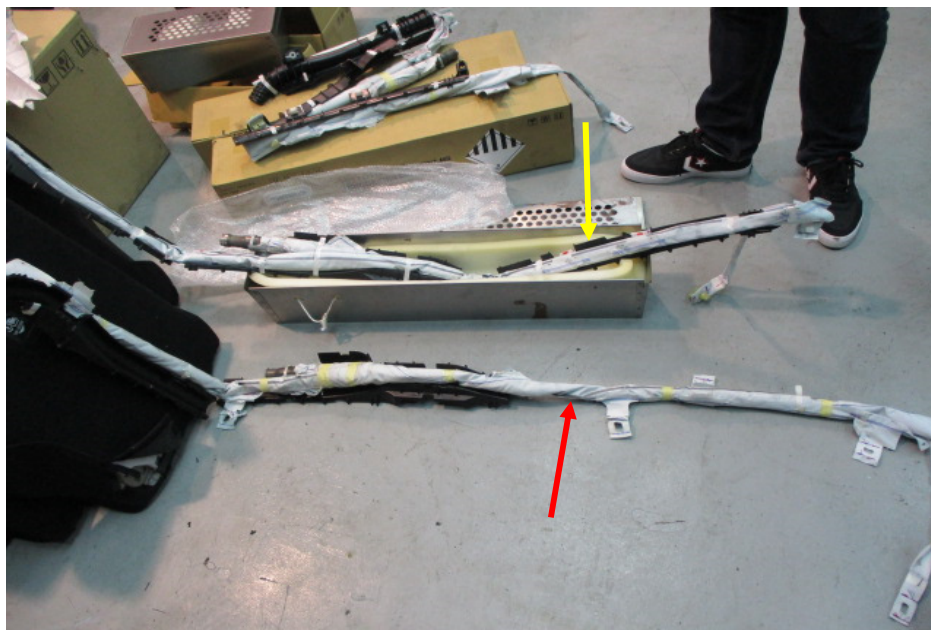
Photo 23 shows the comparison between the left side curtain airbag (red arrow) that was fitted on the Insured Vehicle with new left side curtain airbag (yellow arrow). Generally, the condition of the left side curtain airbag that was fitted on the Insured Vehicle was similar to the condition of the right side curtain airbag that was fitted on the Insured Vehicle. Yellow masking tape was used to secure the left side curtain airbag that was fitted on the Insured Vehicle. The original tape was also observed to be broken.

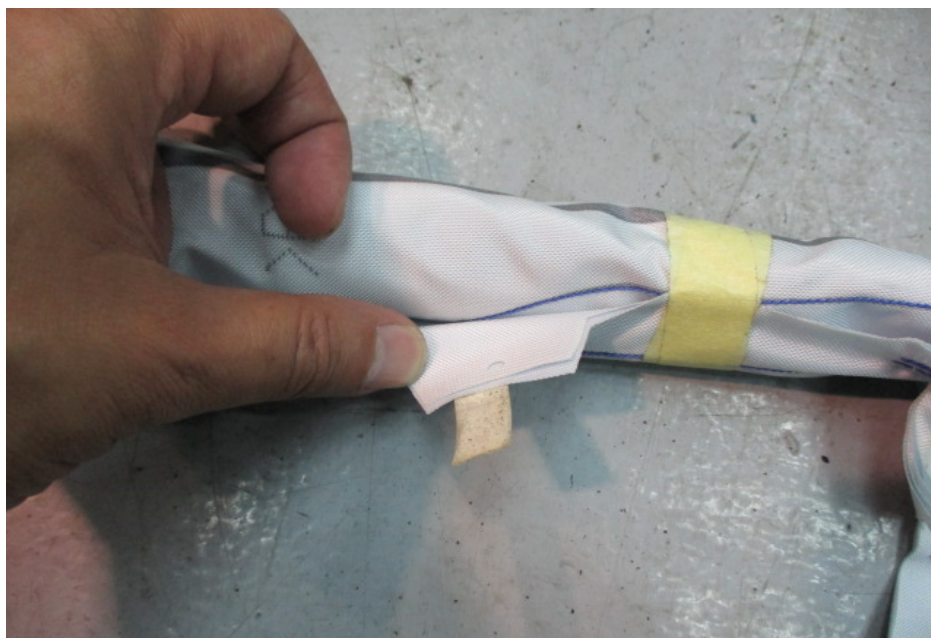
Photo 24 shows a closer view of the yellow masking tape used to secure to the left side curtain airbag that was fitted on the Insured Vehicle. The original tape was also observed to be broken. Again, this is an indication that the left side curtain airbag that was fitted on the Insured Vehicle was re-folded after activation; and a re-used airbag.

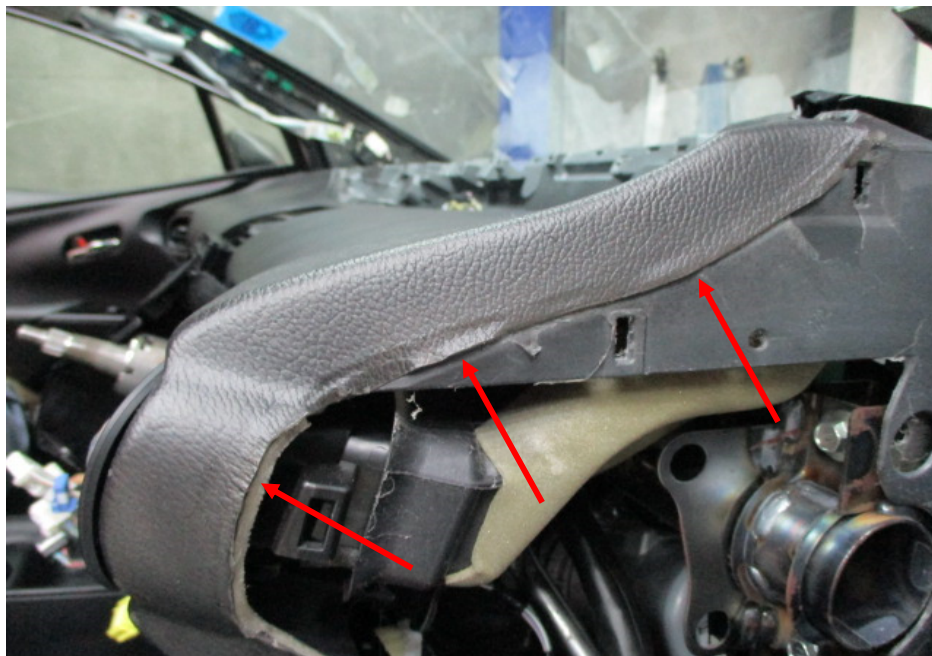
Photo 25 shows the front dashboard that was fitted on the Insured Vehicle. This was at the driver's side of the front dashboard. Signs of re-pasting (arrowed) of the front surface material onto the frame of the front dashboard was observed.

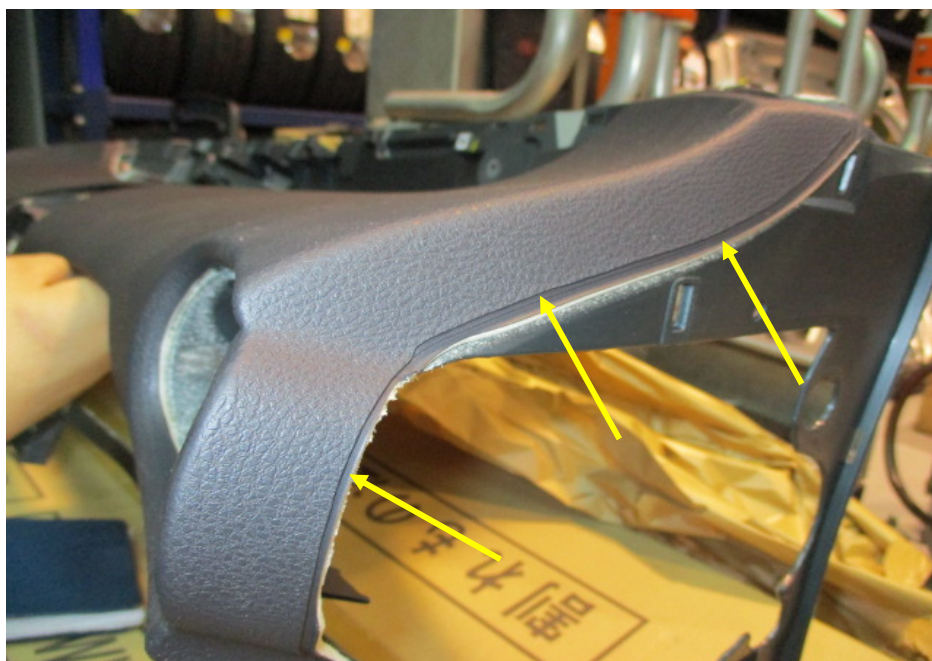
Photo 26 shows a new front dashboard, at the same area as shown in photograph 25 above. In comparison, the front surface material of the new front dashboard was nicely pasted onto the frame of the front dashboard. No peeling off, similar to photograph 25, of the ends of the front surface material were seen on the new front dashboard.
